WATERSHED REHABILITATION IN THE AIRSTRIP CREEK BASIN

REDWOOD NATIONAL PARK WATERSHED REHABILITATION

TECHNICAL REPORT
FEBRUARY 1981

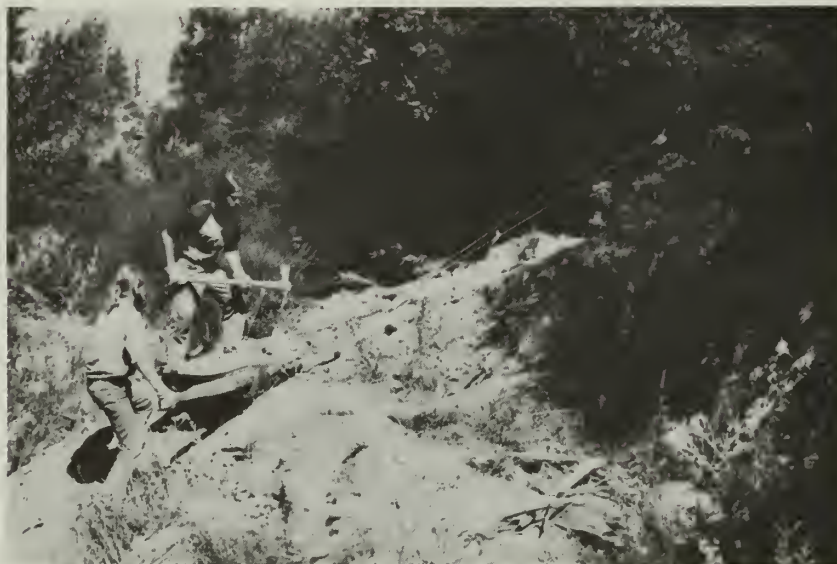
Figure 5

Contractors used a Fresno dragline bucket to drag fill upslope away from an oversteepened streambank adjacent to the East Fork of Airstrip Creek. Site 21. August 23, 1980.

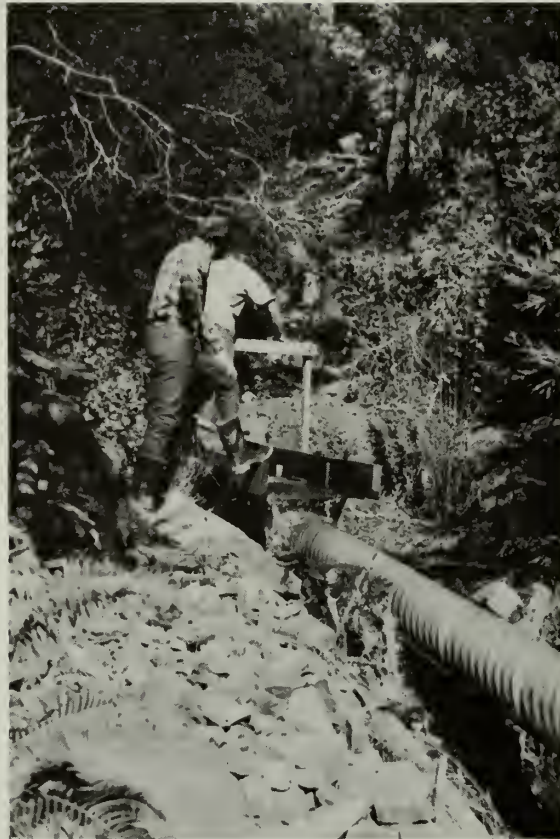
Figure 7

Sediment collection box with adjustable grate that controls volume of water and sediment diverted out of the stream and through the 12-inch culvert to the sediment collection pond. West Fork, Airstrip Creek.

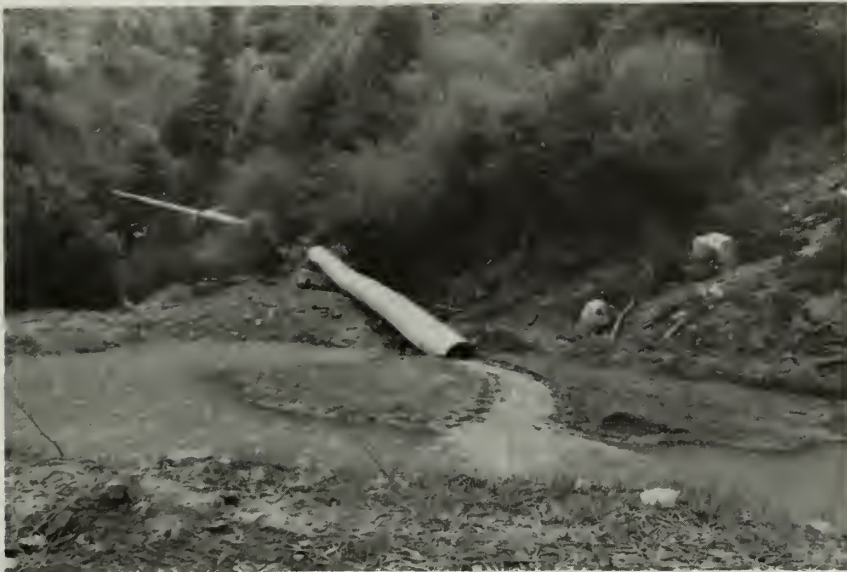
Figure 8

Looking up-basin at sediment collection pond in operation. Note the two 12-inch culverts that join to feed water and sediment into the pond. Note also the alluvial delta at the culvert outlet where coarse sediment accumulates. Part of the winter maintenance program included spreading out the accumulated sediment to prevent choking of the culvert outlet. April 4, 1980.

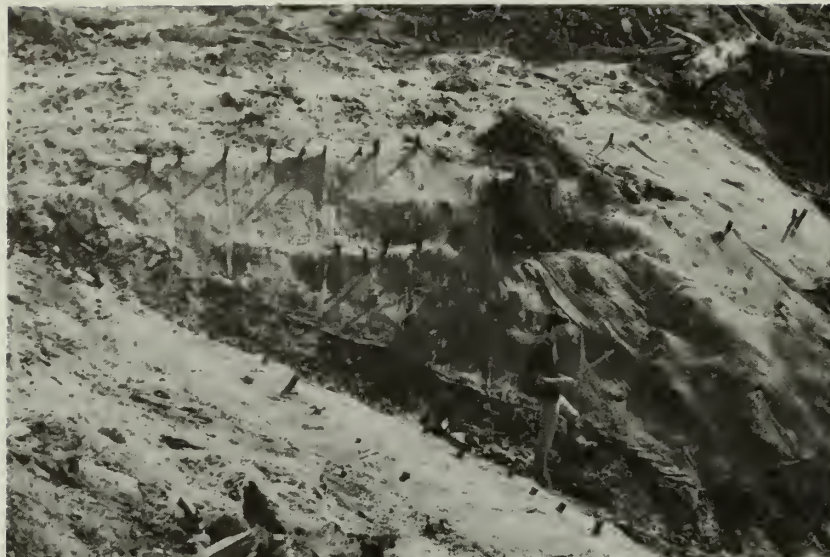
Figure 10

Jute netting stapled down on sideslopes adjacent to excavated stream crossings. The netting was laid on top of ground that had been seeded with grass and mulched with straw. The horizontal wood stakes on the contour hold wattles in place on the slope. Site 19. October 16, 1979.

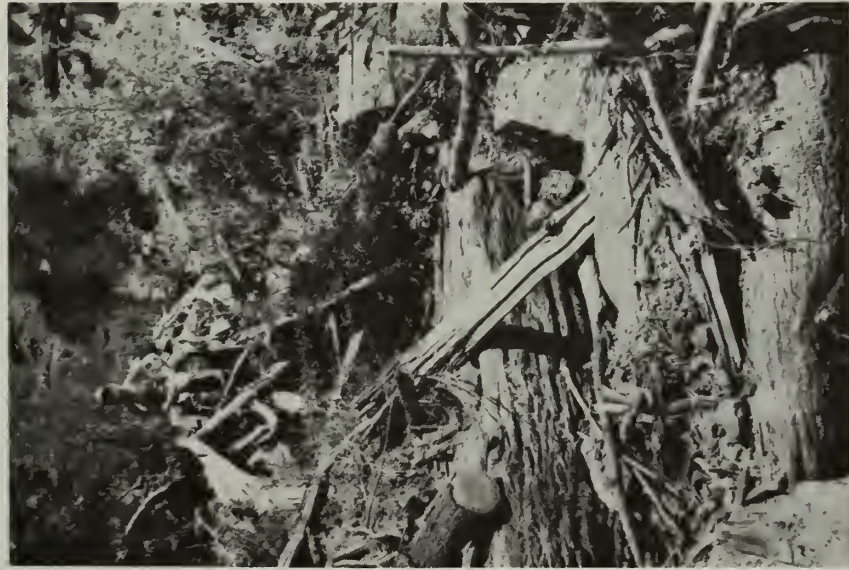
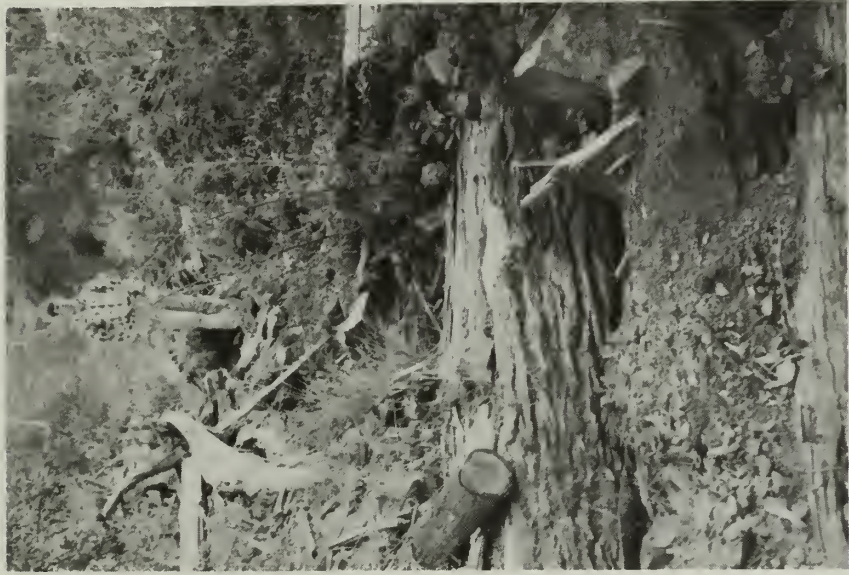
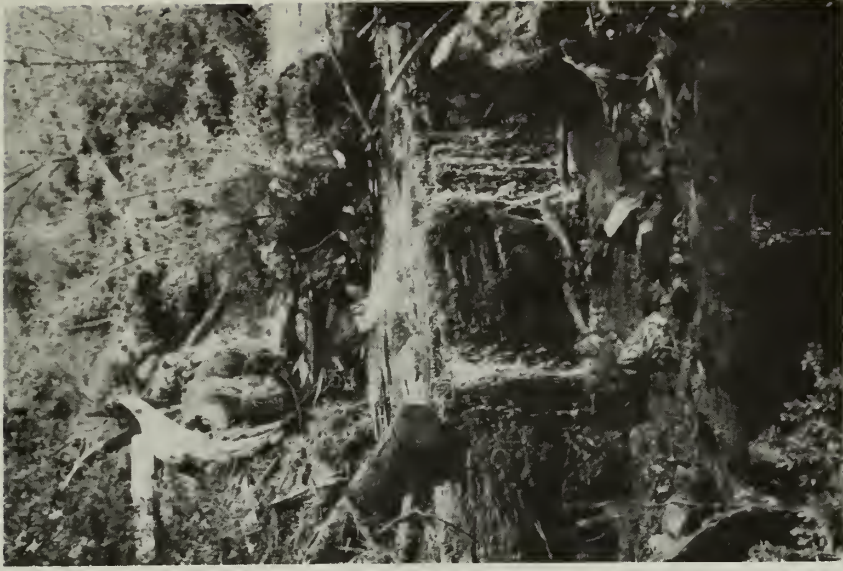
FIGURE 12

- A. August 14, 1979: Pre-stream clearance.
- B. October 16, 1979: After stream clearance before winter rainy season, loose sediment formerly trapped behind organic debris is now ready for immediate downstream transport.
- C. May 6, 1980: After 1979 - 1980 winter rainy season, all the finer-grained, loose sediment in the foreground of Photo B is now gone.

After the early winter storms, stream channels contained the same amount and type of small, loose organic debris that was in the channel prior to removal. There appears to be a continual contribution of this small debris and its removal produces only a temporary change. Removal of small debris is not necessary and it may be advantageous to leave this type of debris which tends to form small, natural check dams that help control downcutting.

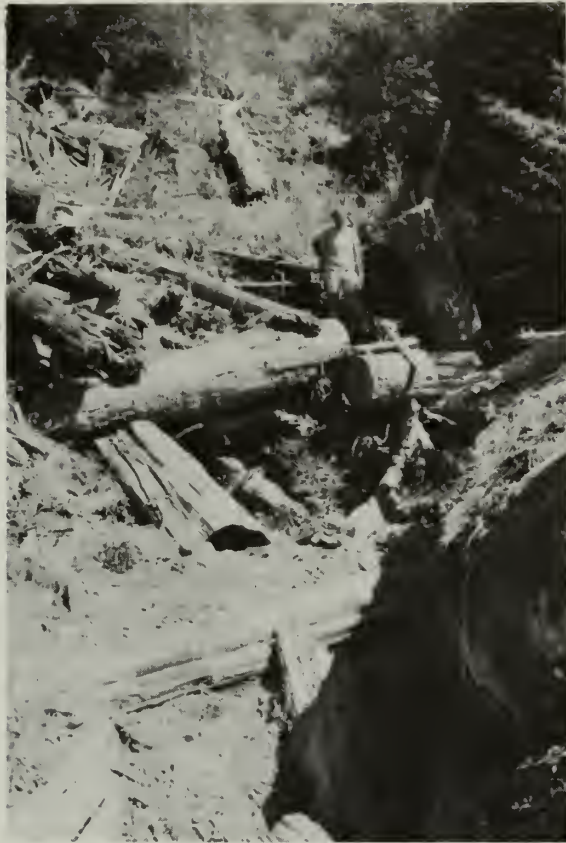
FIGURE 13

Photo showing work in progress on the removal of logs not buried by sediment in a medium-sized log jam above Site 22. September, 1979.

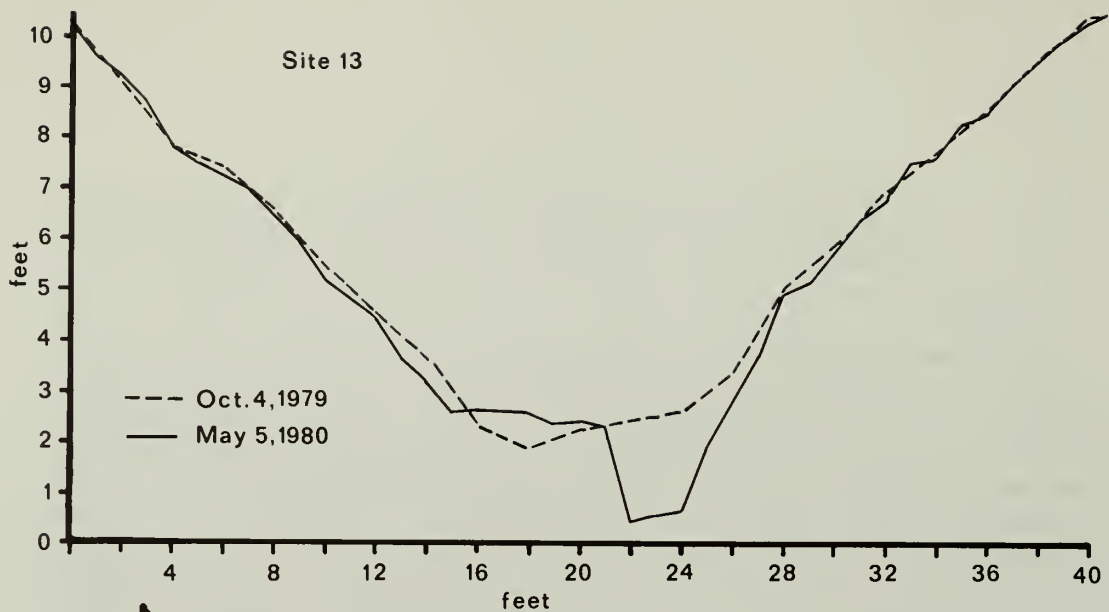
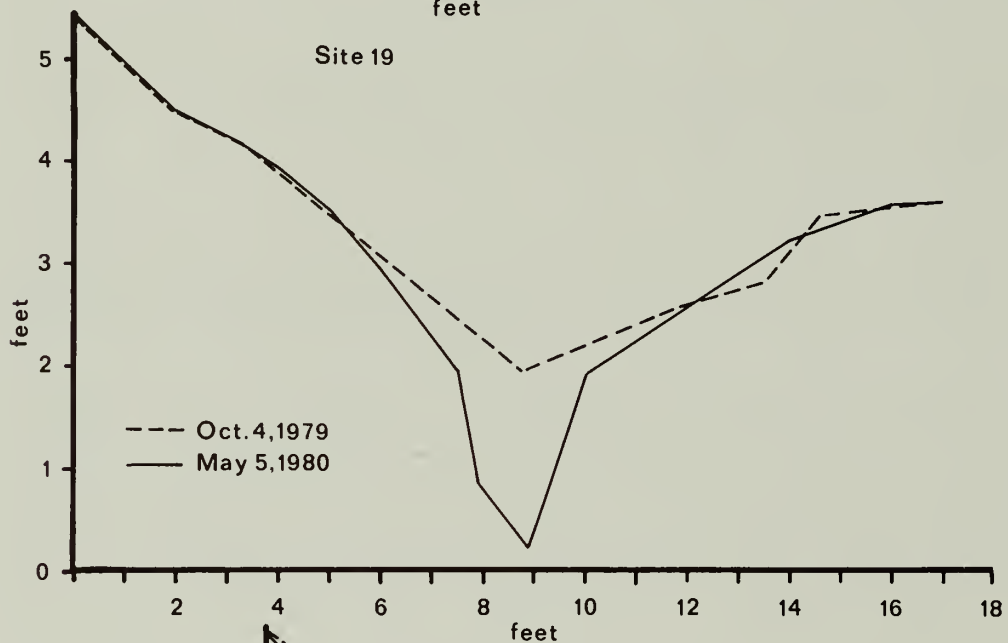
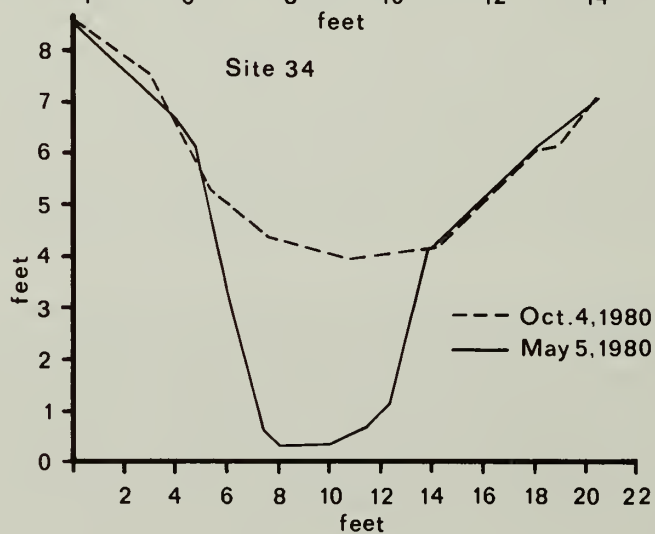
FIGURE 14

Downcutting after the onset of winter flows occurred in all channels. Figure 14 shows the extent of channel downcutting at representative cross sections of three excavation sites. The majority of downcutting occurred during the first three major storms (October 19, 1979 to November 30, 1979). During the remainder of the winter, downcutting decreased despite equally large storms later in the season. Although all the excavated channels except the uppermost (Site 34) and lowermost (Site 13) were hand rocked to prevent downcutting, the rock was too small (five to ten inches in size) and was transported downstream during storm events (Figures 15 and 16, Sites 29 and 30). At Site 17, near a quarry, the contractor carried large rocks to the site (sizes ranged from six inches to thirty inches; average size was twelve inches). These larger rocks effectively prevented downcutting only after they were moved by high streamflows and redeposited in a more stable channel bed configuration that developed following downcutting (Figure 17). Large rock placed in the channel did not prevent downcutting in cases where the channel excavation was not deep enough, the rock was not properly placed, and the rock cover did not completely blanket the channel bed.

Surveyed channel cross sections at three sites of heavy equipment excavation of fill from stream crossings showing the amount of channel downcutting during the 1979-1980 winter season. The profiles are exaggerated vertically two times.

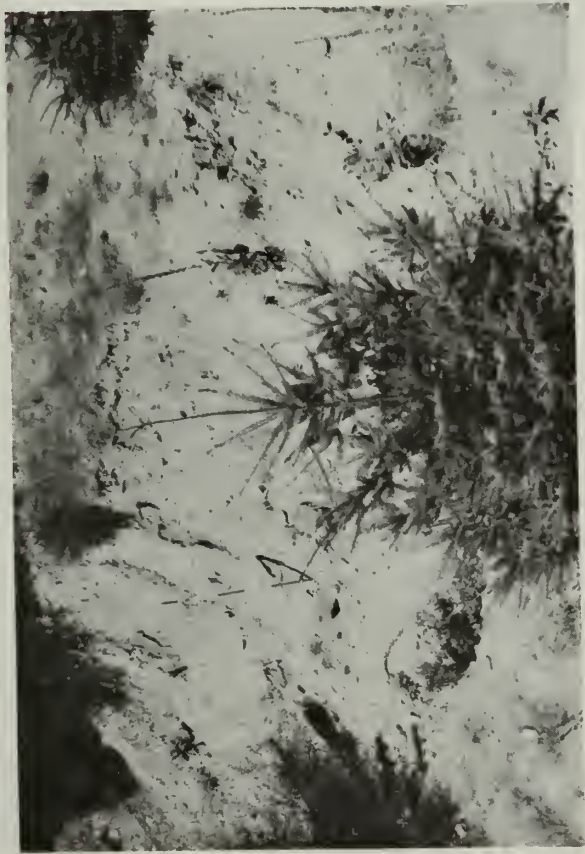
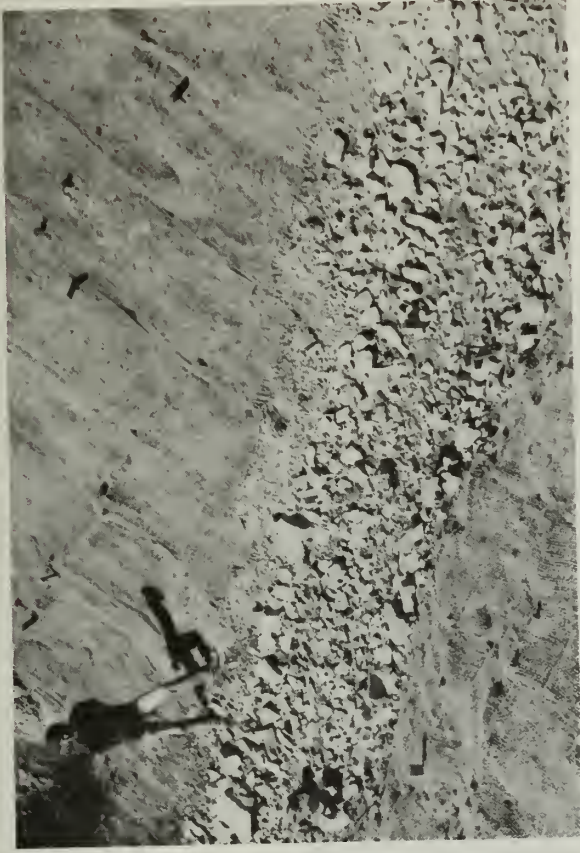
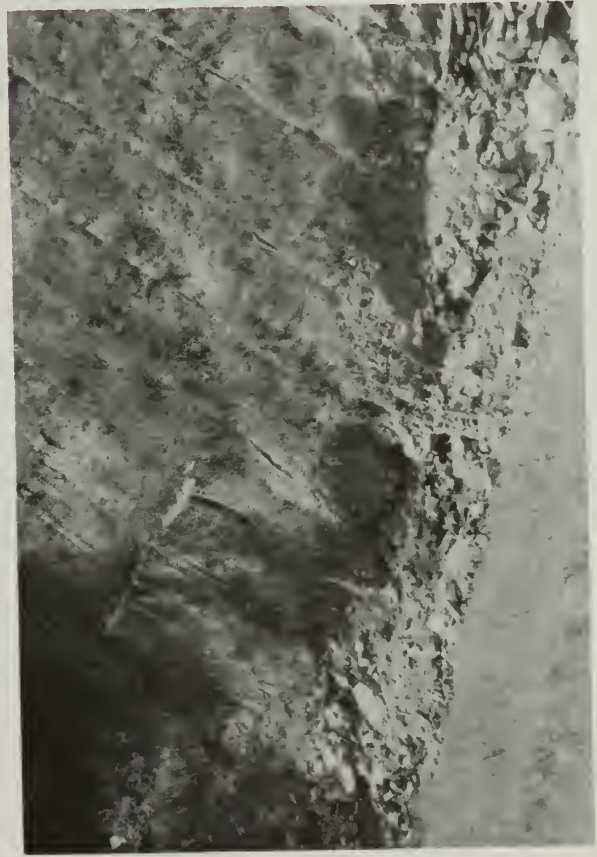
FIGURE 15

FIGURE 15B - October 16, 1979 - After backhoe work, hand-placement of rock in the channel and seeding, mulching and installation of jute, but before winter rains.

FIGURE 15C - May 6, 1980 - After winter rainy season, showing that hand-placed rock has been carried downstream and channel banks are undercut.

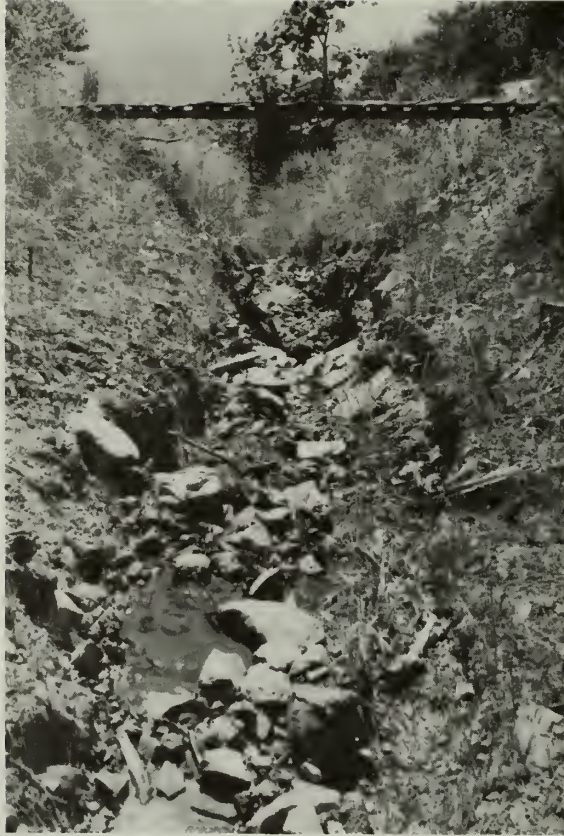
FIGURE 16

The excavated channel had been blanketed with a layer of hand-placed, four inch to ten inch rock prior to the 1980 winter rainy season. Winter storm flows were capable of transporting all the hand-placed rock. More than two feet of downcutting took place before a stable channel configuration became established. Site 30. July 25, 1980.

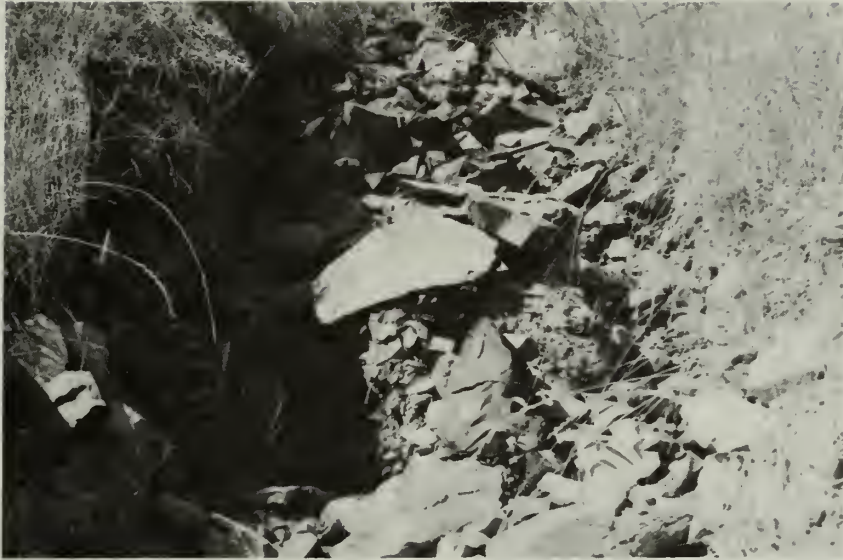
FIGURE 17

Despite the size of these hand placed rocks in the channel at Site 17 (note the small backpack for scale), approximately two feet of downcutting occurred due to incomplete excavation of the channel. Another cause of downcutting may be that the rock blanket did not totally cover the streambed.

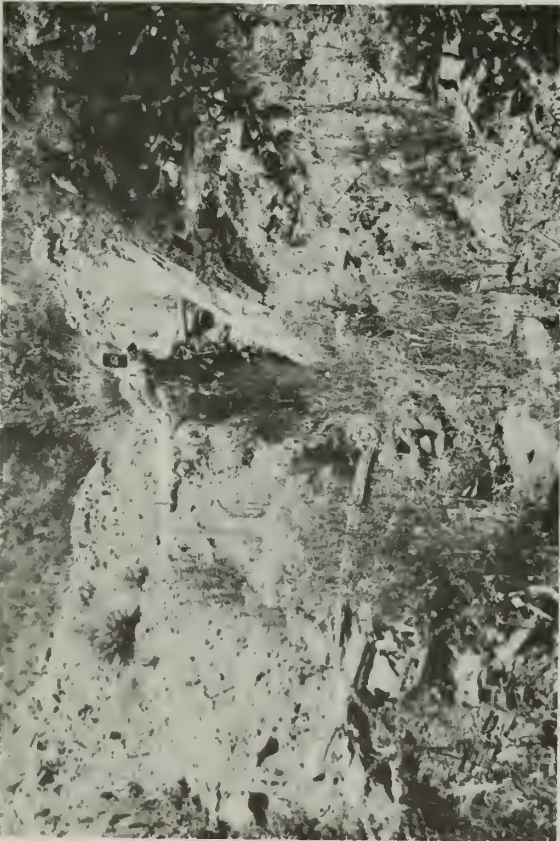
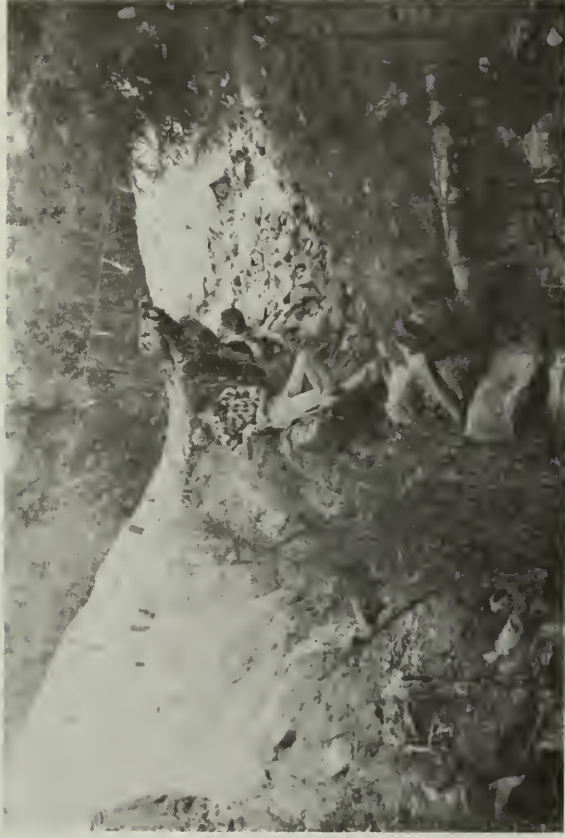
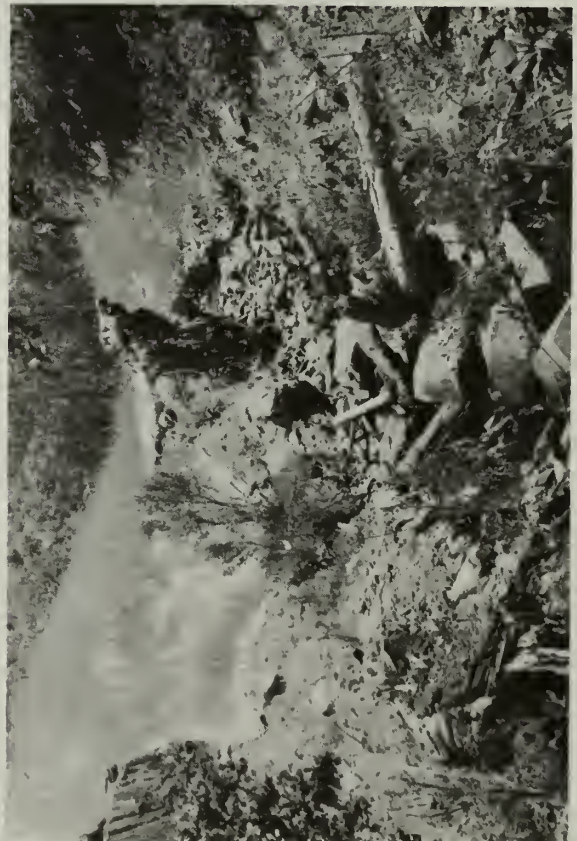
FIGURE 18

FIGURE 18B - October 16, 1979 - Channel and sideslopes after backhoe and hand labor rehabilitation work was finished but before winter rains. Note the distinctive break-in-slope of the channel gradient just upstream of the man.

FIGURE 18C - May 6, 1980 - After the winter rainy period, obvious downcutting in the channel above the protruding stump on the right bank of the channel occurred.

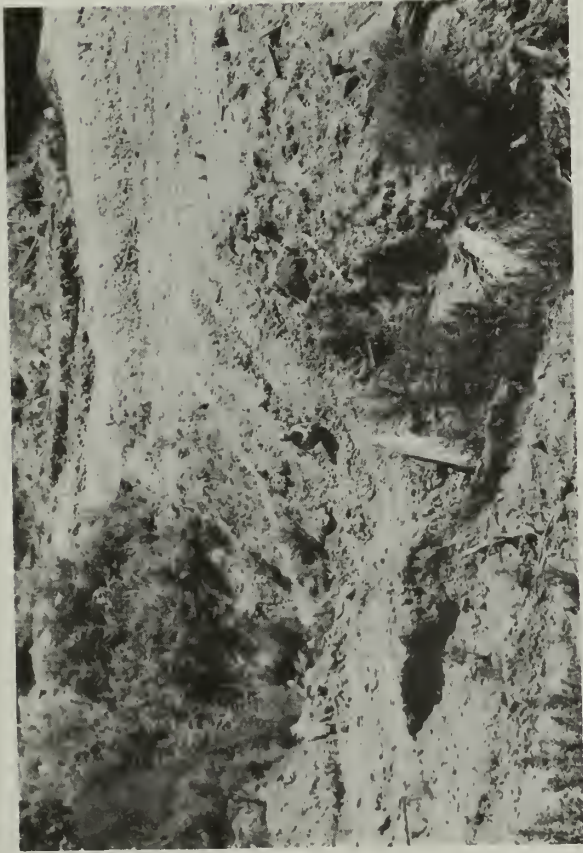
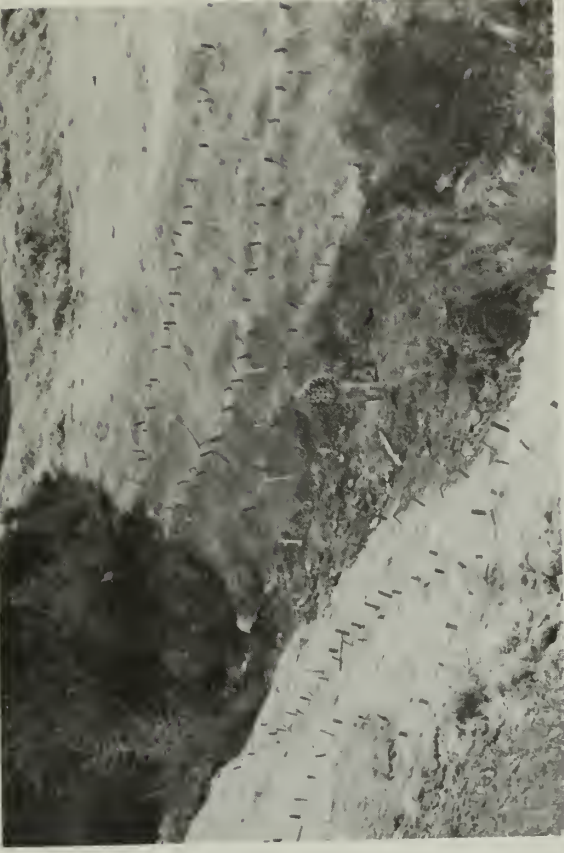
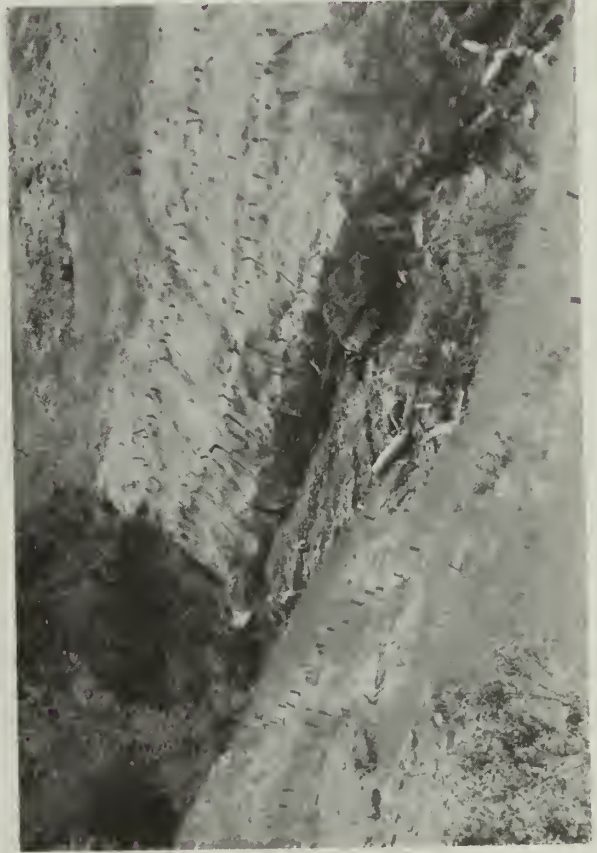
FIGURE 19

In all cases, the greatest downcutting occurred at the downstream end of the excavated channel where the backhoe left a break-in-slope between the excavated channel and the undisturbed channel below. Downcutting was most pronounced where the excavated channel profile was distinctly convex at this slope break (Figure 18, Site 17). At two sites (Sites 13 and 30), where downcutting at the break-in-slope would otherwise have been severe, large chunks of organic debris formed a stable step in the channel that prevented erosion at the slope break. Organic debris also prevented plunge pool erosion below the step. Even a channel bed with negligible rocking (Site 13) did not significantly downcut where there was a stable organic debris step at the lower end of the excavated channel (Figure 19, Site 13).

FIGURE 19C - May 6, 1980 - Condition of the channel after the winter rainy season.

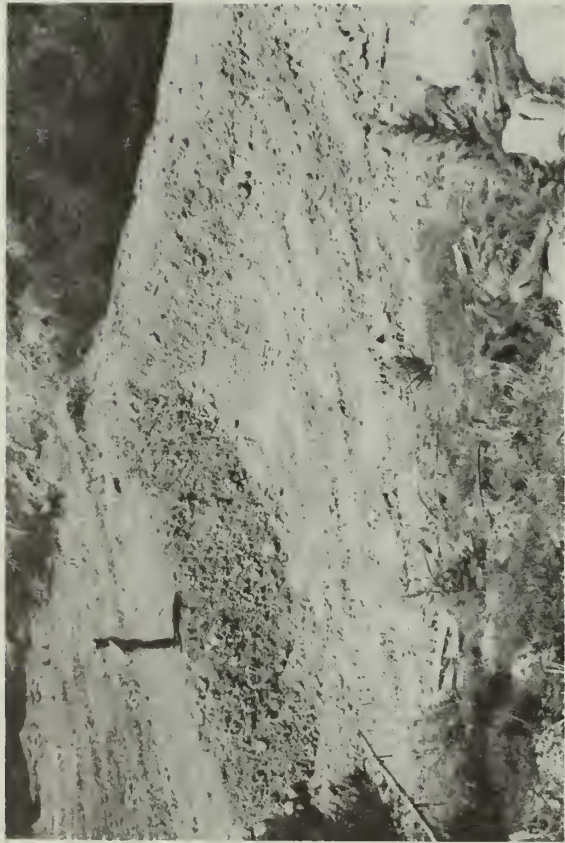
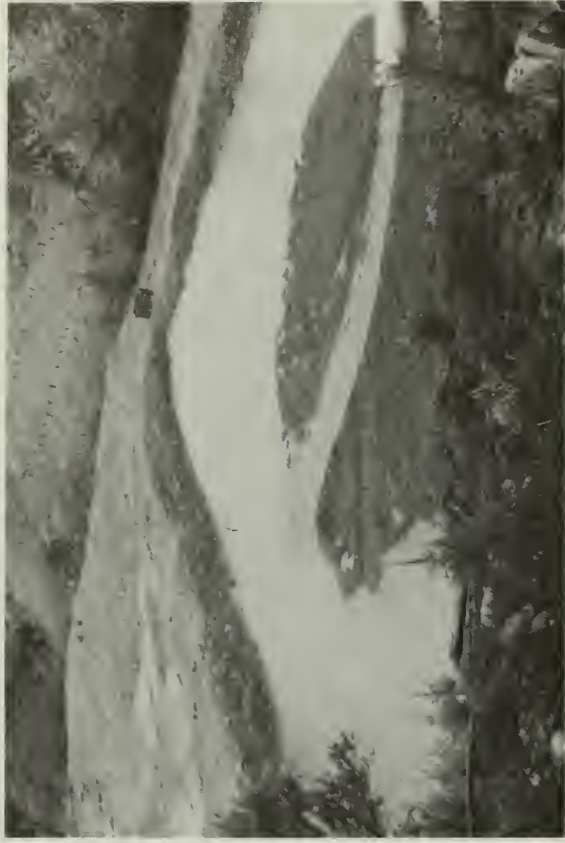
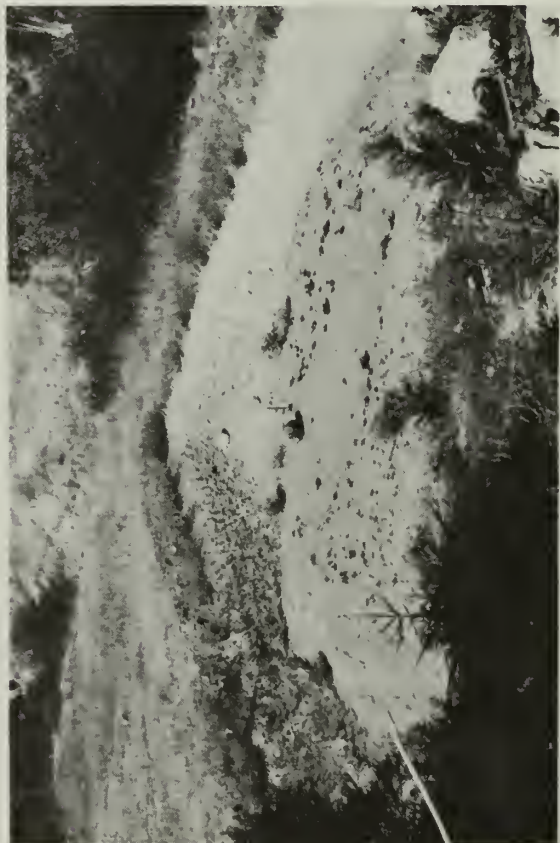
Three sequential photos showing the sediment collection pond on a log landing of the D-Line Road adjacent to Site 13:
