ANSLEY WILCOX HOUSE

HISTORIC STRUCTURE REPORT

Theodore Roosevelt Inaugural
National Historic Site
Buffalo, New York

October 2006

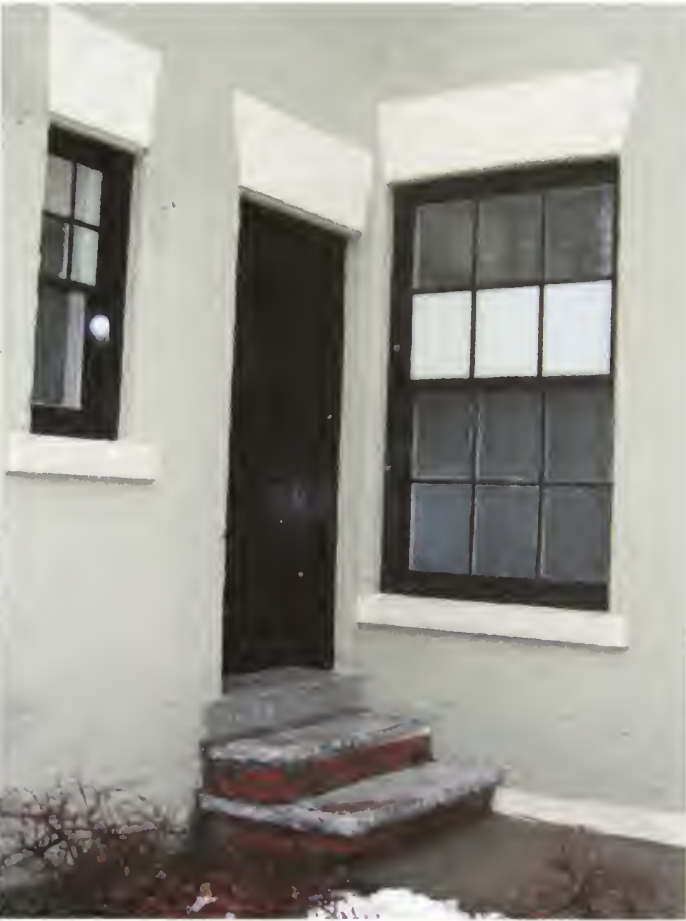
Figure 2.9. North elevation, ca.- 1971 glazing and missing basement window.

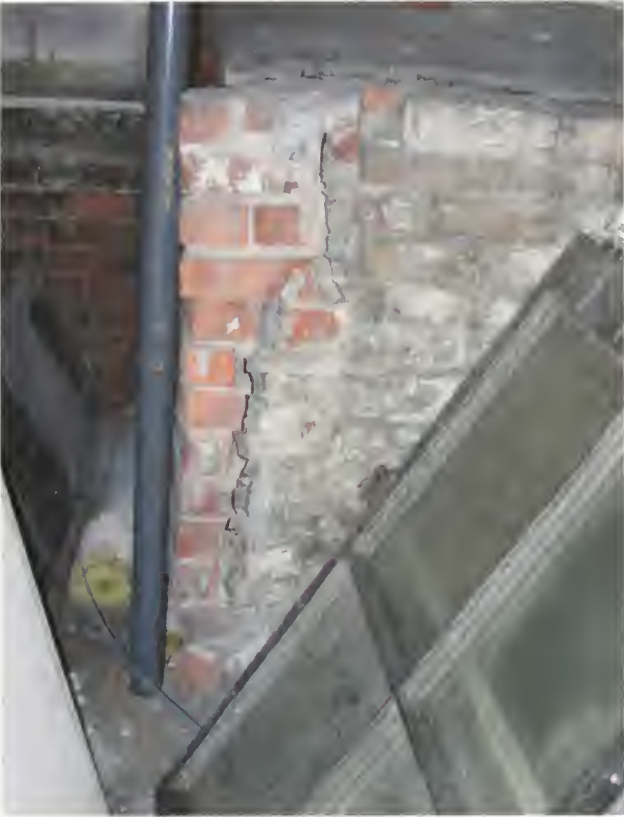
Figure 2.18. Room 001, southeast corner, damaged south retaining wall.

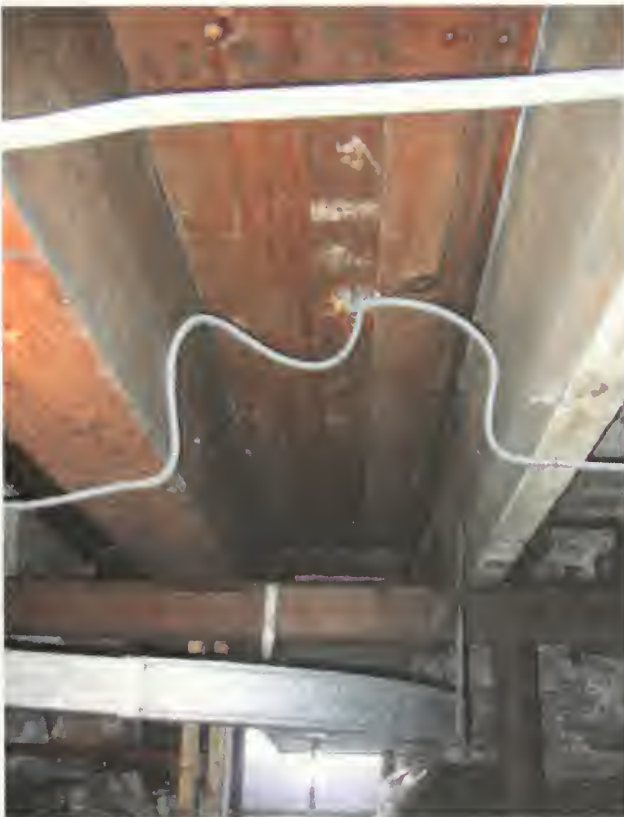
Figure 2.19. Room 001, ceiling duct remnant.

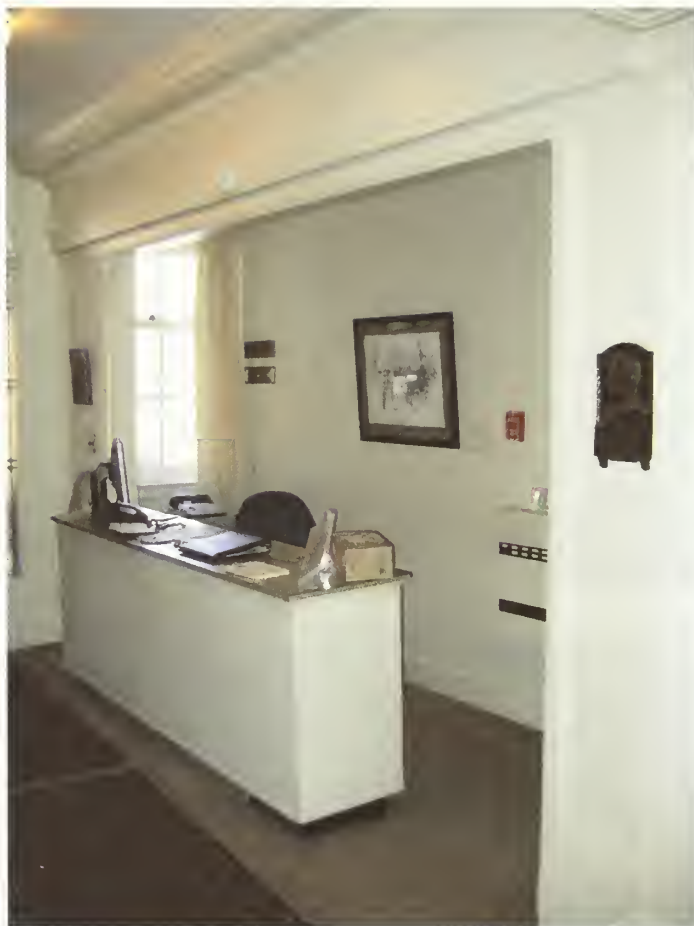
Figure 2.38 Room 106 (Side Hall), former location of missing east wall.

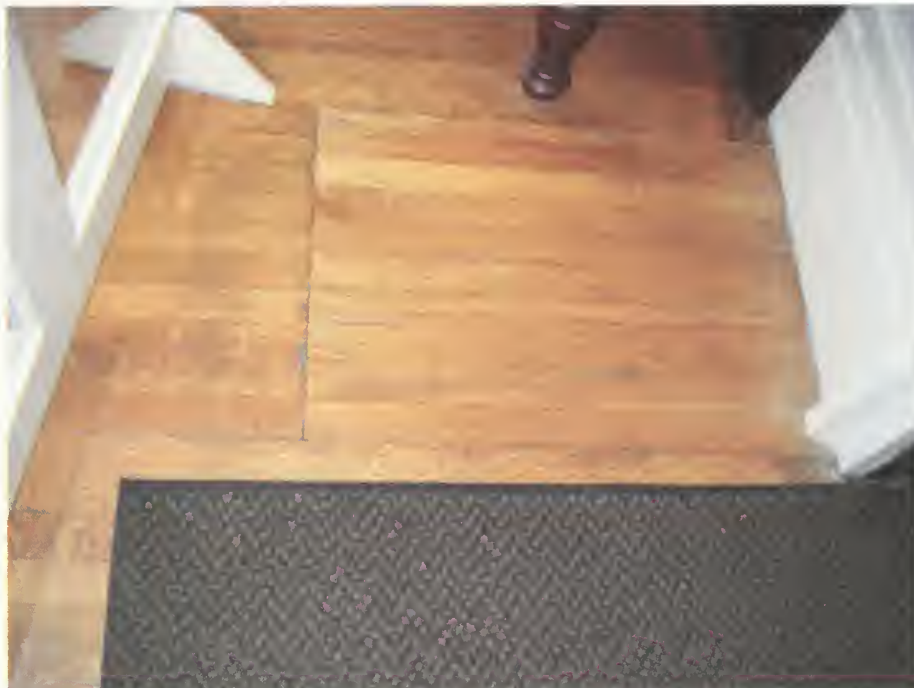
Figure 2.43. Room 108 (Dining Room), former location of missing floor register.

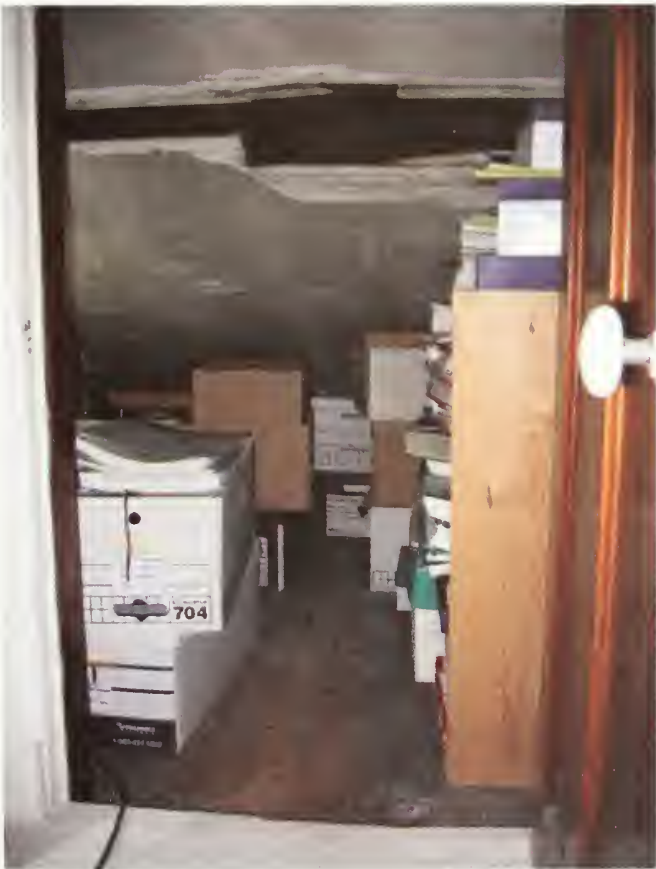
Figure 2.79. Room 305a,
deteriorated plaster ceiling.
