WEST INDIA GOODS STORE

Salem Maritime
National Historic Site

Historic Structure Report

HISTORIC STRUCTURE REPORT Architectural Data

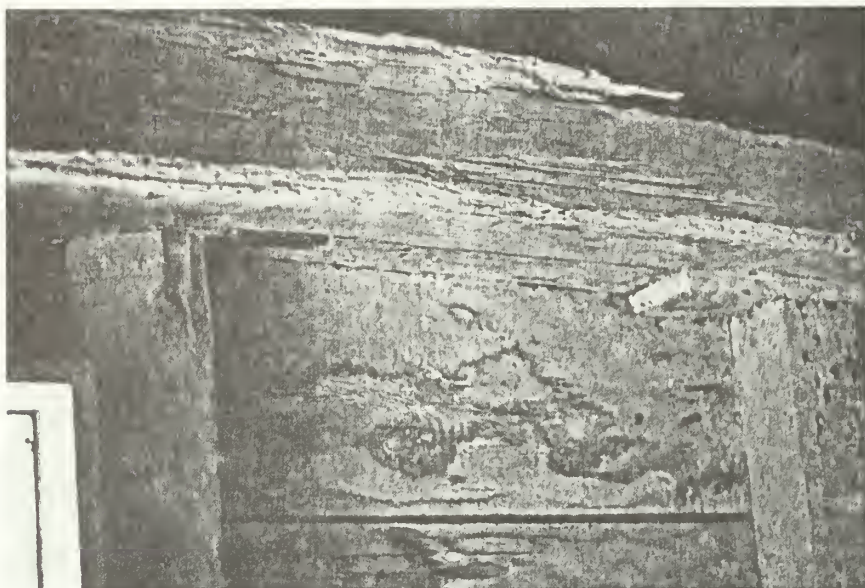
Figure 42. West India Goods Store, interior of second story, south wall, showing girt with vacant stud pocket and two studs in nonhistoric positions. The stud on the right is in the approximate center of the south wall.

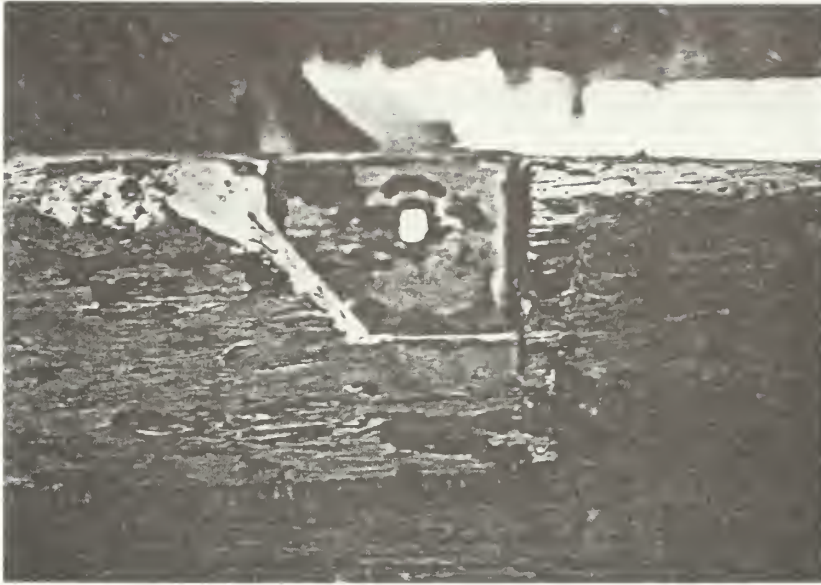
Figure 52. West India Goods Store, interior of second story, west wall looking north, post between bays A and B, showing cut made to accept possible partition framing.

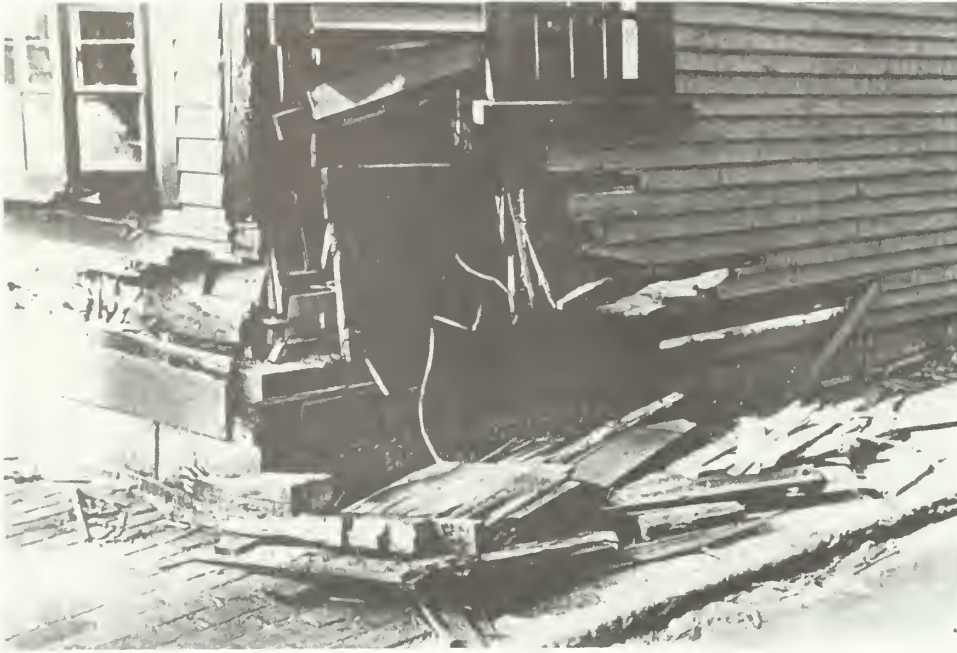
Damage at southeast corner, WIGS, November 1983.

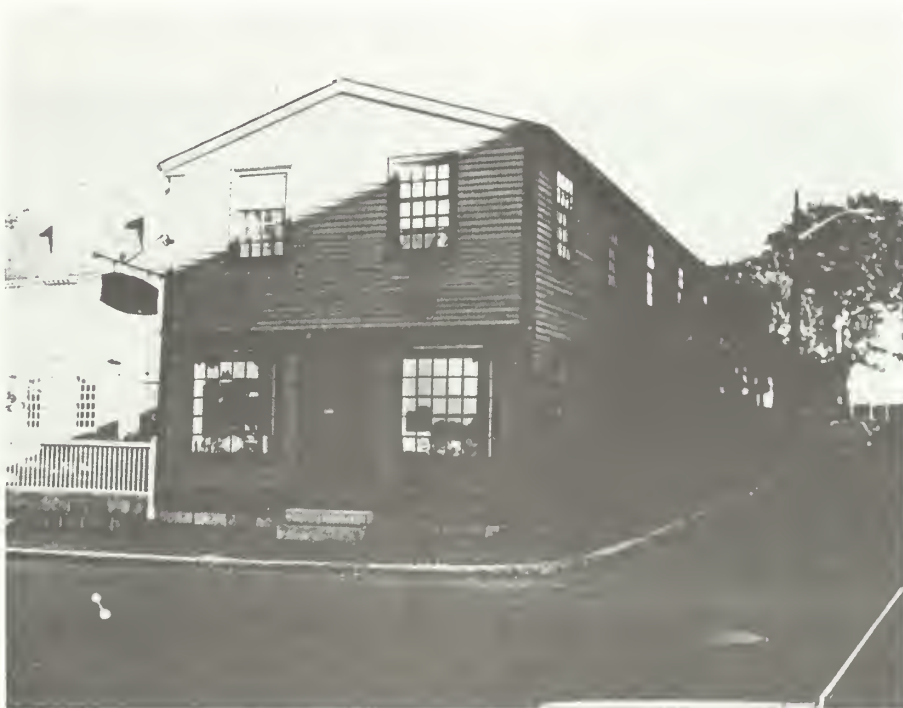
WIGS building after repair and painting work was completed by NPS personnel in 1983-84.

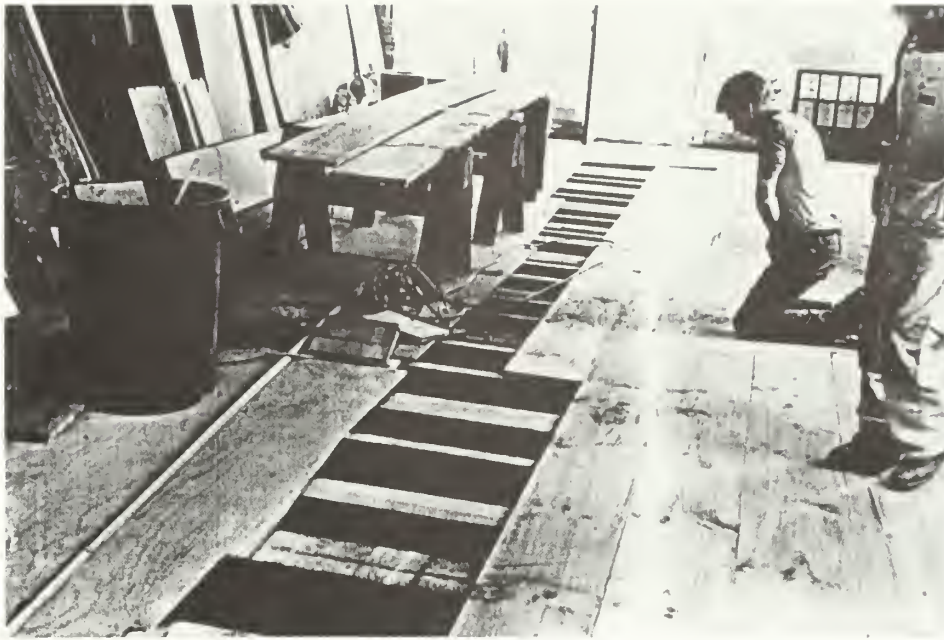
Floor joists, both old and new, and new subflooring were pressure treated with CCA before installation began. View looking south on the first floor of WIGS.

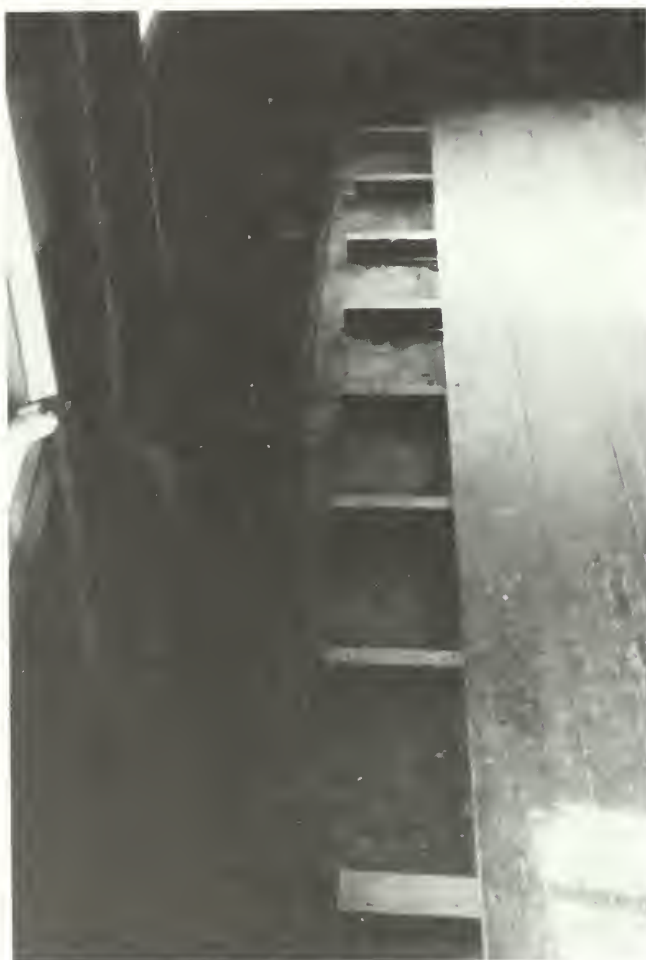
Investigatory work at southwest corner of the WIGS, showing original corner bracing and floor joist of second floor frame. A new floor of undetermined age was laid over the original floor.
