## Historic Structure Report

The Mumma Barn

# ANTIETAM

April 2000

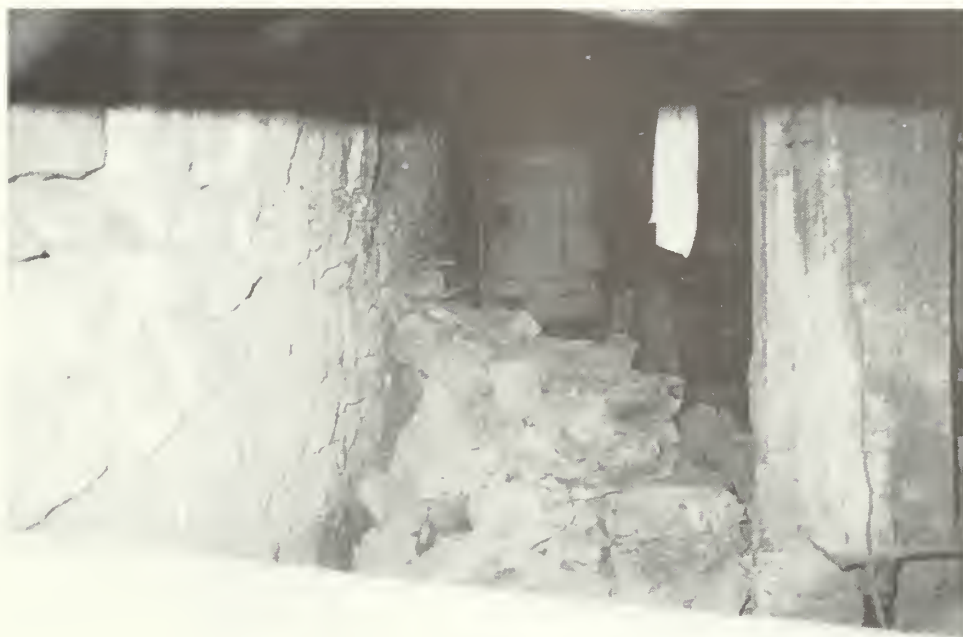
Figure 95: One of two temporary jacks and posts carrying the load of the structure above the northwest foundation wall.

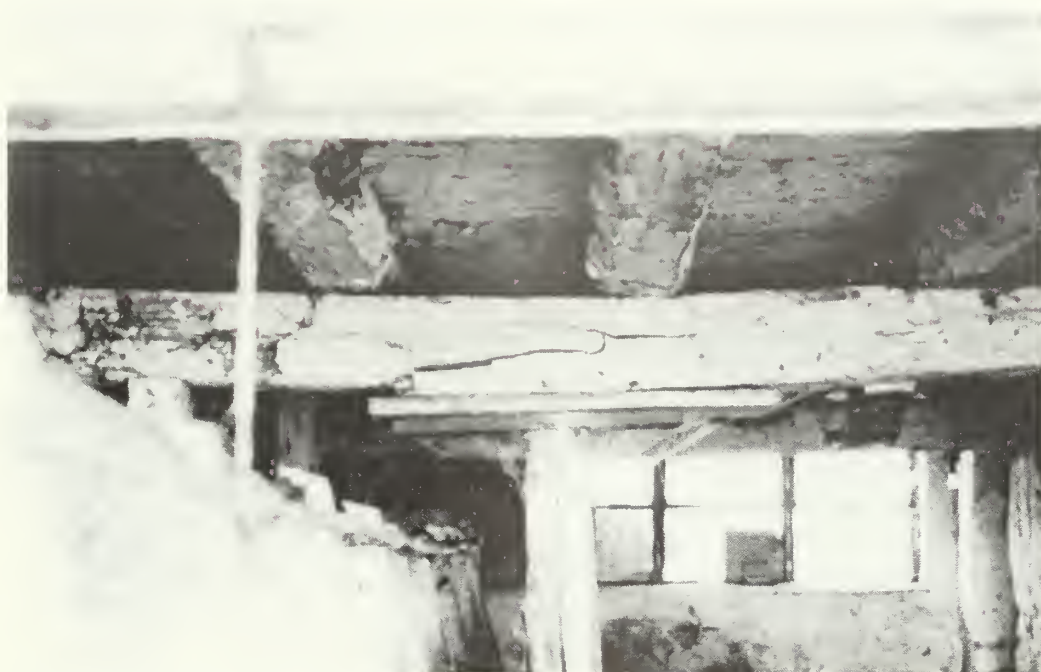
Figure 107: Deteriorated section of post (shown in figure 105) removed. Note both insect and moisture damage

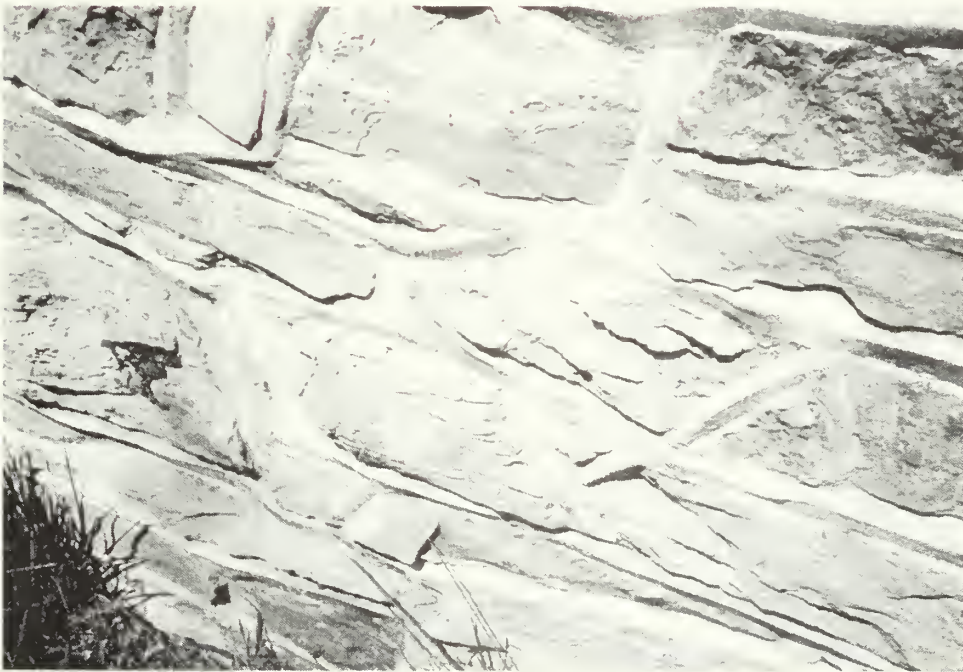
Figure 115: Red color of limestone caused by excessive heat.

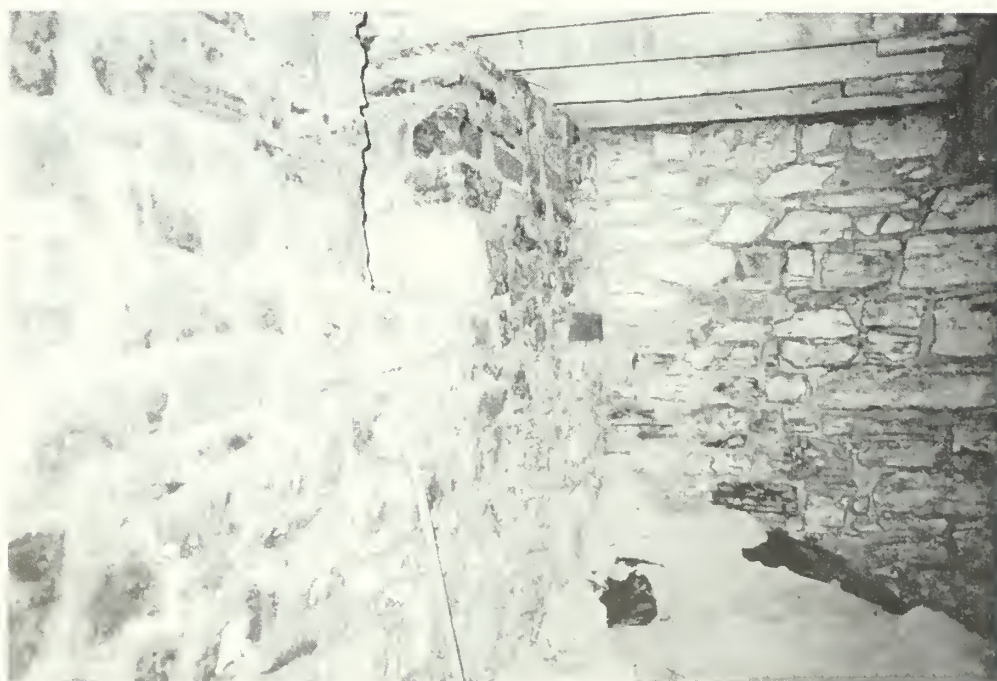
Figure 117: Western corner of foundation in 1992 prior to repointing.

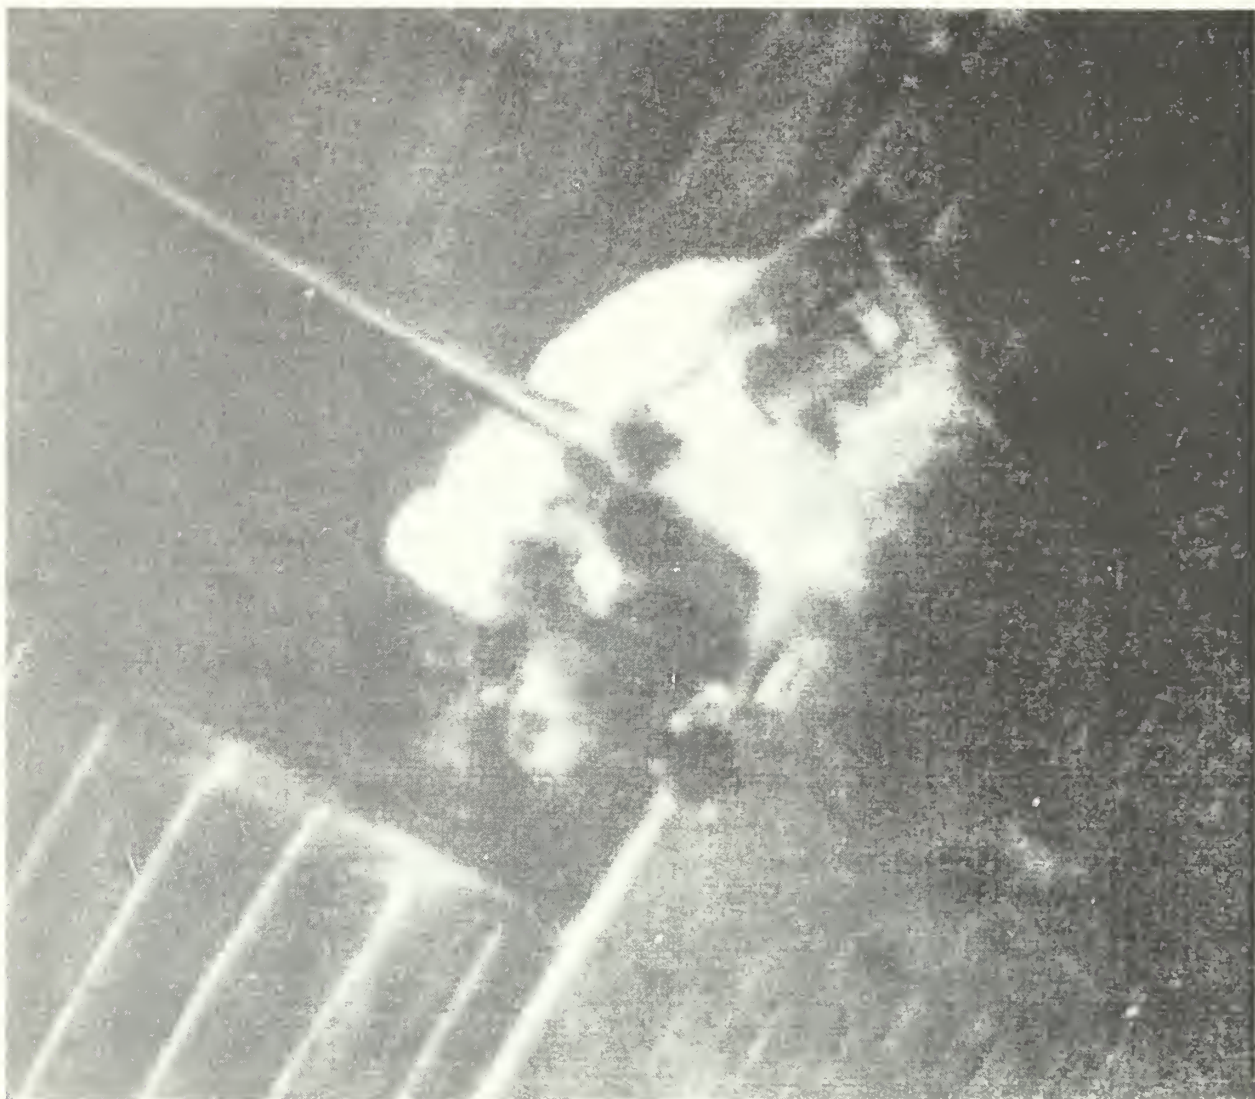
Figure 120: Area along the southeast elevation in need of repair.

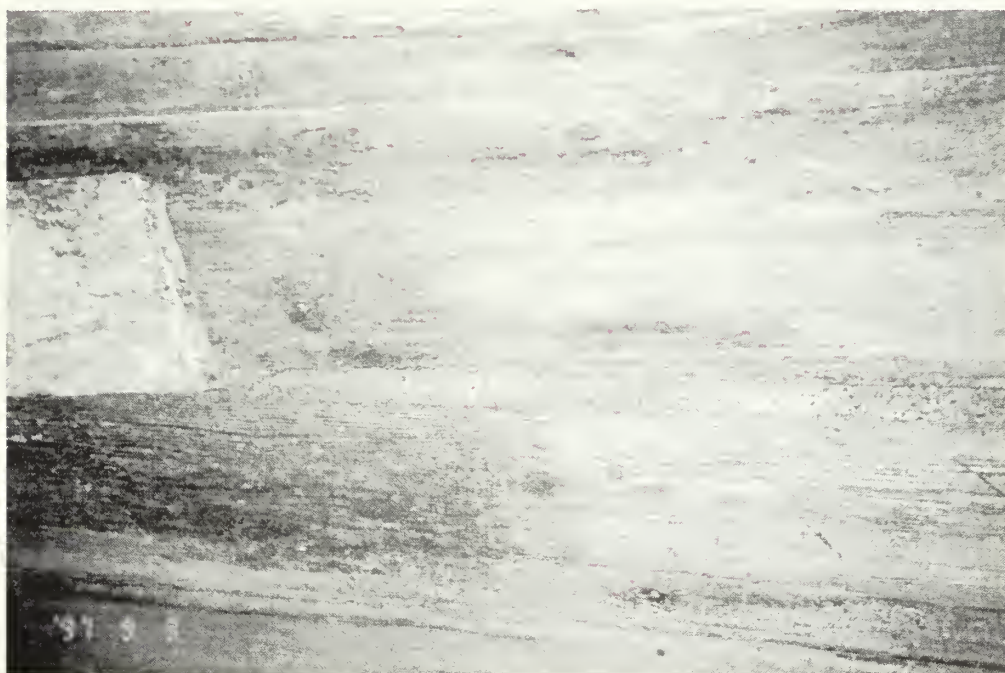
Figure 147: Original, wood threshing floor. Nonoriginal, galvanized patch covers a hole to the grain chute.

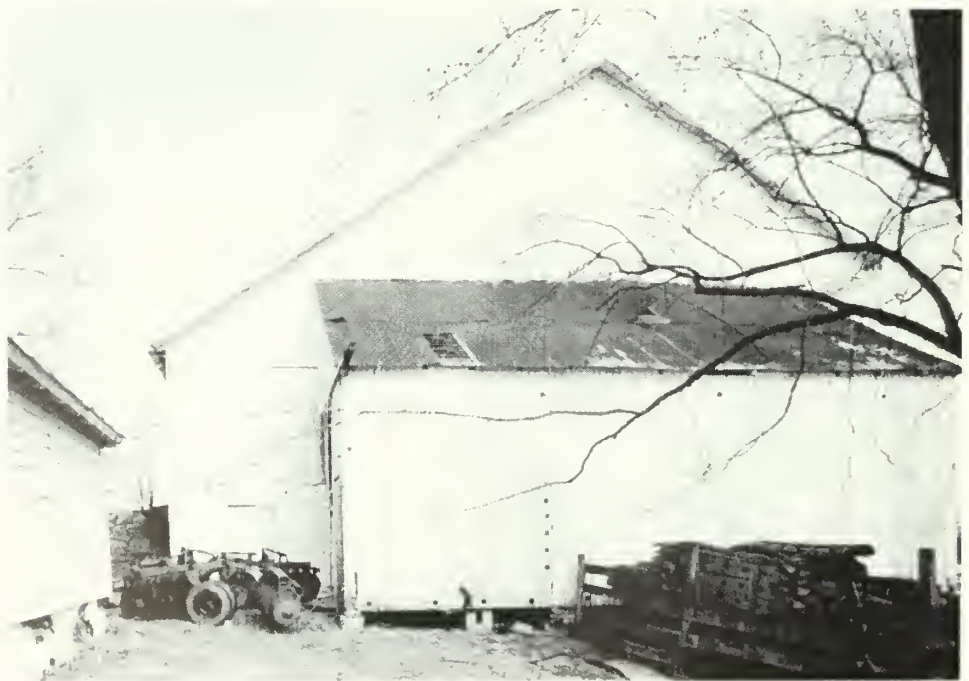
Figure 169: 1990 view of the southeast elevation of the wagon shed and corn crib.

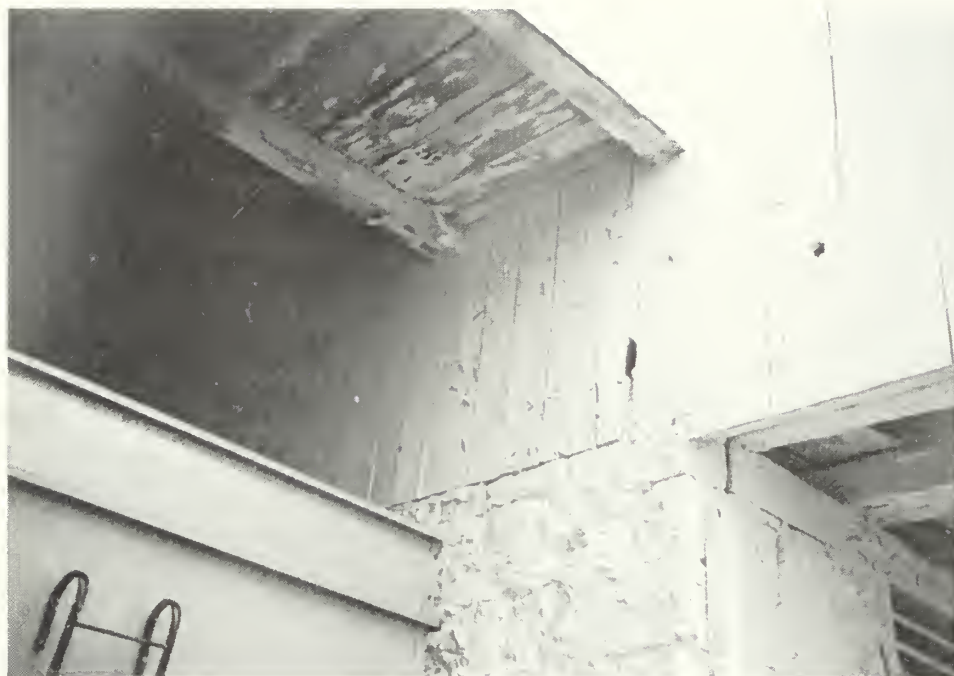
Figure 170: 1990 view of the wagon shed/corn crib roof prior to repair.

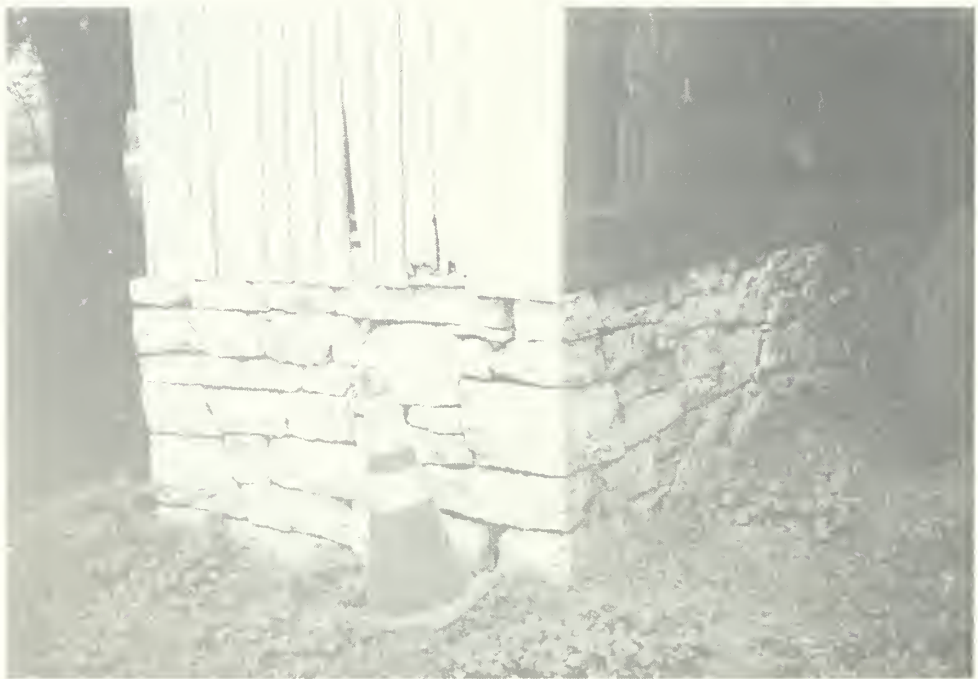
Figure 173: Exterior of corn crib (southwest elevation). Note deteriorated state of foundation.

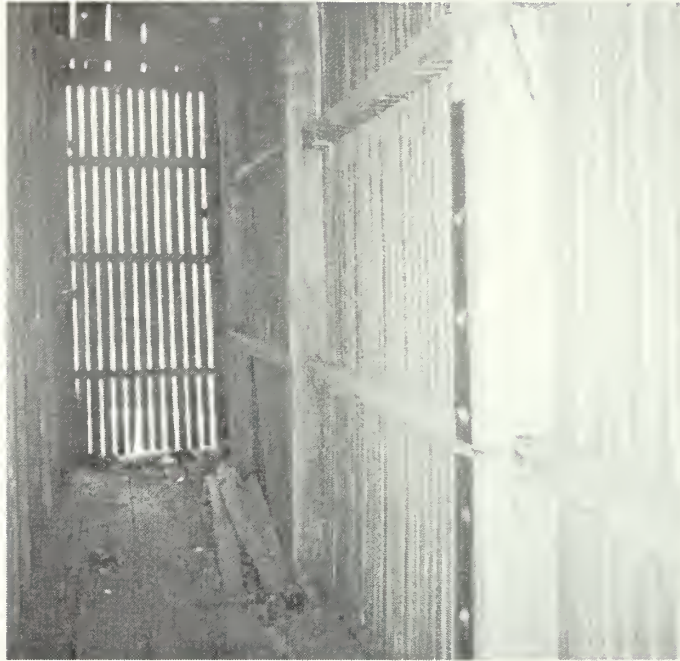
Figure 176: Post at front of corn crib damaged by insect attack.

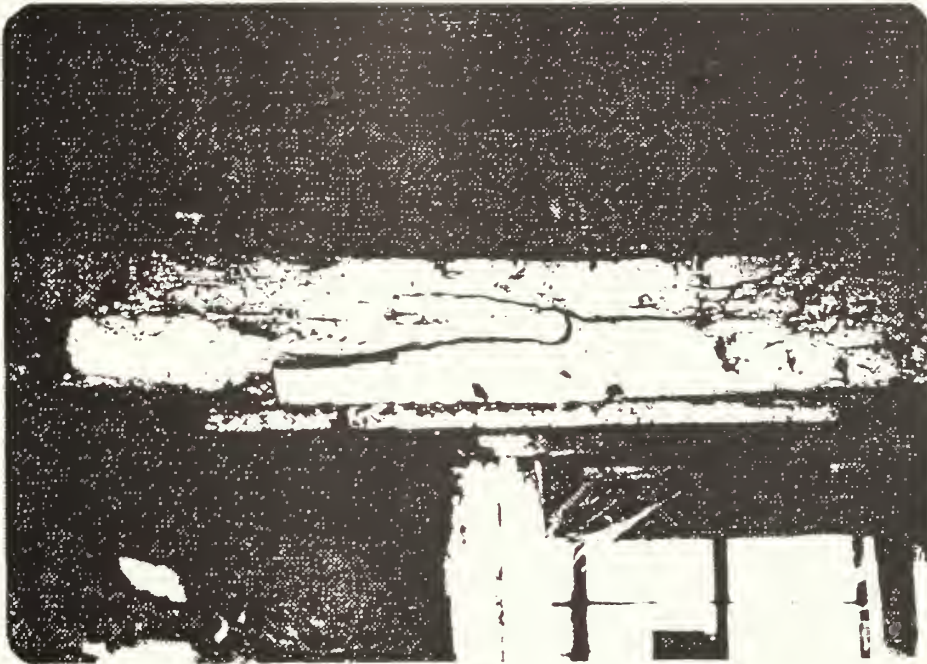
Bldg. 43 - Barn Mumma Farm  
Item 1 - Broken girder - small vertical  
post added for support

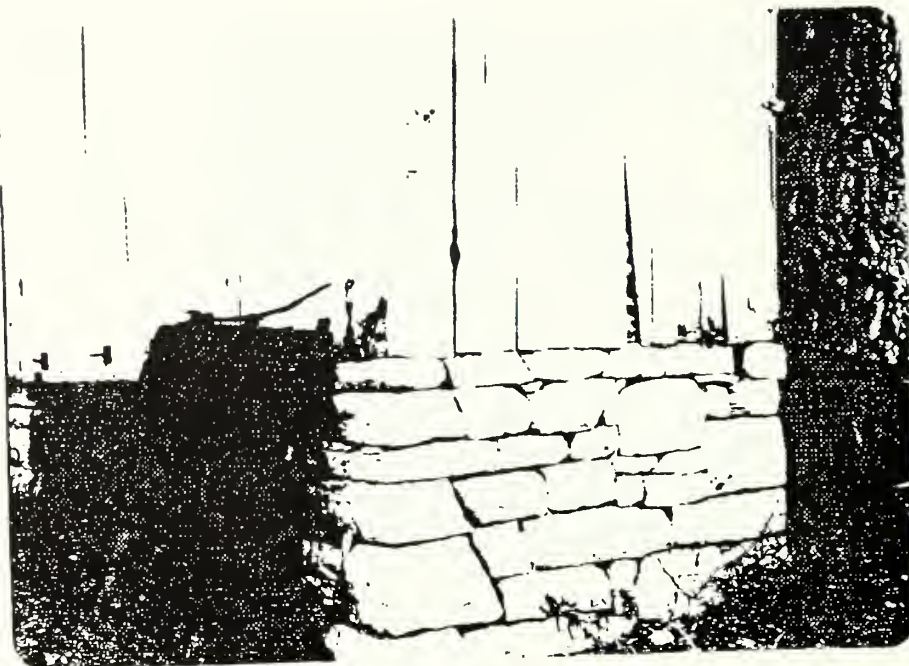
Bldg. 43 - Mumma Farm  
Item 7 - Corn crib footer deterioration
