HISTORIC STRUCTURE REPORT

Architectural Data Section

LINDENWALD

MARTIN VAN BUREN NATIONAL HISTORIC SITE

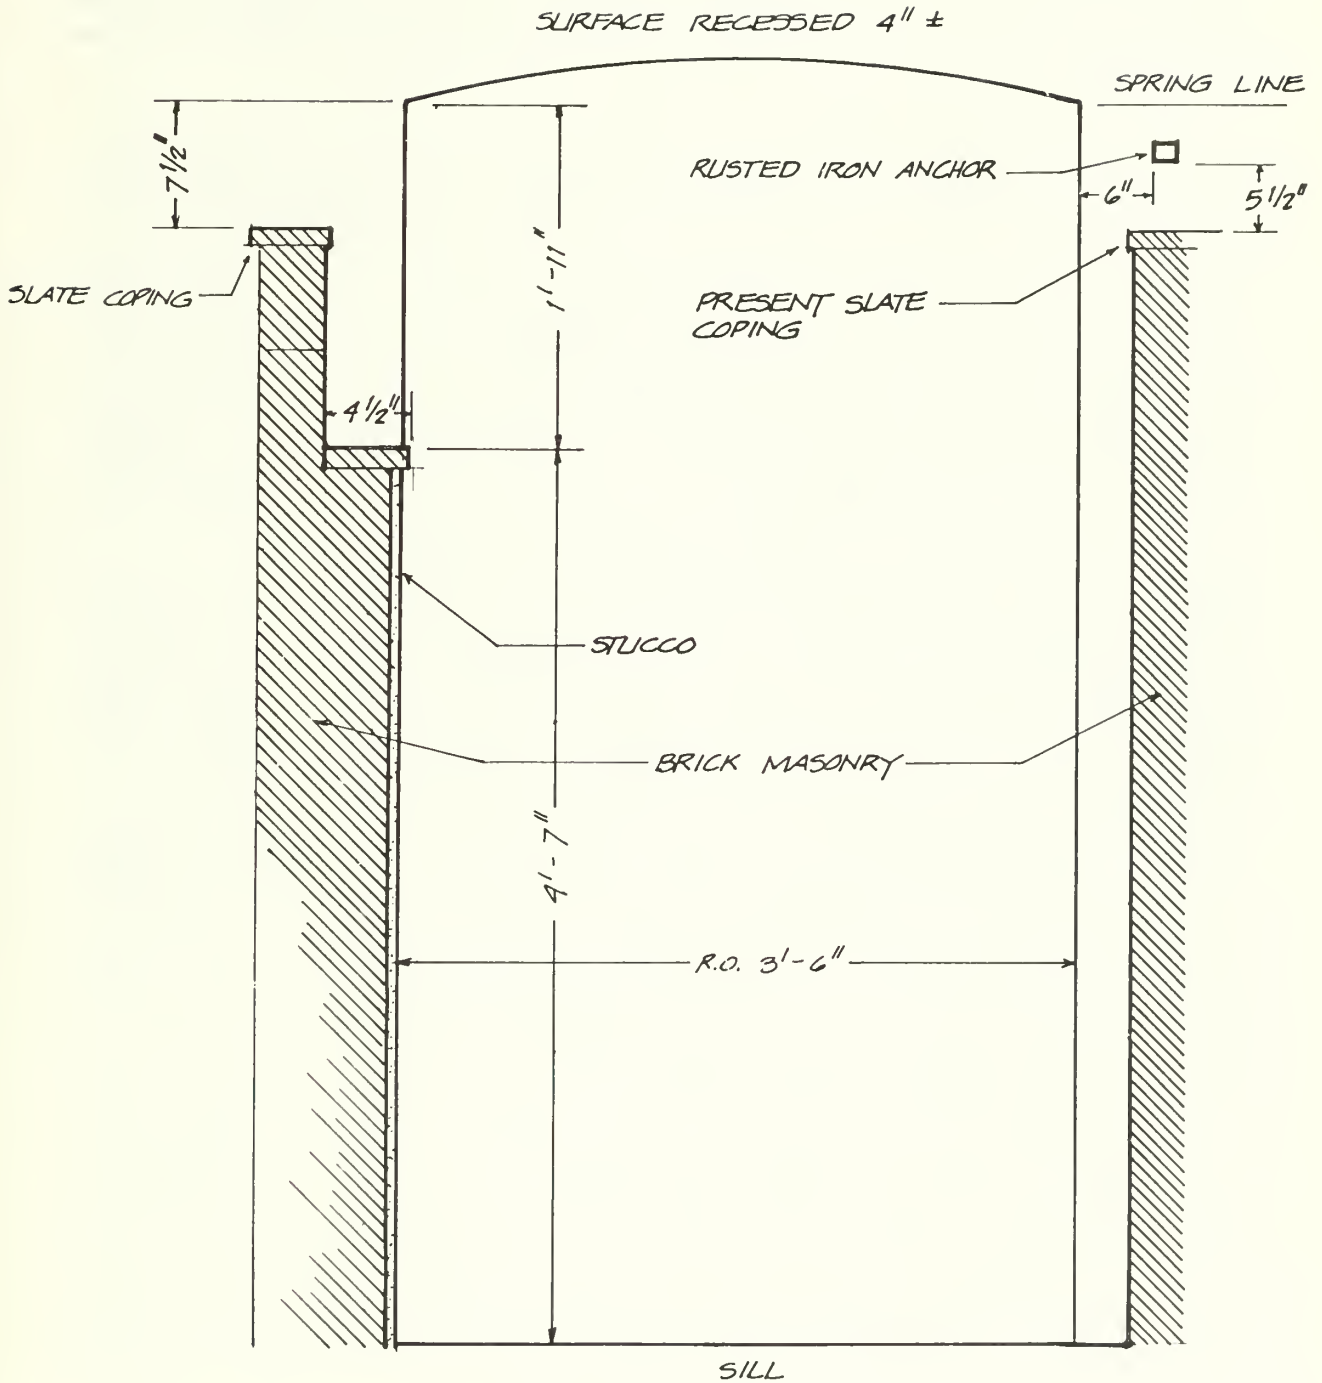
Bulkhead Section

brickwork of the cheeks. A rowlock course seems to be the original coping of the cheek walls. As soil accumulated through the years, four courses of brick were added to the cheeks, and the riser heights were adjusted to keep the bulkhead in proper relation to grade. The bulkhead should be restored to its historic height consistent with the present height of the south cheek, and an appropriate bulkhead cover should be constructed.
