**ELLIS ISLAND
STATUE OF LIBERTY NATIONAL MONUMENT**

**HISTORIC STRUCTURE REPORT
POWERHOUSE**

Volume 3

**Beyer Blinder Belle/
Anderson Notter Finegold**

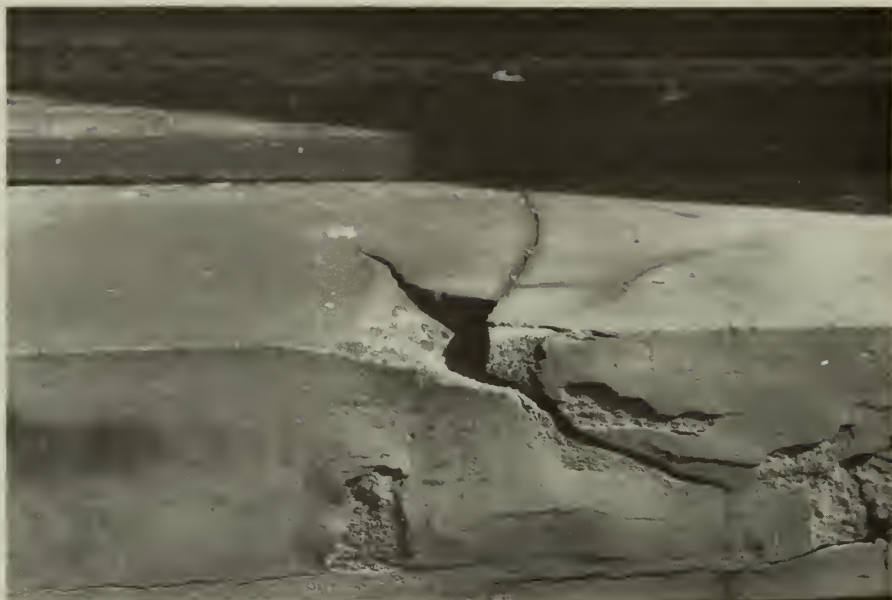
A number of other forms of deterioration were observed. Cracking and spalling have occurred in a number of locations, particularly at window sills (photo 27) and in areas where ferrous anchors and bolts have been inserted (photo 28). Some entire bricks and pieces of limestone are missing (photos 28 and 29). Copper staining appears to be restricted to the quoins on the west elevation of the south pavilion (photo 30). Iron staining is found in various locations though most frequently at limestone keystones which are in close proximity to iron lighting fixtures or pipes (photo 31). Black crust is evident on the granite base (photo 32), the bluestone courses, and in certain sections of brick, most notably on the west and north elevations. Efflorescence appears to be limited to small areas of the east facade and at the corbeled cornice under the eaves on the west elevation. Weathering is so pronounced on the granite base that it has lost its surface contour (photo 33). A number of patches and mortar fills exist on the building's exterior (photo 34).

27. Cracking and spalling at window sill, east elevation.

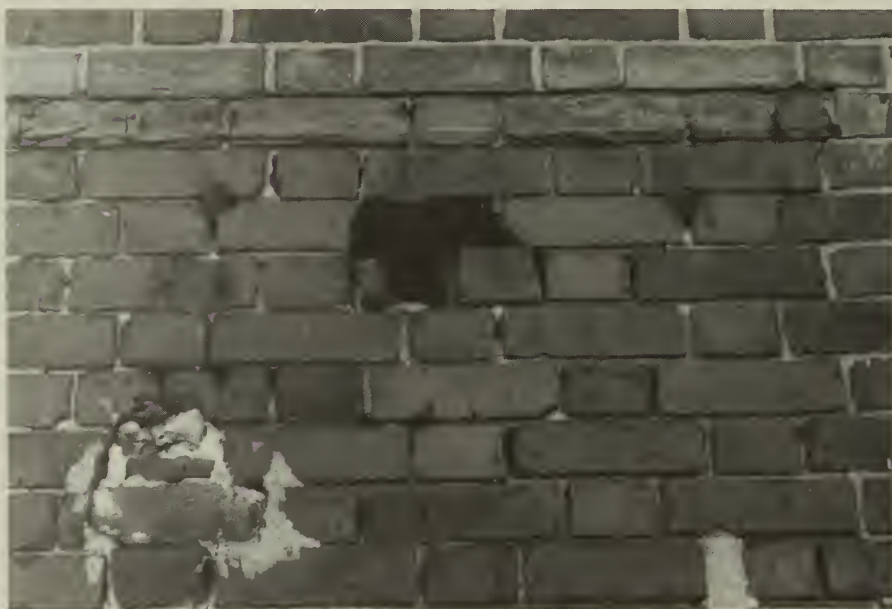
28. Loss of brick, deteriorating mortar, spalling, and patching, west elevation.

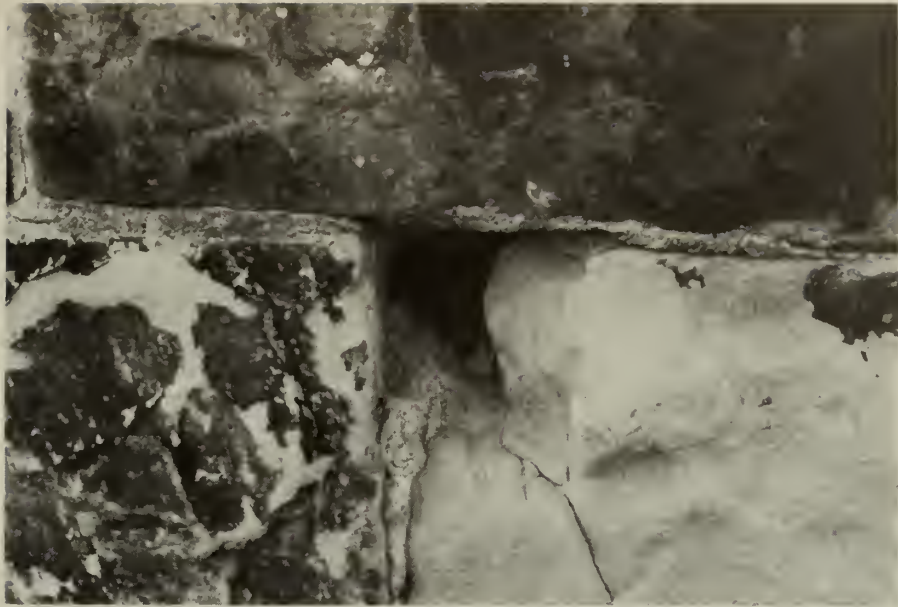
29. Loss of material, granite base, west elevation.

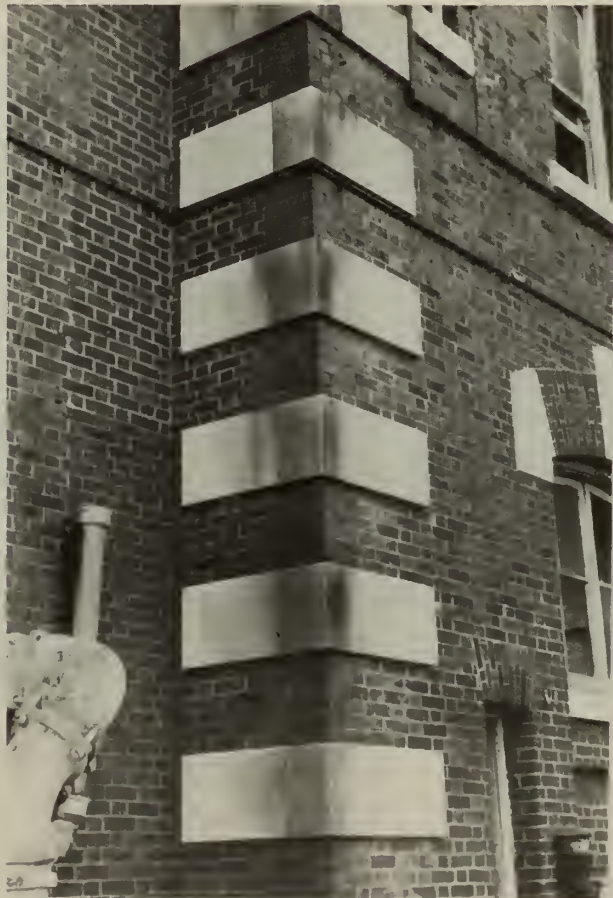
30. Copper staining at quoins, south pavilion, west elevation.

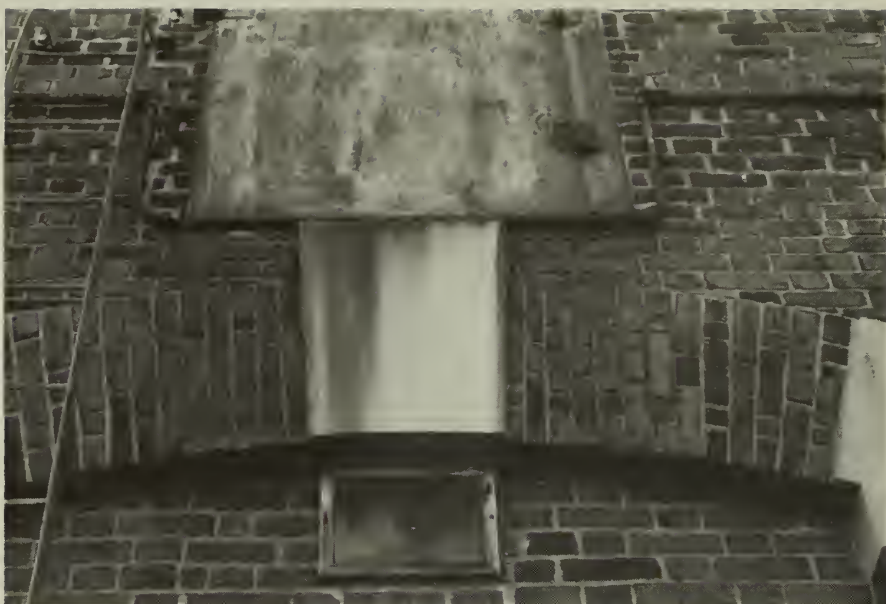
31. Iron staining at keystone, west elevation.

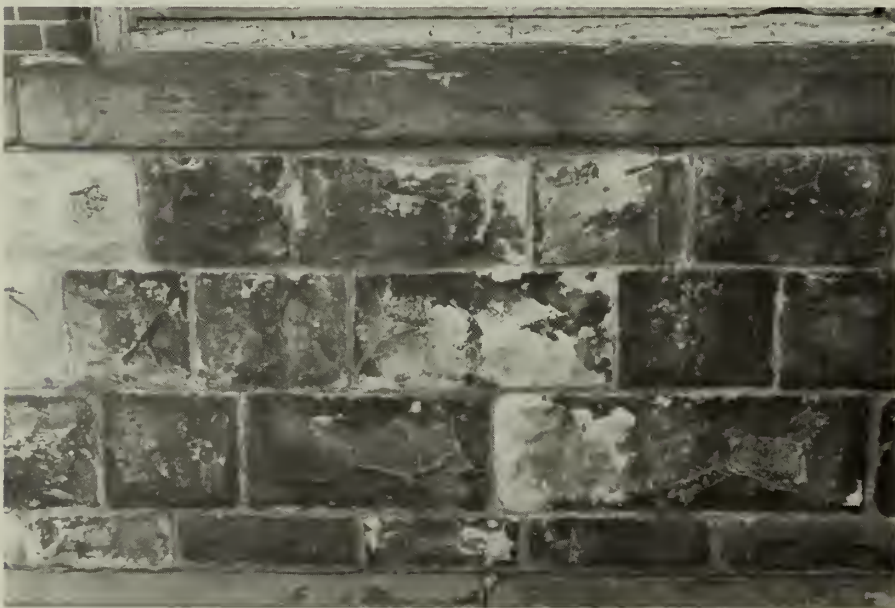
32. Black crust at base, west elevation.

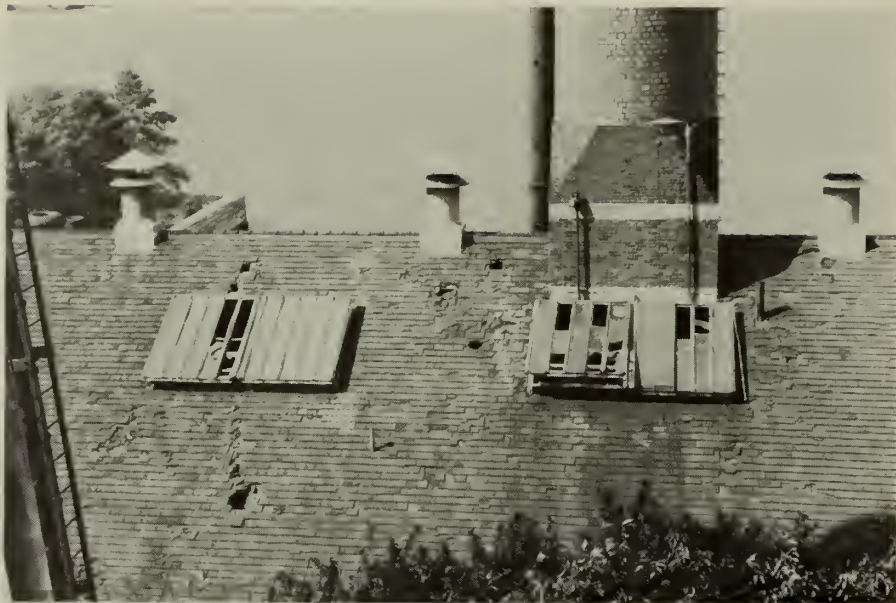
The roof is in poor condition. A significant amount of clay tile is broken or missing. A number of holes are located on the east side of the roof. Copper gutters are torn and missing. All downspouts are missing. The skylight

frames are corroded and much of the glazing is missing (photo 35).

35. East side of roof; holes and broken tiles, view west.

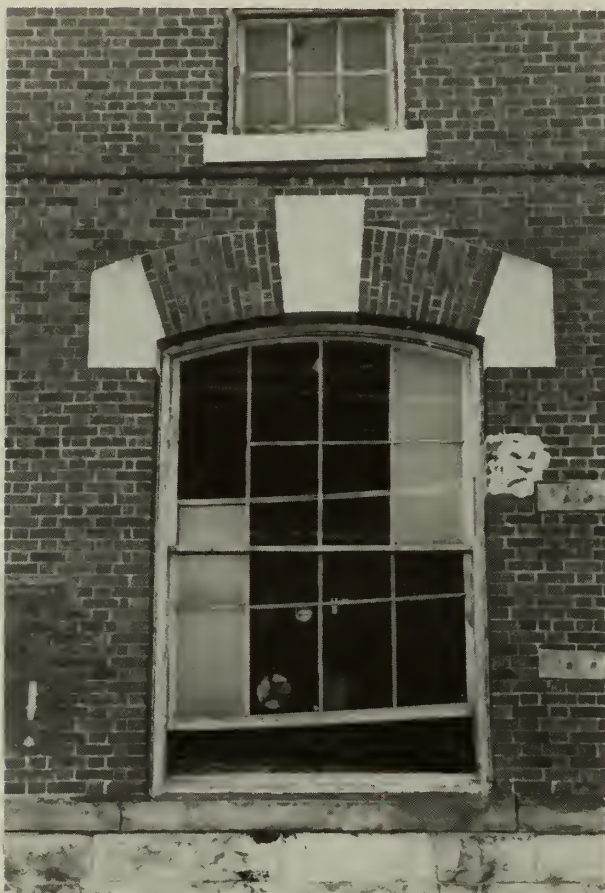
Wood window enframements are in poor condition and are not reusable. Most window sash is splitting and warped. Muntin joints are open and much of the glazing is broken or missing (photos 1, 4, 7, and 36). Several of the dormer windows are no longer extant and have been filled in with plywood.

36. Warped window, west elevation.

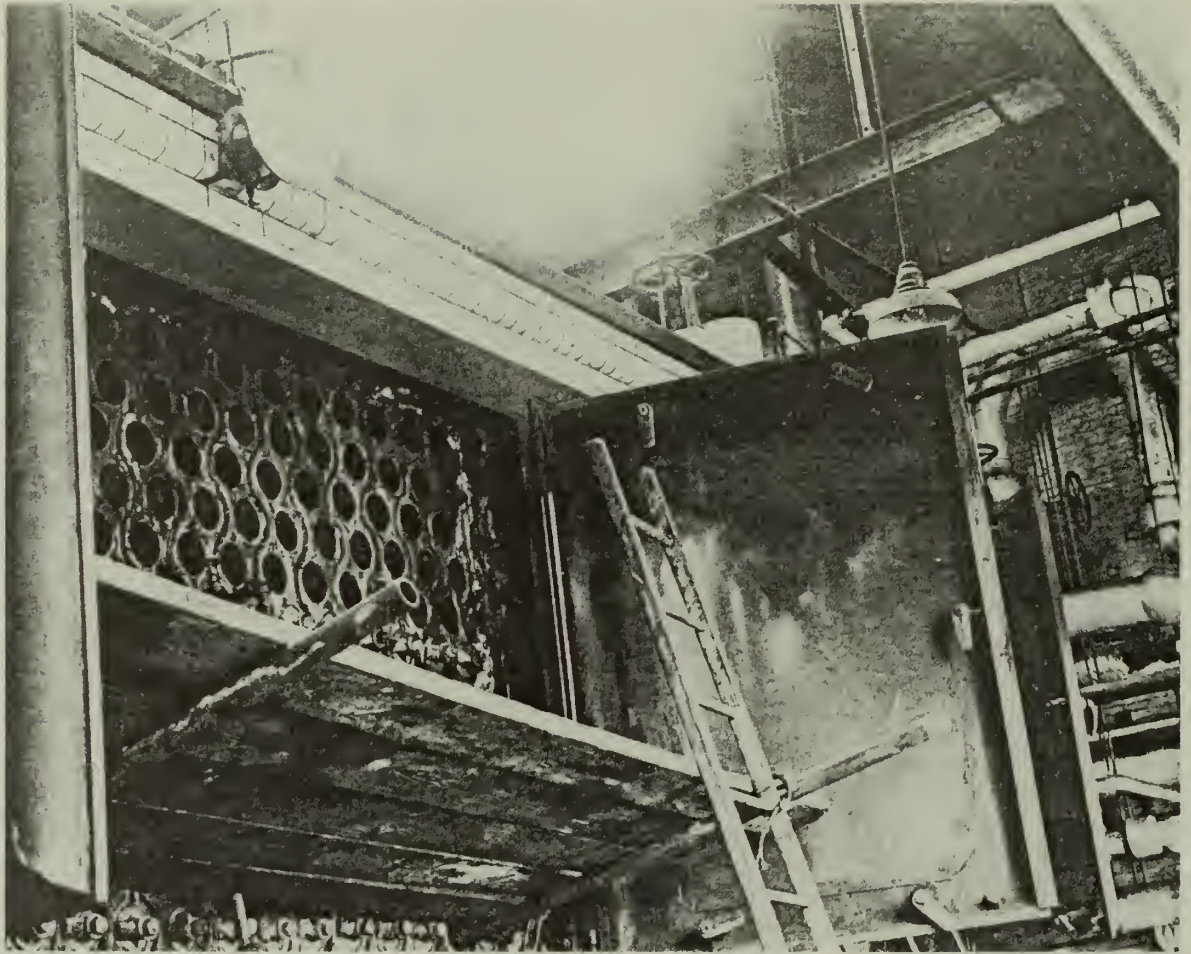
2. Room 105-boiler #4(?) under repair, c. 1940's. U.S. Immigration and Naturalization Service Photograph, Washington, D.C.

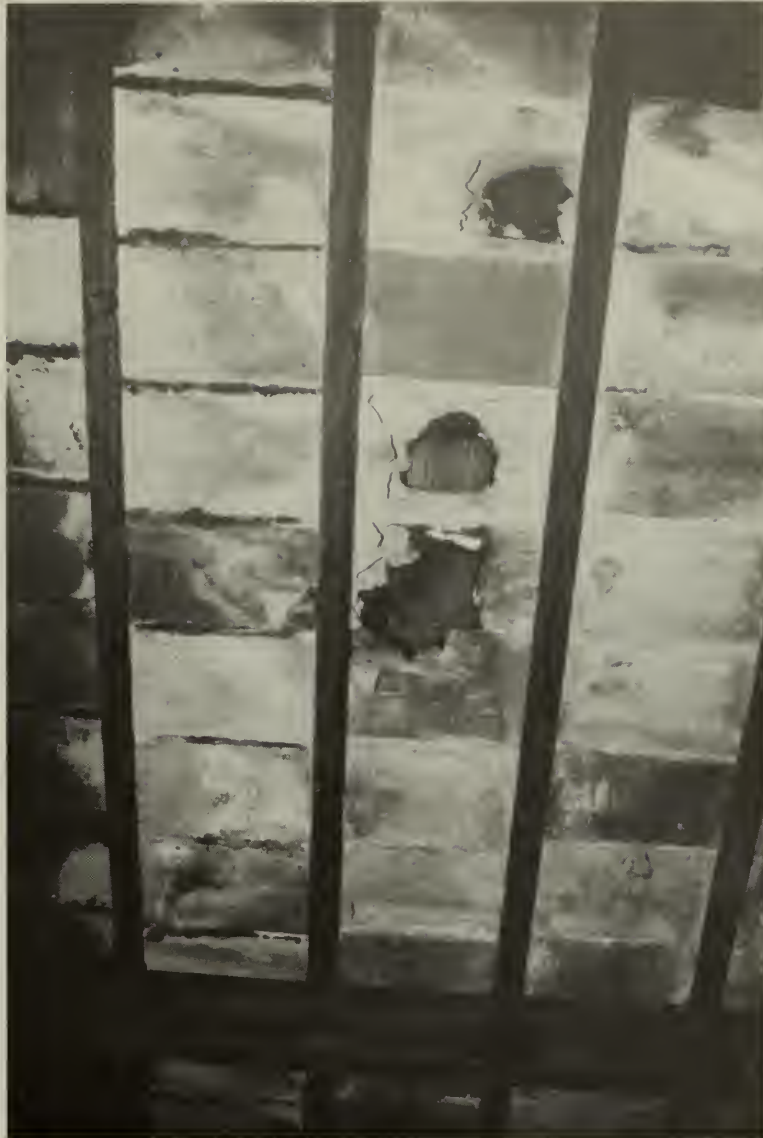
1. Typical condition of structural clay roof tiles and corrosion of tee sub-purlins

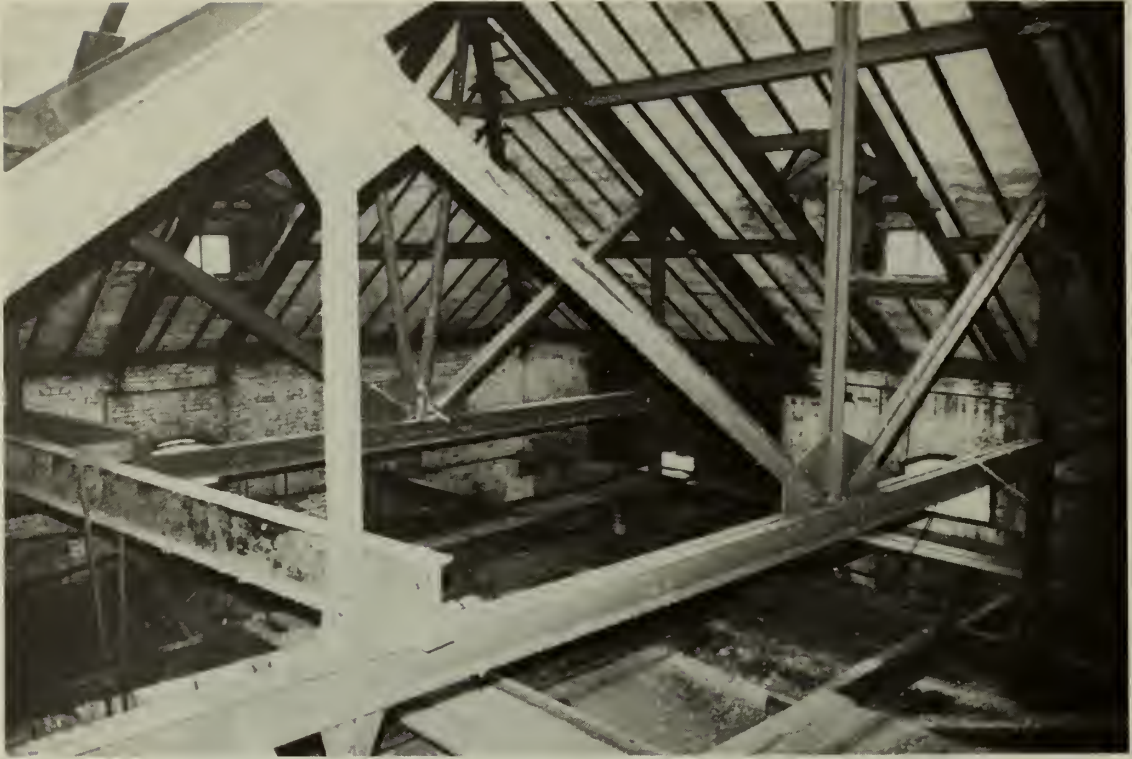
2. View showing the lateral bowing of the purlins due to the lack of sag rods

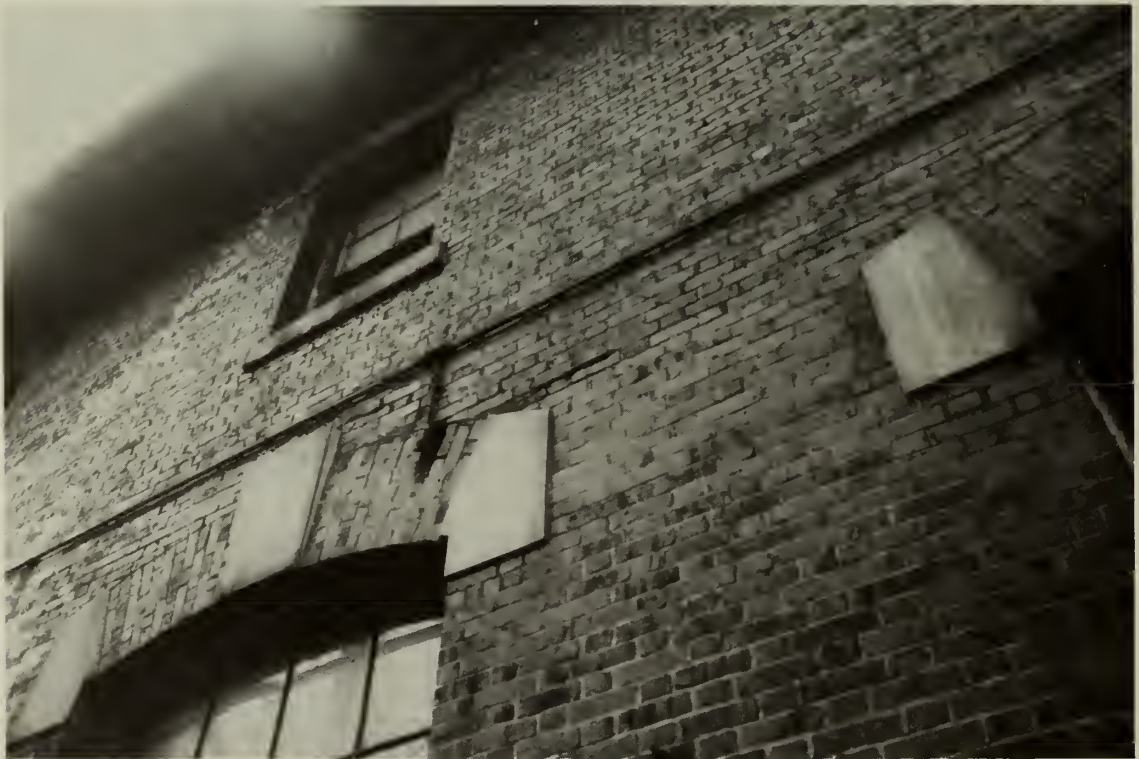
3. Typical example of cracking of exterior bearing walls

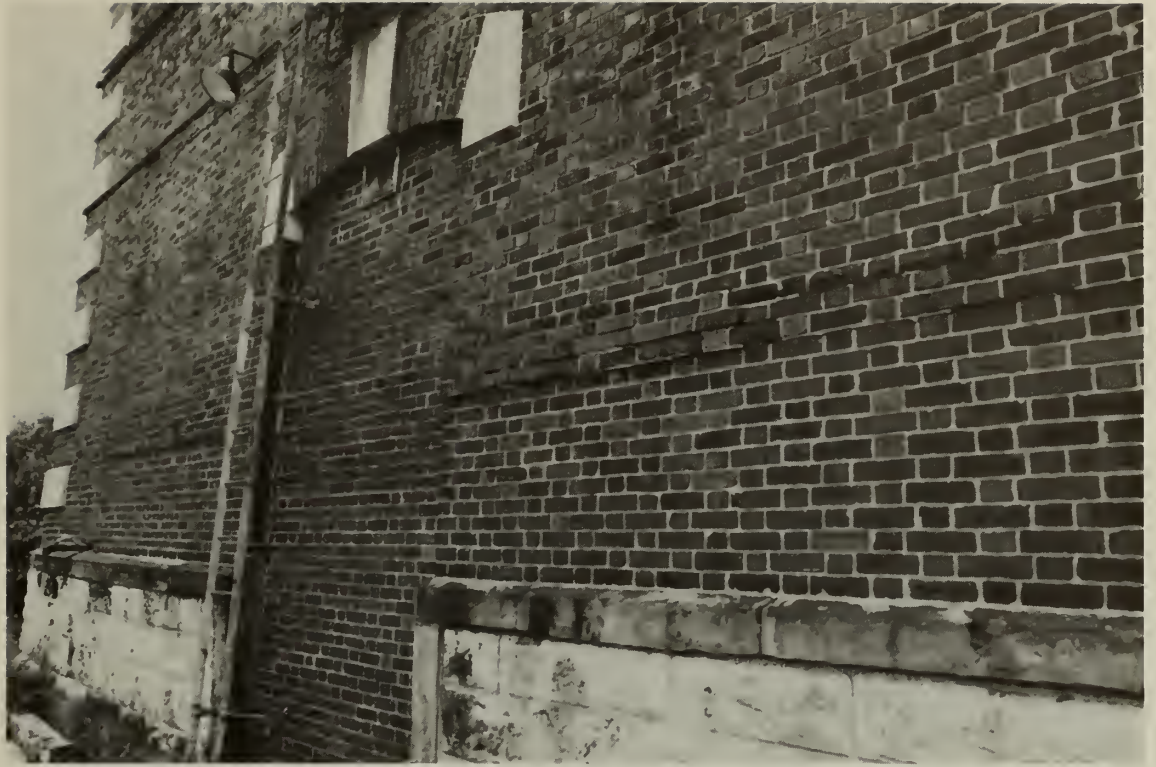
4. View showing bulging and cracking of exterior bearing walls in the area of the northwest corner of the oil tank room due to corrosion of embedded angles

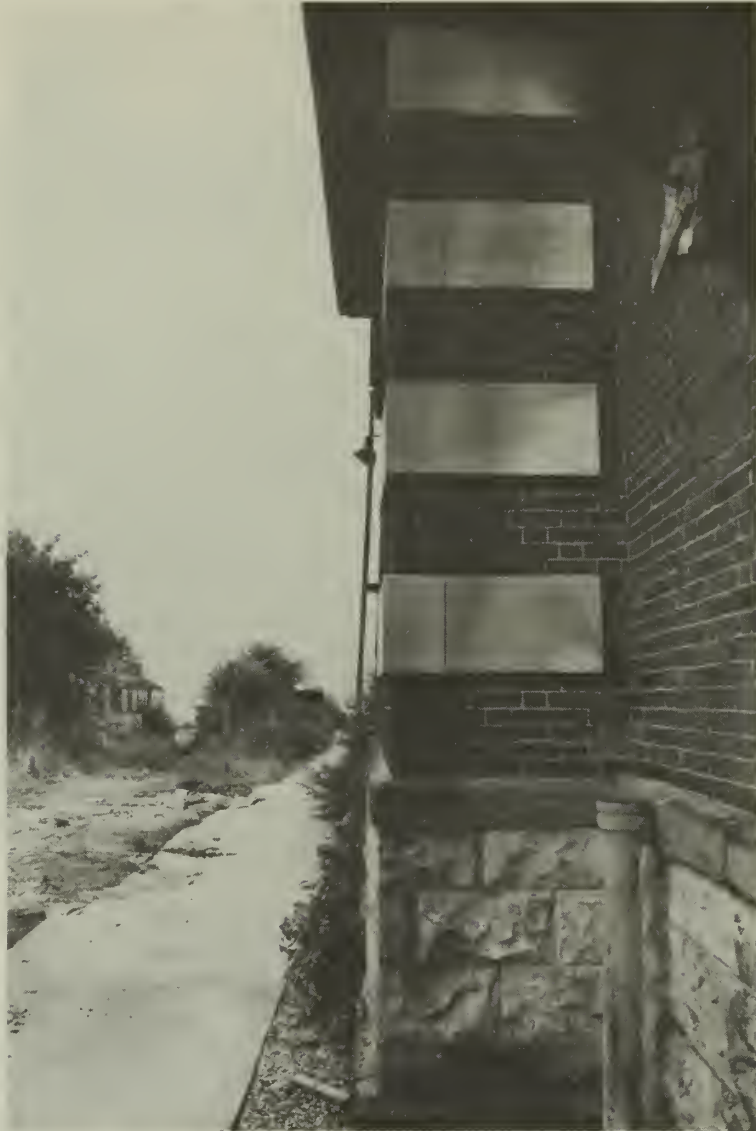
5. View of the bulging of the exterior bearing wall.
As photograph 4

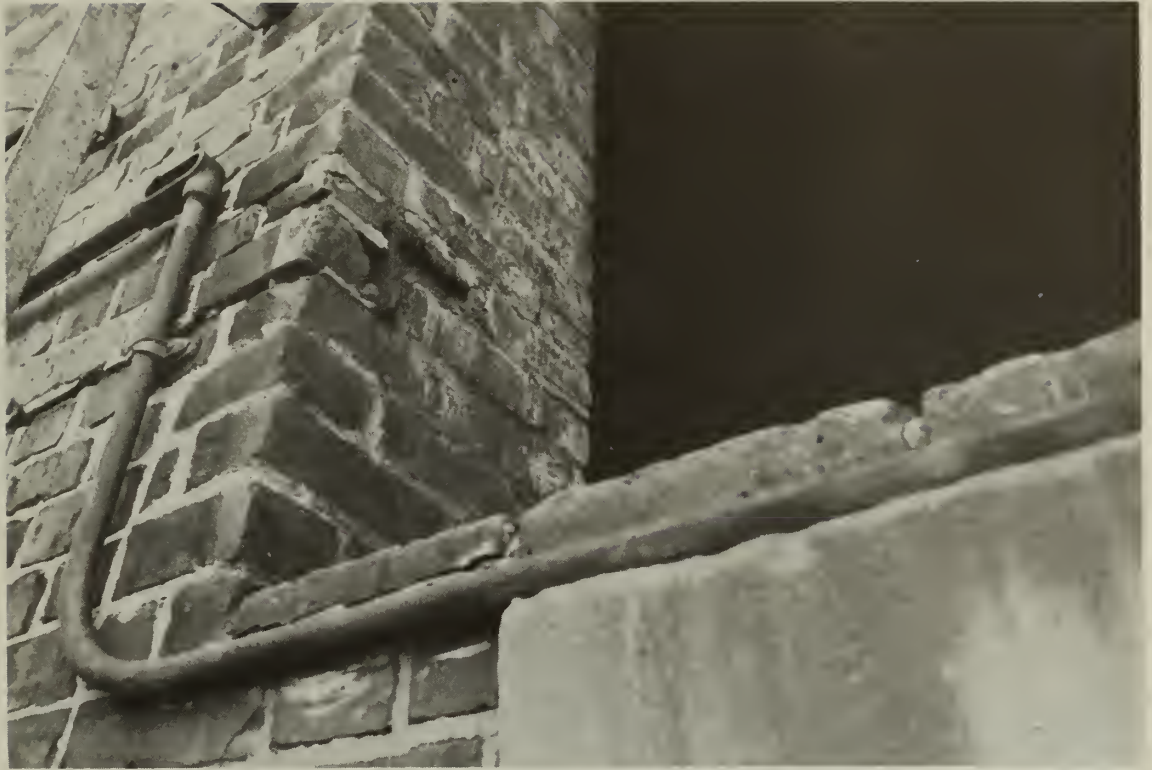
6. Typical example of cracking of exterior bearing walls due to corrosion of embedded angles

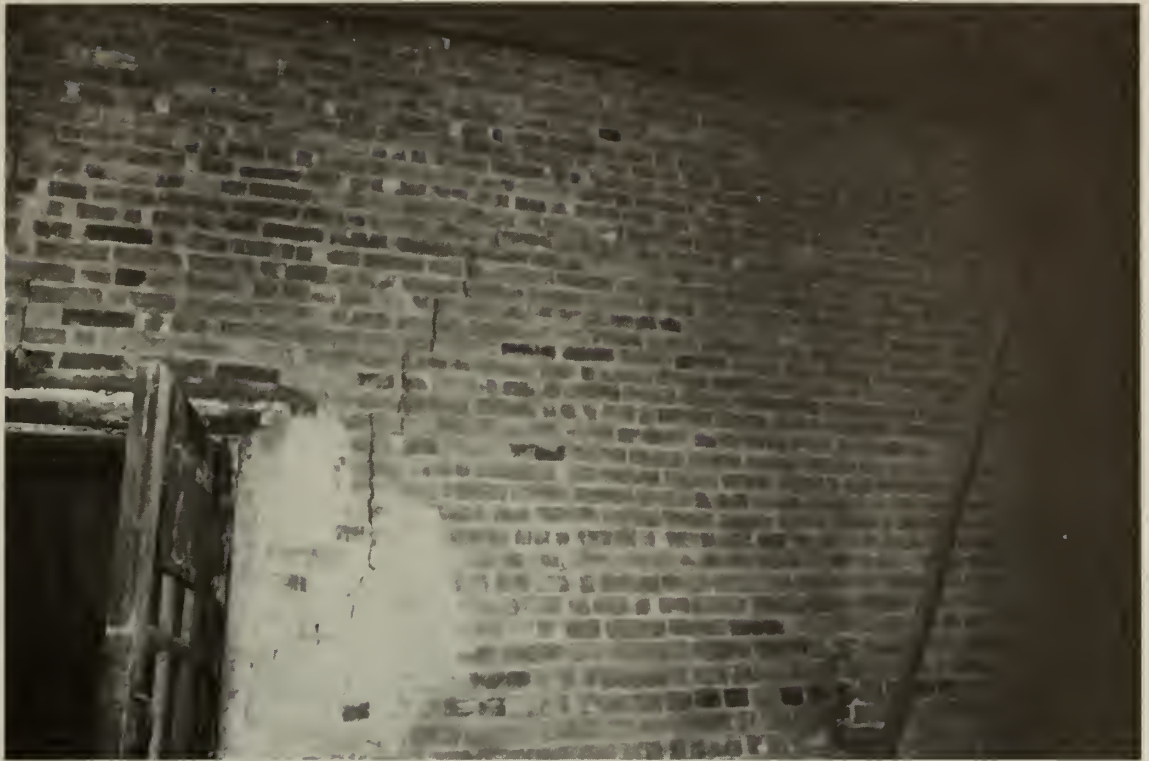
Interior bearing walls showed some severe cracking due to expansion and contraction of the building when it was unheated (photos 7, 8, 9).

8. View showing cracking of interior bearing walls. As photograph 7

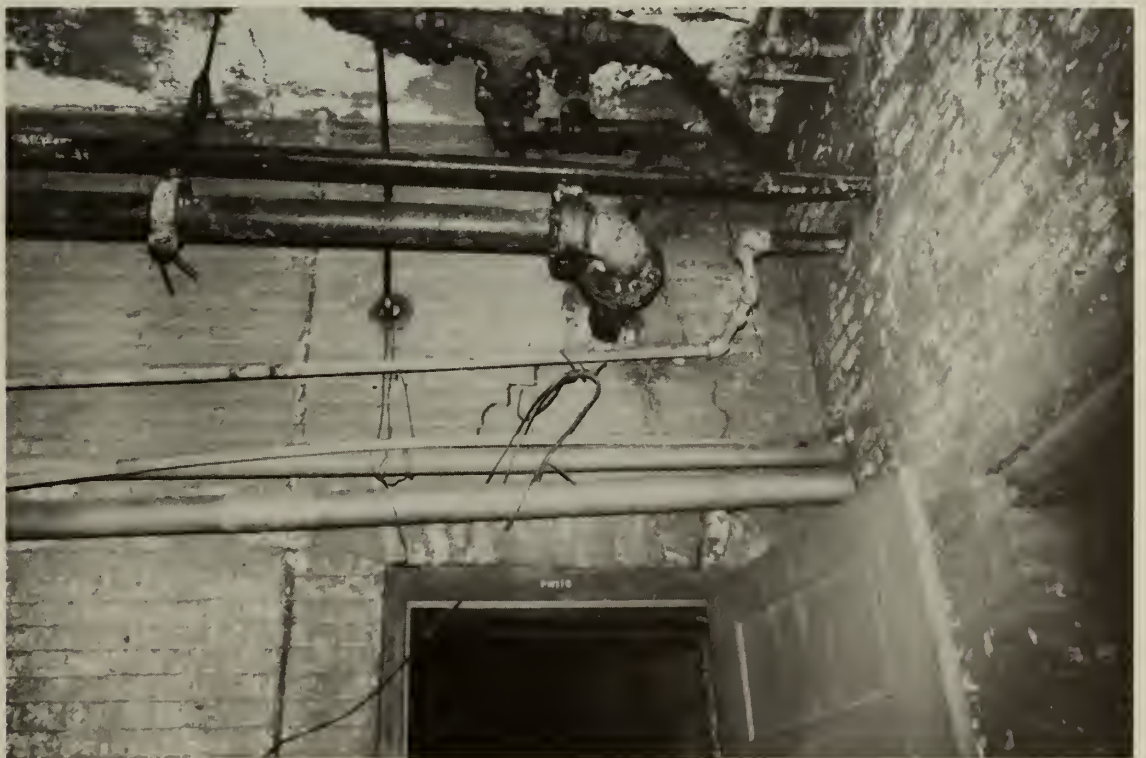
9. View showing cracking of interior bearing walls. As photograph 7

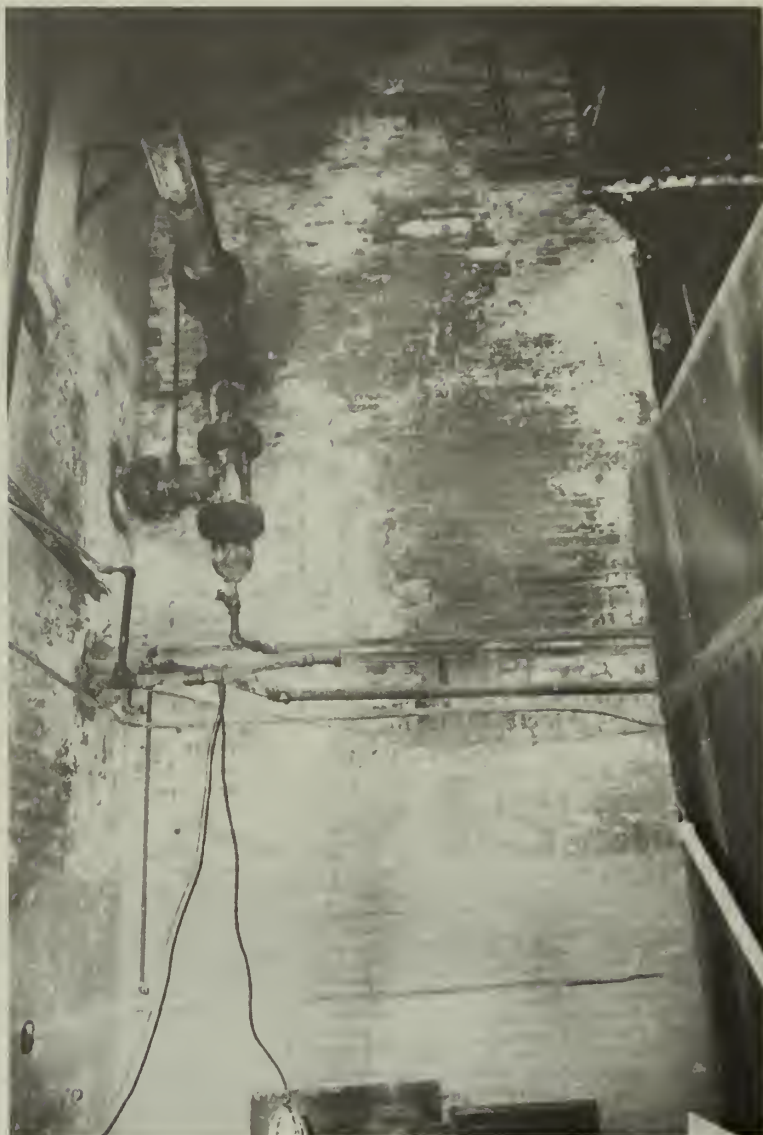
The main stack lower shaft also exhibits severe cracking (photos 10 and 11).

10. Typical example of cracking of main stack lower shaft

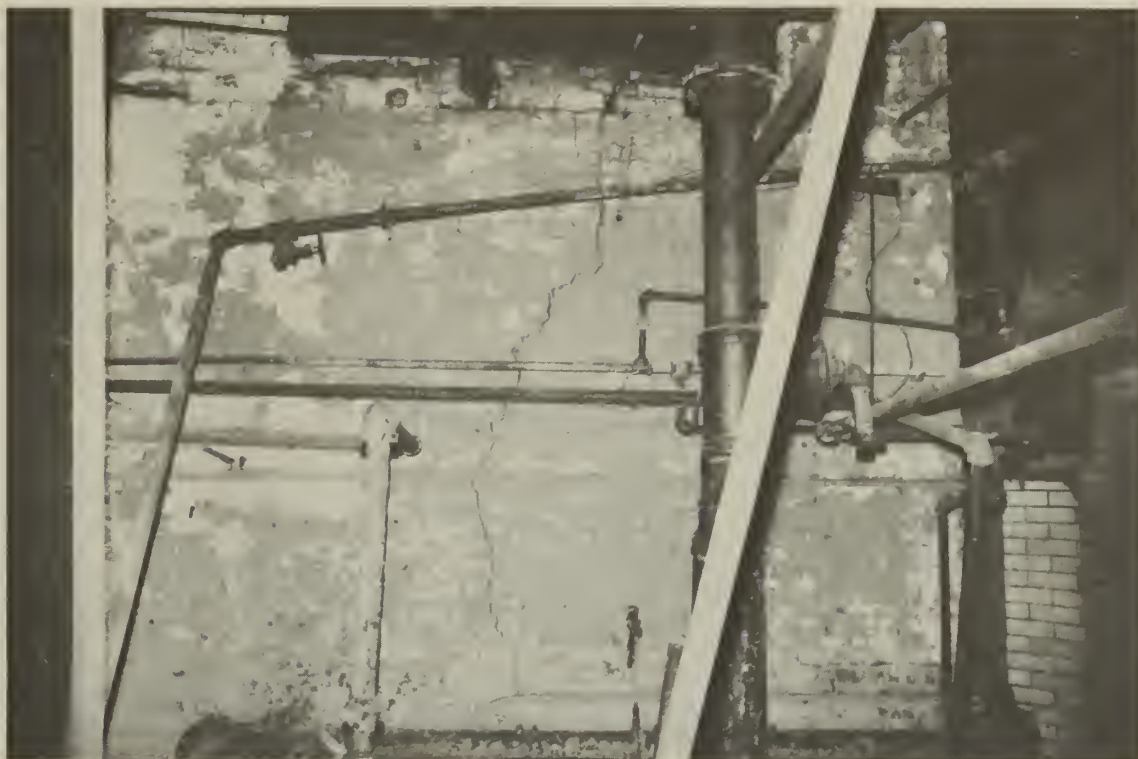
11. View showing severe cracking of the lower shaft of the main stack
