EVALUATION OF 1978 REHABILITATION SITES AND EROSION CONTROL TECHNIQUES

REDWOOD NATIONAL PARK WATERSHED REHABILITATION

TECHNICAL REPORT
APRIL 1980

MARY ANN MADEJ,
HARVEY KELSEY, AND
WILLIAM WEAVER

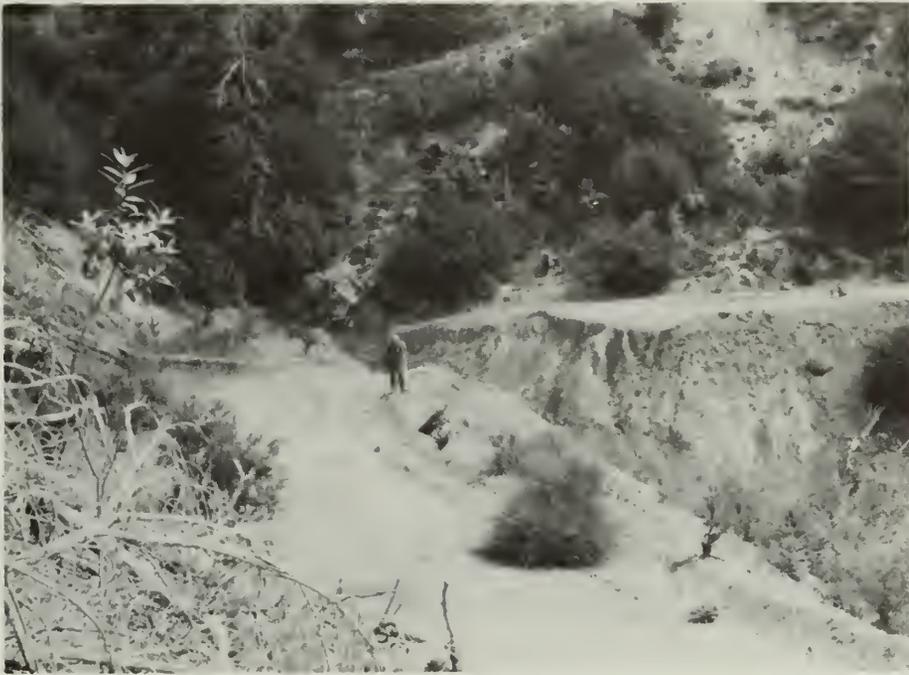
Figure 8: PP5a 8/22/78
Before photograph of former culvert in Drainage 6. Culvert became plugged with debris and winter flows washed out about 800 cubic yards of road fill into the stream channel.

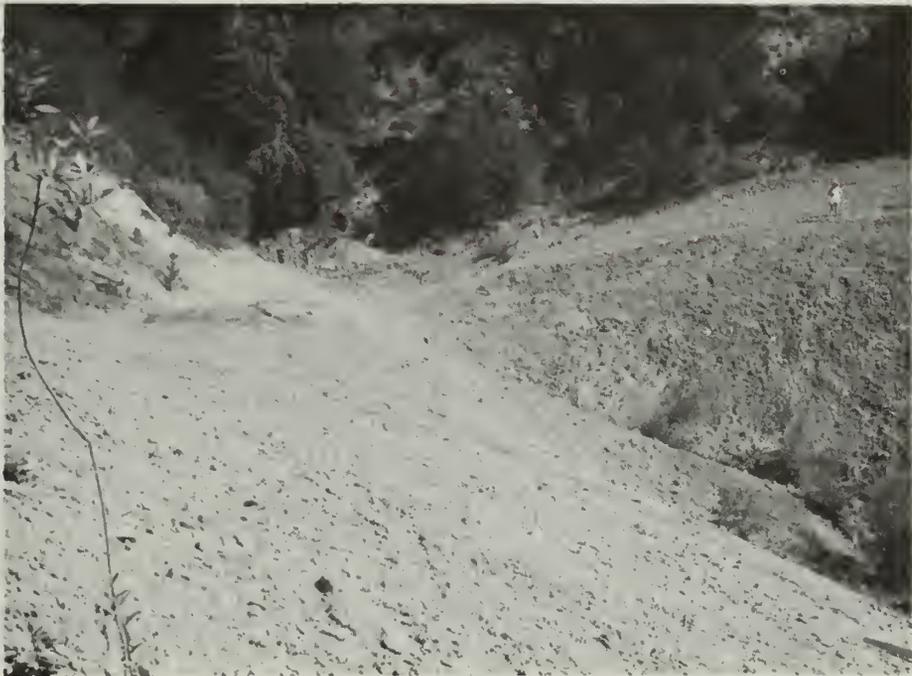
Figure 9: PP5a 10/9/78
After photograph of Drainage 6. Dragline crane pulled back vertical banks to a more stable configuration, and a cat tractor outsloped the fill material removed by the crane.

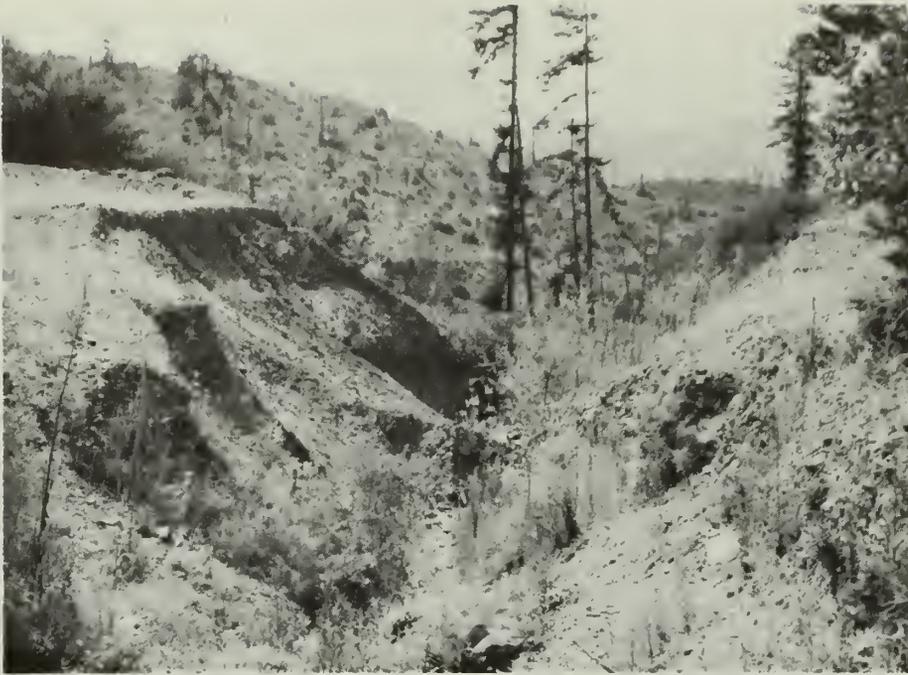
Figure 10: PP7 8/22/78
Before photograph of culvert washout in
Drainage 6, close-up view looking
downstream. Note person in channel for
scale.

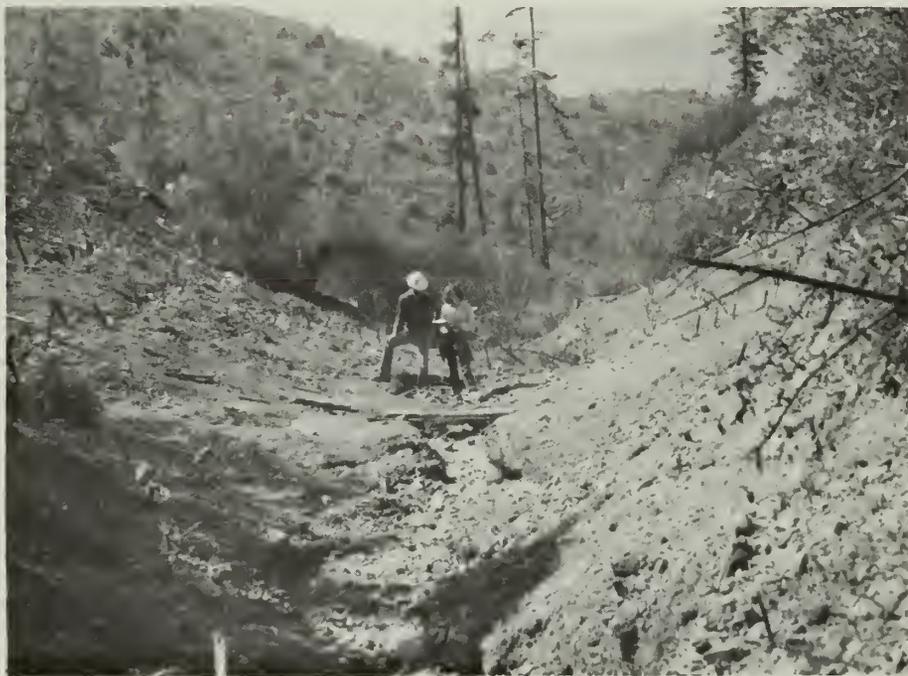
Figure 11: PP7 3/12/79
After photograph of Drainage 6. Newly
excavated channel exhibiting more
gentle banks. Note rows of willow
wattle installed on both banks.

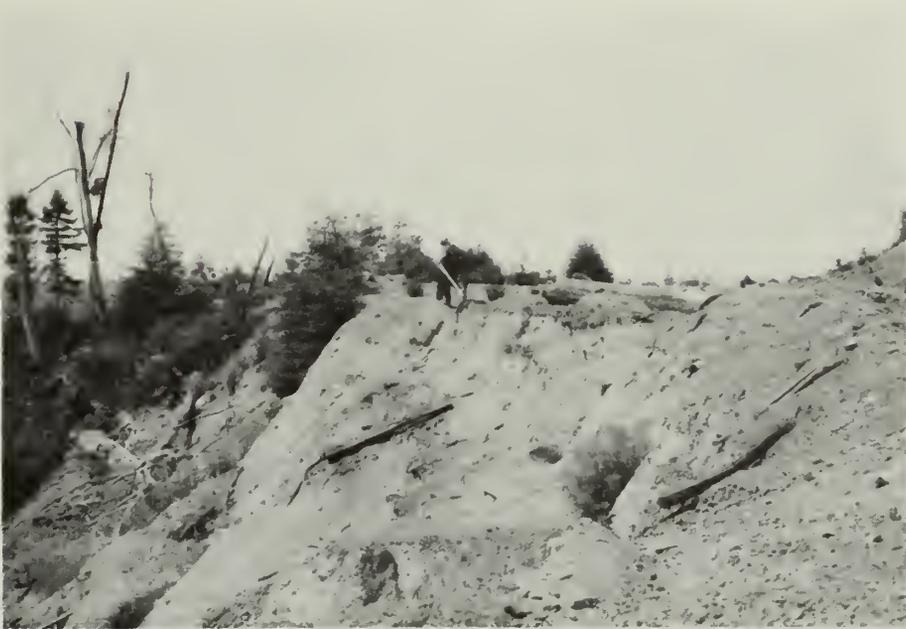
Figure 12: PP3 8/22/78
Before photograph of oversteepened edge of log landing. Some fill material and organic debris have already failed downslope. In addition, water continued to pond on the landing, and tensional cracks suggested future failure of the hillslope.

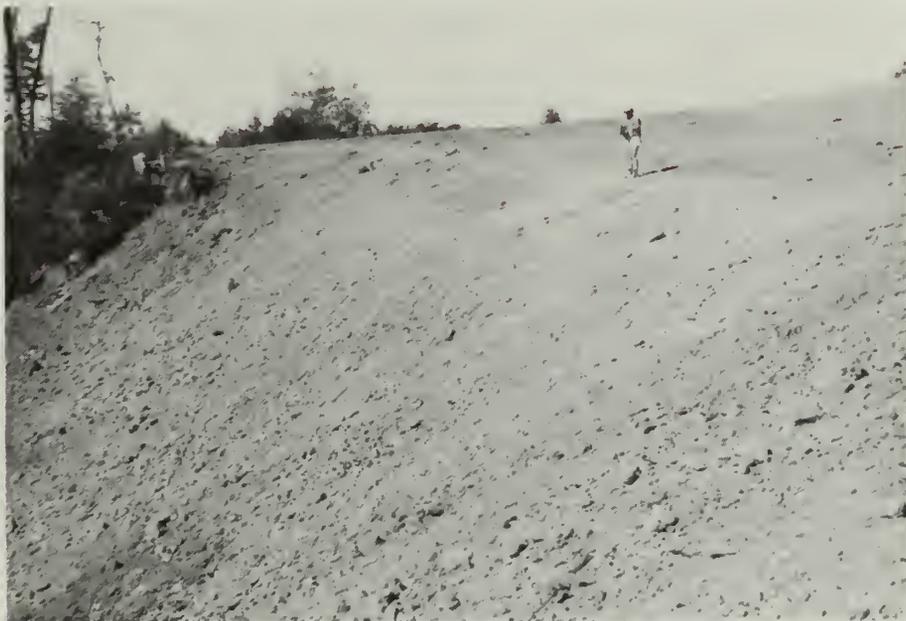
Figure 13: PP3 3/12/79
After photograph of log landing. Edge of landing has been pulled back and fill material was outsloped. Drainage of runoff from the landing has been improved. Willow wattles were planted on the steep slopes below the former landing.

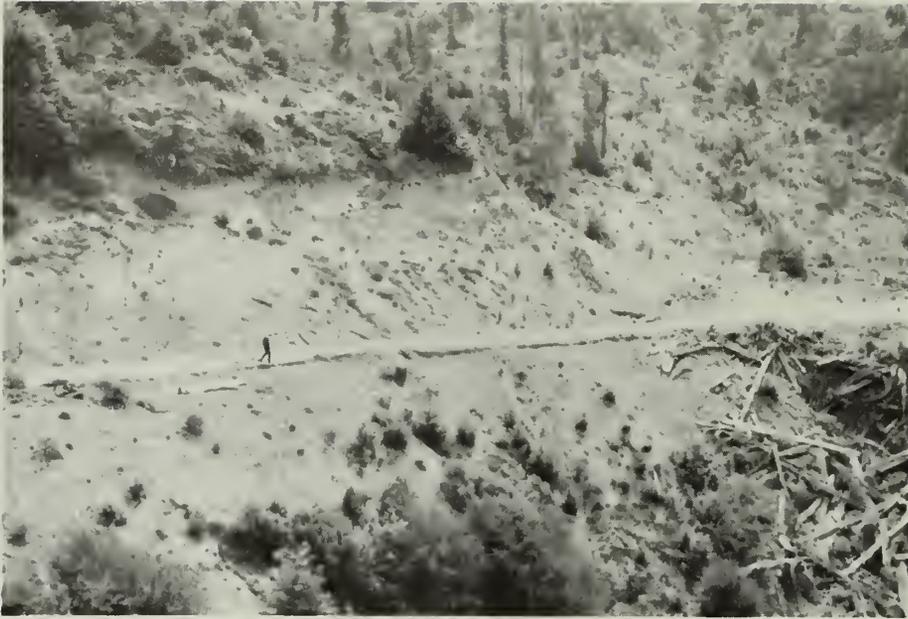
Figure 14: PP5c 8/22/78
Before photograph of abandoned haul road with unmaintained inboard ditch and steep fill slopes. Landing at right of photo shows perched debris beginning to fail downslope.

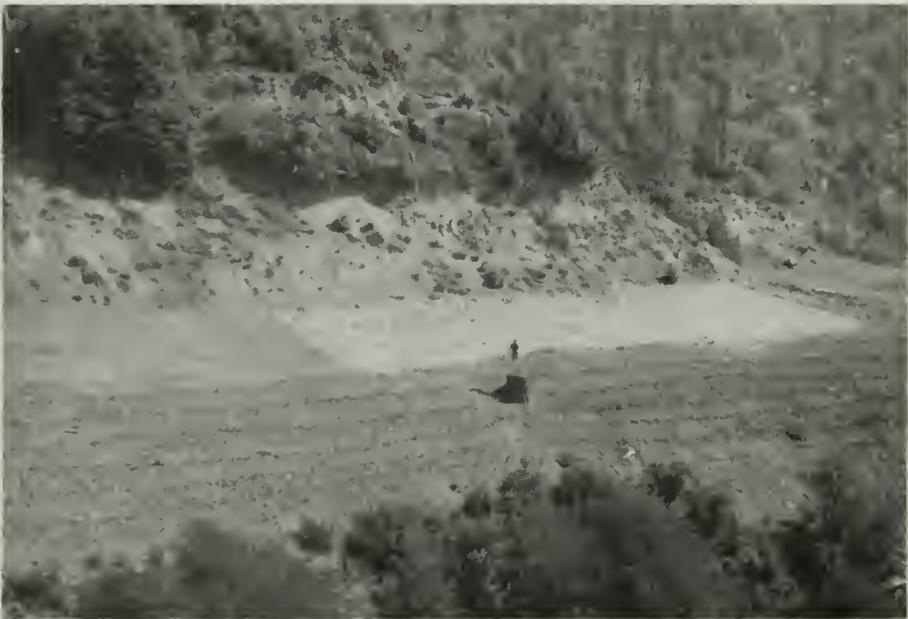
Figure 15: PP5c 10/9/78
After photograph. Inboard ditch has been eliminated. Steep road fill has been pulled back and outsloped. Perched debris on landing has been removed, and the landing itself has been outsloped to improve drainage. Slopes have been willow wattled and partly mulched with straw.

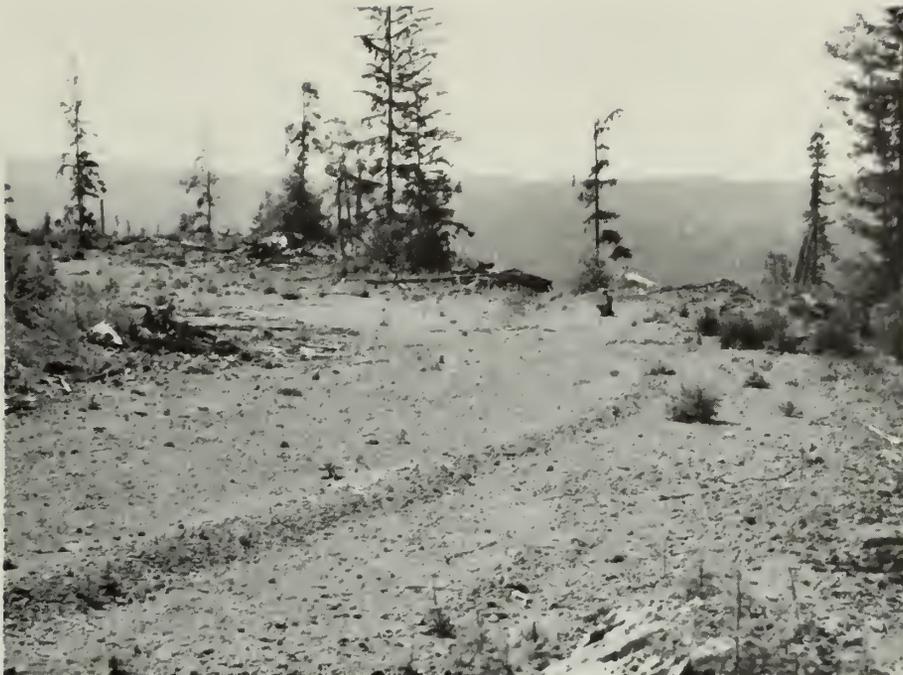
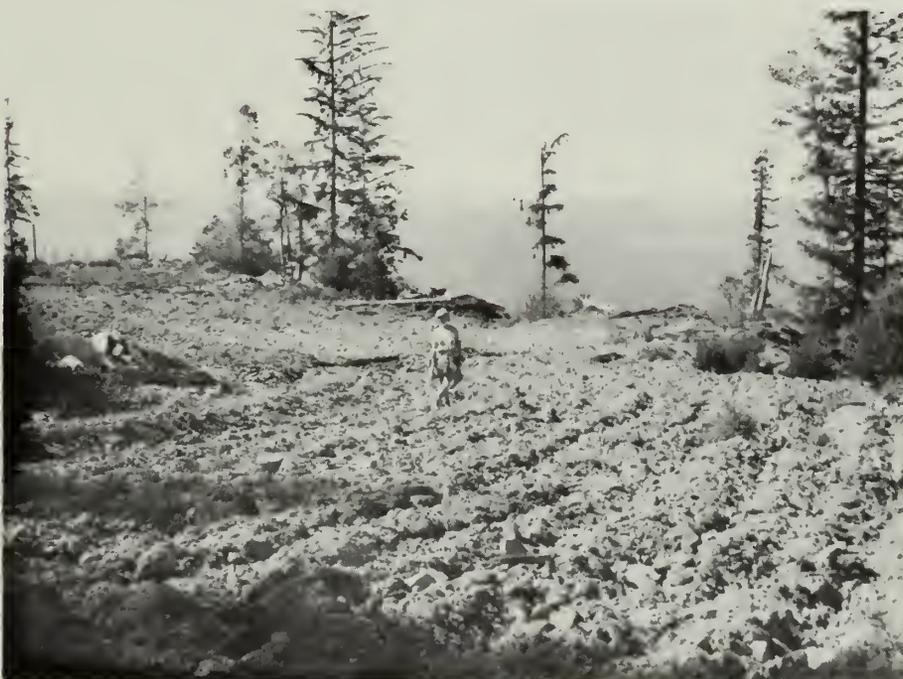
Figure 16: PP22b 8/22/78
Before and after sequence of a rocky haul road that was disaggregated (ripped) by a D-8 cat tractor to promote revegetation and infiltration of runoff. Note the paucity of vegetation on the compacted road surface even following 5 to 7 years of non-use.

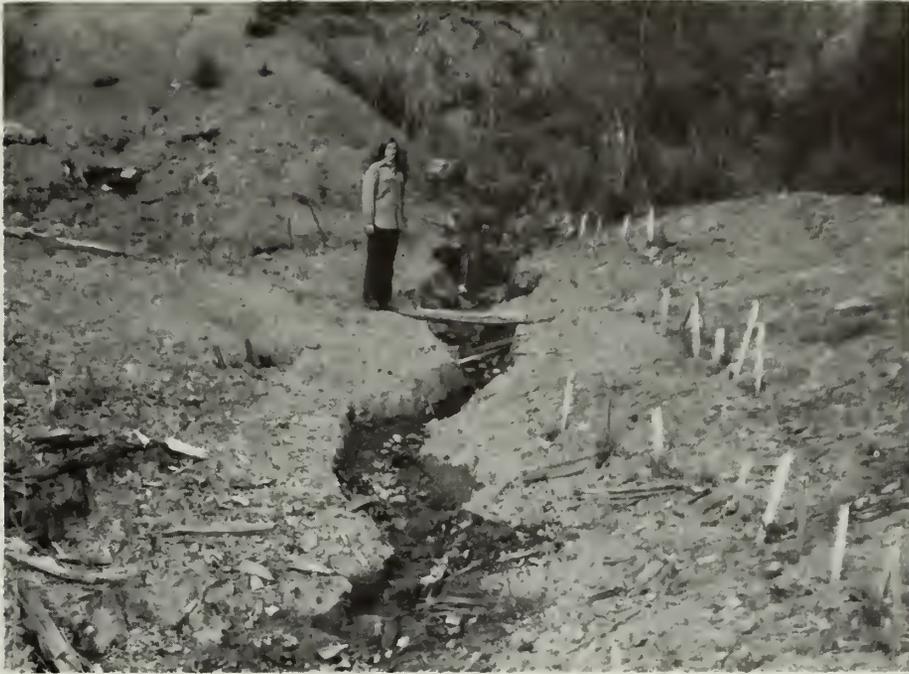
Channels were excavated to the estimated original streambed level. In three cases, excavation was not deep enough and streams downcut 6 to 18 inches during the winter (Figure 18). As the streams downcut, a lag of rocks collected and began to armor the channel bed, inhibiting further downcutting. Channel bed stabilization is important because downcutting undercuts the toes of slopes, resulting in streambank failure. Checkdams were needed to prevent vertical incision in some channels.

Figure 18: Drainage 5 in the Miller Creek Unit. Downcutting occurred in channel that was cleared of debris and road fill. The channel was not protected by an armor of rock prior to downcutting, although a lag of rocks is now beginning to form on the channel bed.

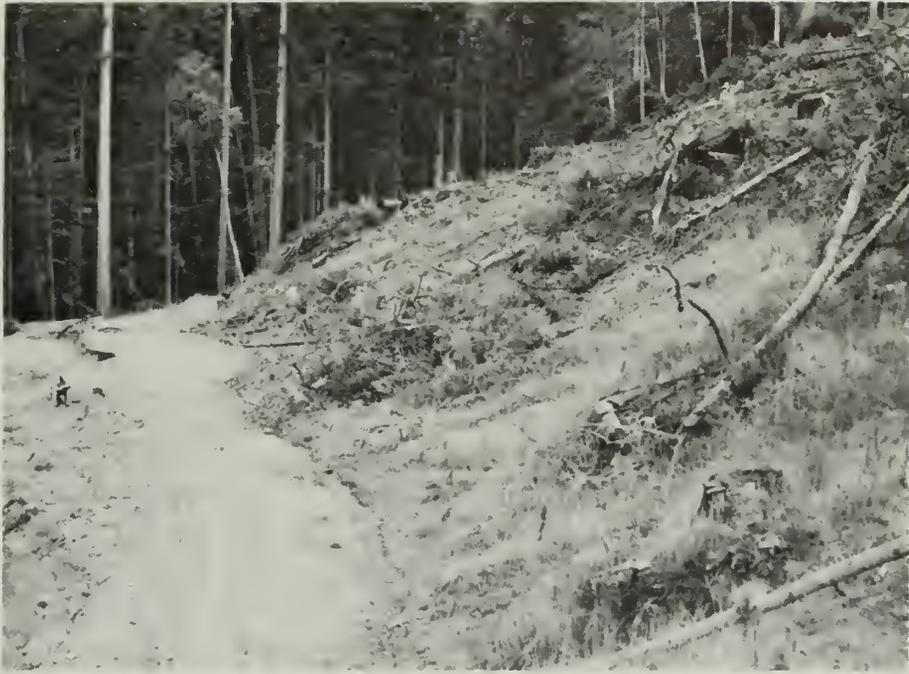
Figure 21: PP16a 8/23/78
C-90 road prior to rehabilitation is showing signs of instability. Small cut bank failures are blocking the inboard ditch. Note the scarp of a road fill failure behind the person at the left of the photo.

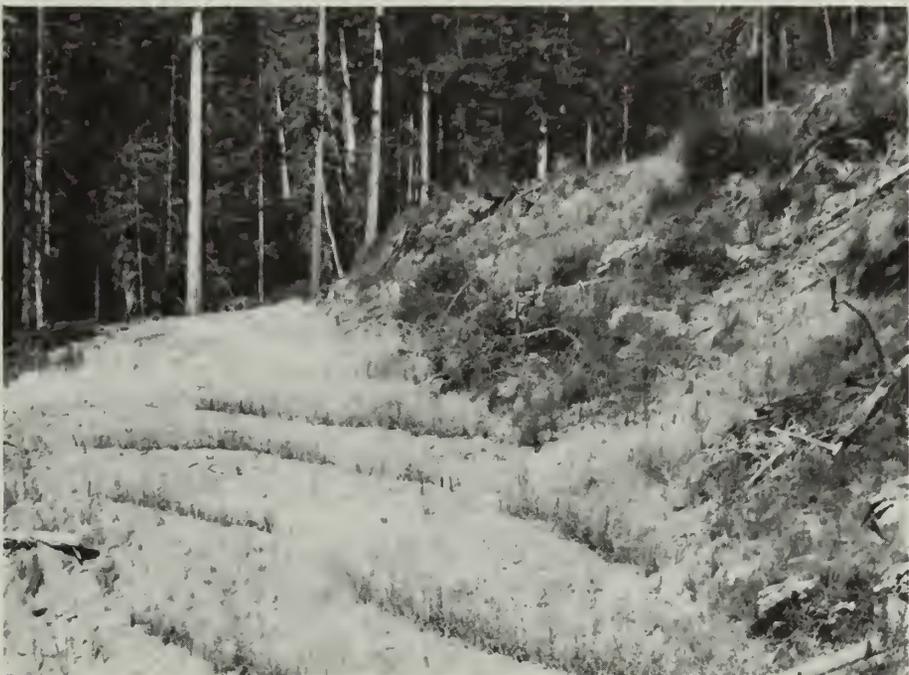
Figure 22: PP16a 10/1/79
C-90 road after rehabilitation. The road has been decompacted, road fill has been pulled back, and the material has been outsloped. Note the rock cross drain behind the people, and the rows of willow wattles on the outsloped road.

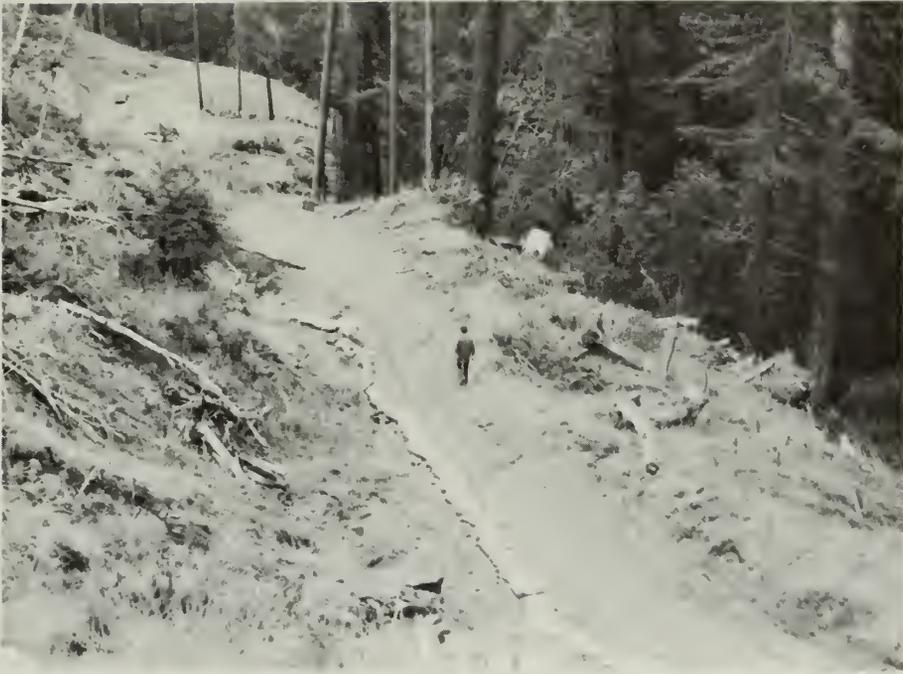
Figure 25: PP16c 8/23/78
C-90 road prior to rehabilitation. Sandbags line the unstable inboard ditch of the rocked haul road.

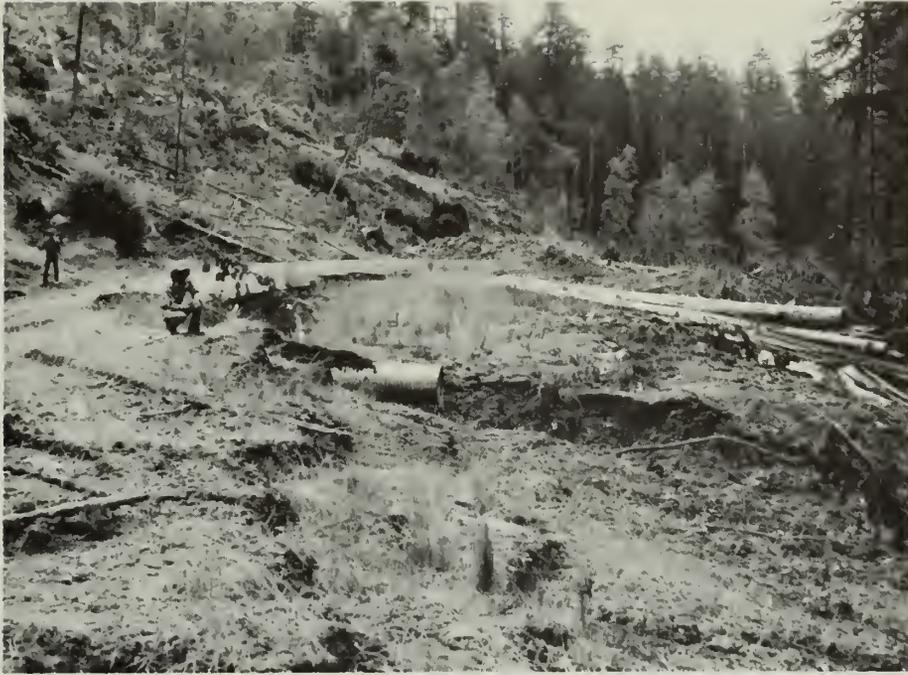
Figure 29: PP14d 8/23/78
Prior to rehabilitation, log landing is truncated by the scarp of a major failure. Culvert is no longer operational.

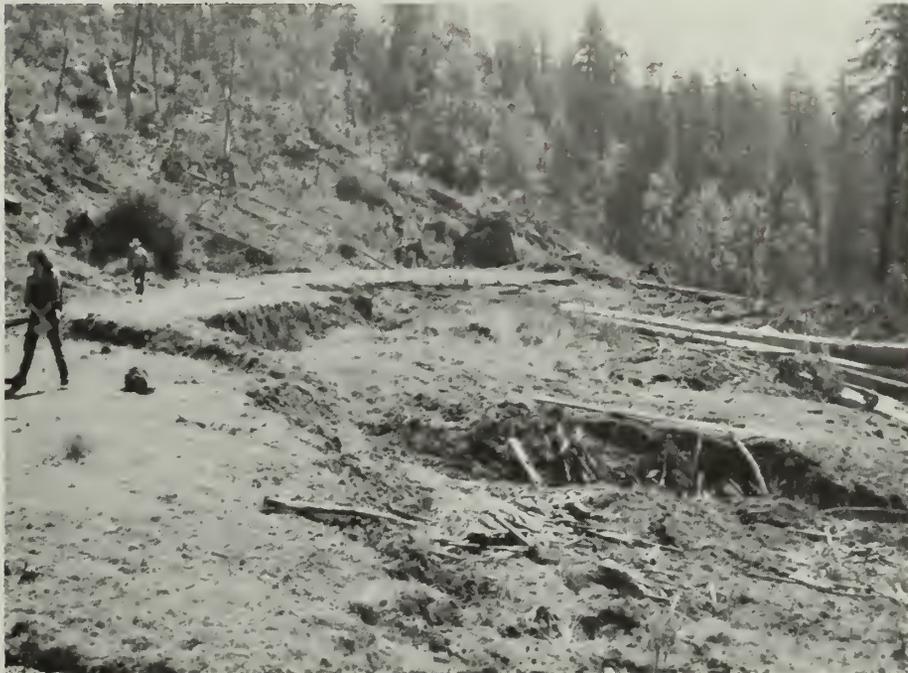
Figure 30: PP14d 3/19/79
After rehabilitation, culvert has been removed and cross road drains have been constructed to drain surface runoff from the site of the failure. In addition, a drainage ditch was dug at the toe of the cut banks to direct runoff into cross road drains. The deep-seated failure was not addressed except through upslope drainage diversions.

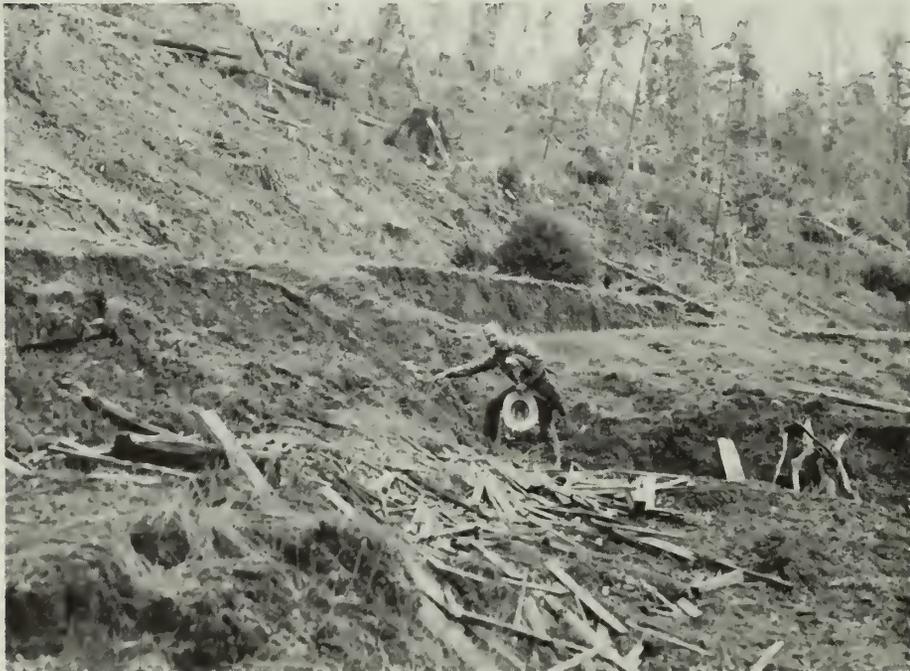
Figure 32: April, 1979.
The outside edge of a landing failed where instability had previously been seen (see Figure 30 for comparison). The man's hand points to a cross road drain that has been truncated by the scarp of this failure.

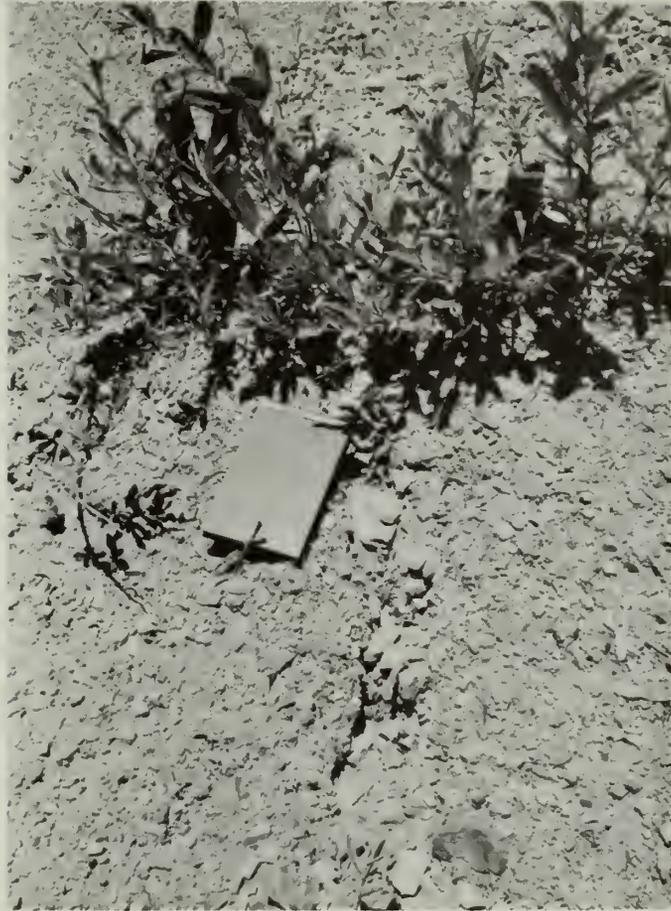
Figure 35: Although willow wattles can disperse small amounts of runoff and impede rilling, they are less effective when subjected to concentrated runoff. Here, a rill beginning upslope of a wattle row carries enough runoff to undercut the wattle and continue rilling downslope.

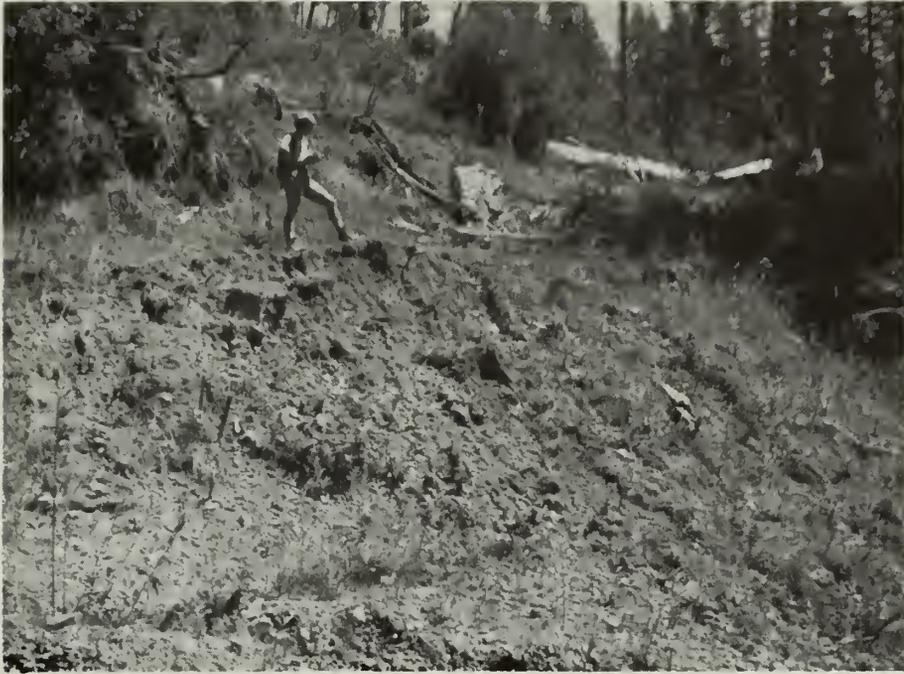
Figure 36: Slump in a cut bank that had been planted with willow stem cuttings a few months earlier. The young sprouts have not yet established an extensive enough root mass to prevent slumping. Note remaining stem cuttings to the left of the center of the photo.

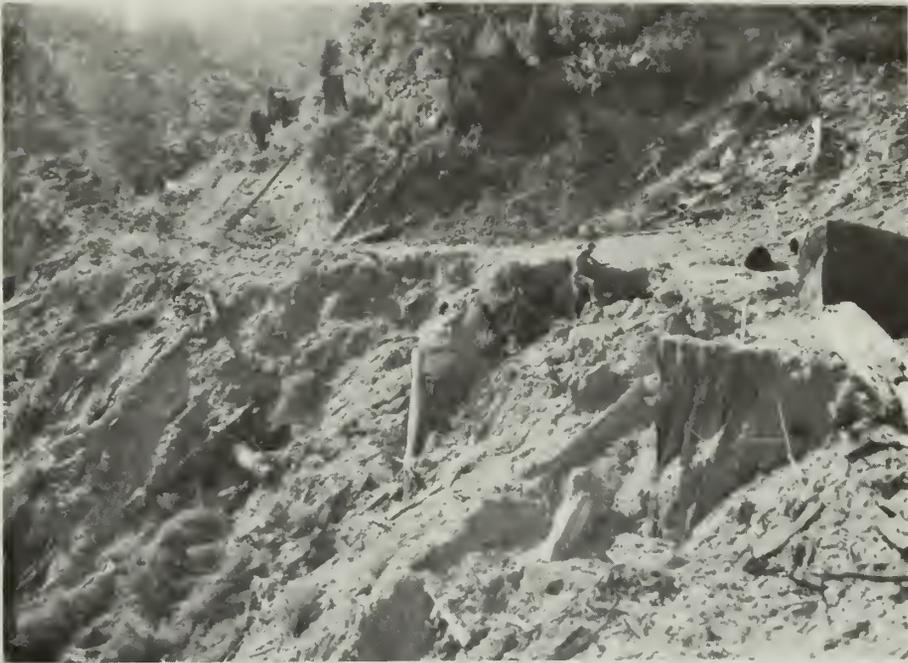
Figure 45: PPA4 9/7/78 Prior to rehabilitation, skid road has unstable, oversteepened fill at outboard edge of road.

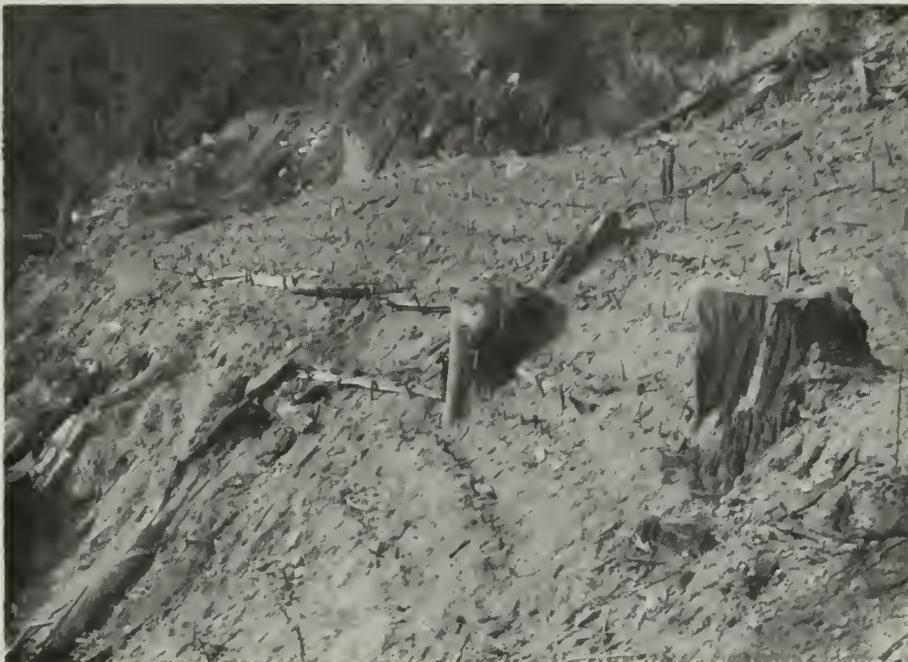
Figure 46: PPA4 1/4/79
After rehabilitation, perched fill has been pulled back by a small backhoe, and road was outsloped. Contour rows of willow wattles were installed just prior to this photo.

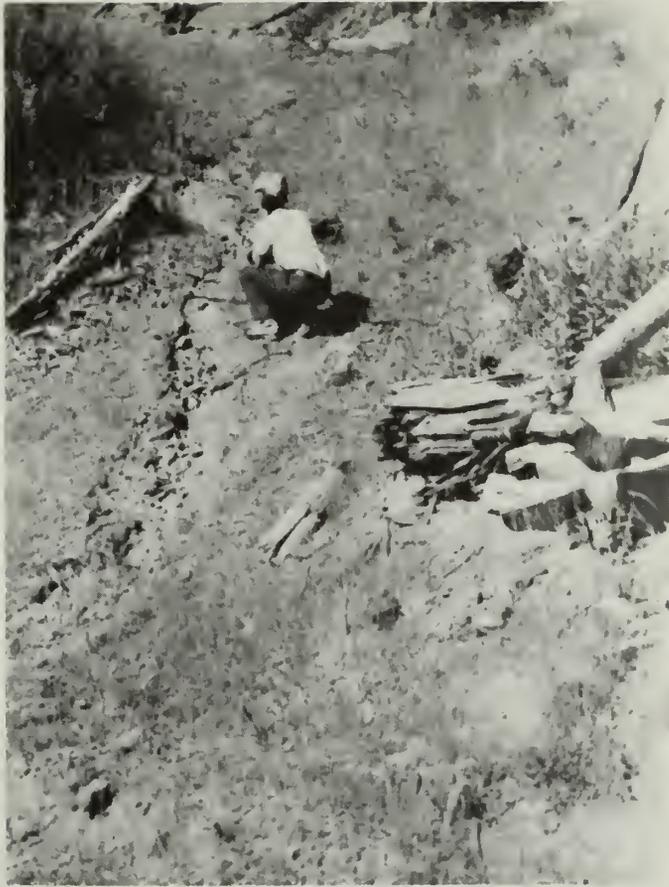
Figure 53: A rill has developed on a skid road which was seeded with grasses. Under high runoff conditions and where runoff is concentrated on roads, a grass cover does not prevent rilling. Ground cover is approximately 50%.

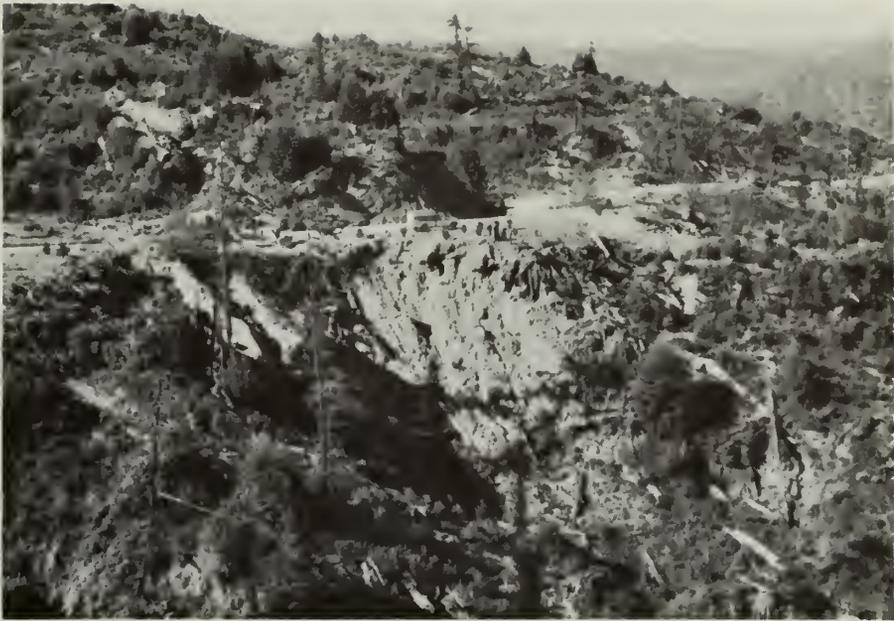
Figure 56: PP3 10/2/78
View towards C-Line landing prior to any rehabilitation work. Part of the landing failed, leaving much of the organic and inorganic debris perched precariously.

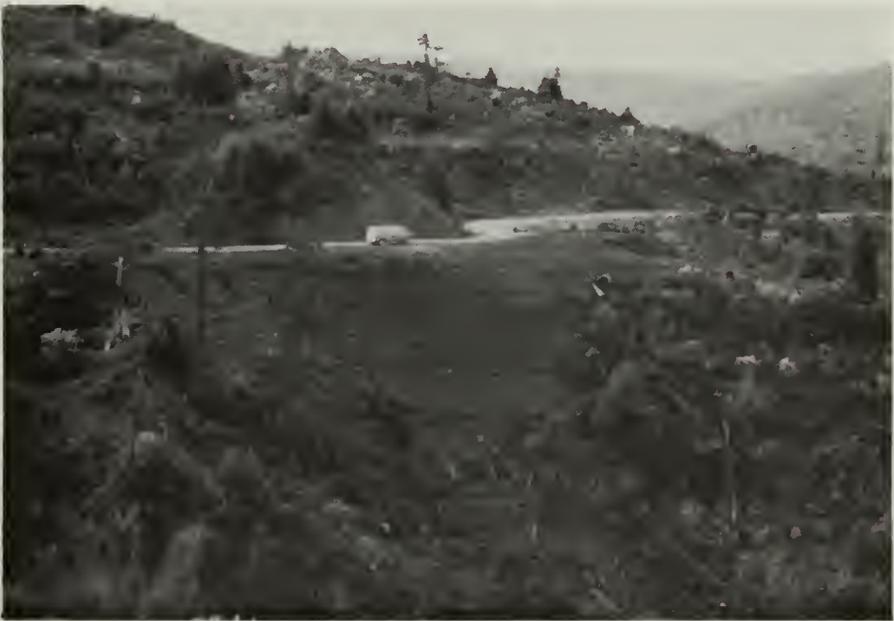
Figure 57: PP3 12/20/78
A dragline crane pulled back the unstable fill and debris, and a cat tractor moved it to stable skid roads. Wattle rows of willows and other species were planted on the slopes.

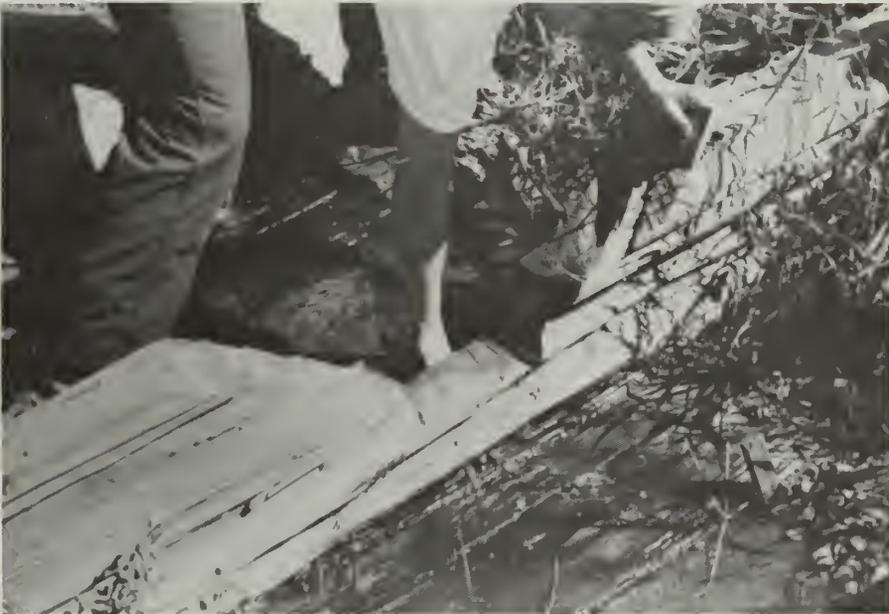
Figure 67: June, 1979
Leakage between splashboard energy dissipator and base of check dam. Ponding effect of the check dam is lost and consequently little sediment is deposited in the catch basin upstream of the dam.
