MEMO

To: Rick L. Bousquet, Liollo
From: Dorothy S. Krotzer, BCA
Date: 5/5/09
Subject: Fort Sumter National Monument

The following is a summary of immediate observations and recommended "next steps" related to the brick masonry of Fort Sumter National Monument, as identified during my site visit and meeting with the project team on 4/21/09-4/23/09. Members of the "project team" include the NPS staff of Fort Sumter National Monument, Liollo Architecture and BCA. The intention of this memo is to provide a prioritized course of action for the maintenance of the brick masonry of the fort, including the development of an appropriate restoration mortar for the site. The observations listed below will also inform BCA's proposal for additional consulting services.

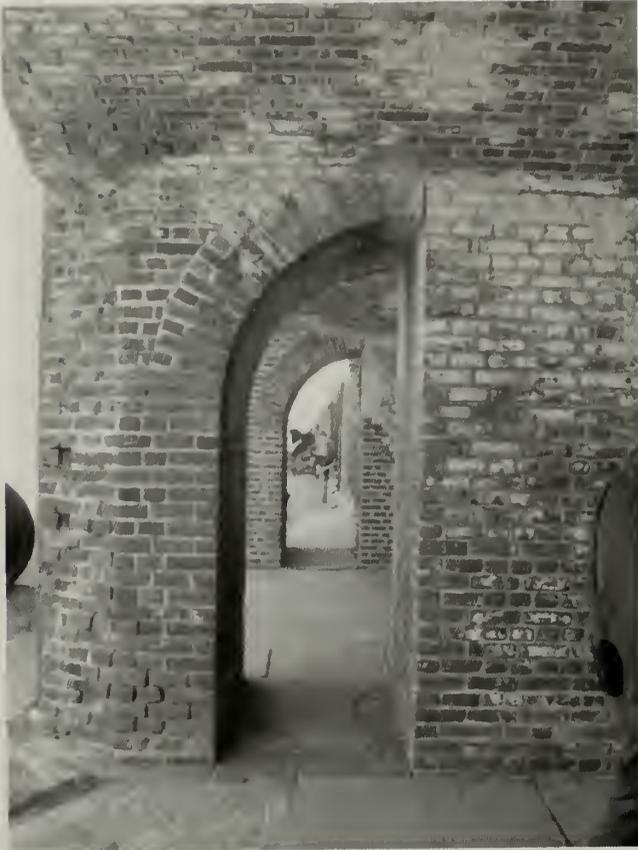
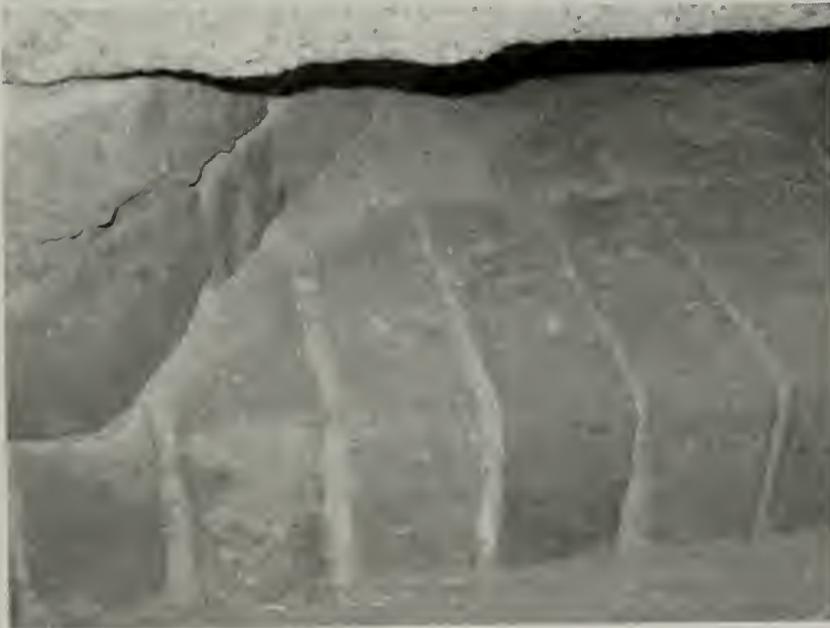
Images 1 and 2. Fort Sumter, April 2009. The first tier casemates contain areas of relatively intact interior brickwork and mortar. These brick represent the original appearance and condition of the Carolina Grey bricks.

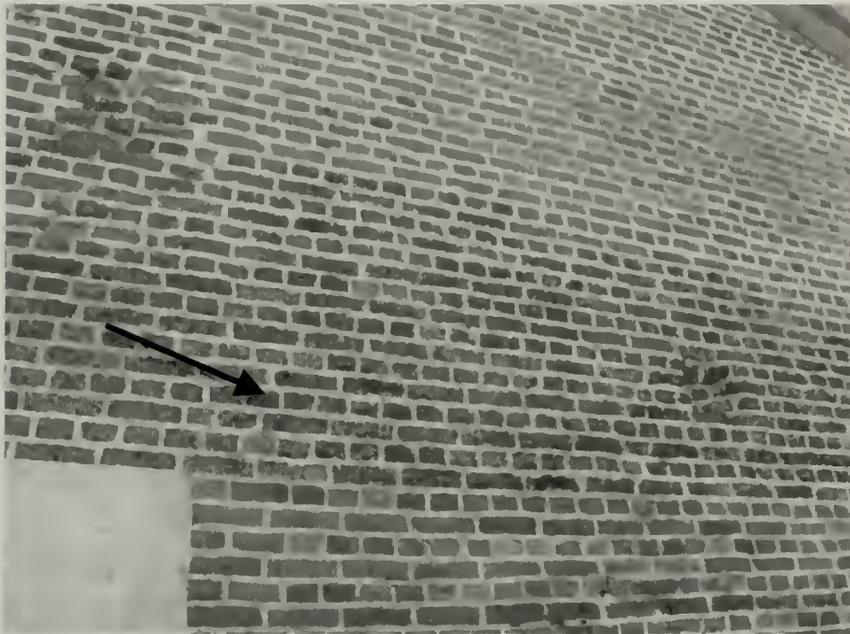
Image 3. Fort Sumter, April 2009. North elevation, showing example of modern re-pointing and condition of brick. Note more deteriorated band of brick at bottom center.

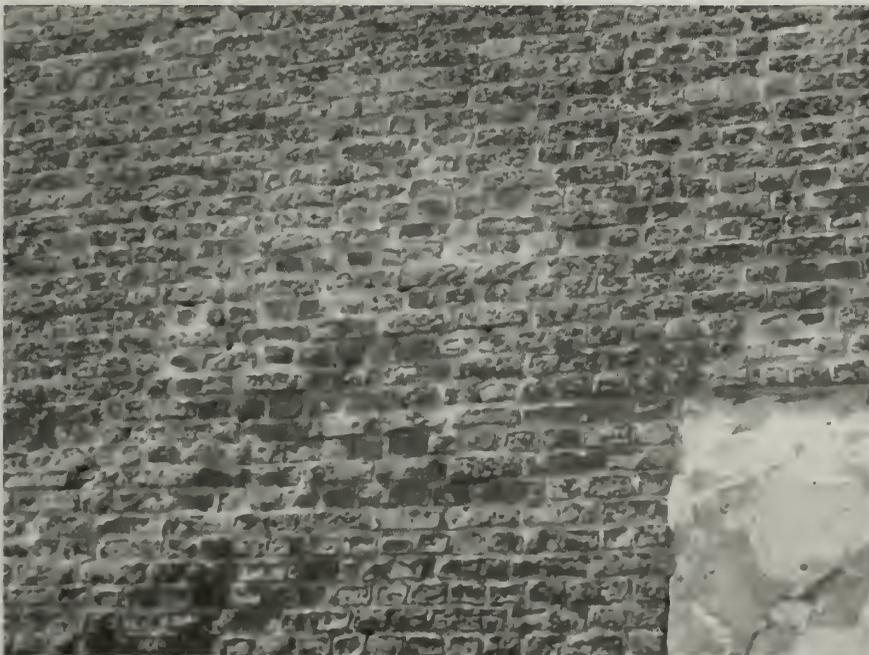
5. It is difficult to assess the impact of the various pointing mortars on the brick. This is due to the fact that the brick is so deteriorated, identifying areas of new damage such as spalls or cracks can be very challenging. The only location where new damage was observed was the east elevation of the exterior scarp wall. This wall receives the greatest amount of wave action (from passing ships) and is presumably saturated with salt water on a regular basis, resulting in cycles of wet-dry conditions and salt crystallization that can damage brick.

Image 4. Fort Sumter, April 2009. East elevation, detail of brick condition. This wall receives more wave impact and saturation with sea water than others and the brick is subsequently more deteriorated.

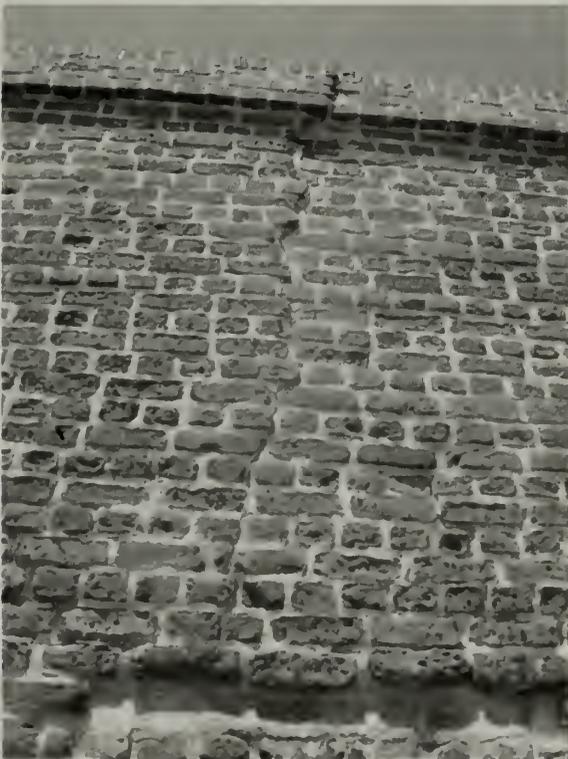
Image 6. Fort Sumter, April 2009. Southwest elevation, area of structural crack.

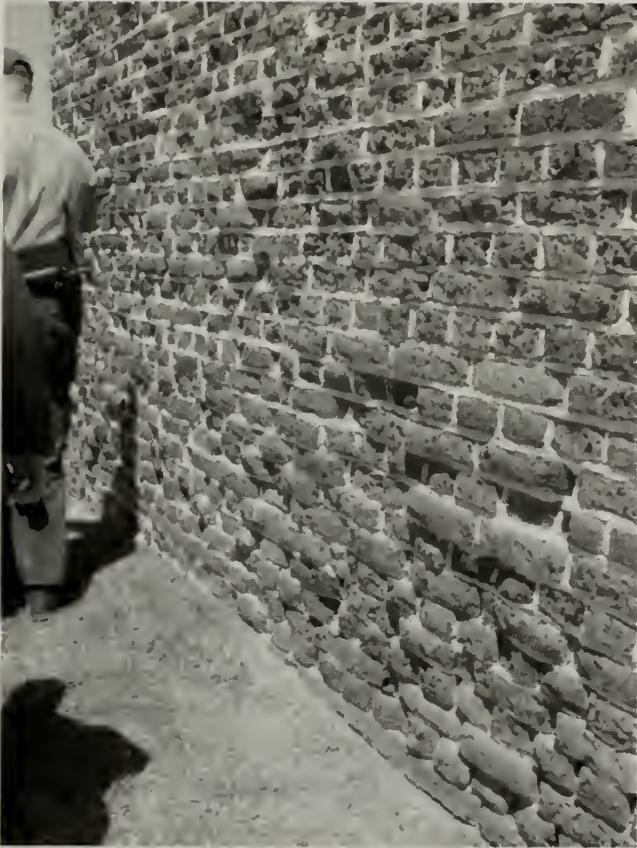
Image 7. Fort Sumter, April 2009. West/Northwest elevation, area of distinct alveolar (wind-driven) erosion.

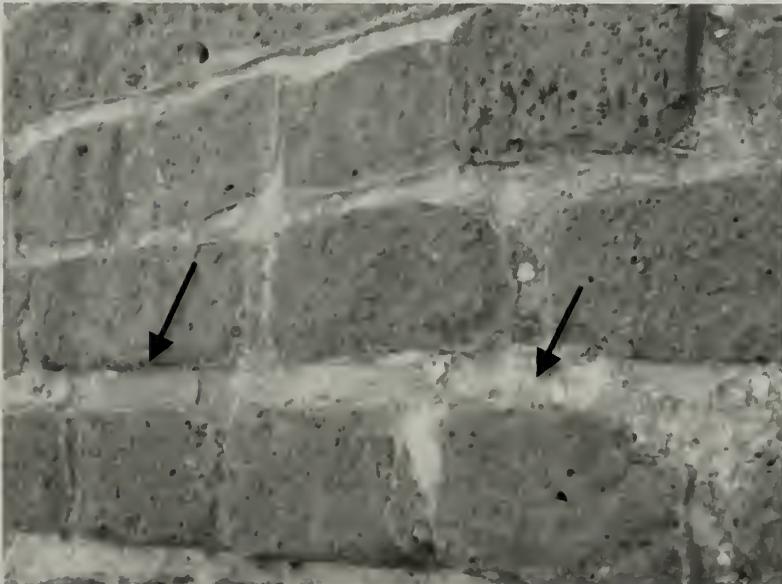
Image 8. Fort Sumter, April 2009. East elevation, mortar failure.

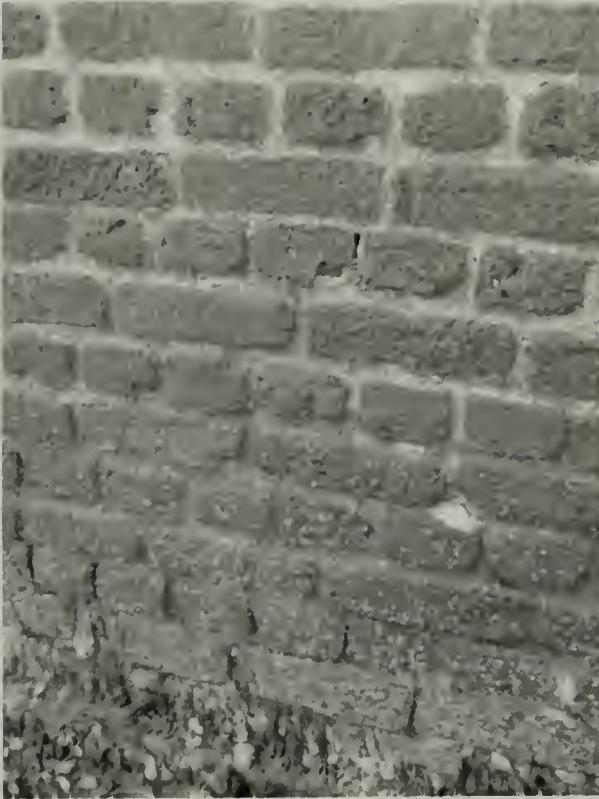
Image 9. Fort Sumter, April 2009. East elevation, condition of mortar (presumably historic) at base of wall with constant exposure to water, particularly at high tide.

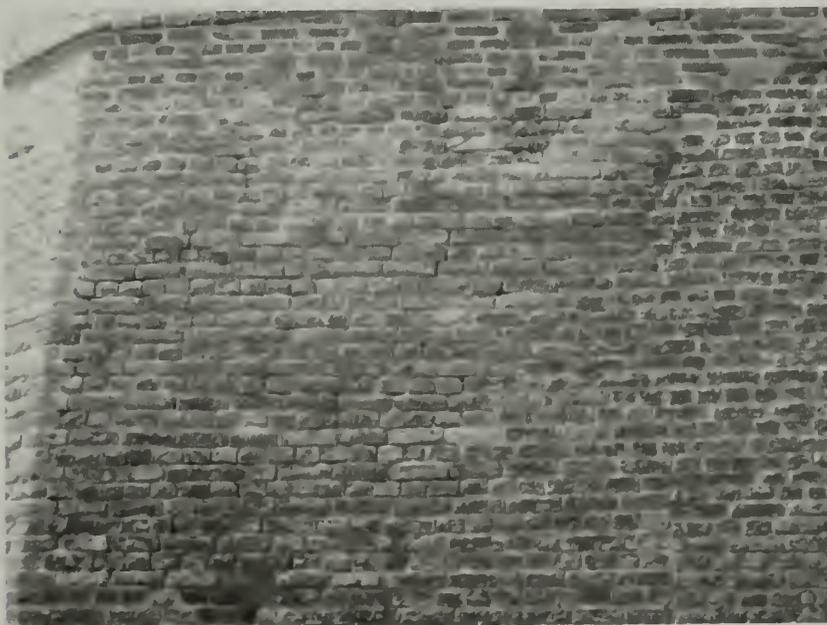
Image 10. Fort Sumter, April 2009. East/Southeast elevation, area of open mortar joints.

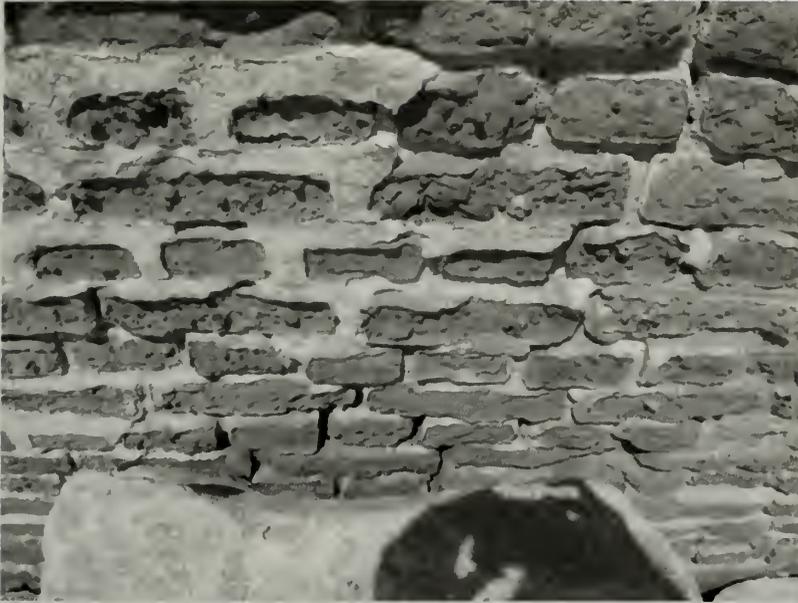
Image 11. Fort Sumter, April 2009. Exterior scarp wall, an area of prior re-pointing campaign based predominantly on Portland cement. Note condition of surrounding brick, it has weathered at a more advanced rate than the mortar, producing a characteristic “honeycomb” effect.

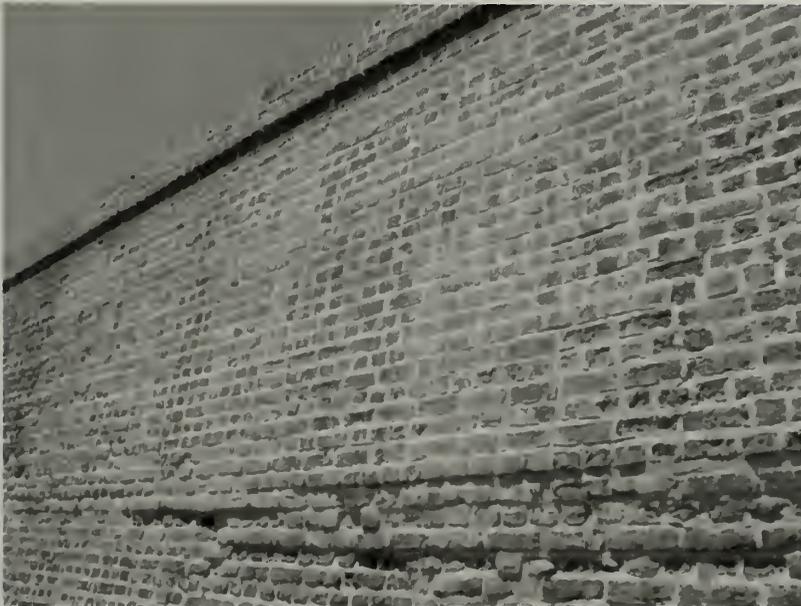
Image 12. Fort Sumter, April 2009. Southeast Elevation, area re-pointed in 2008 using Rosendale natural cement gauged with hydrated lime. The streaking on the wall is most likely due to the lime component of the mortar washing out of the mortar prior to achieving full carbonation.
