**Structural Inspection and
O&M, Occupational and Public Safety Review
of the
Hot Springs Tunnel System,
Hot Springs National Park
Hot Springs, Arkansas**

August, 1993

Bureau of Reclamation
Denver Office

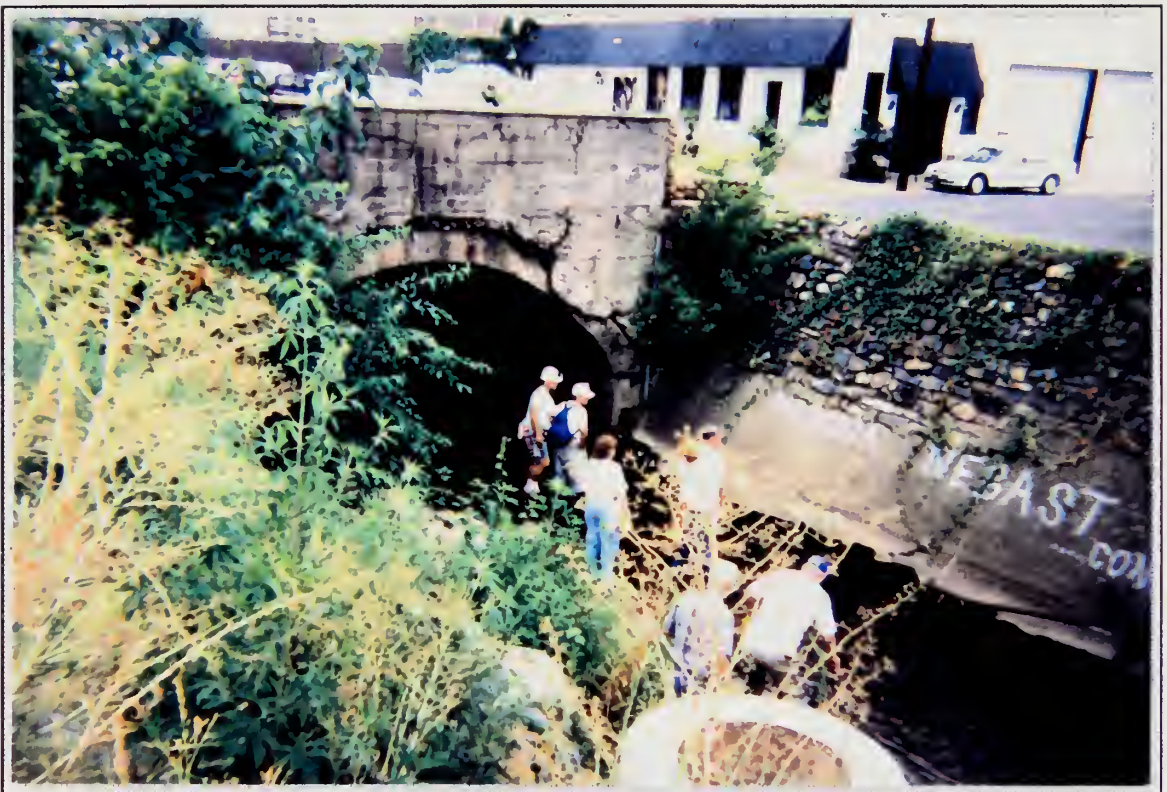
The morning of August 3, those inspecting the tunnel entered the Arch Creek Tunnel at the outlet (about Station 183+00 on Figure 2.3). Photo 3.1 shows the headwall of the outlet.

3.1 Inspection party entering the outlet of Arch Creek Tunnel.
 (About Station 183+00 COE Drainage Map Figure 2.3)

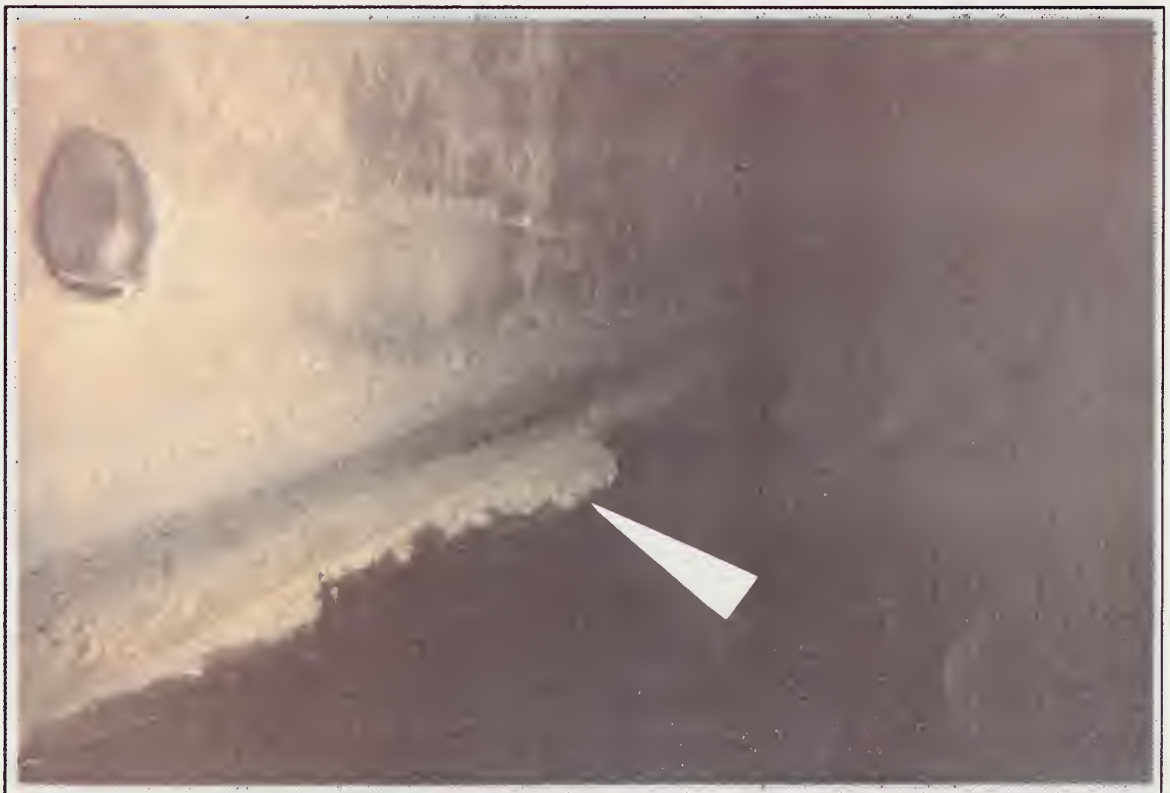
In the outlet reach the Arch sidewalls are founded on a shale rock unit. Significant undermining of the sidewalls was noted in this reach. Photos 3.2 and 3.3 show erosion at the base of the sidewalls and in the invert of the tunnel.

3.2 Sidewall of the Tunnel. The base of the sidewall has been severely undercut. The concrete traces the base of a previous repair. (About Sta. 187+00.)

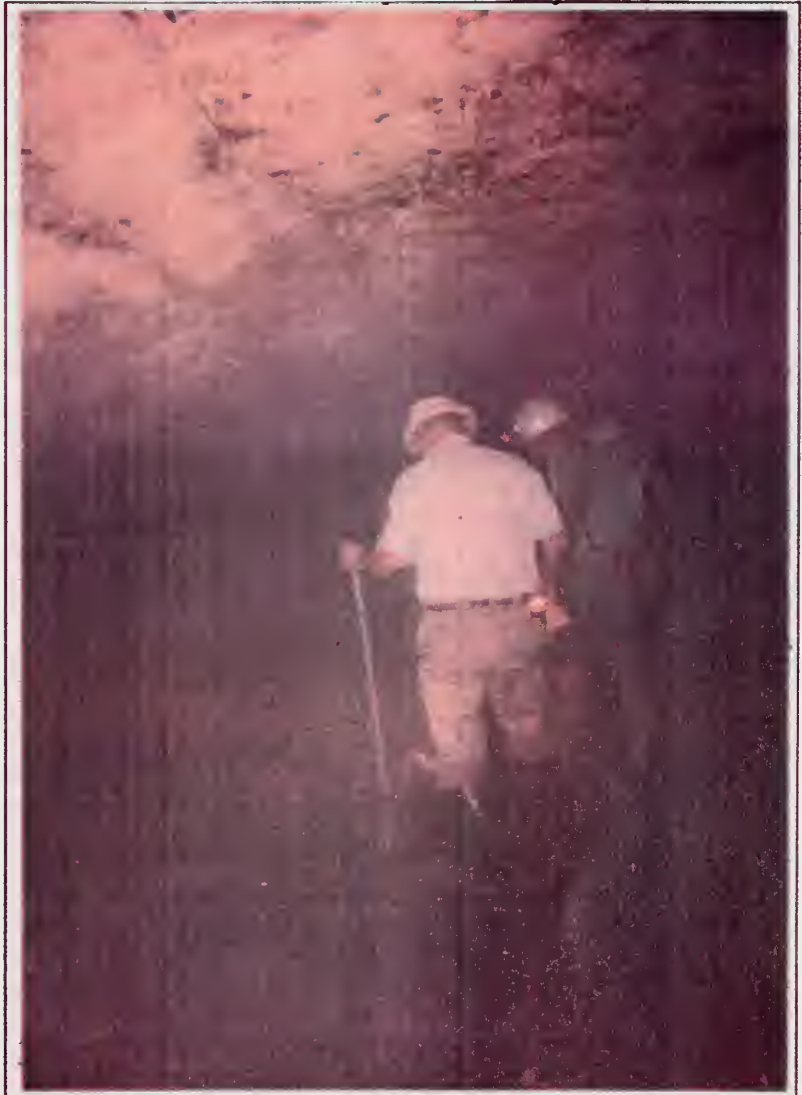
In some reaches the arch has been covered with shotcrete. Photo 3.8 shows a section of the tunnel with a sound shotcrete coating.

3.8 Tunnel Crown. Shotcrete or gunite treatment. (About Sta. 60+00 Whittington Branch)

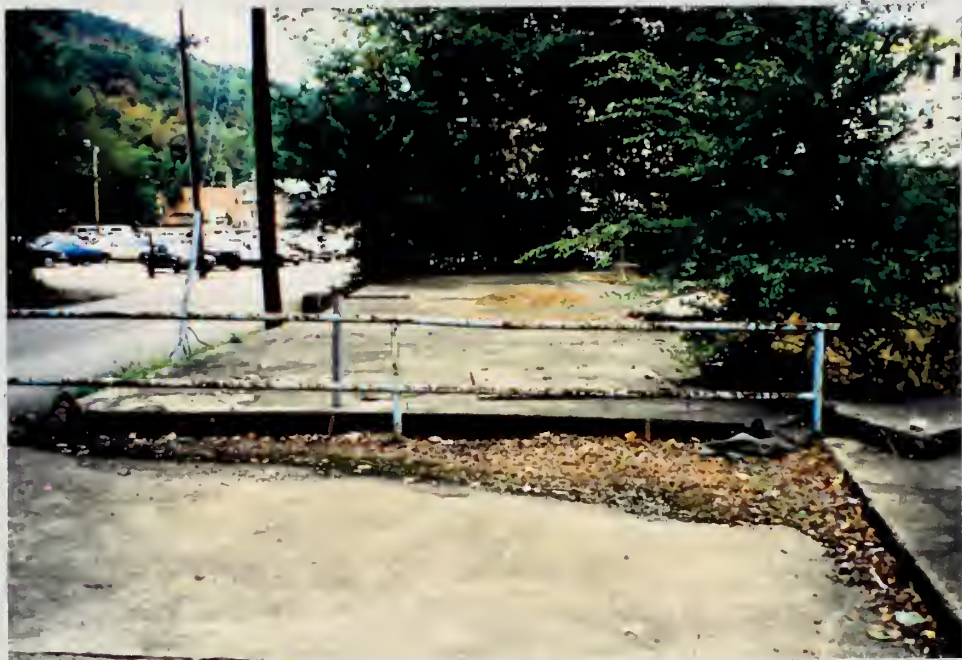
Near the intersection of Loadstone and Arbor Streets a concrete structure covers the tunnel. It is possible for vehicles to access the top of the structure which does not appear to be adequate to support vehicular traffic. The structure also contains unprotected openings to the tunnel below. This condition is a serious deficiency with significant public safety hazard potential

Photos 3.11 and 3.12 were taken from the surface after we exited the tunnel. The area is one of immediate concern. After we observed a somewhat haphazard arrangement of structural steel beams and pipe bracing in the tunnel, we inspected the surface to find the remains of an old structure with unprotected openings to the tunnel. The concrete structure was a thin slab supported by the steel beams we observed in the tunnel. It appeared that vehicles could park on the slab. We discussed the apparent danger with the city representative Dave Stanage on the spot. Structural modifications to this area are needed.

3.11 Vault near Arbor and Loadstone Streets. (About Sta. 238+00)

1993-T1-1. Fence the vault area near the intersection of Loadstone and Arbor streets and cover openings to the tunnel.

A serious safety problem is evident at the vault near Loadstone and Arbor Streets. The area should be fenced to prevent access and structural repair work should proceed.

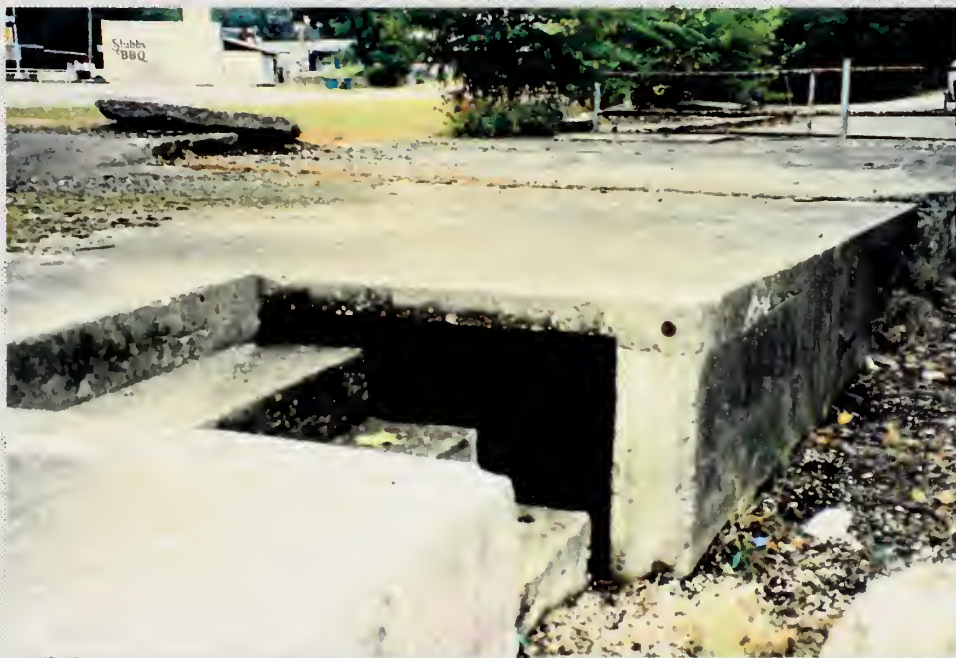
3.12 Vault near Arbor and Loadstone. Unprotected opening and slab thickness are shown.
