Fort Sumter Historic Structure Assessment Report

FORT SUMTER
NATIONAL MONUMENT

National Park Service
November 30, 1992

DATE: INSPECTION AND CONDITION ASSESSMENT REPORT 1992

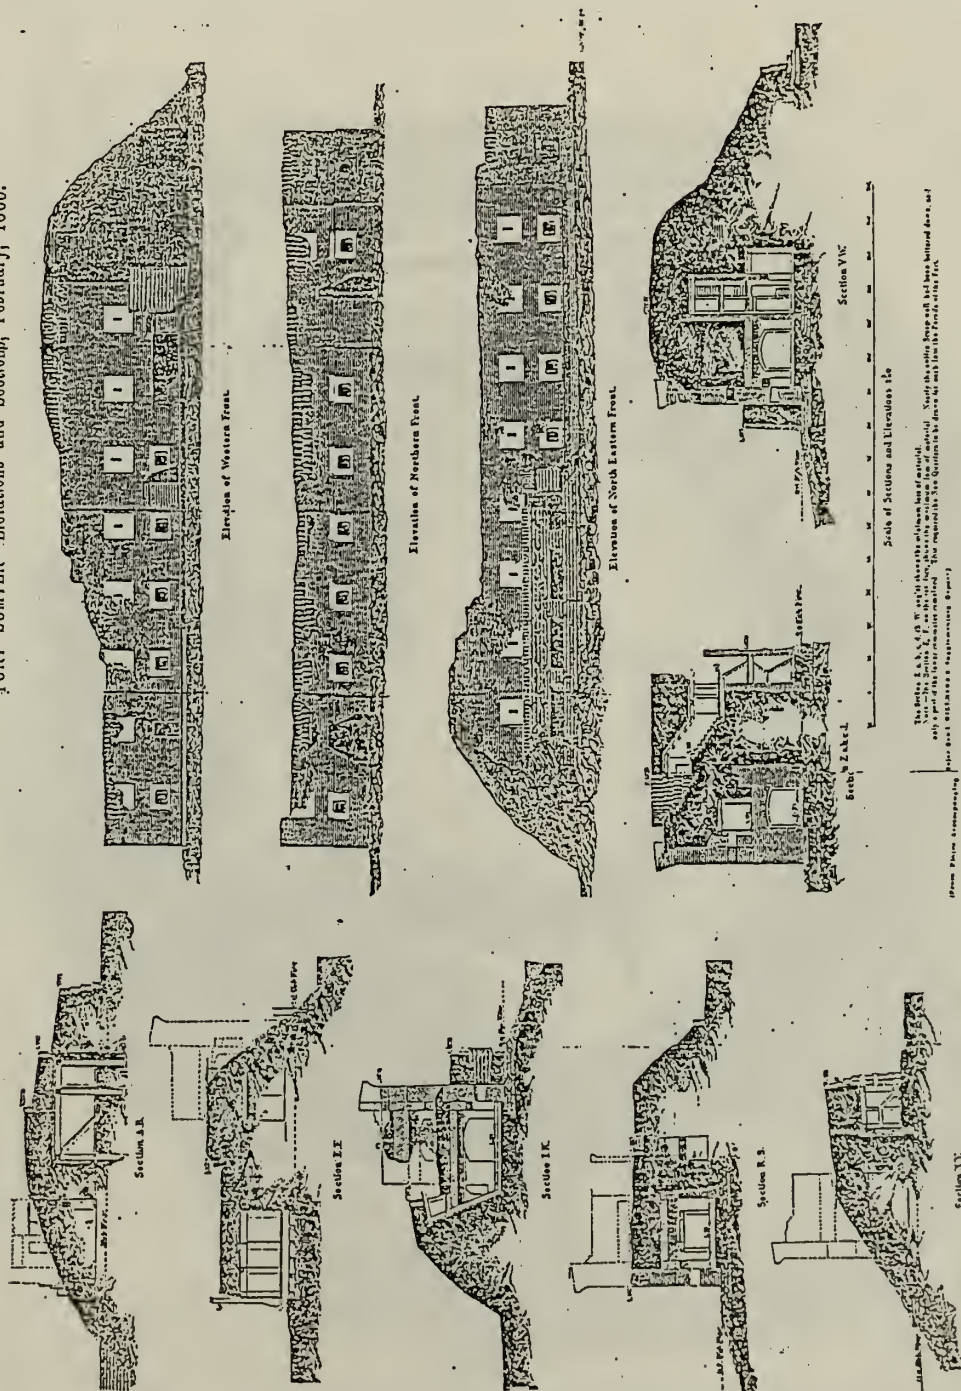
Fig. 2. Elevations and Sections of Fort showing sustained damage by Federal bombardment.

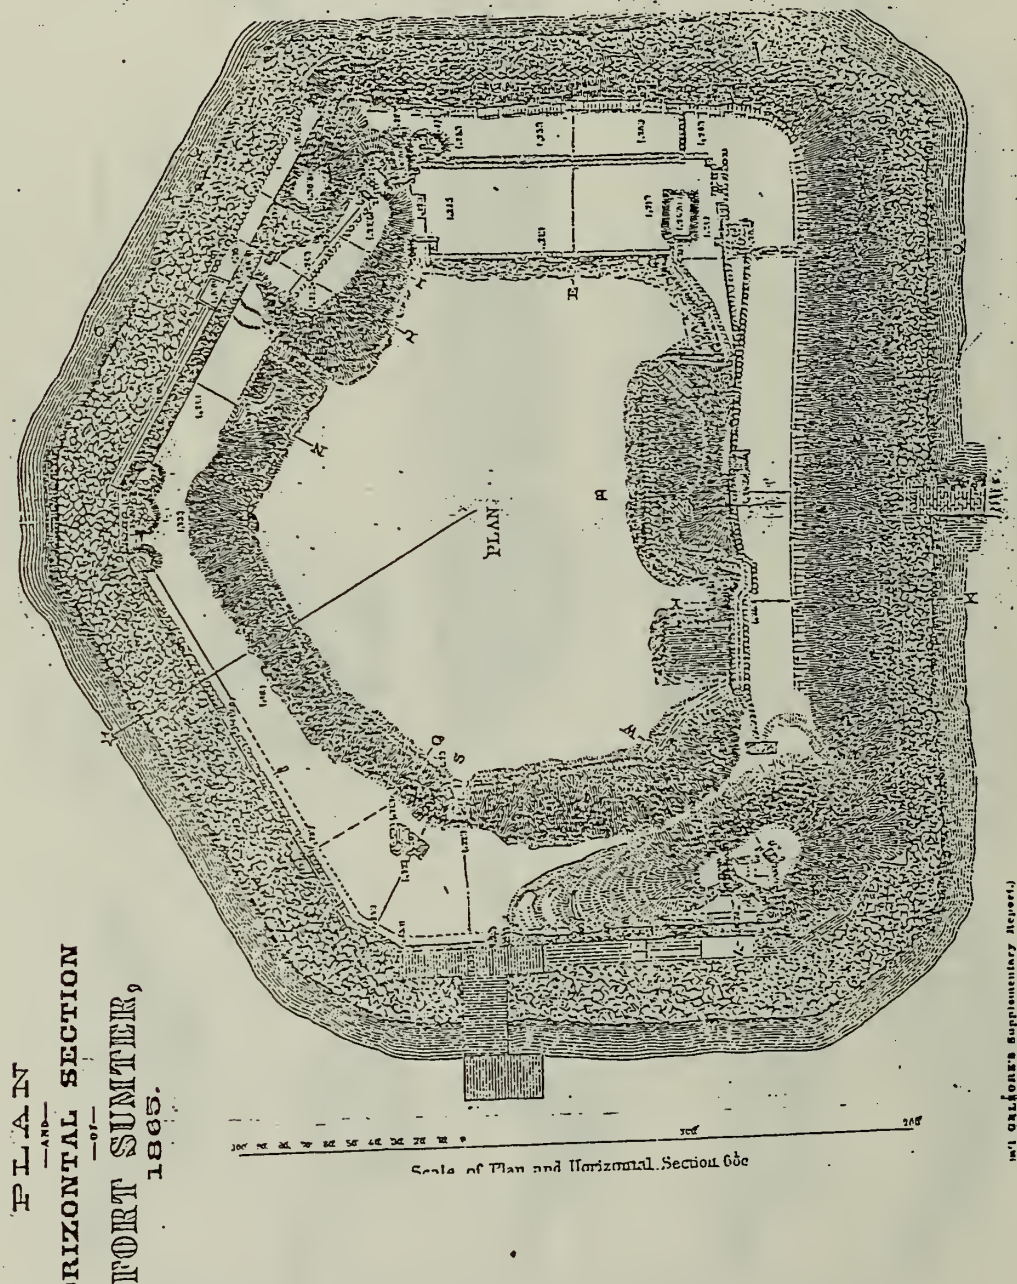
Fig. 3. Plan of Fort at Parade Level showing sustained damage by Federal bombardment

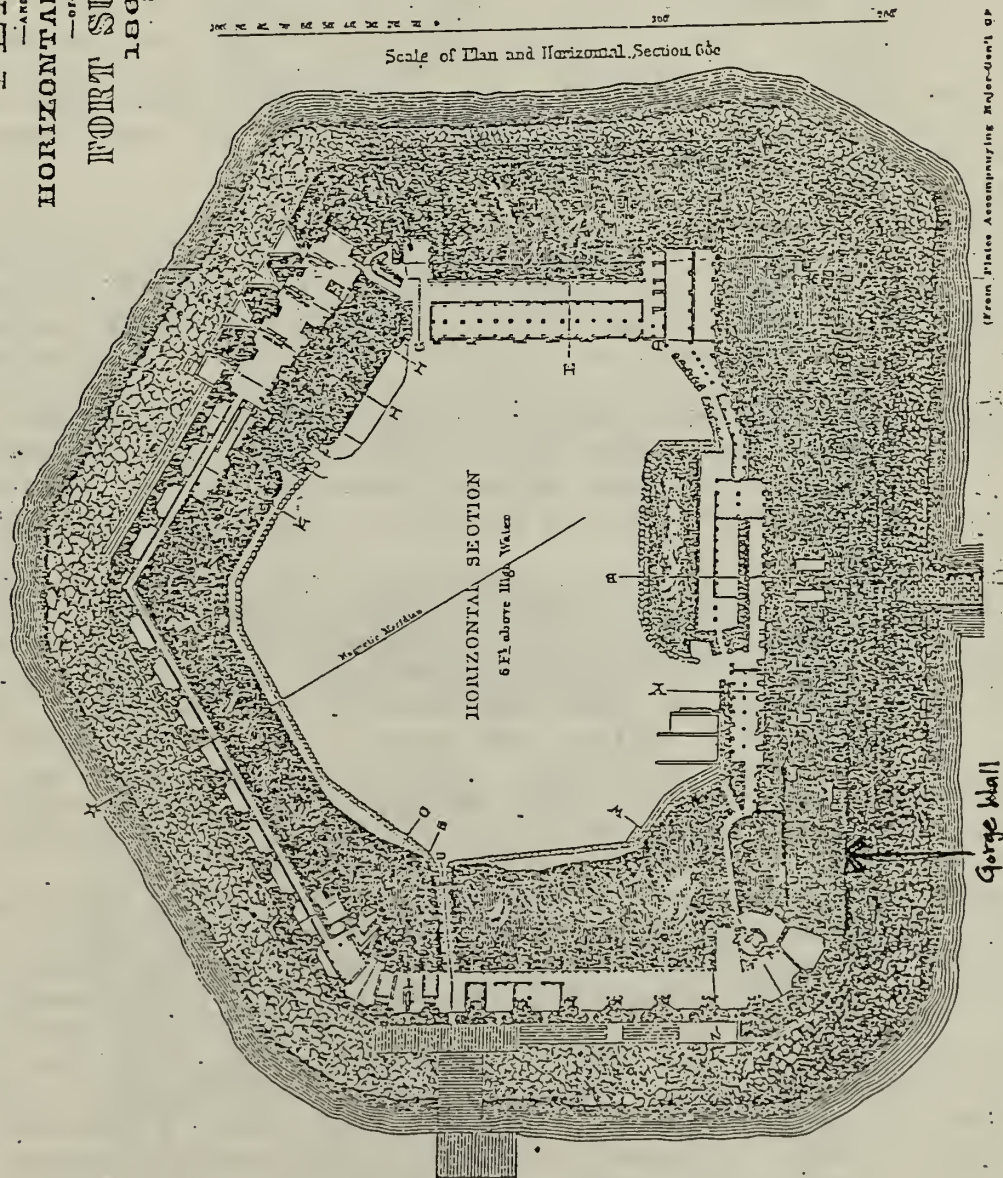
Fig. 4. Plan of Fort at approximate Second Tier Level, showing sustained damage by Federal bombardment.

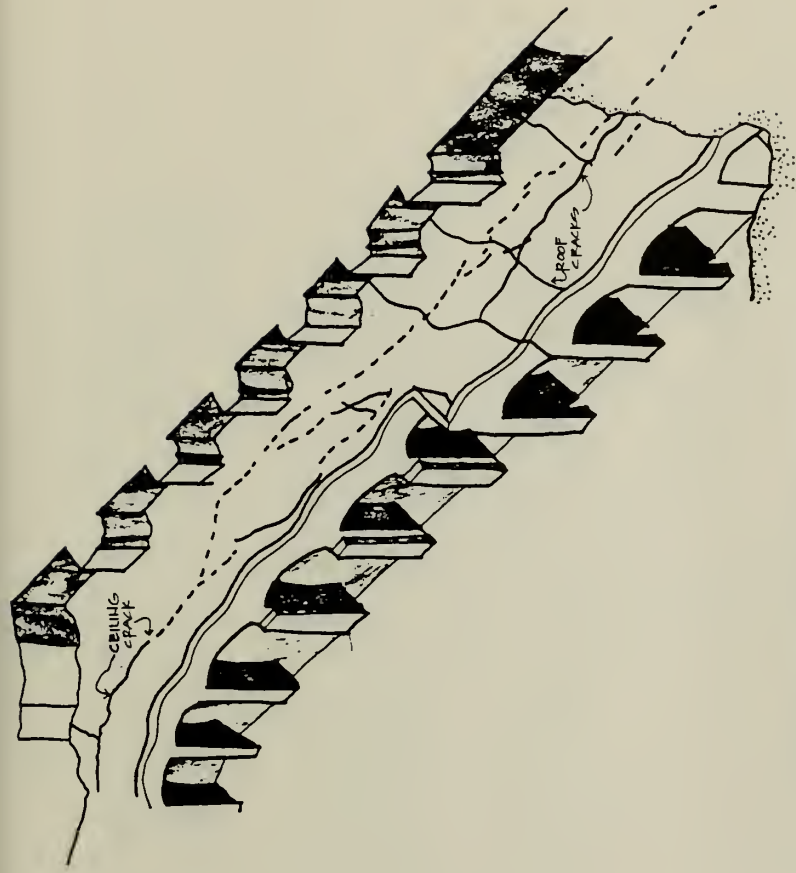
N--tore down 1 casemate arch.

Gorge--Covered/graded 57 LF of parapet, 1' deep

12 May--of two arches in N casemate found intact, the second was found to be substandard.

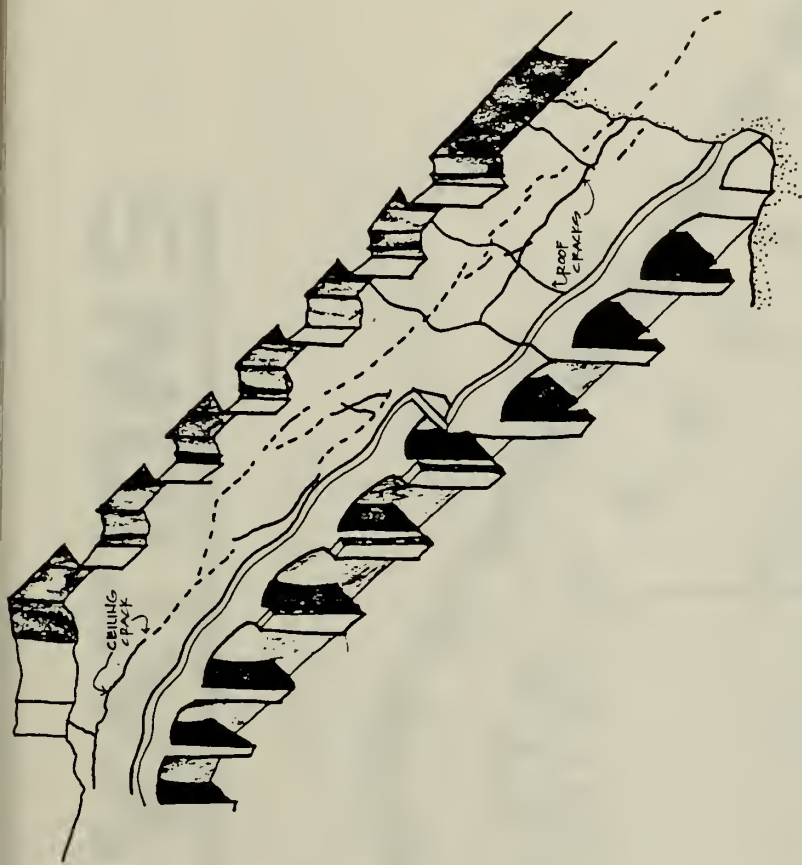
Report of Operations--May (filed 2 Jun 73)

Masonry work (734 cubic feet) as follows: N face scarp wall repair, scarp wall coping at NE and SE angle, repair of NE Casemate arches, NW face retaining wall.

1874
