32 EAST 64TH STREET New York City

Tech Notes

NUMBER 2

Restoring Metal Roof Cornices

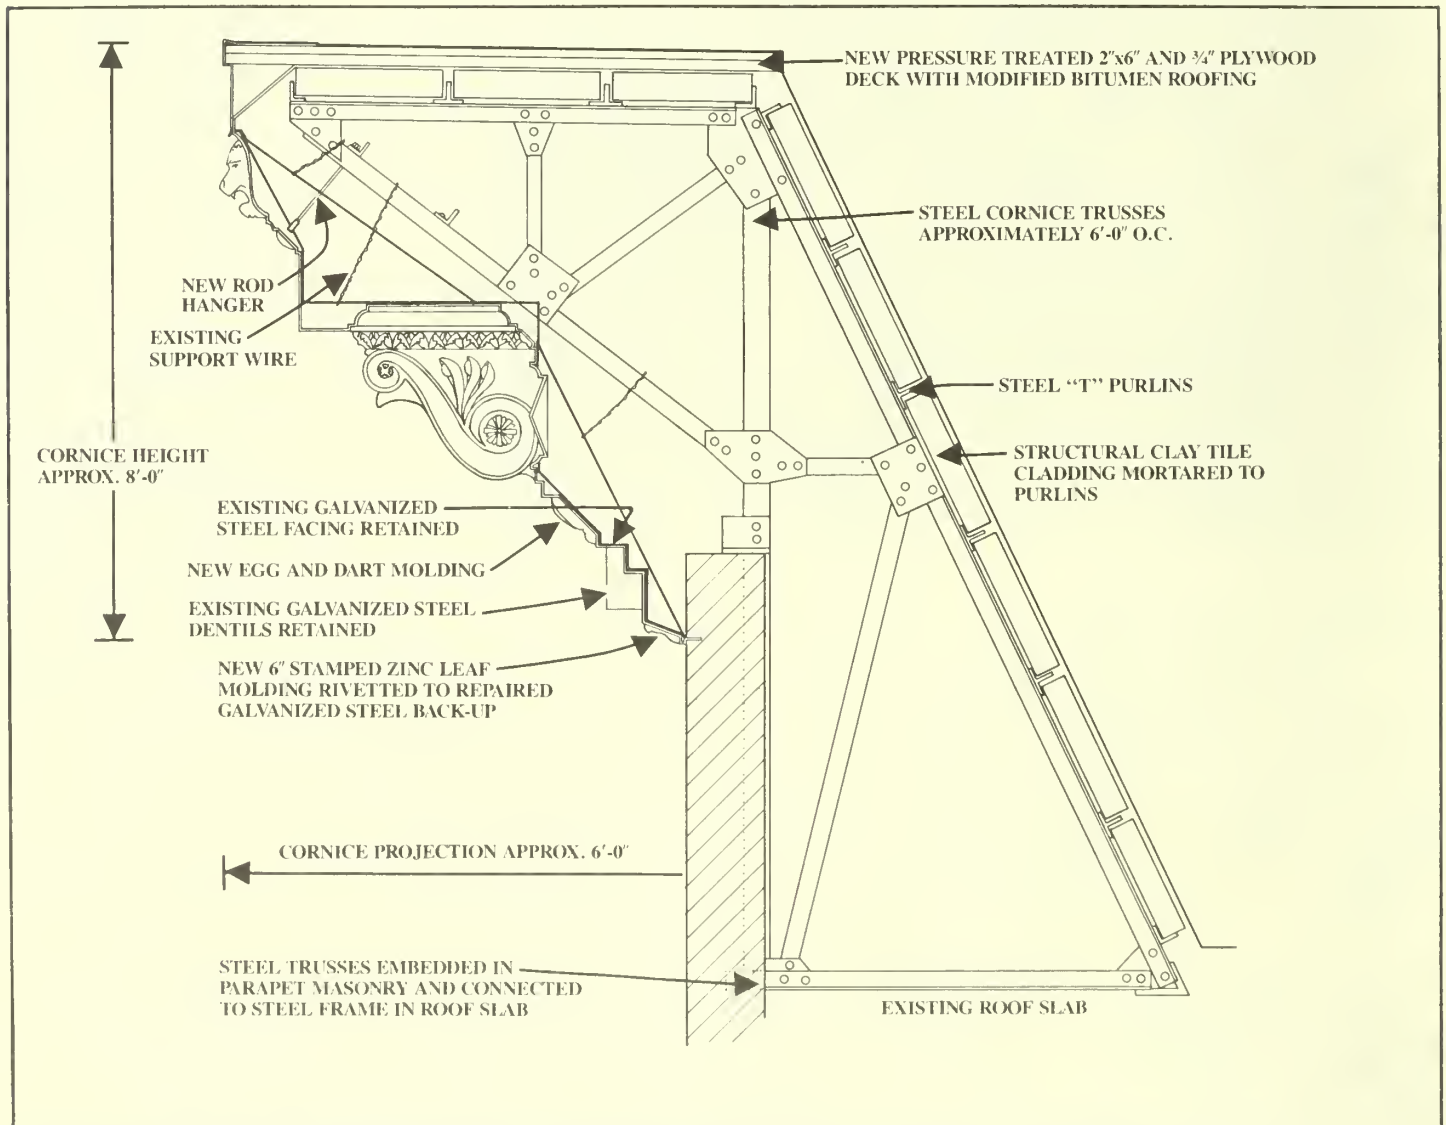
Figure 2. Cornice section shows the manner in which the cornice was supported and attached to the building. Drawing: Michael Devonshire.

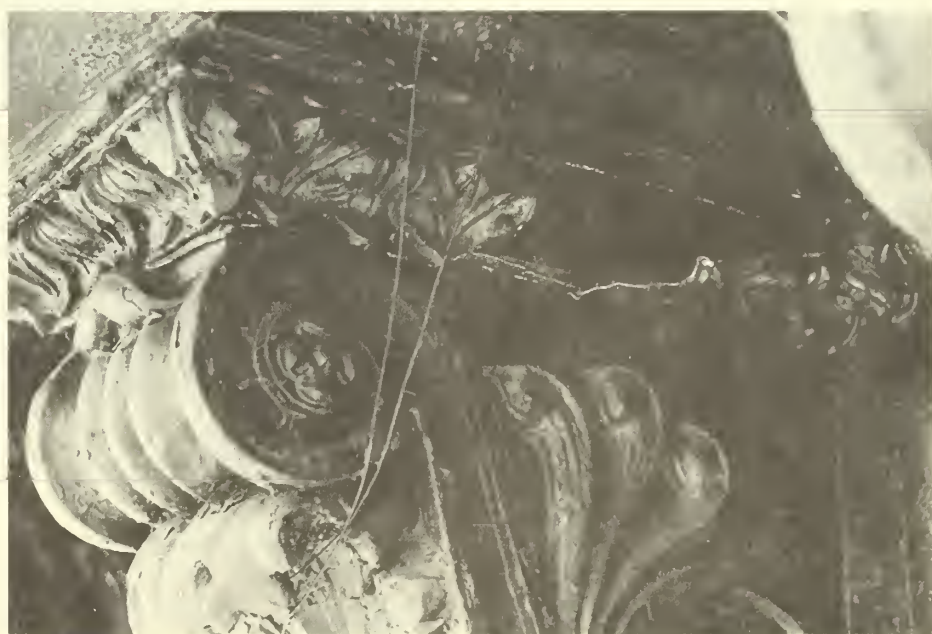
By far the most serious problem with the cornice was the deterioration of the stamped zinc ornament applied to the exterior of the galvanized steel facing. The large 12"-wide zinc modillions projected 24" from the cornice entablature and were in poor condition. The stamped zinc had fractured where integral leaf moldings met the scrolled sides of the modillions, allowing them to separate from the soffit. As a previous temporary safety measure, holes had

Figure 4. As shown in this view, the molding applied to the modillions was extremely deteriorated. A more serious problem was that most of the zinc modillions had fractured where the integral leaf moldings met the scrolled sides, allowing them to separate from the soffit. As a previous temporary safety measure, holes had been cut in the soffit panels to pass supporting wire beneath the modillions. Photo: Richard Pieper.

been cut in the soffit panels to pass supporting wires beneath the modillions (see figure 4). Cracks indicative of metal fatigue were also present in the fronts and sides of the modillions.

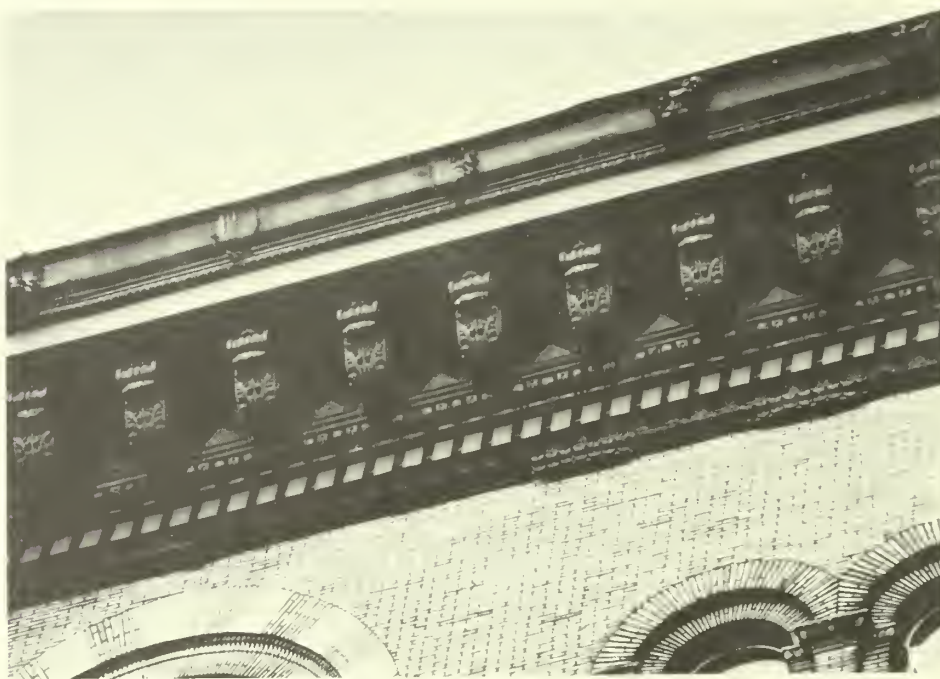
Figure 6. Three of the components of the metal cornice which required replacement because of serious deterioration are shown in this view. They are the lions' heads on the crown molding (several are missing due to failed soldered joints), modillions, and the egg and dart molding at the base of the cornice. The brake-formed galvanized steel that comprised the lineal moldings of the cornice, the soffit and dentil band were in sound condition. Photo: Richard Pieper.

Inspection showed that the galvanized steel facing of the cornice was in repairable condition but that much of the applied zinc ornament was not salvageable. The trusses supporting the cornice, the steel tee purlins and the structural clay tile were generally in excellent condition. Budget estimates were prepared for repair-in-kind and for replacement of the cornice. The architects considered two replacement alternatives; one with new metal and one with glass-fiber reinforced plastic. Repair of the existing cornice facing was the most economical alternative. The New York City Landmarks Preservation Commission also favored repair rather than replacement. Repair of the cornice included replacement of all modillions and nearly all applied zinc moldings; installation of new galvanized steel crown molding and cornice roof edge details; placement of new roofing on the top of the cornice; insertion of new rod hangers to supplement existing wire hangers supporting the face of the cornice, and repainting both the interior and exterior (see figure 6).

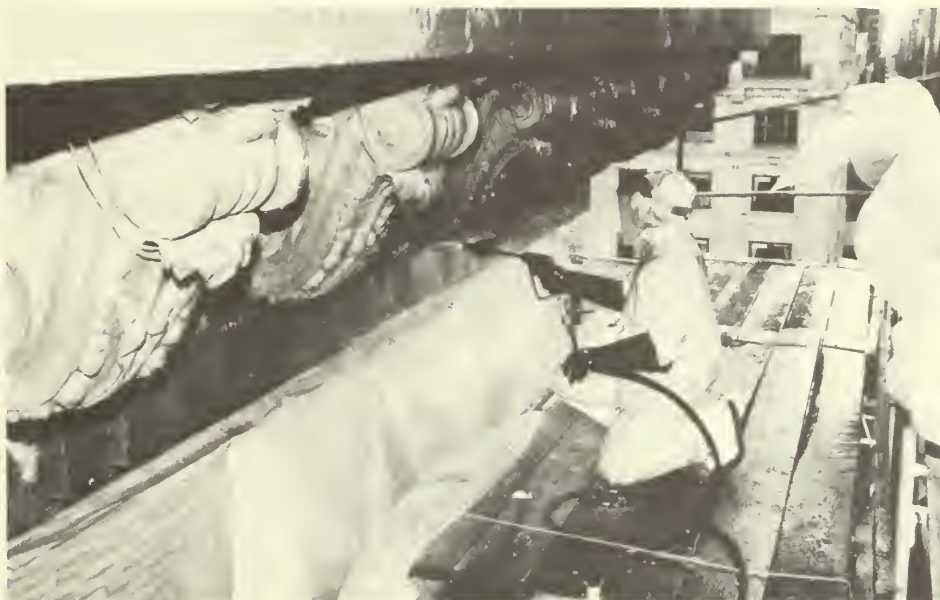
Figure 7. A water spray was used to remove most of the paint from the components of the cornice that were being retained. With the more delicate egg and dart molding, care was required to avoid possible dimpling of the metal. Steps were taken to keep water from collecting inside the cornice. Photo: Michael Devonshire.

removal was dismissed because of environmental and public safety considerations and potential problems of the residue soiling the exterior masonry. Tests of water spray removal techniques showed that successful cleaning was achieved with a rotating tip spray device, which removed nearly all paint without harming the metal substrate (*see figure 7*). Care was required when spraying the zinc molding that was to remain, since the water pressure required to remove the paint was sufficient to dimple the projecting metal of the ornament. Water and paint chips were collected in troughs of sheet plastic. Paint residue was gathered to the extent possible, but the spray effluent was difficult to control and some spilled onto the building and sidewalk bridging. In some areas it was necessary to supplement water removal with light hand scraping, using a flat scraper after most paint had been removed.

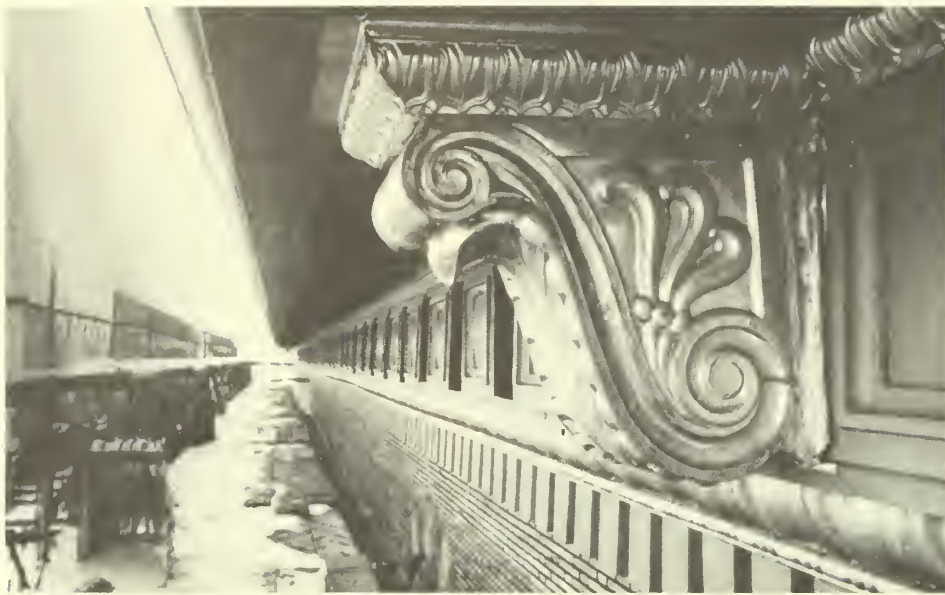
Figure 9. The new modillions, shown here in an installation test, were the same size as the originals but not precisely the same design. Had the difference in appearance been discernible from the street below, matching pieces could have been manufactured at an additional cost. Photo: Michael Devonshire.

New stamped zinc ornament closely resembling the original was available in stock sizes from a Midwest manufacturer. In some cases it was necessary to gang two moldings (an 8" egg and dart and 3" bead and disk moldings for instance) where a larger original molding had incorporated two designs. Modillions were the only zinc elements requiring significant assembly prior to installation. Modillions were comprised of 6 stamped pieces, which were soldered together in a shop by the contractor prior to installation. While preassembled ornament was available from the manufacturer, assembly by the installer greatly simplified shipping and assured that mounting flanges met installation requirements (*see figure 8*). Since the new stock modillions did not incorporate a leaf molding at the top as did the originals, it was necessary to attach new mitered leaf molding sections to the top of each modillion. New galvanized steel back-up was attached at the top of the modillions for better anchoring to the soffit and to avoid riveted zinc to zinc joints which might fracture in this location (as did the originals due to metal fatigue). New modillions were the same size (24"L x 22"H x 12"W) as the originals, but were not precisely the same design (*see figure 9*). This difference in appearance is not discernible from the street below. (New molds matching the original modillions could have been fabricated at additional cost if this had been necessary for authenticity.)

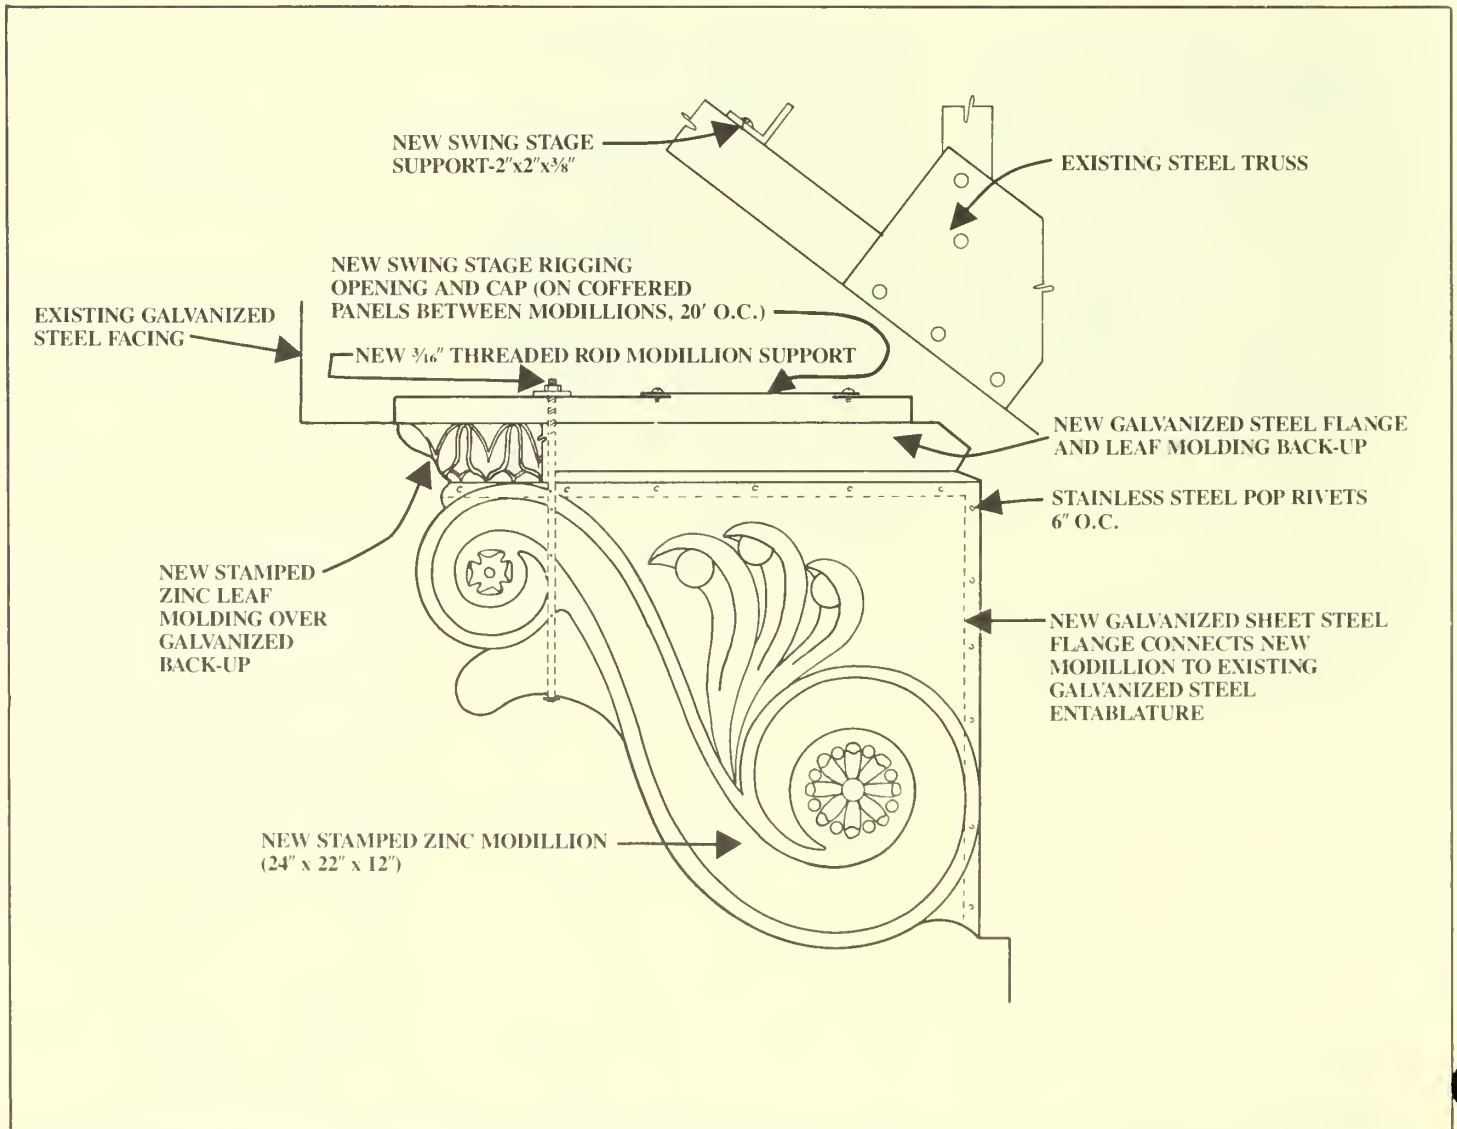
Figure 10. Detailed section shows the supporting technique for the new modillions, which consisted of riveted galvanized steel flanges and threaded rods. Drawing: Michael Devonshire.

Pop rivets were set through flat surfaces on the top and bottom flanges of each molding and were spaced no further than 6" apart (*see figure 10*). Modillions were pop riveted to the soffit through the new galvanized backing used to support the leaf moldings. New galvanized steel flanges

attached the modillions to the entablature. Variations from 90 degrees in the soffit/entablature angle were taken up by the new rear flanges at the entablature.

The $1\frac{1}{4}$ " x $\frac{1}{4}$ " ferrous armatures to which the cornice facing was bolted were lightly rusted, but in satisfactory condition. The original system of twisted wires which attached these armatures to the trusses was also in good condition, but appeared haphazard. Additional threaded rod and clamp anchors were added to supplement these wires. Rods were also

added to attach modillions to the soffit in the event that the new leaf molding flange rivets broke.

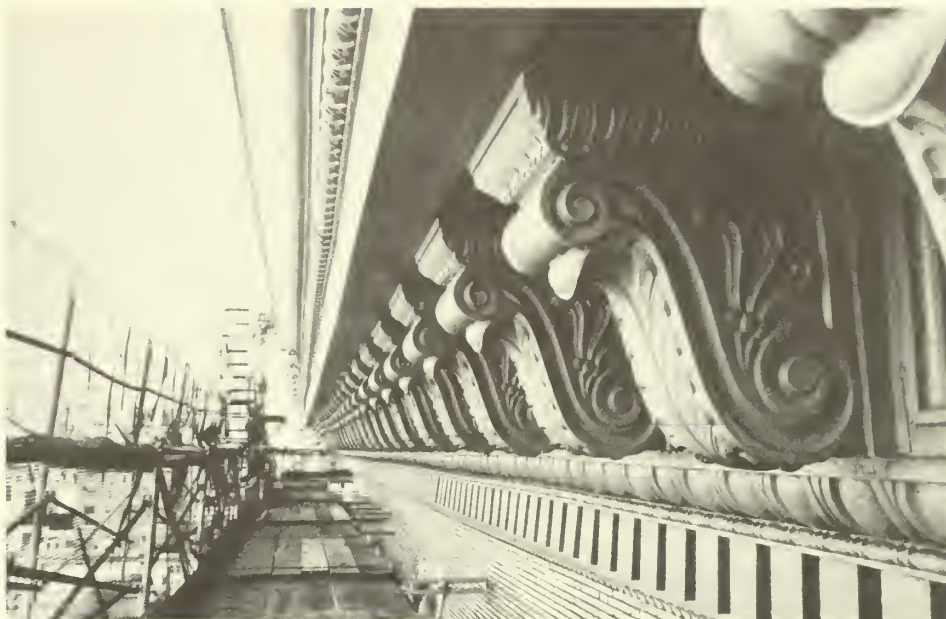
Figure 11. The completed cornice is shown after painting and immediately prior to removal of the scaffolding. Photo: Richard Pieper.

Because it seemed likely that paint maintenance of the cornice would be neglected, a zinc dust/zinc oxide primer was selected to give the cornice a measure of galvanic protection if the paint film was compromised. The primer was used on all surfaces, including the back of the new ornament and the interior of the cornice. The primer and two coats of alkyd finish paint were brush applied (*see figure 11*).

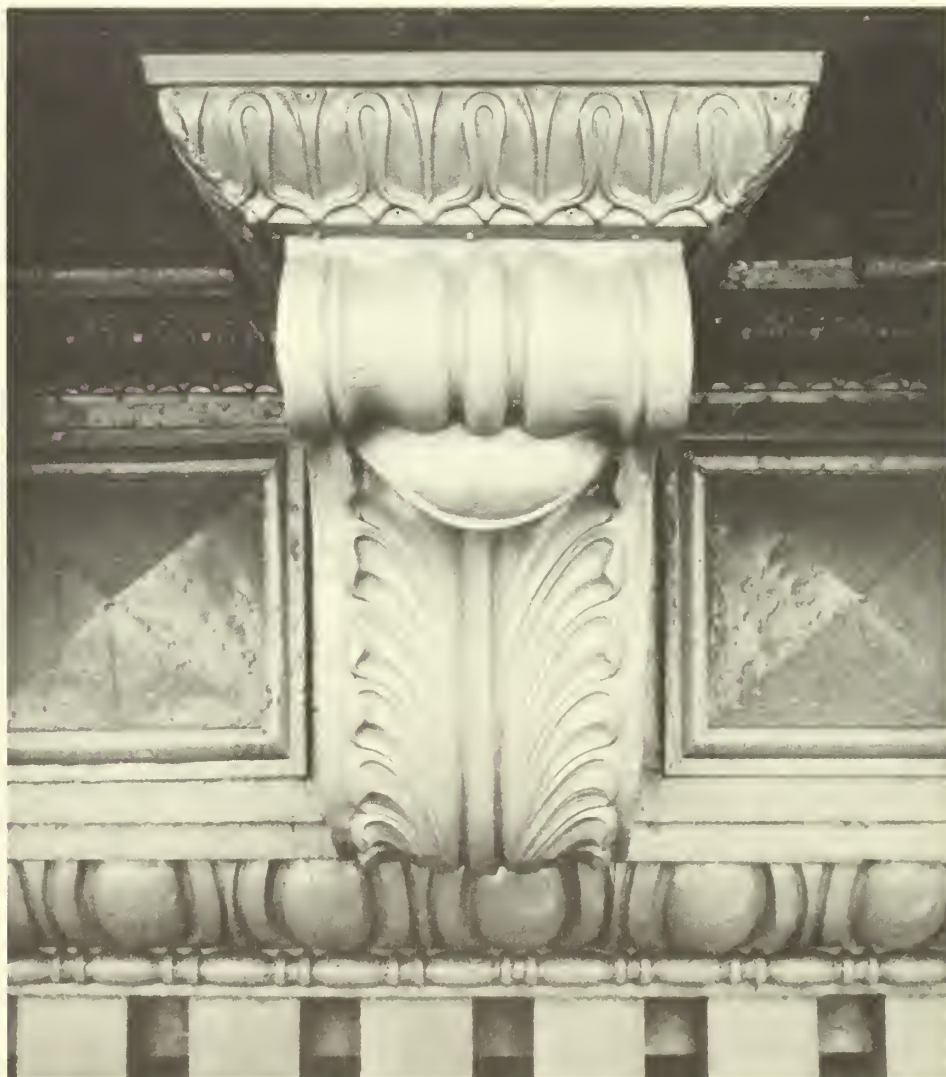
Figure 12. Detail of the completed cornice shows the new zinc modillion and the leaf and egg and dart moldings attached to the historic cornice. This repair approach, which involves in-kind replacement of deteriorated components, is the recommended treatment for such distinctive features as this cornice. Photo: Michael Devonshire.

Repair of the cornice at 32 East 64th Street with in-kind replacement of stamped zinc ornament provided for thorough rehabilitation of the cornice at an acceptable cost (*see figure 12*). The utilization of stock replacements of lions' heads, modillions, and moldings resulted in some savings and hastened delivery of stamped ornament with little effect on the appearance of the rehabilitated cornice. A change of the cornice roof edge detailing to prevent further leaking was the only significant change made to the original design.
