UNITED FIRST PARISH CHURCH (UNITARIAN)

CHURCH OF THE PRESIDENTS

HISTORIC STRUCTURE REPORT

April 1996

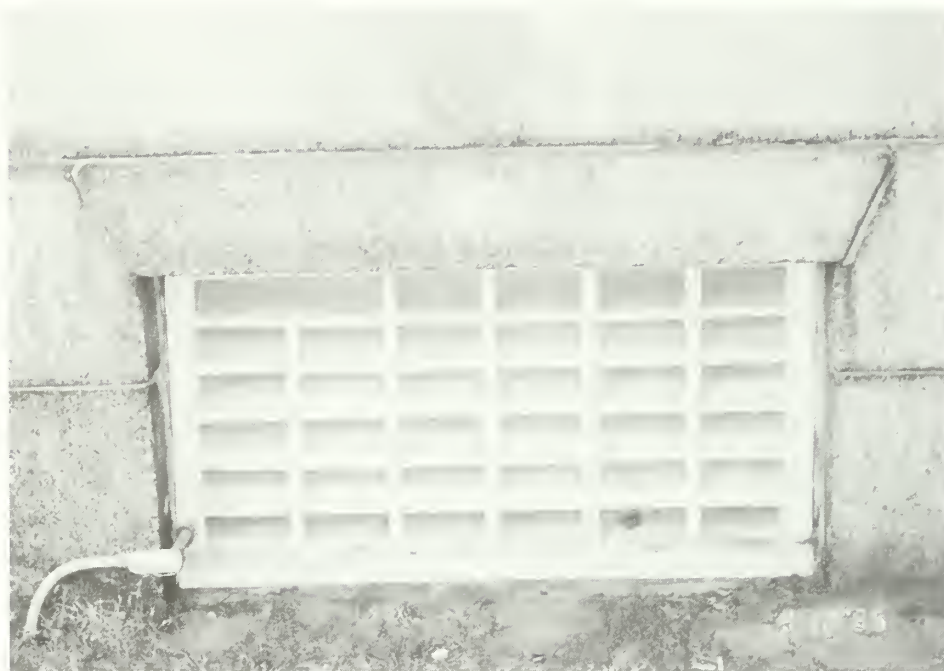
Figure 89. Church exterior: north wall, basement window (W016), showing sash replaced with metal furnace room ventilation panel. Note that grade is above sill level.

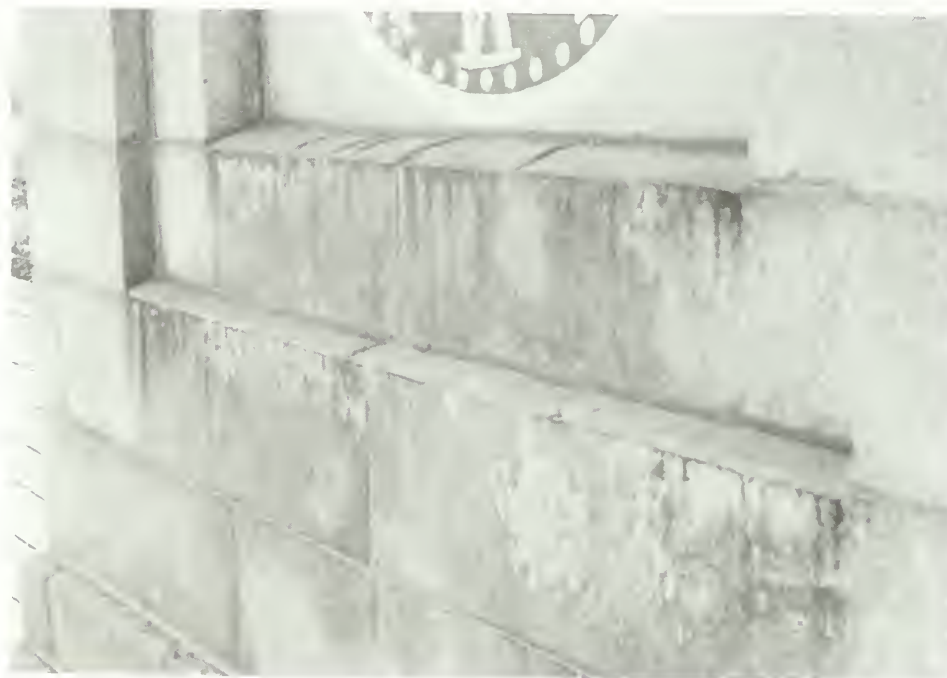
Figure 94. Tower exterior: shaft, north side below clock face. Note minor stains and discoloration and open joints of granite.

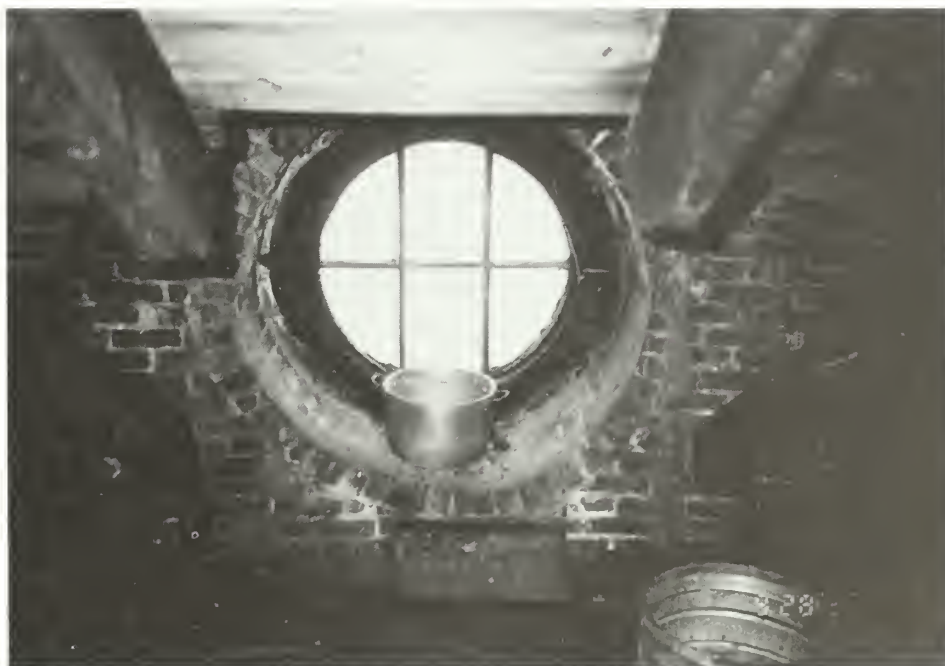
Figure 104. Addition interior: east wall, attic oculus (W202). Note effects of leaks through the flashing and/or the open joints of the sash and surround, and repointing of brickwork.

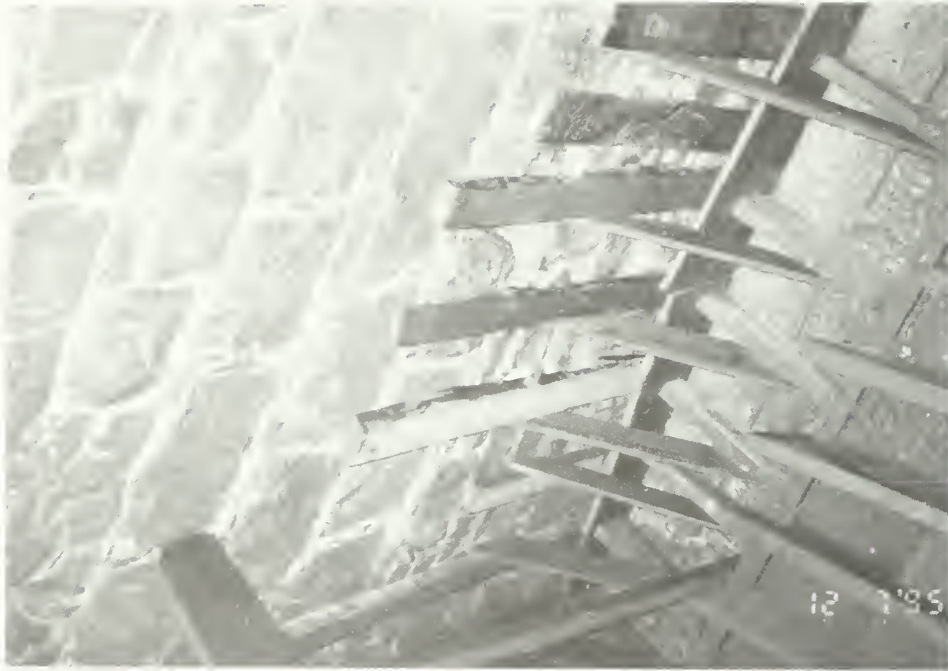
Figure 112. Church interior: attic, north end of east wall, at intersection with sanctuary ceiling. Note repointed mortar joints of wall.
