WILSON'S BRIDGE

Chester County,
Pennsylvania

Preservation Tech Notes

Rehabilitating a Historic Truss Bridge Using a Fiber Reinforced Plastic Deck

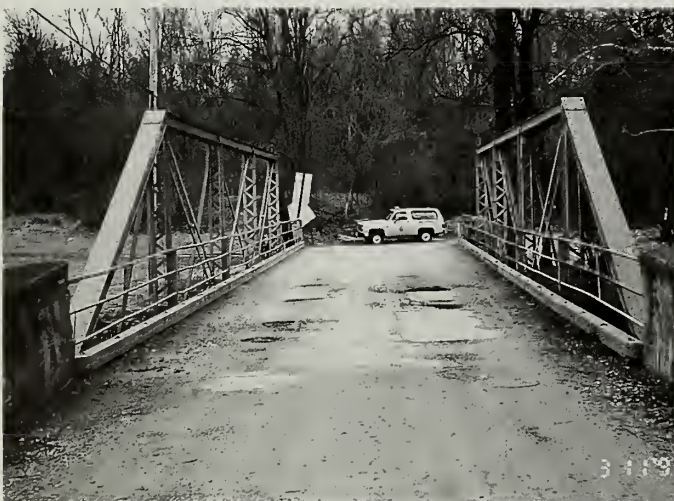
extensive cracking and was losing adhesion with the deck below (*see figure 2*). The thirty-five year old nail-laminated deck, made up of individual timber boards placed on edge and spiked together to form a 4-1/2" thick continuous surface, was uniformly soft and unable to support the wearing surface above. The steel stringers were also in poor condition (*see figure 3*). Though the full extent of their deterioration was not clear until the deck was removed, preliminary examination indicated that the I-beam stringers were severely corroded, particularly over the abutments where they had suffered approximately fifty percent section loss.

Figure 2. Before rehabilitation, Wilson's Bridge had an asphalt wearing surface that was delaminating from the deck below. Extensive cracks and numerous potholes were also present.

only option seriously considered was to rehabilitate the existing bridge. A plan was developed to repair the superstructure and abutments following standard practices, along with the replacement of the deteriorated 1960s deck and wearing surface. Several conventional choices were identified for the replacement deck: a glue-laminated timber deck, a nail-laminated timber deck similar to the existing surface, or a steel and concrete deck. Each was ruled out in turn before a new material that met all of the bridge rehabilitation requirements was identified, evaluated, and selected for the job.

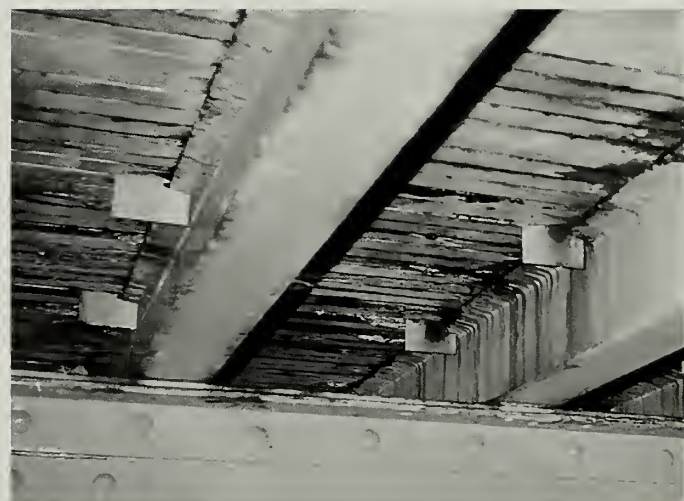
Figure 3. A view of the underside of Wilson's Bridge before rehabilitation. The timber nail laminated deck sat on steel "I-beam" stringers which, in turn, were supported by wrought iron floor beams. Failure of the wearing surface had allowed water to penetrate the laminated deck planks causing further deterioration to both the deck and the stringers below.

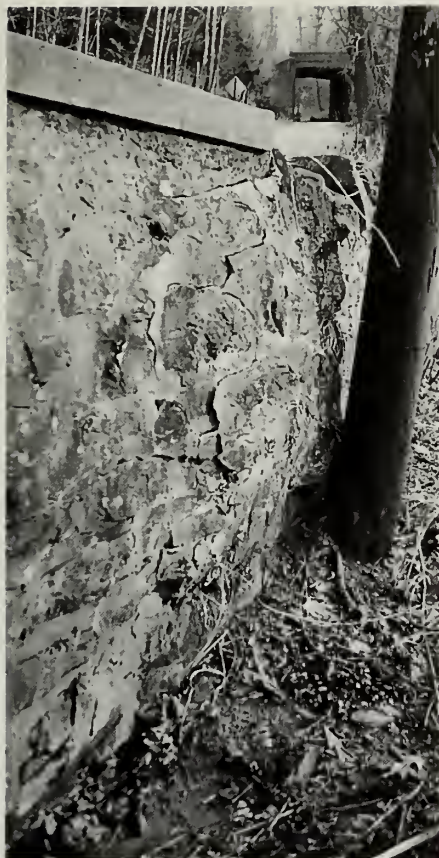
Figure 4. The Wilson Bridge wingwalls had loose and crumbling mortar joints. Much of the wall surface required removal of this deteriorated material and significant repointing.

While the deck was being fabricated in Delaware, the Chester County bridge team began work on the truss and abutments. Both the masonry abutments and wing wall approaches required significant repointing. Existing mortar from earlier patch jobs had separated from the joints in many locations. This deteriorated mortar was gently raked out with hand tools and a new mortar pointed into place. The existing asphalt wearing surface, nail-laminated deck, and steel stringers were all removed. Wrought iron U-bolt hangers, several of which had suffered impact damage, were known to be weak links in the structure. As part of the rehabilitation they were replaced with high-strength steel substitutes that had a higher structural capacity than the original hangers but were identical in appearance (*see figure 8*).

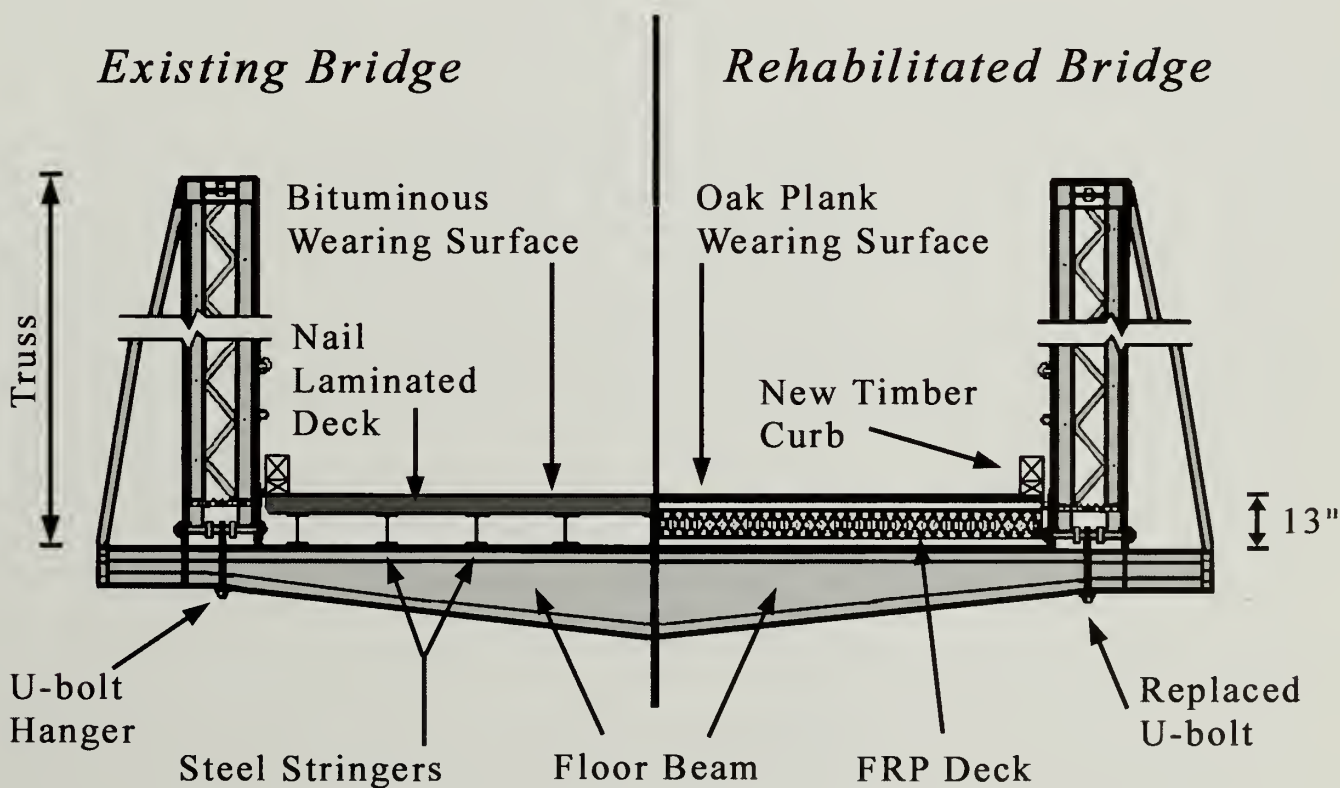
Figure 5. A section drawing of the Wilson's Bridge. The left side shows the construction of the span before rehabilitation, while the right side shows removal of the stringers and the installation of an FRP deck with a plank wearing surface. Both systems were approximately thirteen inches thick. Drawing: Chester County Engineering Department.

The characteristics of an FRP deck matched those sought by Chester County for Wilson's Bridge (*see figure 5*). Composite decks are chemically stable and resistant to deterioration caused by moisture, freeze-thaw cycles, chemicals and other forces that act on bridge surfaces. They also have a higher strength-to-weight ratio than conventional decks. This strength makes the use of steel stringers unnecessary. The reduced dead load of an FRP decked bridge allows a corresponding increase in the live loads the bridge is able to carry. Resins used in the FRP deck harden to a solid state so they can not leach or deteriorate, thus avoiding the release of any potentially harmful materials into the surrounding area, especially the creek below. Though the cost of a composite deck is somewhat higher than that of a nail-laminated timber deck, the estimated life span of the former is more than twice as long. Additional cost savings are usually realized in the short construction times and low level of required maintenance.

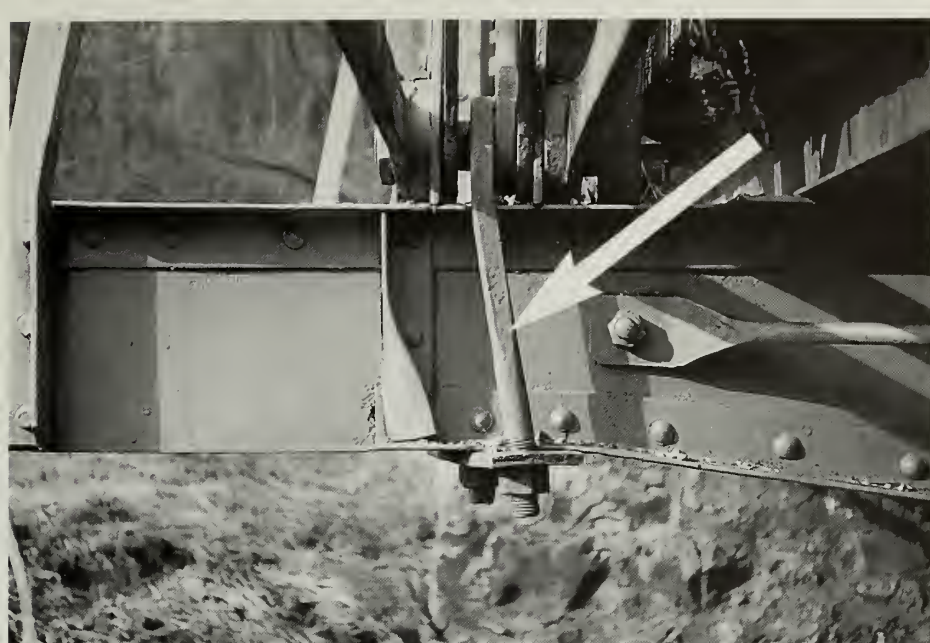
Figure 8. U-bolts connected each of the four floor beams to the superstructure above. Prior to rehabilitation, some bolts, like the one in the photo, showed signs of impact damage. The engineers determined that all of the wrought iron bolts were near the threshold of their stress level and called for replacement with high-strength steel U-bolts of the same dimensions.
