Cultural Landscape Report for the Historic Motor Road System Acadia National Park

SITE HISTORY, EXISTING CONDITIONS, ANALYSIS, AND TREATMENT

Cultural Landscape Report For the Historic Motor Road System Acadia National Park

Jeffrey Killion Historical Landscape Architect

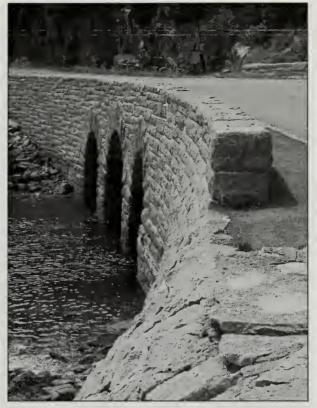
Figure 2.56. The handsome curved bridge is part of the Otter Creek causeway and was recently rehabilitated. (Acad0300_ 8.618(5), OCLP 2005)

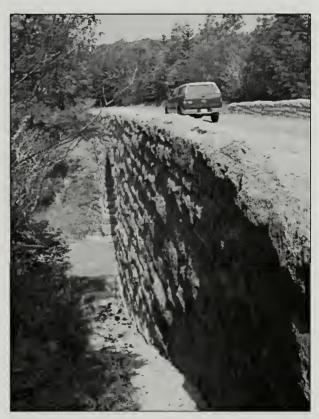
Figure 2.57. The Fishhouse Road Bridge is another example of grade separation. The bridge was recently rehabilitated. (Acad0300_8.469(4), OCLP 2005)

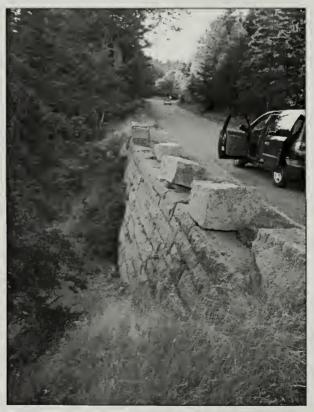
Figure 2.61. Guardwall/retaining wall employing mortared stonework. Note the skewed and missing blocks on top. (Acad0300_10.203(2), OCLP 2005)

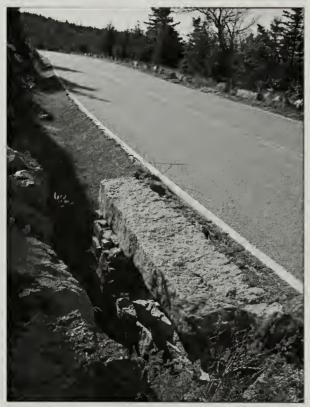
Figure 2.93. There are 25 waterways along Cadillac Mountain Road, and all but two are paved. (Acad0013_2.246, OCLP 2005)

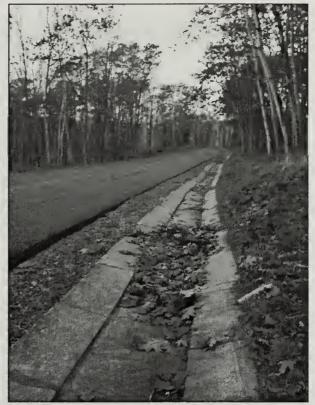
Figure 4.10. A demonstration section of a new mortared rubble waterway was installed off of Schooner Head Overlook Access Road in the mid-1990s. (IMG 0237, OCLP 2005)

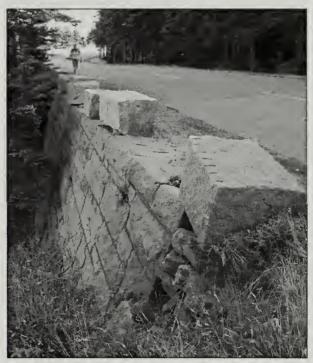
Figure 4.11. Some of the guardwall stones have fallen down the embankments or have become skewed, as seen in this photograph near Western Point on the Otter Cove Causeway and Blackwoods Road. (Acad0300_9.701(2), OCLP 2006)

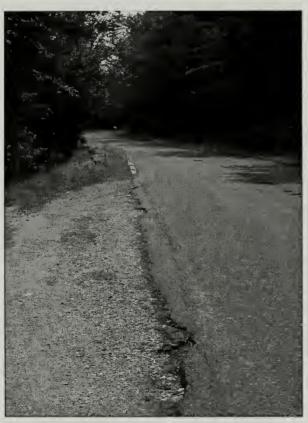
Figure 4.13. View of pavement overlays and pavement failure caused by poor drainage along the often shady section of Otter Cove Causeway and Blackwoods Road, just after the causeway. (Acad0300_8.931, OCLP 2005)
