historic structure report PUBLIC INFORMATION
unit one buildings DEPOS. SYSTEM
volume 2
part two

ELLIS ISLAND
STATUE OF LIBERTY

**HISTORIC STRUCTURES REPORT
UNIT ONE BUILDINGS**

**Beyer Blinder Belle/
Anderson Notter Finegold**

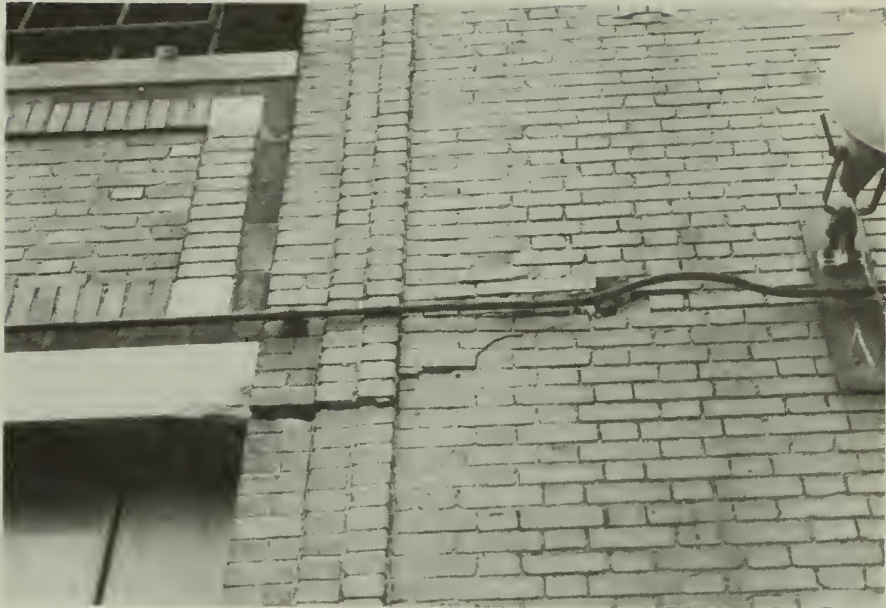
9. Severe cracking at lintel level, west elevation.

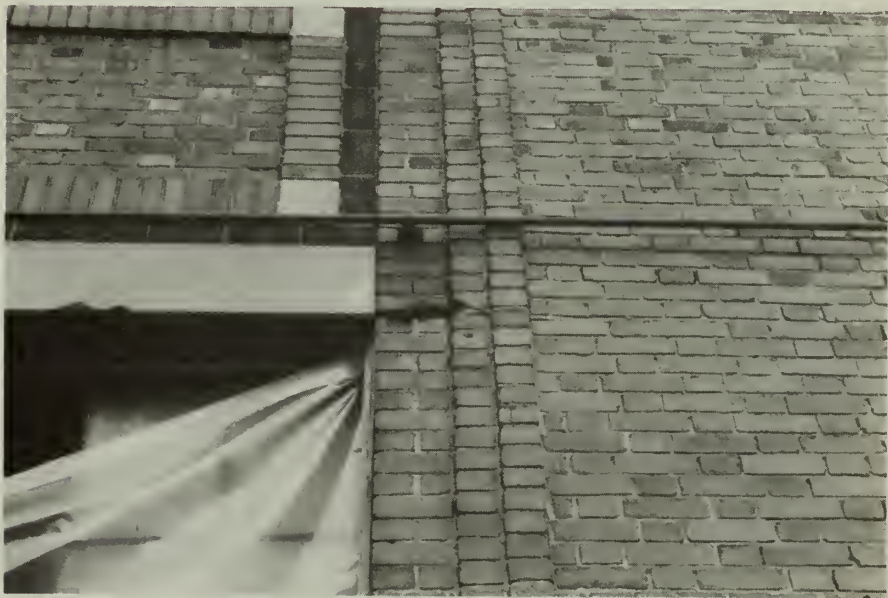
10. Spalling at lintel, west elevation.

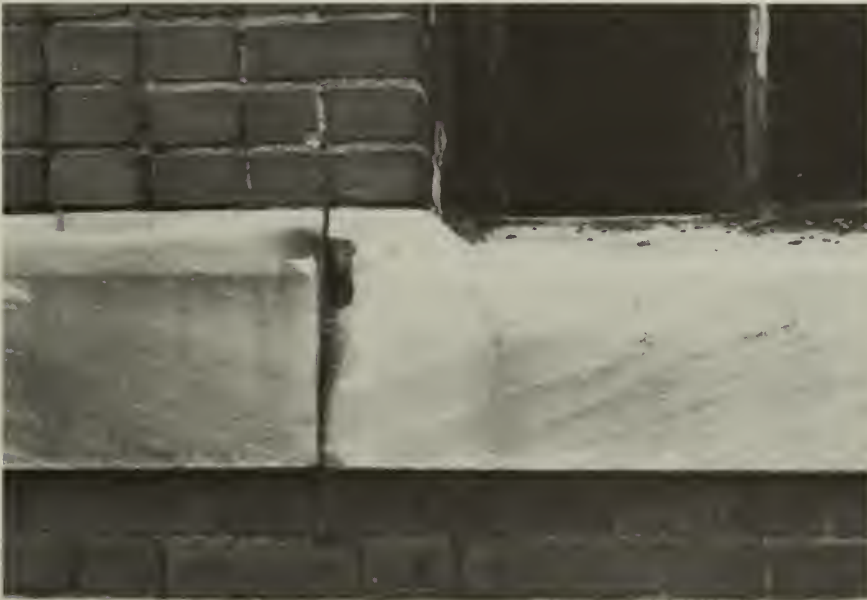
12. Spalling at limestone window sill joints.

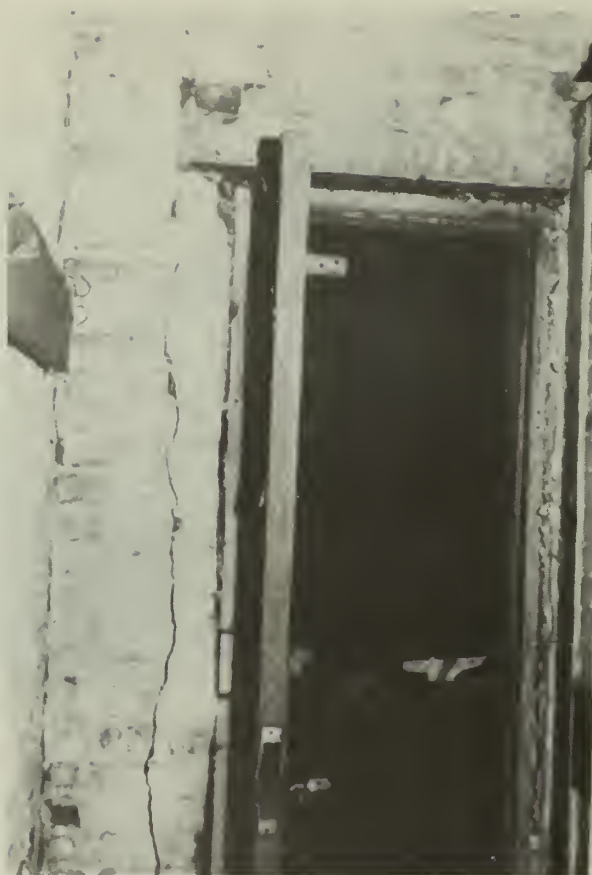
A variety of cracks are found at the underside of the second floor slab (first floor ceiling) in a north-south or east-west direction (photo 1). One of these cracks extends vertically down a west wall. A severe diagonal crack has also occurred on the south wall of room 103. In the one-story bake shop (room 101), structural cracks approximately 1/16" wide appear on the underside of the roof slab running diagonally across the northwest corner (photo 2). Additional roof slab cracks running north-south are severe, with some exposed slab reinforcing. There is a vertical crack in the north wall along the west side of the door (photo 3).

3. Crack along west side of door,
north wall, room 101.

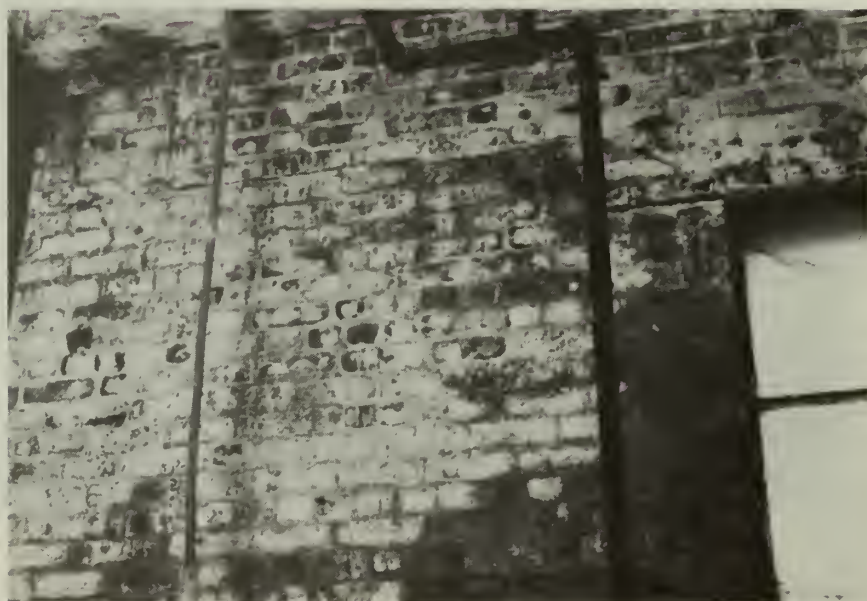
Ceiling cracks occur on the second floor in a similar pattern to those at the first floor ceiling. For the full length of the west wall and at the west end of the north wall horizontal cracking occurs at the level of the window tops (photo 4). The cracks occurring in the floor and roof slab were caused by temperature-related building movement.

4. Crack at level of window tops, west wall, second
floor.

The rusting of beam flanges is causing horizontal wall cracks. Remedial measures include the removal of outside brick, determining the extent of damage and executing necessary reinforcing, cleaning, corrosion proofing and painting.

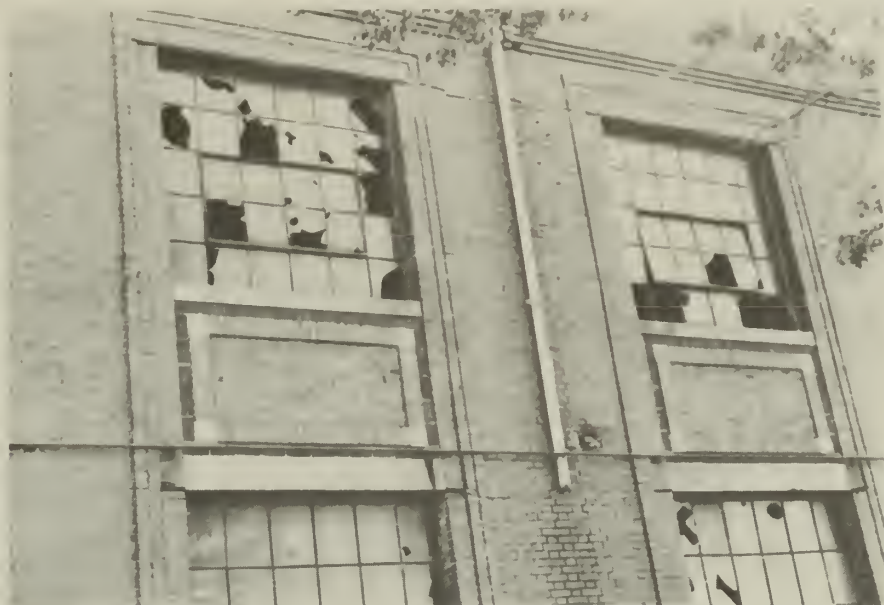
Severe horizontal cracking on the exterior is similar in location and extent to the cracking on the interior walls. Rusting of the flanges of the roof spandrel beams has caused brick to be pushed out at these exterior cracks (photo 5). In addition, a diagonal crack was found where the north wall joins covered way 5 near the powerhouse (photo 6).

5. Brick pushed out at crack along second floor window tops, west elevation.

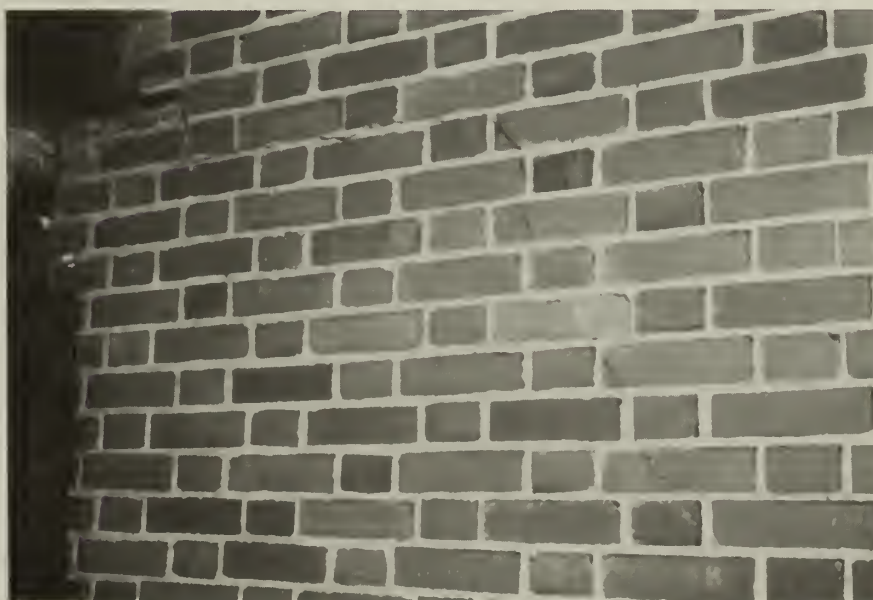
6. Crack on north elevation, near covered way 5.

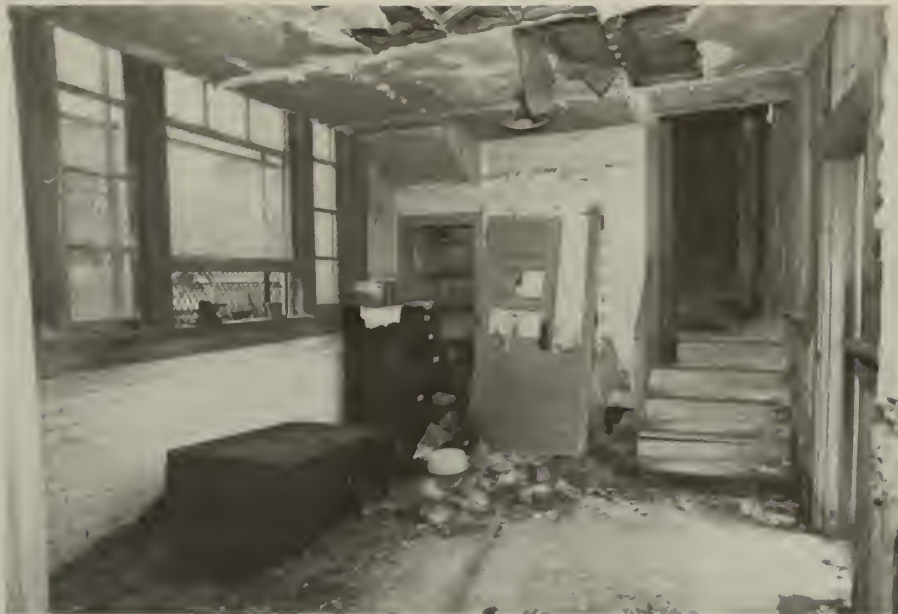
12. Room 104- lowered ceiling forming mezzanine level above. Deteriorated vinyl flooring revealing original hexagonal floor tile.

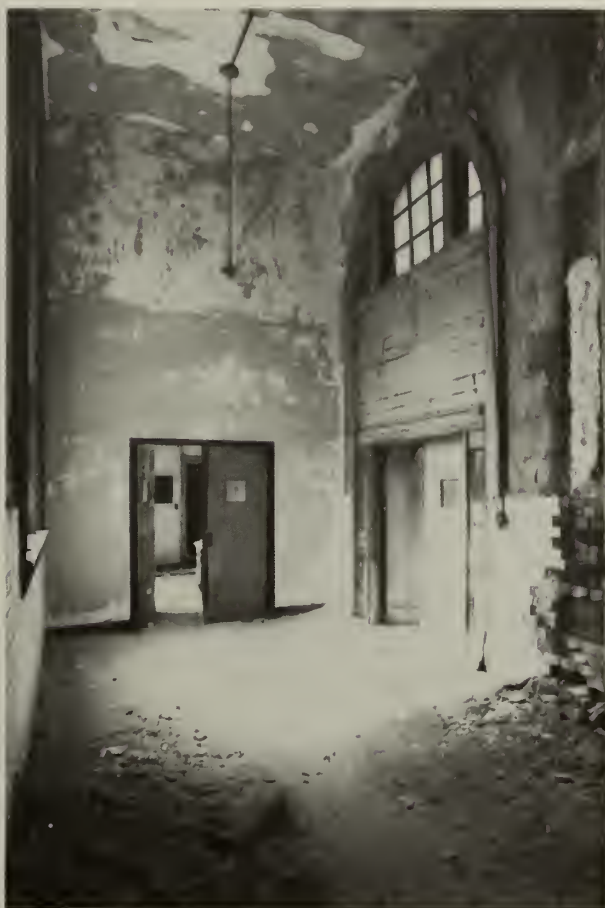
The overall condition of C-2 is poor, with sections of wall and ceiling plaster largely destroyed, exposing terra-cotta block and reinforced concrete ceilings (photo 13). The vinyl flooring on the mezzanine and first floor survives in a very deteriorated state. The wood platform erected over the ramp at the south end of the first floor has rotted through in several locations and presents an unsafe condition. Exhibits 6 and 7 depict the existing conditions of all floors.

13. Room 101- deterioration of plaster on wall at right and of ceiling parging.

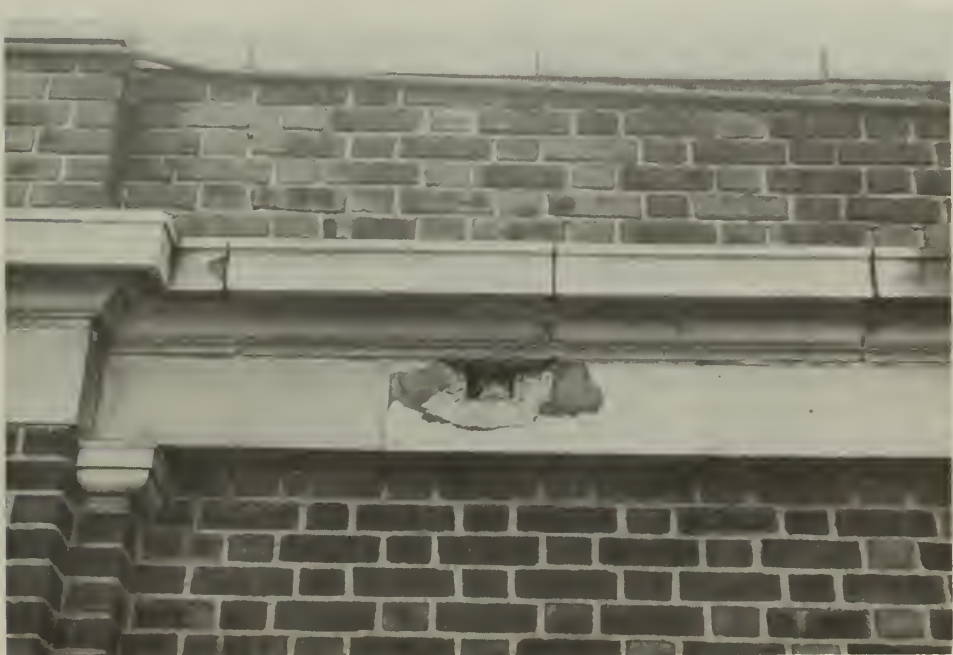
7. Hole and spalling, west elevation.
