HISTORIC STRUCTURE ASSESSMENT REPORT

SNEE FARM (MAIN HOUSE)

CHARLES PINKNEY NATIONAL HISTORIC SITE
Mount Pleasant, South Carolina

1997

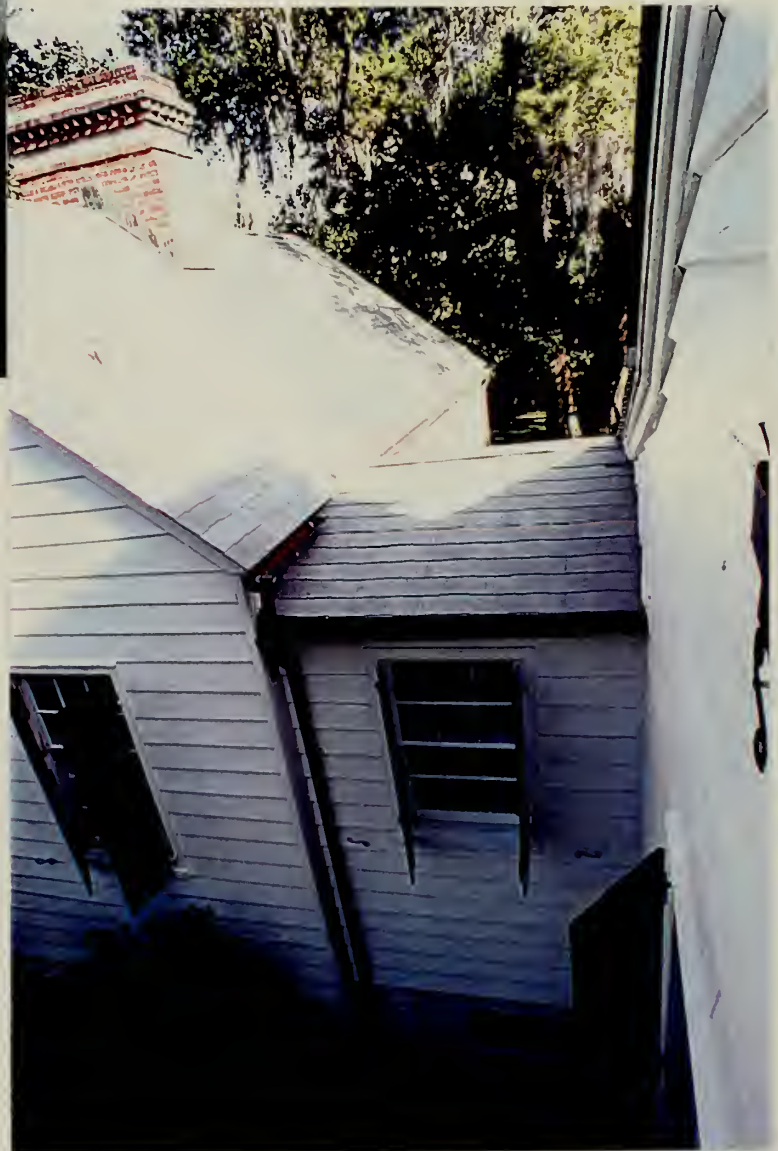
Photo shows the southeast corner of the east wing; note the downspout drains right in the ground adjacent to the brick wall foundation and causes damage.

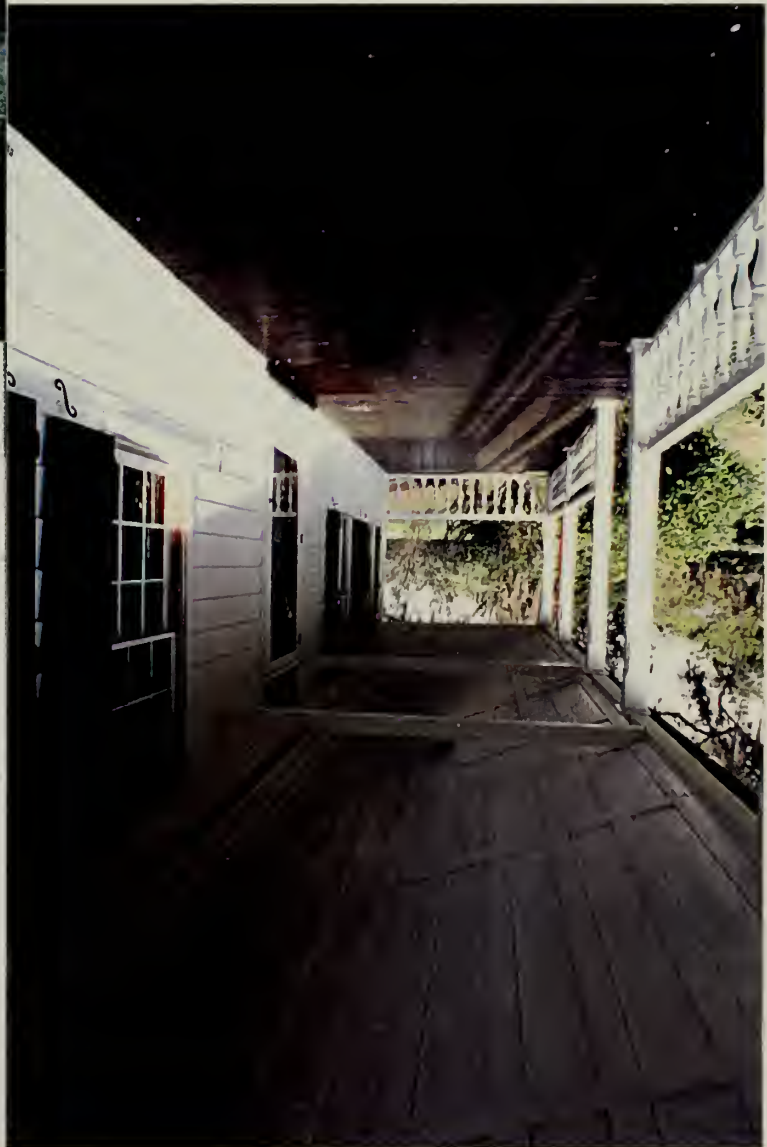
Southeast elevation of the porch. Note the size of the copper gutter and downspout. It appears the size of downspouts are not enough to drain all of the water from the roof. Downspout drains adjacent to the brick pier and causes damage.

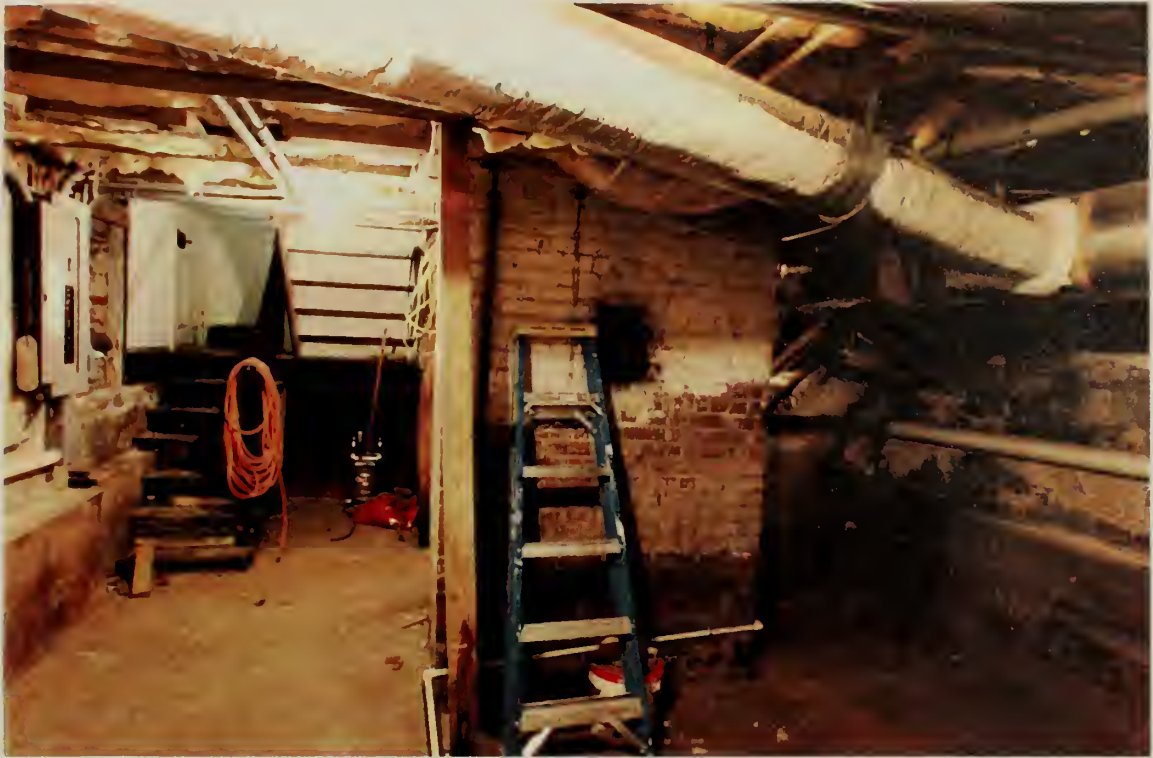
View toward the east wall of the basement under the west wing. Note the surface damage on the concrete wall caused by moisture.

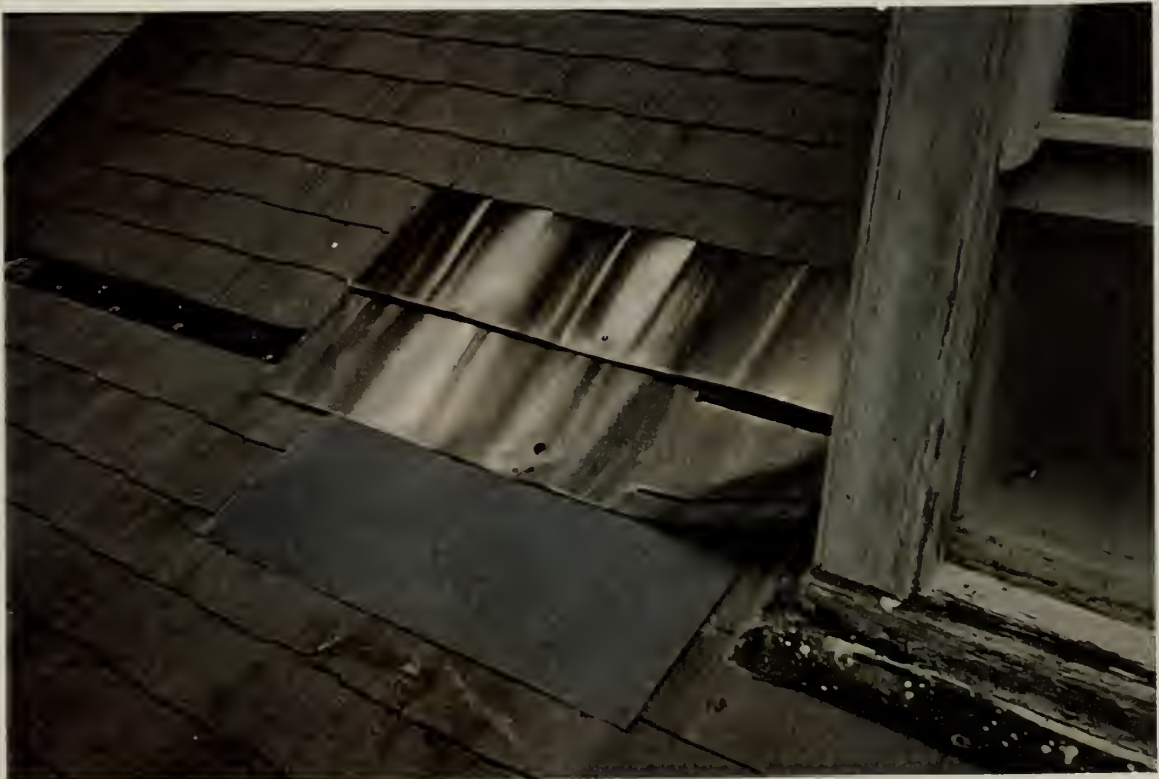
These photos show the damage and broken fiber cement shingles on the left side of the middle dormer in the south that has been covered with sheet metal. Sheet metal has not been installed properly and that has caused rainwater to penetrate the roof and eventually the ceiling of the first floor.

1. Damaged and broken fiber cement shingle on the left side of the middle dormer in the south part and the other parts of the roof.
2. Temporarily covered damaged area in the left part of the middle dormer in the south with sheet metal. Sheet metal cover has not been installed properly and that caused rainwater to penetrate to the roof and eventually to the ceiling of the first floor.

1. Replace all of the damaged fiber cement shingles with new, match the size, shape and color with the existing. For the removal of the damaged shingles and installation of the new shingles follow the Supradur application instruction.
2. Remove all of the temporary sheet metal from the area adjacent to the middle dormer in the south.
3. Repair the damaged sheathing in proper way.

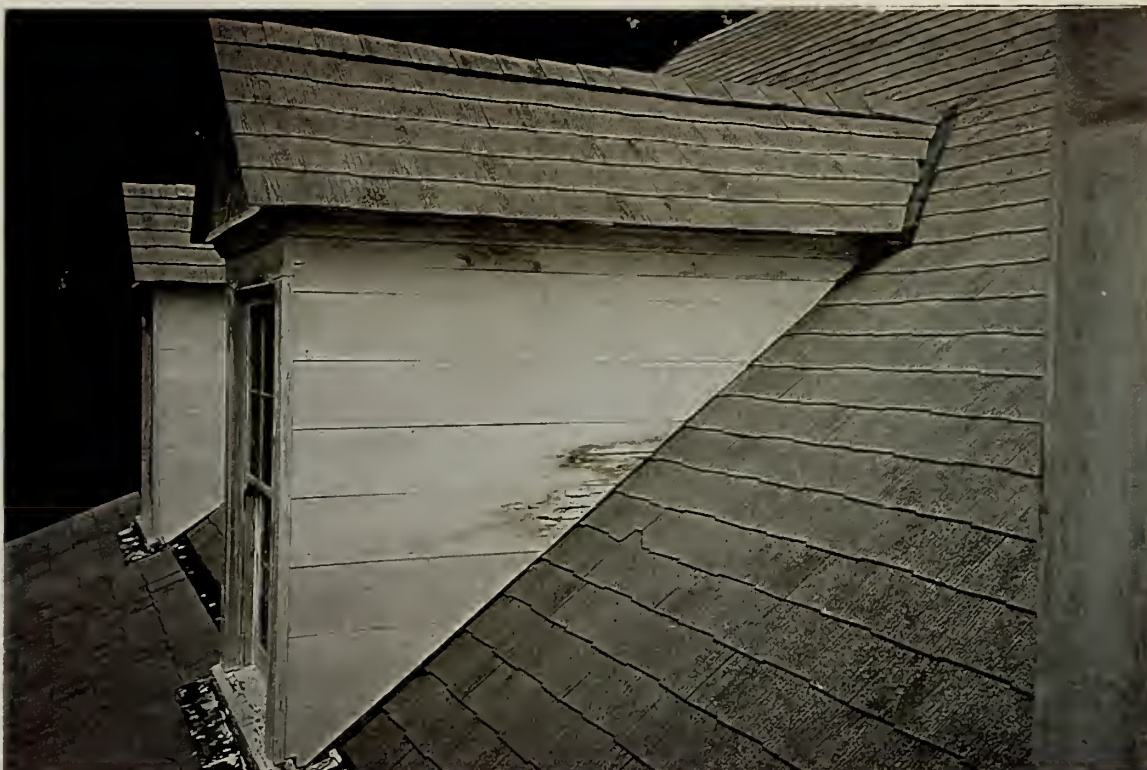
Damaged wood siding on the dormer walls in the south part of the main building.

damaged wood board siding on the dormer walls in the south part of the main building.

Replace all damaged wood siding board in the dormers in the south part of the main building with new, match the size, shape and the quality of the boards with the existing.

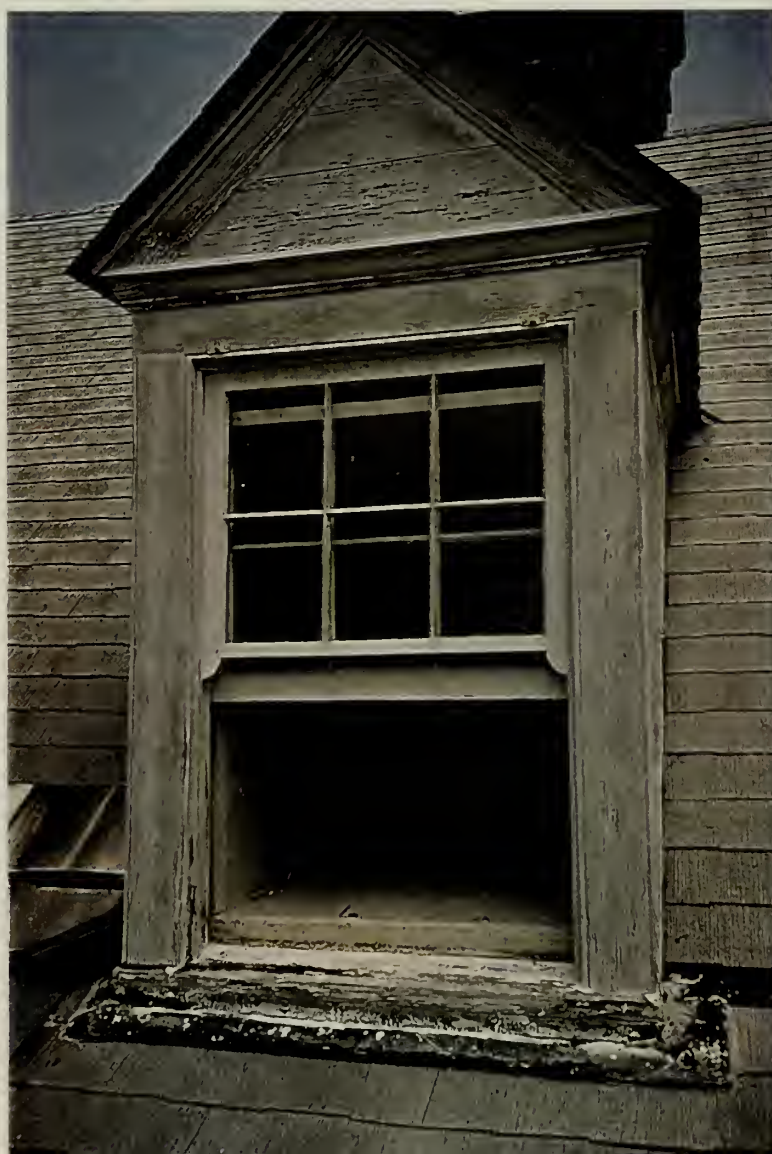
Some of the existing copper flashing on the dormer sills are not installed in a proper way. This has caused the rainwater to penetrate under the metal flashing through the roof and finally through the ceiling above the north entrance door. See detail C in the appendix.

Some of the existing copper flashing on the dormer sills in the north part of the main building are not installed in a proper way. This has caused the rainwater to penetrate under the metal flashing through the roof and finally through the ceiling above the north entrance door.

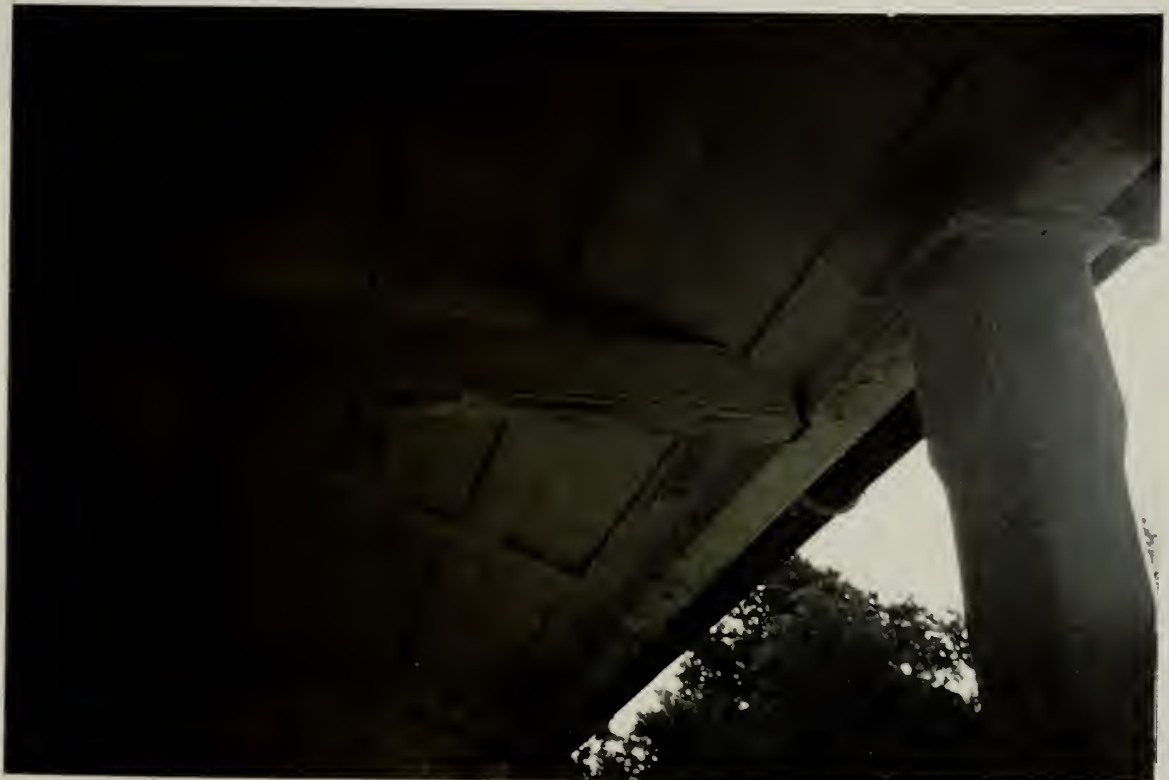
Mildew damage on the paint surface of the south porch ceiling , similar to this is on the surface of the gable in the east and west part of the main building.

2. Mildew damage on the paint surface around the gable area in the east and west part of the main building and on the south porch ceiling.

4. Paint all of the dormers and damaged mildew area. The painting job should take place in a dry season when the moisture in the environment is low, perhaps in the fall

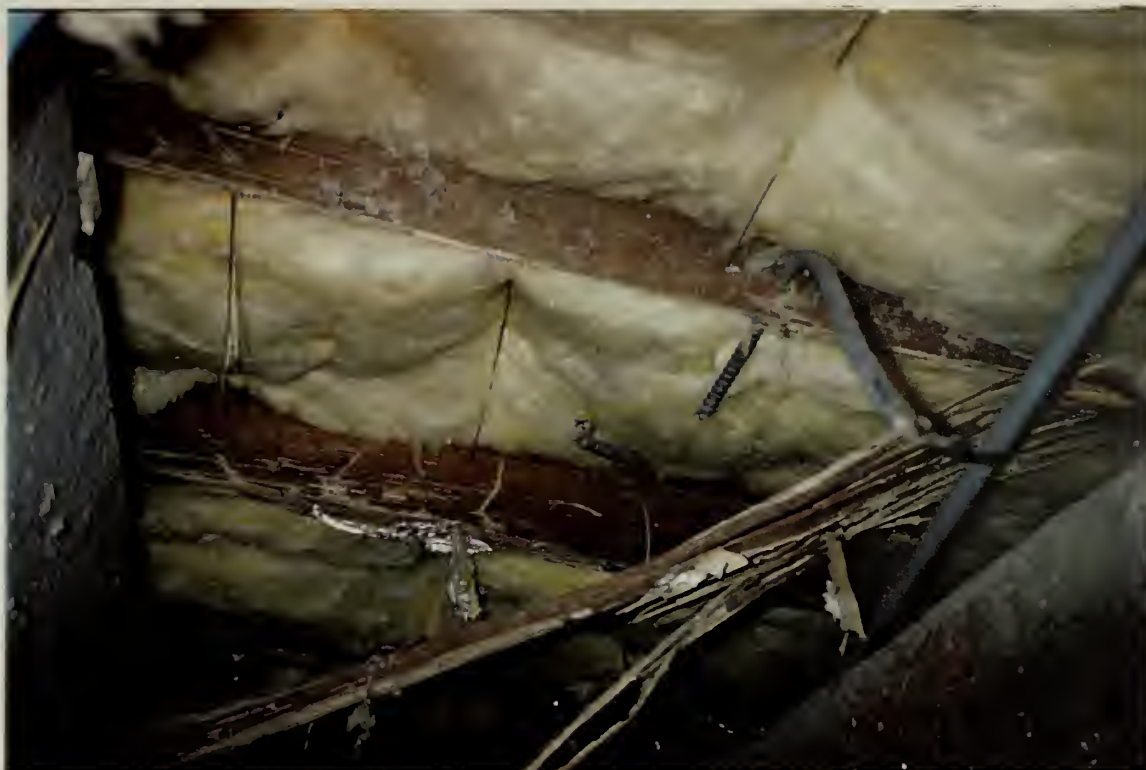
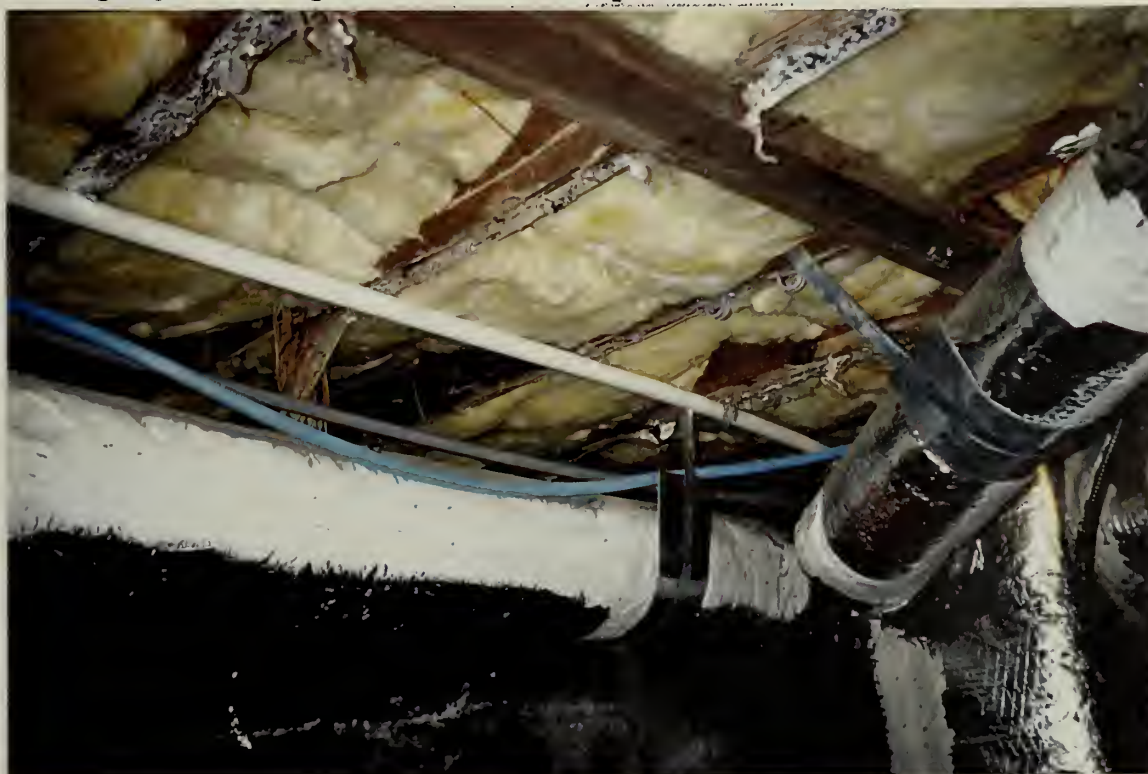
These photos show the termite damage in the joists and girders in the basement ceiling in the west wing in the north part of the brick chimney. These damaged joists and girders need to be replaced with new.
