BUREAU OF RECLAMATION

HIGH-PRESSURE RESERVOIR OUTLETS

BUREAU OF RECLAMATION INSTALLATIONS

1923

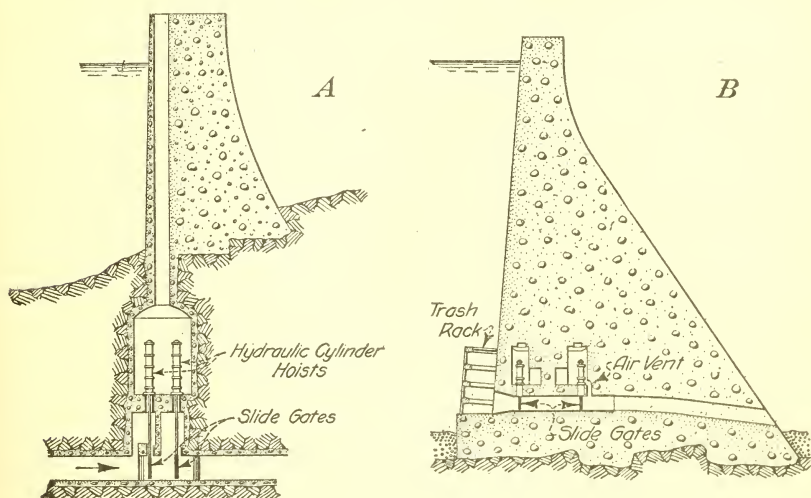
The arrangement shown in Figure 13, *A*, embodies the principles of the original outlets at Roosevelt Dam, the failure of which is fully described in Chapter VI. The Roosevelt outlets, which were not air vented, were designed to operate under a maximum head of 220 feet, but were soon destroyed under a much lower head. A very similar outlet for the Strawberry Reservoir, provided with air vents, has proved successful under heads as high as 50 feet.

FIG. 13.—*A*, Slide-gate control in tunnel; *B*, Double slide-gate outlet.

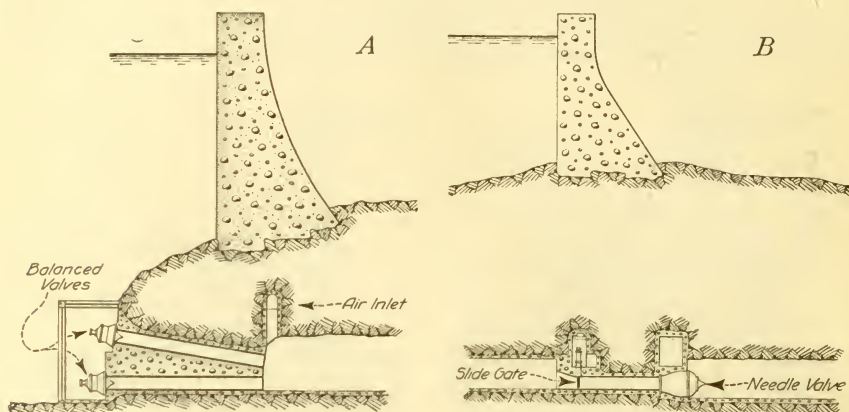
The outlet shown in Figure 16, *A*, embodies the principles of the south tunnel outlet at Pathfinder Dam, the operation of which is discussed in Chapter IX. Unless air is provided, the conduits and the tunnel are rapidly destroyed. This is not a desirable type.

FIG. 16.—*A*, Balanced valves in tunnel; *B*, Needle valve in tunnel.

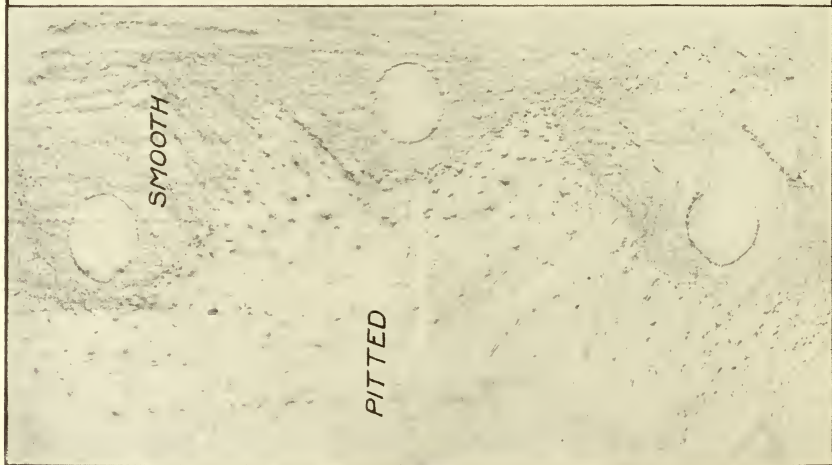
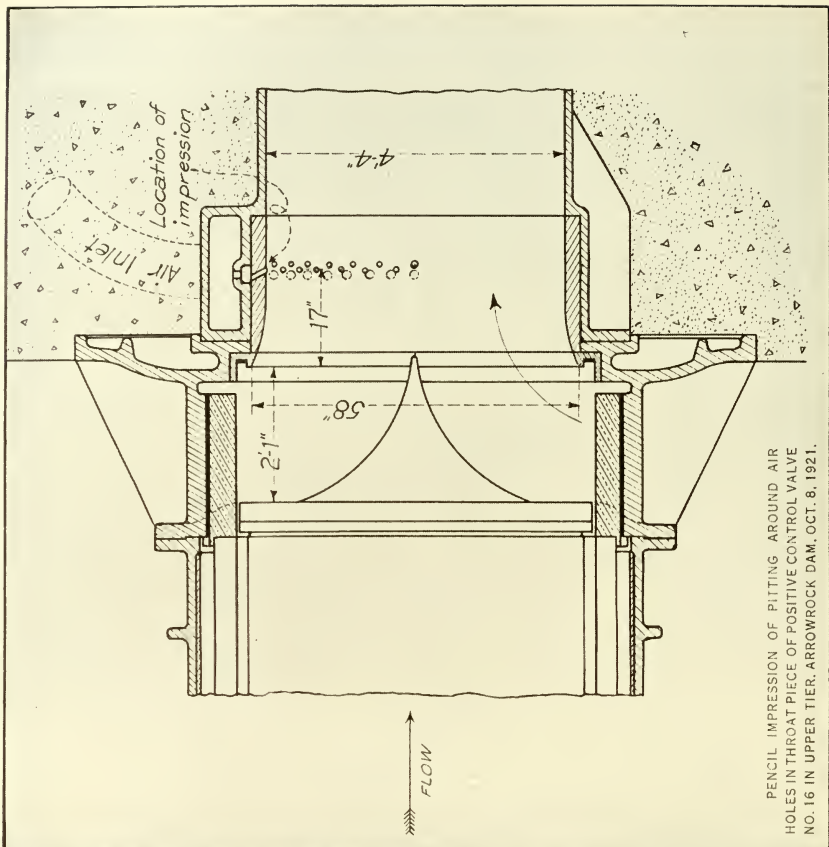
Patching of conduits required in 1921.—Annual inspections of the outlets have been made since the valves were first installed. The wear in the conduits was very slow at first, and the condition of the valves and conduits in the fall of 1920 was reported to be practically as good as when first installed. In the fall of 1921, however, the throat liners and the concrete conduits below the semisteel linings were found to be considerably worn. In the positive-control outlets the wear was most extensive in the concrete of the conduits, while in the plain-control outlets the throat liners showed the greatest wear. The pitting of the throat pieces had the peculiar, rough, honeycomb appearance noted in many of the other outlets of the service and was most severe immediately below the V guides of the balanced valves. In the positive-control valves air is supplied through holes in the upper half of the throat piece for the purpose of relieving the vacuum at this point and thus preventing cavitation. The effectiveness of this remedy is indicated by the impression shown on Plate XXII of the pitted surface of valve No. 16. The metal for a distance of about one-half inch upstream from each air hole is smooth, but above this

PENCIL IMPRESSION OF PITTING AROUND AIR HOLES IN THROAT PIECE OF POSITIVE CONTROL VALVE NO. 16 IN UPPER TIER, ARROWROCK DAM, OCT. 8, 1921.
