# Bathhouse Row Adaptive Use Program

The Ozark Bathhouse: Technical Report 7

HOT SPRINGS NATIONAL PARK  
Garland County, Arkansas

June 1985

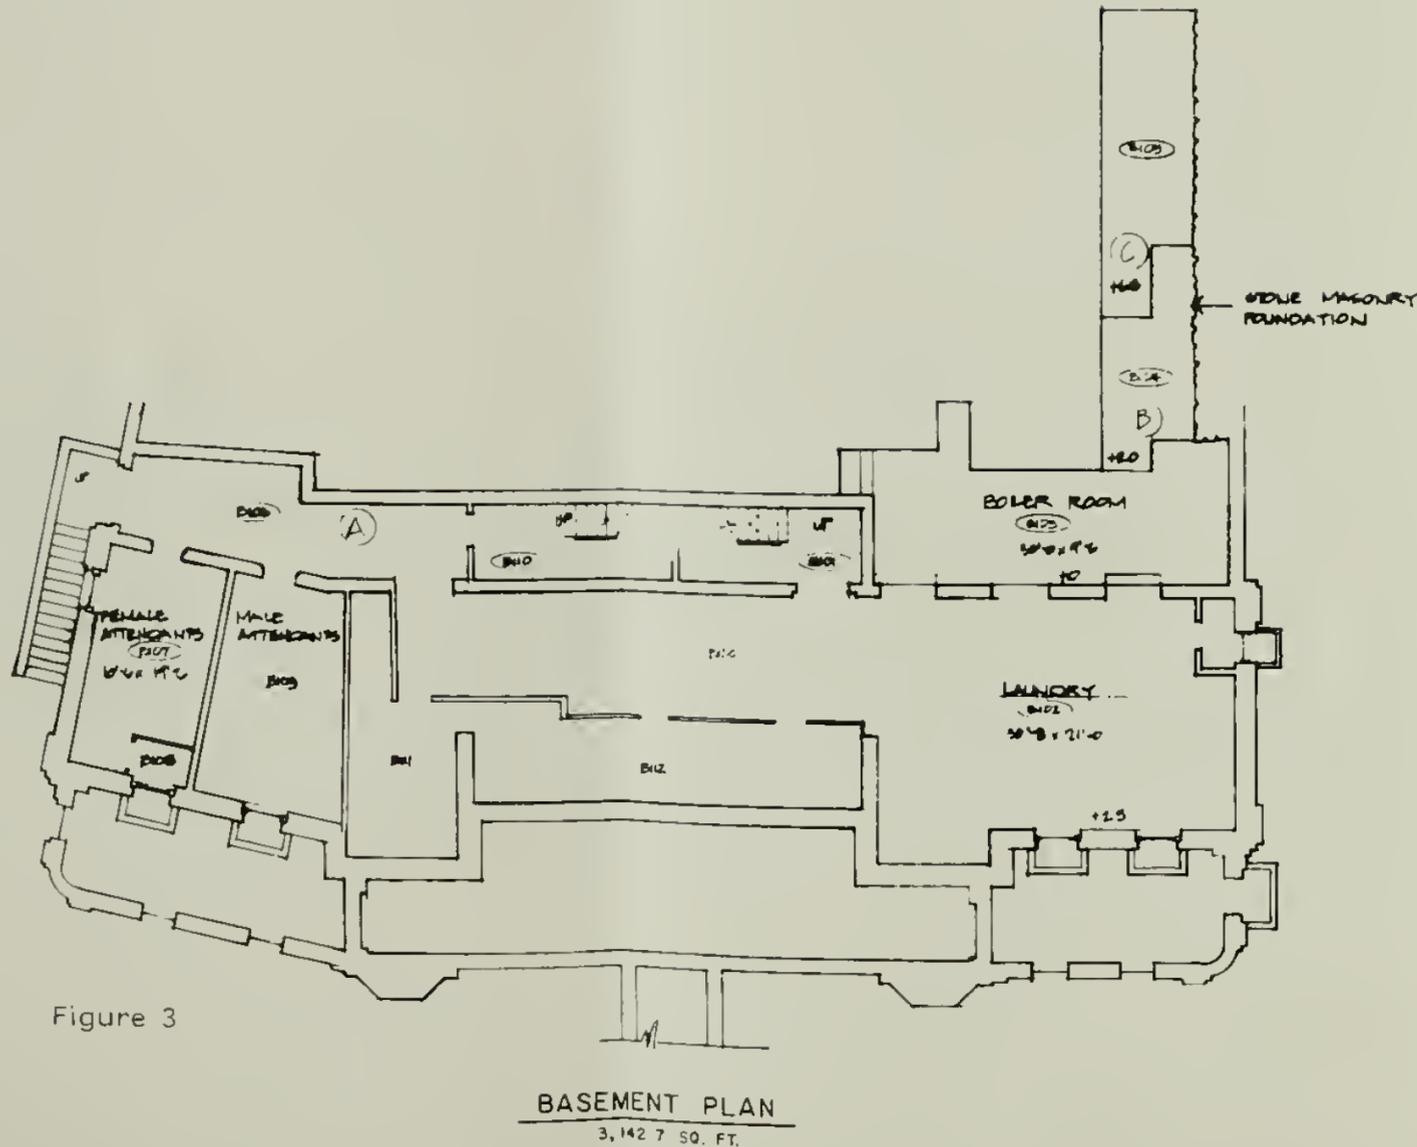
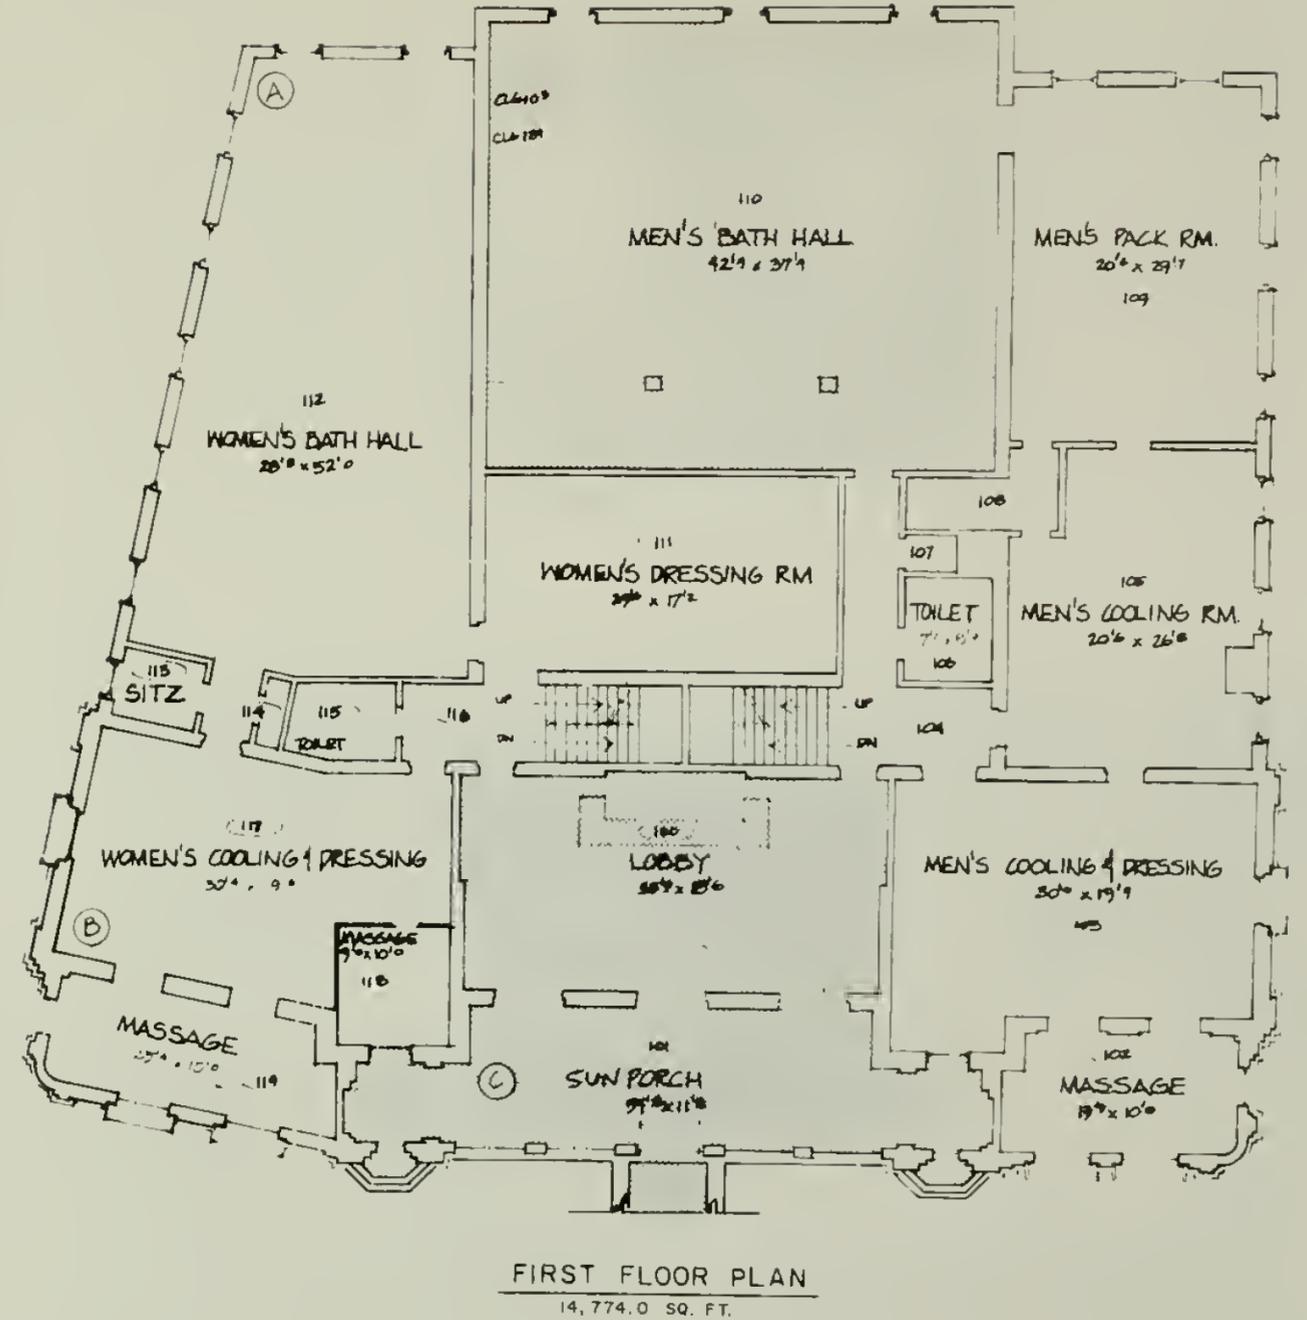
Figure 3

[Note: The letter symbols are cross references to the bathhouse floor plans, figures 3 and 4.]

<u>1973 Historic Structures Report</u>	<u>Investigative Study of Five Bathhouses</u>	
Basement:	A	Settlement or shrinkage crack in floor.	The settlement crack on the floor is very small. Probably, no change has occurred since 1973. There is a larger settlement crack in the east basement wall, adjacent to the floor crack. It is stabilized.
	B	Crack in concrete ceiling.	Minor stress-relief crack. Some deterioration in the floor tile above. Crack appears stabilized.
	C	Crack in concrete ceiling.	Same as B.
First Floor:	A	Moisture damage.	Stabilized.
	B	Crack in floor.	Several cracks in the floor tile. They appear to be stress-relief cracks and are now stable.
	C	Crack in porch area.	Referring to the 1973 photo it appears to be about the same. There is a similar but much smaller crack at the south arch. These cracks will probably reoccur after being patched. We don't believe that there is any danger of life or serious property damage.

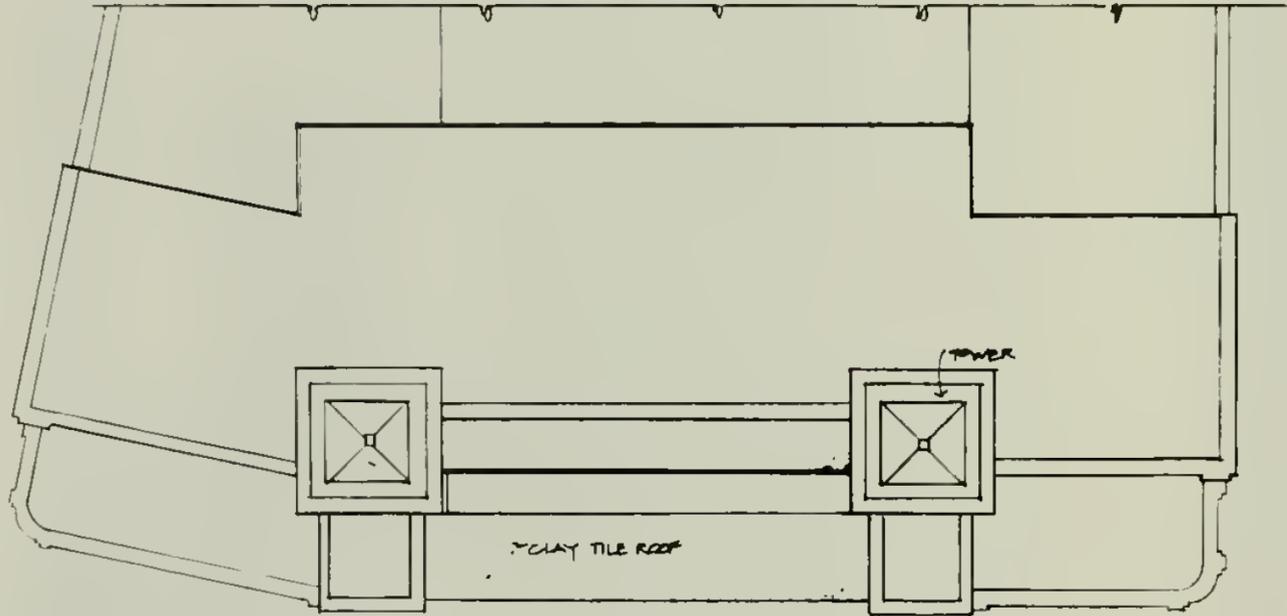
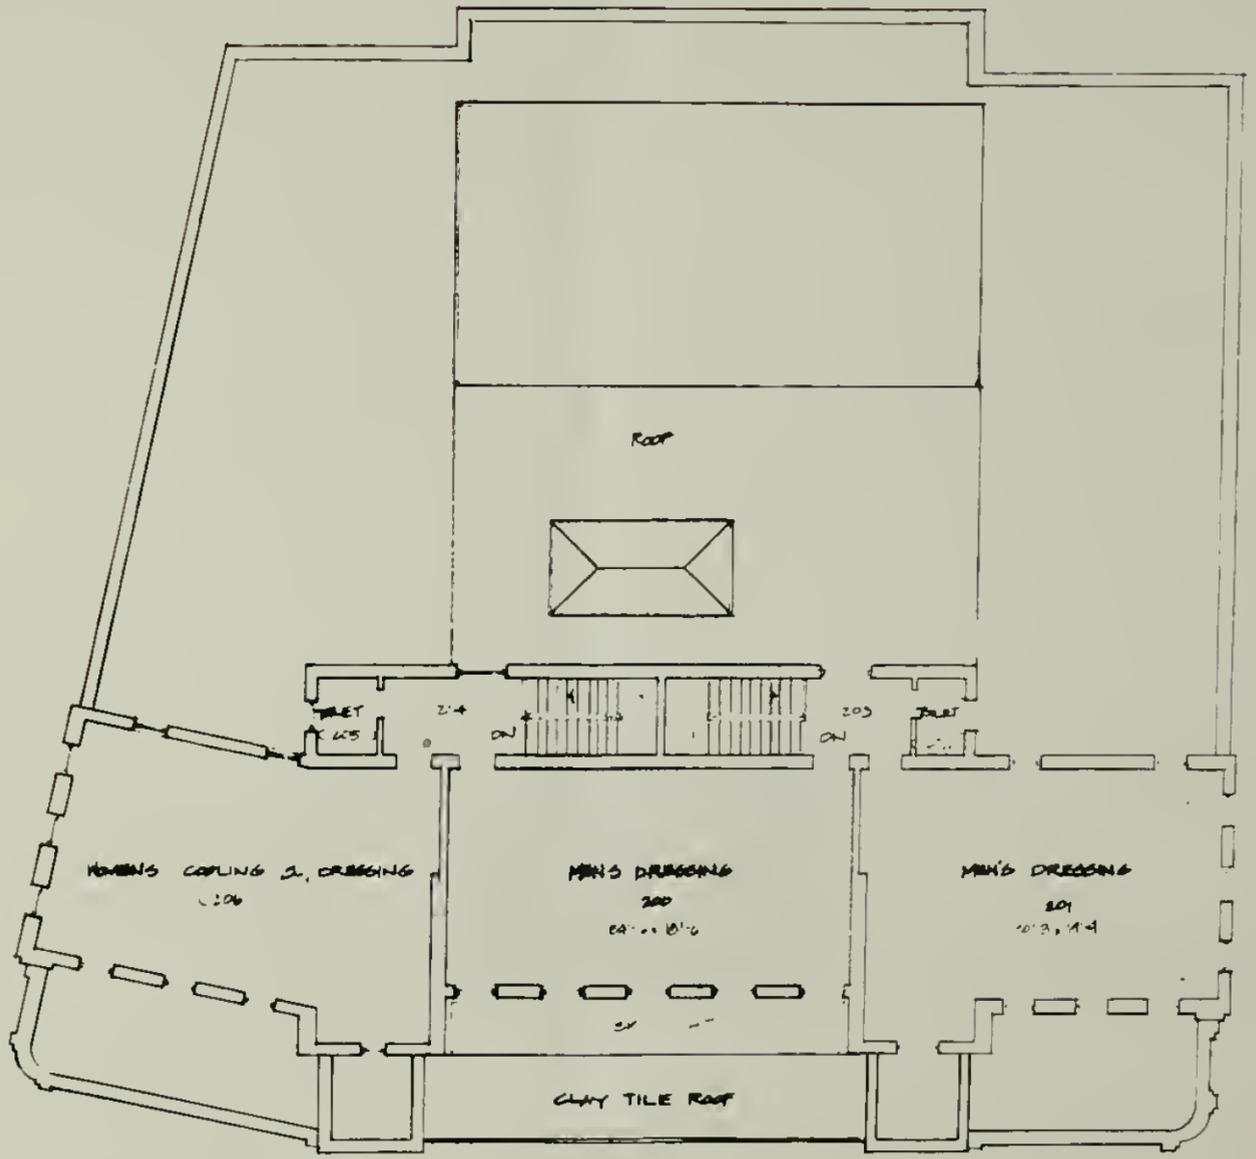
Figure 4

Second Floor:	A	Leak in roof.	Stabilized but not repaired. The new roof has resolved the continuing deterioration in this area.
	B	Plaster and paint decay on walls.	Same as A.
