THE  
KITCHEN BUILDING  
AND ASSOCIATED  
CHIMNEY STRUCTURE  
AT  
HAMPTON PLANTATION  
STATE PARK

McCLELLANVILLE, SOUTH CAROLINA

BUILDING SURVEY AND DOCUMENTATION  
SEPTEMBER / OCTOBER 1998

WILLIAM R. JUDD

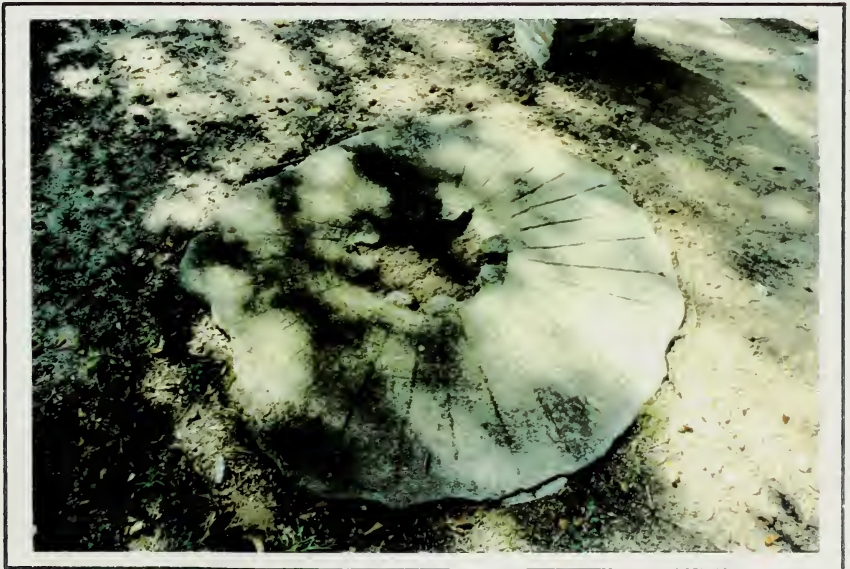
**Figure 2 – Mill Stone**

Located in front of the kitchen building is a mill stone buried flush with the ground surface. (Figure 2) Its outer edge is broken away in places reducing its original diameter of six feet. This stone was used in unison with a similar stone for milling rice.

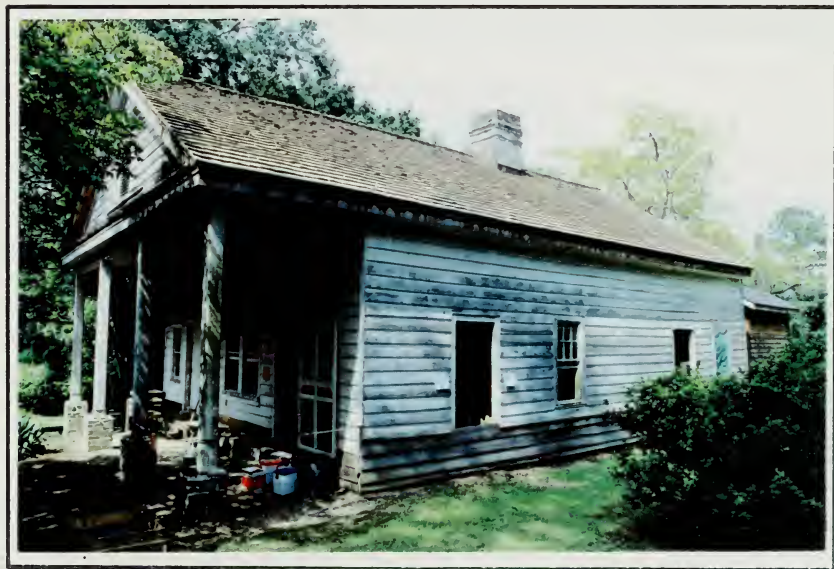
**Figure 3 – South and East Elevation**

The original windows have mostly been replaced with a mix-match of window sashes and pieces of plywood. This replacement was probably the result of vandalism or deterioration from neglect during the time the plantation was idle and unmanaged.

The 1900s photograph mentioned earlier reveals a single window located between the two entry doors in the south wall rather than the present double window. Also no window is shown on the west side of the entrance door leading to the living quarters. These evidently were a later addition. The timbers used to frame these windows appear to be of the same material used throughout the building. Had the photograph not been available the existing windows would have appeared to be part of the present building's original design.

- The uncovered interior stud walls should be cleaned and left "as is" for construction interpretation.
- The building's exterior should be repaired and painted and new matching windows of their original size installed.

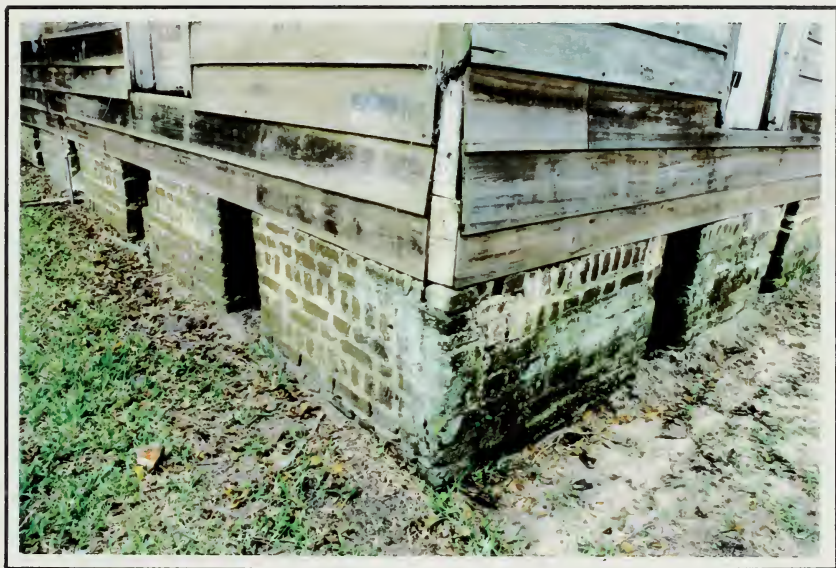
The brick pattern used throughout the foundation walls is something similar to an offset Flemish bond. Each coarse has a stretcher, header, stretcher, header, etc. but the header of one coarse does not center on the stretcher of the upper and lower coarses. To further confuse the pattern a "rowlock" coarse or two is thrown in as well as a "shiner" brick now and then. This pattern is similar in both the original and added brickwork of the foundation walls. (Figure 9)

**Figure 9 – Vents in North and West Foundation Walls  
Also Notice Irregular Brick Pattern**

- The Rafinesque bats living in the building's attic should be removed by a professional bat handler and the building sealed to prevent their reoccurrence. The vent openings within the foundation walls should be sealed with framed wire or plexiglass inserts so as not to distract from the building's appearance.

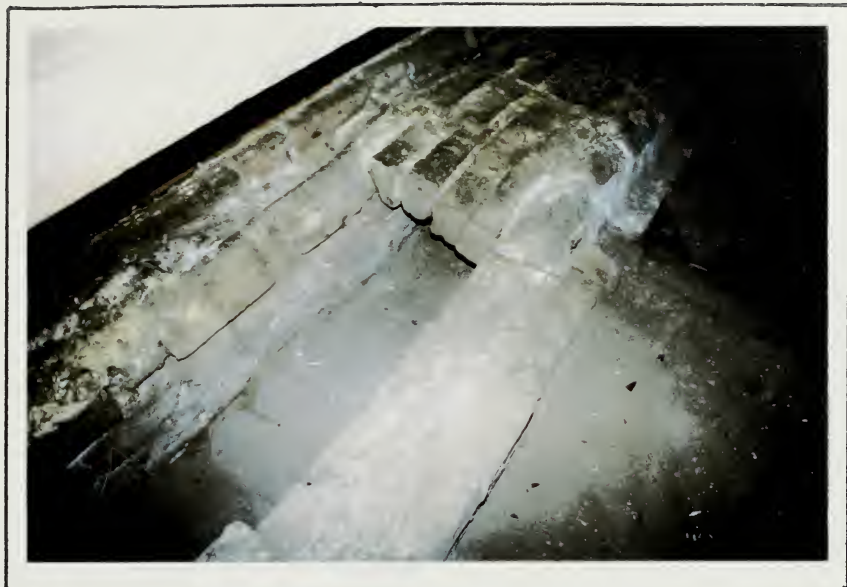
**Figure 10 – Floor of Drain Trough**

The inside height of this drain, from its floor to the under side of the bricked arch was, roughly, twelve inches. Its floor was nine inches wide or the length of a single brick. Each brick of the floor was laid flat, on grade, side by side. They were cemented together, in place, the full length of the drain. (Figure 10) The whole drain structure slopes approximately eight degrees toward an arched opening in the west outer foundation wall. Approximately four feet of the arched brick top that once covered the length of the drain is still intact on the west end. (Figure 11)

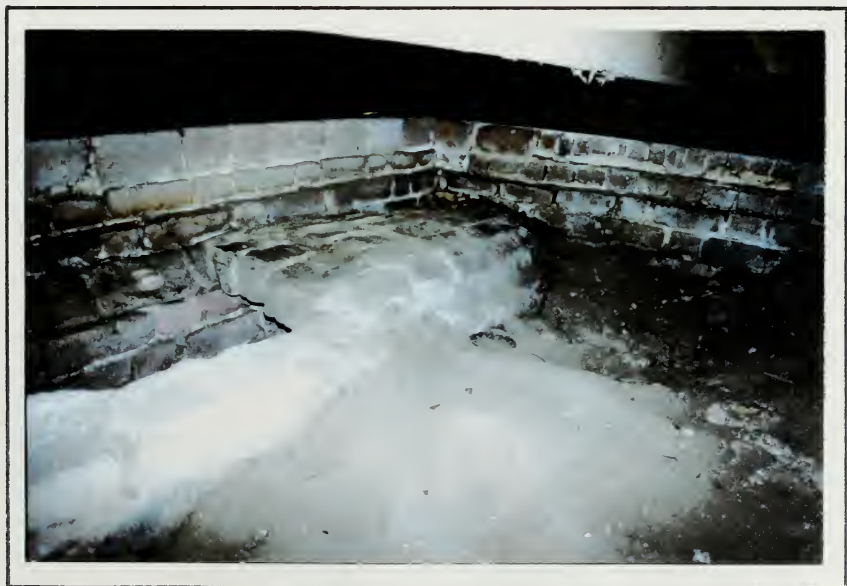
**Figure 11 –Remains of Brick Arch Over Drain**

With the extra height added to the foundation walls the brick drain beneath the southwest room was, basically, left intact. A portion of its top at the east end has been removed to accommodate the nine by ten sill which rests on the mid-foundation wall.

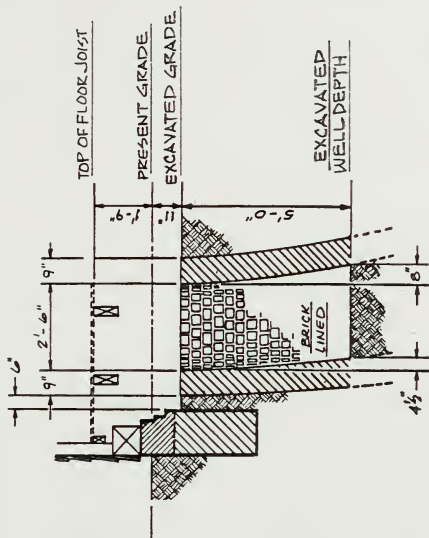
Figure 13 –Section Through Well  
Notice angle as Well Descends

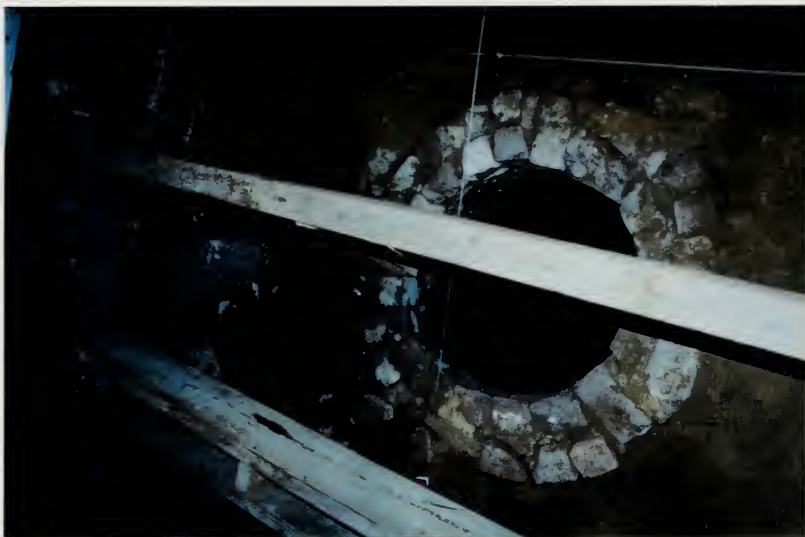
Figure 12 –Partially Excavated Well  
Notice Drain Opening in Wall Above

The well's inside diameter is thirty inches. Its center is located thirty inches from the south foundation wall and five feet from the mid-foundation wall. Five feet of earth fill has been excavated from within the well. Its original depth is unknown at this time.

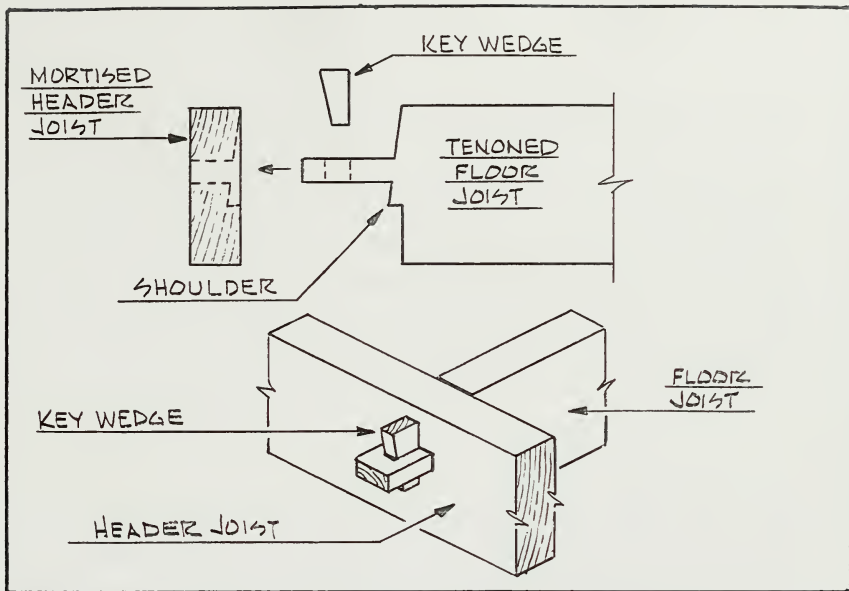
Figure 17 – Joint Detail - Floor Joist to Header Joist

The floor joists are attached to the header joists at the chimney's base by means of a through mortise and tenon joint with a shoulder. (Figure 17) This probably was a keyed tenon joint but the original floor joists have been replaced by more modern sized two by eight inch lumber.

- The floor structure should be repaired using the original type and sized lumber to afford an authentic appearance and meet safety requirements for public access.

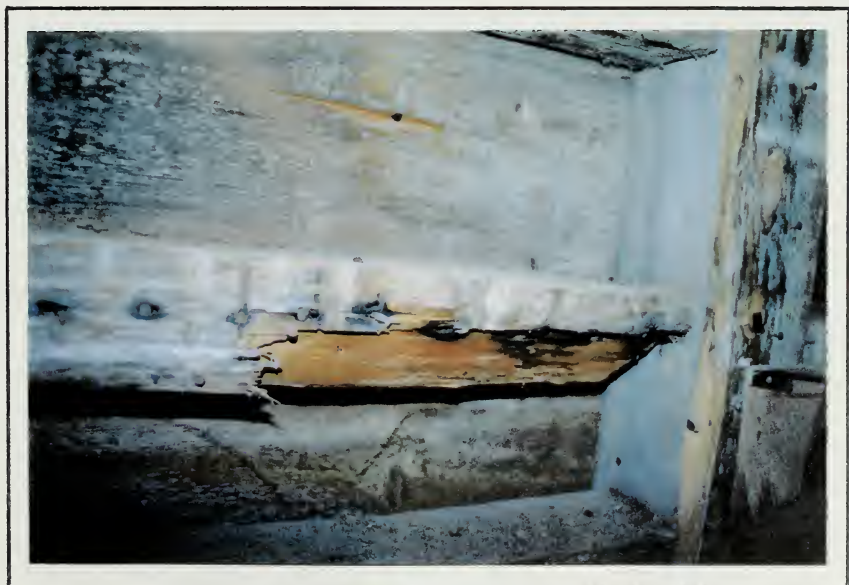
Figure 18 – Wall Purlin - Notice Roman Numeral Marking IIIXXX From Former Application

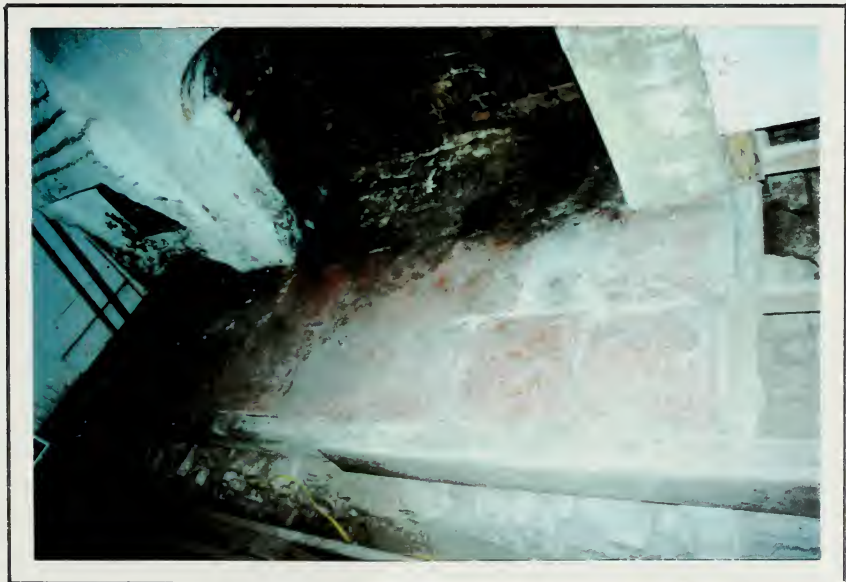
To answer these questions the stone hearth in the main kitchen area (room "A") was dismantled and its earth bed excavated in two separate areas down to the bottom of the chimney's base. The first area excavated was in front of the oven from the left edge of the fireplace opening over to the mid-foundation wall and outward from the chimney to the floor

**Figure 24 – Stone Hearth of Main Kitchen Fireplace  
Notice Brick Retaining Wall Around Hearth**

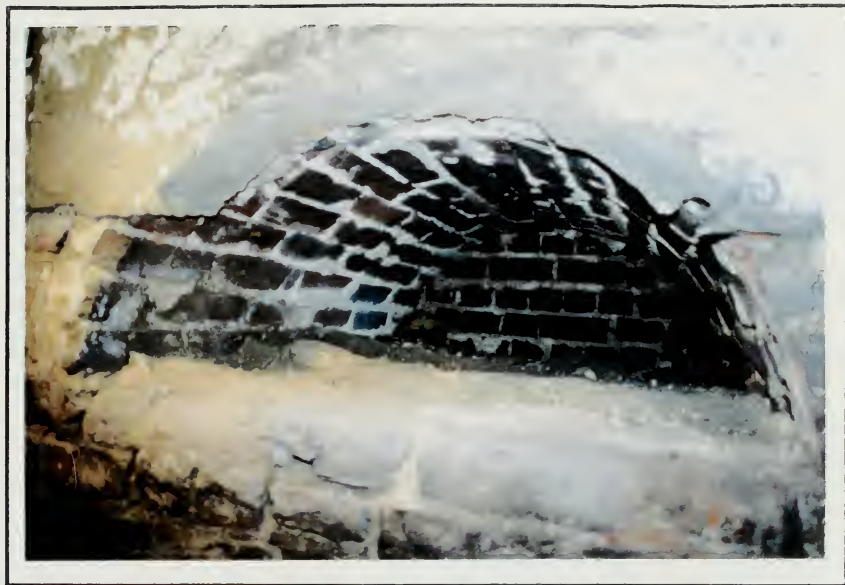
joist which retained the earth fill within the hearth area. Once the complete arched area was exposed the recessed wall closing its opening was removed revealing an arched cavity extending 51-1/2" back to the opposite brick wall of the chimney structure. The interior measured 42" wide by 18-1/4" high at the center of the arch. This arch supports the floor of the oven above. (Figure 25)

**Figure 25 –Brick Wall Removal Revealed an Arched  
Opening for Storage of Firewood**

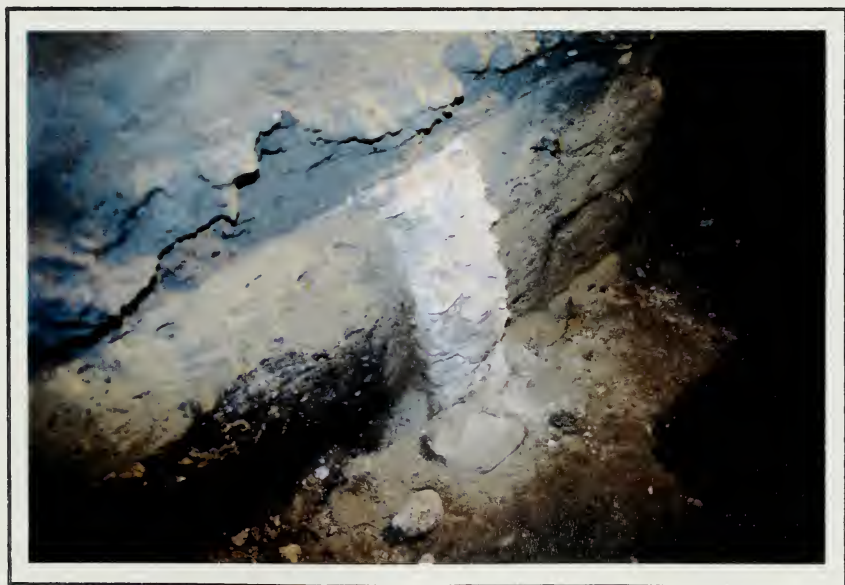
Also found in this area was the partial remains of a 6" wide tabby wall running north and south beneath the present grade level and hearth's retaining wall. (Figure 26) It is unknown as to what function this played in the original foundation.

**Figure 26 –Hearth Excavation Revealed the Remains  
of "Tabby" Wall**

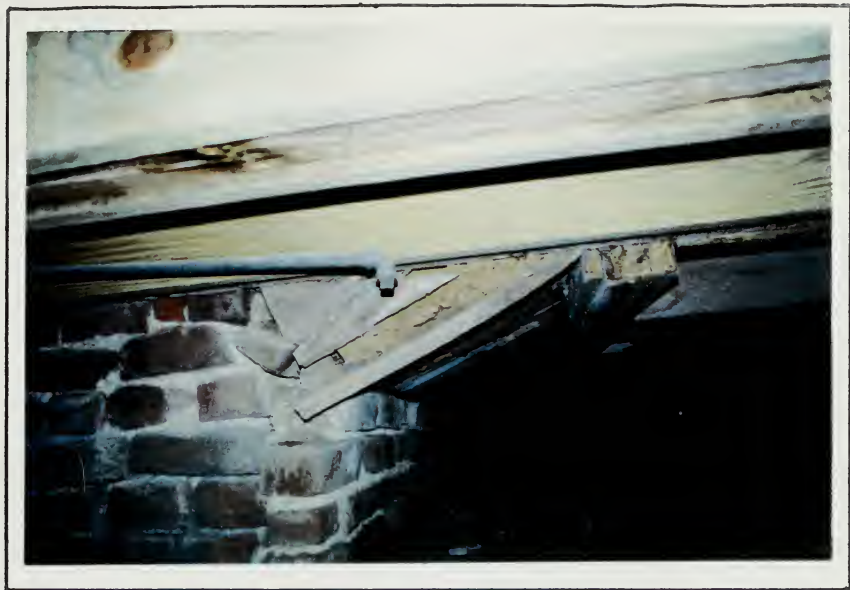
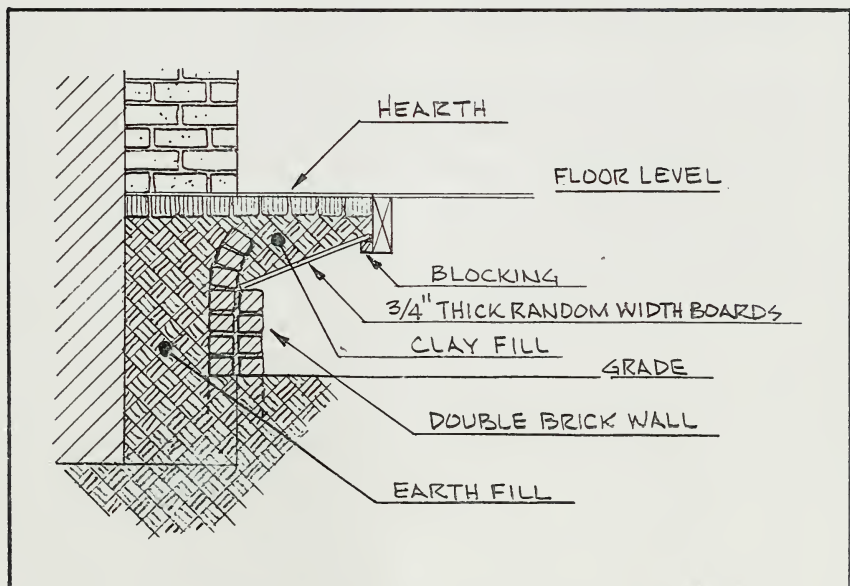
Figure 28 –End View of a Suspended Hearth

Figure 29 –Suspended Hearth Design

running the length of the two fireplaces only. It is an earth filled suspended hearth projecting 24" into room "C" at floor level. (Figures 28 and 29) This is a typical hearth design used in early slave houses with raised wooden floors and later, tenants houses, which in some cases were one in the same.

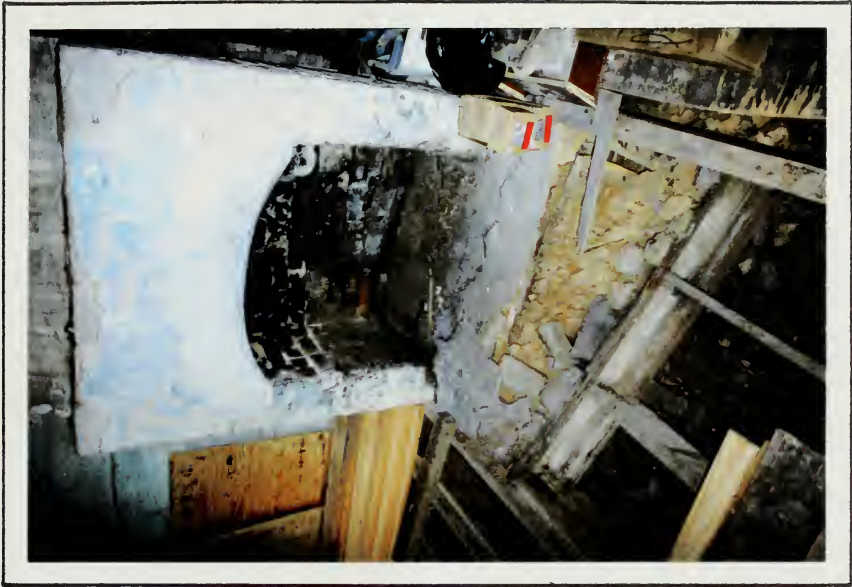
During the documentation of the fireplace in room "D", the front hearth and its header joist collapsed revealing its construction details. (Figure 31) The area was left as is and not cleared of this debris. This accident can provide an opportunity for further investigations of this area concerning the original floor level like that found in the main kitchen area.

**Figure 31 – Same Fireplace as Figure 30  
Suspended Hearth Collapsed  
During Survey**
