Ruins Stabilization in the Southwestern United States

RUINS STABILIZATION IN THE SOUTHWESTERN UNITED STATES

National Park Service
U. S. Department of the Interior
Washington 1974

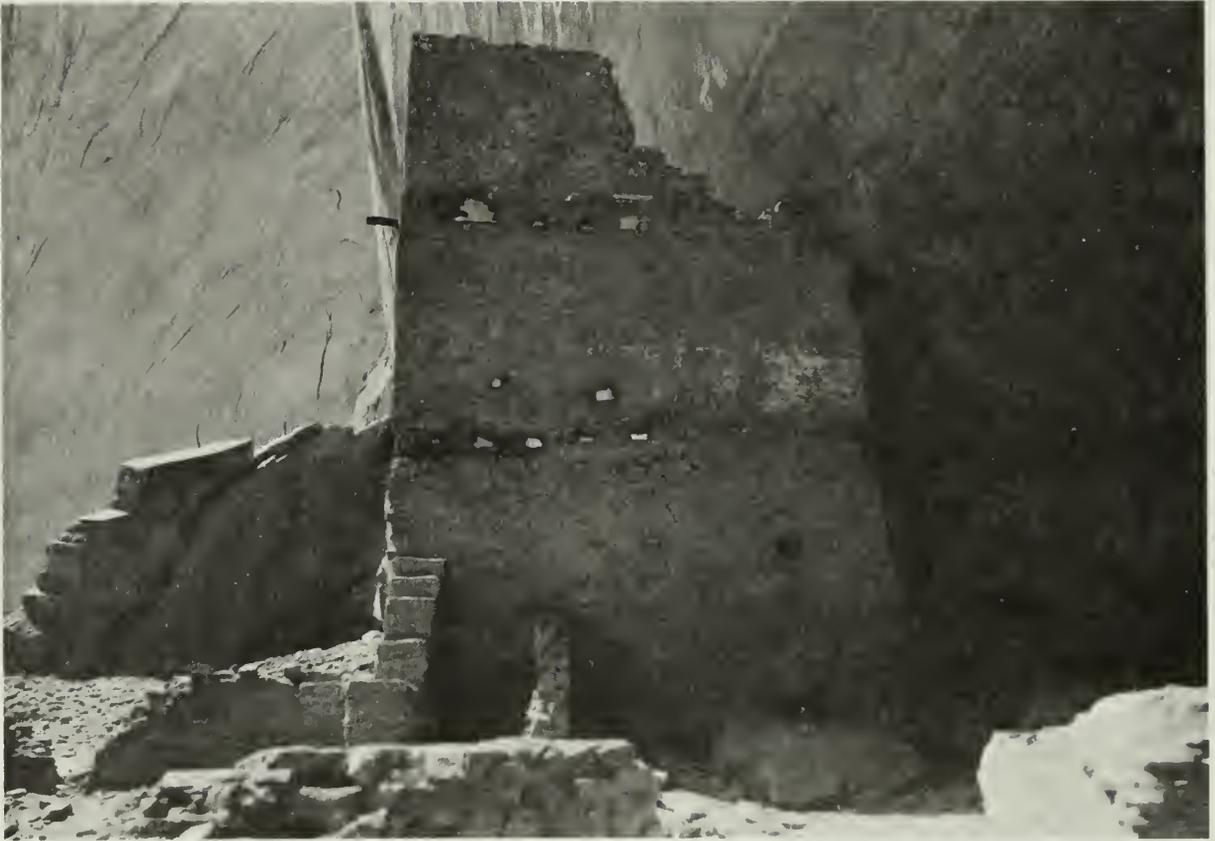
FIGURE 1. Settling caused by lack of foundations and unstable fill. Bond between stone and soil mortar is poor. Holes are caused by decay or theft of wood members. (Antelope House Ruin, Canyon de Chelly National Monument, Ariz.)

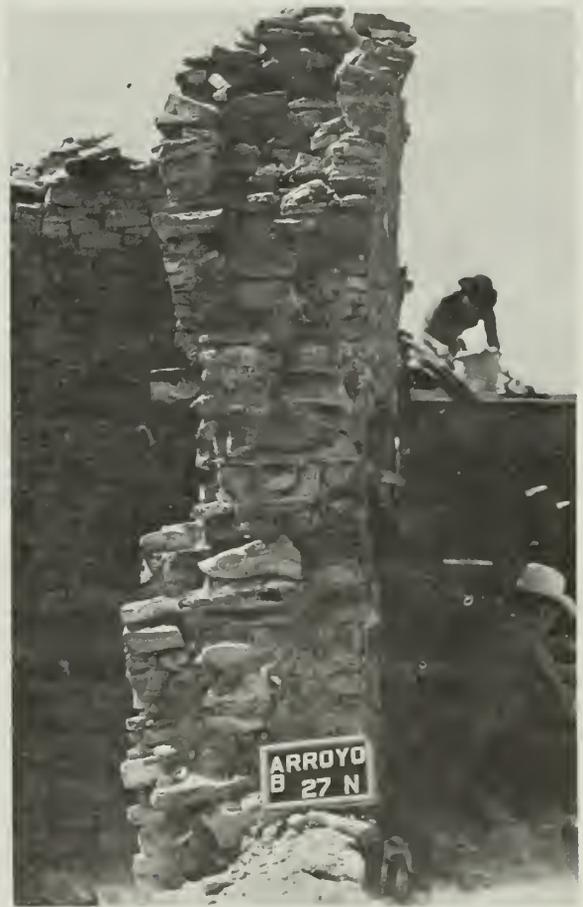
FIGURE 2. Aboriginal construction often left narrow strips at ceiling line. This wall is much wider at the top than in the center. (Room 27, north wall, Pueblo del Arroyo Ruin, Chaco Canyon National Monument, N. M.)

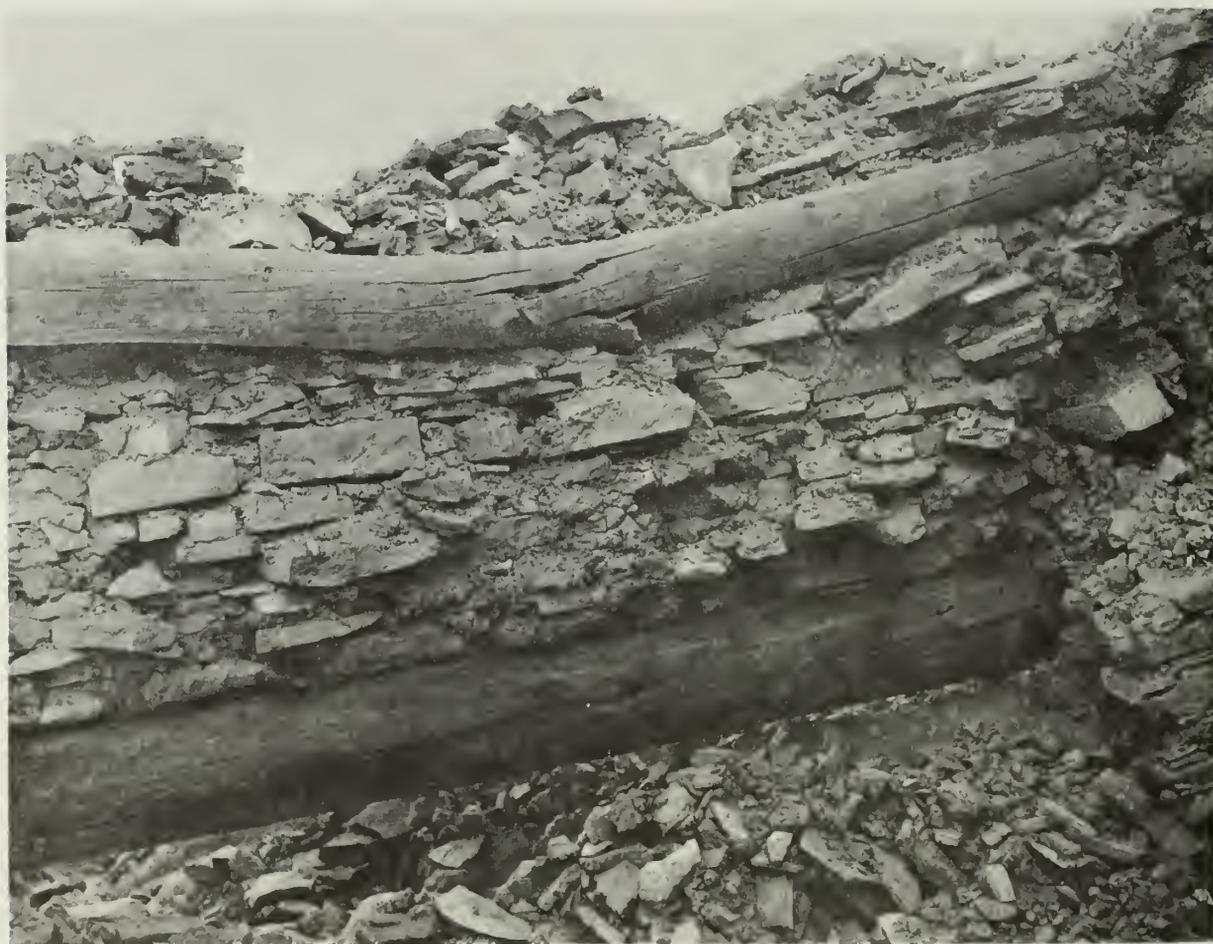
FIGURE 3. The inclusion of heavy timbers within cored-type walls was a usual practice of prehistoric builders. Collapse of walls from flood damage at Chetro Kettle exposed 300 logs similar to those above. (Chetro Kettle Ruin, Chaco Canyon National Monument, N. M.)

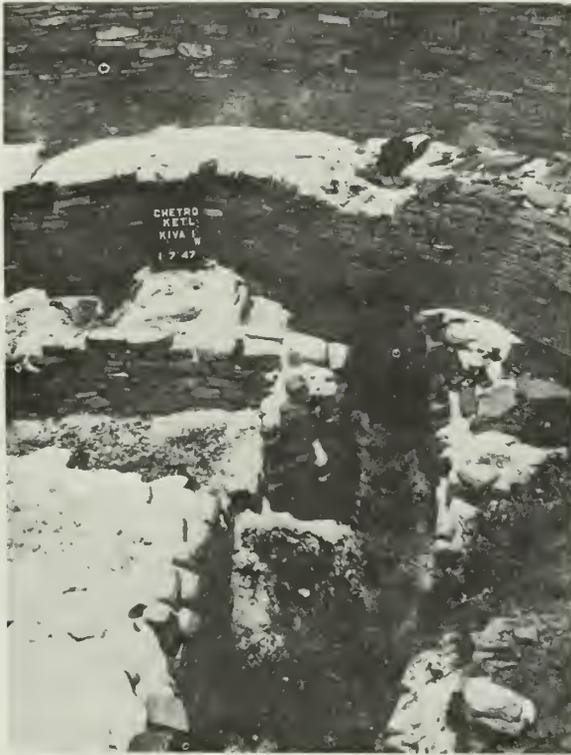
FIGURE 4. Excavation neither proceeds nor ends on a single plane and often leaves walls unsupported. (Kiva I, west perimeter, Chetro Kettle Ruin, Chaco Canyon National Monument, N. M.)

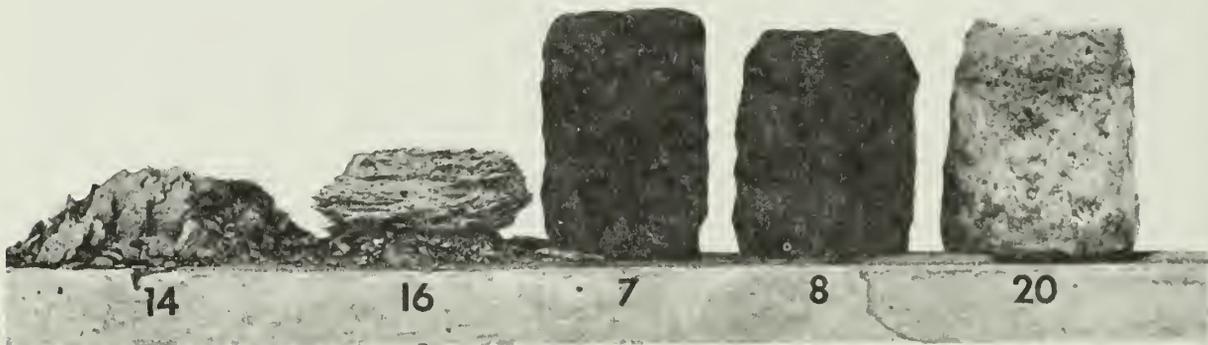
FIGURE 7. Selected cylinders subjected to freeze-thaw test. Nos. 14 and 16, with 10 and 12 percent cement by volume respectively, failed at the third cycle. Both were made up with equal parts clay and silt-loam. No. 20, with 15 percent cement by volume, is shown at the 12th cycle. Nos. 7 and 8, consisting of three parts clay, two parts silt-loam, and emulsified bitumen, were tested in conjunction with the soil-cement and are shown at the 15th cycle.

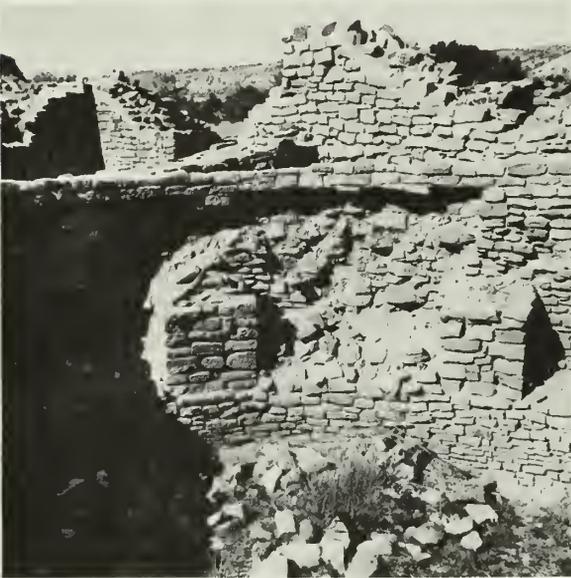
FIGURE 15. Damage caused by outward movement of moisture from fill behind kiva wall. The most severe disintegration is at the limit of capillary rise, just below the concrete capping. (Clan Kiva, West Ruin, Aztec Ruins National Monument, N. M.)

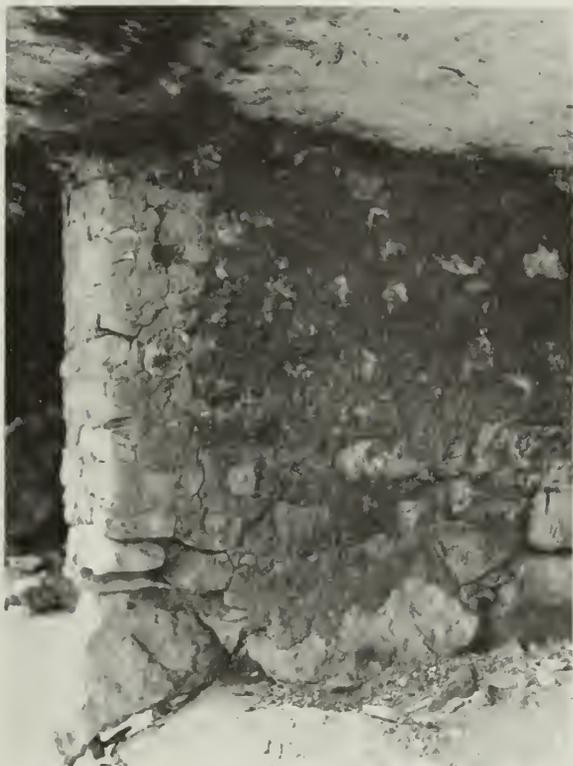
FIGURE 16. Damage as the result of rising moisture from melting snow. Note that decay is confined to the limit of capillary rise in the mortar column. (Cliff dwelling in Walnut Canyon National Monument, Ariz.)

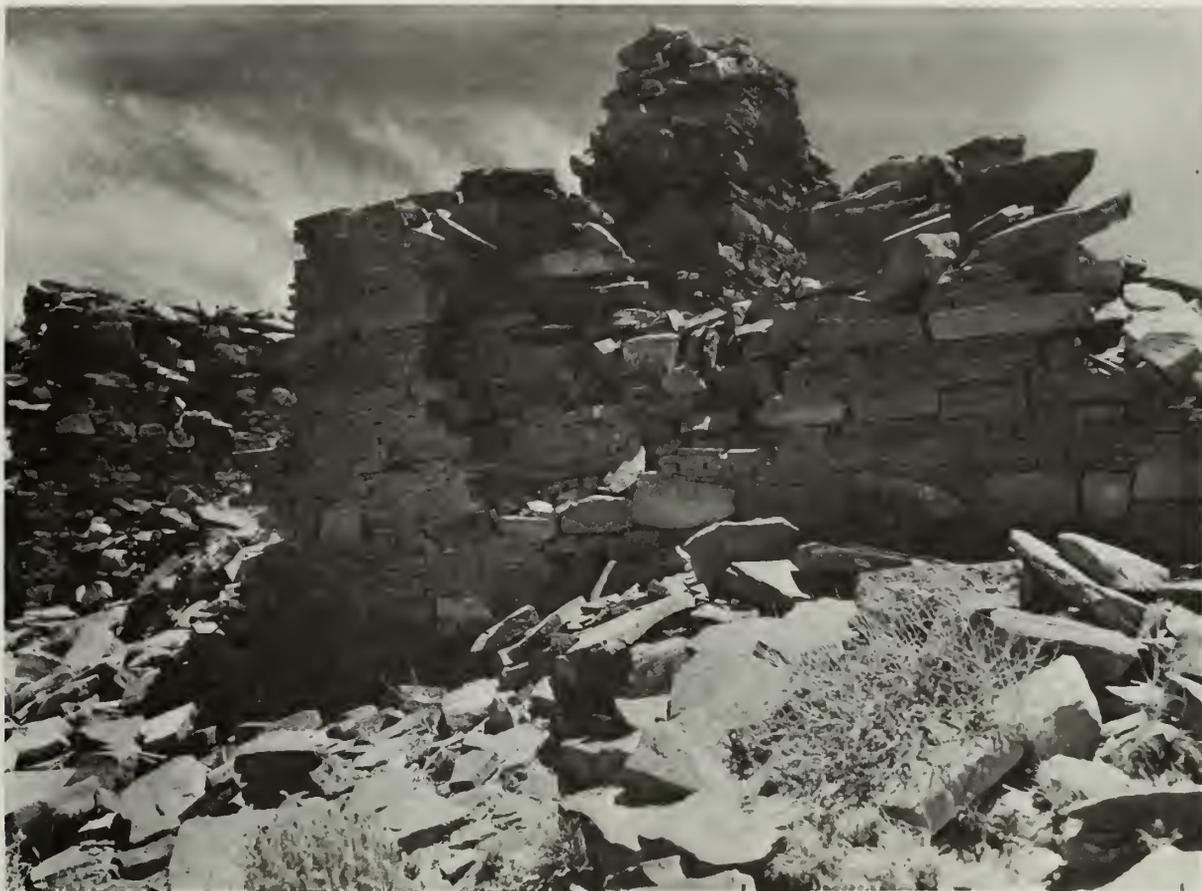
FIGURE 23. An example of soft, pecked and dimpled stone in random areas over wall surface. Replacement of the stone requires extreme care if the character of the wall is not to be changed. (Peñasco Blanco Ruin, Chaco Canyon National Monument, N. M.)

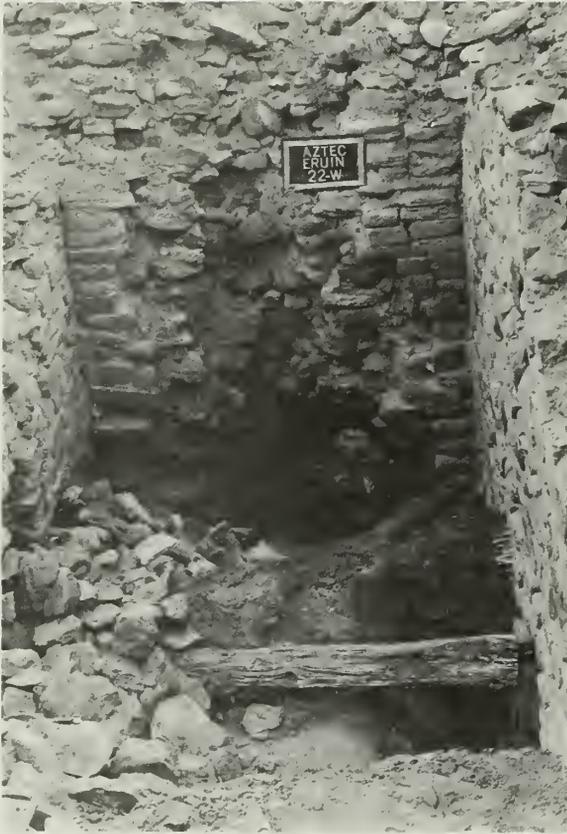
FIGURE 24. Wall break in a partially excavated site. A patch must be designed to prevent further flow of water and fill at the top, and some excavation will be required to base patch on sound masonry. (East Ruin, Aztec Ruins National Monument, N. M.)

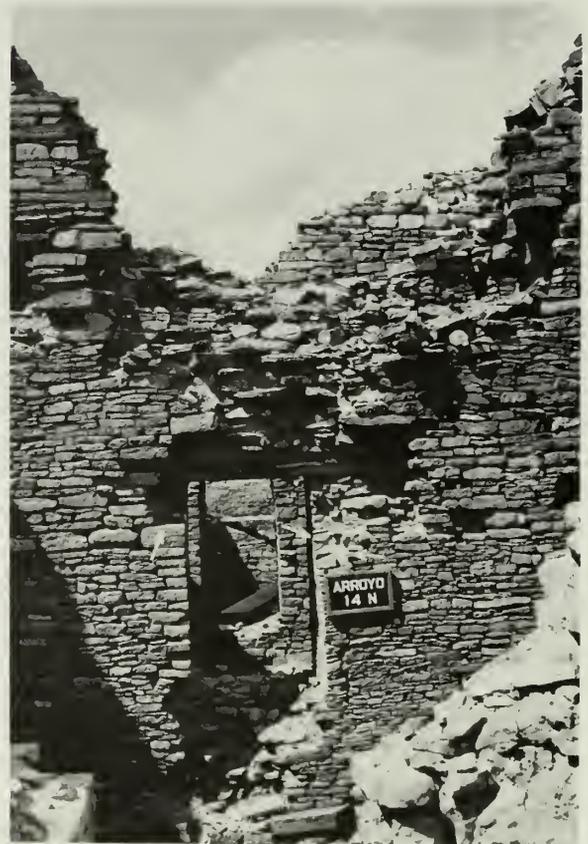
FIGURE 25. Repair at the position of the arrows will be based on a very small area in comparison with the total size of break. Every effort should be made to tie such patches securely to the existing wall. (Pueblo del Arroyo Ruin, Room 14, north wall, Chaco Canyon National Monument, N. M.)

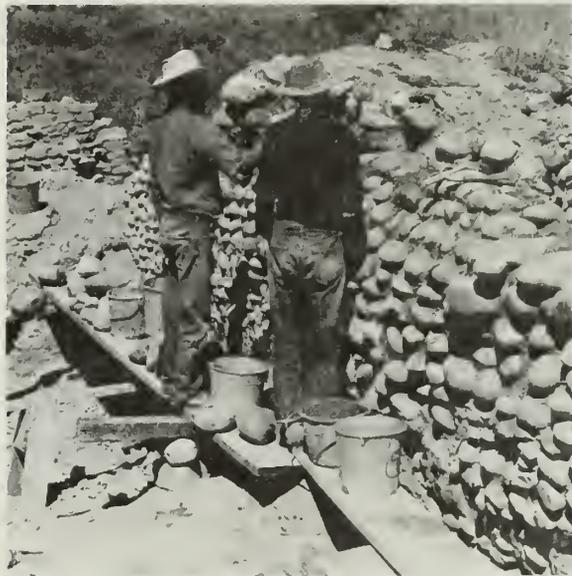
FIGURE 26. Deep grouting with soil-cement on the badly weathered face of this cobblestone wall will not change its appearance, but will halt the rapid rate of erosion. (East Ruin, Aztec Ruins National Monument, N. M.)

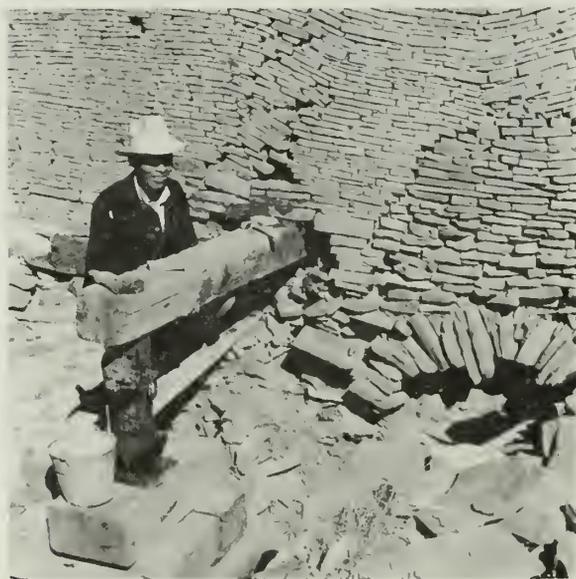
FIGURE 28. The temporary support of a heavy wall with timber. The arch at lower right was constructed in the 1920's as a repair measure. The first step in stabilization involved the placing of a beam through a hole adjacent to the arch. Not of aboriginal origin, the arch was subsequently removed. (Room 1, Chetro Kettle Ruin, Chaco Canyon National Monument, N. M.)

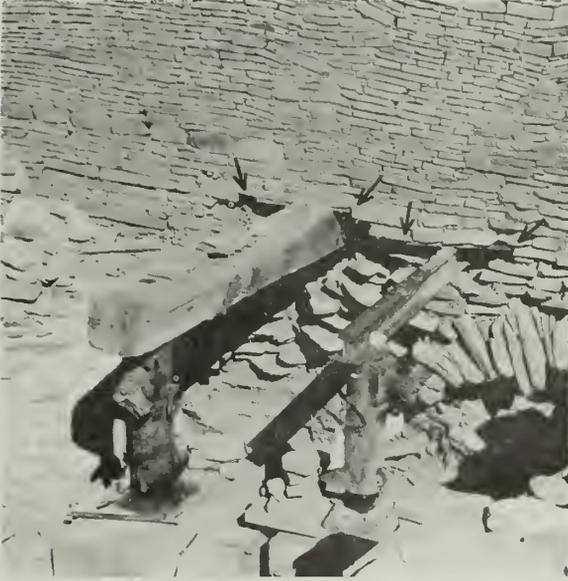
FIGURE 29. A second beam resting on jacks is placed through the wall depicted in figure 28. Arrows indicate extent of steel plates above the beam. The area of settling was reduced with upward pressure.

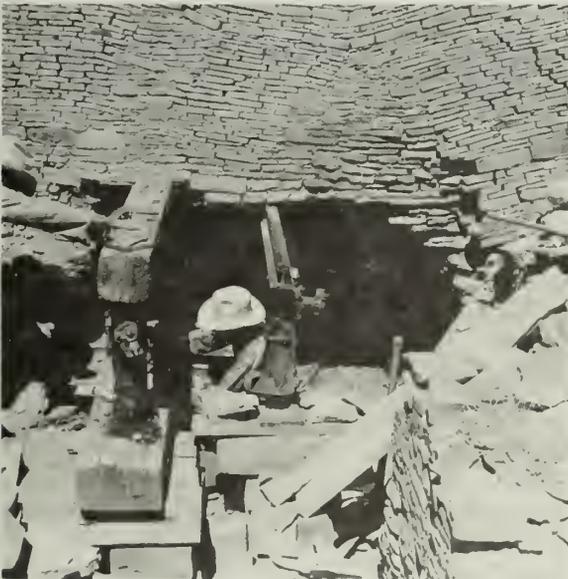
FIGURE 30. Jacks and beams provide support of wall depicted in figures 28 and 29 while arch section is removed. The break is filled with repair masonry.

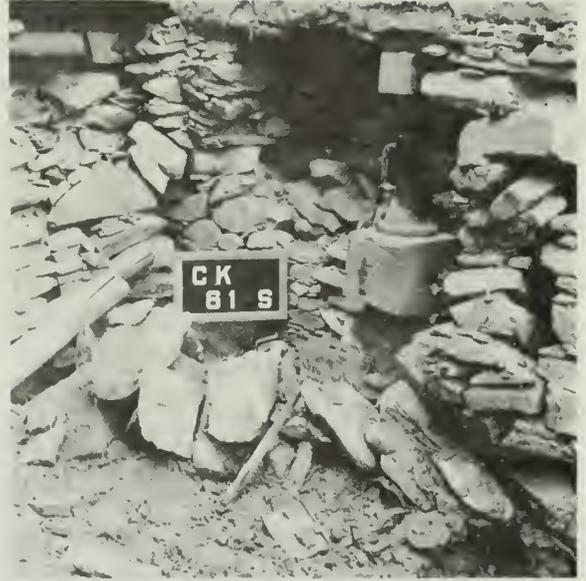
FIGURE 31. Placement of jack in line with shattered facing near the bottom of a 14-foot wall. The jack provided support while the broken area at the right was being replaced. (Chetro Kettle Ruin, Chaco Canyon National Monument, N. M.)

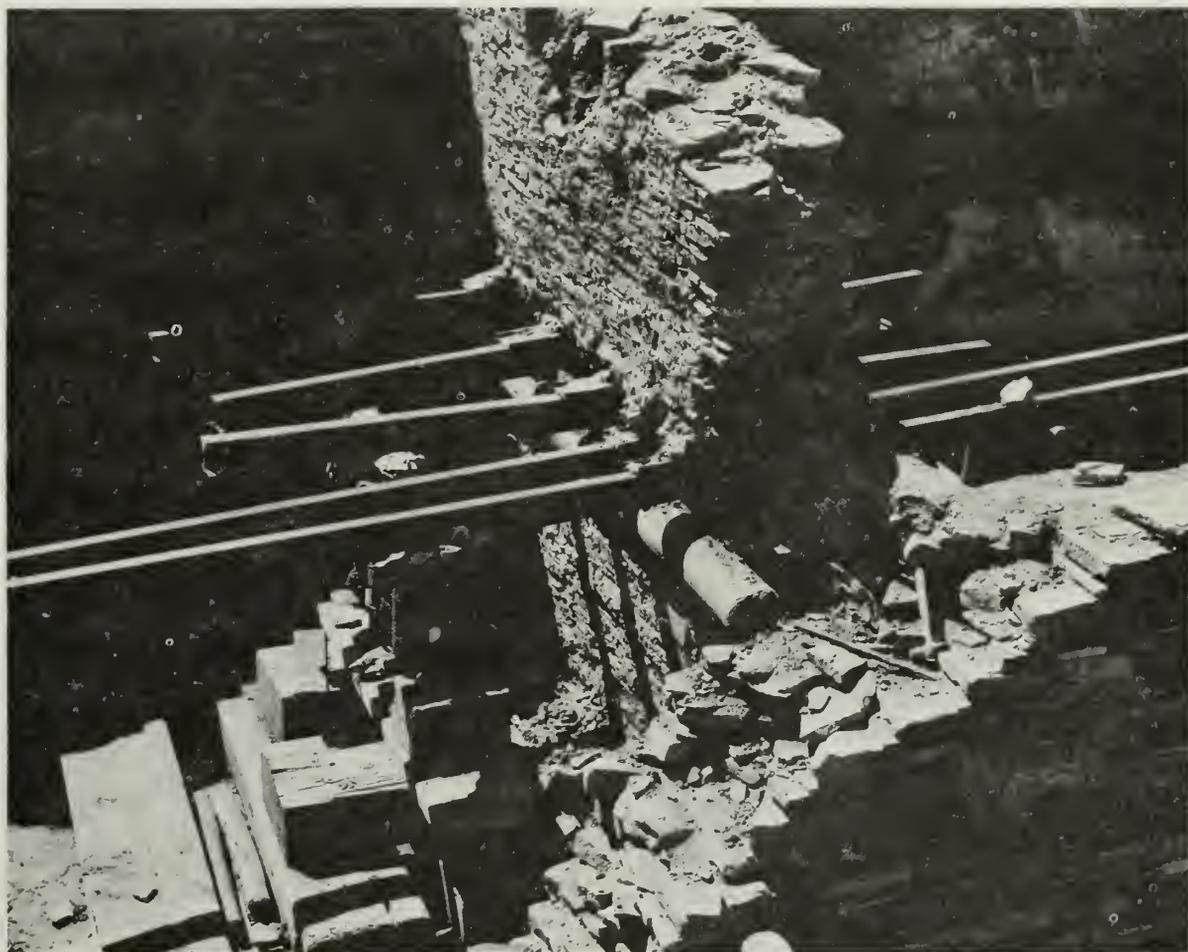
FIGURE 32. A temporary support. Six steel beams buttress the upper half of the wall while a decayed horizontal timber is replaced. The timber is partly removed here. With care, steel beams can be run through pole sockets or other natural openings without damage to the wall. (Chetro Kettle Ruin, Chaco Canyon National Monument, N. M.)

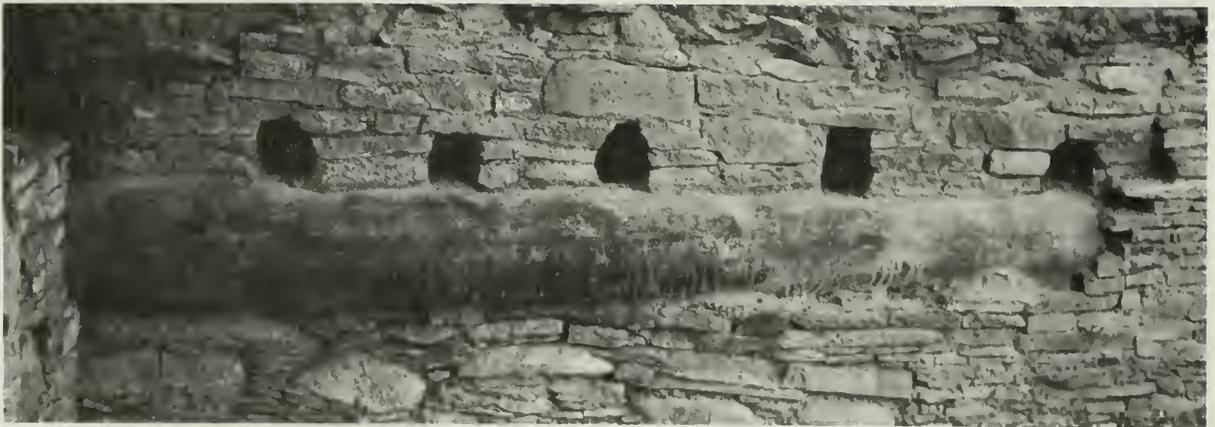
FIGURE 38. A horizontal cast log replaces the original timber which had rotted on the interior and in the embedded portions. (Chetro Kettle Ruin, Chaco Canyon National Monument, N.M.)

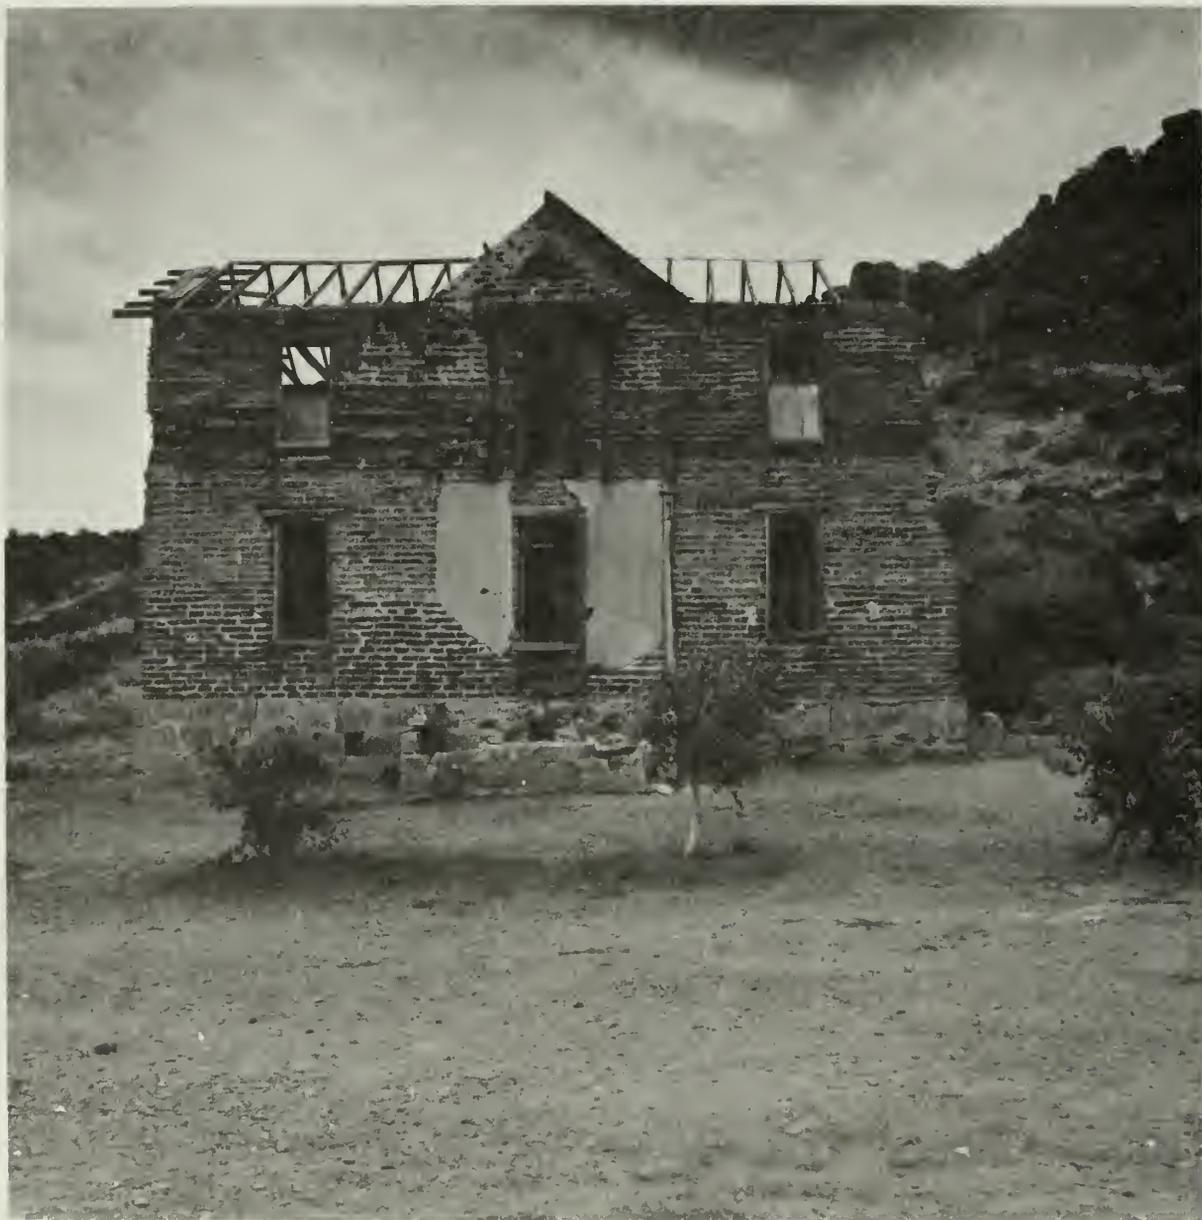
FIGURE 55. One of four 2-story adobe structures, designated HB-14, at Fort Davis National Historic Site. The building was probably used as a residence for important non-commissioned officers. Front view in 1964 before repairs were undertaken by the National Park Service.

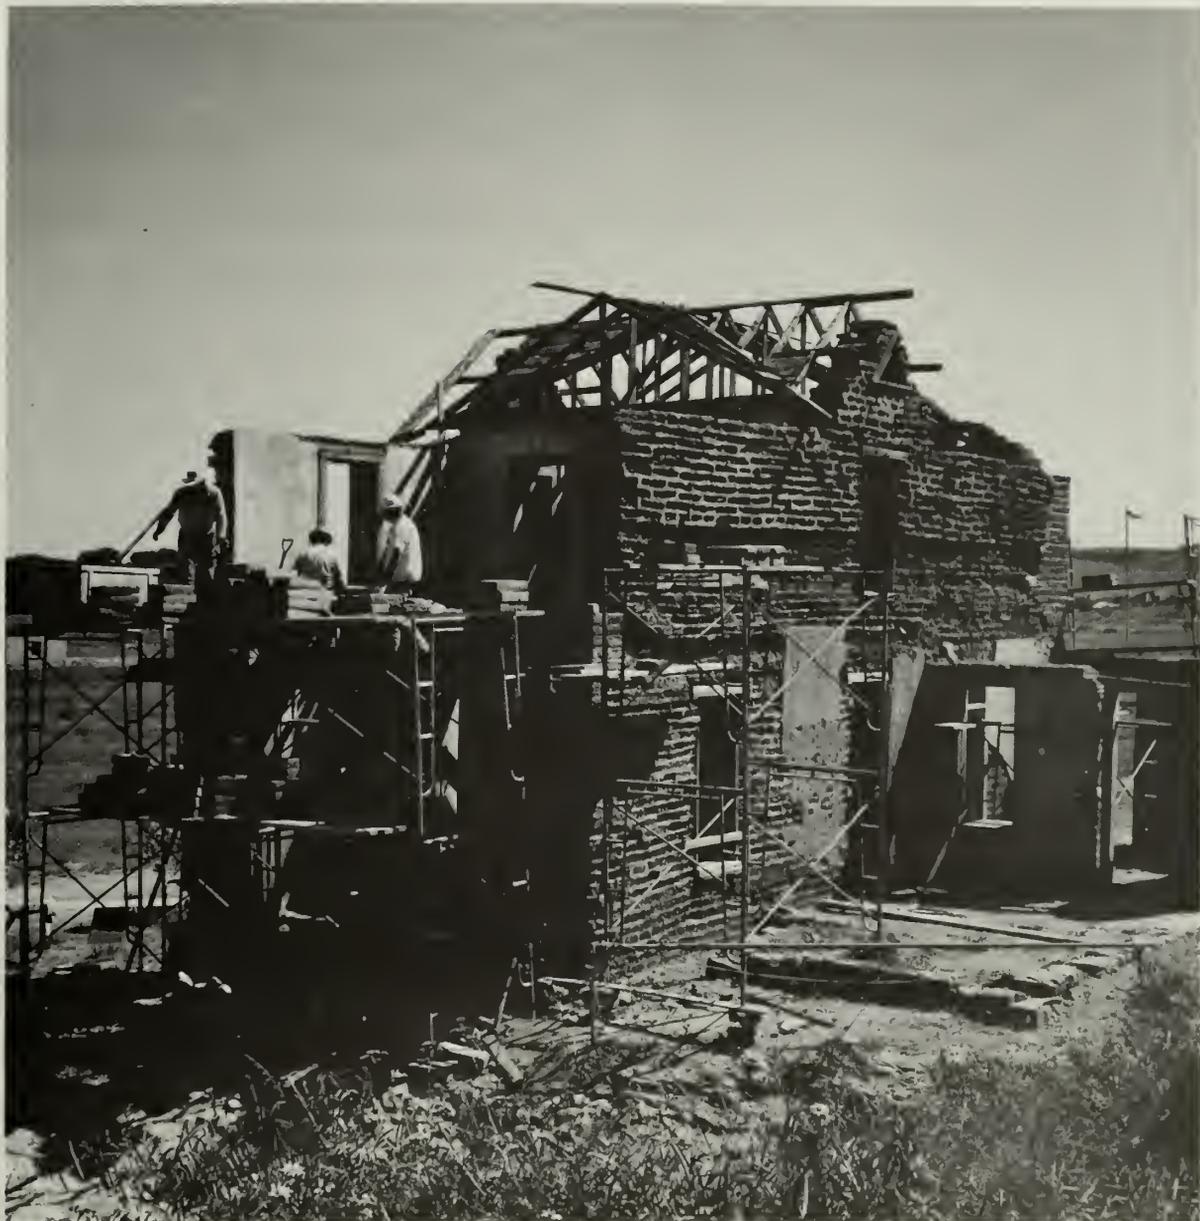
FIGURE 56. Stabilization and modified restoration in process at HB-14, shown in figure 55. Soil-cement adobes were used for repairing walls. A concealed integral bond beam was installed around the building between the first and second story levels. Concrete bearing beams were installed at roof line to support restored roof.

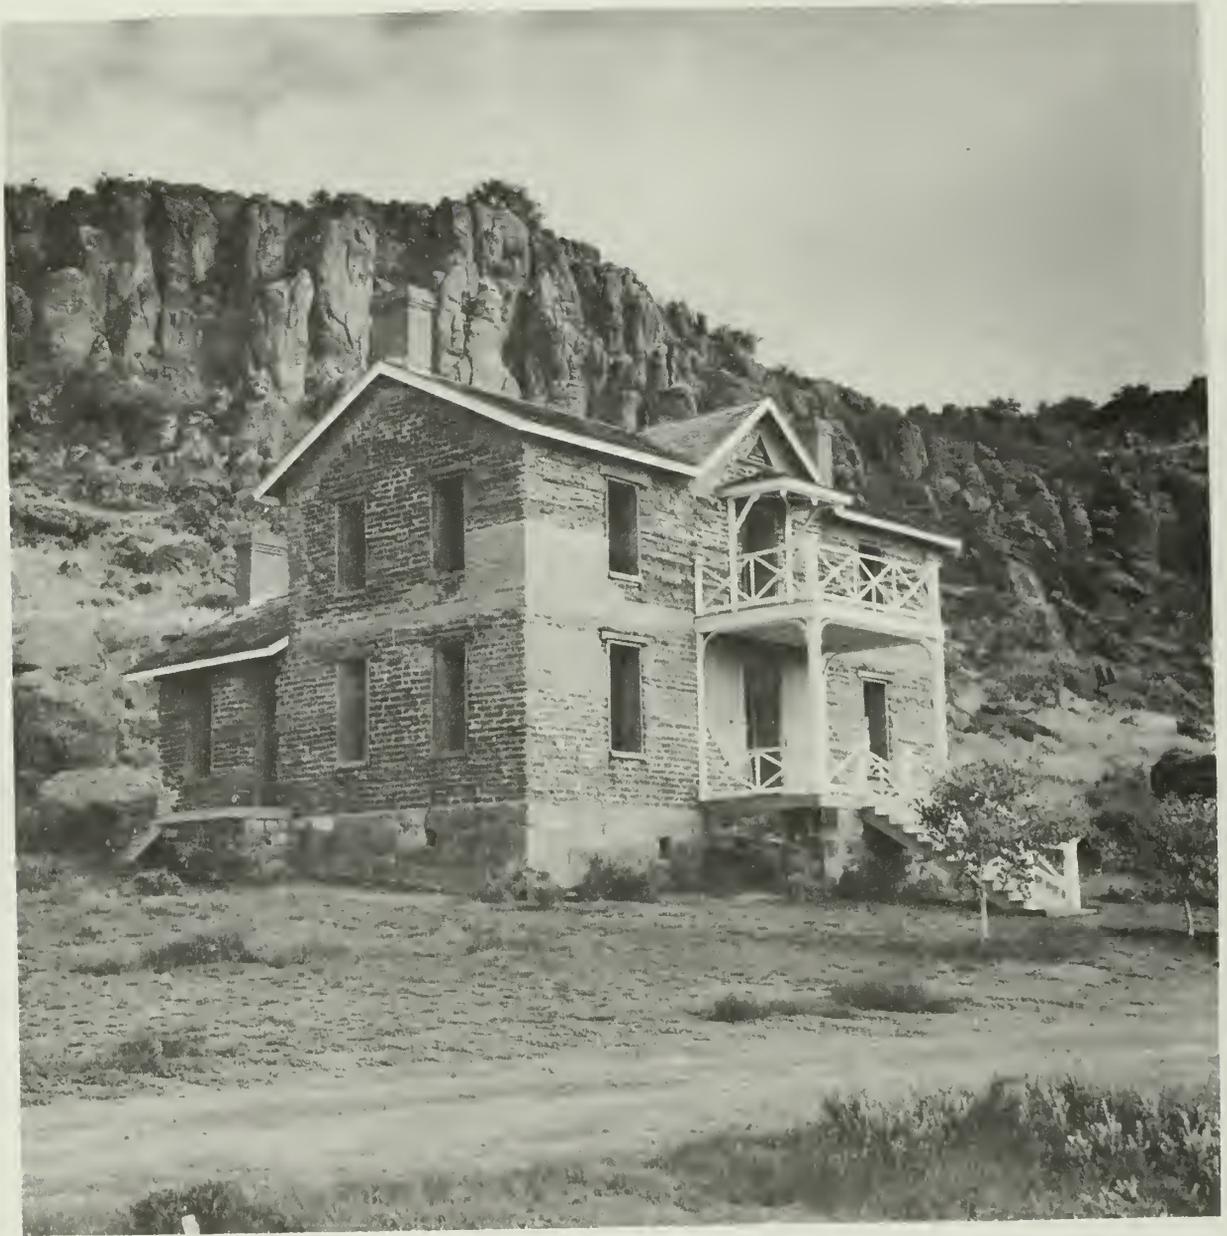
FIGURE 57. The completed stabilization and modified restoration of building HB-14, Fort Davis National Historic Site. Compare with figures 55 and 56.

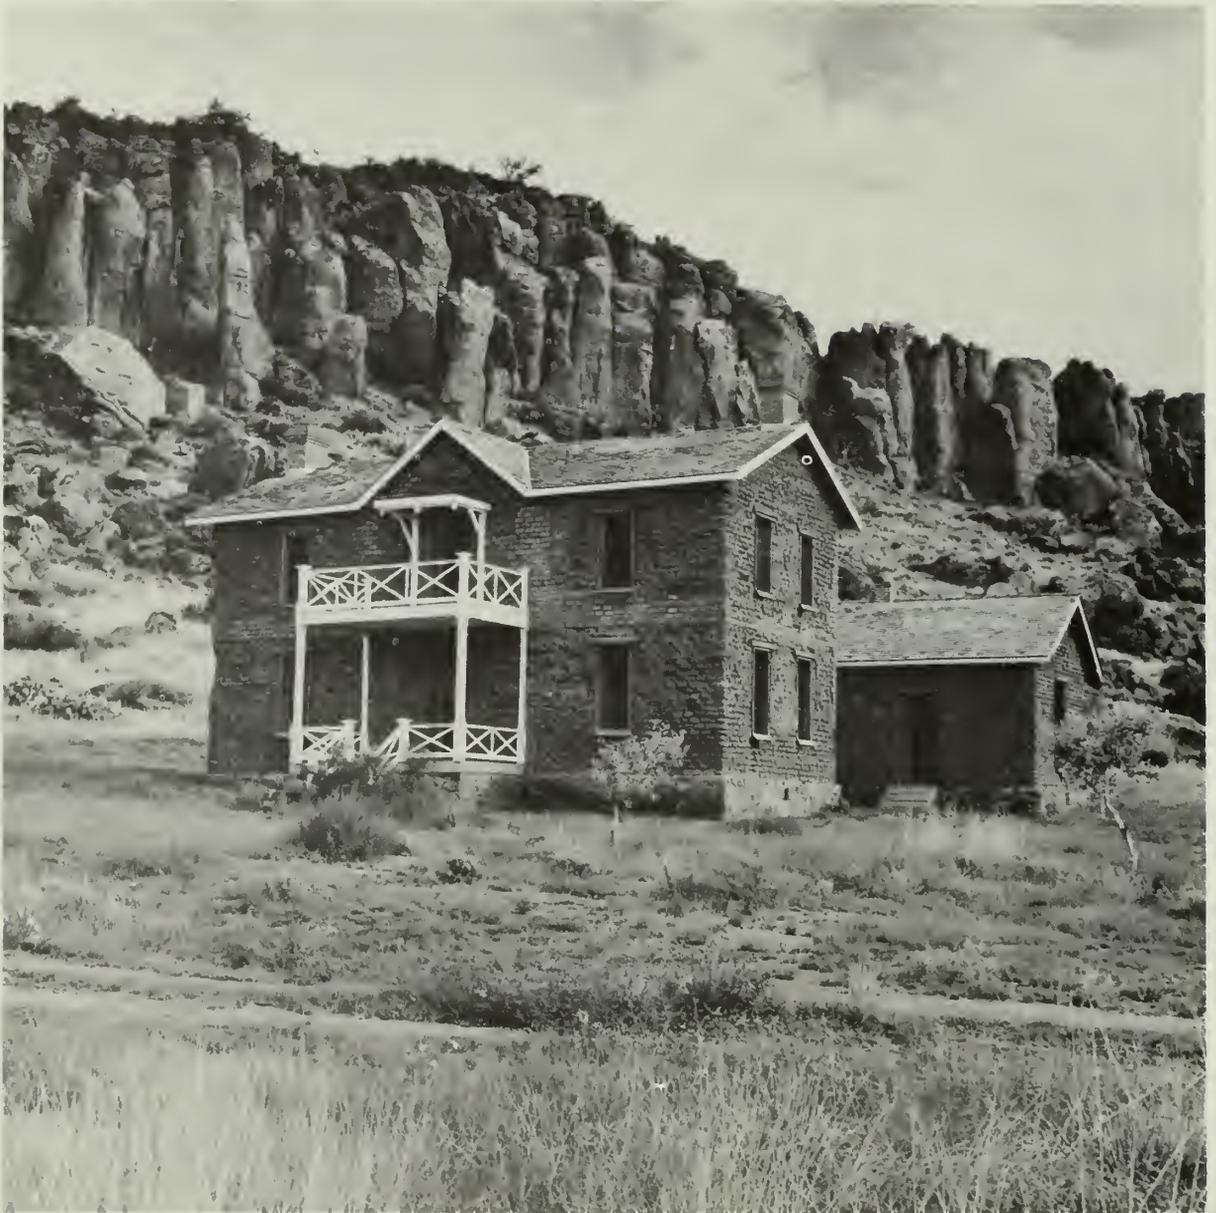
FIGURE 59. Building HB-15 and its outbuilding, a kitchen, following modified restoration by the National Park Service. Soil-cement adobes simulating original adobes were used as modular units of repair. Compare with figure 58.

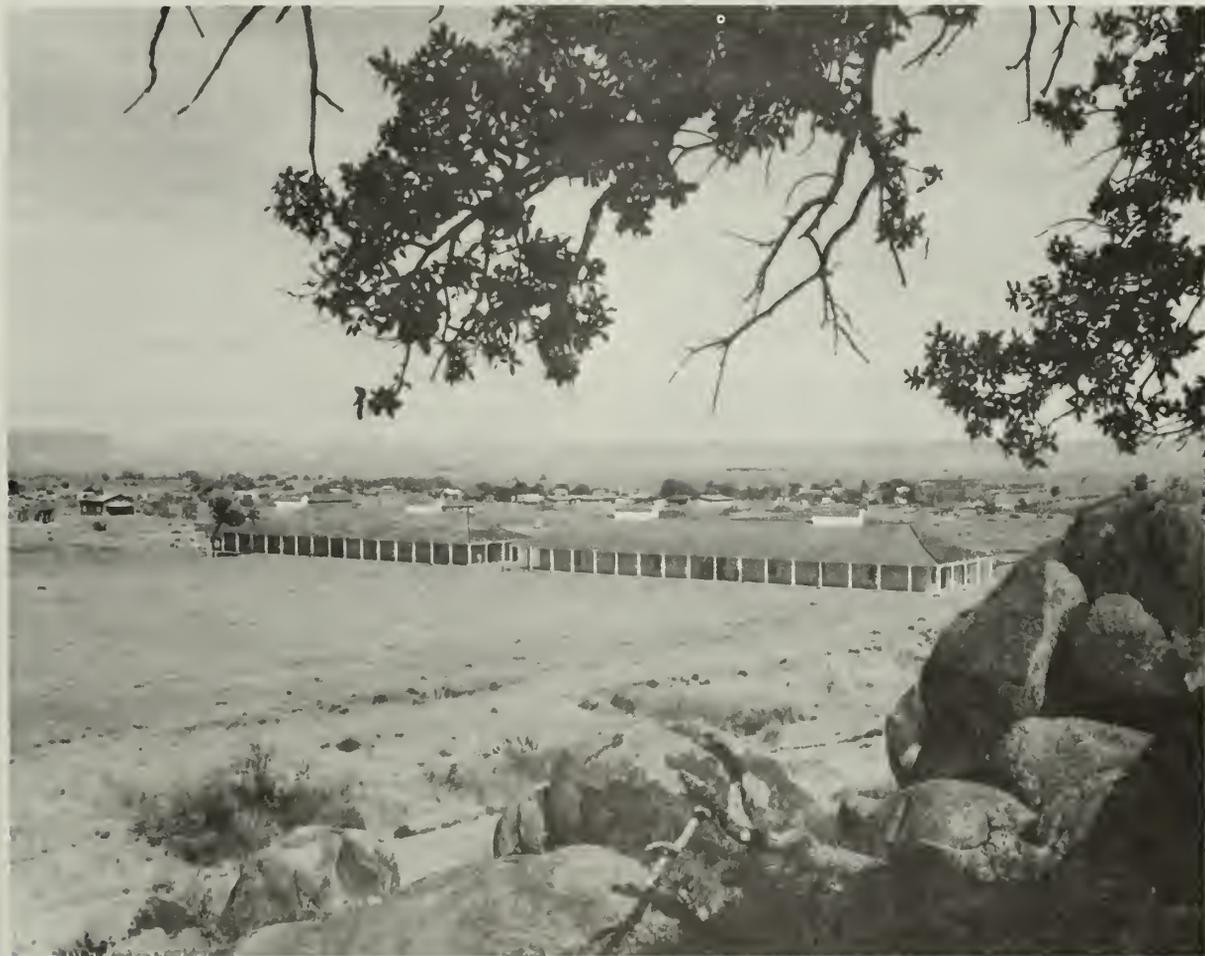
FIGURE 61. A view of the Fort Davis barracks after restoration. The ruinous shell seen in figure 60 was veneered with hand molded soil cement bricks, 4" x 4" x 12". They were made with one part portland cement (untinted), three parts unwashed sand, and three parts native soil. The bricks laid in masonry mortar with rough joints, set with spalls, were wire-brushed. Original walls were pared down where required to accommodate the veneer brick and to retain original wall dimensions and thickness. Bond beams were installed at roof line to support the restored, hipped, shingled roof. The soil cement brick walls were painted with white cement paint, although originally they were whitewashed. The building is used functionally today as the Visitor Center. Cost of the restoration: \$129,000 or \$12.90 per square foot.

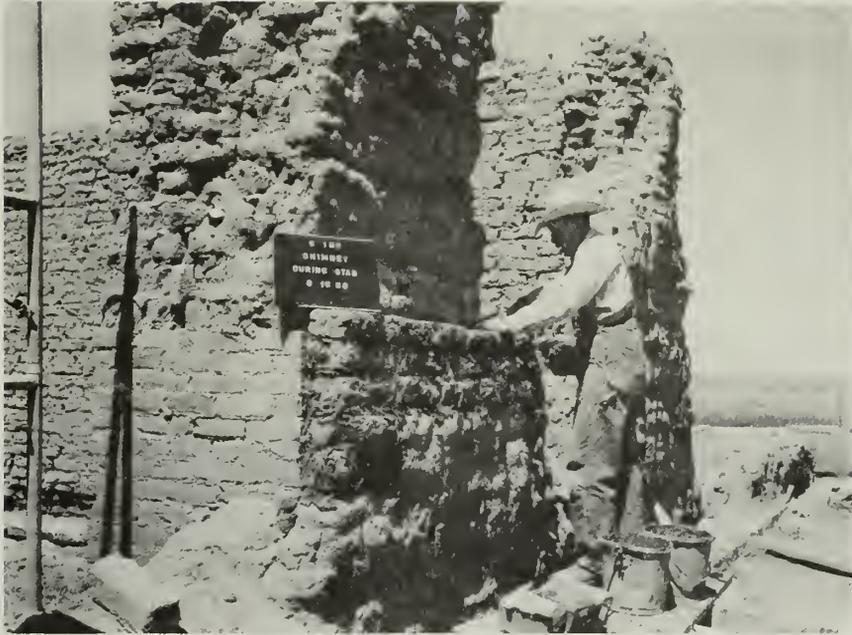
FIGURE 97. Building 6-160, Room 163, flue and chimney in east wall, during stabilization. Soil adobes are being laid to replace those that had fallen away. Fort Union National Monument.

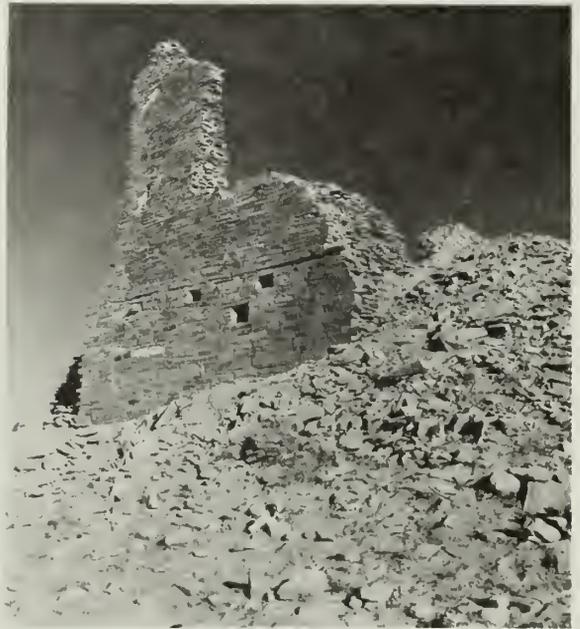
FIGURE 102. Hole at base, square openings (the two upper held beams, the lower was a ventilator) and insets repaired and wall stubs capped. Beam stub at left and two beam holes in line above (arrows) either represent reinforcing ties for kiva corner or supports for some sort of prehistoric scaffolding used in construction or a balcony.

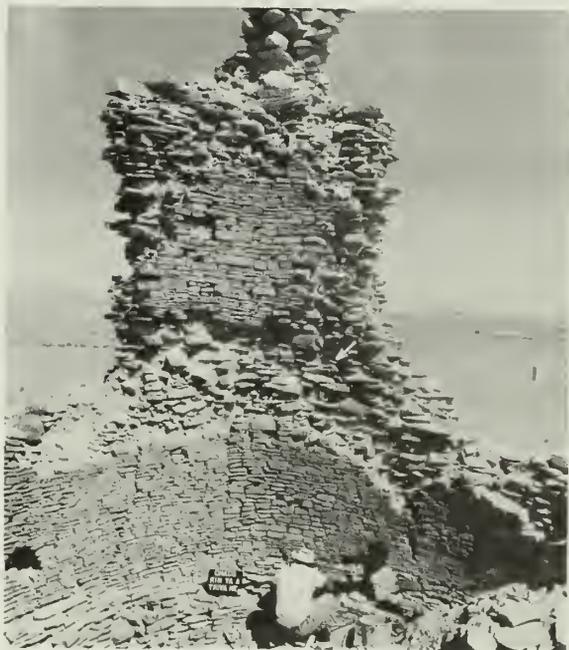
FIGURE 103. General view of northeast interior of Tower Kiva at start of project. The circular wall is stepped back or inset at two points: (1) at narrow ledge or bench where workman is beginning repairs, and (2) where facing is gone, exposing core (arrow).

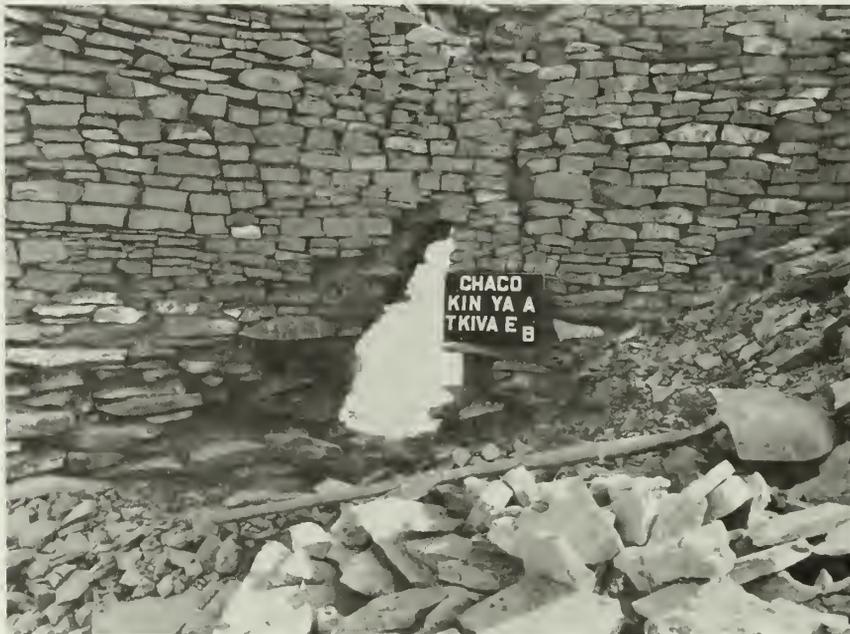
FIGURE 105. Detail of hole in Tower Kiva caused by breakdown of savino sockets. The beams for the sockets extended part way into this wall from the opposite side, and originally supported the ceiling of the adjacent room.

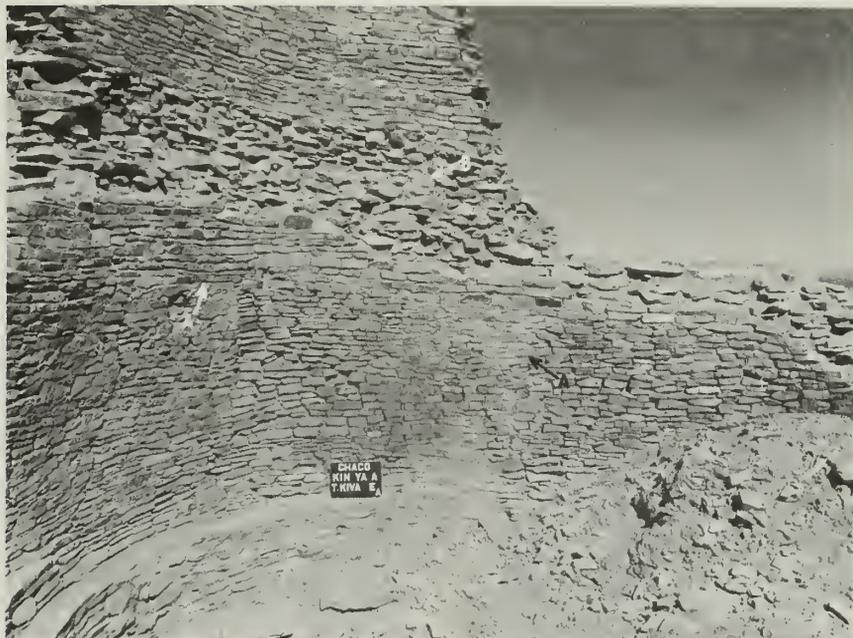
FIGURE 106. Lower portion of Tower Kiva, north and east segments, after stabilization. Offset ledges repaired, holes filled with repair masonry, facing reset (arrows A), top capped and inset core (arrow B) grouted.

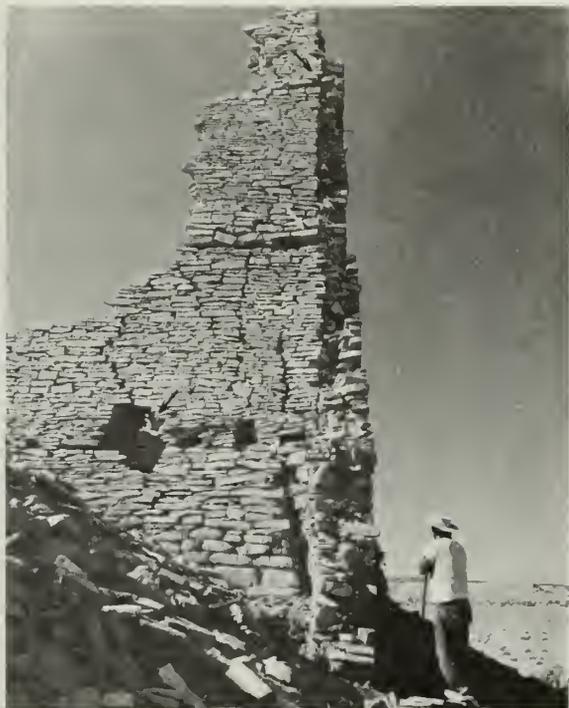
FIGURE 112. Tower Kiva, east wall exterior at juncture with north wall stub (at sign). Note the vertical cracks, eroded savino sockets (arrows) and loose, fragile spire. Portions of 4 stories are visible.
