Ruins Stabilization in the Southwestern United States

RUINS STABILIZATION IN THE SOUTHWESTERN UNITED STATES

National Park Service
U. S. Department of the Interior
Washington 1974

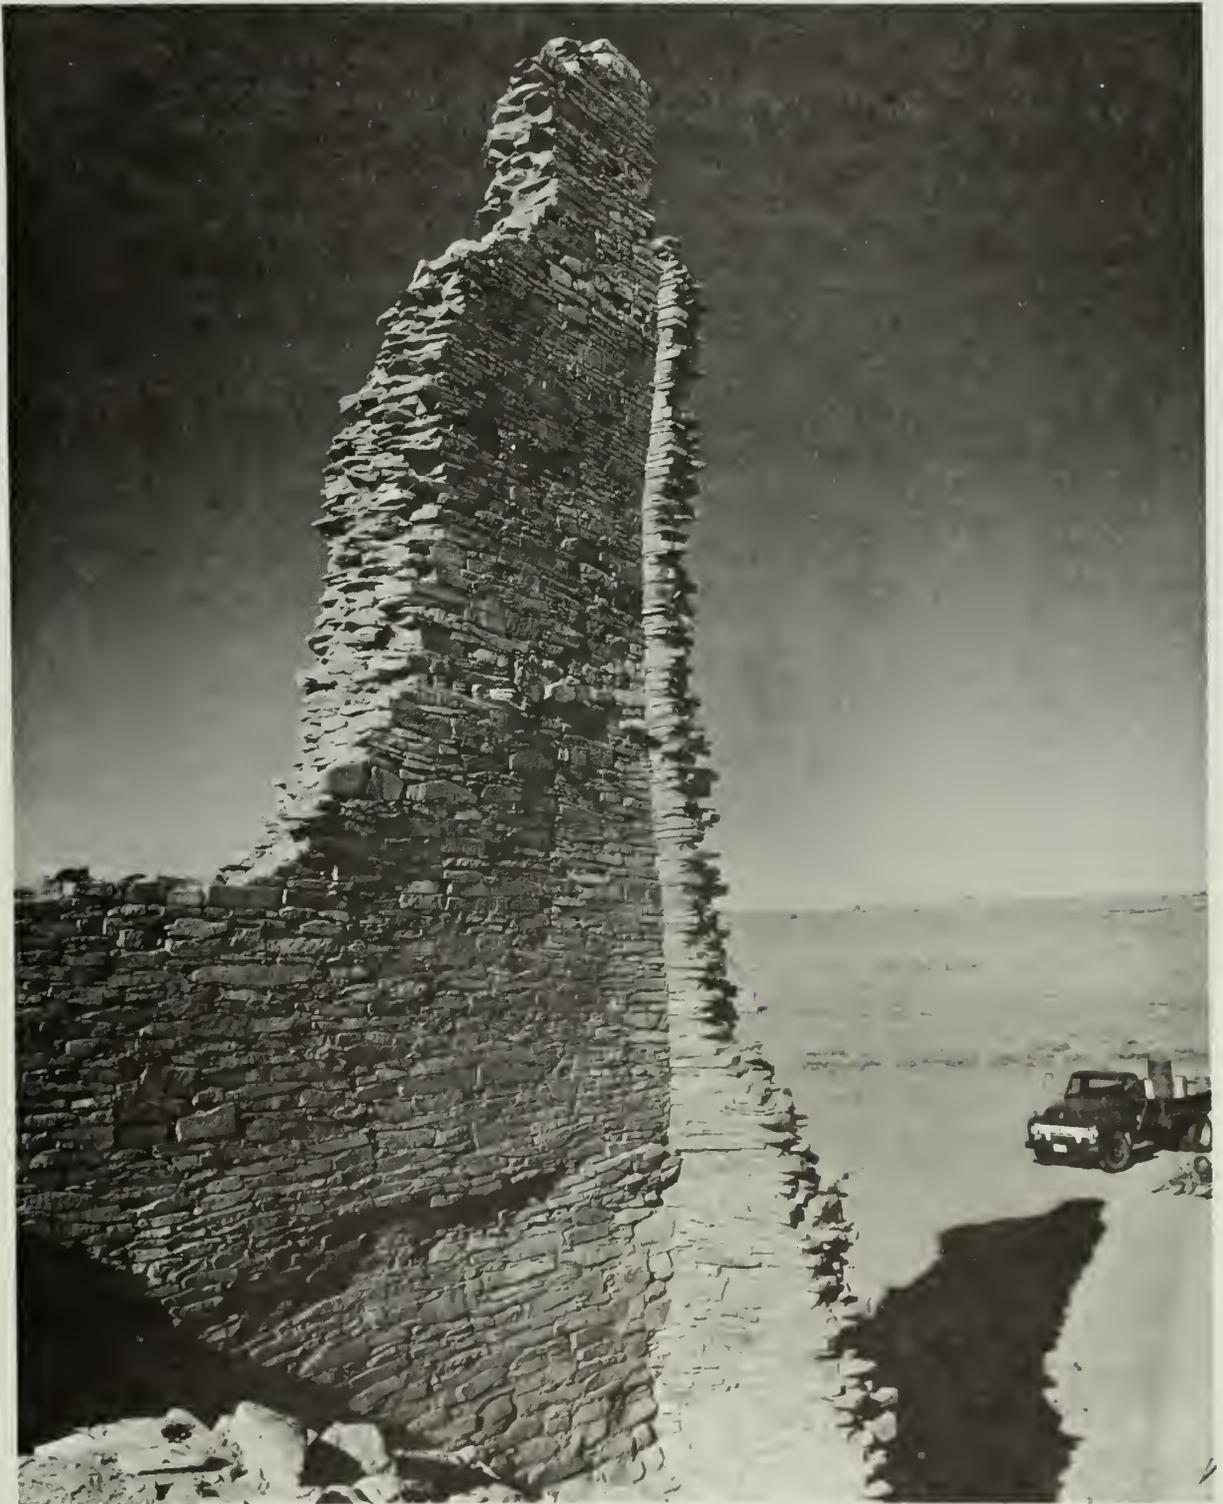
FIGURE 114. View of Tower Kiva showing north wall stub buttressed, cracks repaired, savino sockets re-molded, and facing grouted.

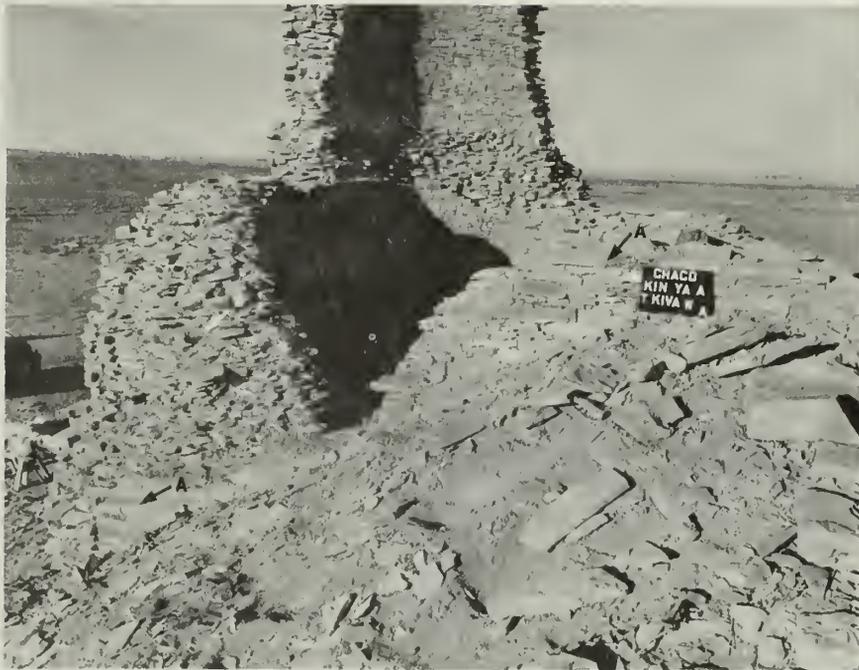
FIGURE 117. Tower Kiva, west wall. This fragmentary section of the square tower enclosing a round one was repaired by resetting the facing (arrow A), capping and grouting the thick core (B).

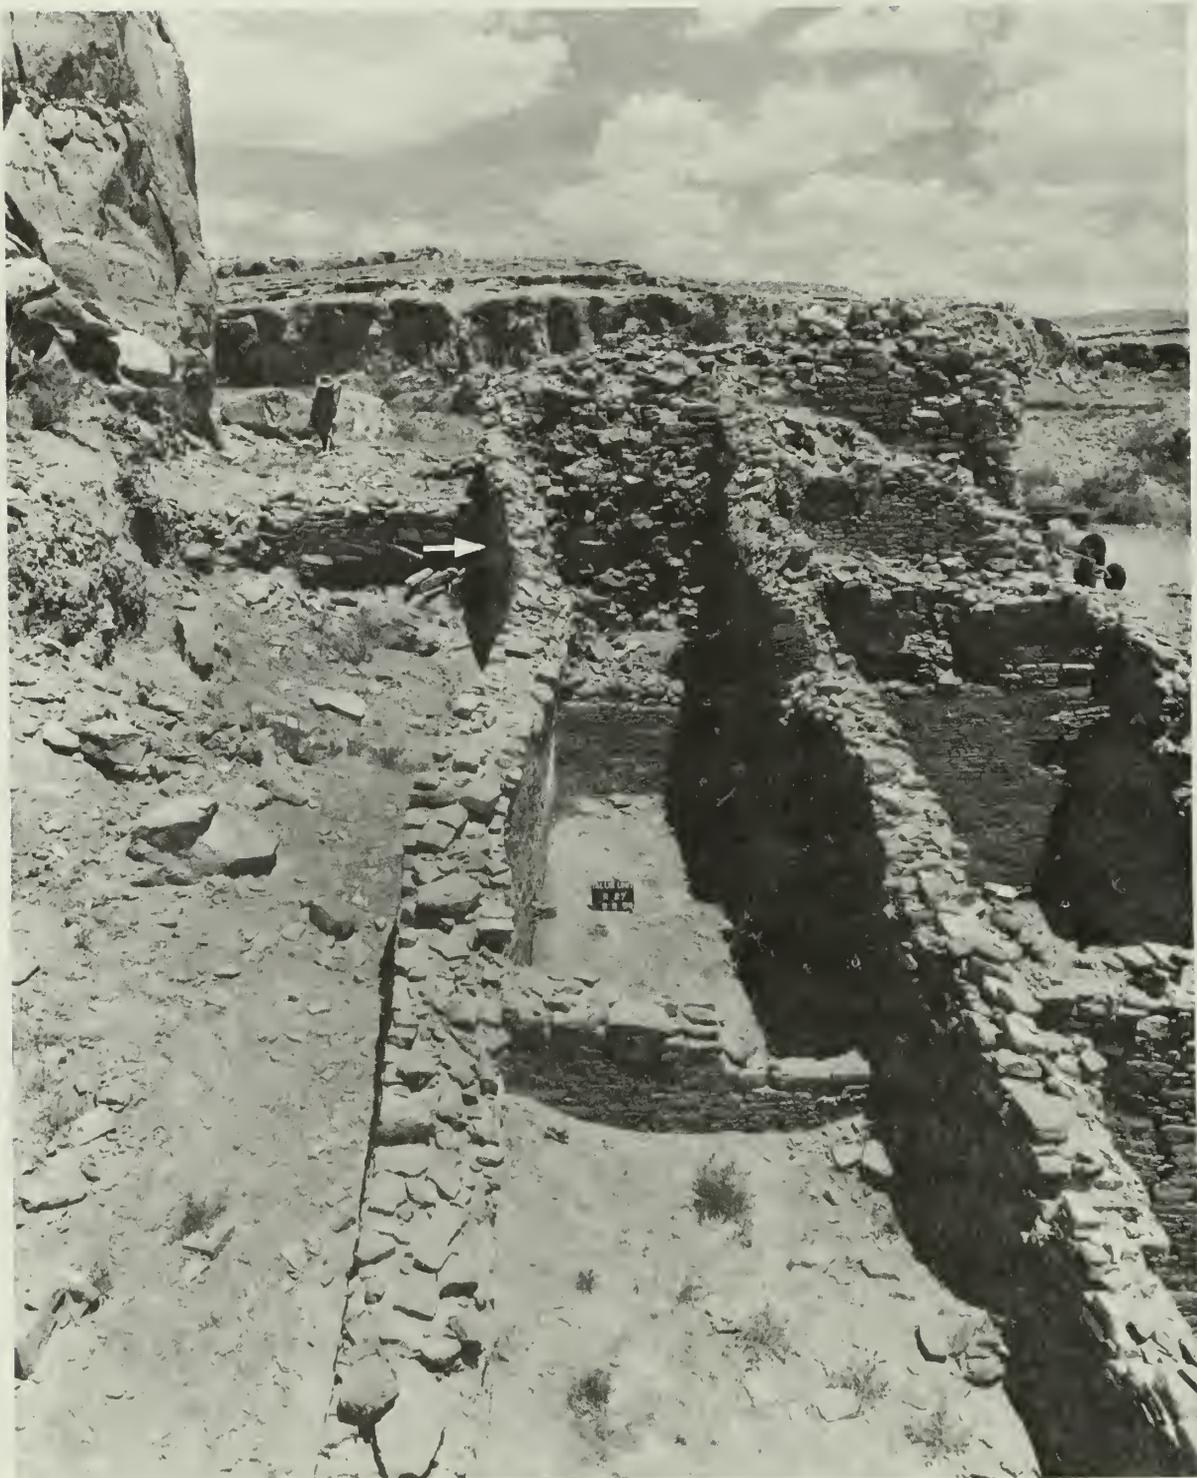
FIGURE 120. The wall between Rooms 27 and 28, Talus Unit No. 1, was distorted and pushed out of line by pressure of fill, often damp, at left. Arrow shows direction of force. The purpose of the stabilization was to strengthen the wall against the pressure.
