Arlington House, The Robert E. Lee Memorial

South Dependency Historic Structure Report

Report prepared by Charles Fisher, Chad Randl and Kaaren Staveteig

2010-0053-P

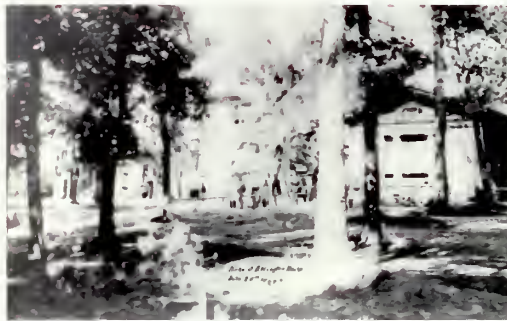
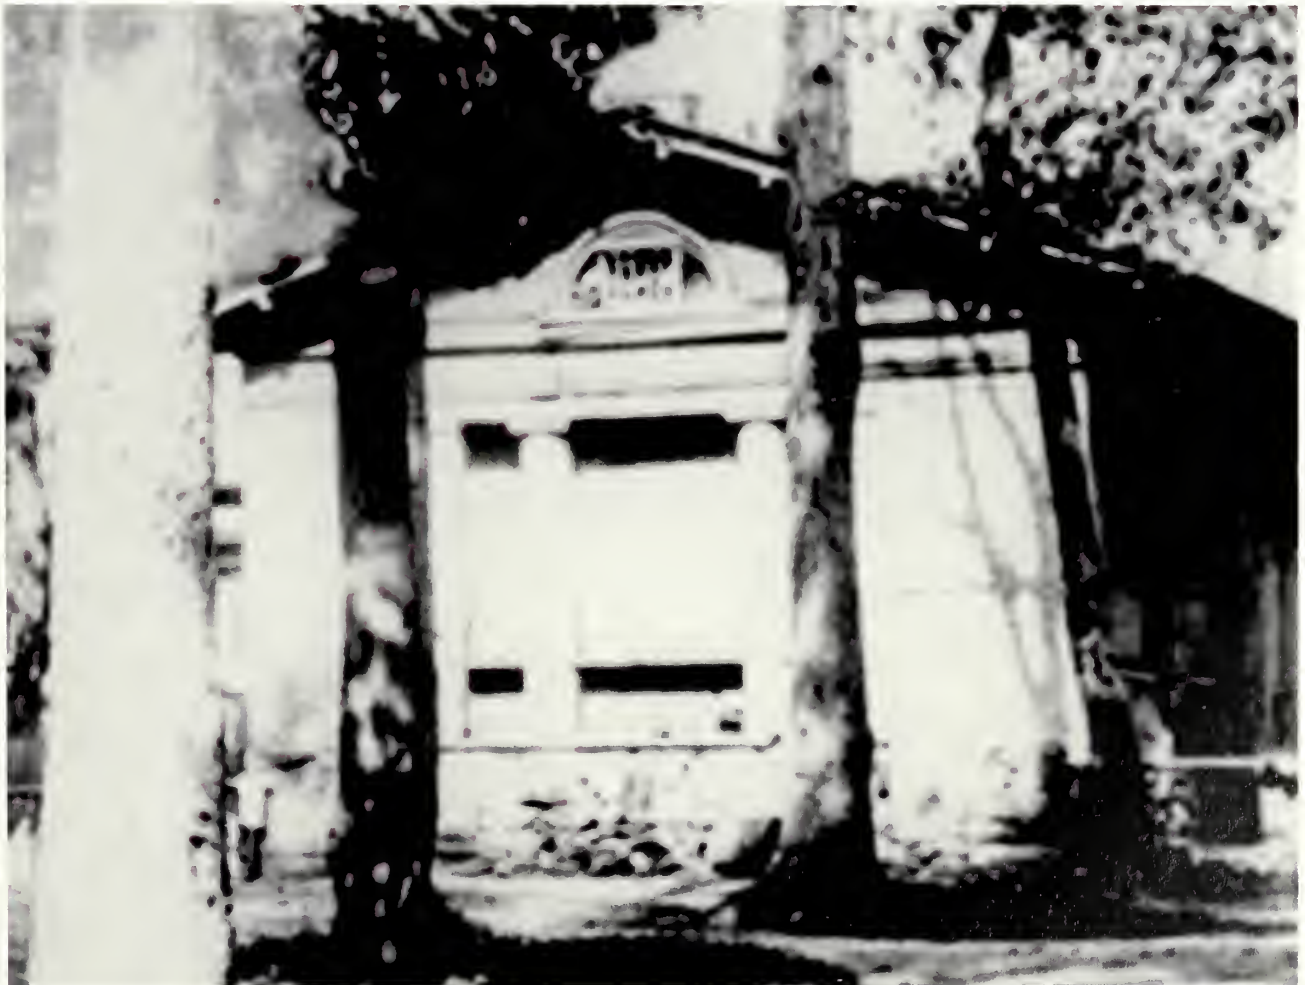
Figure 6 (left and below). West elevation, 1864, original and close-up. Photos by Andrew Russell show that the South Dependency was poorly maintained at the time. Note the missing louvers in the arched attic vent and the deteriorated mortar joints in the exposed masonry foundation.

Most of the masonry foundation visible in the photographs needed repointing. The louvered vents set within the arched opening in the west gable were almost completely missing, the space behind them apparently filled in with a flat board. A molding was unseated from its place below the arch. It is not clear whether this level of deterioration (also seen on the North Dependency in other contemporary photographs) was a result of the Army's use of Arlington during the war, or whether this condition predated the Lee's departure.

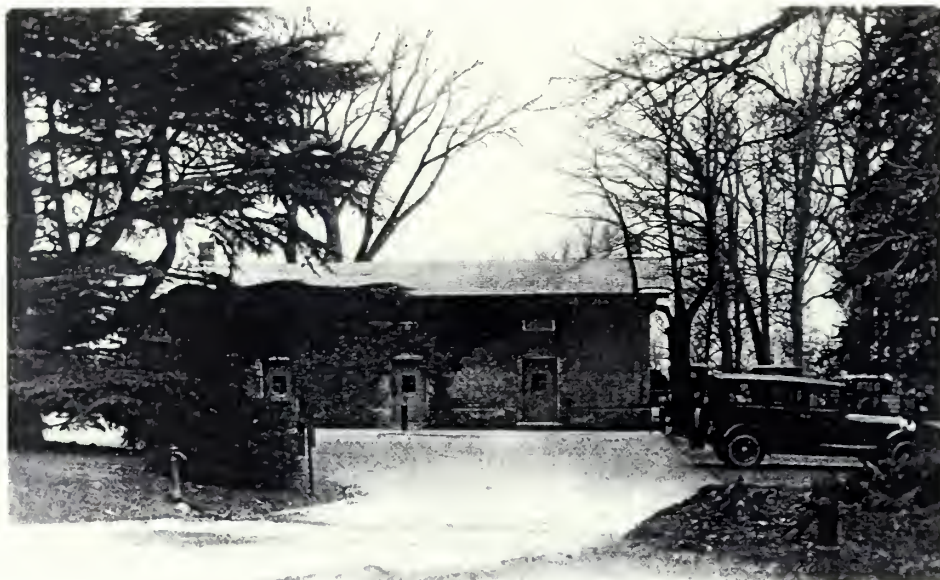
Figure 18. South Dependency, north elevation, shortly after the QMC restoration, 1923. Ongoing moisture issues are plainly evident on the lower portions of the wall.

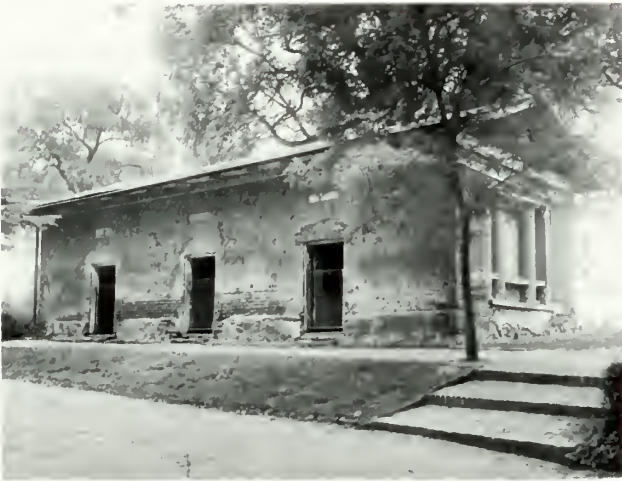
Figure 25 (top left). Southwest corner, 1957, exterior conditions before the NPS restoration. Note deterioration of rough cast along lower third of facade. Metal gates across the doorways allowed visitors a view into each of the rooms.

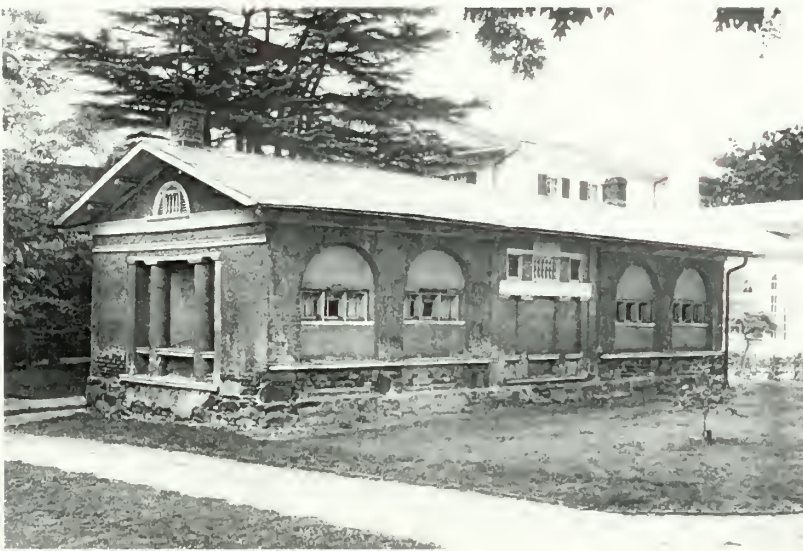
Figure 27 (left). Southwest corner, 1957, exterior conditions before the NPS restoration. Note the poor condition of the foundation and areas of stucco and rough cast which can be largely attributed to moisture issues.

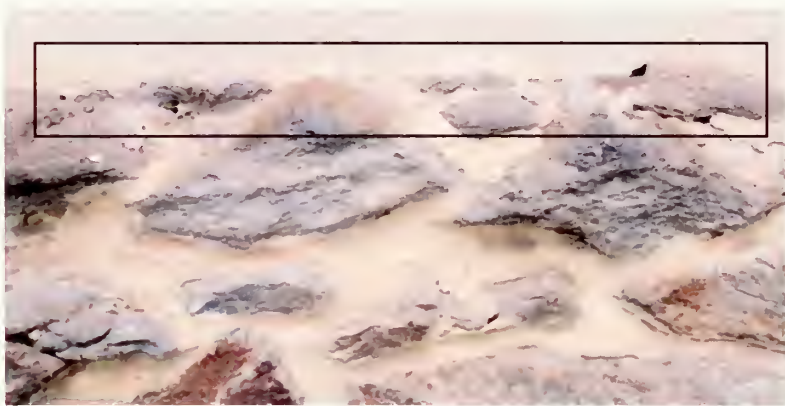
Figure 4. The exposed ledge of the foundation wall should be covered with mortar with a slope away from the building.

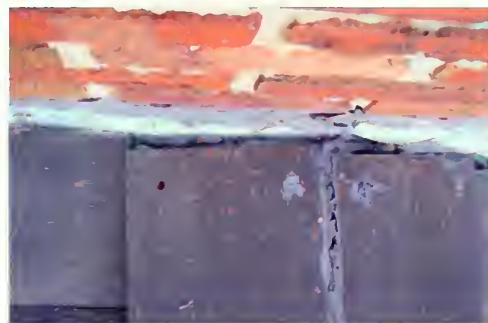
Figure 6. Tar seals to the tile roof have failed in a number of locations allowing water to infiltrate.

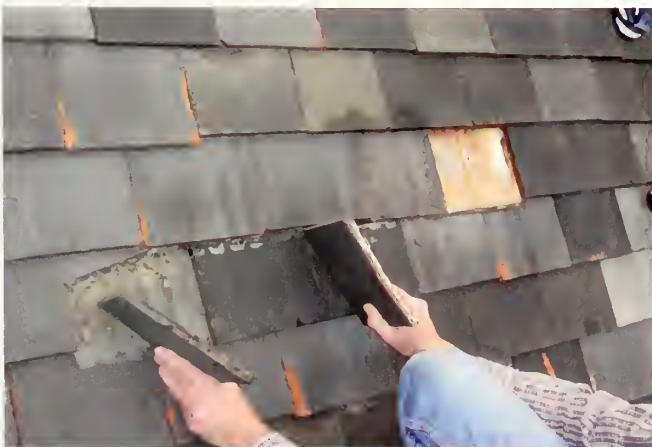
Figure 9. Delamination, chipping, crazing, and structural failure of shingles are widespread.

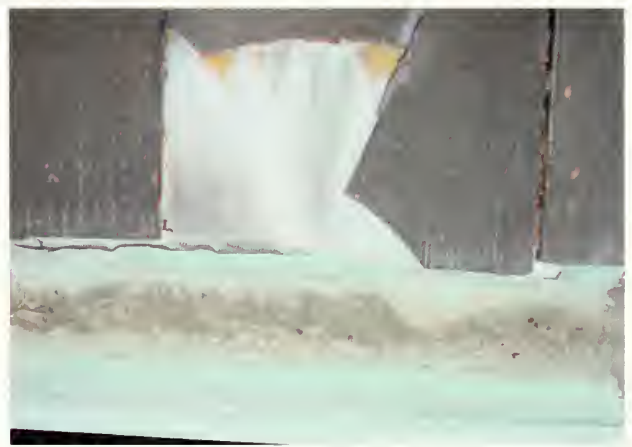
Figure 10. A variety of temporary repairs have been made in an effort to keep a weather seal.

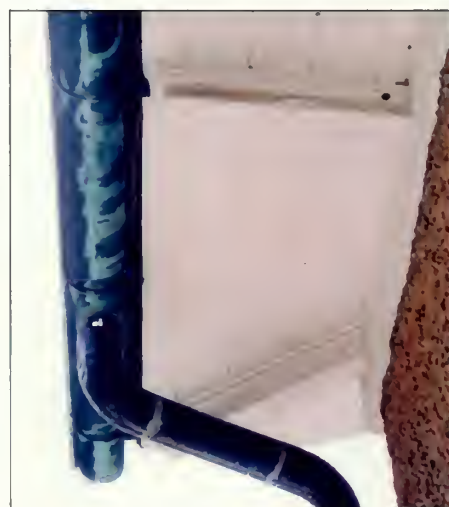
Figure 11. Eave boards on south elevation are bead board. The size of the gutter troughs are not adequate to accommodate heavy rains.

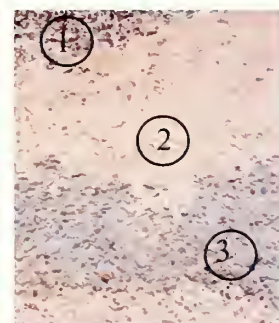
Figure 15. Three different applications of rough cast stucco: 1. The Army's brown 1929 restoration mix, 2. The 1958 NPS restoration mix and 3. A gray repair mix applied more recently by NPS.

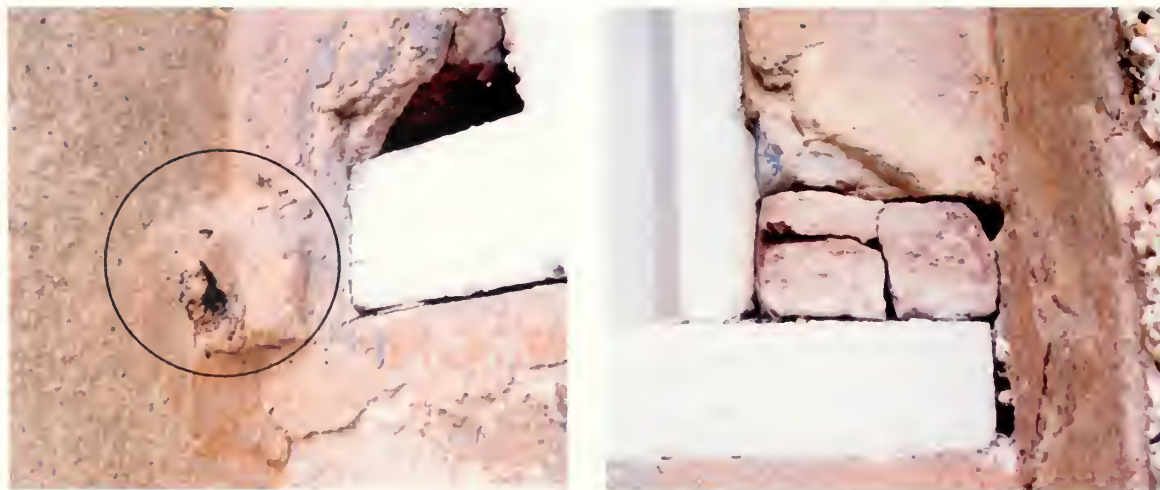
Figures 18 (left). The ears of the window sills extend to the abutting arch wall on the east but have been cut shorter on the west ends. Blocks of wood, presumed to be once the ends of these pieces, are extant in the abutting walls of various openings. Figure 19 (right). Edges and ends of indow sills and frames are exposed to the elements in many locations.

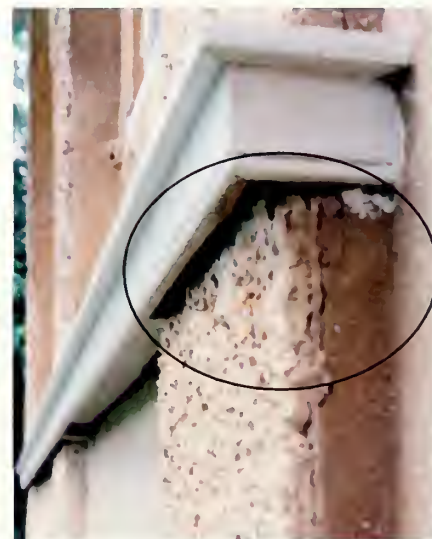
Figure 24 (right). Sections of the early skirtboard configuration remain however there are many areas where the lower piece is missing as shown in the circled areas.

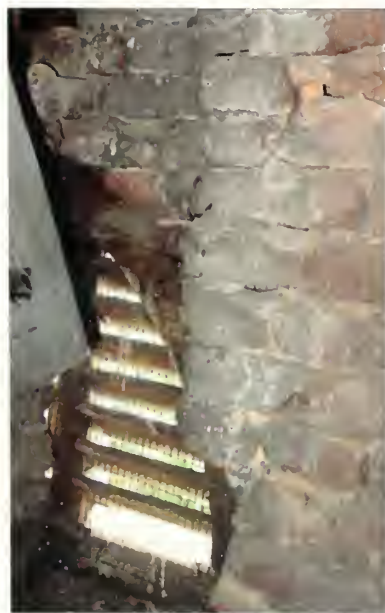
Figure 28. The header is missing from above the attic ventilation unit, west wall.

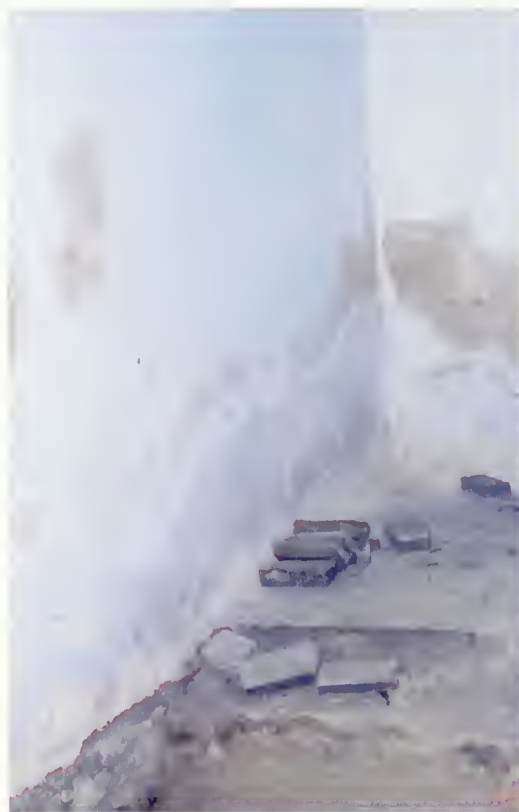
Figure 1. Center room, east and south walls show evidence of rising damp.

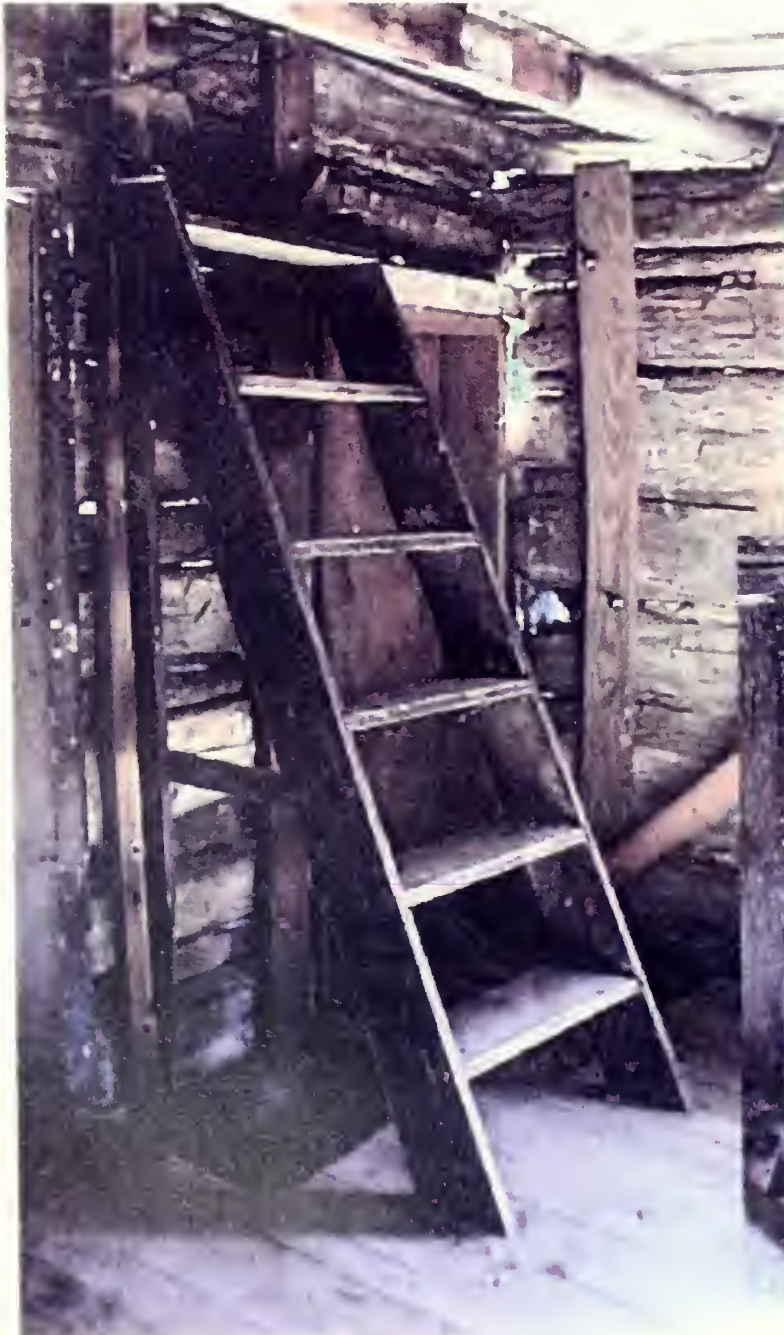
Only the upper portion of the original loft stairs remains. The lower platform and two stairs were missing.
