Comet

Submerged Cultural Resources Site Report

Channel Islands National Park

Submerged Resources Center
Professional Reports
Number 17

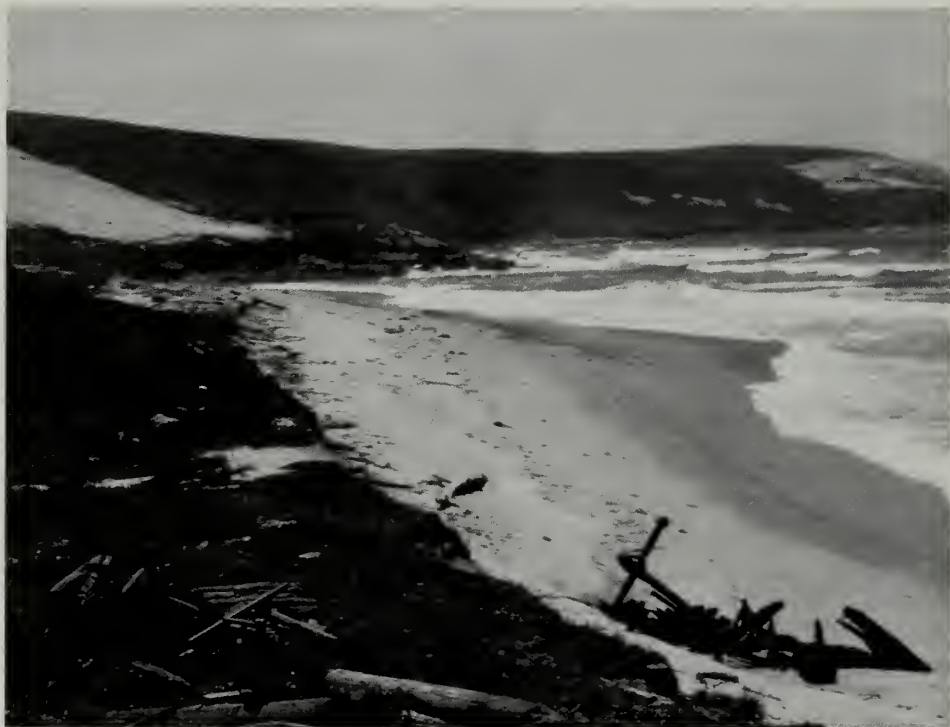
Figure 1.1. The *Comet* site exposed in Simonton Cove in 1984. NPS photo by Reed McClusky.

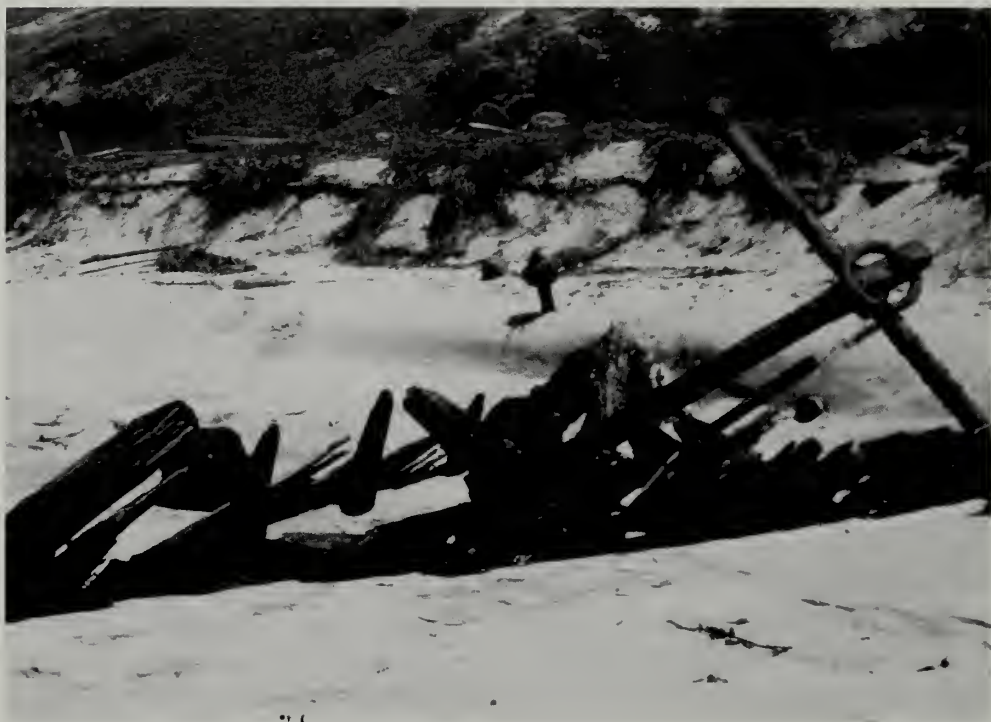
Figure 1.2. *Comet* timbers and anchor exposed in 1984. NPS photo by Reed McClusky.

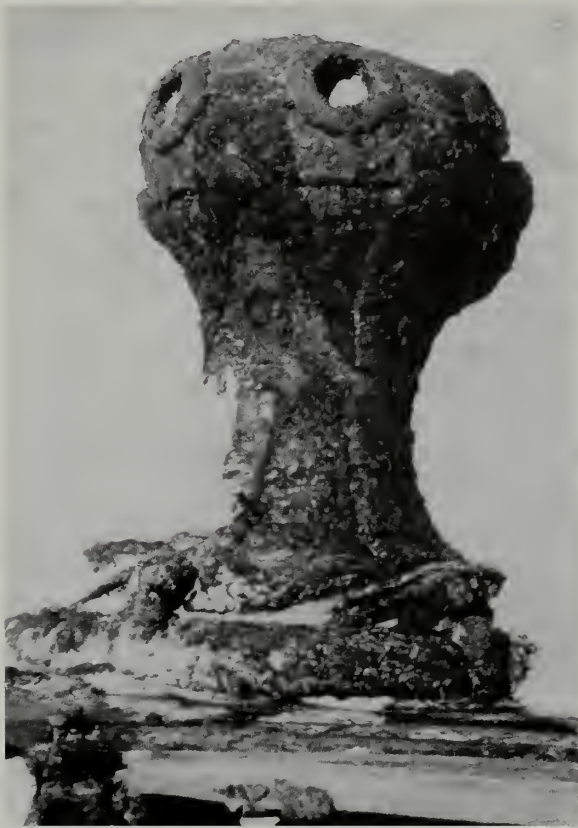
Figure 1.3. *Comet's* capstan in 1984. NPS photo by Reed McClusky.

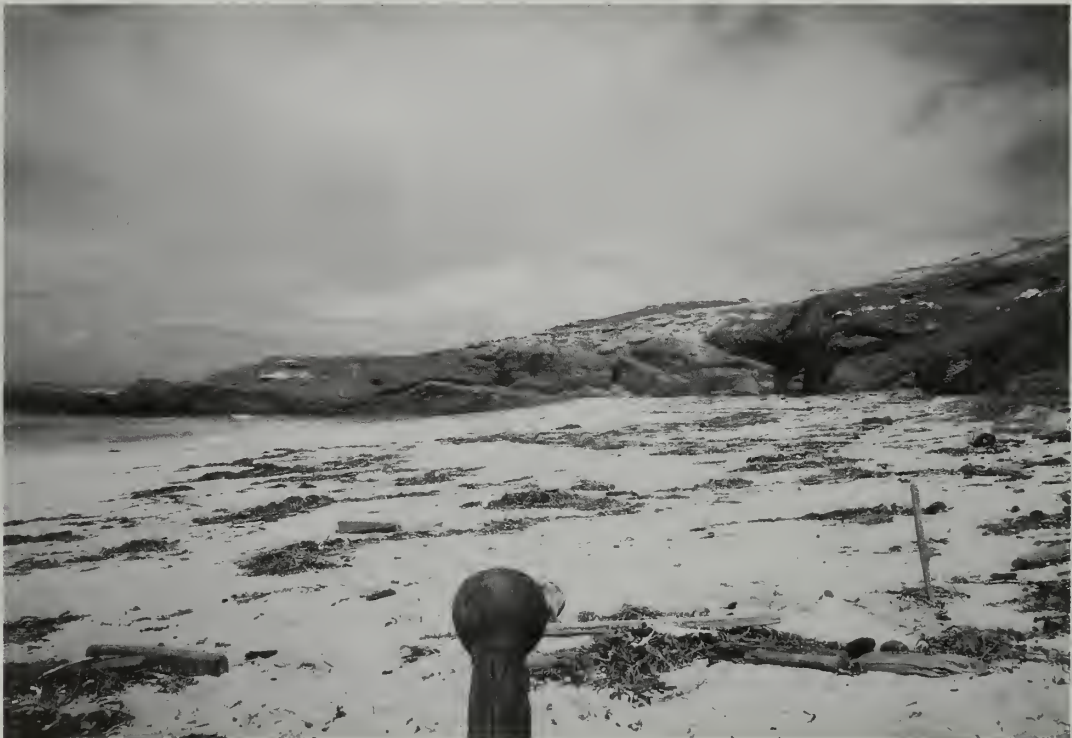
Figure 3.8. Anchor stock sticking out of the sand in Simonton Cove in the 1980s. Compare the rock ledge in the background to Figure 3.6. NPS photo by Don Morris.

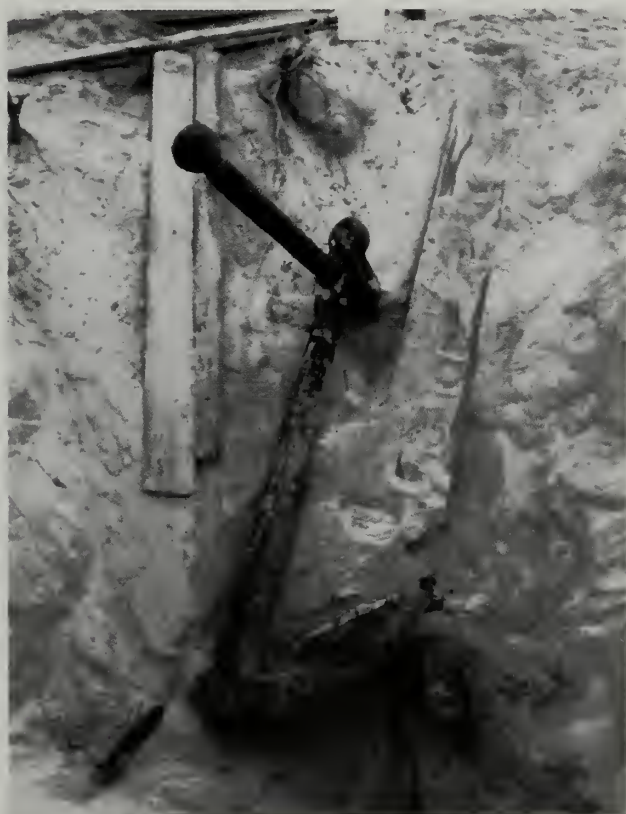
Figure 3.12. *Comet's* anchor after exposure in 1993. NPS photo by Matt Russell.

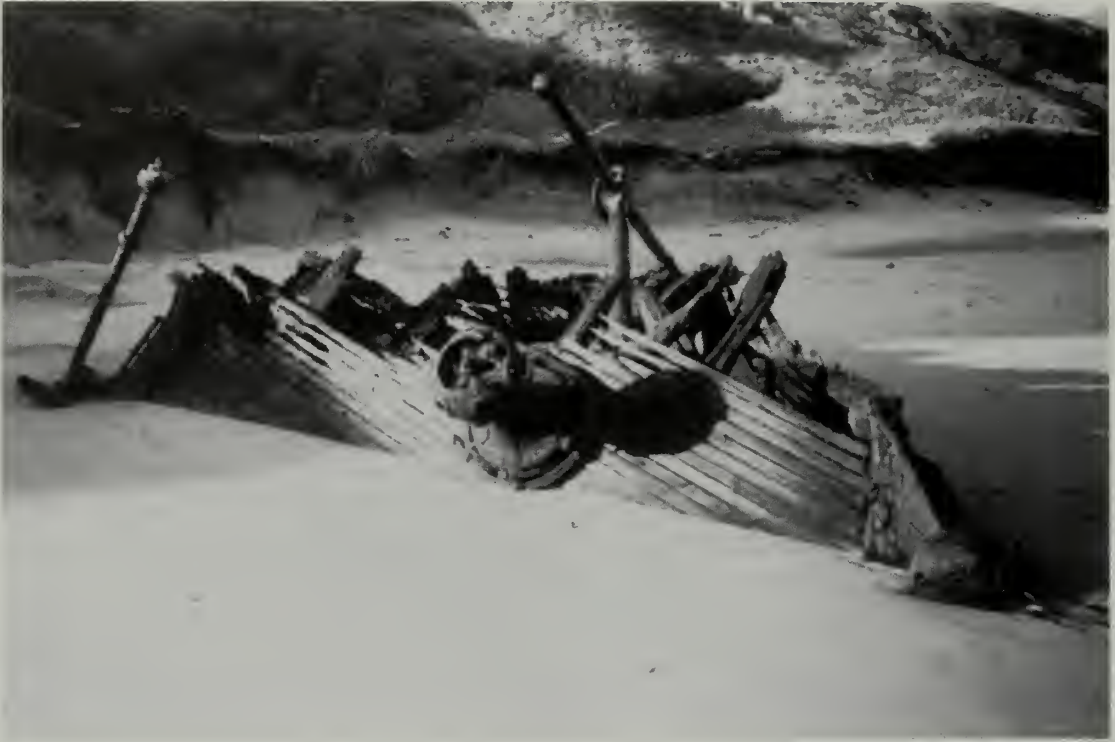
Figure 4.3. *Comet* site in April 1999, looking down on the forecastle deck with the capstan mounted to it. The bow is to the right. NPS photo by Matt Russell.

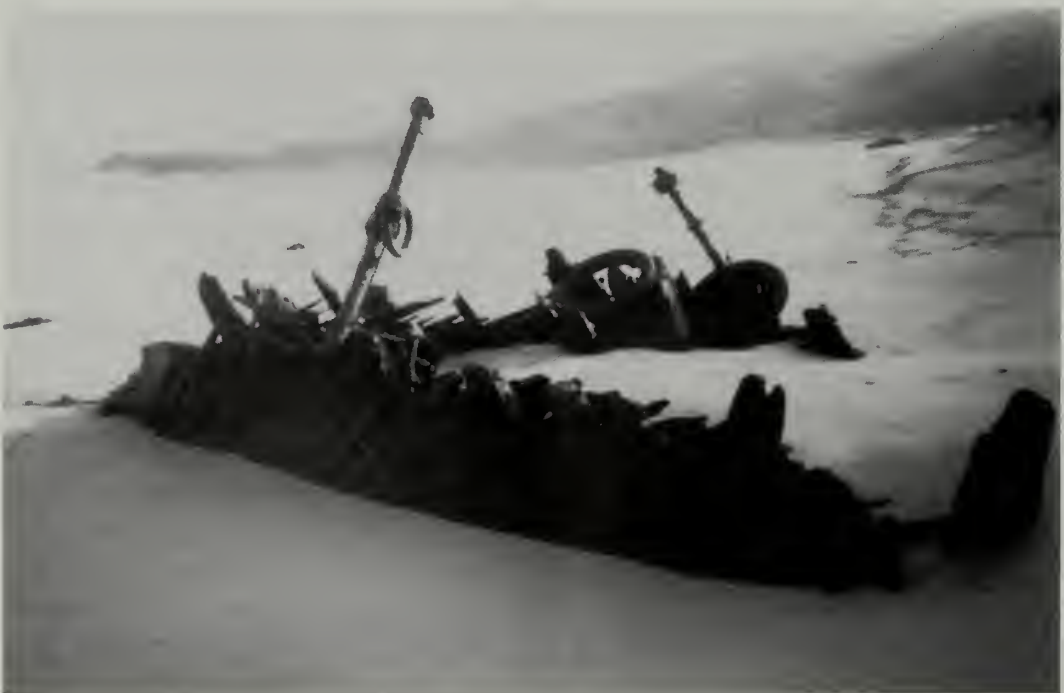
Figure 4.4. *Comet* site in April 1999, looking at the port side outer hull timbers. NPS photo by Don Morris.

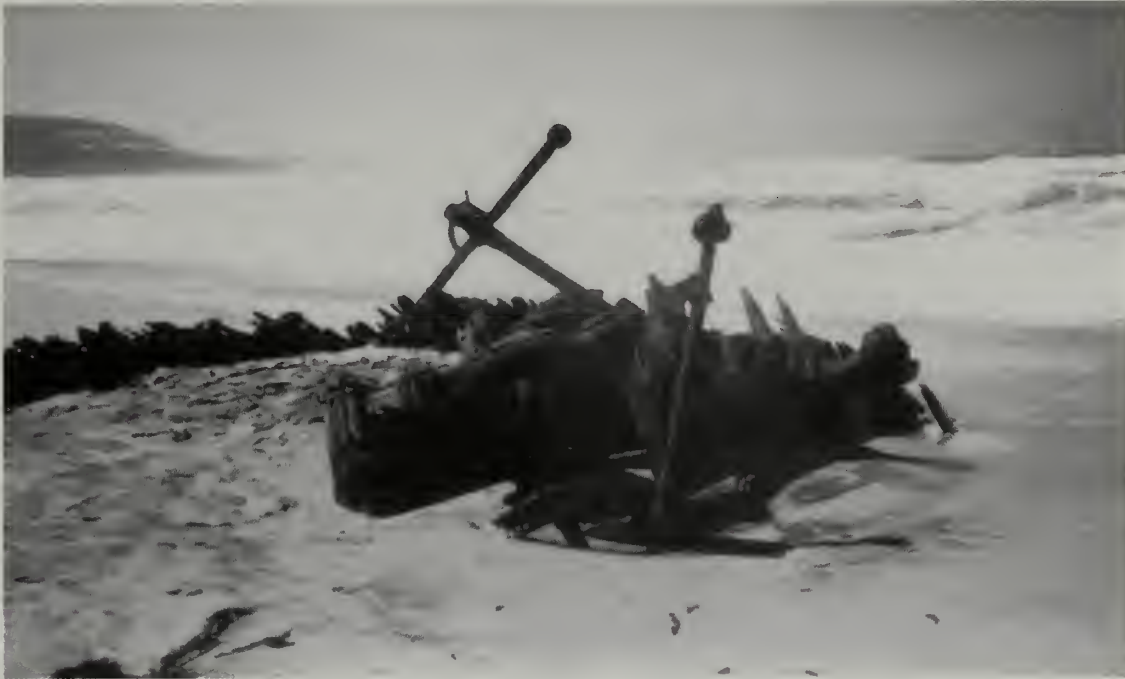
Figure 4.5. *Comet* site in 1999, looking towards the windlass (mounted on the main deck) in the center of the photo, with the capstan (mounted on the forecastle deck) to the right. NPS photo by Don Morris.

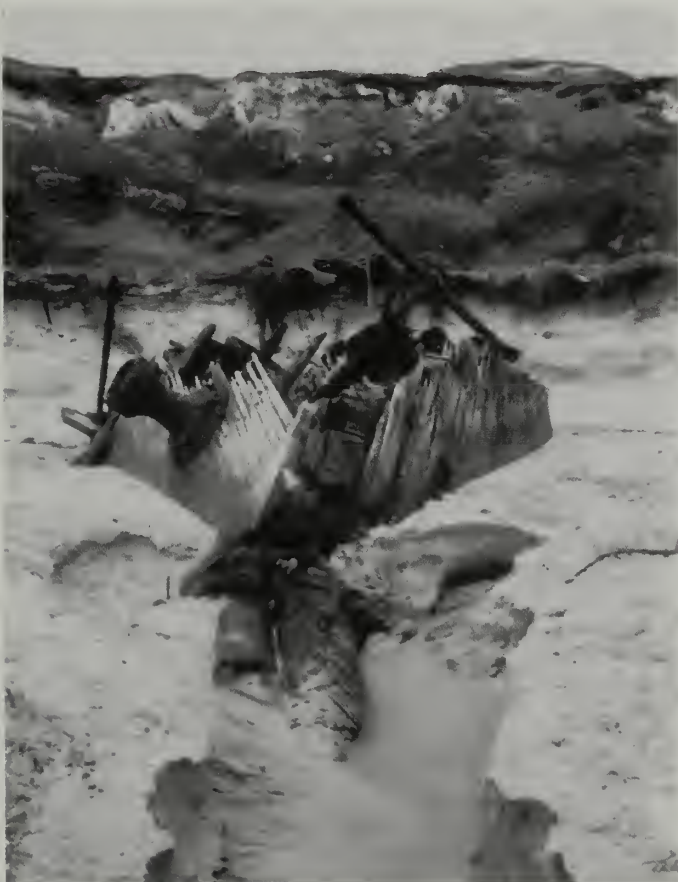
Figure 4.6. *Comet* site in April 1999, looking straight towards the bow, which is canted to the left in this photo. The forecastle deck is to the left, port side outer hull planking to the right, and the bowsprit is in the bottom of the photo. NPS photo by Matt Russell.

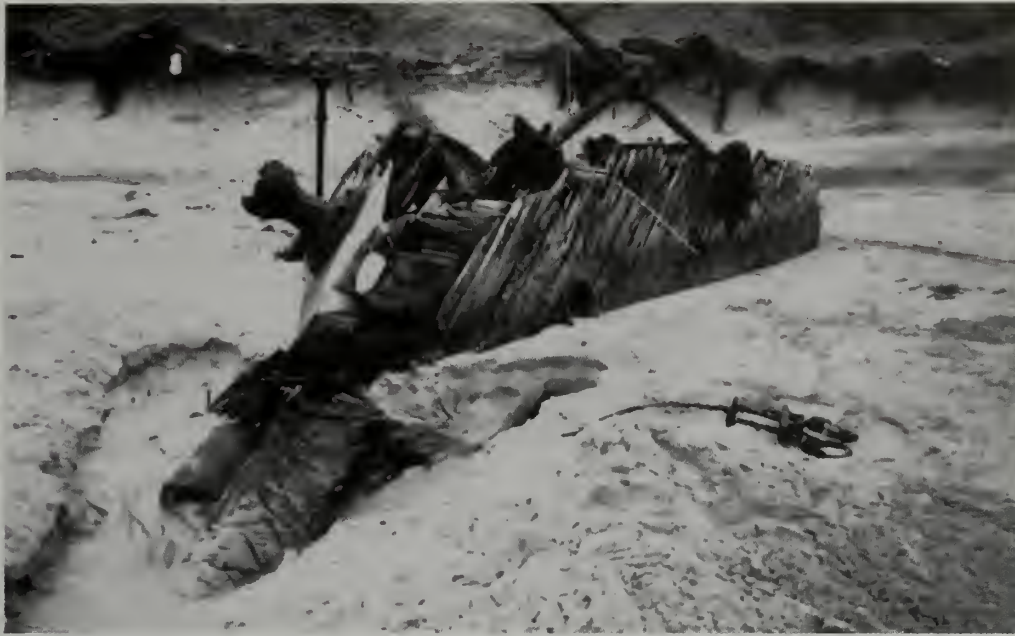
Figure 4.12. *Comet's* bow. The hawse timbers are in the center with the white float on them. The hawse pipe is visible at the sand-line, to the right of the hawse timbers. In the right foreground is an unattached rigging element. NPS photo by Matt Russell.

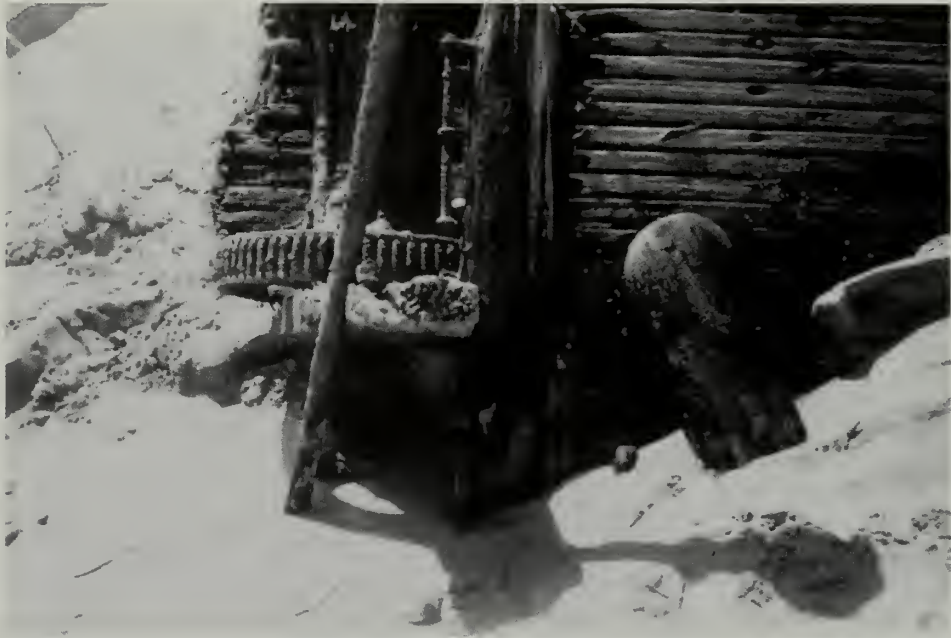
Figure 4.17. Top-view of the aft end of the forecastle deck. The aft-most forecastle deck beam is the vertical timber in the center of the photo. The windlass is to the left, mounted on the main deck below; the starboard cathead is the angled timber to the right. NPS photo by Matt Russell.

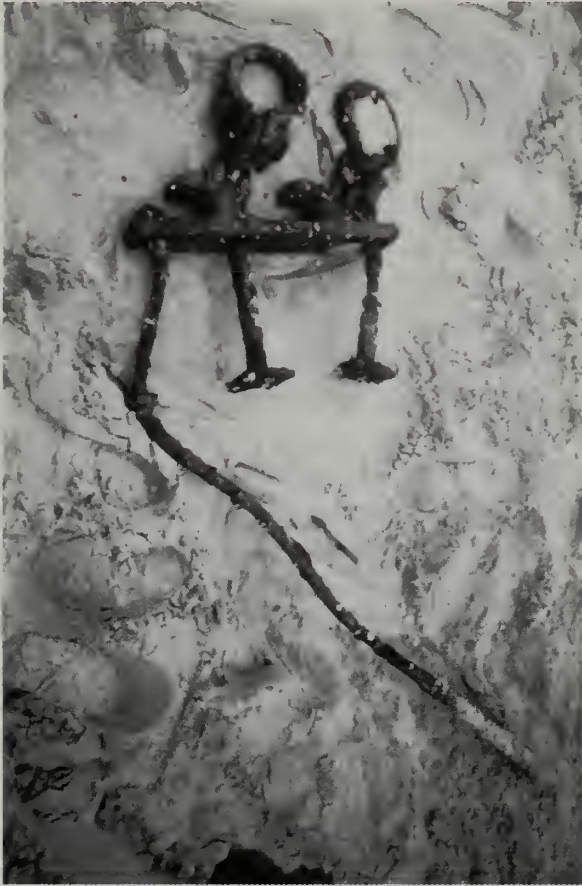
Figure 4.26. Rigging element off *Comet*'s port bow. NPS photo by Matt Russell.

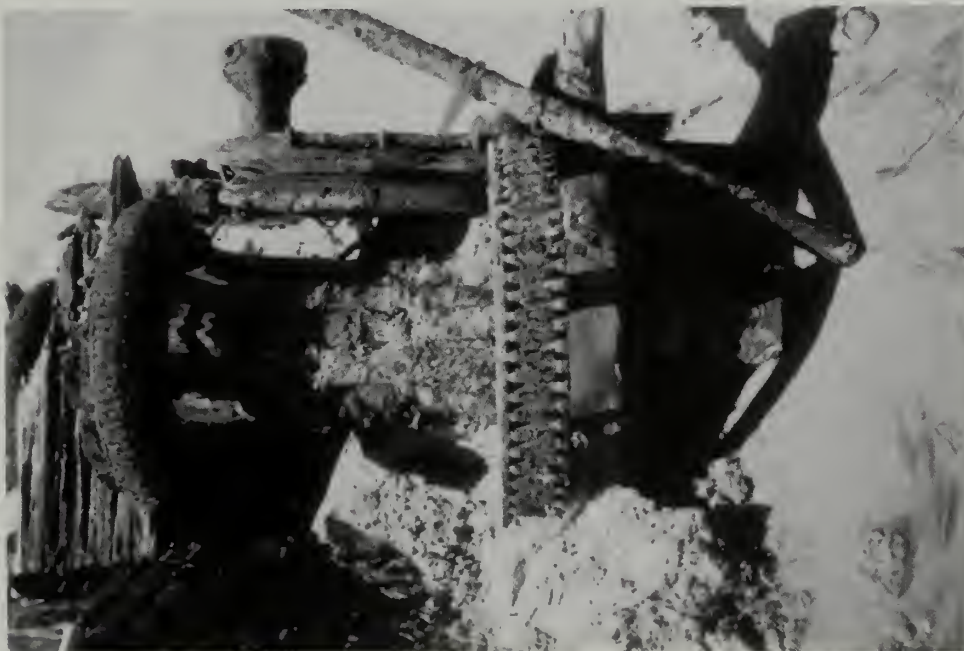
Figure 4.35.
Comet's windlass,
mounted on the
main deck. NPS
photo by Matt
Russell.

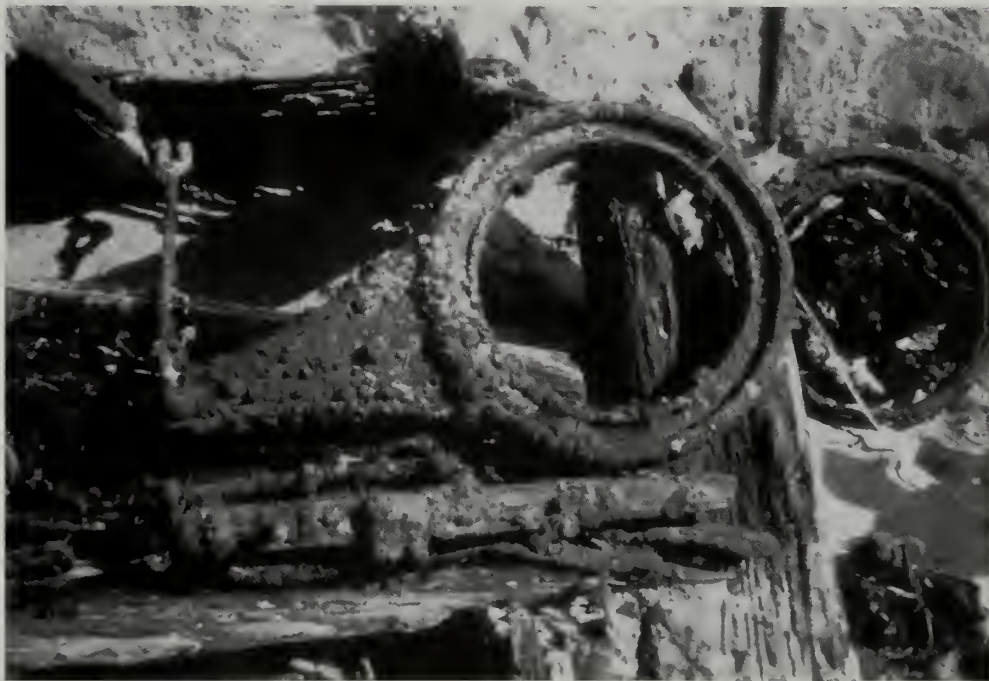
Figure 4.38. *Comet*'s port windlass purchase arm and windlass hardware on the main deck laying against the port side of the pawl post and bowsprit. NPS photo by Don Morris.

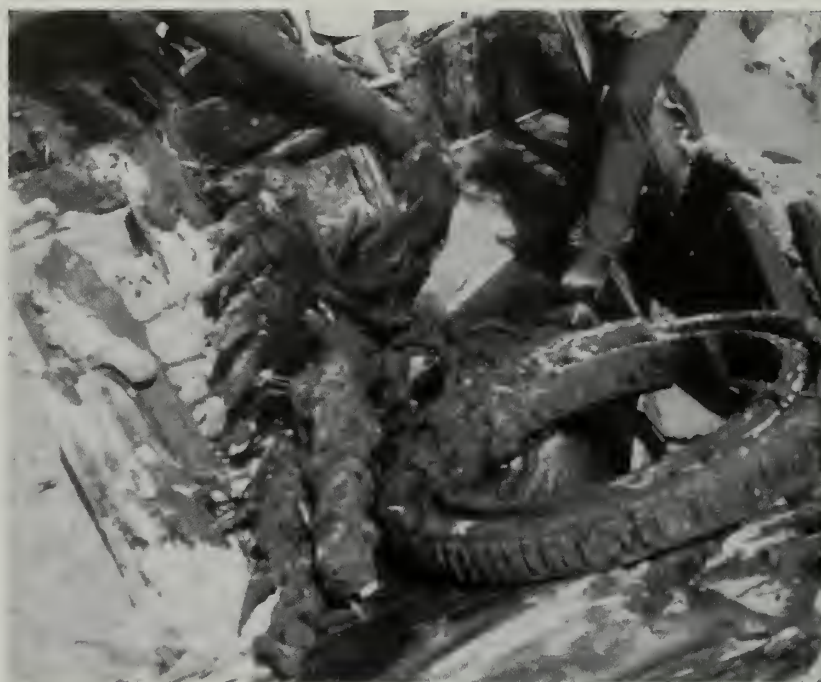
Figure 4.39. *Comet's* port windlass hardware laying on the main deck. NPS photo by Don Morris.

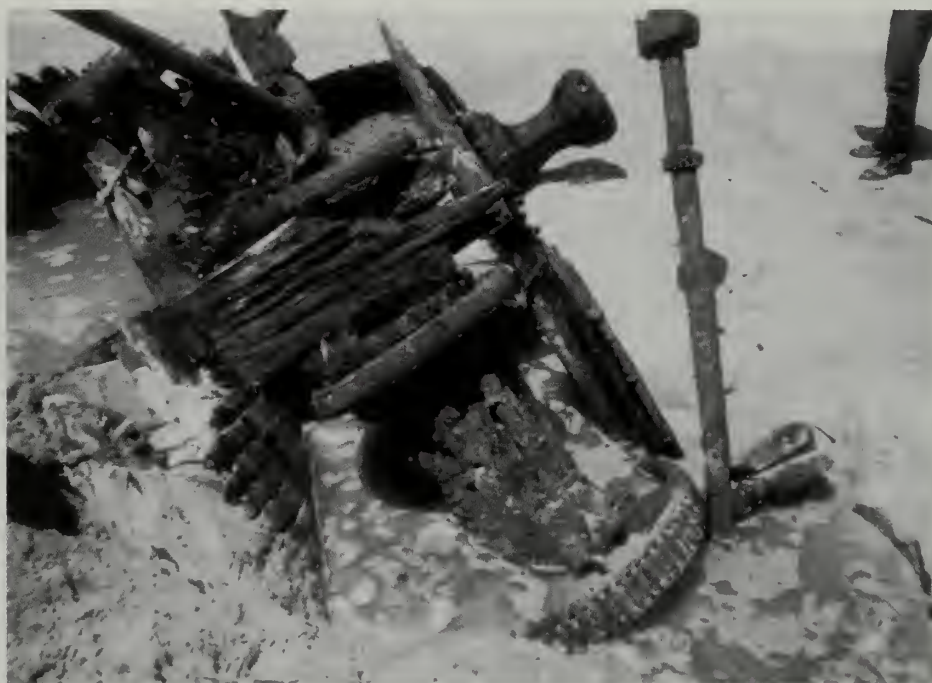
Figure 4.40. *Comet's* windlass and the iron shaft sticking out of the sand on the right side of the photograph. NPS photo by Matt Russell.

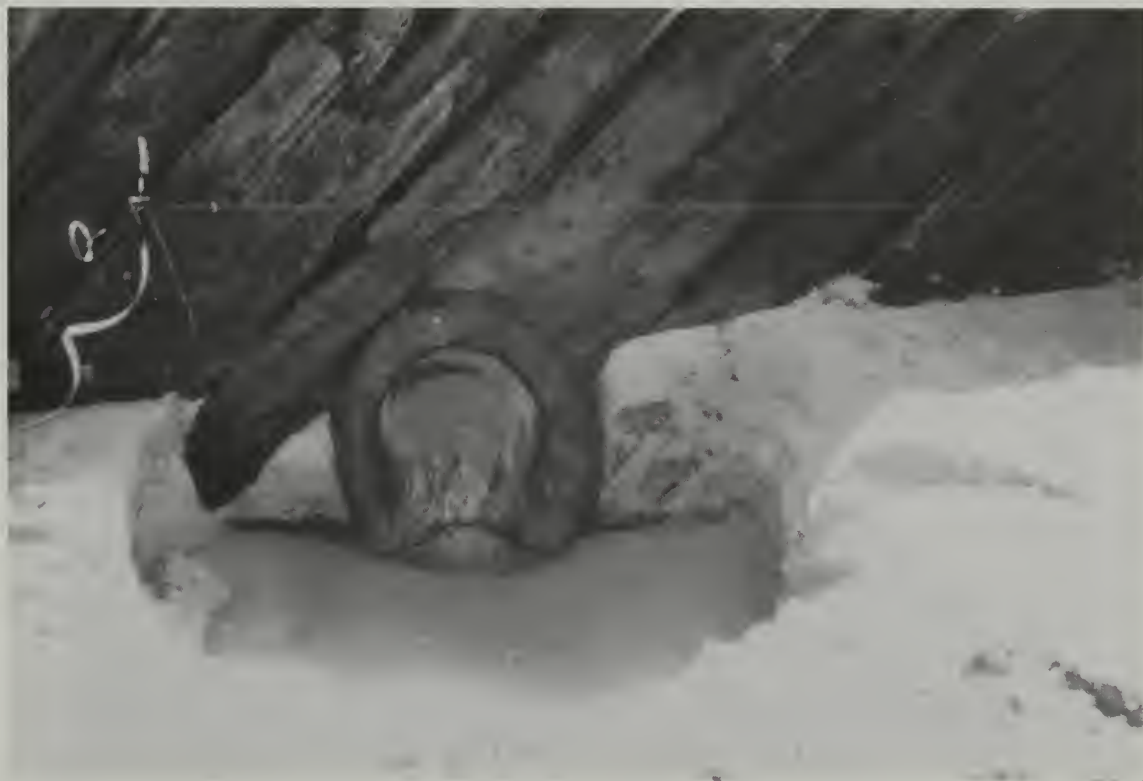
Figure 4.43. *Comet's* port-side hawse pipe. NPS photo by Don Morris.

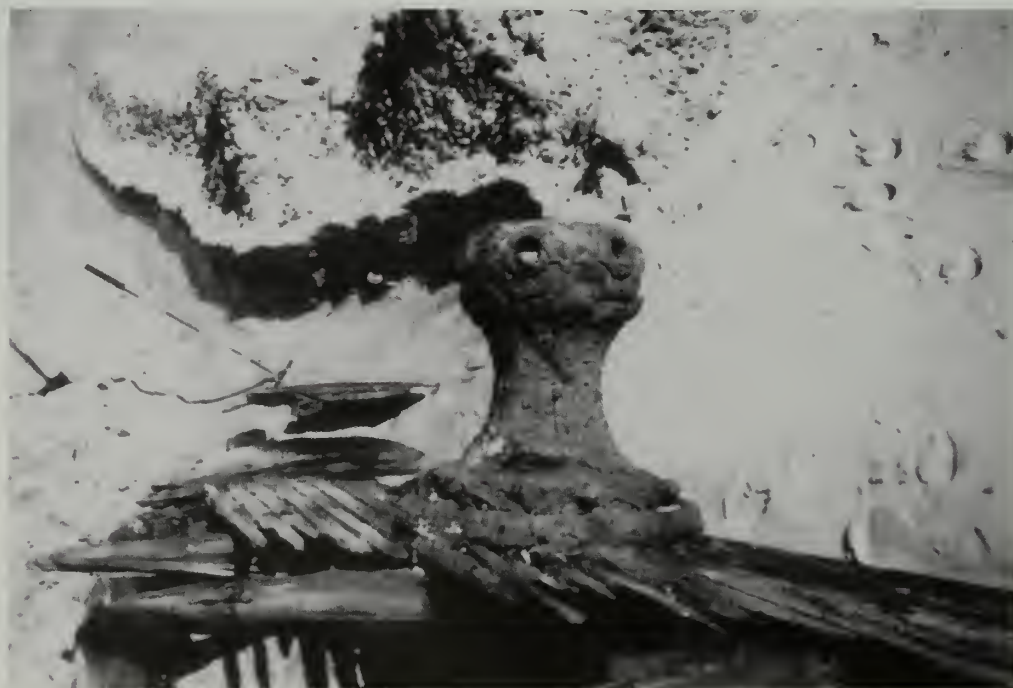
Figure 4.44. *Comet*’s capstan, mounted in the center of the forecastle deck. NPS photo by Don Morris.
