HISTORIC STRUCTURES REPORT

CROOK HOUSE

SEPTEMBER 1984

SAN JUAN ISLAND
NATIONAL
HISTORICAL PARK

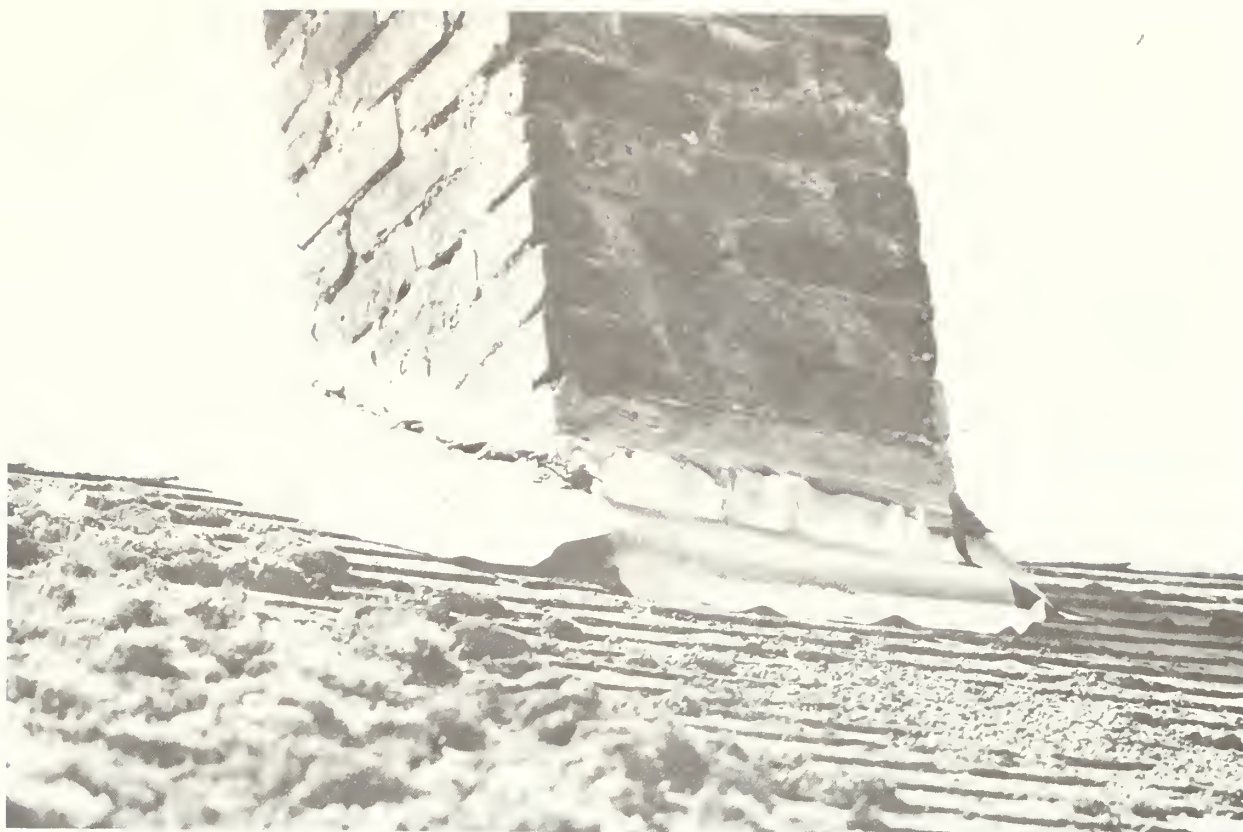
FIGURE 45 East gable roof of Crook House, 1984. Shingles, brick and flashing show advanced deterioration. Photo by Barry Schnoll, National Park Service.

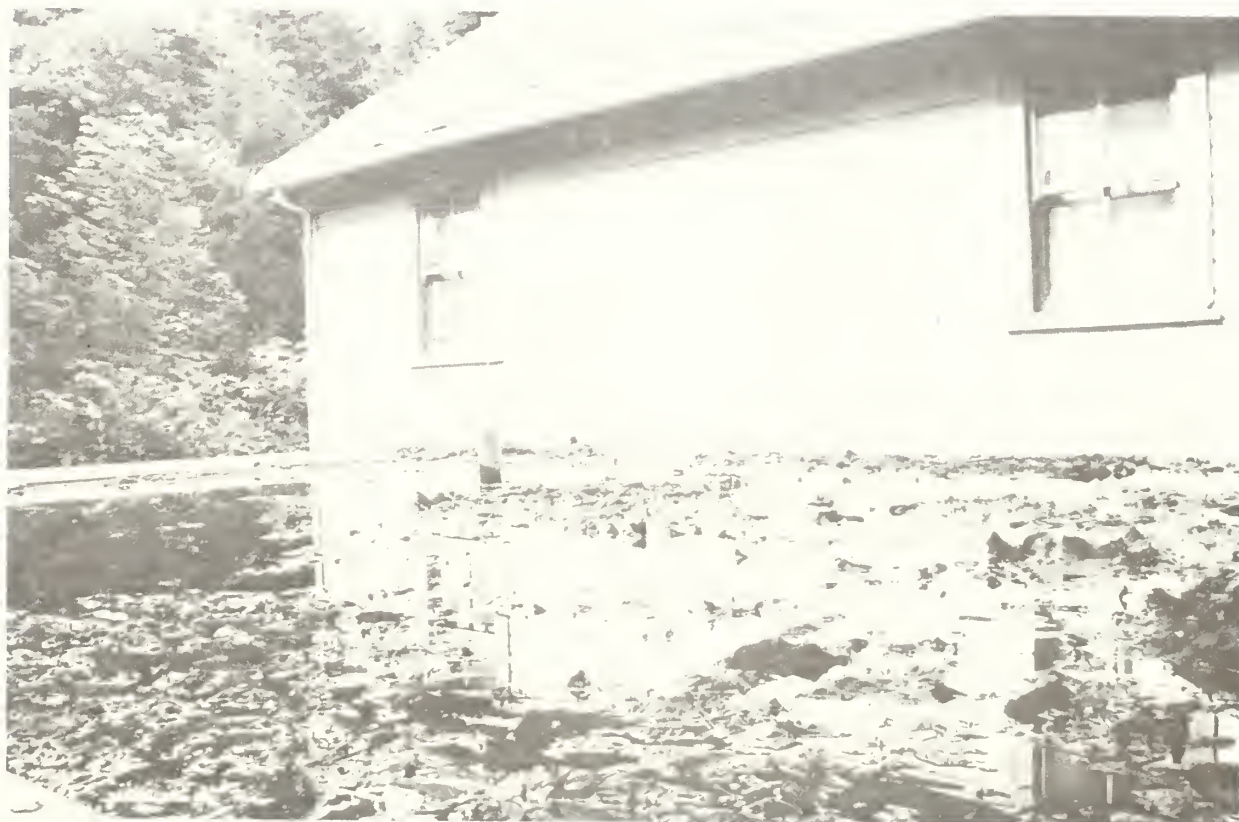
FIGURE 46 Crook House addition, 1984. Flat roof contributes to ponding. Photo by Barry Schnoll, National Park Service.
