HISTORIC STRUCTURE REPORT

THE U.S. COMMISSIONER'S COURT,
THE U.S. COMMISSIONER'S RESIDENCE, AND THE WOMEN'S JAIL
CHISANA HISTORIC DISTRICT
WRANGELL-ST. ELIAS NATIONAL PARK & PRESERVE
ALASKA

ALASKA REGIONAL OFFICE
NATIONAL PARK SERVICE
UNITED STATES DEPARTMENT OF THE INTERIOR
ANCHORAGE, ALASKA

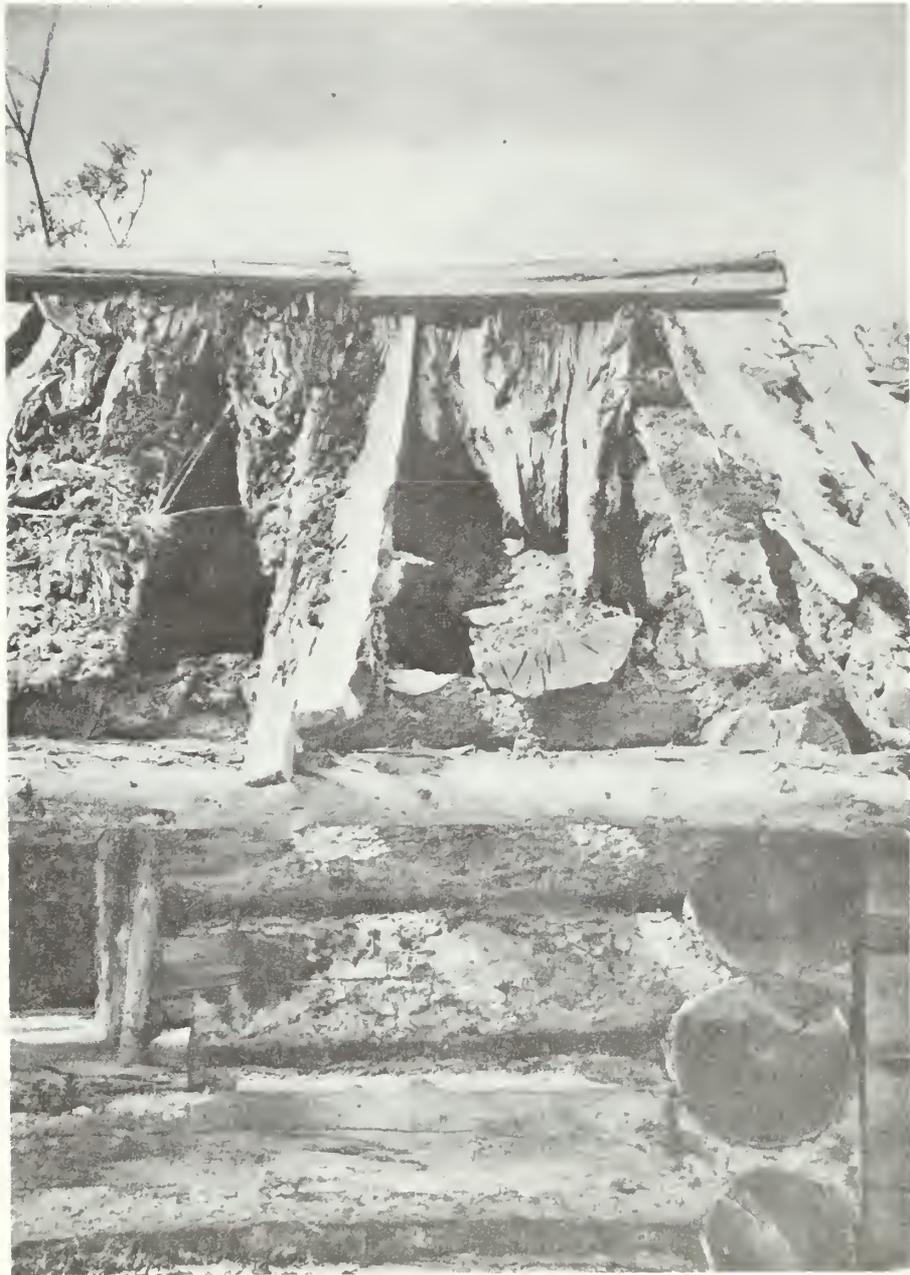
Photograph 6
Women's Jail, Chisana
"Hole-in-Roof" Detail, South Side.

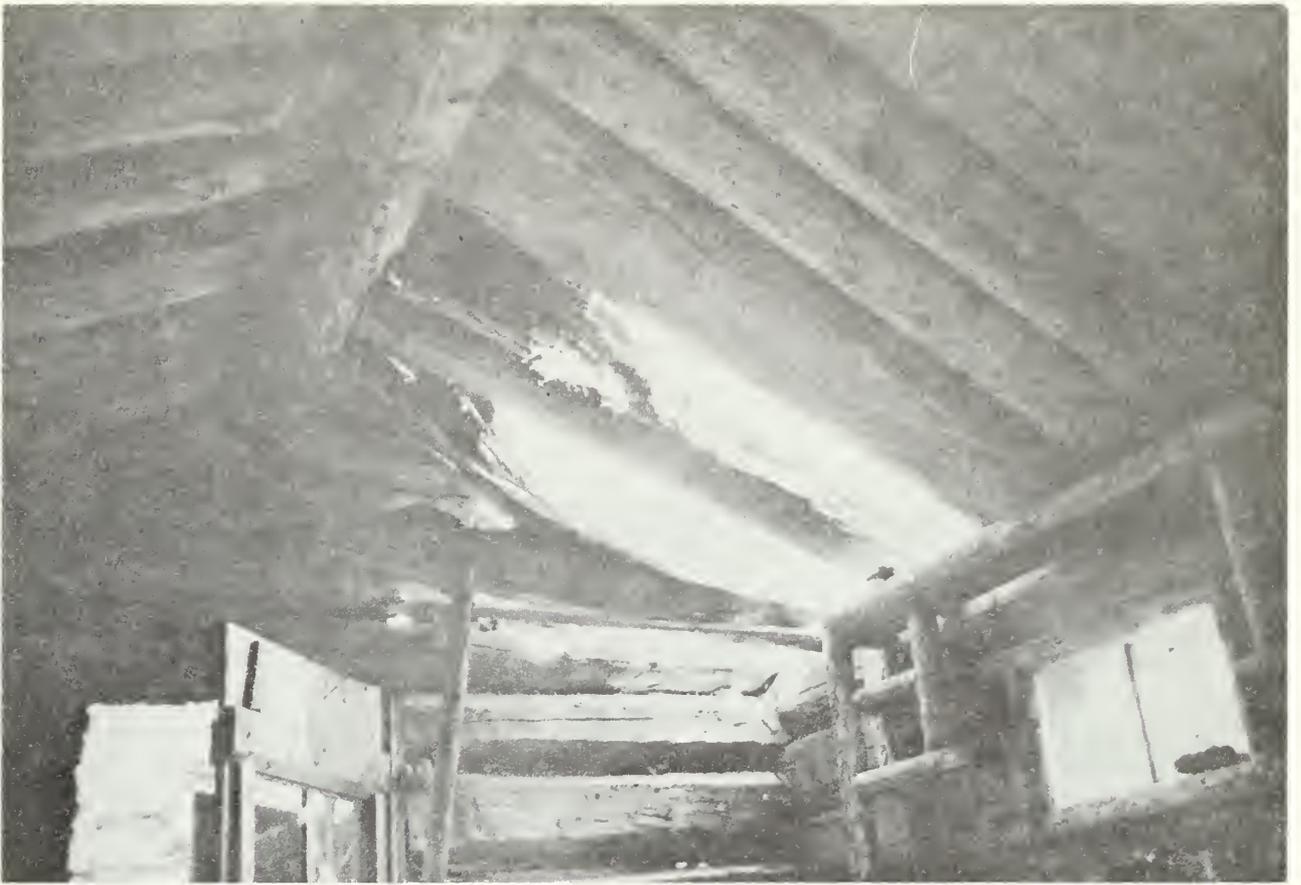
Photograph 7
Women's Jail, Chisana
Collapsed Ceiling, South Side.

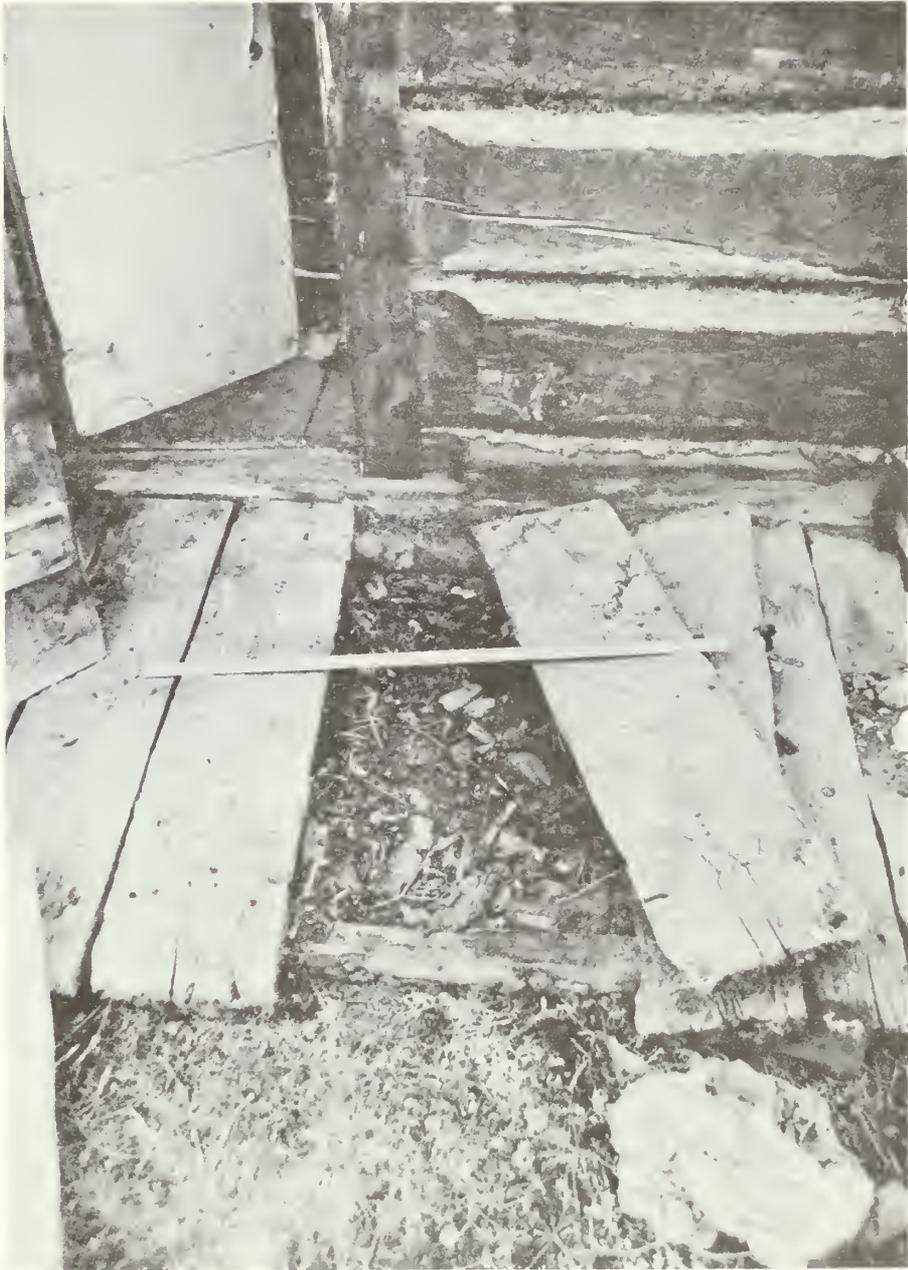
The porch floor is heavily weathered and deteriorating in places. The boards are loose and the two stringers underneath are rotting considerably.

Photograph 13
Women's Jail, Chisana
Floor planks, porch.

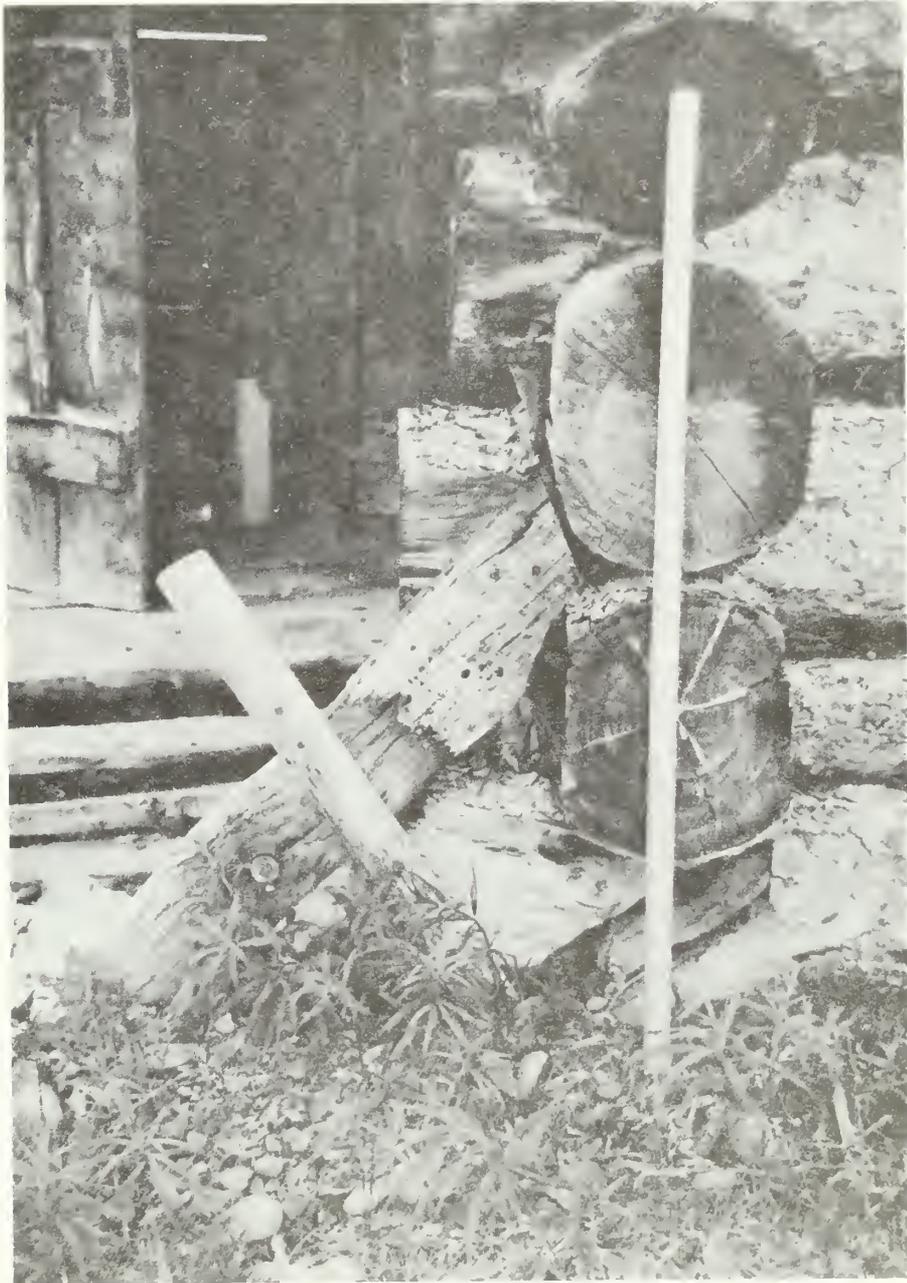
Photograph 14
Women's Jail, Chisana
Corner bracing at sill logs.

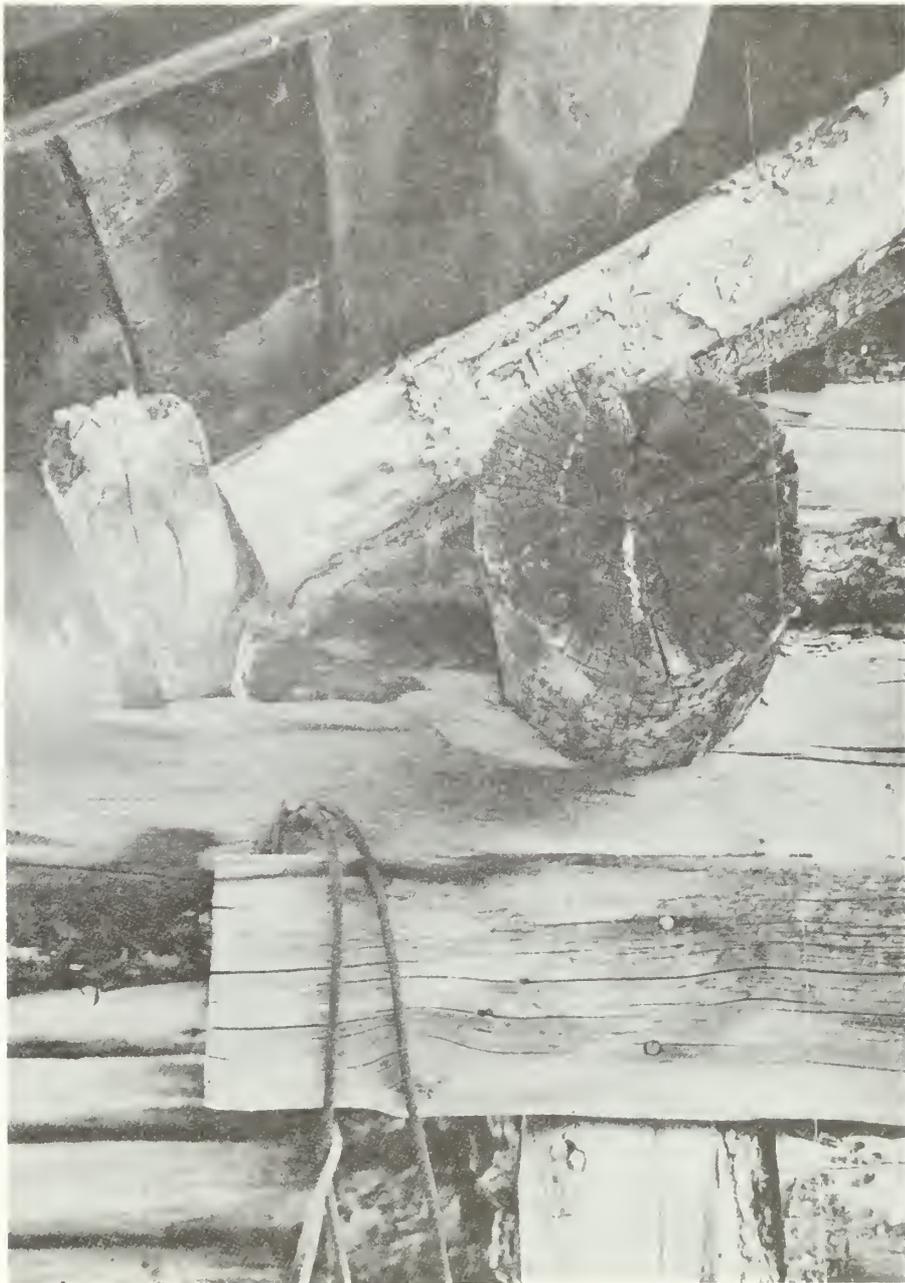
Photograph 19
U.S. Commissioner's Court, Chisana
Junction of the ceiling timbers,
butting pole, eave log and
plate log w/newer roof above
ceiling members

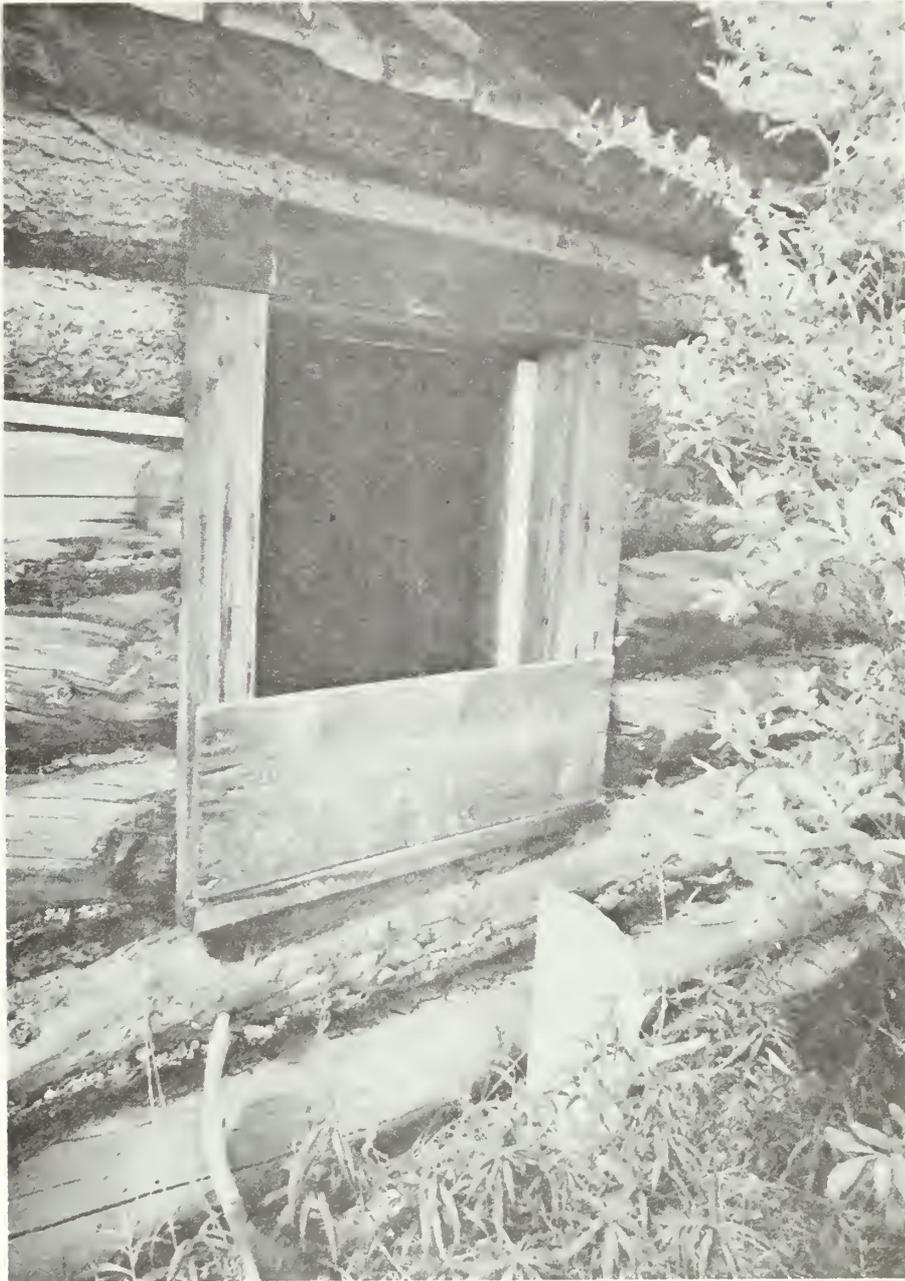
The window on the east side is intact with the glass missing. The frame was built around a manufactured sash. The sash is held in place with wood stops. Logs on outside hewn flat on both sides of the window to allow trim to lay flat. Trim made from 1 inch x 4 inch rough sawn boards.

Photograph 22
U.S. Commissioner's Court, Chisana
Window in East wall - logs hewn to
receive flat trim pieces.

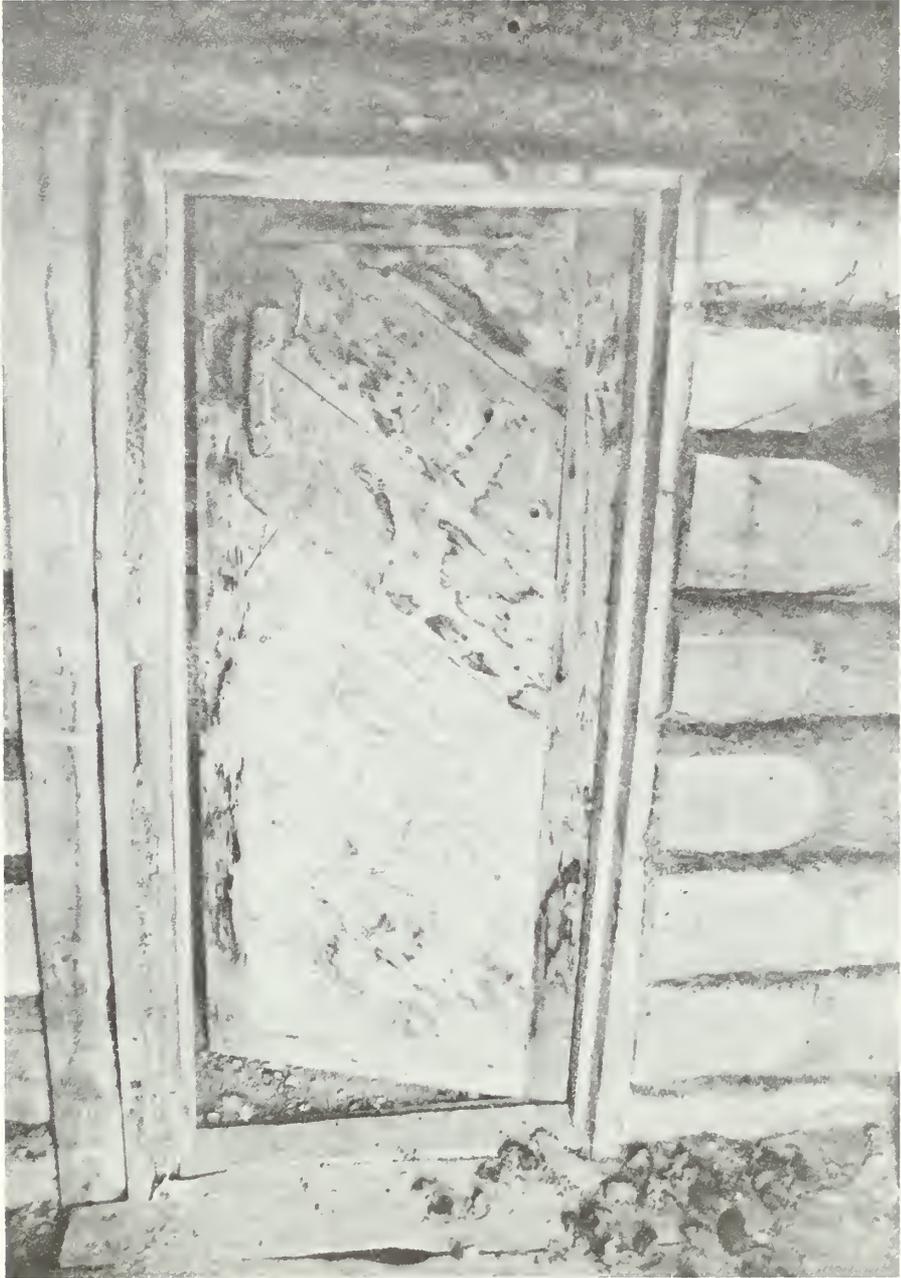
Photograph 23
U.S. Commissioner's Court, Chisana
Front entry to main cabin with hewn
logs at trim; trim missing on
right side.

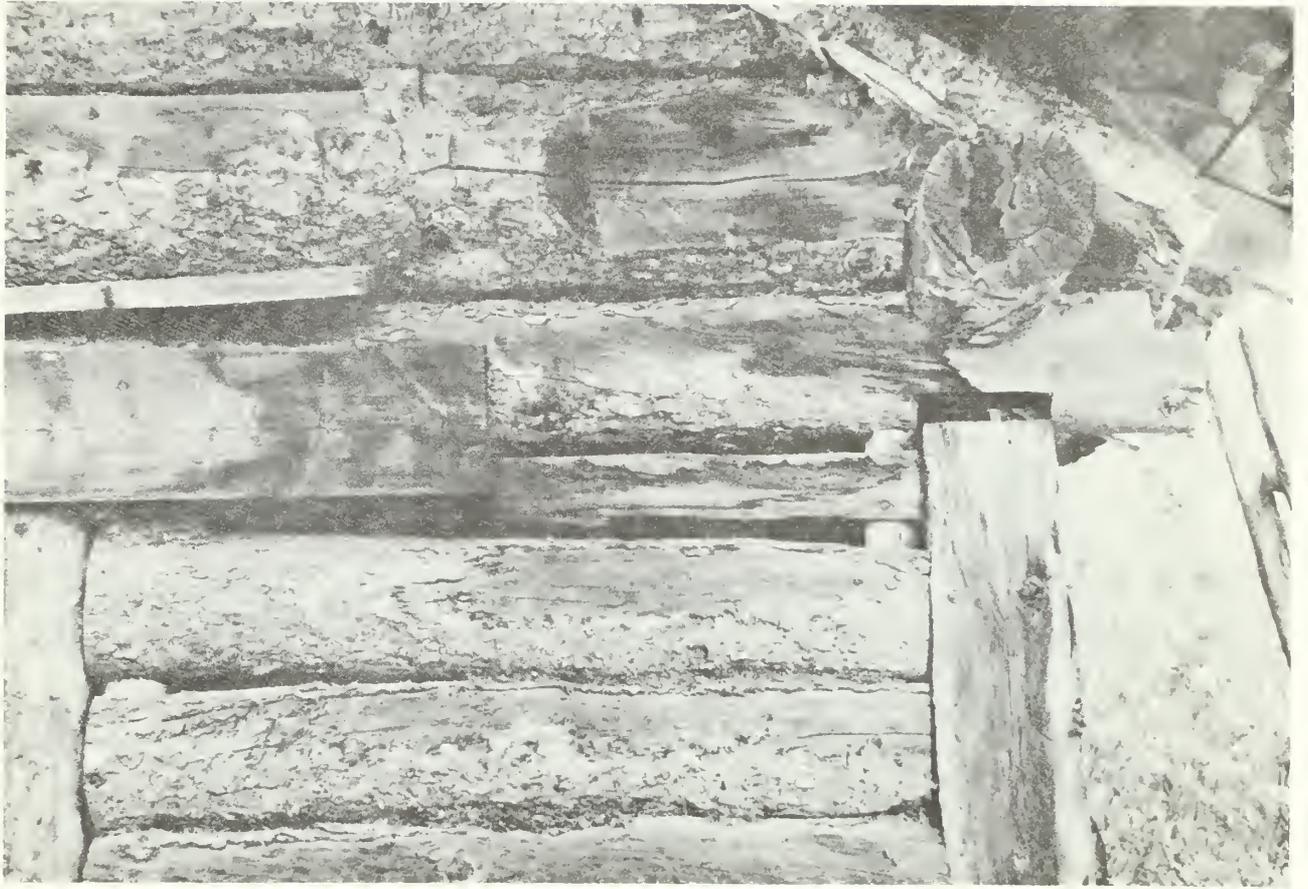
The porch walls consists of 5 1/2 inch-6 inch logs horizontally stacked with Hudson Bay corners. Corner splines are loose on most joints. Horizontal logs are notched around the splines but nailed to splines in very few places. Large cracks are opening up between logs toward the tops of the corner posts - due to settling of the outside corners (or potentially, to heaving under the door toward the center of the wall). The posts on each side of the door are similar in detail to the corner posts. The door posts are also notched into the eave log which doubles as the header log over the door.

Photograph 25
U.S. Commissioner's Court, Chisana
Hudson Bay corner at front of porch,
post dropping away from eave log.

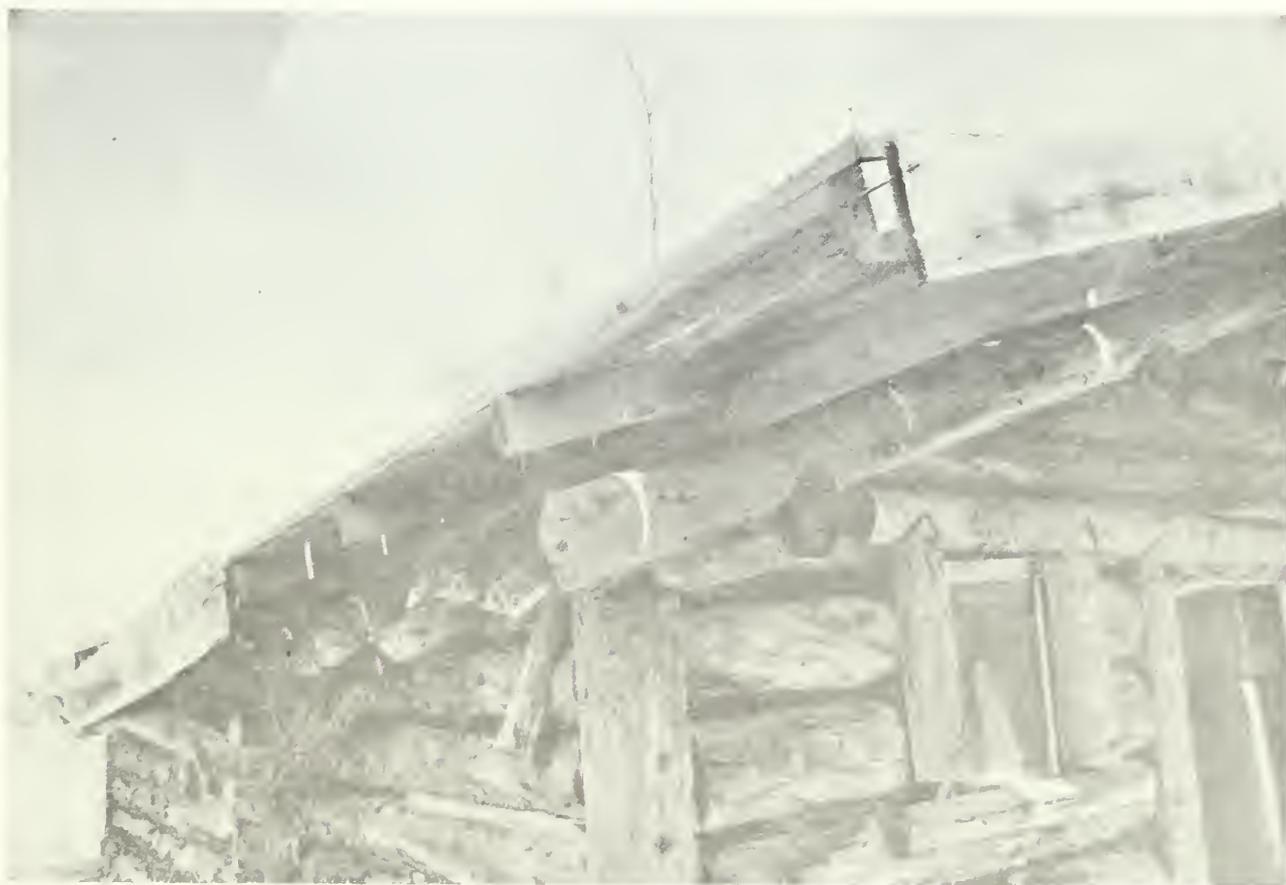
Photograph 35
U.S. Commissioner's Residence, Chisana
Eave detail with newer roof over decaying
ceiling members (note sag in roof line).

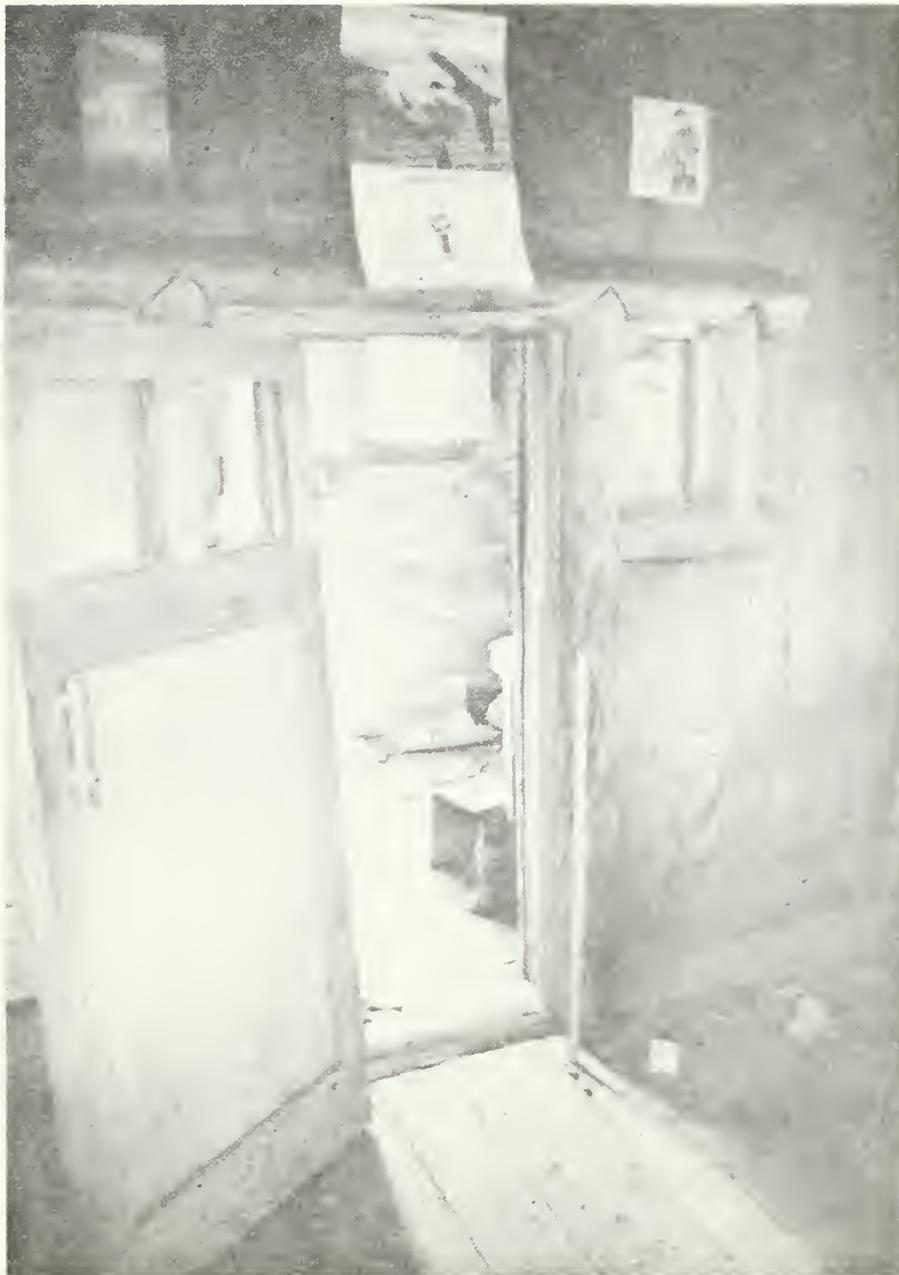
The same green burlap fabric that covers the ceiling also covers the walls. The fabric is brittle in many places. It is water stained around and below leaks and faded where the sun or the heat of the stove strikes it. In places the fabric is held in place with brass upholstery tacks and in others by staples. The water stained areas are decayed and deteriorate at a touch.

Photograph 39
U.S. Commissioner's Residence, Chisana
Interior of entry to main cabin - note
water stained burlap and seperating window
trim.

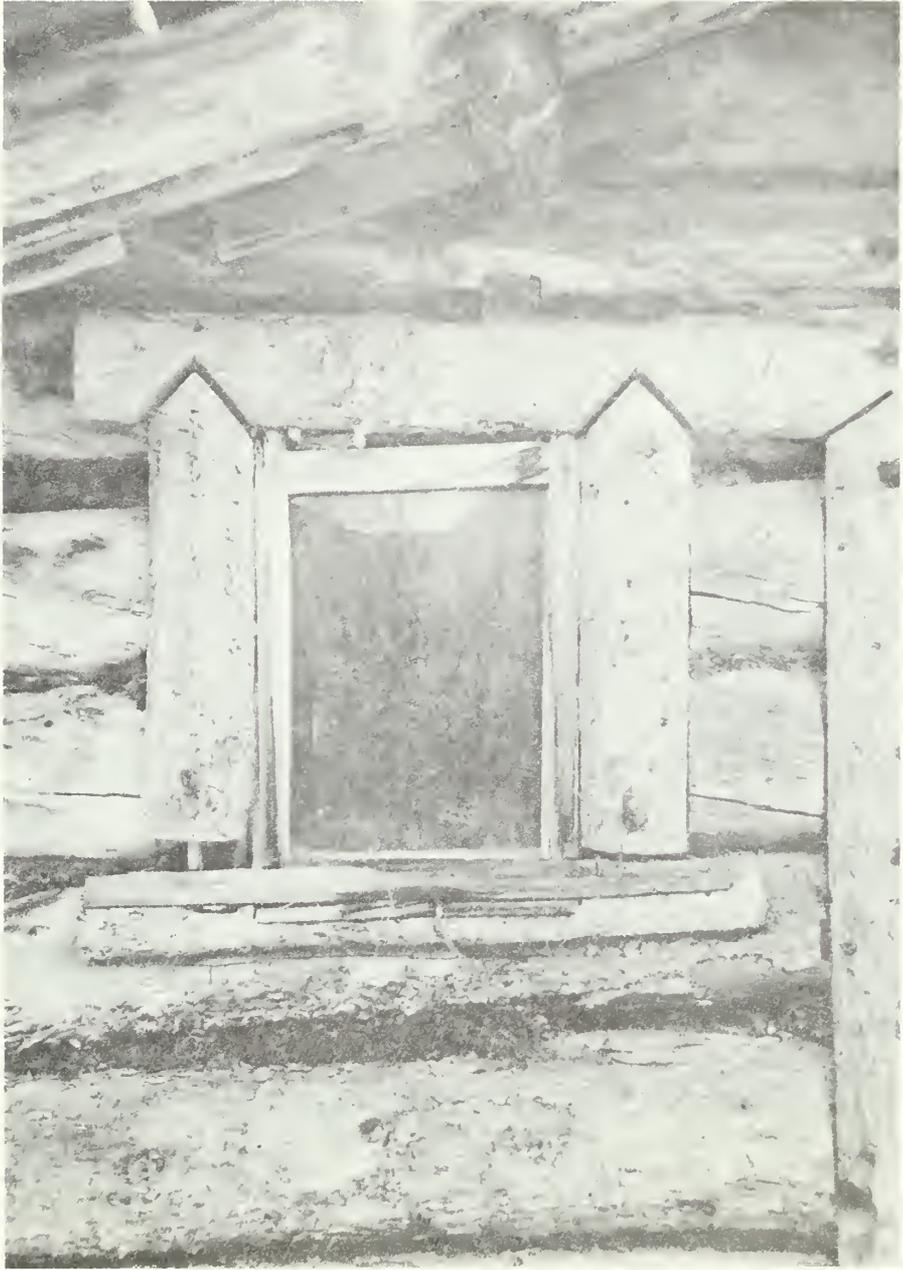
Photograph 42
U.S. Commissioner's Residence, Chisana
Front window with racked frame and
seperating trim (note pegs nolding trim
in place).
