## Magnolia Plantation Gin Barn

# Historic Structure Report

CANE RIVER CREOLE NATIONAL HISTORICAL PARK  
MAGNOLIA PLANTATION

2004  
Historic Structure Report  
Gin Barn  
Cane River Creole National Historical Park  
Magnolia Plantation  
LCS#: 91561

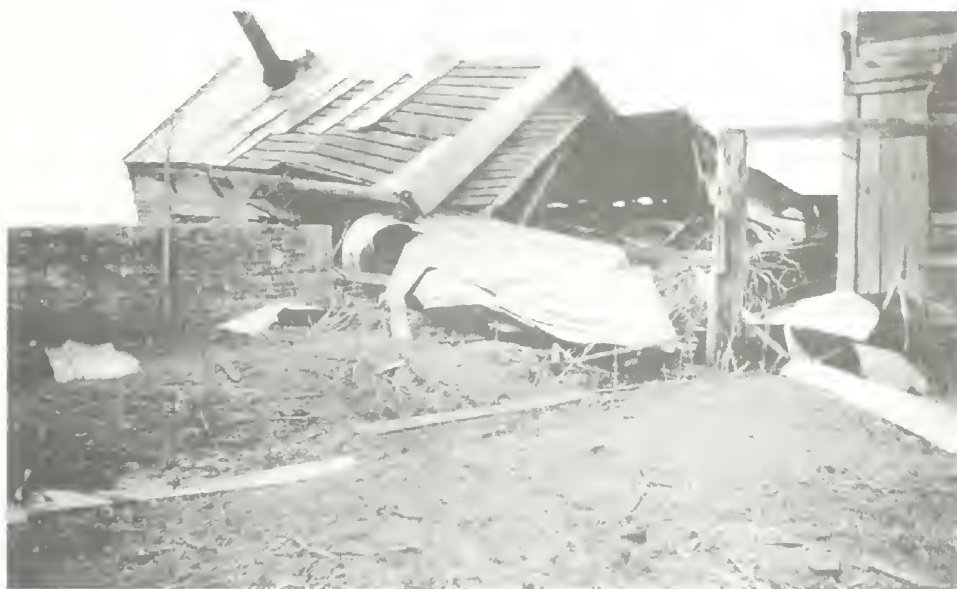
**Figure 6** View of destroyed engine house at Gin Barn after 1939 tornado. The barn is partially visible at right. (Hertzog Family Collection, Magnolia Plantation)

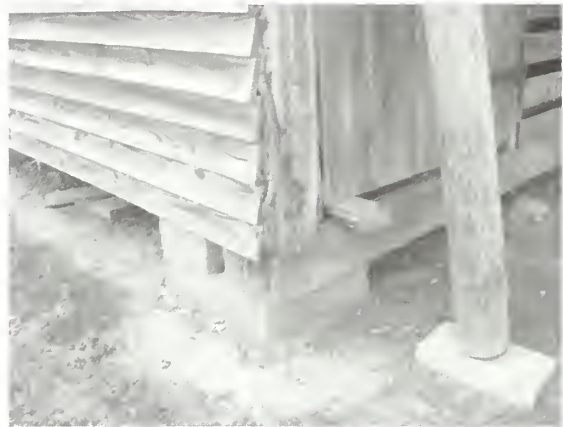
**Figure 18** View of northeast corner of barn, showing brick pier rebuilt in 1996. (NPS-SERO-CRS, 2001)

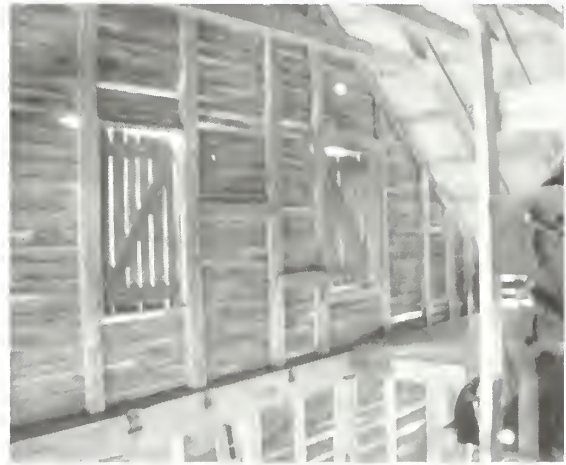
**Figure 26** View to southeast showing part of east end of barn; note empty mortises for framing around missing stairway. (NPS-SERO-CRS, 2001)

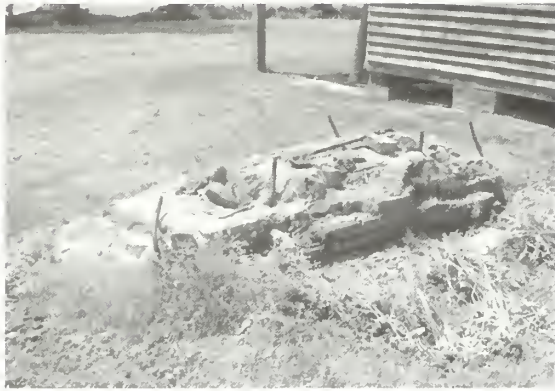
**Figure 37** View to southwest of brick foundation for steam engine. (NPS-SERO-CRS, 2001)

- Conduct complete archeological investigation around and within footprint of present building.
- Repair and repoint cistern; preserve engine base.
- Define appropriate routing of visitors around building.
- Keep perimeter of building free of vegetation.

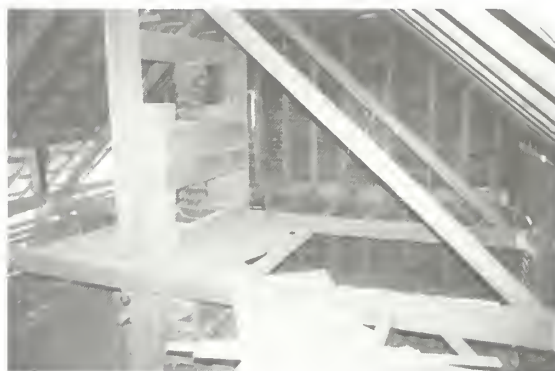
**Figure 45** View of top frame of wood-screw cotton press, which would have originally been surrounded by flooring. (NPS-SERO-CRS, 2001)

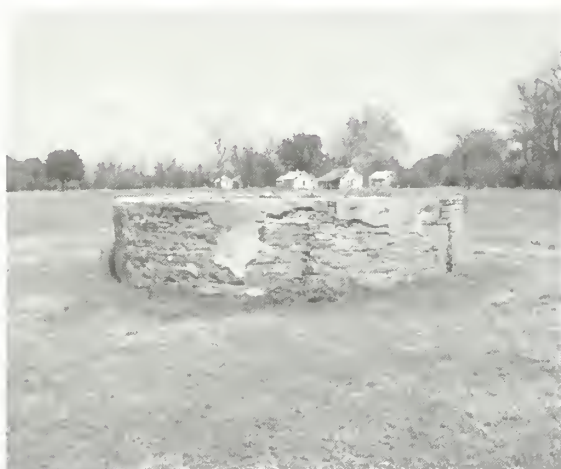
**Figure 47** View to northeast of cistern at Gin Barn. (NPS-SERO-CRS, 2001)
