THE STILLWATER ROAD (SHEA) BRIDGE Cumberland, Rhode Island

METALS NUMBER 4

Rehabilitating a Historic Iron Bridge

Joseph P. Saldibar, III

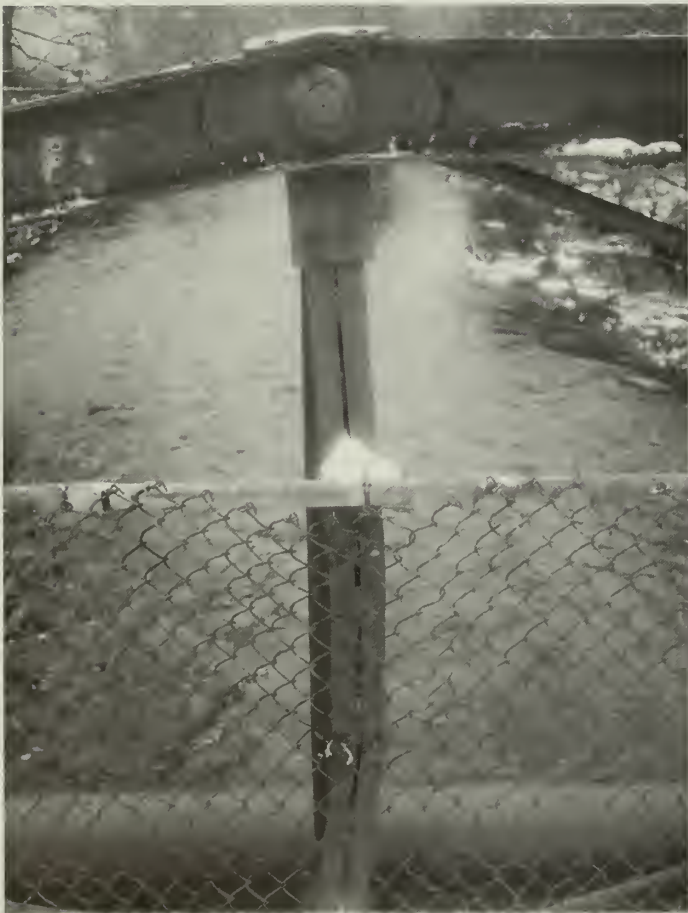
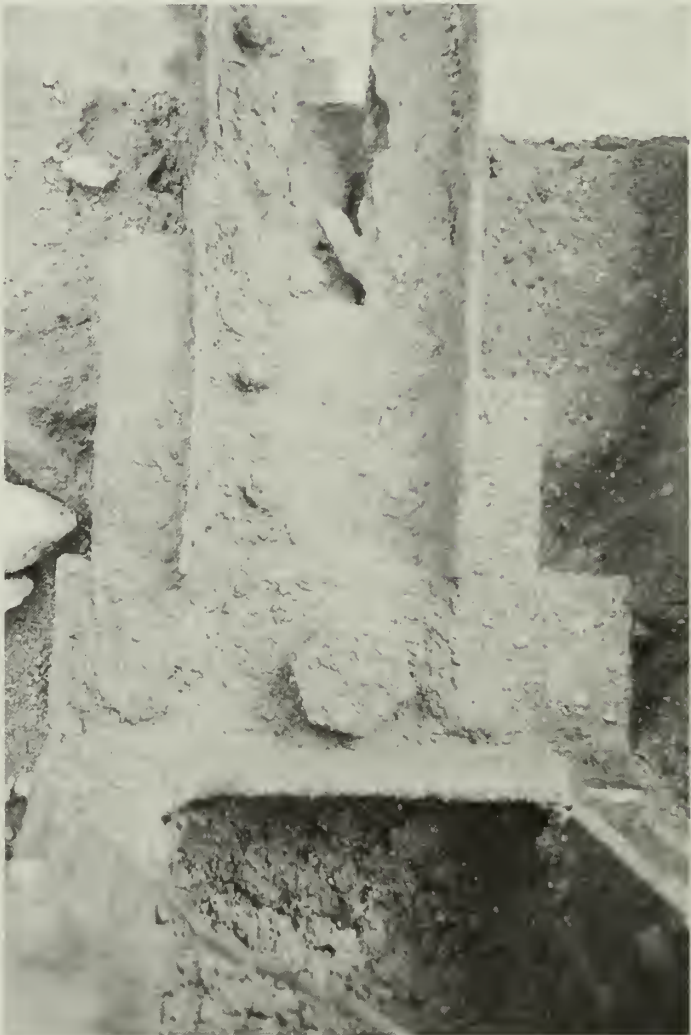
After a century of use, the bridge showed signs of major deterioration. Three of the four upright posts were bent from automobile collisions. The U-bolt floorbeam hangers had rusted, the result

of moisture and dirt collecting on the flange. The lattice girder stiffeners (zero-force members which serve to prevent "racking" or lateral movement) had lost their latticework and were severely corroded. In addition, the endposts of the bridge showed signs of serious decay (see figures 2 and 3).

Figures 2 and 3. The extent of damage can be seen in the bent vertical post member (below, left) and the heavily corroded end post (right). Similar problems existed throughout the structure. Photo: Beta Engineering.

Some parts were so deteriorated that they could not be preserved and re-used as planned, including the end posts, lattice girder stiffeners, and all four vertical (lattice girder) stiffeners. This was somewhat disappointing, as the original specifications called only for the removal of the floorbeam hangers, and the intent was to save as many of the original parts and fasteners as possible. The new, matching members would be more cost-effective and actually stronger than repairing the original pieces. The other drawback was that the new elements would need to be fabricated of steel, rather than higher-priced wrought iron. Once completed, however, the

Meanwhile, the endposts, lattice girder stiffeners, and vertical posts were being fabricated from steel (see figure 8). The original end posts had been constructed as a box section; one plate and two angle iron pieces were riveted together to form a column with one lattice side.

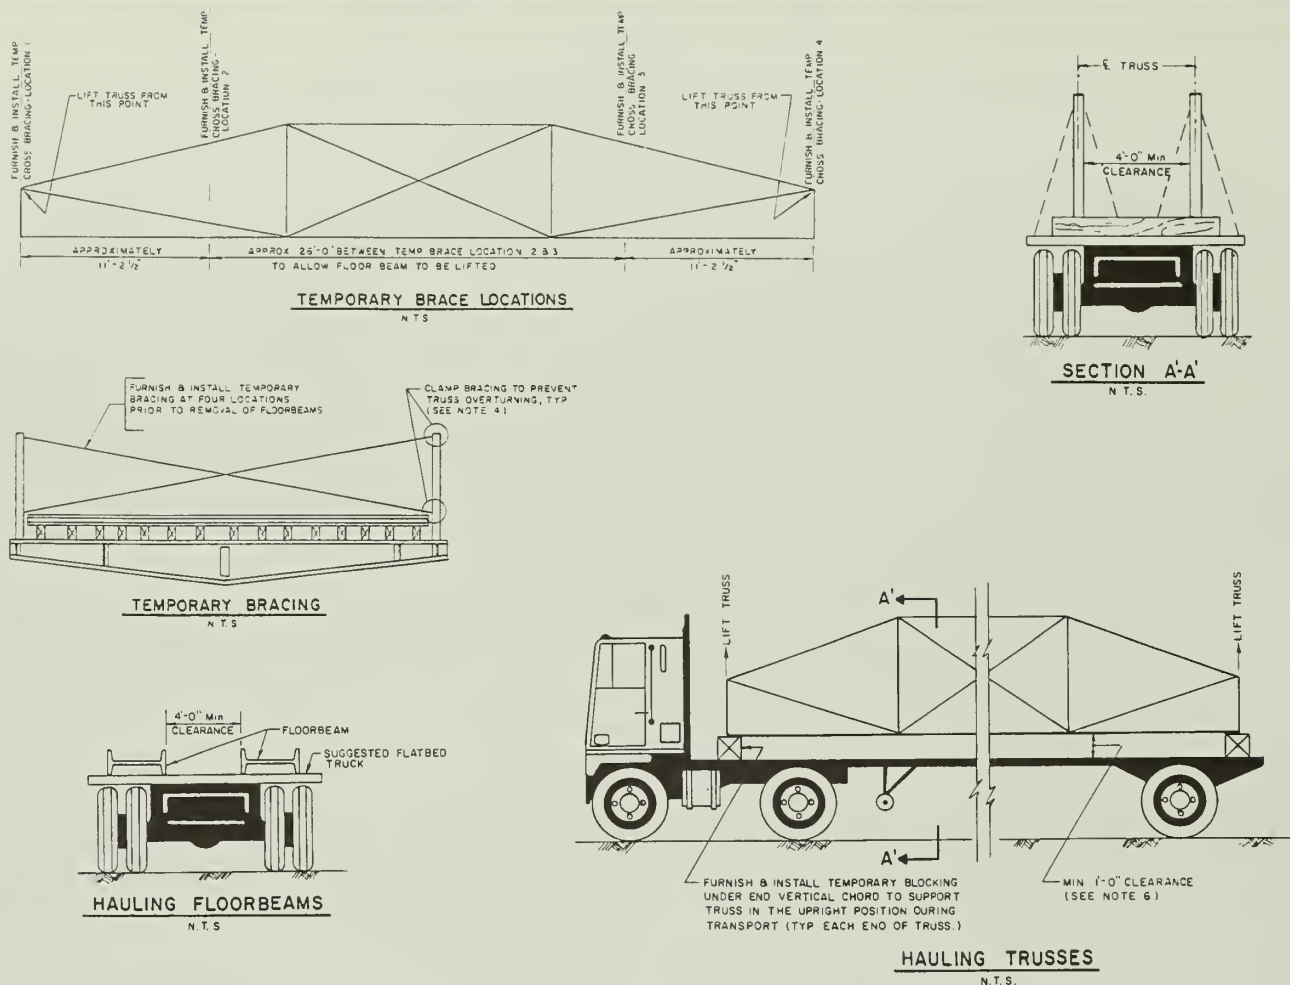
Figure 5. A temporary bracing system assured the protection of the bridge during disassembly.

At this point, a temporary bracing system was built to stabilize the trusses before construction work proceeded (see figure 5). This wooden system was extremely important—without it, the trusses might have twisted or overturned during the remaining disassembly work.

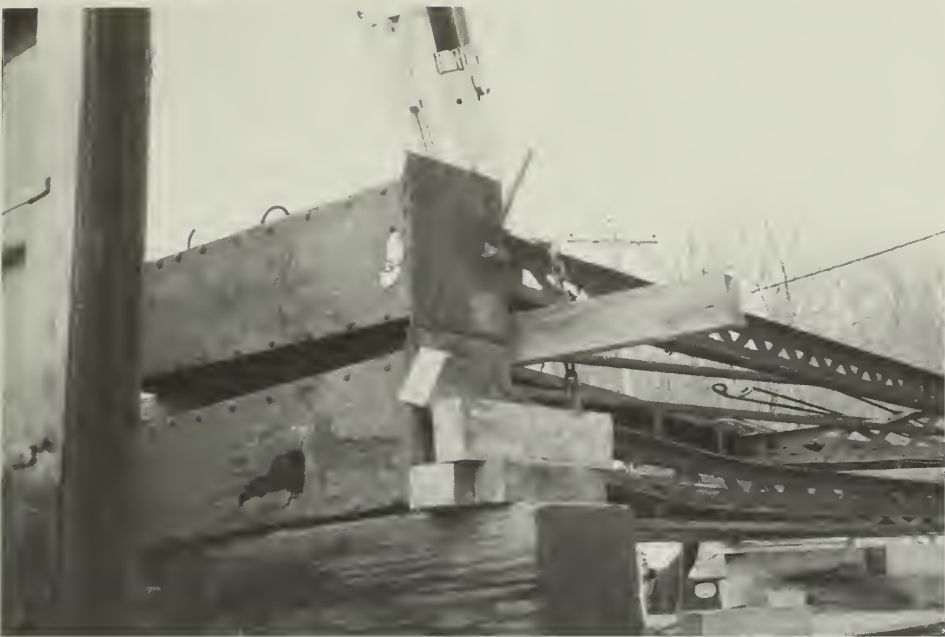
With the trusses stabilized, the deteriorated floorbeam hangers were removed. The floorbeams themselves were lifted, one at a time, by crane onto a flatbed truck, and transported to the shop. With the temporary bracing removed, the trusses were then attached to the crane and lifted in one piece, then placed on their sides on the truck (see figure 6). The plans had specified that the trusses be placed on the truck in an upright position, with protective bracing. But when the first truss was mistakenly laid on its side, the deteriorated lattice girder stiffener was severely bent. Fortunately, this lattice girder was slated for disposal before the damage occurred. The other truss was removed without damage.

Figure 6. Although plans specified that the trusses be placed in an upright position, they were placed on the truck on their sides (left). The lower truss was damaged during the loading operation. Photo: Beta Engineering.

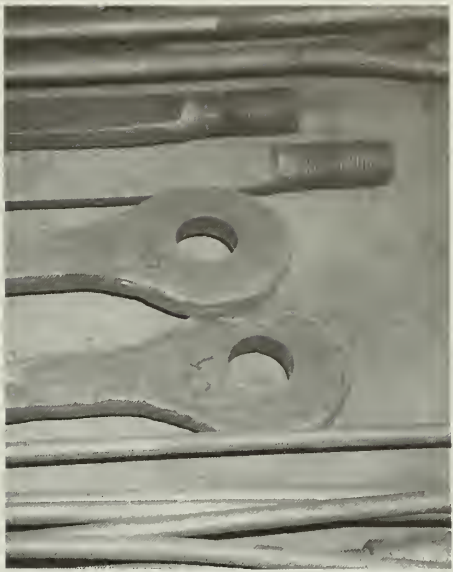
Figure 7. The pieces were disassembled in the shop, then cleaned of rust and paint. The worn condition of the eye bars can be seen in the center of the photograph. Photo: Beta Engineering.

The salvageable parts were placed in a Wheelbrator, a machine which removes rust through repeated vibration. The iron members were then sandblasted to remove paint and any remaining rust, then subjected to magnetic particle testing to determine which pieces had unseen damage or decay. The test was useful in determining wear in some of the parts, particularly the eyebars of the lower chord and the middle panel tension rods. In addition, some of the pins had worn by more than 1/4" over time.

In order to reuse as much of the historic material as possible while ensuring sufficient structural integrity, it was decided to "build up" through welding those pieces that were worn down. In order to match the metallurgical composition of each part, a chemical test was undertaken. This testing allowed for an exact metallurgical match between the new built-up welds and the original metal of each part. Such a match reduced the possibility that a harmful physical or chemical reaction would take place between the weld and the wrought iron.

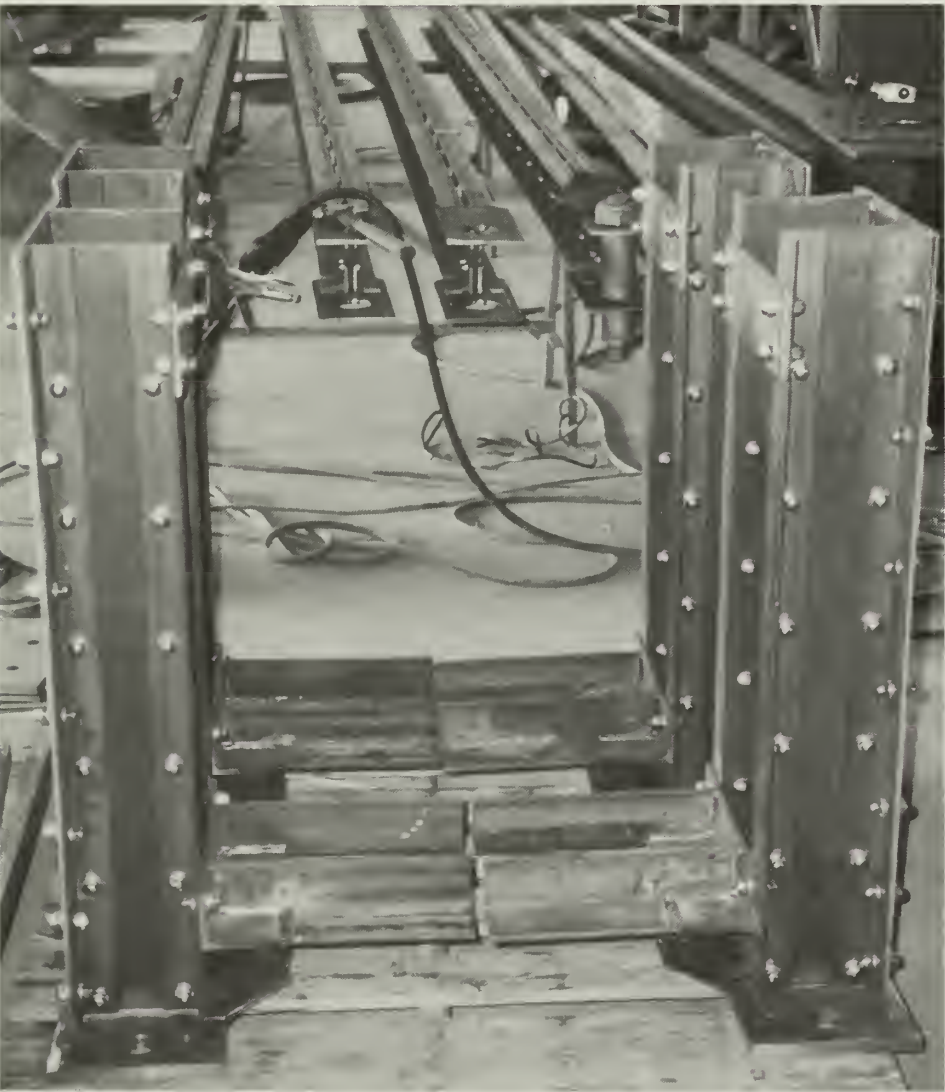
Figure 8. New endposts (foreground) and lattice vertical posts (background, center) were fabricated from steel. The rivets are actually threaded; hidden bolts help keep the pieces together. Welding provides additional strength. Photo: Beta Engineering.

Only the rivet heads could be found, and there seemed little use for them. But after some thought, a creative solution was formulated. The shanks of the rivet heads were threaded, and the plates screwed together. For structural strength, the pieces were also welded, but this weld is invisible from the outside. The result is a welded box girder that looks, from the outside, like an authentic riveted member. Had no rivets been found, a similar procedure could have been followed using hack bolts. (These are bolts with heads that look like rivets but have nut fasteners.)

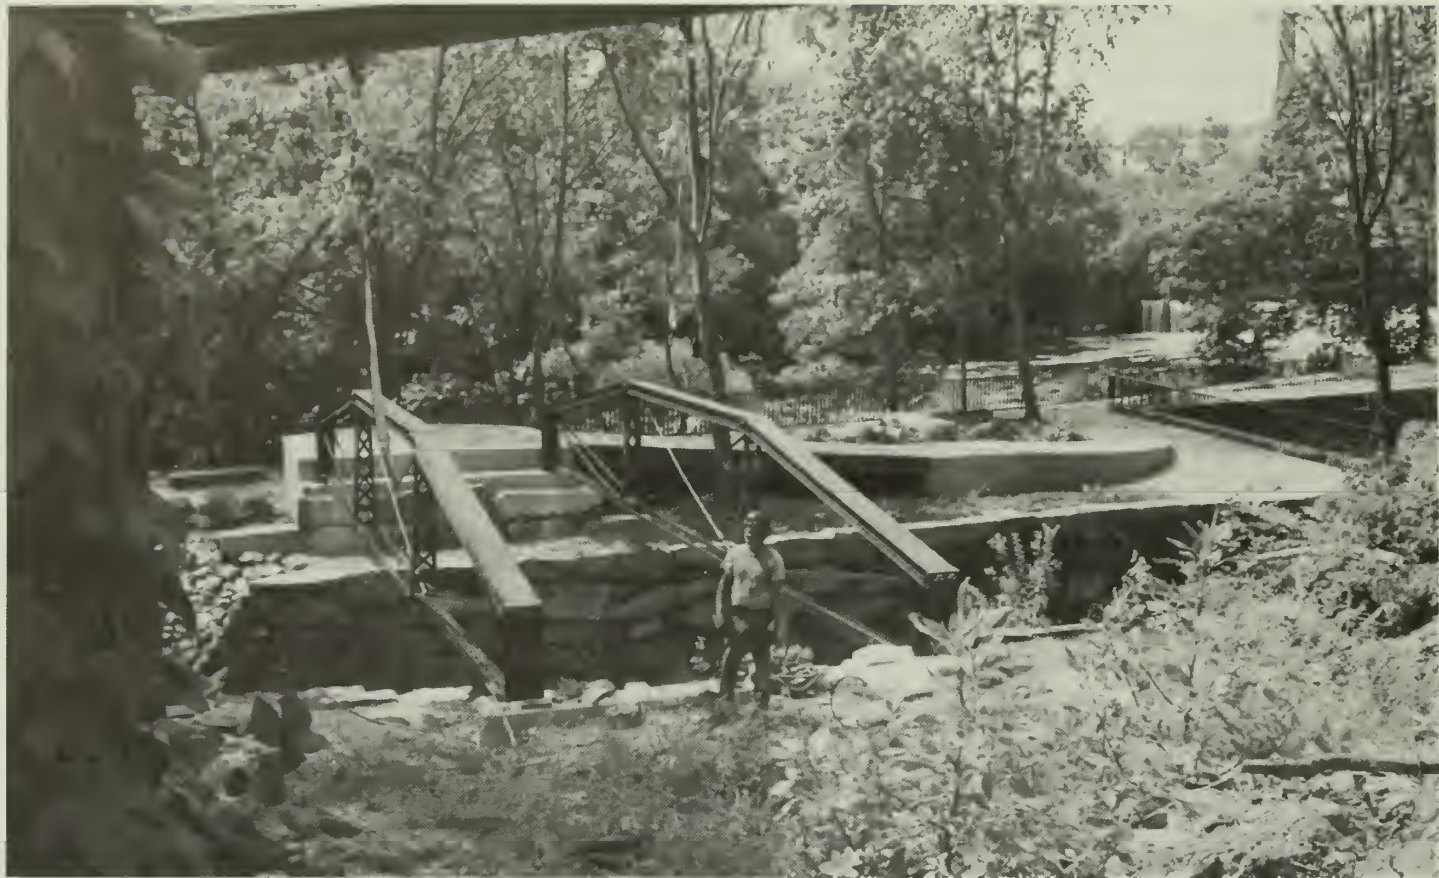
Figure 9. The trusses were lifted by crane and set into position on the new site. Photo: Beta Engineering.

When the new foundation was completed, the trusses were lifted by crane to the site, installed in place, and secured with temporary wooden bracing (see figure 9). The rest of the bridge (floorbeams, hangers, stringers, etc.) was then
