# CULTURAL LANDSCAPE REPORT AQUATIC PARK

SAN FRANCISCO MARITIME NATIONAL HISTORICAL PARK

**CULTURAL LANDSCAPE REPORT, AQUATIC PARK**  
**SAN FRANCISCO MARITIME, NATIONAL HISTORICAL PARK**

**NATIONAL PARK SERVICE**  
**PACIFIC WEST REGION**  
**2010**

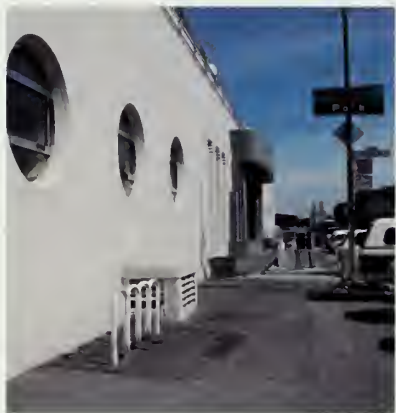
**Figure 89.** On the west side of the front entrance to the Bathhouse, a bicycle rack, accessibility ramp, and various small-scale features and utilities create a cluttered appearance. Note asphalt paving where planting bed was originally located. (NPS, 2010)

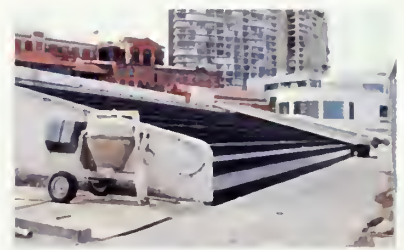
**Figure 90** View of the East Bleachers showing new waterproofing material applied during rehabilitation. Note mildew on the concrete wall. Cleaning and repainting this portion of the structure is important to the character of the structure, and should be integrated into overall maintenance. (NPS, 2009)

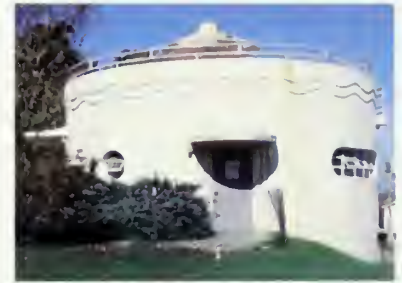
**Figure 92.** Staining on the exterior of the West Convenience Station. (NPS, 2007)

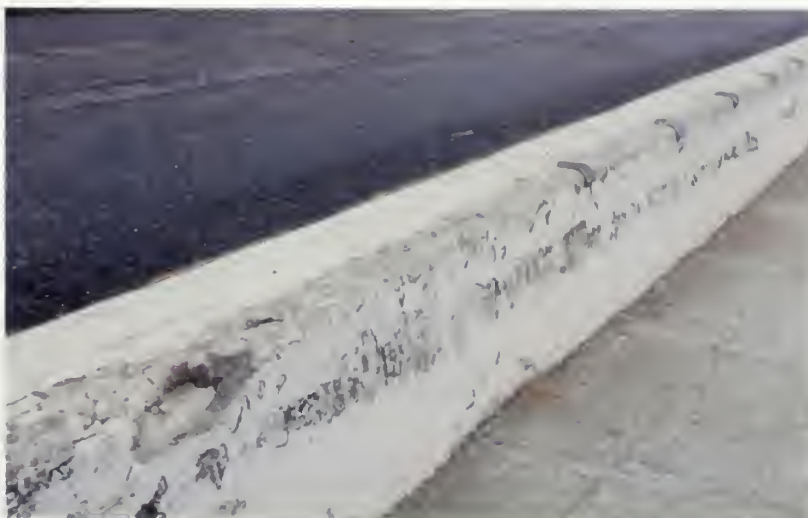
**Figure 96** Flaking and loss of material along the concrete wall occurs as deterrent bolts fail and water penetrates the under layers of the concrete. Repair may require patching, reapplication of a skim-coat, or some combination. View of the east end of the wall, looking west (NPS, 2007)

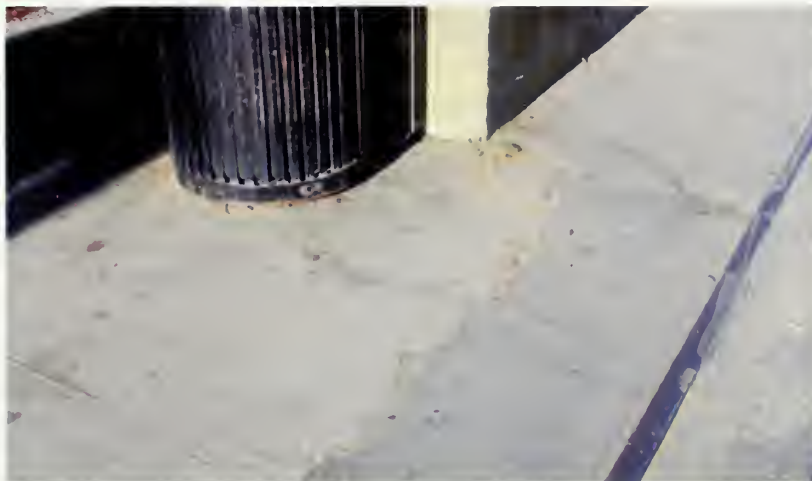
**Figure 100** In some areas walkways have been resurfaced with paving added over existing layers creating a patchwork of materials. (NPS, 2008)

- paving material. (Figure 100)
  - Remove excess paving material in places where past repairs have altered the historic width, alignment, material, edge treatments, or character of the historic walkway.

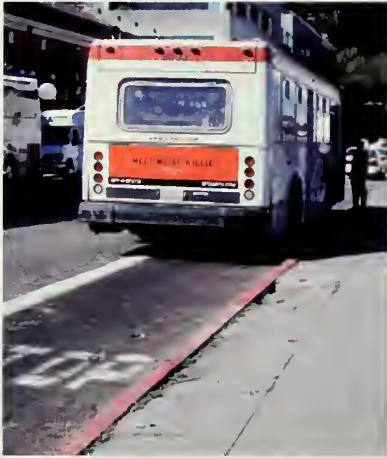
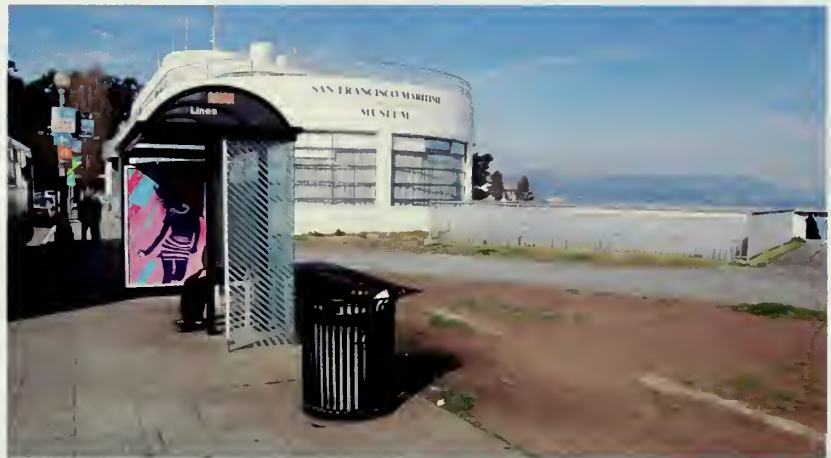
**Figure 107 a&b.** The bus stop located on the east side of the Bathhouse is an area significantly impacted by heavy use in a relatively compact zone. Overall, the combination of degraded concrete sidewalks, denuded vegetation, damaged concrete curbs, visually incompatible structures, and a diverse variety of small-scale features create an adverse impact to the NHL district. View from the shelter looking east along Beach Street. (NPS, 2006)

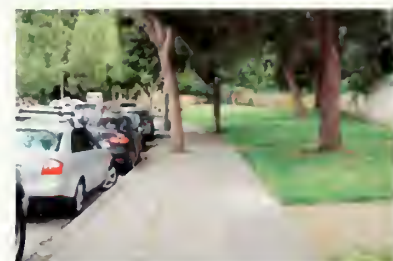
**Figure 108** Displaced, cracked, and patched sidewalk along Van Ness Avenue next to Pocket Park. At a certain point, rather than patching, a holistic approach to rehabilitation of the sidewalk will assure a more uniform character. View looking south (NPS, 2008)

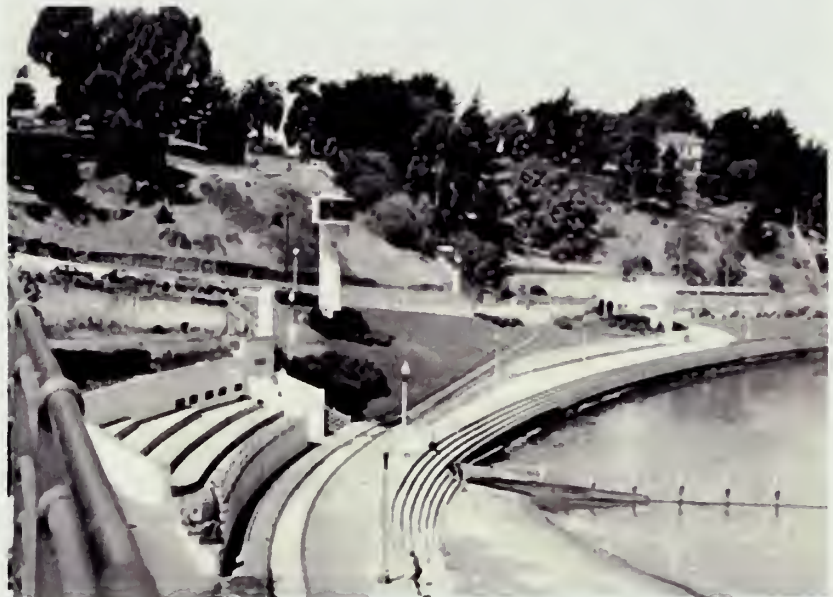
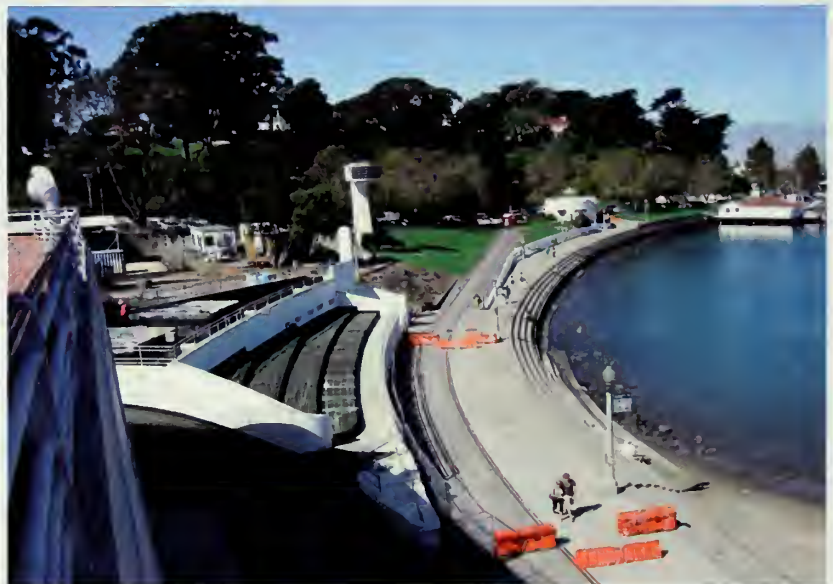
**Figure 109 a&b.** Comparison showing the degree to which vegetation has encroached on the slope above Van Ness Avenue (Fort Mason). Historically this area had a more open vegetative character during the period of significance for Aquatic Park. Top: view looking west, 1946. (Courtesy of the San Francisco History Center, San Francisco Public Library AAA 6697; bottom: view looking west, 2009 (NPS, 2009)
