THE ADMINISTRATION BUILDING (THE RYAN CENTER)

Gateway National Recreation Area Floyd Bennett Field Unit Brooklyn, New York

Historic Structure Report

By Judith A. Quinn

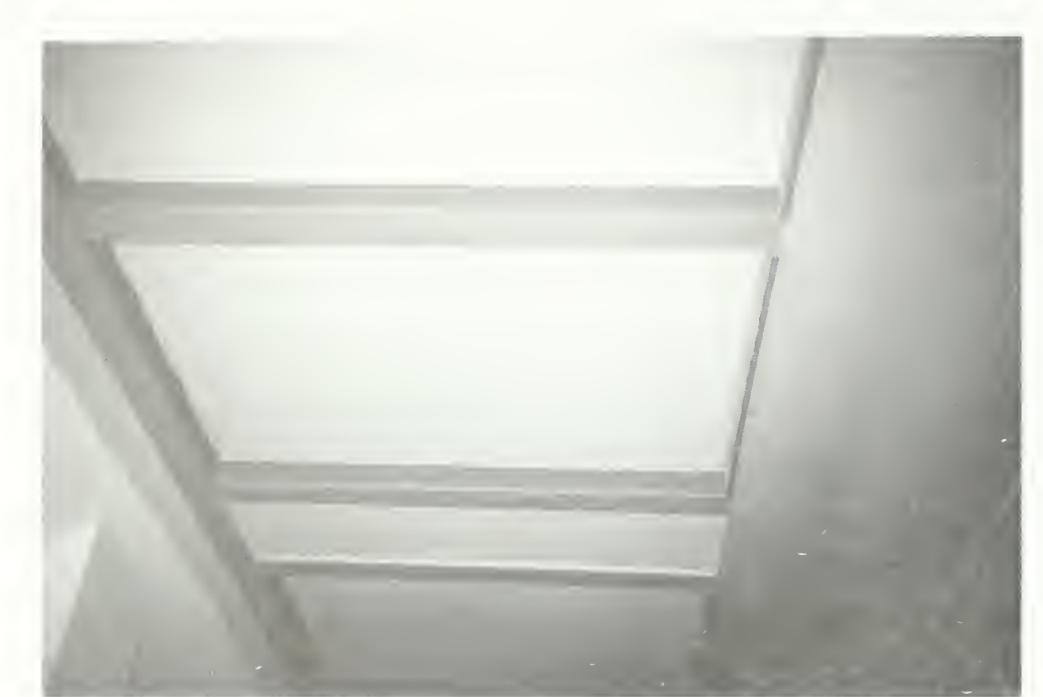
Figure 29. North corridor, east wall: former window wall looking into Room 110, plate glass now replaced with plywood.

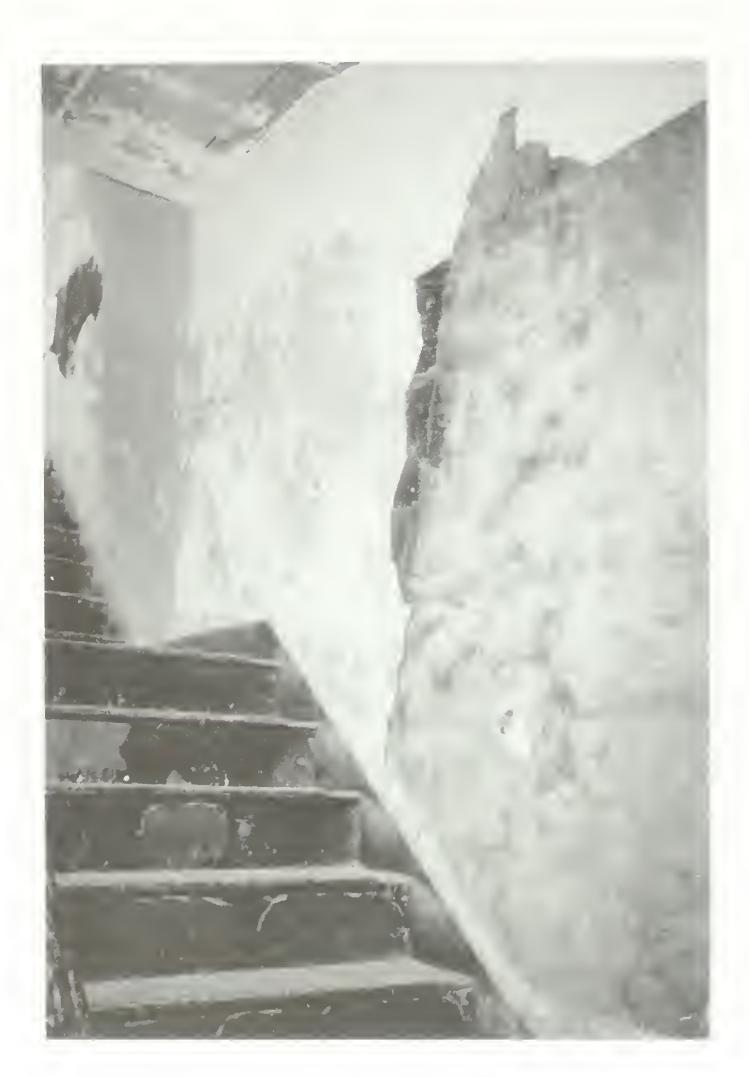
Figure 46. Imitation Caen stone on wall of Stairway #5 between second and third floors, showing pargeting spalling from scored cement brown coat.

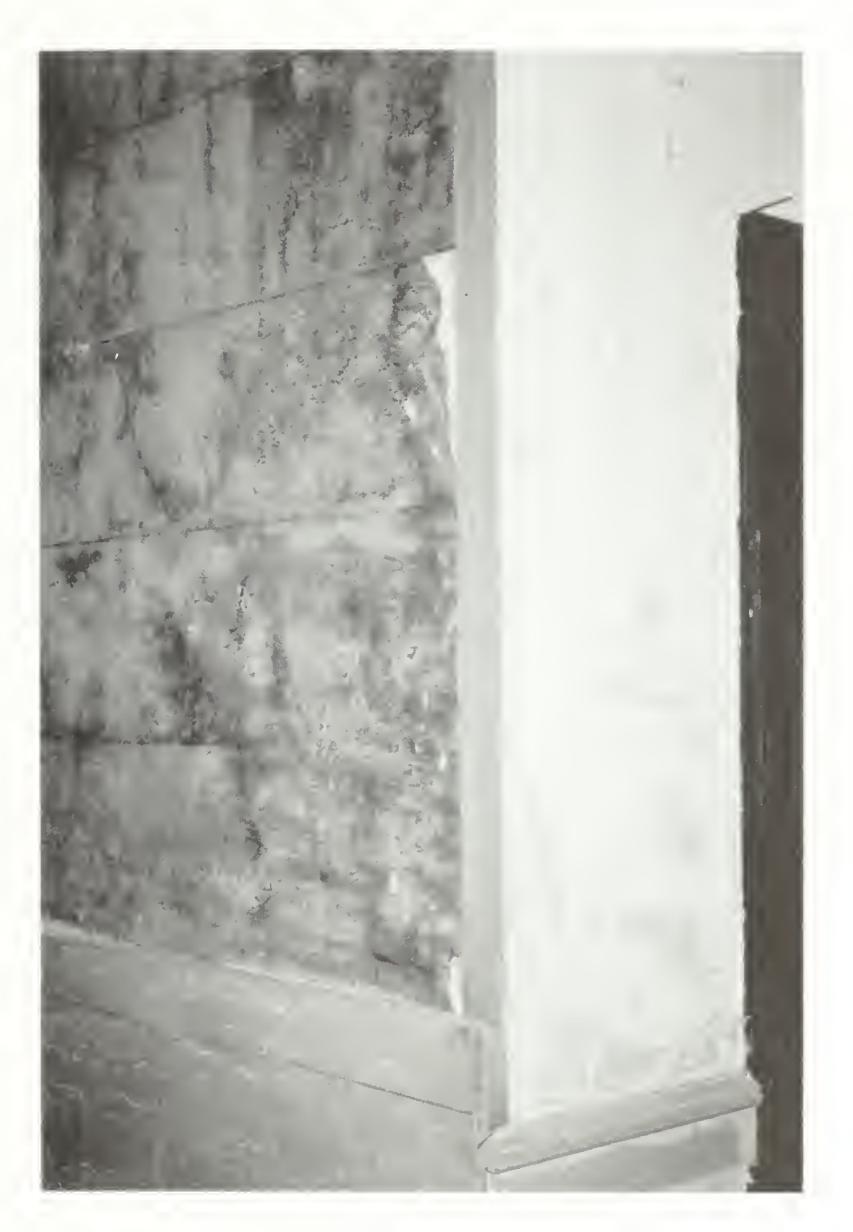
Figure 47. Imitation Caen stone at juncture of wall of Stairway #5 and east wall of south corridor, second floor. Exposed cement brown coat of imitation stone on left, scored plaster on right.
