historic structure report architectural data section volume 2: appendixes

#### HISTORIC STRUCTURE REPORT

#### LINDENWALD

## MARTIN VAN BUREN NATIONAL HISTORIC SITE

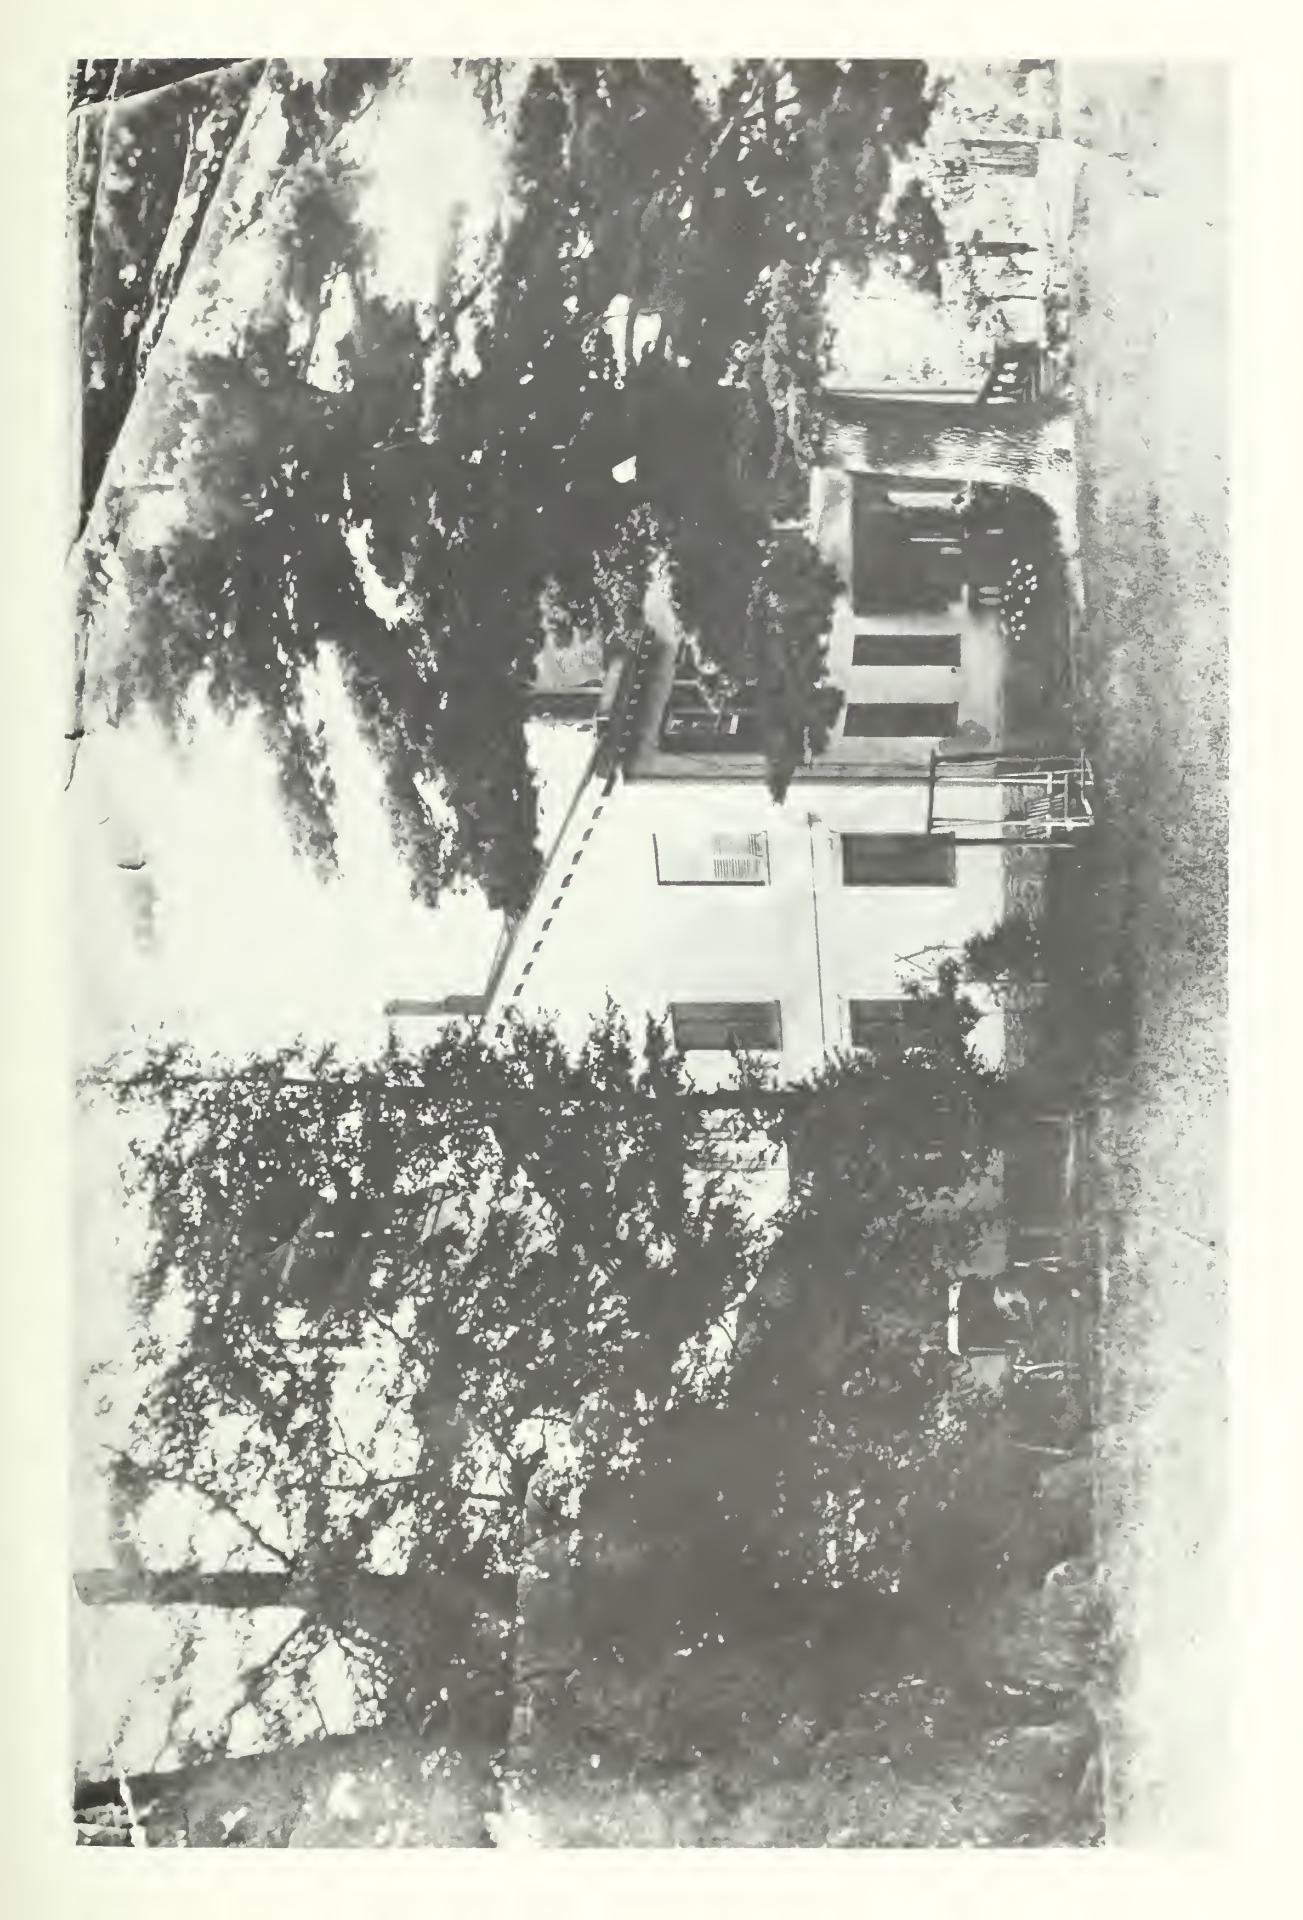
based on The assigned date is similarities with HP8. The following details are noteworthy: Lindenwald, ca. 1910-1917. HP9.

The foundation, window frames, shutters, and front porch seem to ŋ The bricks and cornice are painted be painted a dark tone. lighter tone.

There are ferns planted along the north foundation wall.

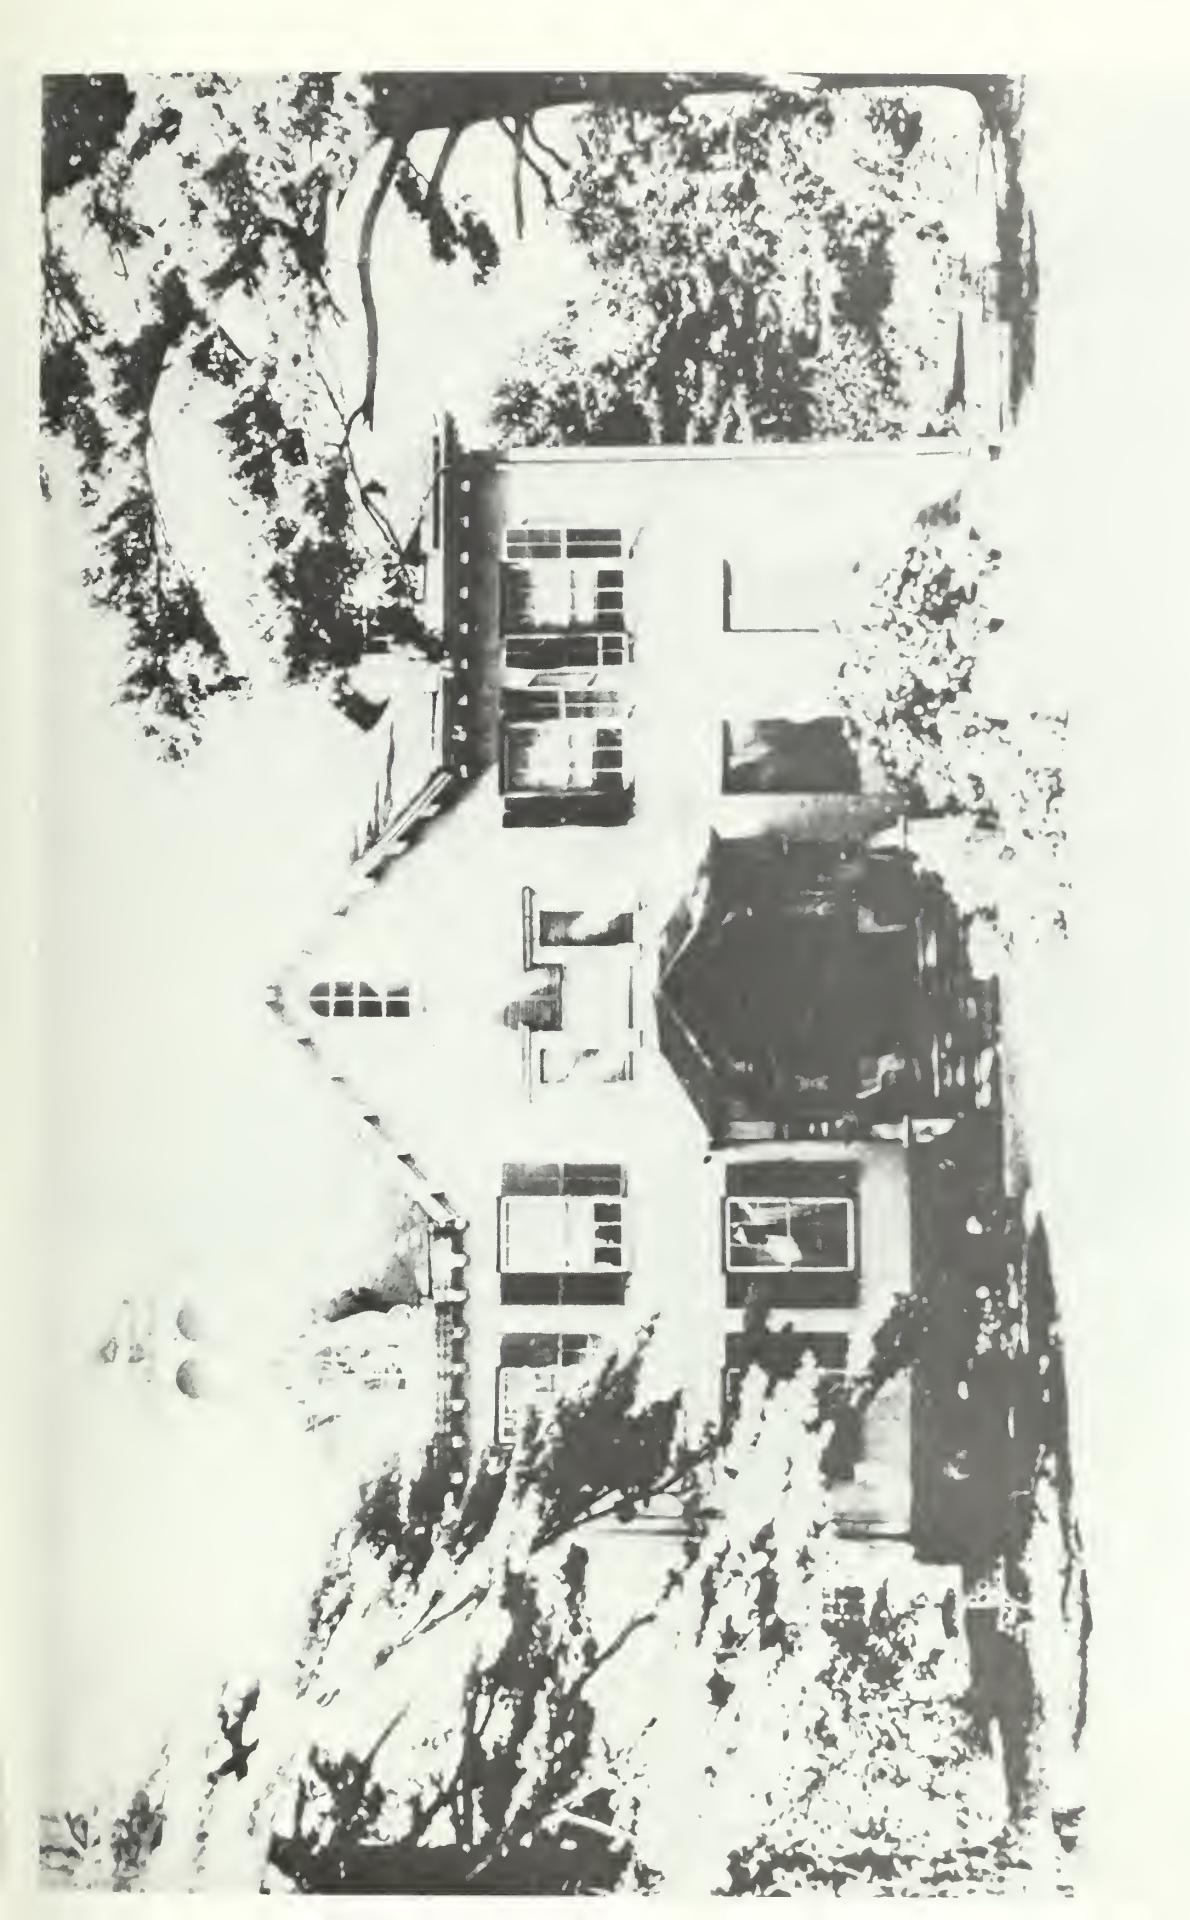
HP12. Mrs. Bascom Birney at Lindenwald, after 1917. This photograph was probably taken after the Birneys' acquisition of Lindenwald in 1917. The following details should be noted:

The foundation and trim appear to be painted a dark tone. Brickwork has been painted a light tone but is now quite weathered. Window frames are painted a lighter color.

The replacement cornice on the door pediment is in place.

The downspout appears to be a replacement consisting of lengths of stock corrugated pipe and a wooden board and trough to direct rainwater away from the foundation.

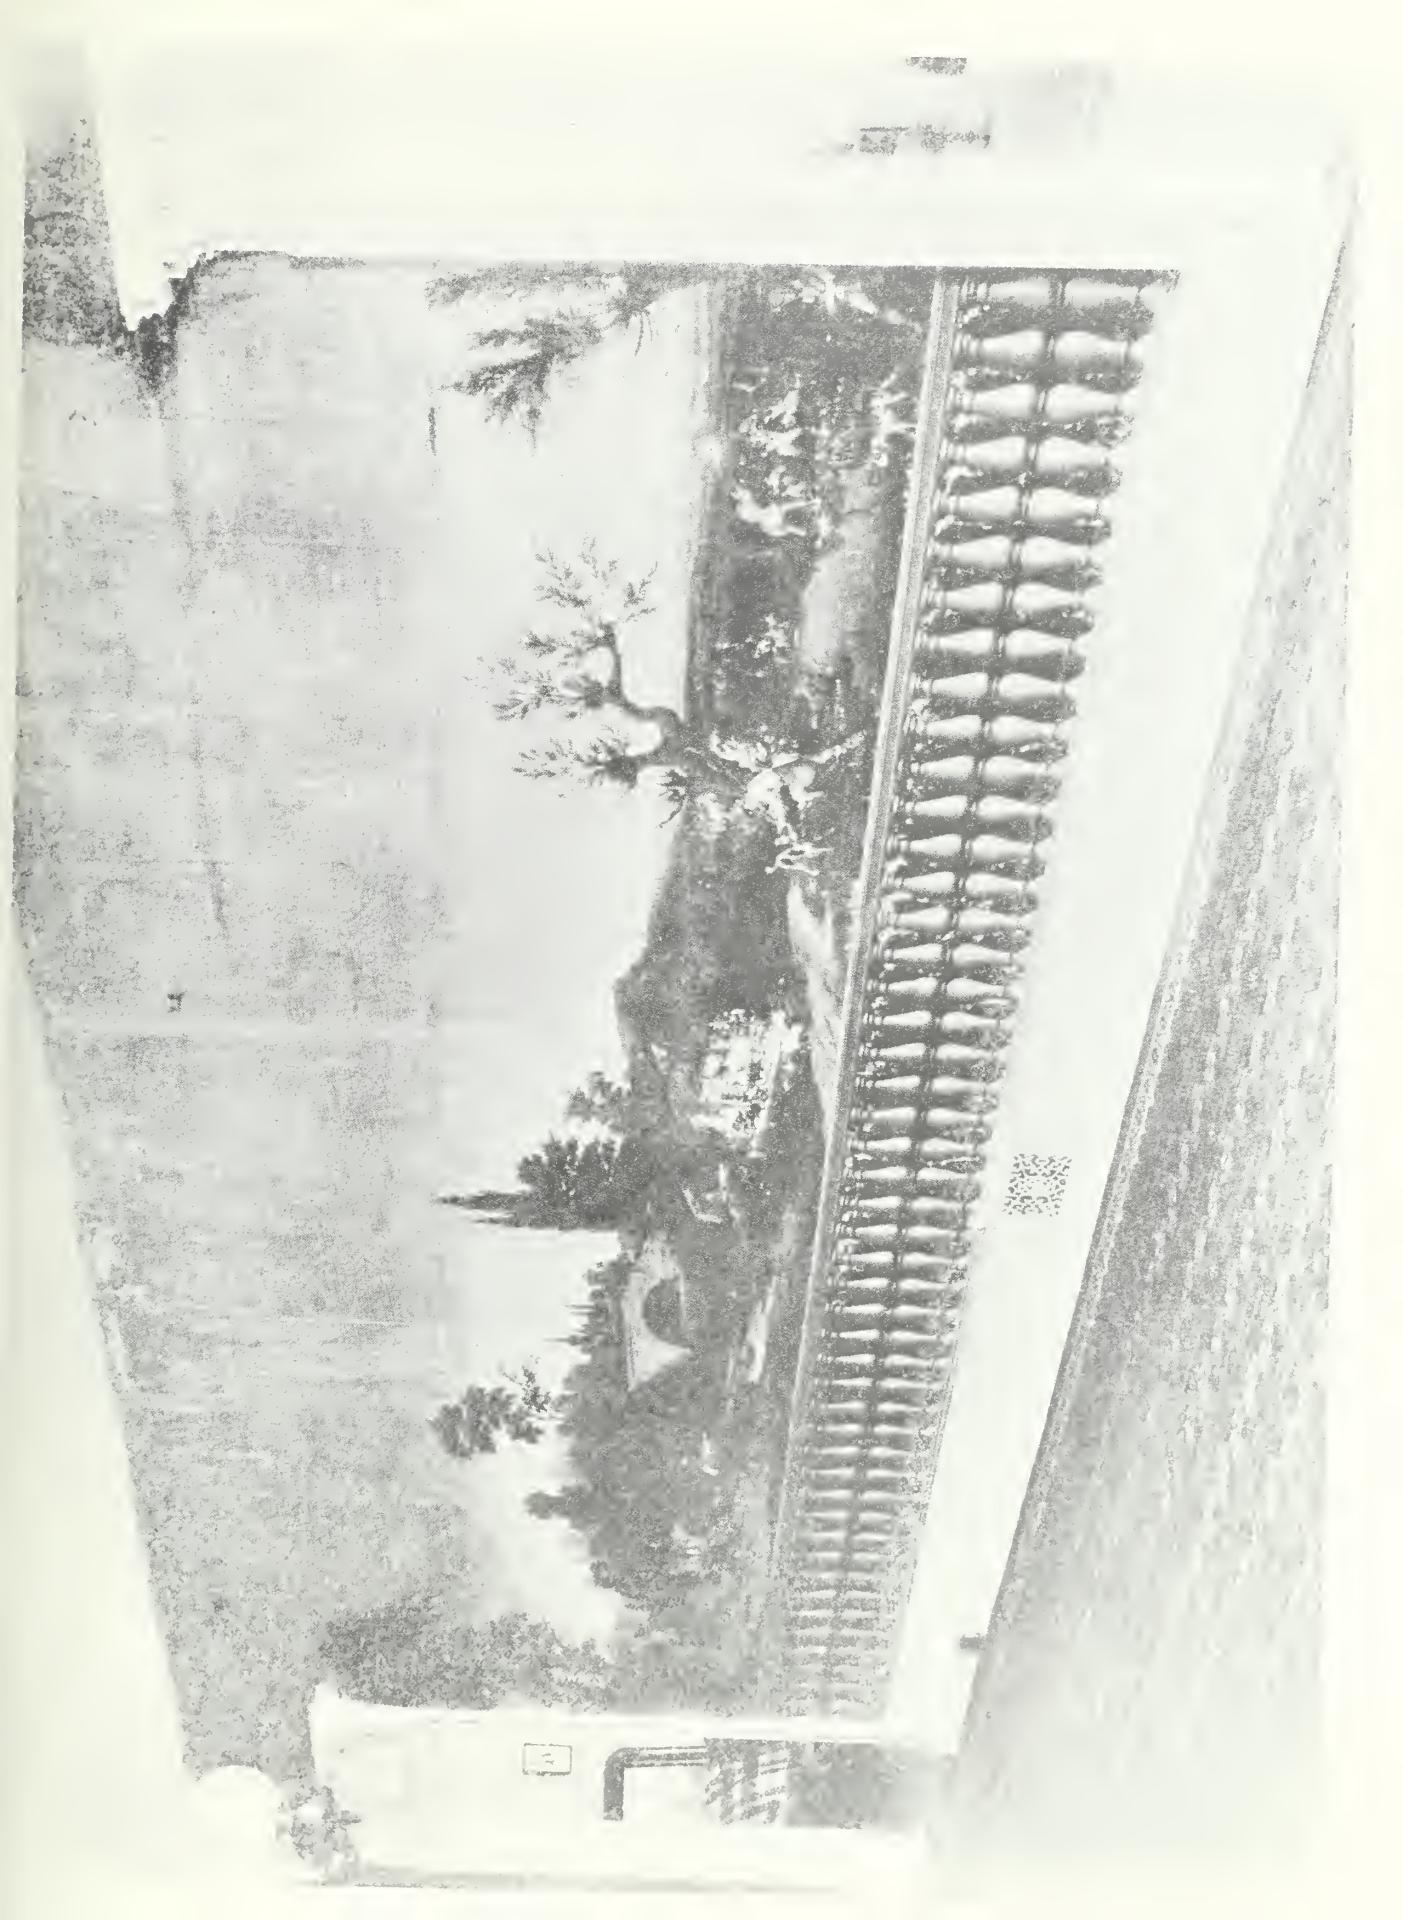
is still in progress). It is considered to predate 1925 because the tie rod is still in place on the front porch, and shutters are still in place This rods are missing from the front of the house and because roofing brackets and a plank are still attached to the roof (indicating that roofing work on the Venetian window (see HP22). This photograph was taken by photograph is considered to postdate 1917 because the lightning South and East Facades of Lindenwald, ca. 1917-1925. Rowles Studios. The following details should be noted: HP18.

The return for the sill at the north dormer is missing

Brickwork, oriel window, and cornice seem to be painted a light tone. Window frames, shutters, foundations, and front porch seem a dark tone. On the addition, window frames are a light tone and hoods and roof are a dark tone. to be painted

Bricks are loose in the flat arch over window 127.

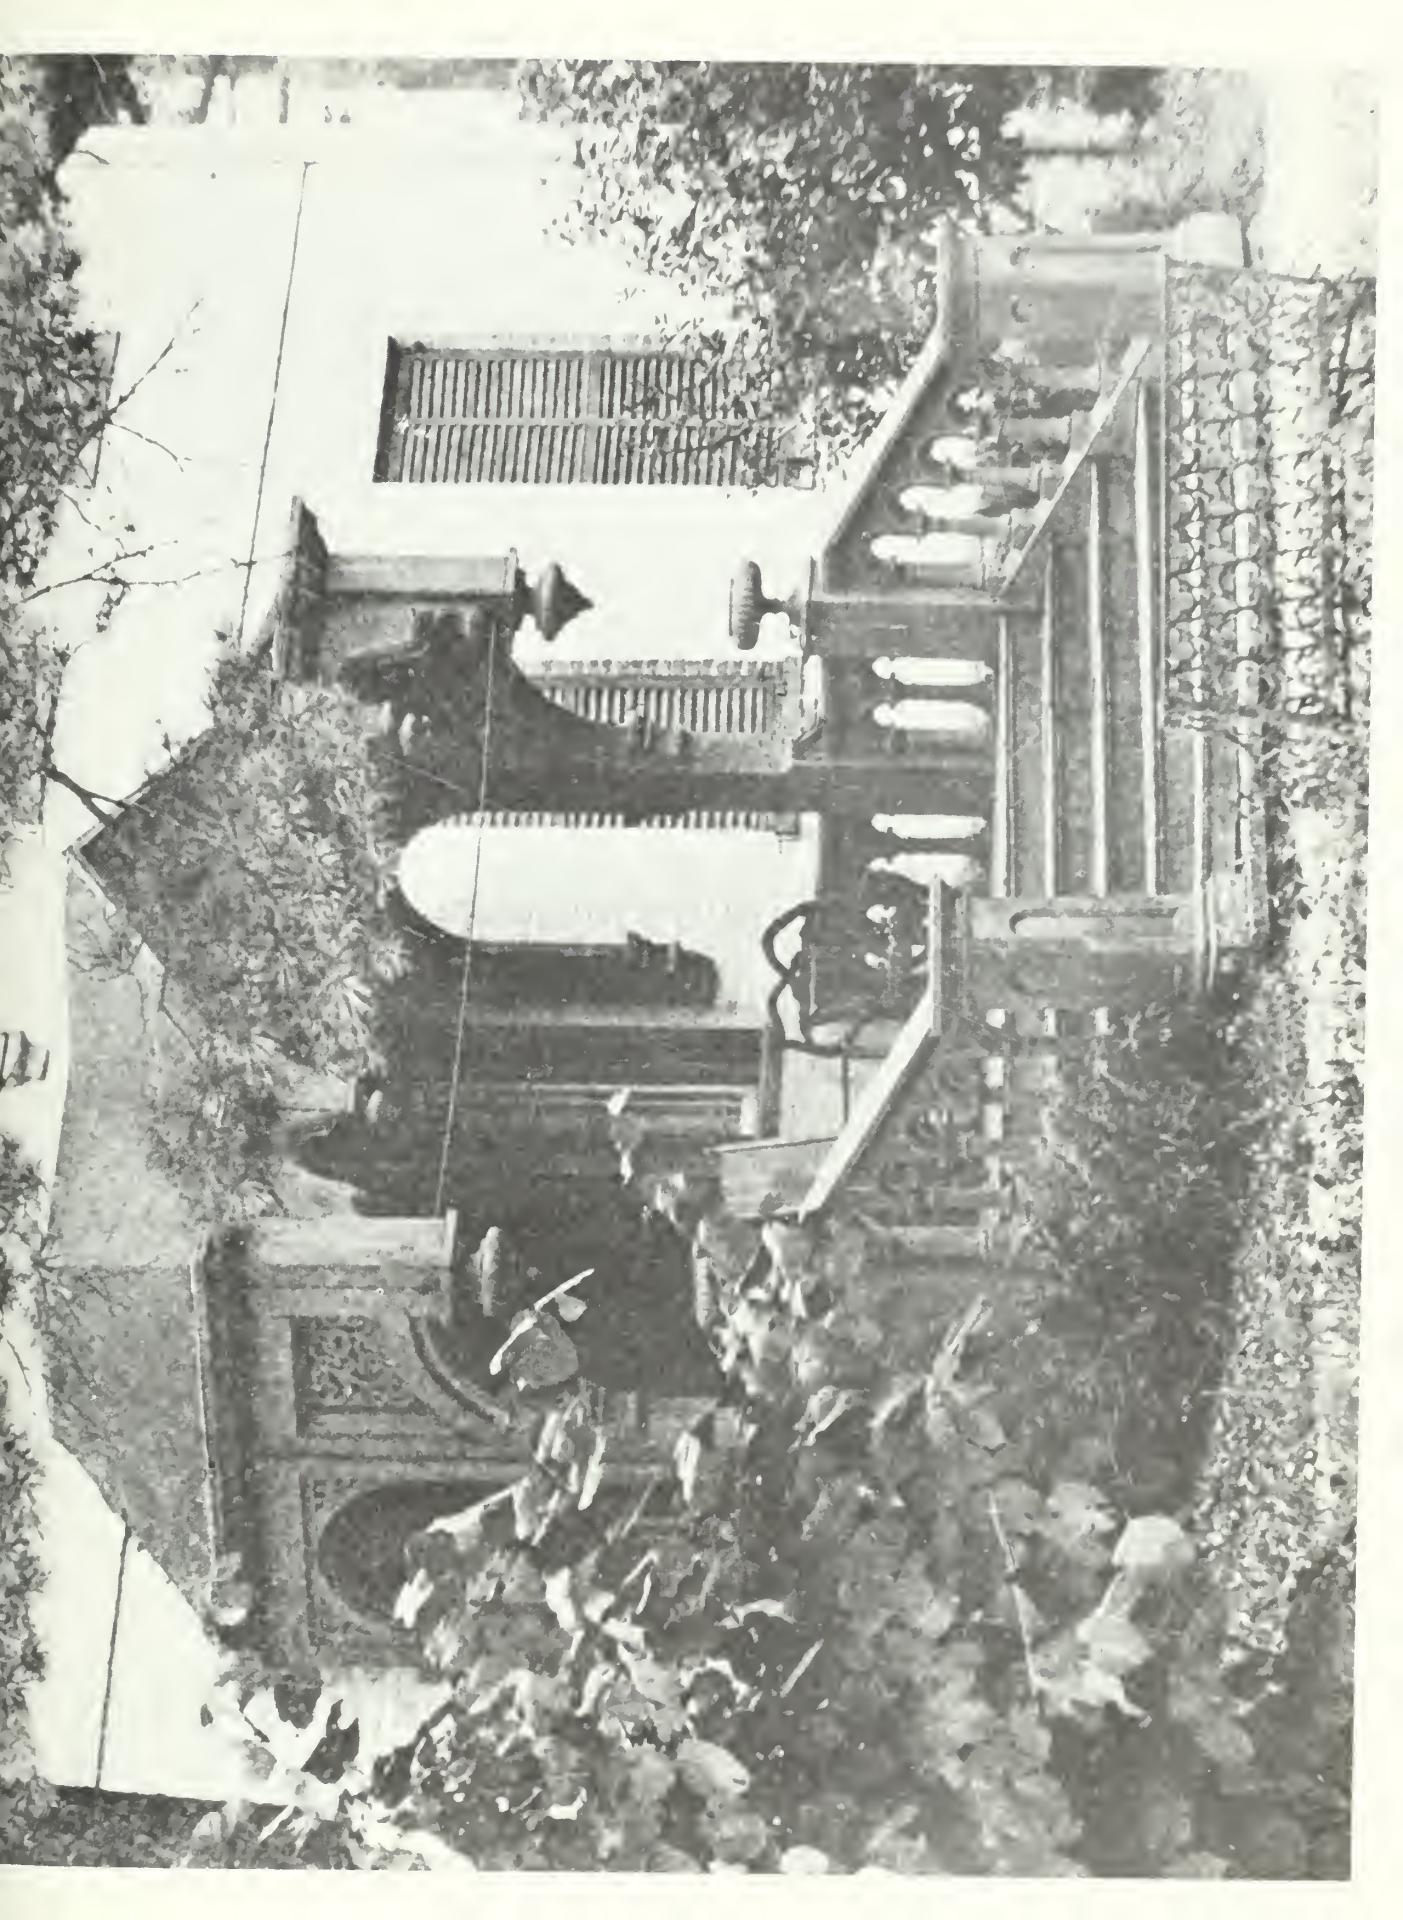
photograph is associated with HP18 and assigned the same range of Because of the absence of front lightning rods and the presence of roofing brackets and planks, the tie rod on the front porch, and the shutters on the Venetian window, this The following details should be noted: Lindenwald, ca. 1917-1925. dates. HP20.

The front board of the sill box under the south dormer is missing

The brickwork, cornice, and sash seem to be painted a lighter Window frames, foundation, and front porch are painted a darker tone. Shutters seem to be painted an even darker tone. tone.

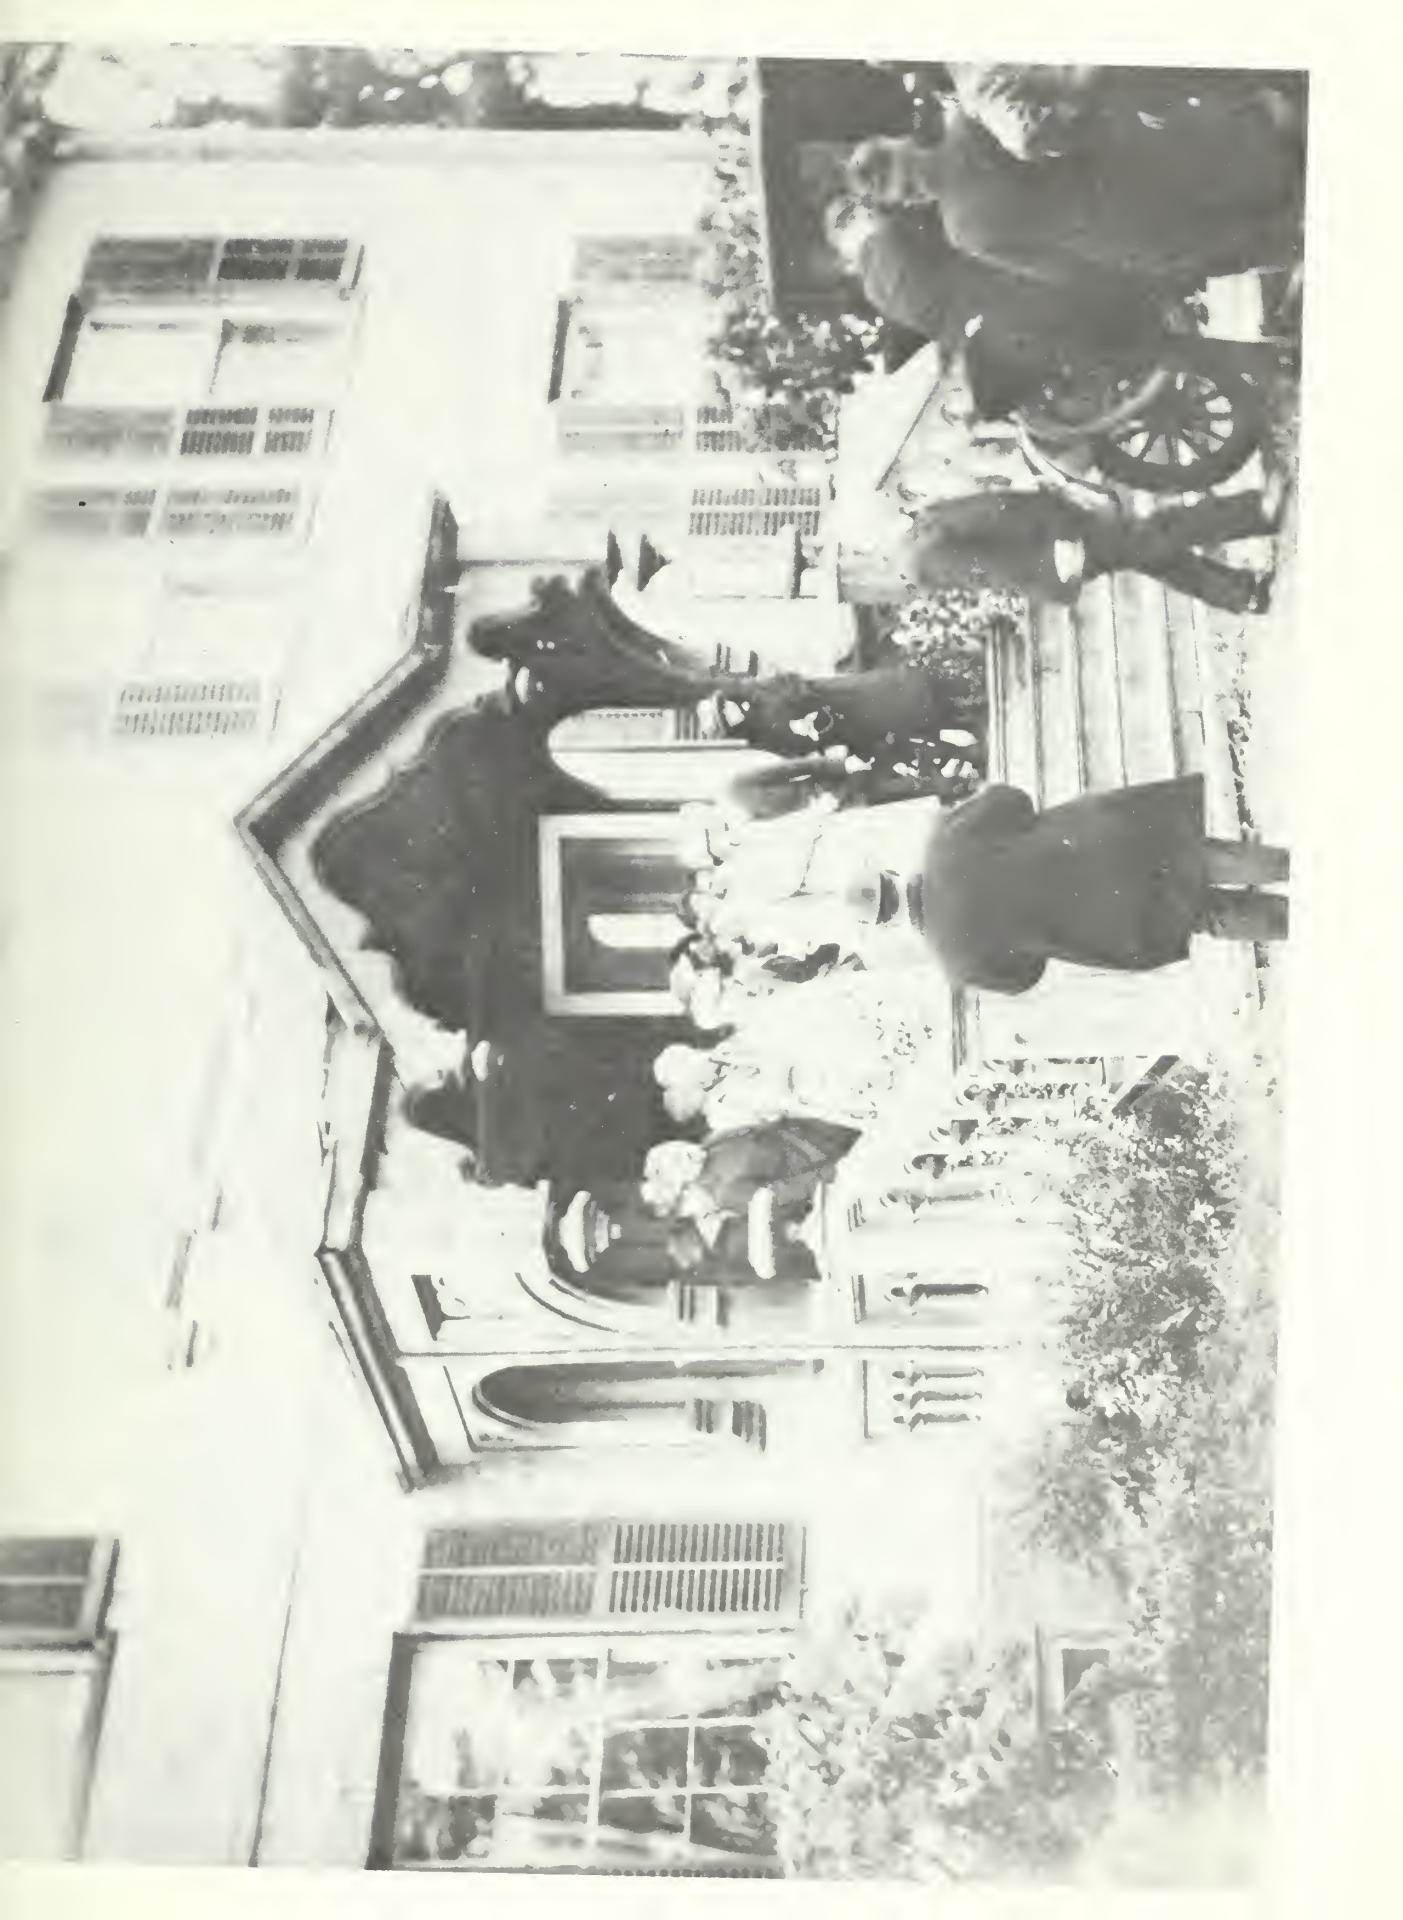
was taken by Melvin Weig, National Park Service historian, on August 3, 1936. This date is documented in the captions of all the photographs in his report "Lindenwald," the President Martin Van South and East Sides of Lindenwald, 1936. This photograph Buren Homestead, near Kinderhook, New York" dated November 3, 1936. The following details should be noted: HP23.

Some bricks are missing from the cap of the south chimney.

tone. Foundations, window frames, and the front porch are The light paint on the brickwork is very weathered and most brick courses on the south elevation can be seen. Sash has also been painted a light tone, but now the cornice appears to be a dark Shutters appear to be painted an even a dark tone. darker tone. painted

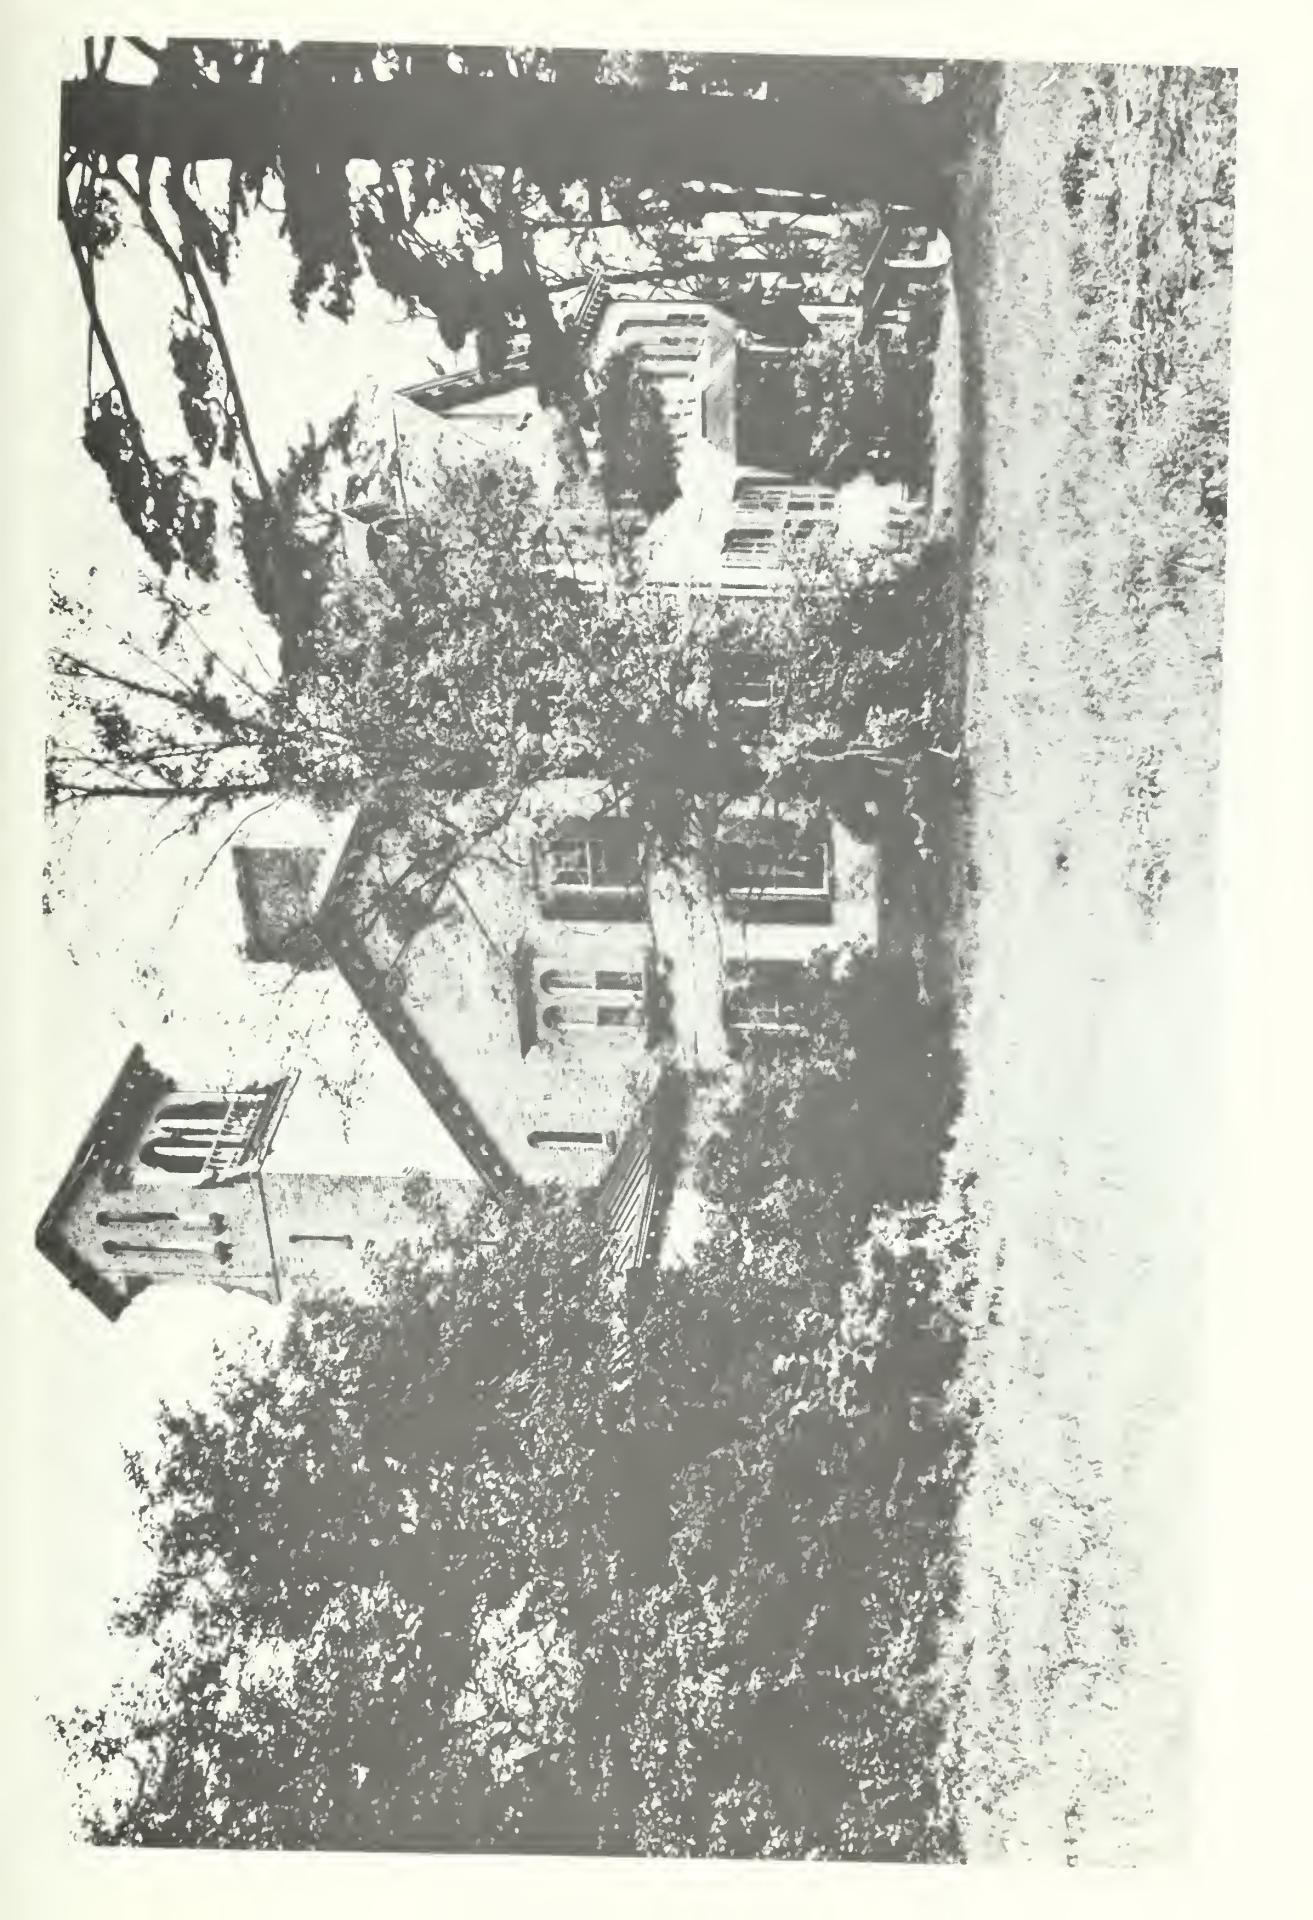
HP24. Lindenwald, East Elevation, 1936. This photograph was taken on August 3, 1936, by Melvin Weig. This date is also documented in his report, "'Lindenwald,' the President Martin Van Buren Homestead, near Kinderhook, New York." The following details should be noted:

Some bricks are missing from the cap of the south chimney.

been painted a light tone, but now the cornice appears to be a dark tone. Foundations, window frames, and the front porch are The light paint on the brickwork is very weathered, and most brick courses on the east elevation are discernible. Sash has also dark tone. Shutters appear to be painted an even darker tone. painted a

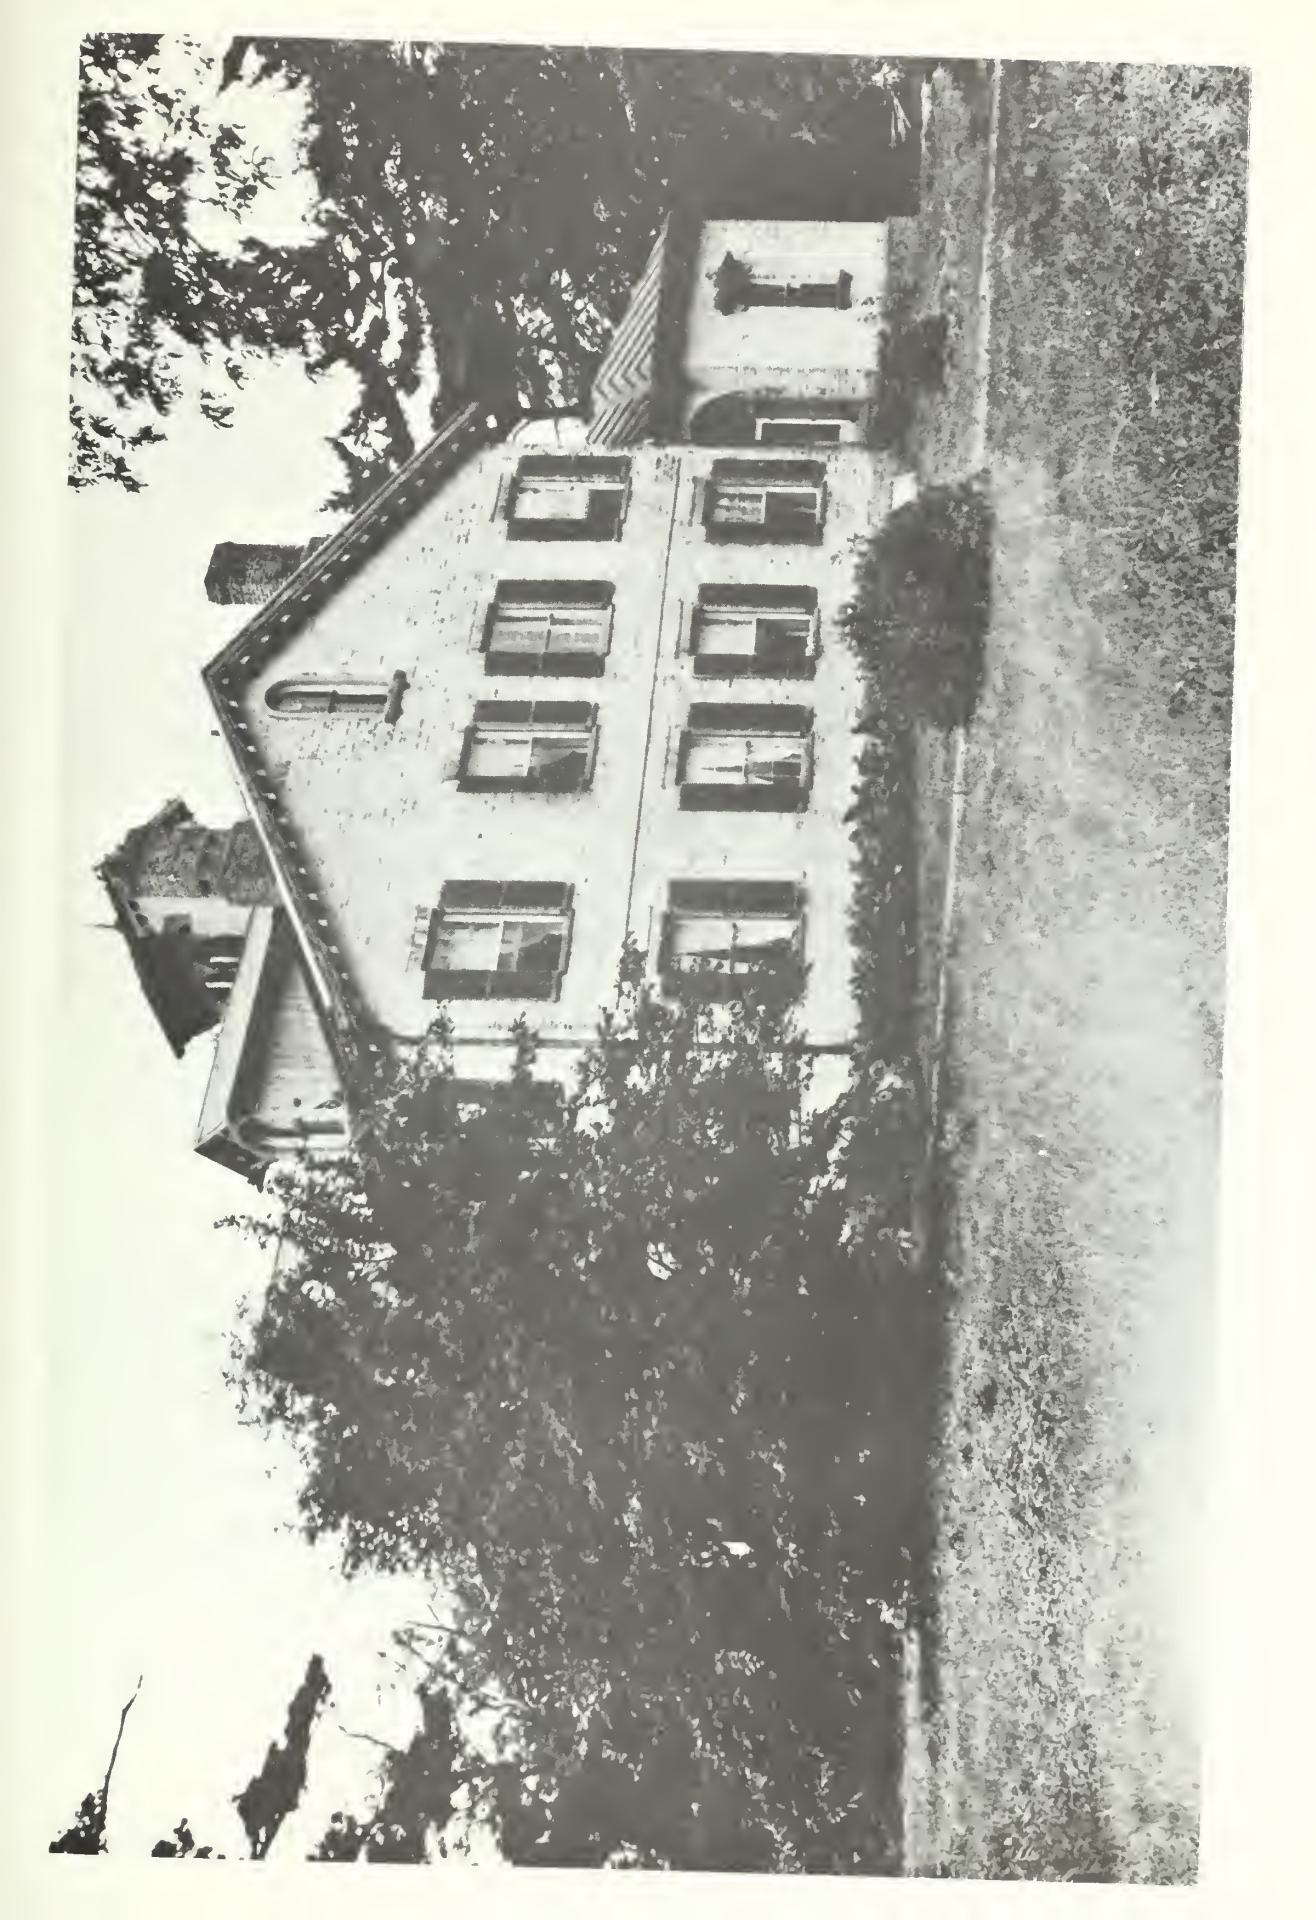
HP27. West End of the North Elevation of Lindenwald, 1936. This photograph was taken by Melvin Weig on August 3, 1936. The following details should be noted:

The belvedere windows are missing lights.

The lower section of the downspout is stock corrugated sheet metal (replacement).

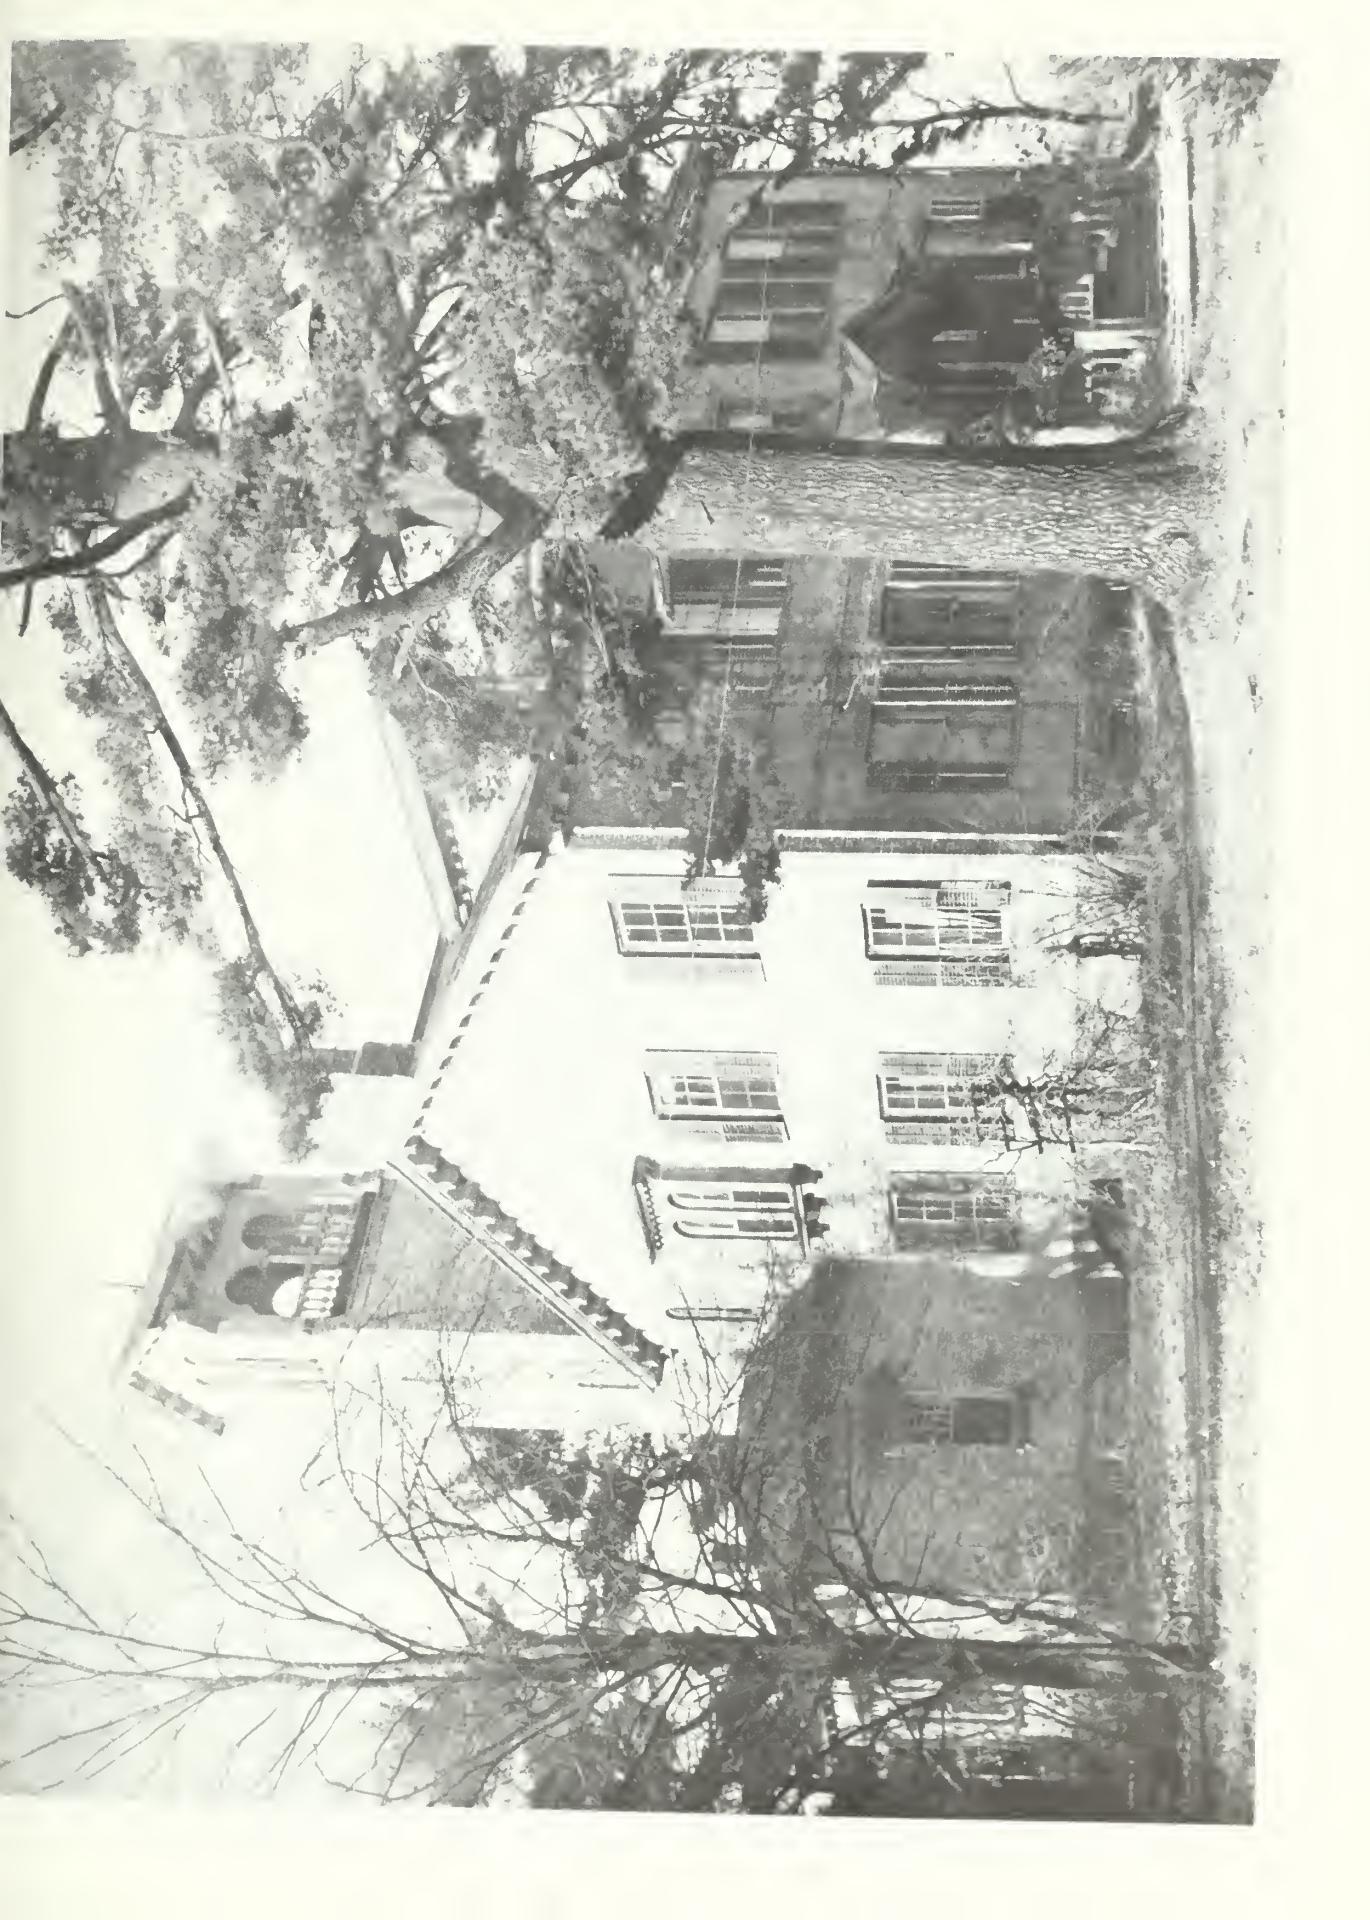
This photograph was taken should be by Nelson Baldwin in January 1937. The following details East Elevation, 1937. HP34. Lindenwald, noted: There are a slate roof and sheet-metal ridge rolls, new flashing on gable capping boards, and a rainwater diverter on the north capping board.

There are half screens on windows 105, 201, 203, 205, 206, and 207. The northeast chimney brick coursing above the stone water table then consists of five courses to the tops of the corbels (ledges), thirteen courses and a corbeled cap of five courses. The main cornice crown molding is deteriorating at the joints.

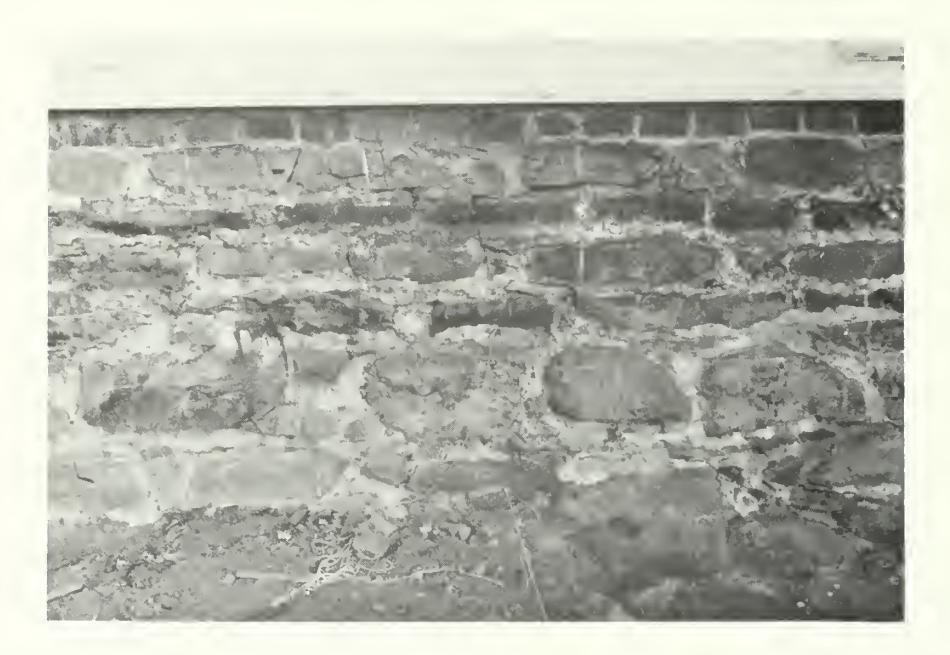
IP001, N002-04. Ca. 1797 foundation below door 101.

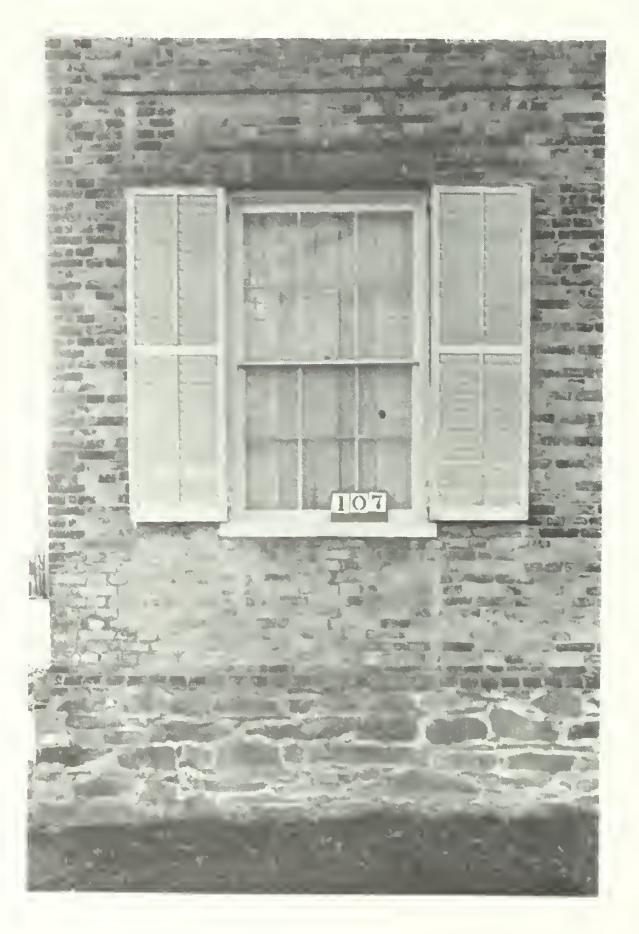
IP002, N012-14. Closure pattern at east corner of north wall.
