LAWNFIELD

HISTORIC STRUCTURE REPORT JAMES A. GARFIELD NATIONAL HISTORIC SITE

Prepared by Paul Newman

DENVER SERVICE CENTER NATIONAL PARK SERVICE UNITED STATES DEPARTMENT OF THE INTERIOR DENVER, COLORADO Digitized by the Internet Archive in 2012 with funding from LYRASIS Members and Sloan Foundation

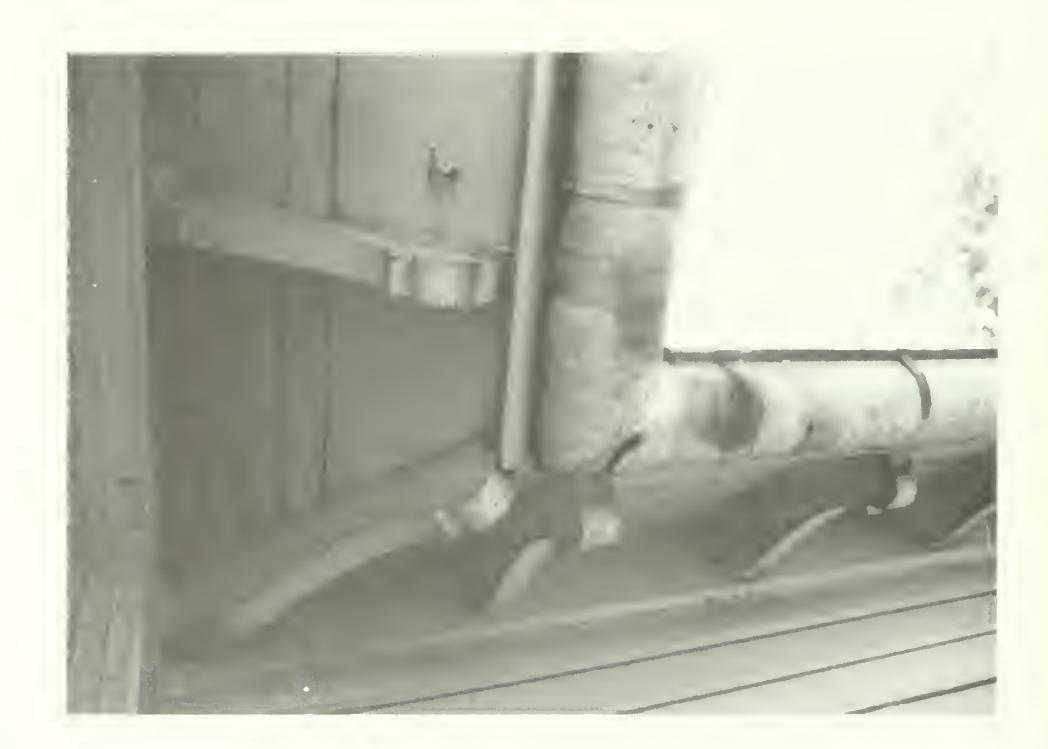
CP-15, Eave detail at the downspout. The hole through the roof sheathing at the right is from original downspout. Half-round gutter at the left has replaced the original trough gutter sys Pigeons on the bracket soil the building with waste.

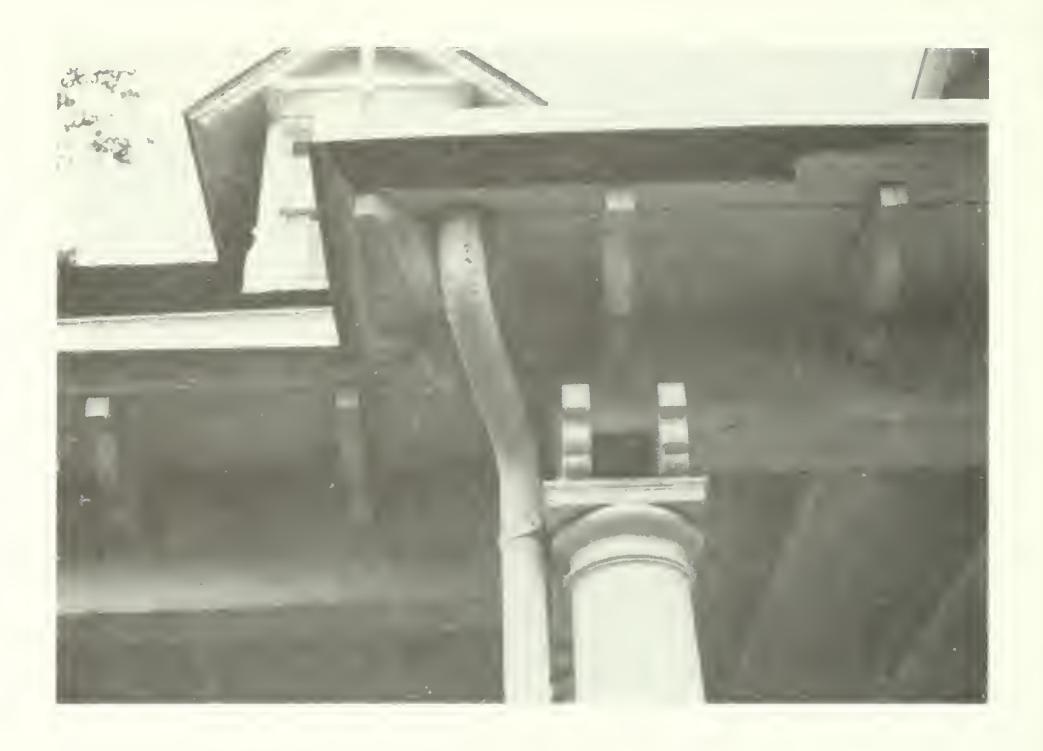
(P-18, Deteriorated roofing of the east porch.

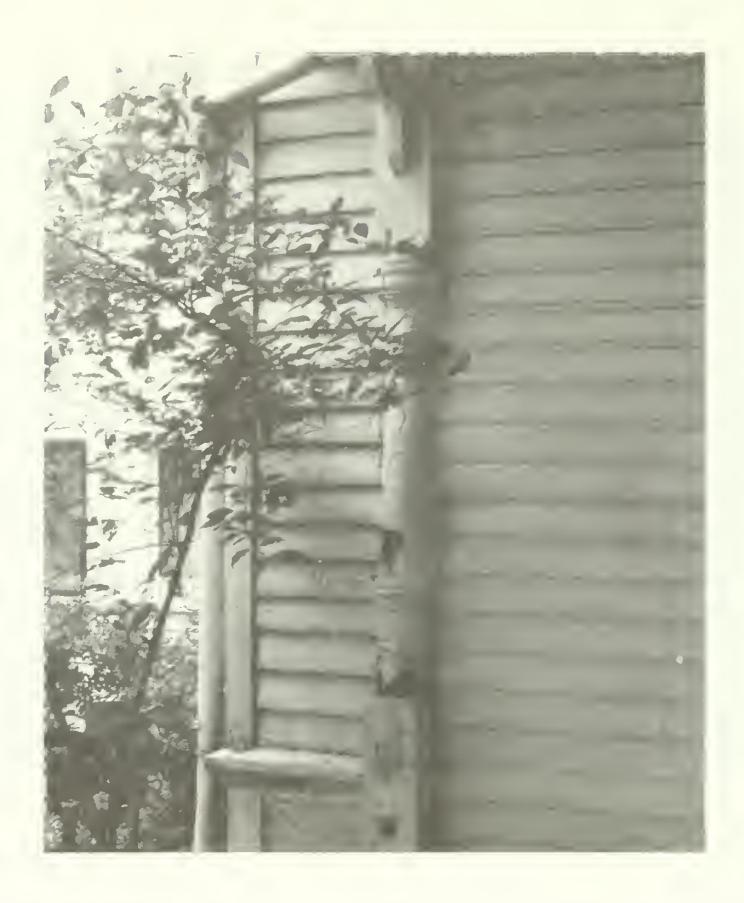
CP-34, West porch, shadow of original porch brackets is visible below the replacement.

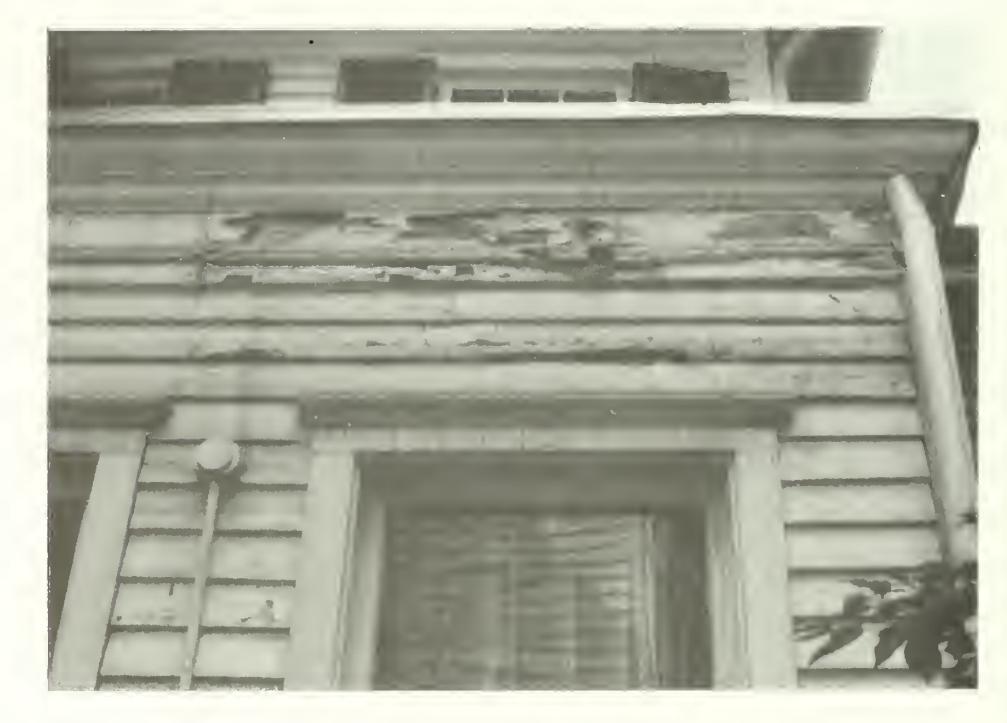
CP-35, Roof and flashing problems have caused severe deterioration at the exterior of the parlor stain and west porch. Engaged porch column, siding, trim are rotted. Porch rail is missing entirely.

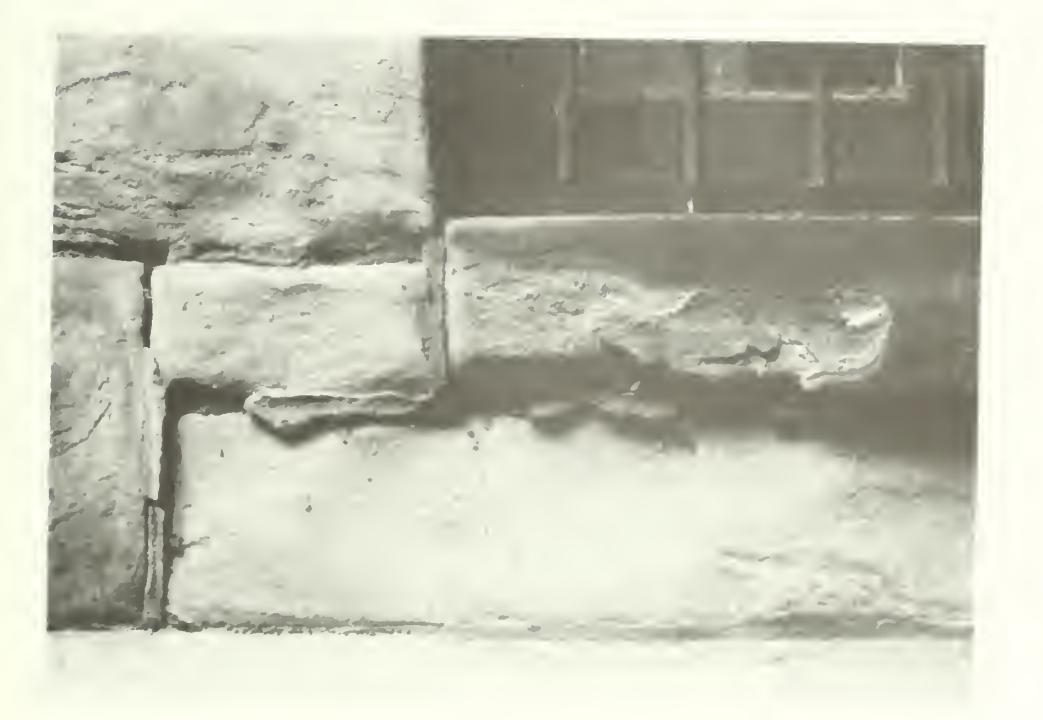
CP-37, Severe sandstone erosion at the memorial library first-floor window (W:114). This sill requires replacement.

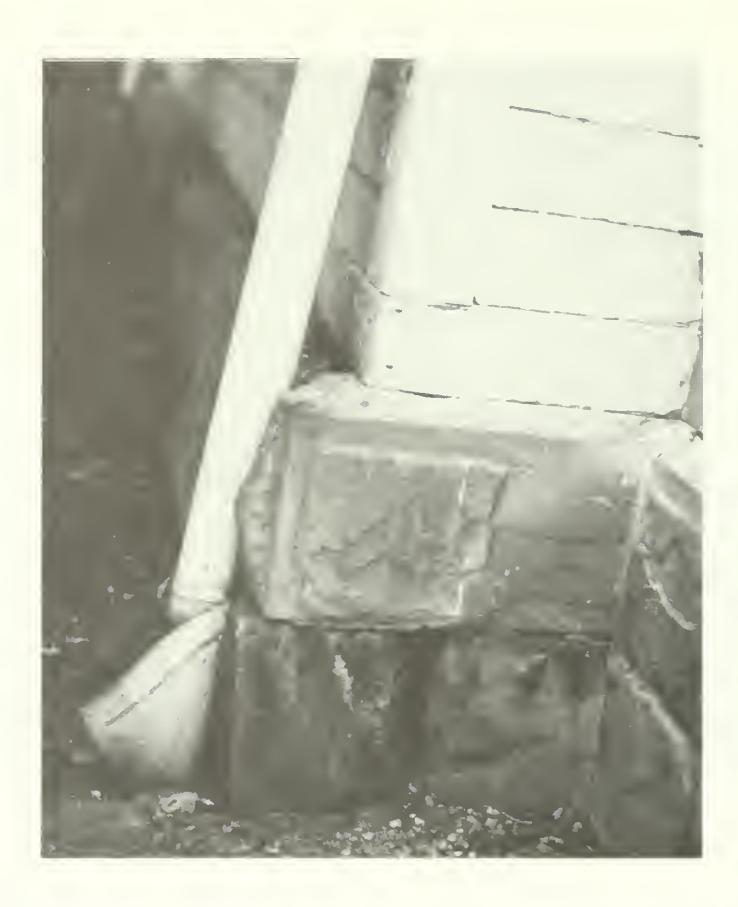
(P-38, All ground level memorial library stone window openings have stone problems, although not a severe as the above window.

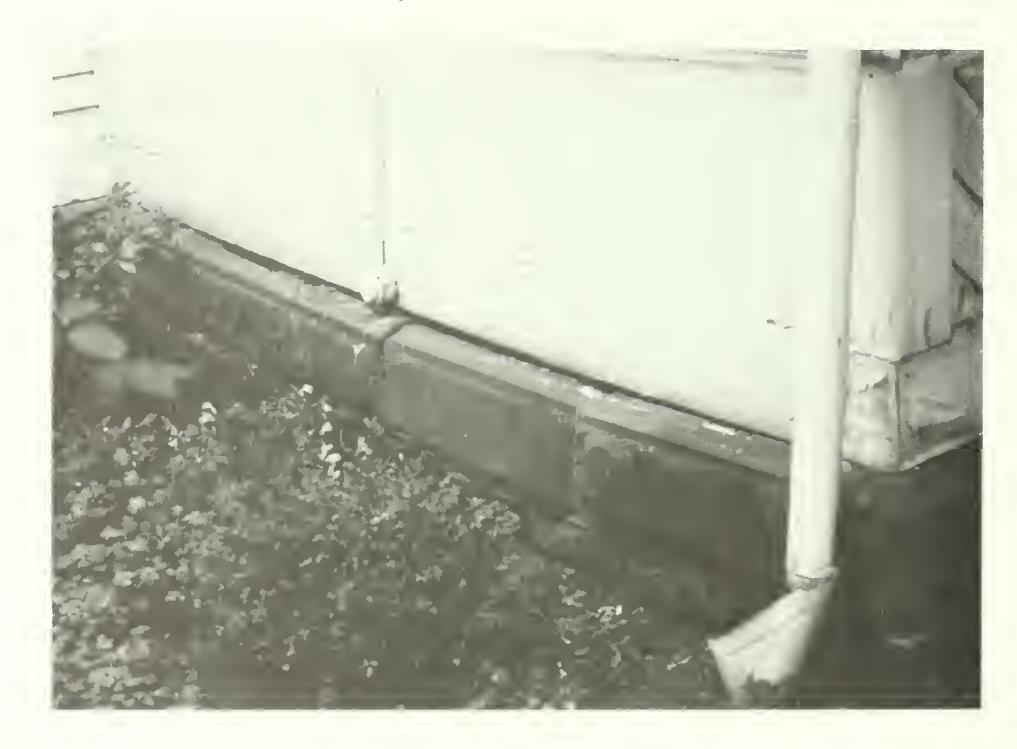
CP-39, An often blocked drain and separated stone veneer channeling into the foundation wall have caused deterioration of the brick masonry.

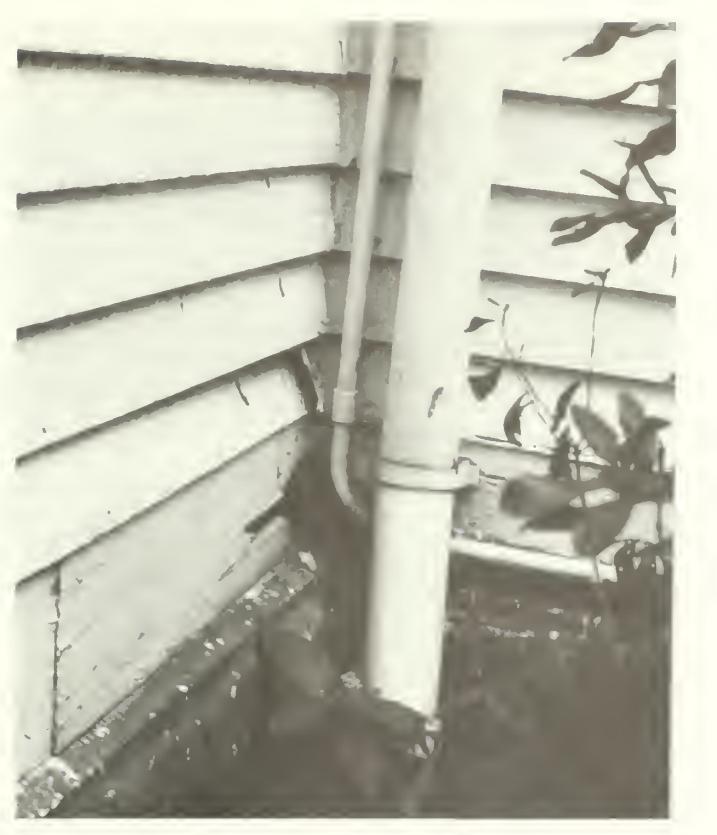
CP-40, Typical separation of sandstone foundation veneer channels moisture into the masonry.

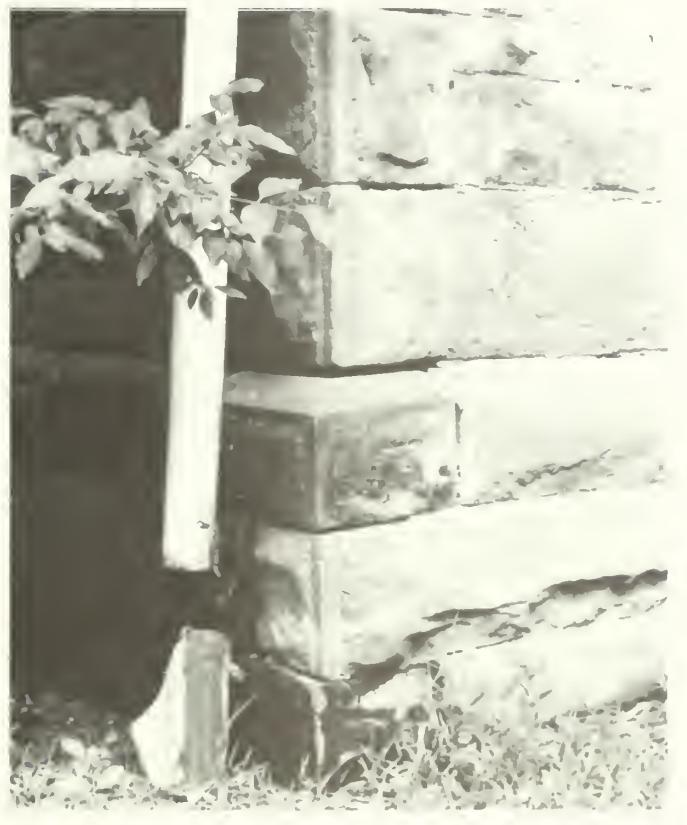
CP-41, Inside corner at 1885 kitchen. Water intrusion in the wall from the gutter above has caused severe deterioration from roof to foundation.

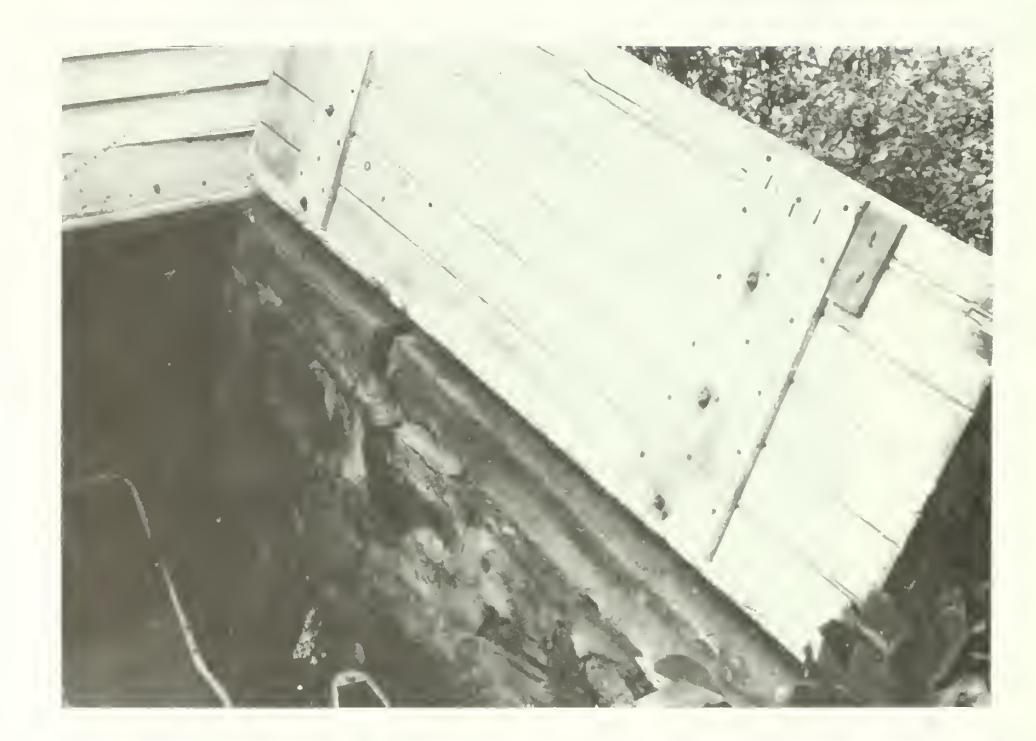
CP-47, Typical deteriorated basement window. The grade is too high and the foliage is too close the wood frames, keeping them continuously damp.

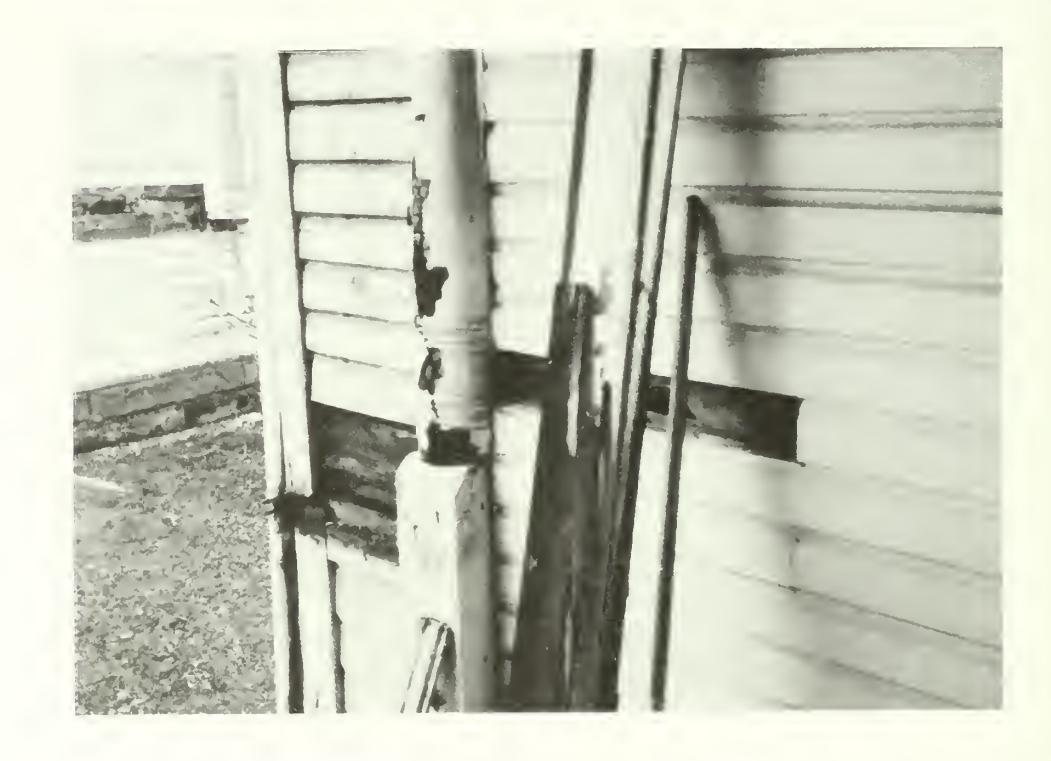
SP-8, Wall deterioration adjacent to the porch.
