## Damaged and Threatened National Historic Landmarks 1991 Report

**1991 Section 8 Report**  
**Damaged and Threatened**  
**National Historic Landmarks**

**National Park Service**  
**U.S. Department of the Interior**  
**Washington, D.C.**

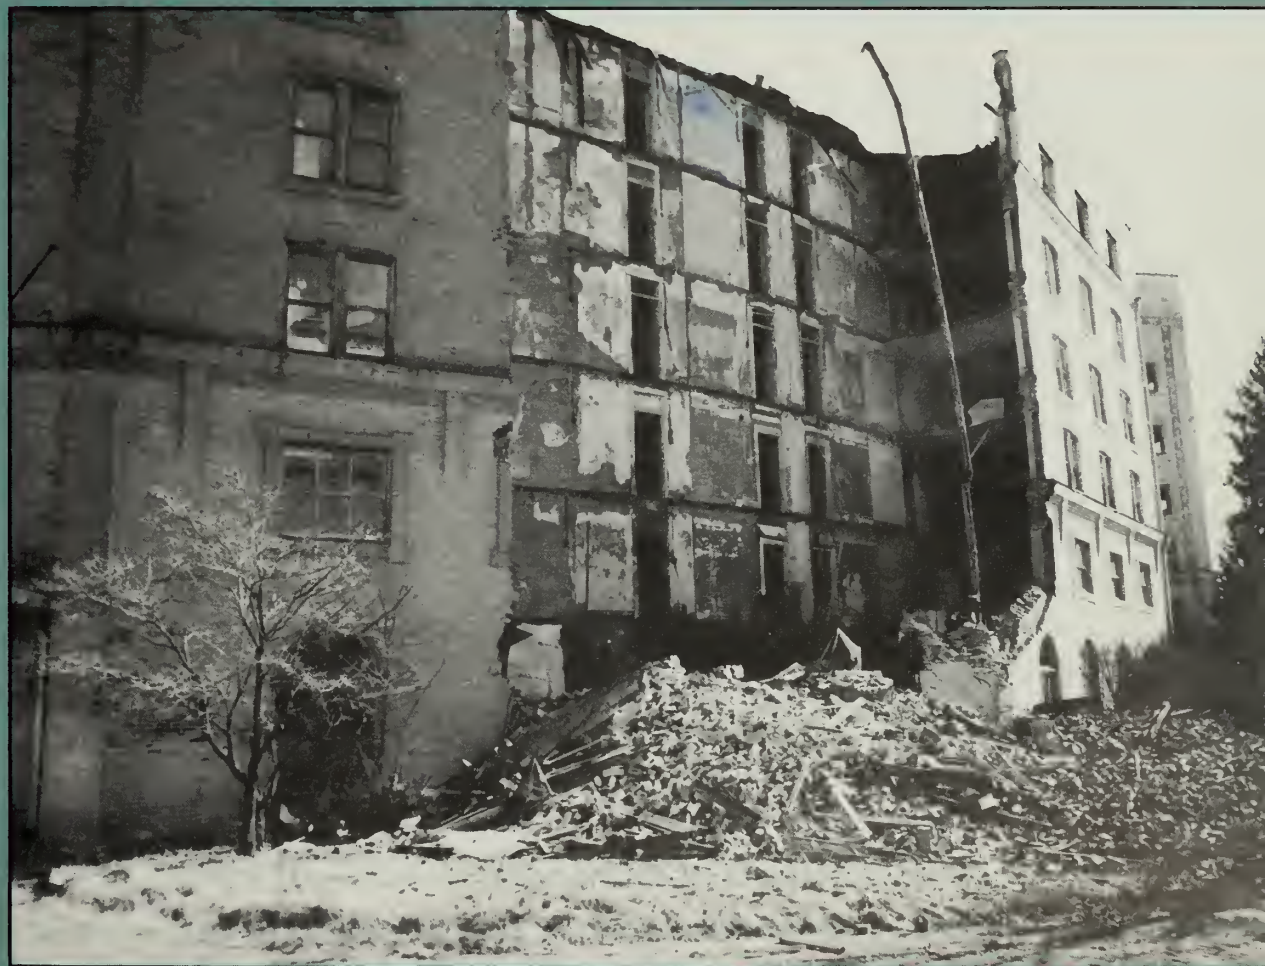
*Cover: West Baden Springs Hotel, West Baden, Indiana. The immense steel and glass covered dome of this building was the largest in the world when constructed in 1902. The interior photo was taken between 1902 and 1916. Photo courtesy of Jerrold Johnson, Division of Historic Preservation and Archaeology, Indiana Department of Natural Resources.*

*HAER drawing showing the structure of the dome. Delineated by Roland David Schaaf, courtesy of the Historic American Engineering Record, National Park Service.*

*The West Baden Springs Hotel today. Neglect and vandalism have led to its current condition. Water damage is extensive, and a section of the exterior wall has collapsed. Photo courtesy of Jerrold Johnson, Division of Historic Preservation and Archaeology, Indiana Department of Natural Resources.*

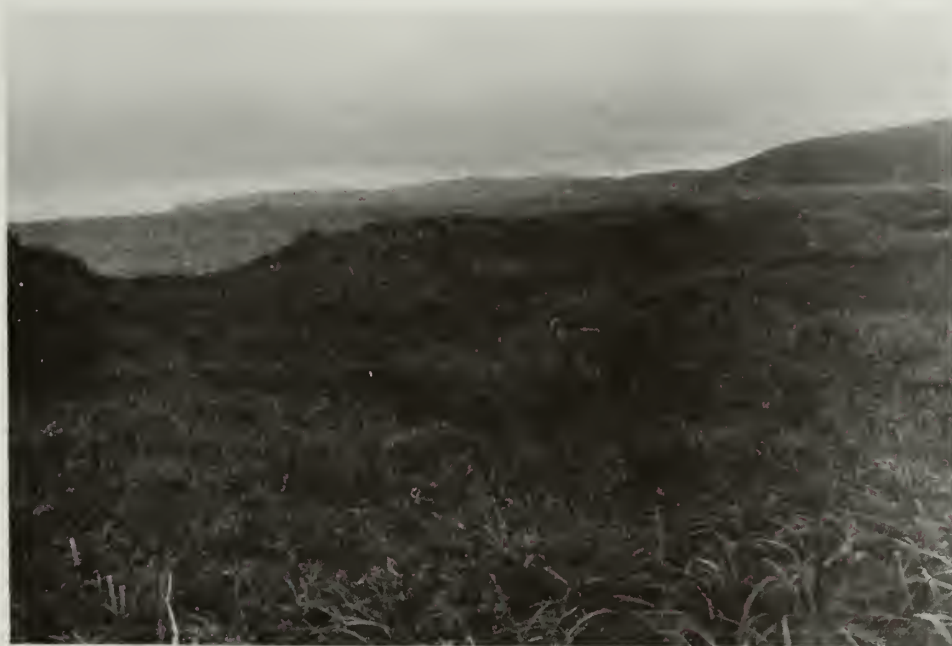
*Before evacuating Kiska, the Japanese removed critical parts and set internal charges to immobilize the equipment they left behind. The shell of this two-man submarine is still on the island, although all that remains of the pen is a footprint in the tundra. Photo by Susan Morton, NPS, August 1989.*

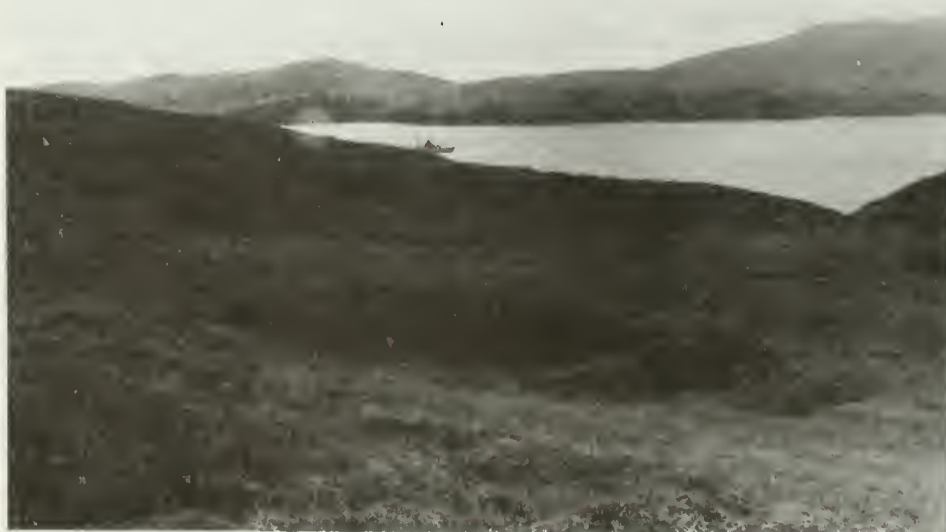
*The landscape along Kiska Harbor today is pocked by bomb craters. Japanese entrenchments also remain visible across the tundra. Photo by Susan Morton, NPS, August 1989.*

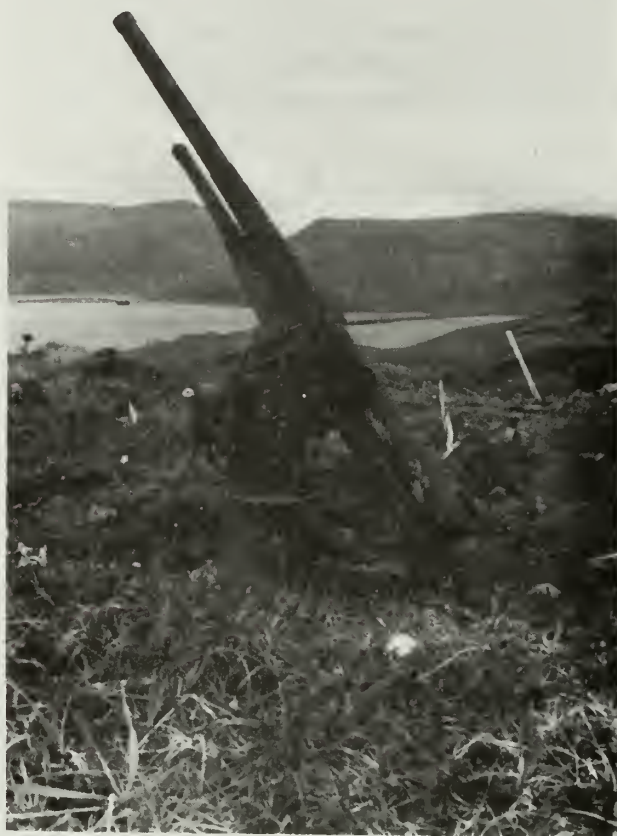
*Japanese 70mm anti-aircraft guns emplaced on hills surrounding Kiska Harbor. Photo by Susan Morton, NPS, August 1989.*
