## CULTURAL LANDSCAPE REPORT FOR GLENMONT

THOMAS EDISON NATIONAL HISTORICAL PARK  
WEST ORANGE, NEW JERSEY

# CULTURAL LANDSCAPE REPORT FOR GLENMONT

SITE HISTORY

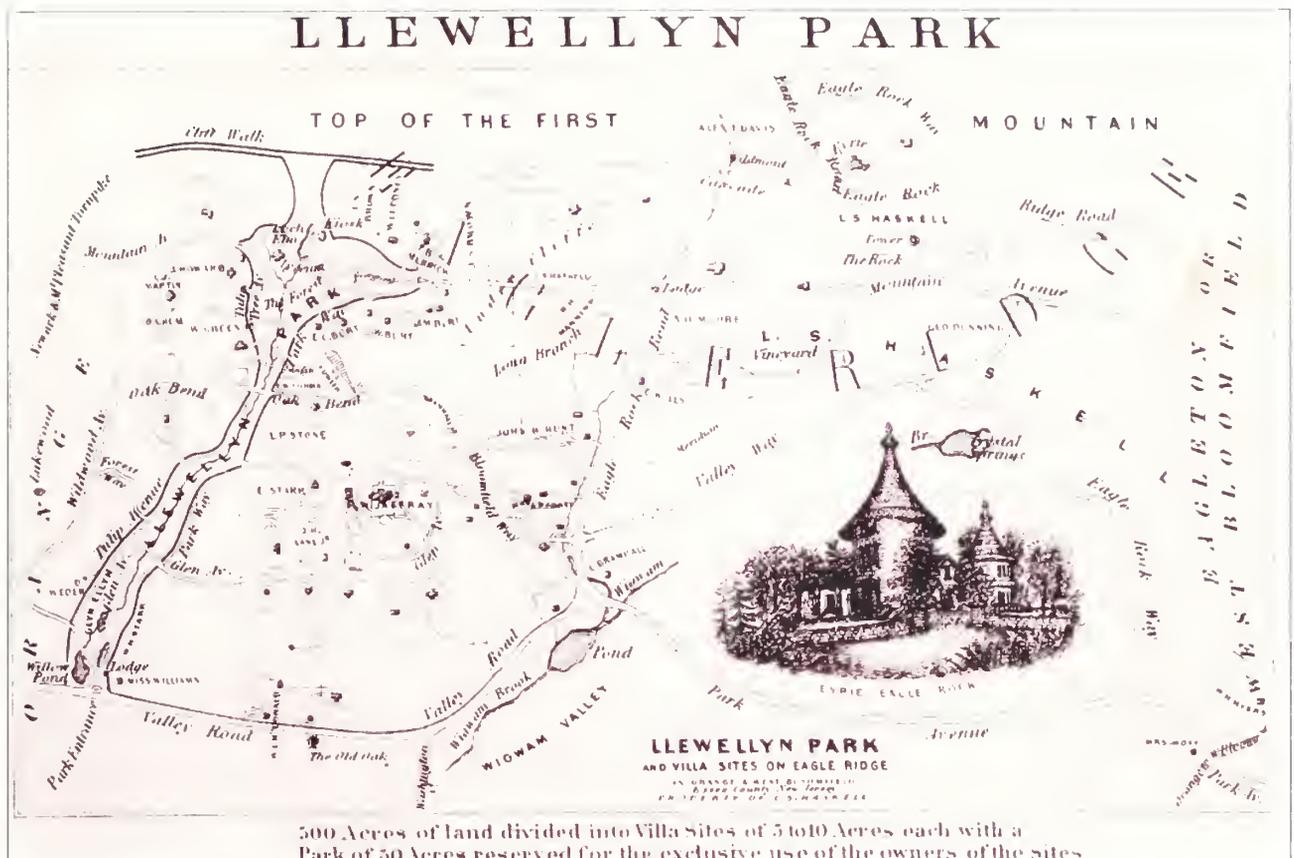
Figure 1.03. This 1857 plan entitled “Llewellyn Park and Villa Sites on Eagle Ridge in Orange & West Bloomfield Essex County, N.J.” shows the layout of the plots of land and offers an architectural sketch of Haskell’s home, the Eyrie, which helps establish the character and feel of the overall park (Llewellyn Park Archives).

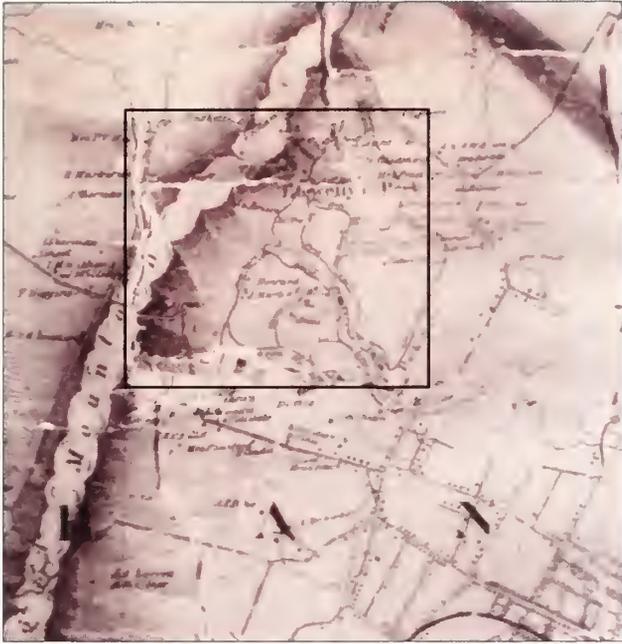
Figure 1.05. (left) In this H.F. Walling “Map of Essex County, New Jersey,” the topography of the area in 1859 is depicted. Note how the features of the land in the Llewellyn Park area lend themselves to the celebration of nature that was integral to the Romantic Movement (Newark Public Library, Special Collections, The Charles F. Cummings New Jersey Information Center; annotated by the OCLP).

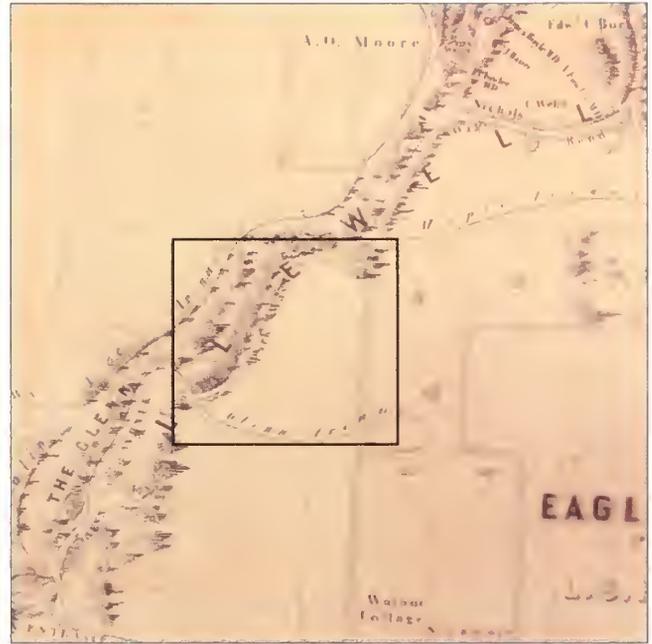
Figure 1.06. (right) The Thomas Hughes’ “Map of the Town of Orange, Essex County, N.J.” shows the topography of the land and some vegetation. Note that the future Glenmont site is undeveloped between Park Way and Glenn [sic] Avenue in 1856 (Llewellyn Park Archives).

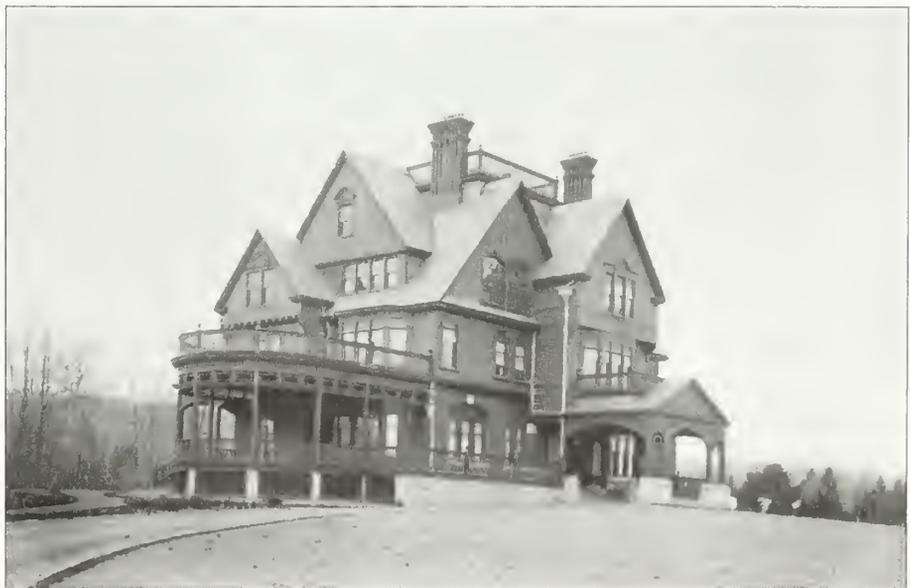
Figure 1.14. The earliest known photo of Glenmont taken ca. 1882-1883 shows the semi-circular open-air porch and young plantings along its foundation. Note the openness of the surrounding area behind the home and the lamp post at right. (Edison National Historic Site, Historic Structure Report, Volume I).

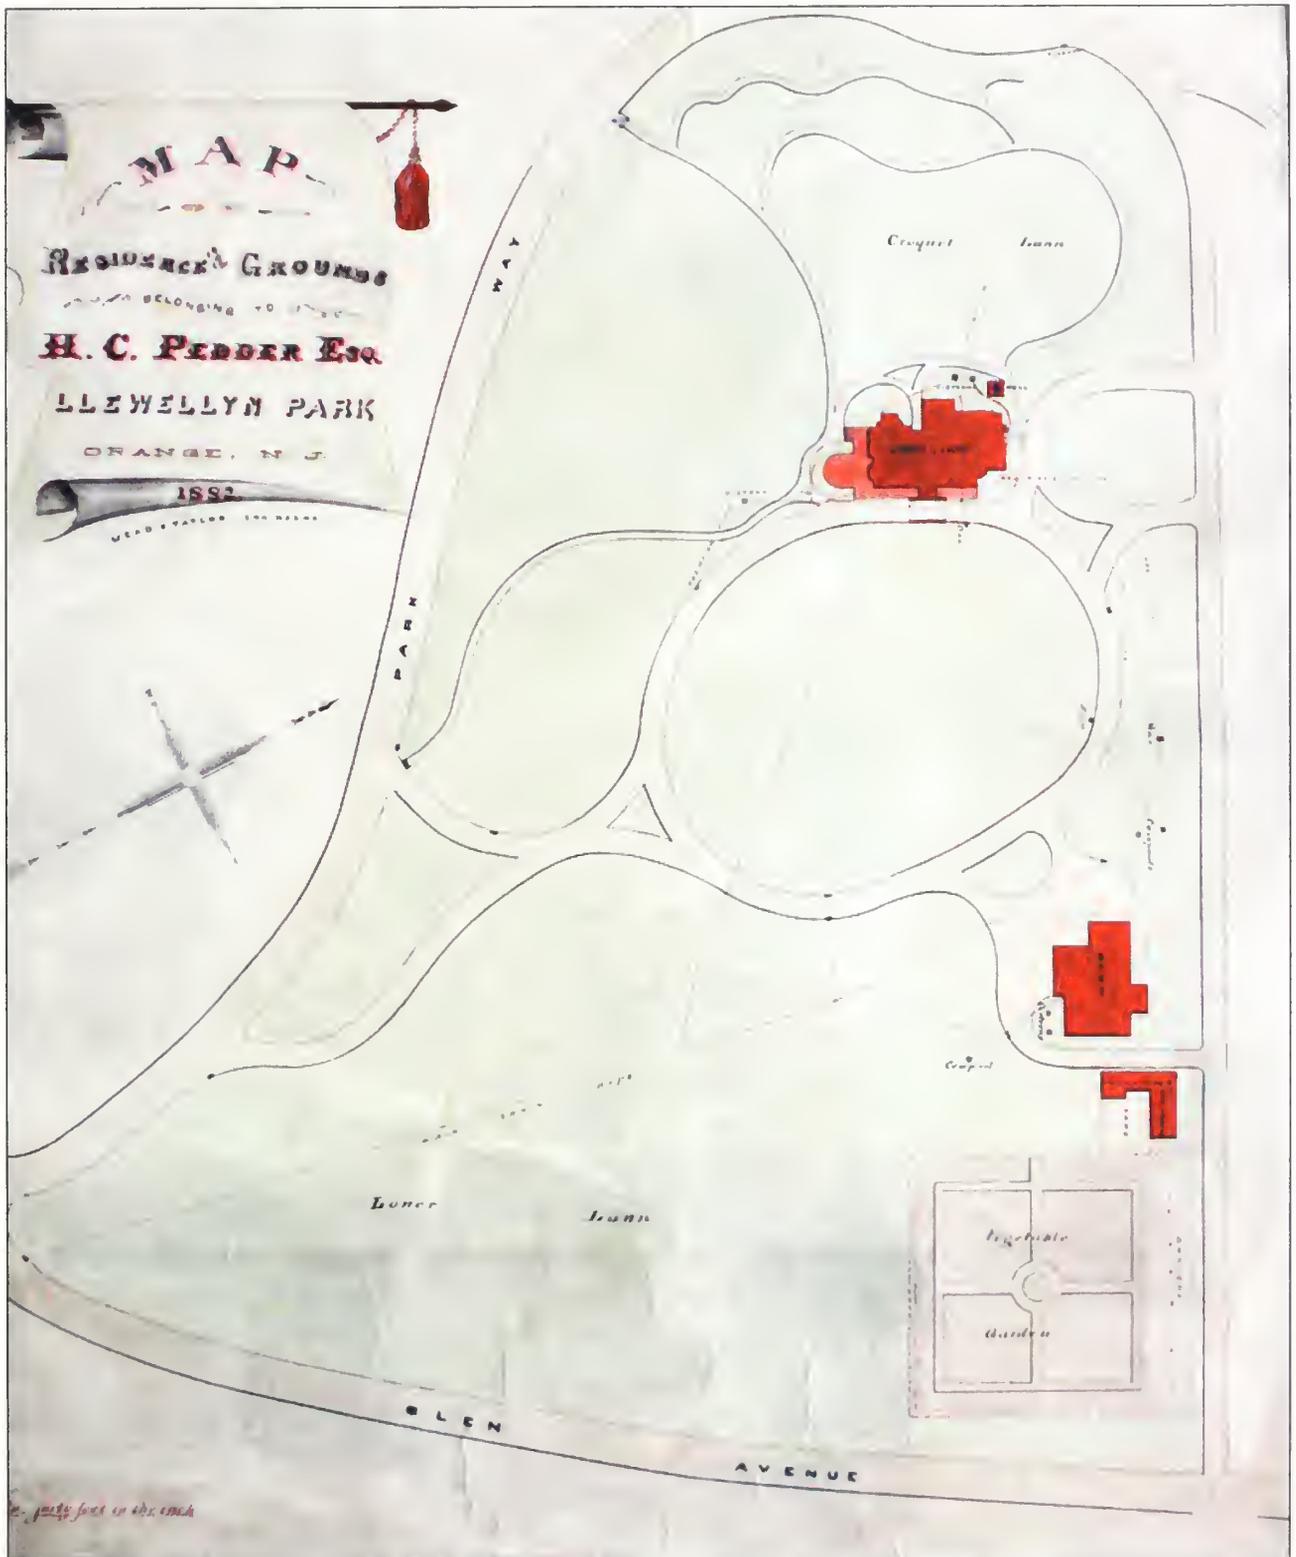
Figure 1.16. An 1882 Mead and Taylor map, entitled "Map of Residence and Grounds Belonging to H.C. Pedder Esq., Llewellyn Park, Orange, New Jersey 1882," shows the configuration of the house, drives and walks, the barn, chicken house, and vegetable garden in 1882 (EDIS Archives, 114424).

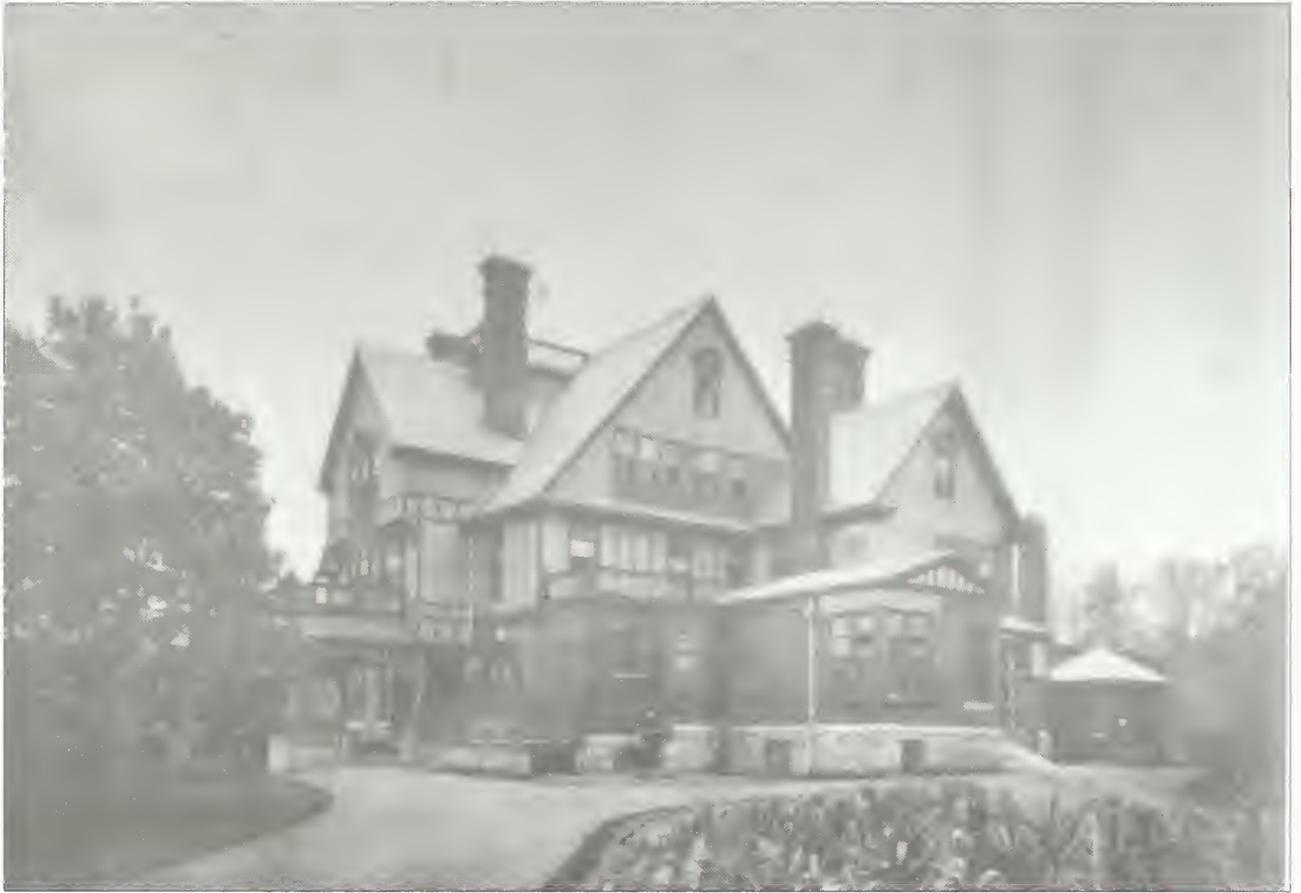
Figure 1.18. An image of the northeast elevation of the Glenmont house, c. 1884-1886, showing the bedding-out design at the entrance from Honeysuckle Avenue. This bed appears to be planted with rows of annuals encircling a perennial bed planted with yucca. Note the well house at right. (Edison National Historic Site, Historic Structure Report, Volume I).

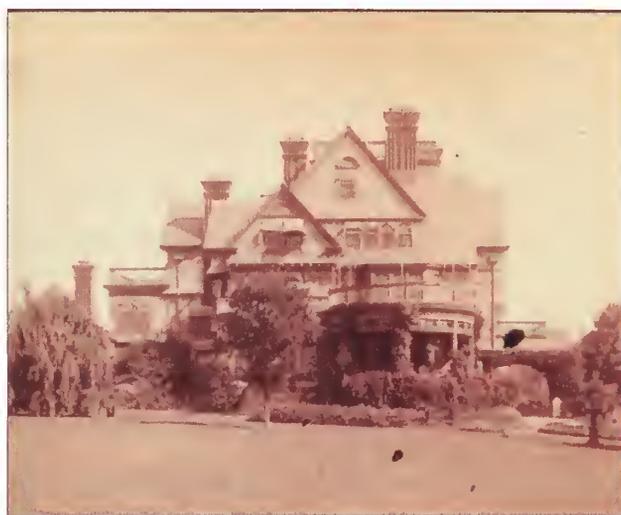
Figure 1.21. (right) This image ca. 1886-1890 shows the bedding out schemes for flower beds that are shown bordering either side of the walking paths, south of the conservatory (EDIS Archives, 12.420.11).

pathways near the house, flowerbeds—laid out in geometric shapes—were planted in the typical “bedding-out” fashion and informal flowerbeds were found along the foundation of the house and within the main drive islands. In addition to the flowerbeds, urns planted with large tropical foliage plants were displayed along the main drive within the front lawn. Along with the flowerbeds and planted urns, the landscape included evergreen and deciduous trees and shrubs. Some of the more notable trees and shrubs—as seen in the earlier images, included the weeping cherry, weeping beech, Norway maple, royal paulownia, and three dwarf Alberta spruces (Figures 1.20-1.25).

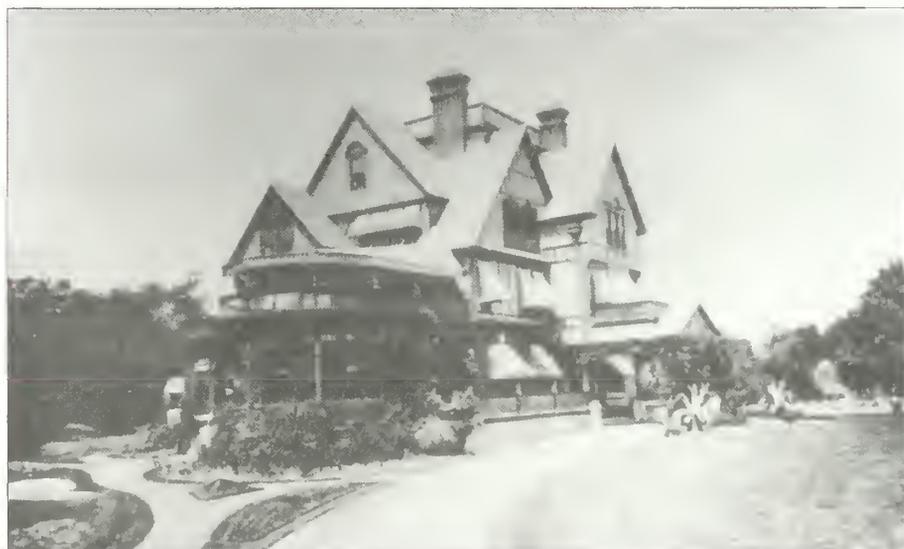
Figure 1.22. The bedding out schemes for flower beds are shown bordering either side of the walking paths, south of the conservatory. The planted oval to the northeast of the house is seen to the upper right, c. 1890 (EDIS Archives).

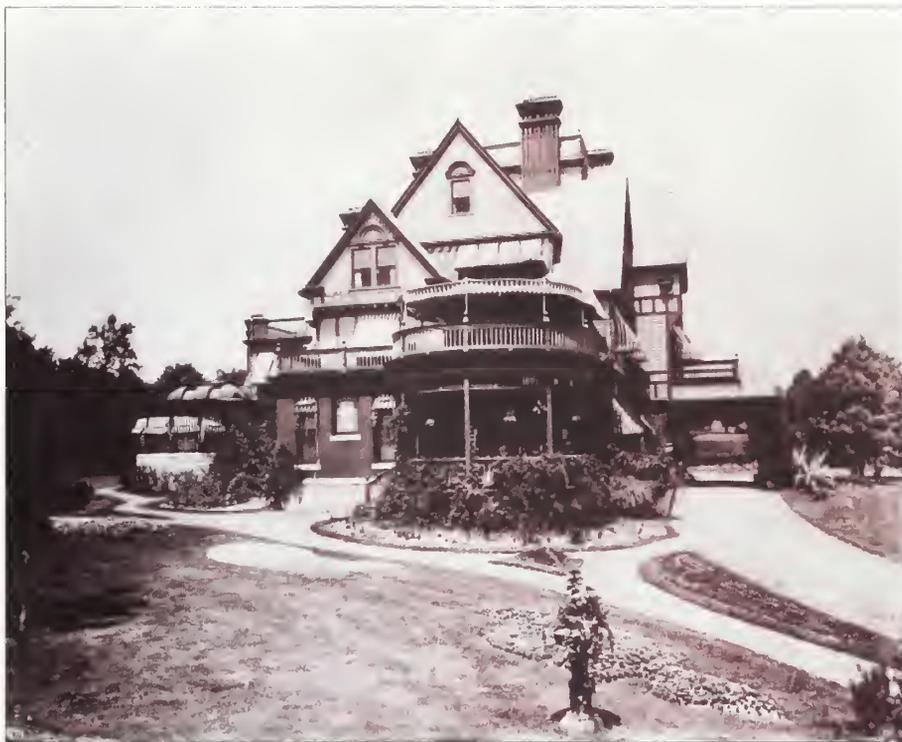
Figure 1.23. The ornamental beds ca. 1886-1890 were cut into the turf and planted with annuals. Note the planted urn in the lower foreground. Other ornamental beds are seen through the porte cochere to the north and in front of that structure to the west (EDIS Archives, 12.420.10).

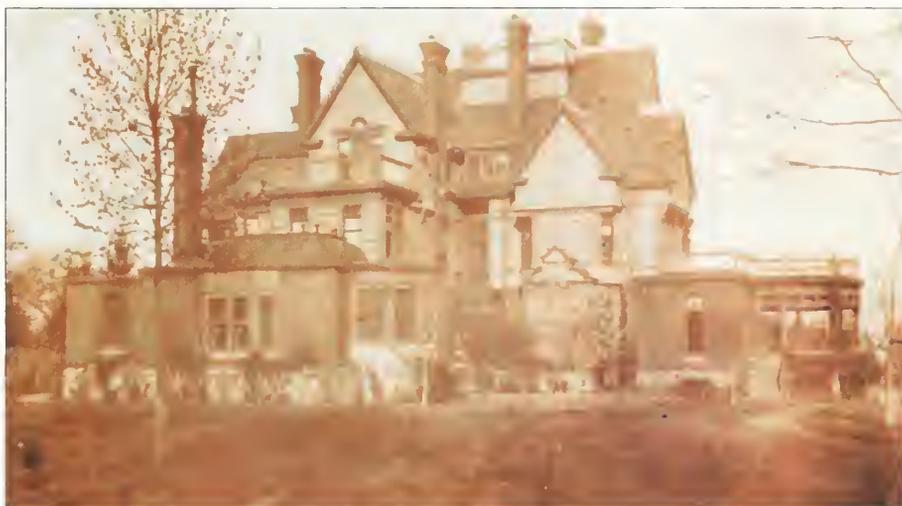
Figure 1.24. A c. 1890s-1900s image of the west lawn showing young specimen trees, foundation plantings and walking path (EDIS Archives).

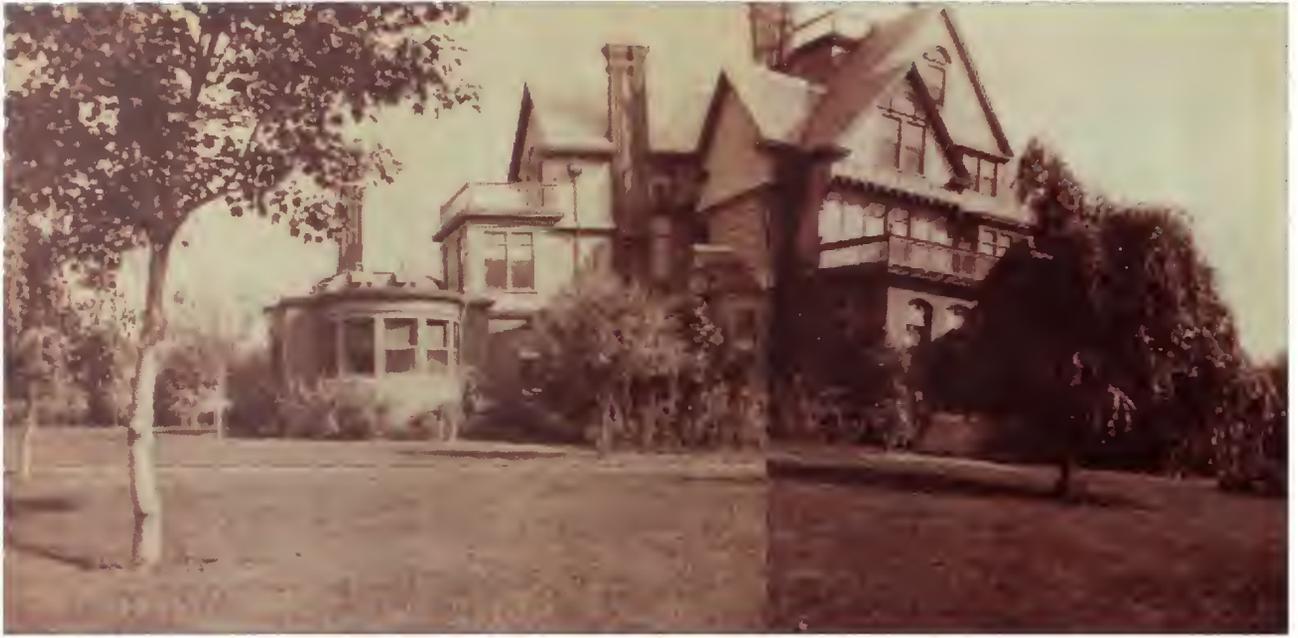
Figure 1.25. A c.1890-1900s image of the west lawn showing the young trees and foundation plantings. Note the weeping cherry (right) (EDIS Archives, combined 12.420.17 and 12.420.29).

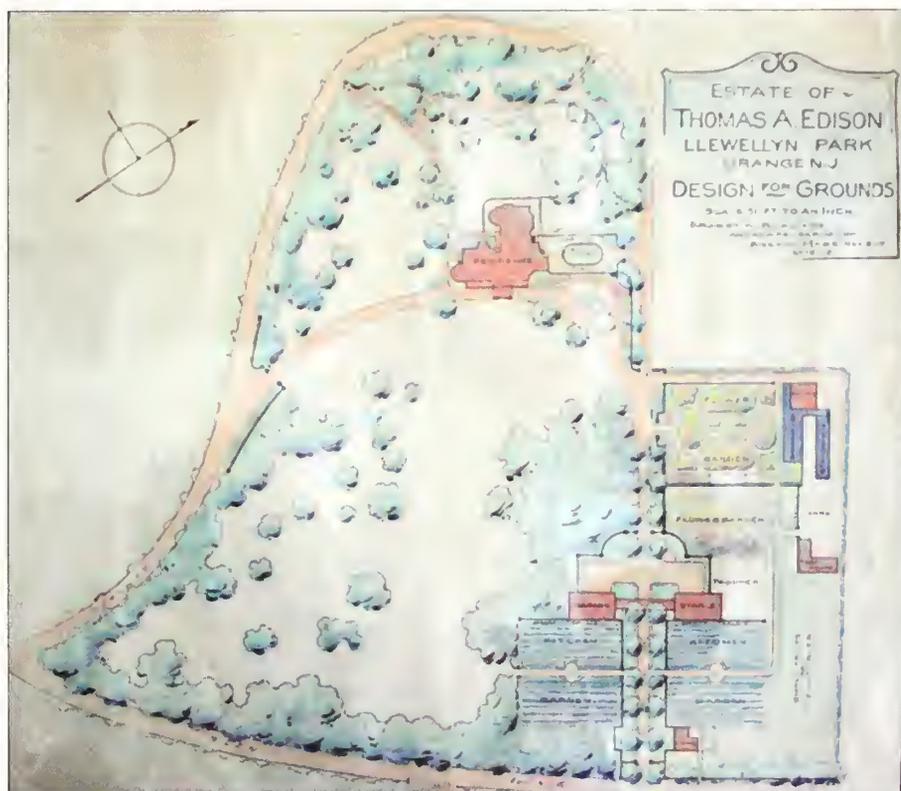
Figure 1.26. This plan, entitled “Design for Grounds,” shows the 1907 master plan for Glenmont by Ernest Bowditch shows a number of significant proposed changes to the landscape, designed with the intent to move service related functions away from the house. Many of these land-planning ideas were realized in some form over the ensuing years (EDIS Archives, 114486).

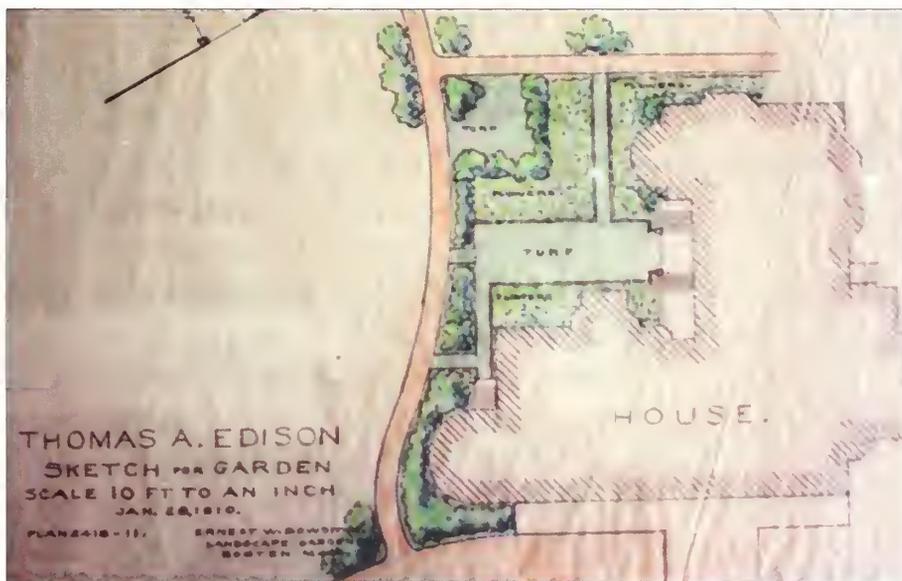
Figure 1.30. A 1910 Bowditch design (2418-12) for the southwestern garden areas. This plan shows the most informal and naturalistic design. (EDIS Archives.)

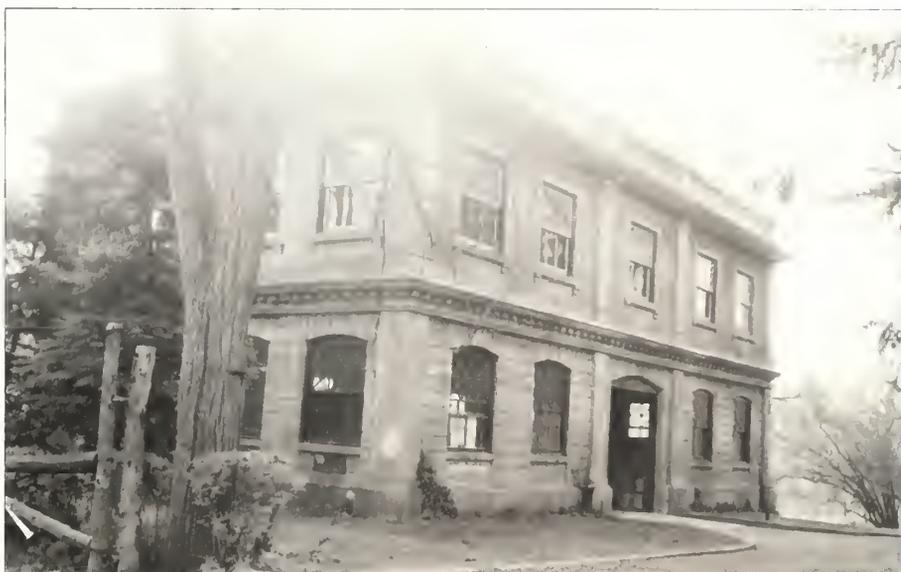
Figure 1.31. A 1950s image looking southeast towards the 1908 concrete garage, constructed during Thomas Edison's experimentation with concrete (EDIS Archives).

Between 1907 and 1908, around the same time Mina engaged Bowditch to prepare plans for the Glenmont landscape, Edison, began to experiment with concrete buildings on the grounds. With assistance from Frank D. Lambie, owner of the New York Steel Form Company, Edison constructed a garage and a two-story concrete gardener's cottage (Figures 1.31 and 1.32). As proposed in the 1907 Bowditch plan for the grounds, the garage was built east of the house along Honeysuckle Avenue and across from the Pedder barn, in the former location of Pedder's L-shaped chicken house/cow barn. The chicken house/cow barn was relocated across Honeysuckle Avenue, as Bowditch had recommended. According to a bill from house mover George F. Robinson, the building was relocated across Honeysuckle Avenue in 1907 to accommodate the new garage. Around the same time, within close proximity to the barn, a rectangular pool was constructed, measuring approximately twenty-six feet by forty-five feet. It is unclear whether or not it was an Edison experiment.<sup>25</sup>

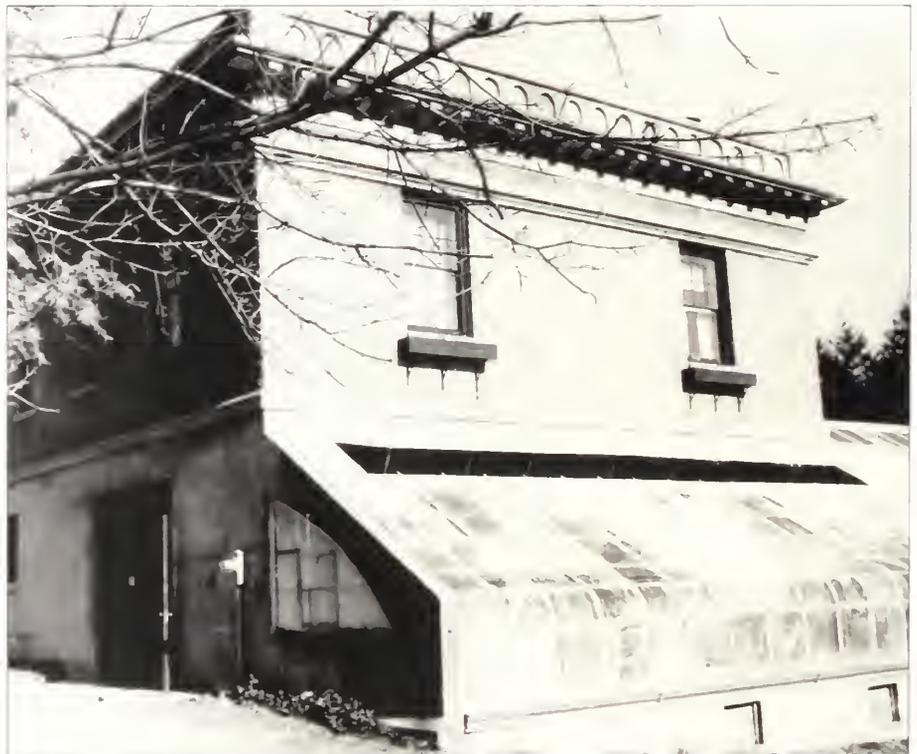
Figure 1.32. A 1970s image looking northeast towards the 1908 concrete gardener's cottage and potting shed, constructed during Thomas Edison's experimentation with concrete (EDIS Archives).

Following the principles of the Bowditch plan, the Edisons had a new gardener's cottage and potting shed built east of the house, across Honeysuckle Avenue, and in the same location as the previous greenhouse complex built by Henry Pedder. During construction of the gardener's cottage and potting shed, Mina turned to Pierson U-Bar Company to design and construct new greenhouses to be attached to the new cottage and an existing north wing of an earlier greenhouse built by Pedder. The company's design, similar to the layout Bowditch indicated, called for a U-shaped plan, with the main greenhouses in an east-west orientation that provided southern exposure, necessary to maximize sunlight.

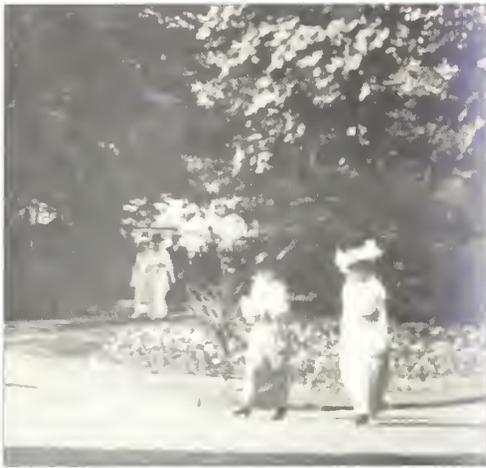
Figure 1.33. (left) A photograph taken during Madeleine Edison's wedding in 1914. Note the temporary planting arrangements and triangular island planted with annuals and dracaena (EDIS Archives, Album 113).

By 1910, after years of careful development of the landscape, the Glenmont grounds had matured into a lush landscape that was an integral to the family's life. In 1914, Edison's daughter, Madeleine, married John Sloane at Glenmont, and in celebration of the event, the grounds were embellished with temporary plantings. Plants were used to screen the utilitarian laundry yard, and potted evergreens complemented with annuals were set as a backdrop near the large maple tree that stood nearby the house in the driveway oval. Within the triangular island, located within the main drive and northeast of the house, a bed of annual plants were planted with two spiky plants, such as dracaena, spaced apart at the bed's center (Figure 1.33).

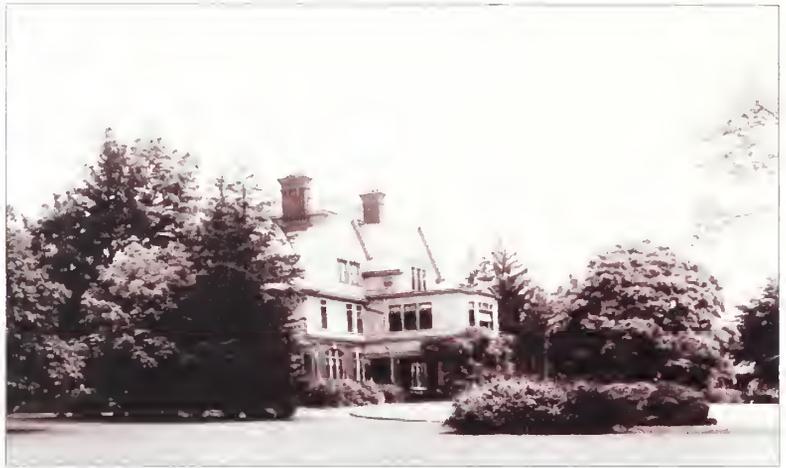
Figure 1.34. (right) Taken in 1913, this image facing north shows a simplified but maturing landscape. Note the absence of the southwest path and carpet bedding (EDIS Archives, 12.420.32).

During the following years, the Edisons gradually simplified the landscape. These changes coincided with the increased maintenance requirements for the grounds, as well as the ensuing First World War. By 1914, carpet bedding and container plants were removed, followed by a few damaged trees in 1916 (Figures 1.34 and 1.35). In response to storm related damage to certain trees, Mina sought the assistance of the Olmsted Brothers to assess the condition of all the trees and plantings as stated in an October 16, 1916 letter:

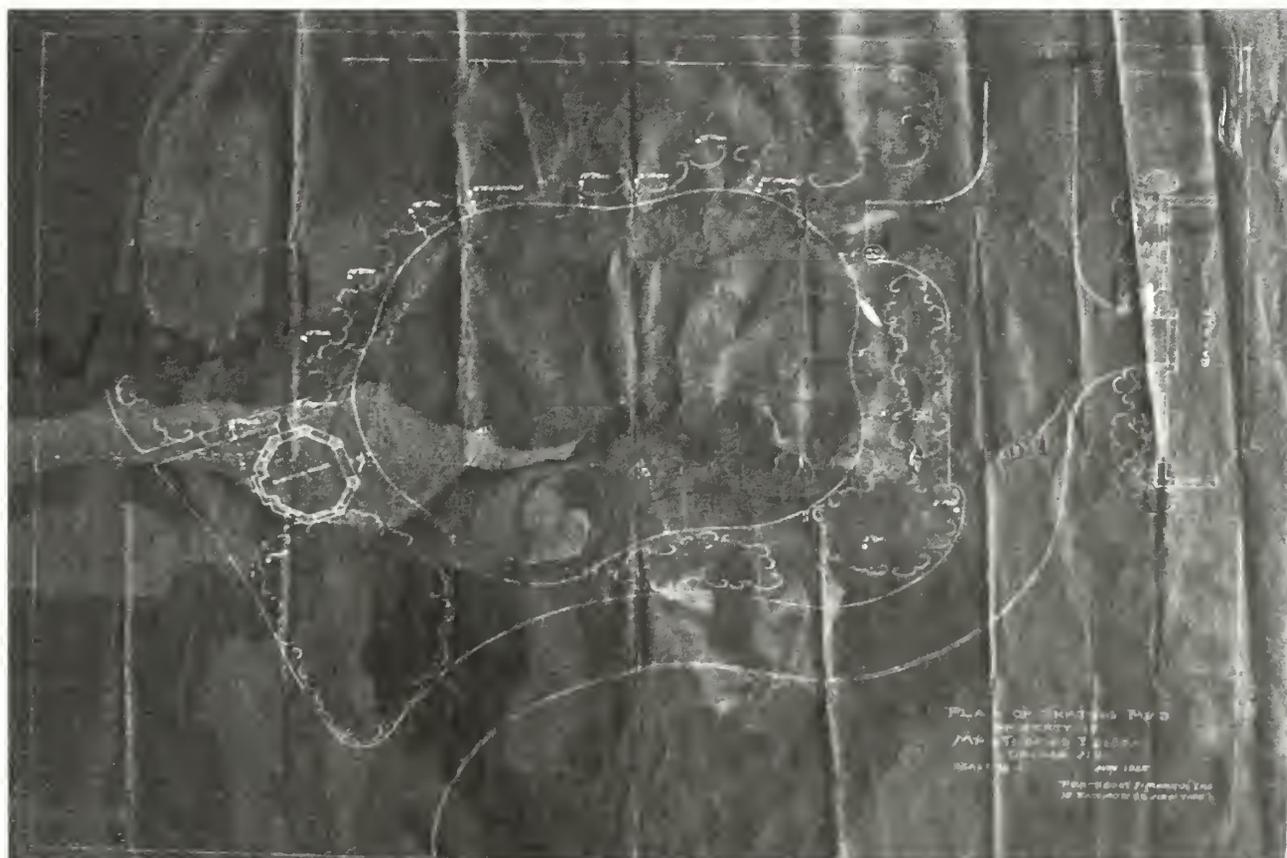
Figure 1.39. The 1925 Pentecost and Martin Plan for the Skating Pond. The skating pond, completed in 1926, was poorly constructed and did not retain water (EDIS Archives, 114496).

In 1925, at the urging of her son Theodore Edison and his wife, Anna Marie Osterhout, who were both skating enthusiasts, Mina contracted with Pentecost & Martin, Inc., Landscape Architects, and William Neill and Son, Landscape Engineers and Contractors, for the construction of a new skating pond and shack – a replacement of a previous pond built in the early 1900s – in the former location of the Pedder barn.<sup>38</sup> While it is unclear whether the skating shack was constructed, the skating pond was completed by 1926. However, it was poorly constructed and did not retain water as evidenced by a series of correspondences among George Pentecost, William Neill, and John V. Miller, Mina’s brother and assistant manager of Glenmont (Figure 1.39). The unsatisfactory condition of the

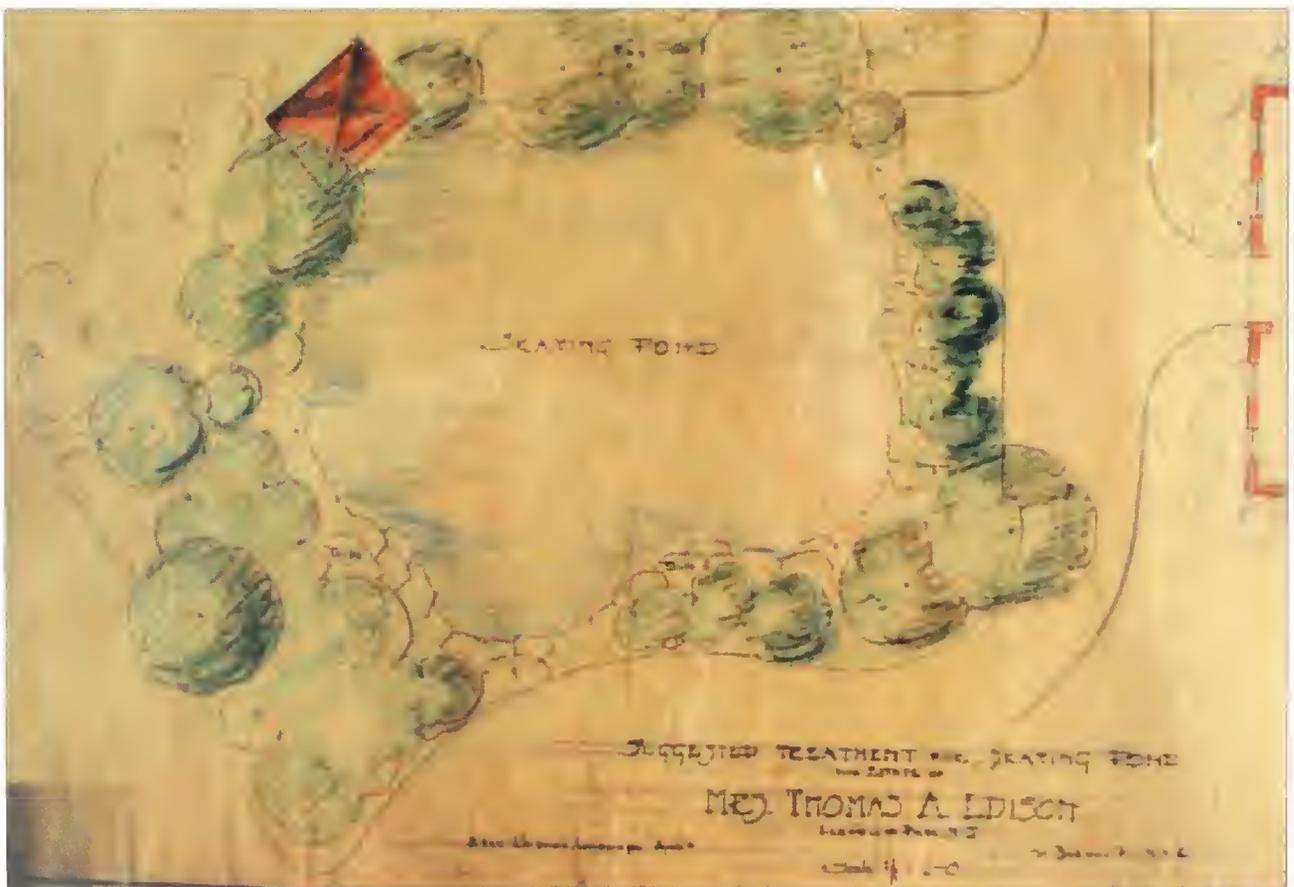
Figure 1.40. In this 1926, entitled “Suggested Treatment for Skating Pond,” landscape architect Ellen Shipman provided her vision for a skating pond west of the garage. Separately, she provided construction drawings. Although estimates were prepared for Shipman’s proposal, it is unclear as to whether or not her design was ever implemented; present-day conditions resemble Pentecost and Martin’s 1925 plan (EDIS Archives, 11495).

Clearly disappointed with the pond, Mina turned to Shipman to redesign the skating pond in 1926. By October 1926, Shipman had prepared a conceptual plan, accompanied by two construction details for the pond (Figure 1.40). As shown in the plan and details, the organic shape of the pond and plumbing systems remained the same, but construction materials were changed as Shipman proposed the use of brick and concrete for the walls and base. In addition, the documents proposed a new skating shack (Figure 1.41).

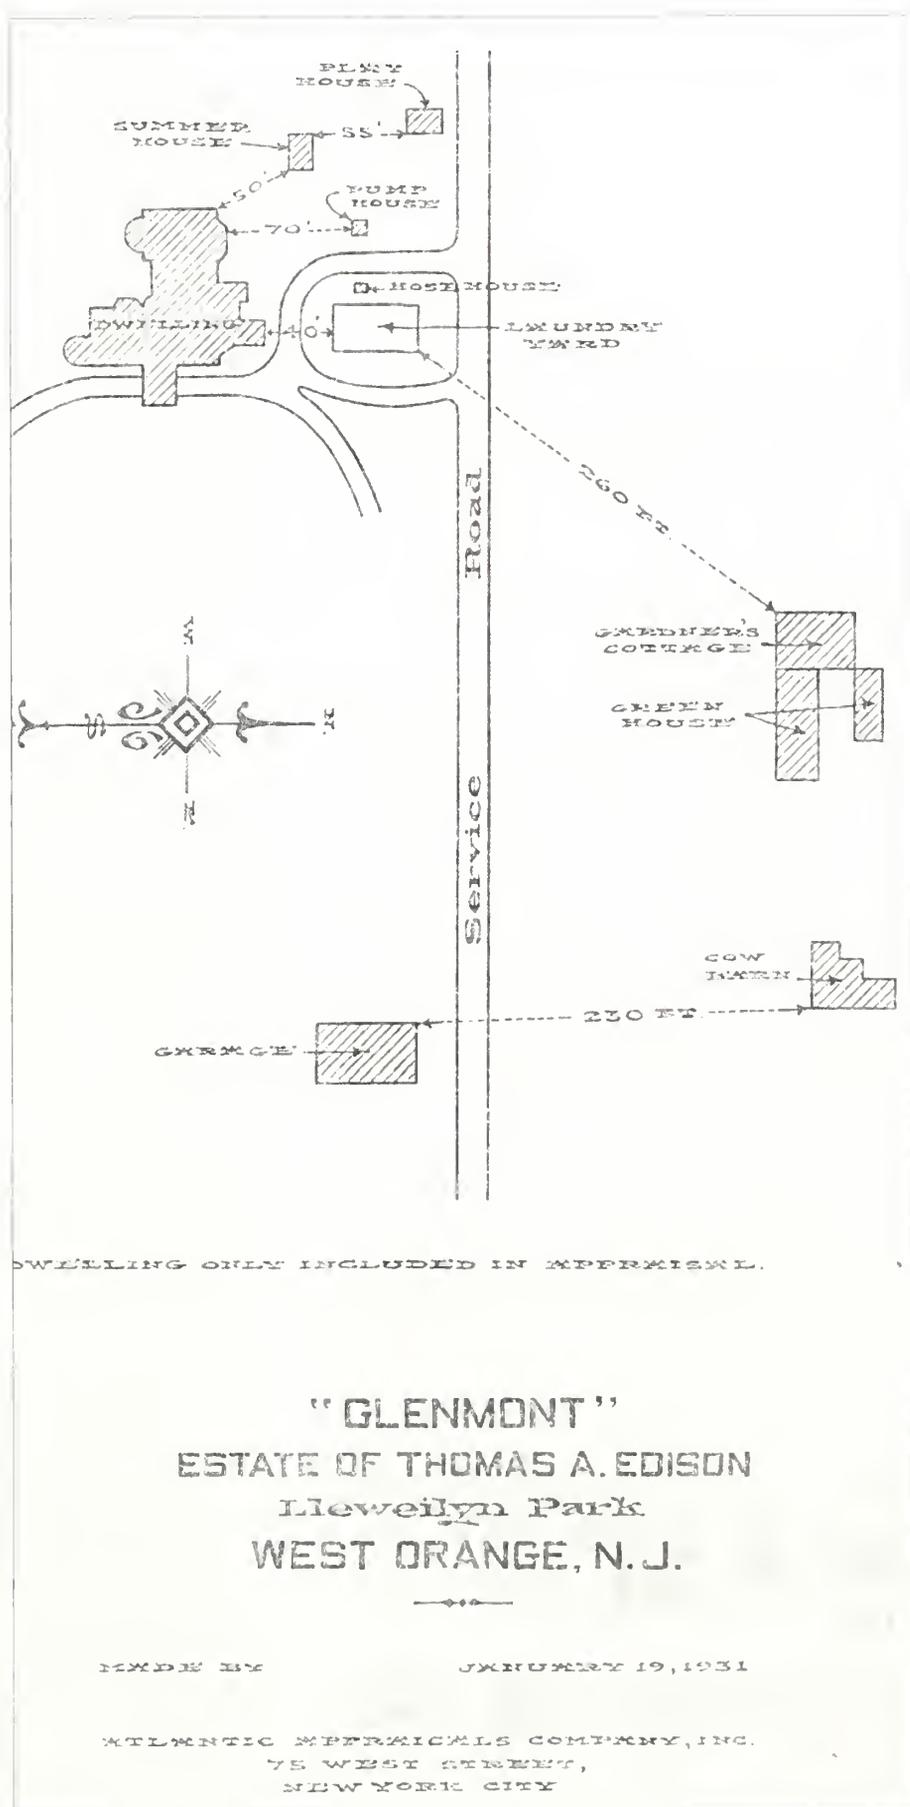
Figure 1.42. This map, entitled "Glenmont, Estate of Thomas A. Edison, Llewellyn Park, West Orange, N.J.," was completed for a 1931 appraisal of the property. It locates the garage, barn, and greenhouses, but more importantly the playhouse and summerhouse about which little is known (EDIS Archives).

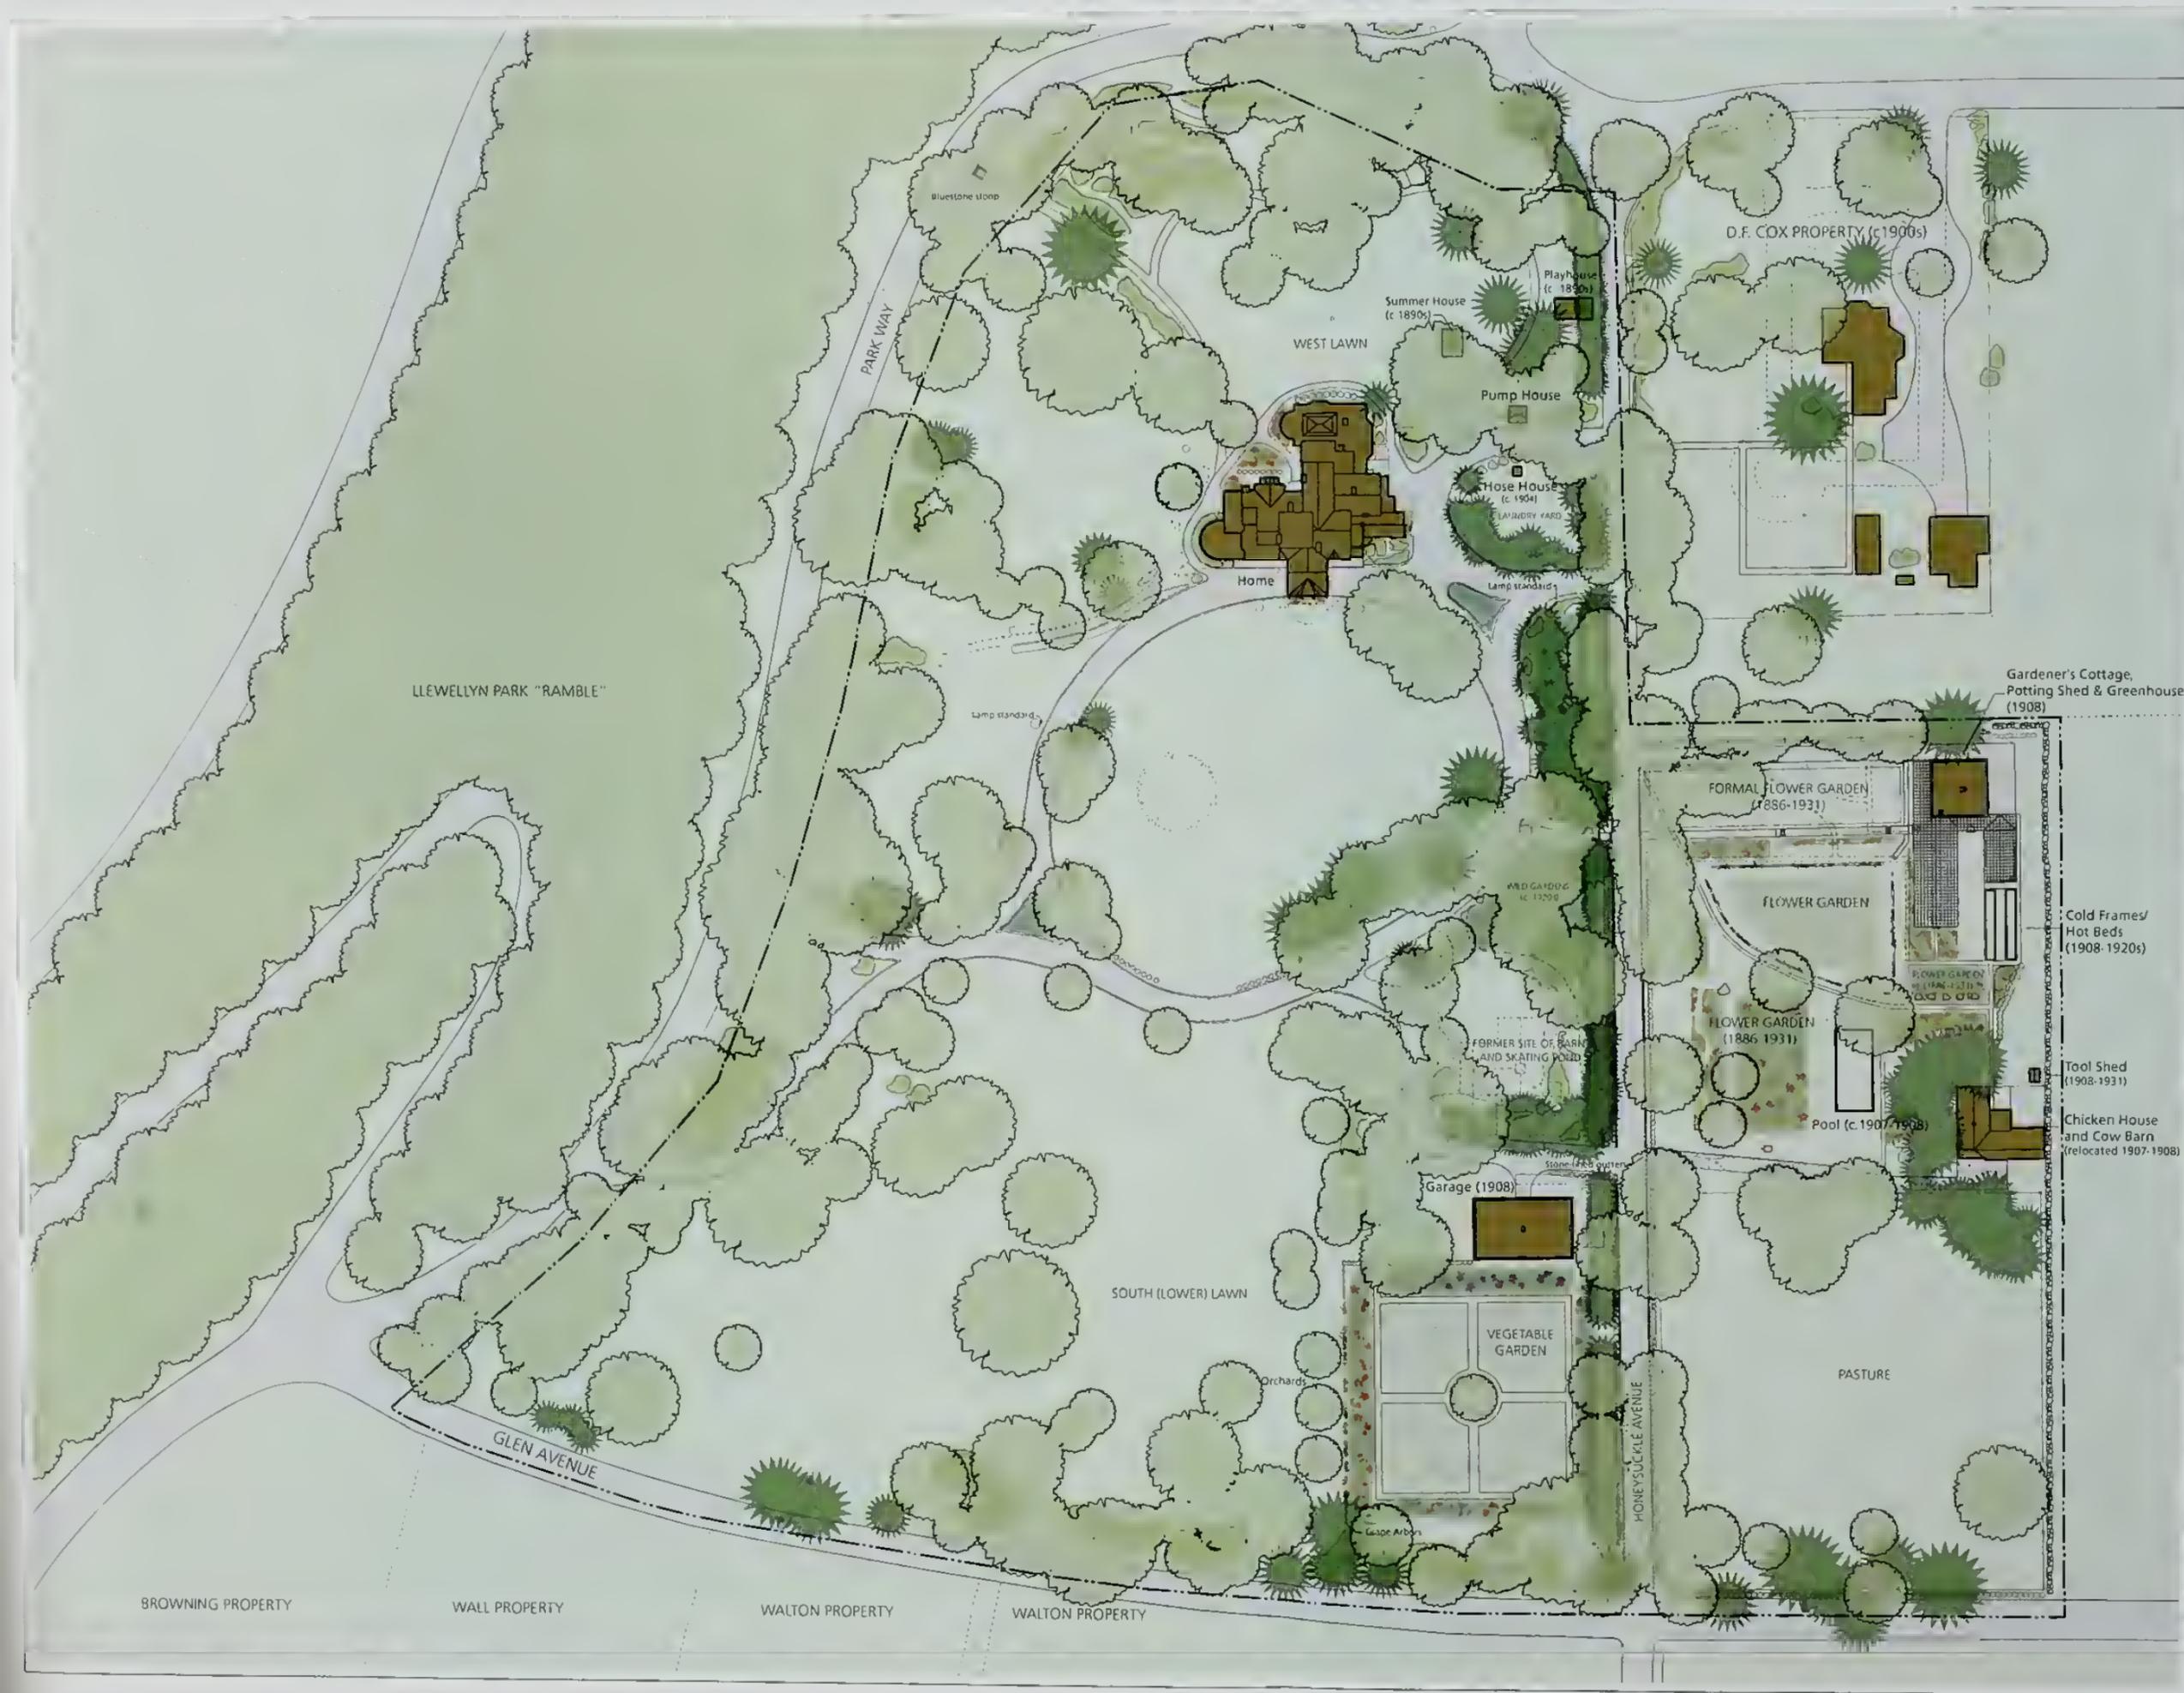
Drawing 1.2

1. Plan shows conditions in 1931 with changes since 1886.
2. All features shown in approximate scale and location.
3. Contours shown only in project area and not in Cox Property or other adjoining properties.

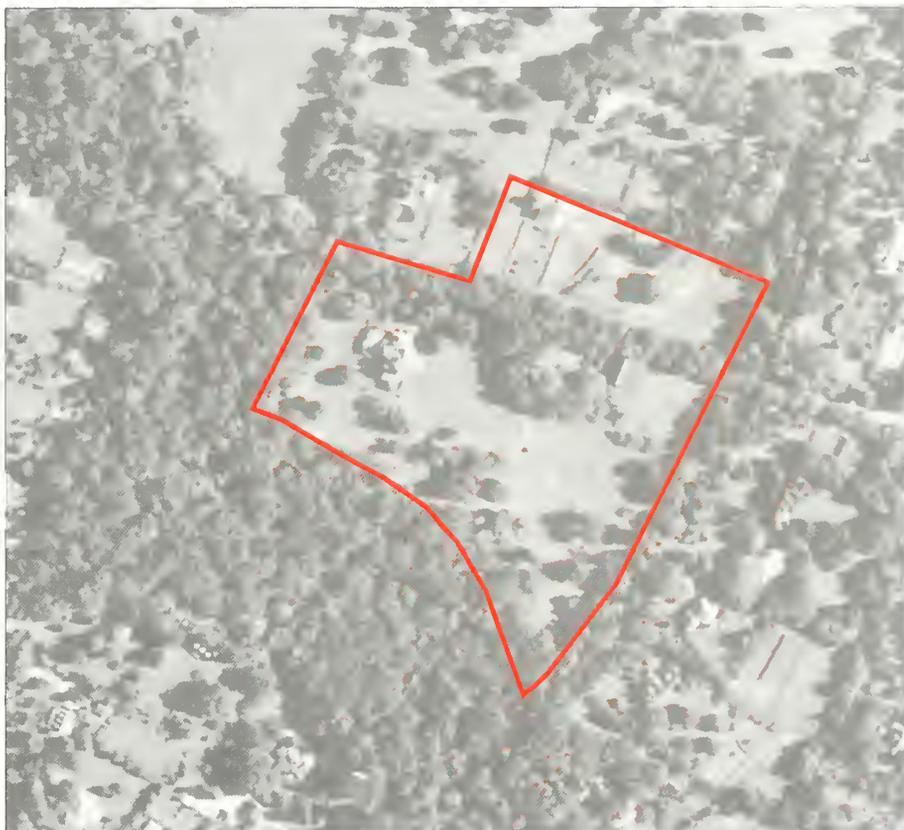
Figure 1.47. A 1940 aerial photograph of the Glenmont property shows the grounds, buildings, and circulation (Aerial Viewpoint).

(Figure 1.45)<sup>11</sup>. The triangular island near the northeastern corner of the house was reshaped with rounded corners, and the geraniums were removed and later planted with begonias. Other changes to the landscape included the planting of rhododendrons along the perimeter of the laundry yard and the removal of the playhouse and summerhouse to the north of the house, and the deutzias at the southern end of the oval lawn (Figure 1.46). Meanwhile, rhododendrons were planted along the perimeter of the laundry yard. Upon completion of these improvements, Mina commented in a 1940 letter to her son, Charles Edison, that “Glenmont looks so green and perfect.” The condition and extant features of the landscape were captured in an aerial photograph taken in 1940 (Figure 1.47).<sup>12</sup>
