## CULTURAL LANDSCAPE REPORT FOR GLENMONT

THOMAS EDISON NATIONAL HISTORICAL PARK  
WEST ORANGE, NEW JERSEY

# CULTURAL LANDSCAPE REPORT FOR GLENMONT

SITE HISTORY

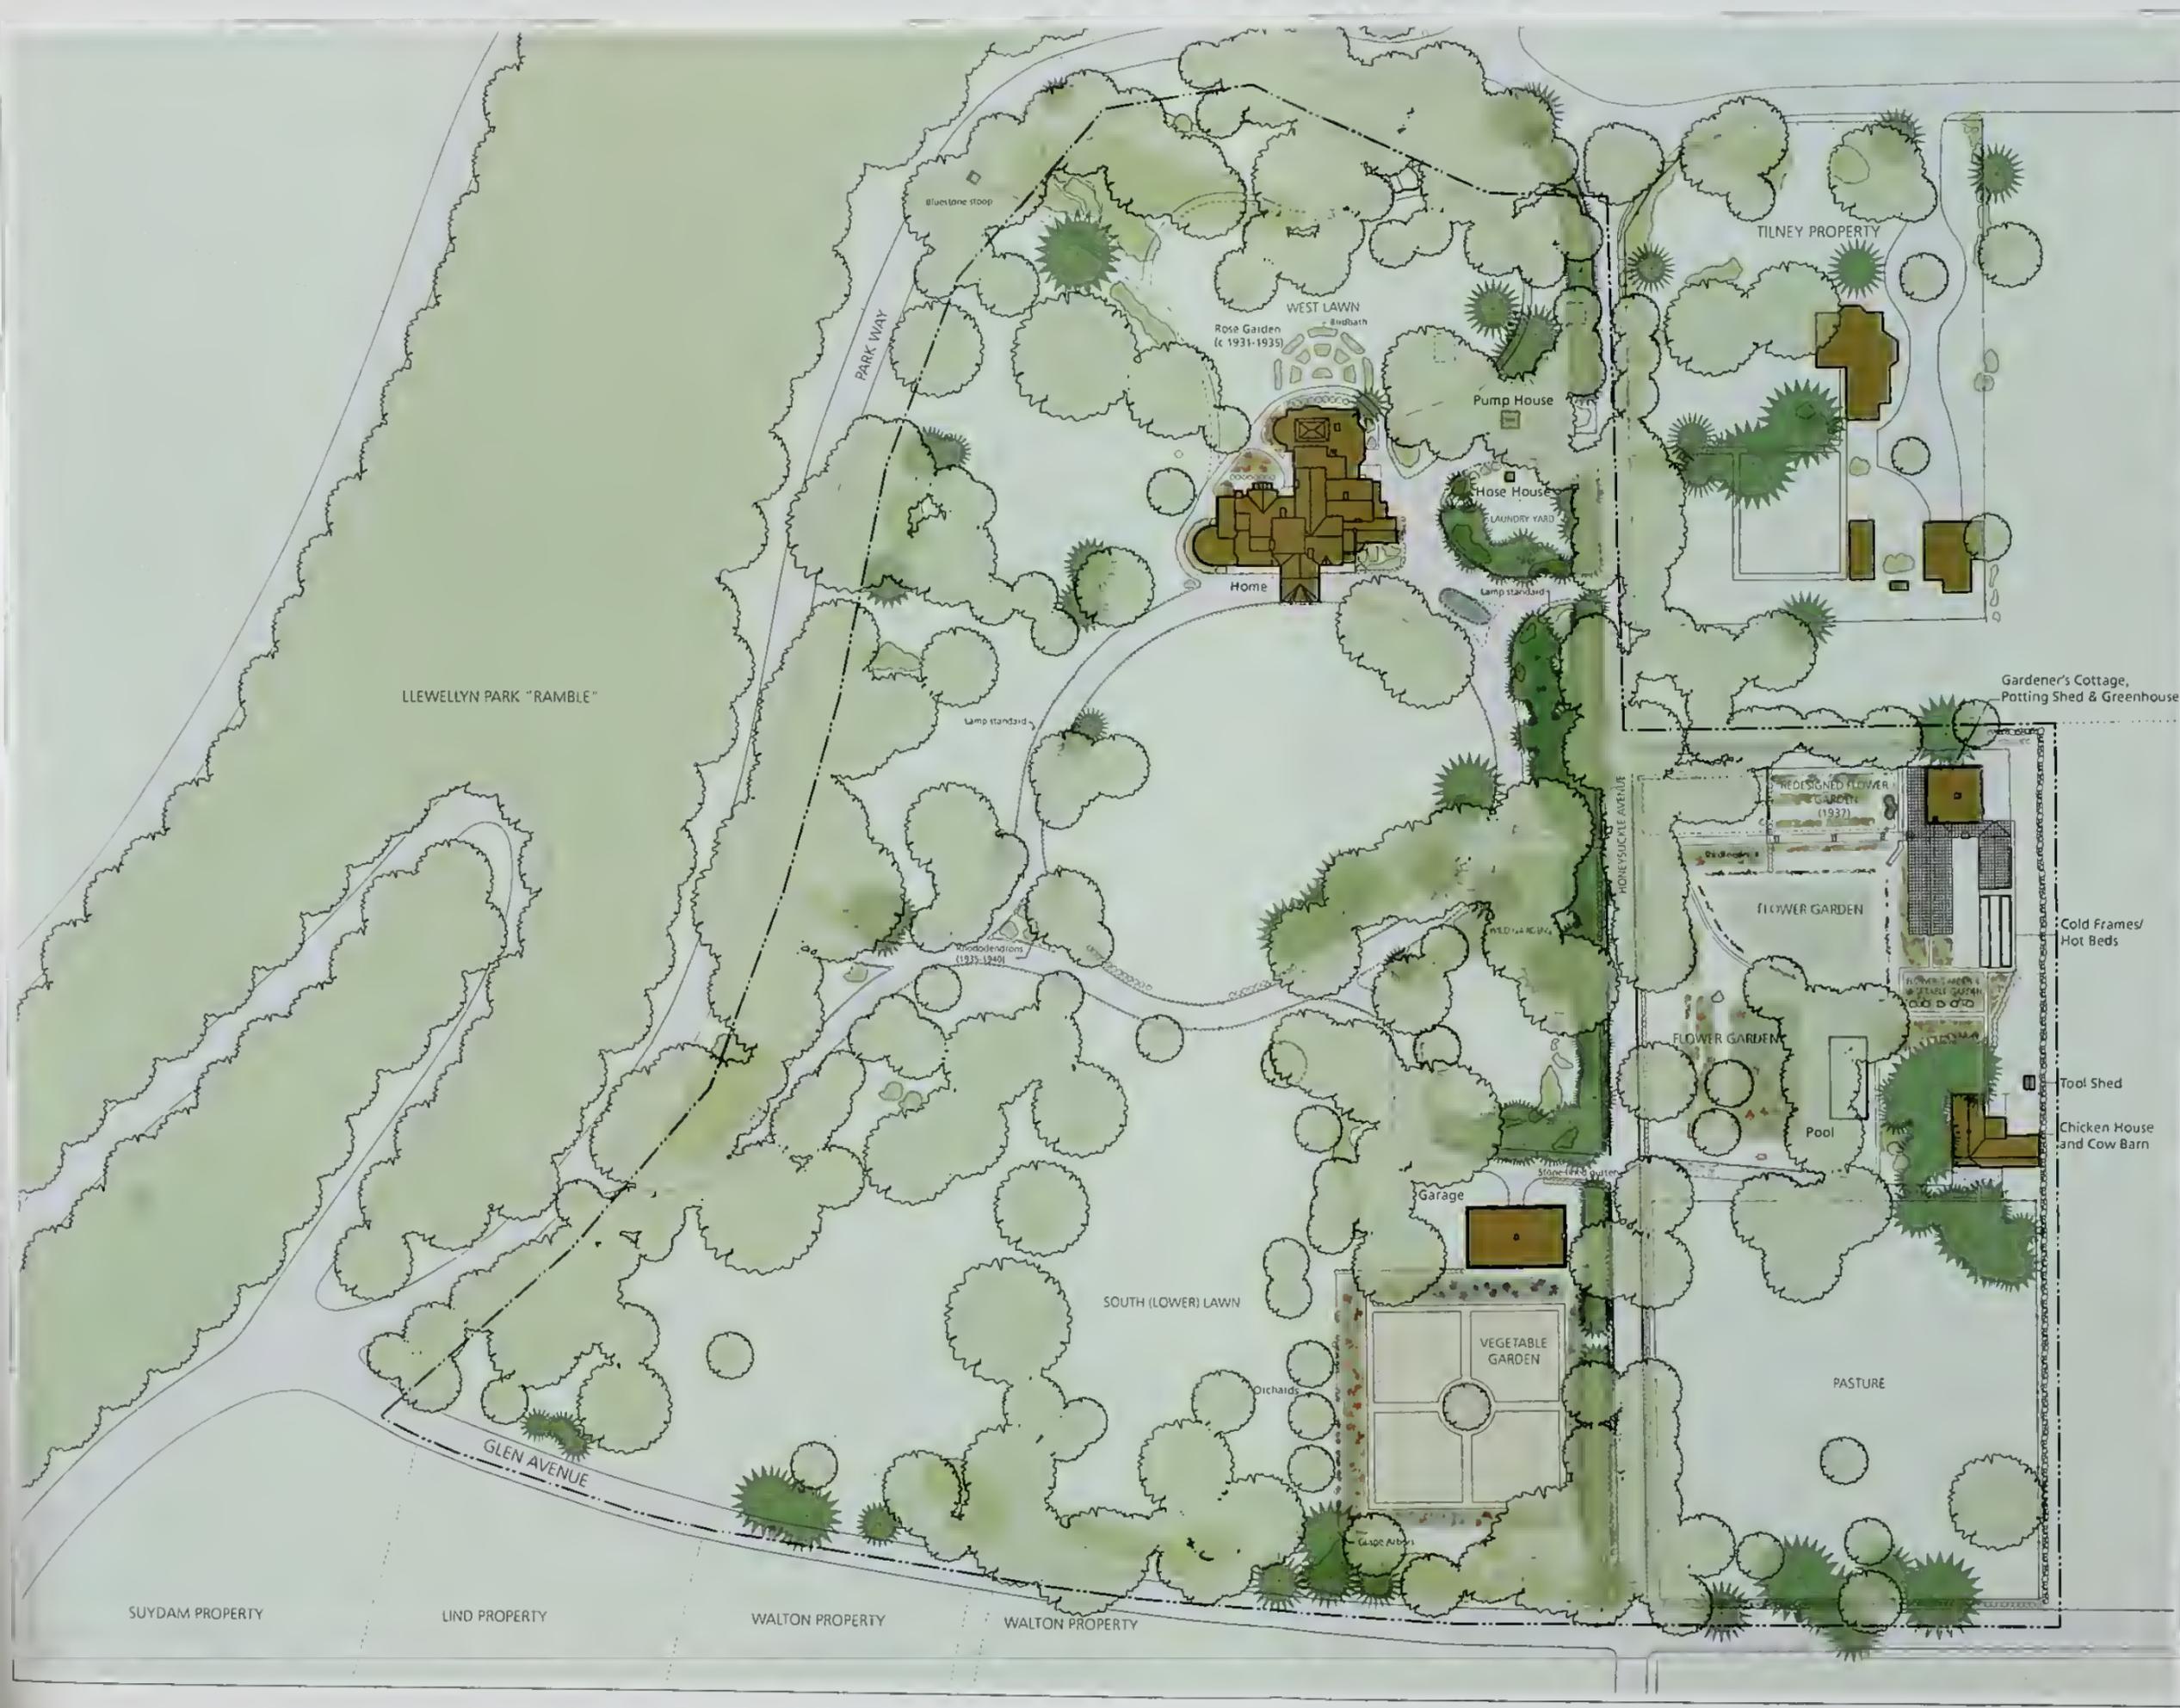
Drawing 1.3

- Plan shows conditions in 1947 with changes since 1931.
- All features shown in approximate scale and location.
- Contours shown only in project area and not in Tilney Property.

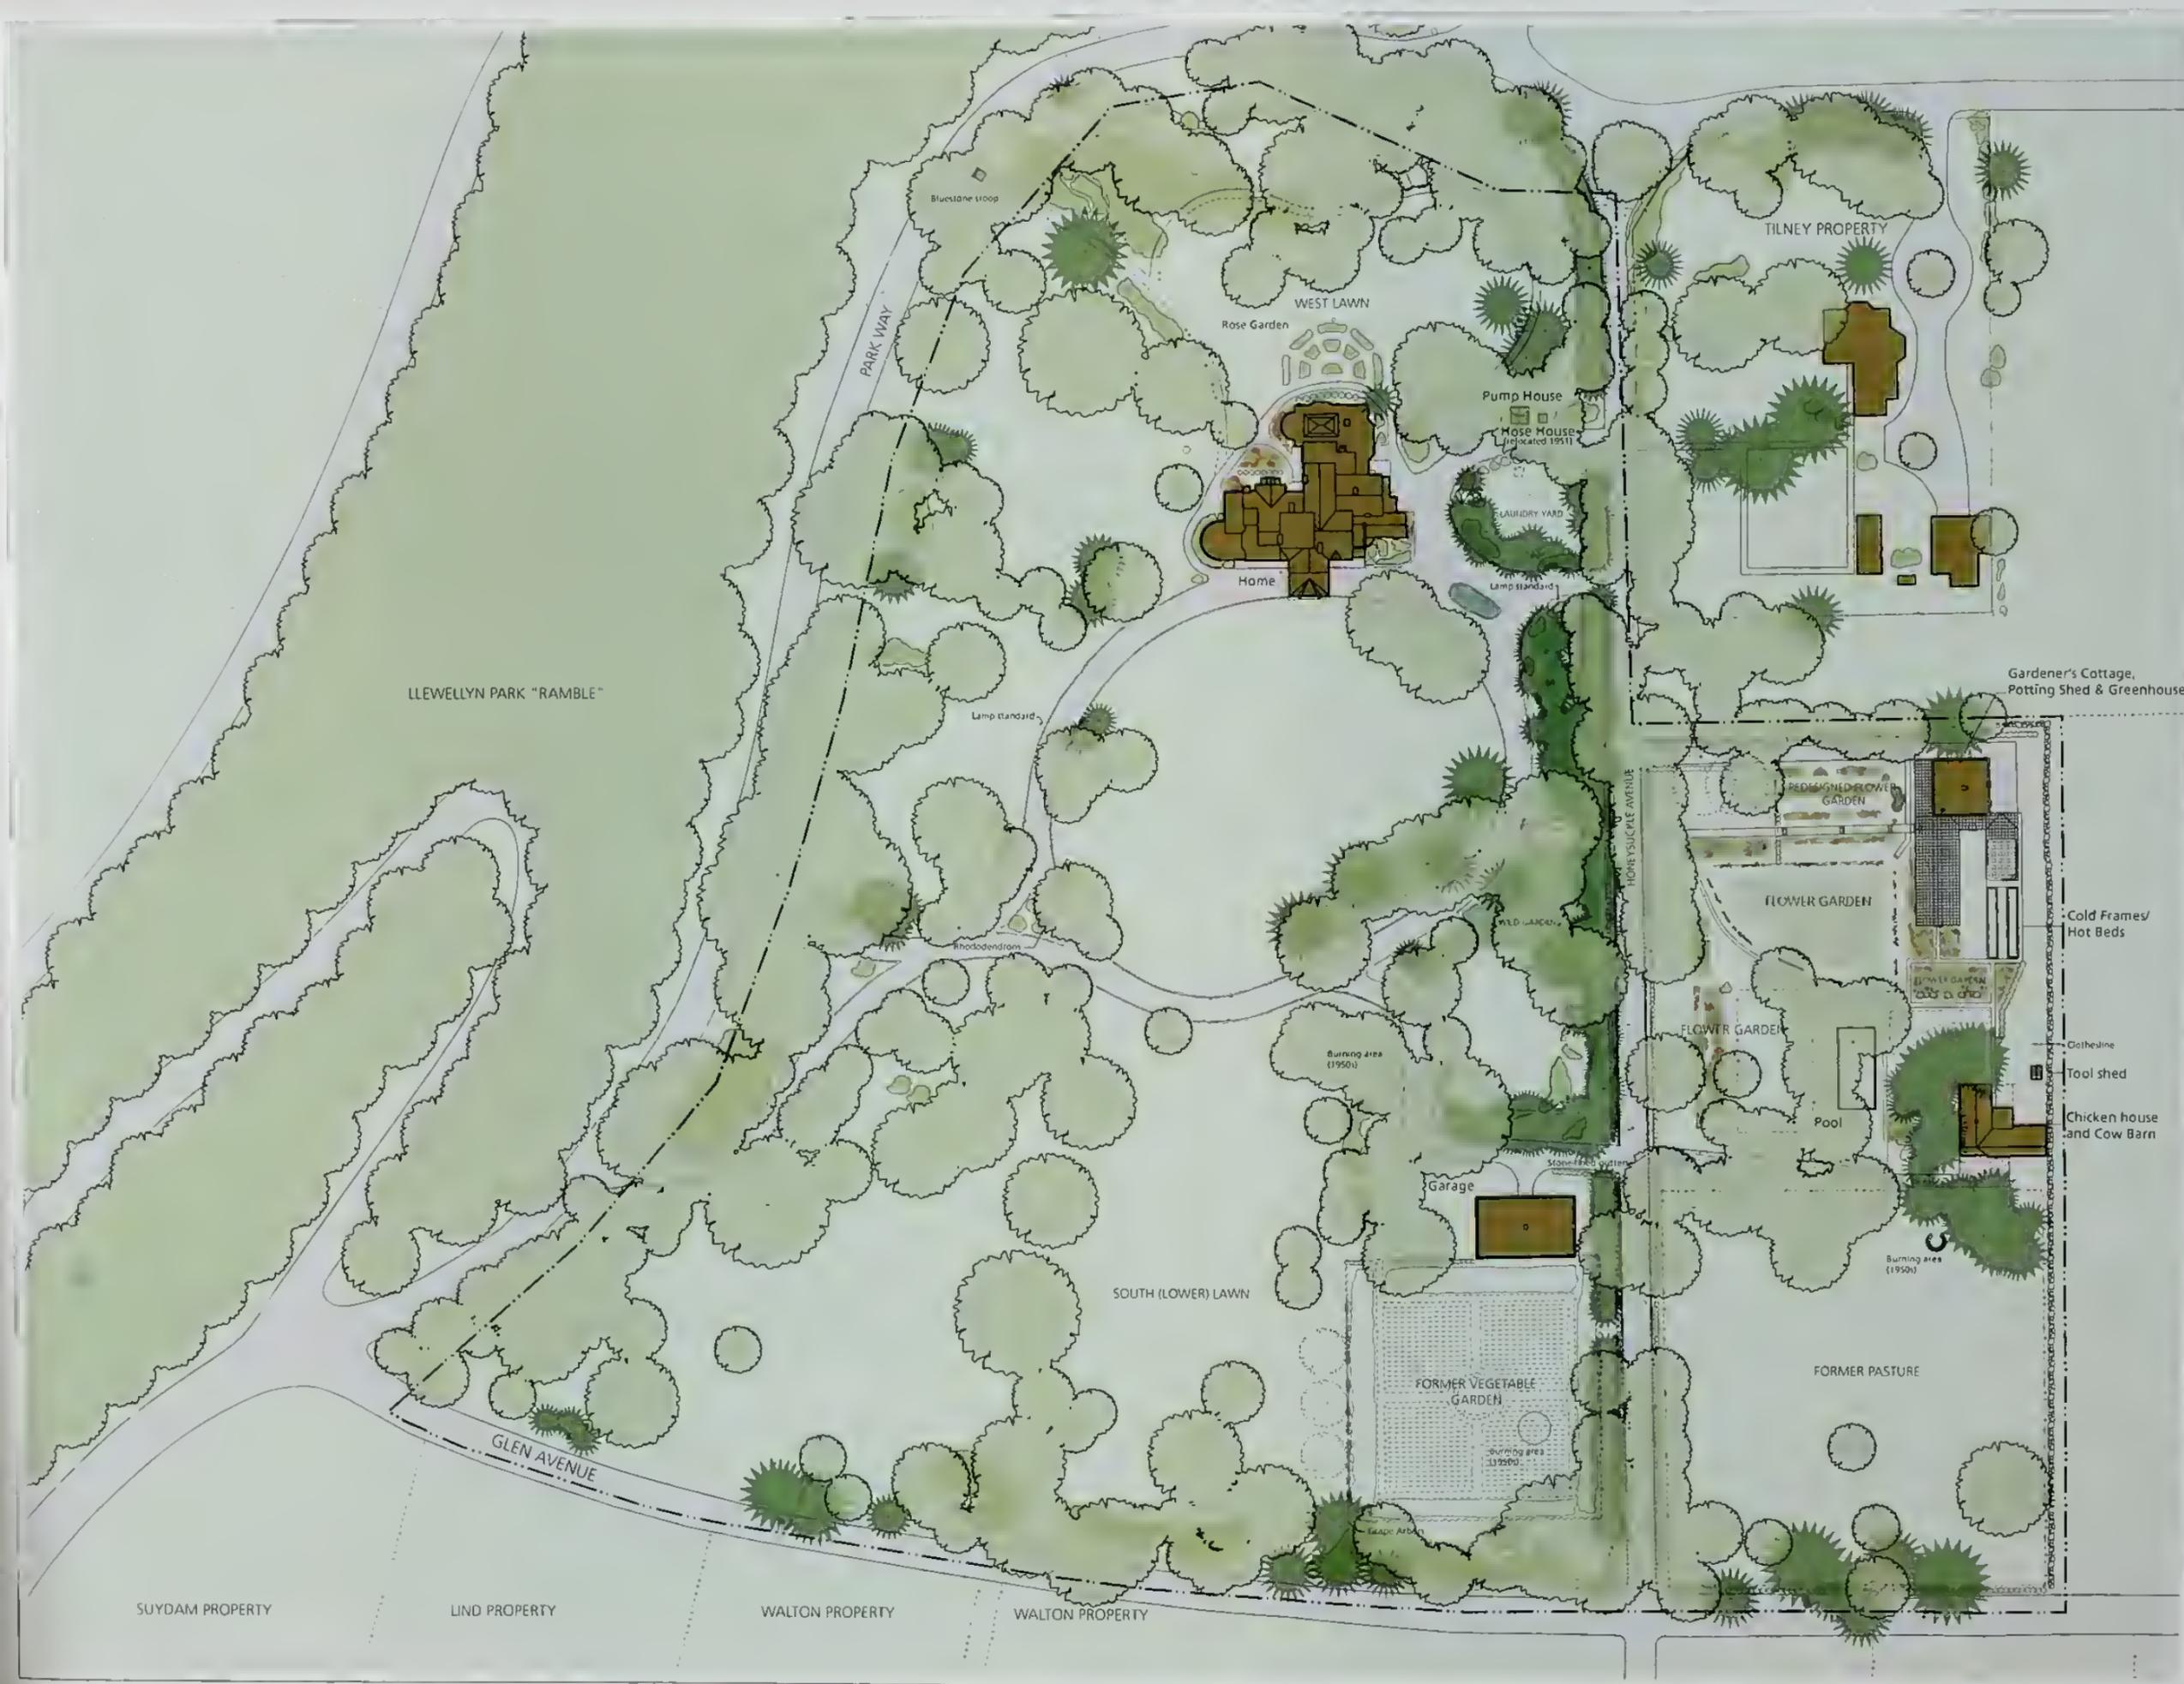
Drawing 1.4

1. Plan shows conditions in 1959 with changes since 1946.
2. All features shown in approximate scale and location.
3. Contours shown only in project area and not in Tilney Property.

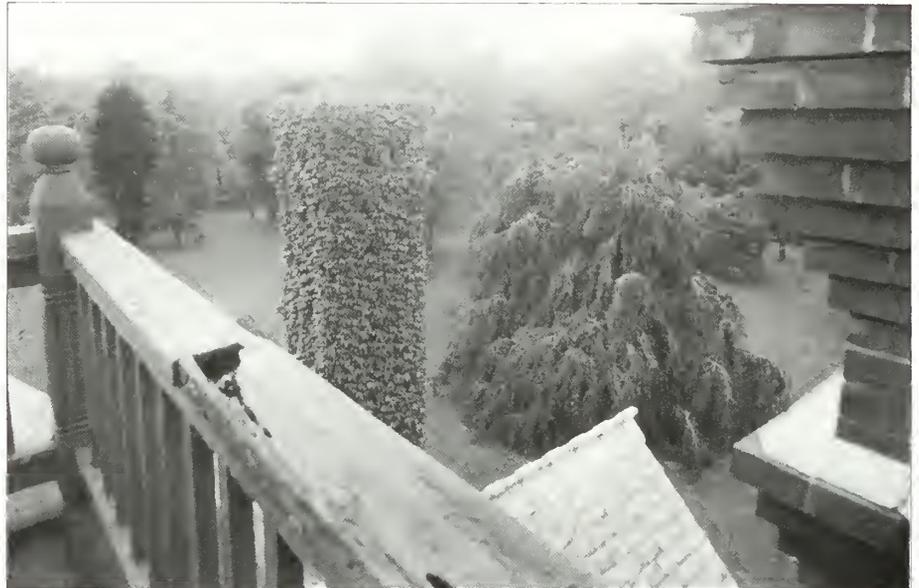
Figure 1.63. View looking at the southern portion of the property from the second floor of the house in 1960. Note the existence of mature trees and shrubs within the oval lawn area. Many of these trees and shrubs were later removed (EDIS Archives, #6810).

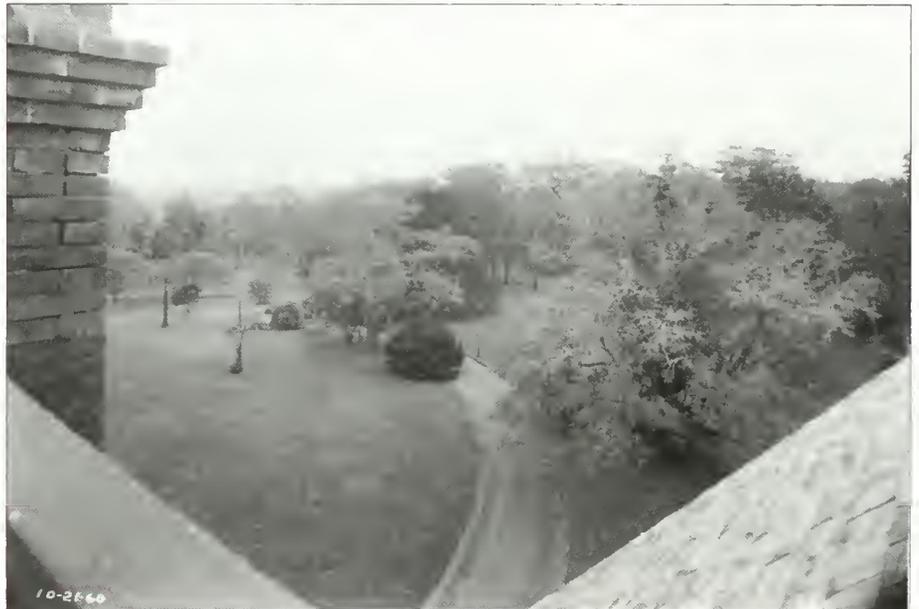
Figure 1.64. View looking at the southern portion of the property from the second floor of the house in 1960. Note the existence of mature trees and shrubs within the oval lawn area. Many of these trees and shrubs were later removed (EDIS Archives, #6811).

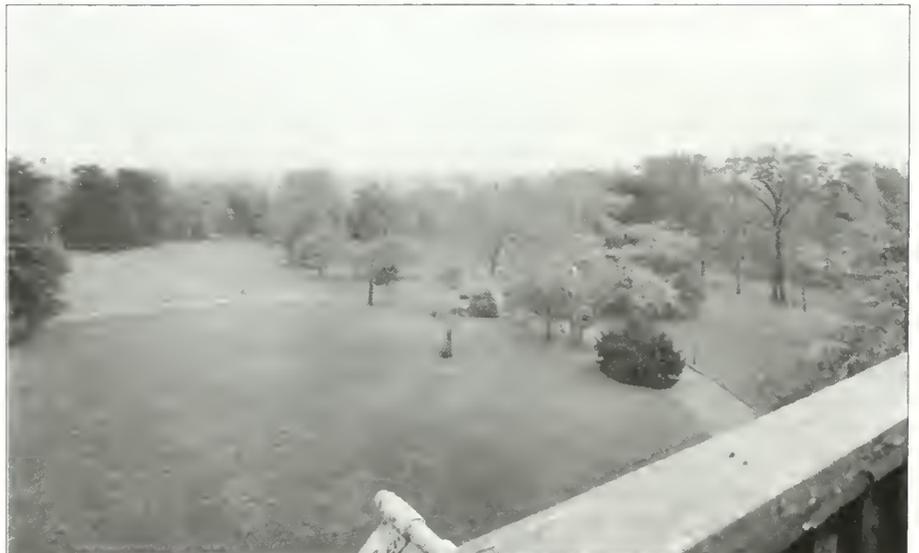
Figure 1.65. View looking at the southeastern portion of the property from the second floor of the house in 1960. In the foreground is a Norway Maple, a favorite of the Edison family, removed in the 1960s (EDIS Archives, #6812).

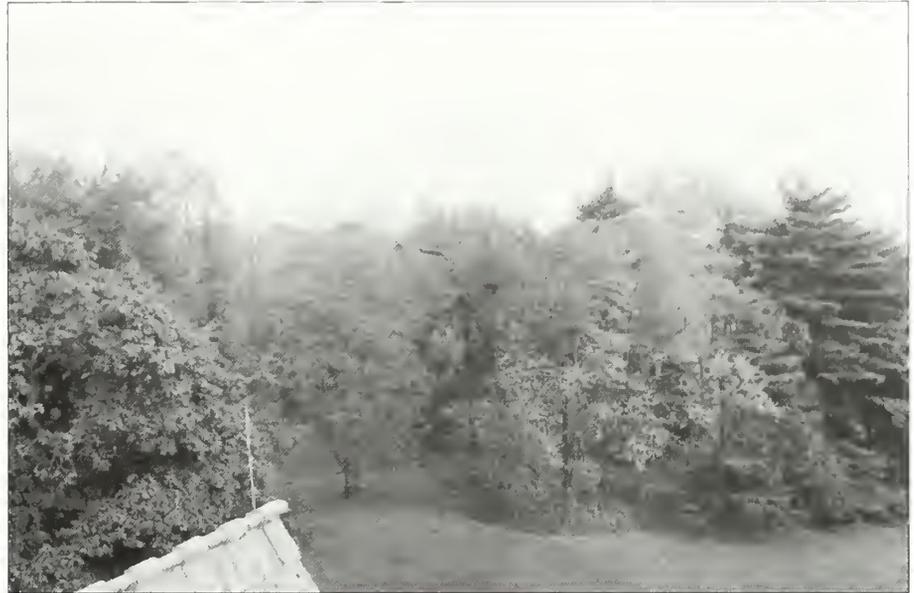
Figure 1.66. View looking west at the northeastern portion of the property in 1960. Note the existence of the pumphouse and hose house. Historically, the hose house was located across from the pumphouse in the laundry yard (EDIS Archives, #6816).

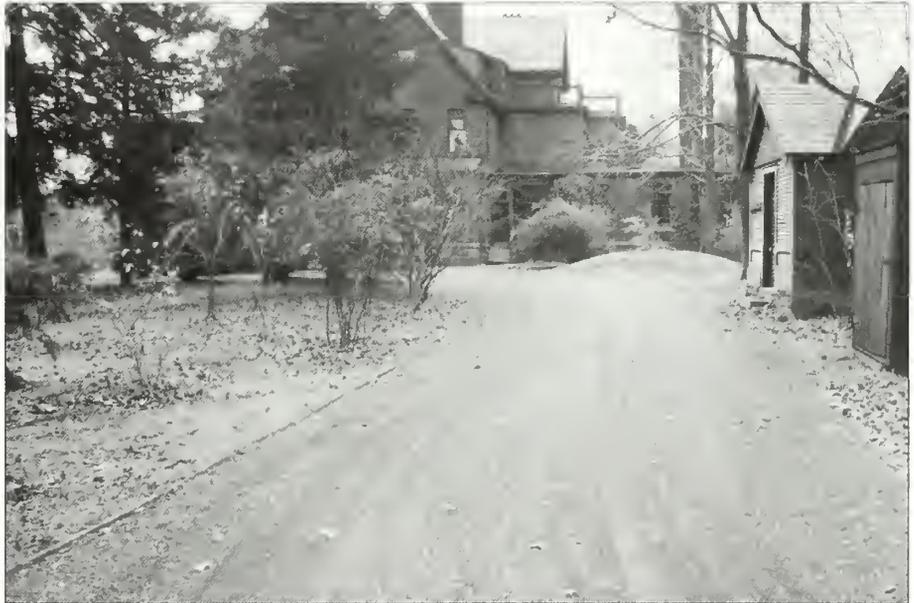
Figure 1.67. View of the north elevation in 1960. The pathway passes through the area, extending into the western portion of the property (EDIS Archives, #6818).

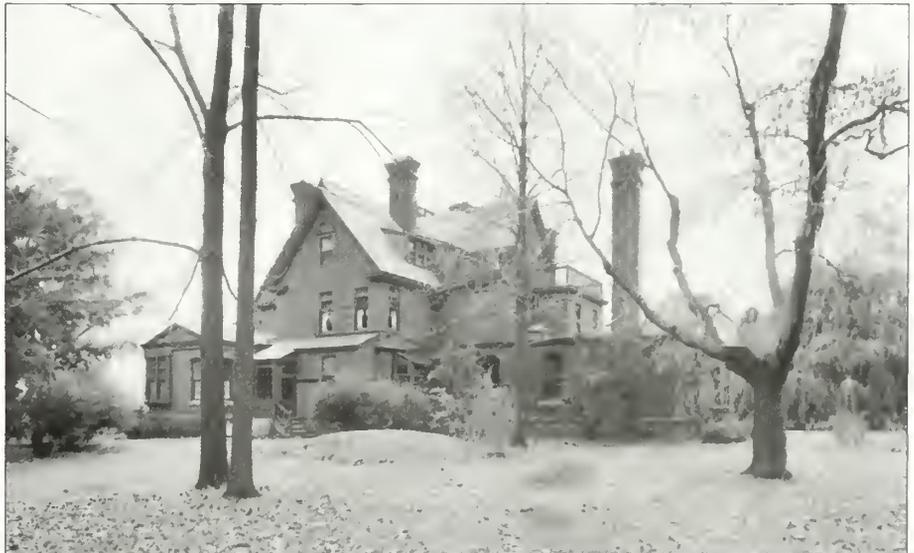
Figure 1.69. View looking south towards the northwest portion of the property in 1960. Seen in the foreground is the rose bed, removed in 1982. Note the ivy covering the house. The ivy was later removed in the mid-1960s (EDIS Archives, #6820).

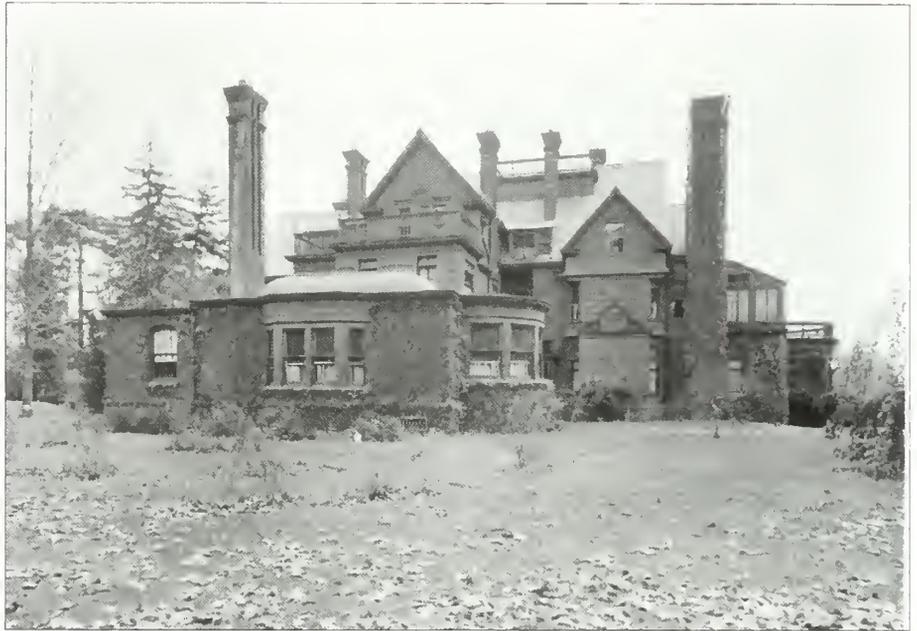
Figure 1.70. View looking northwest of the south elevation of the property in 1960. Seen in the foreground is the Norway Maple, removed in the 1960s, replanted shortly thereafter with a Silver Maple, but again was lost by 1995 (EDIS Archives, #6824).

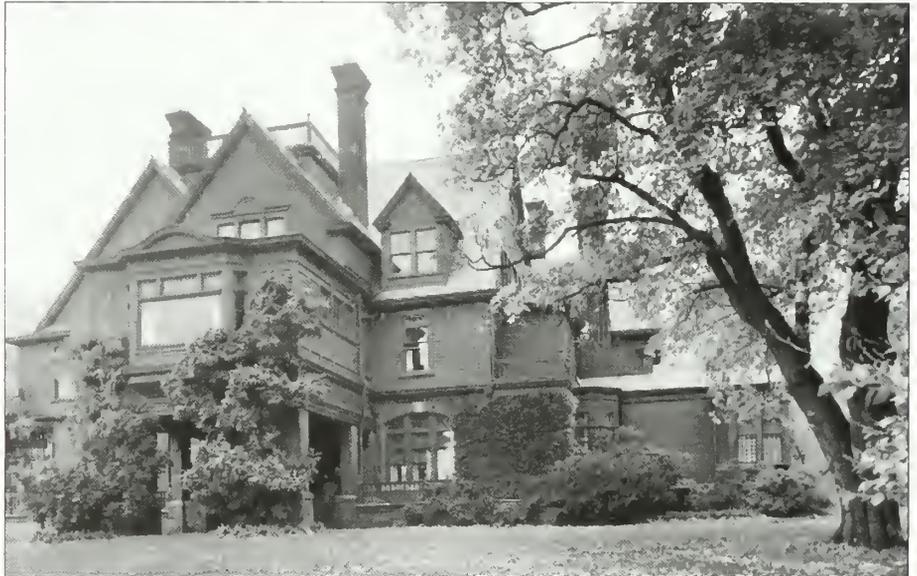
Figure 1.71. View looking south towards the expanse lawn in 1960. Many trees shown in the image were planted between 1886 and 1931 (EDIS Archives, #6826).

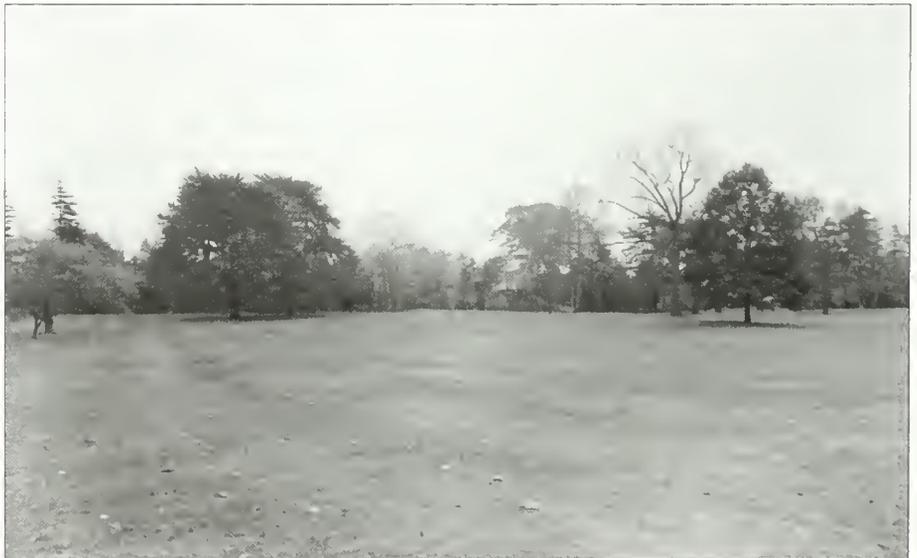
Figure 1.72. View looking northeast towards the greenhouse, gardener's cottage and potting shed, pool, and barn in 1960. Prior to the late 1940s and early 1950s, this area contained fruit trees, flower and cutting gardens, as well as vegetable gardens (EDIS Archives, #6829).

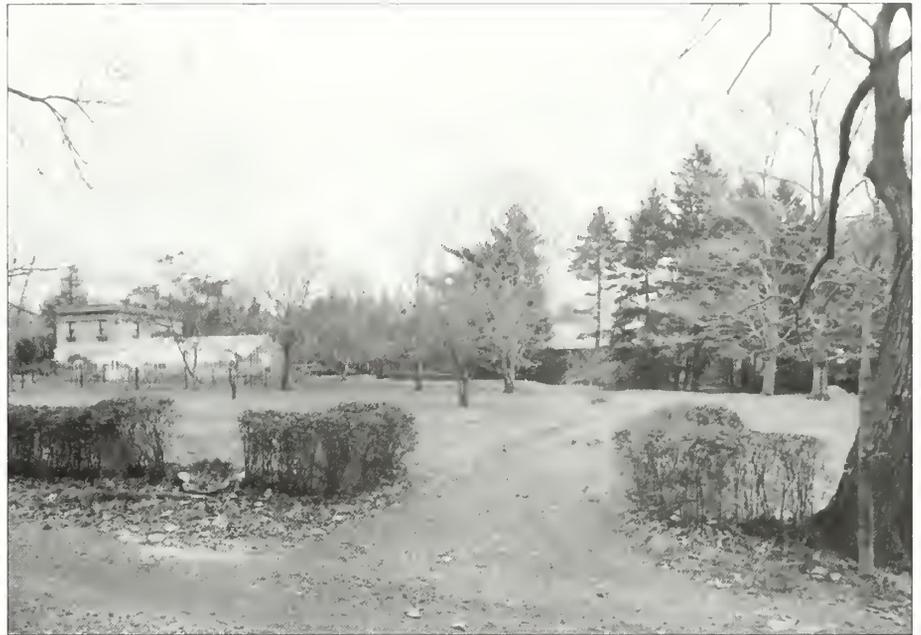
Figure 1.73. View looking west towards the previous location of the vegetable garden near the garage in 1960. The vegetable garden fell into disuse between 1947 and 1959. Seen in the foreground is a burning area, established after 1959 (EDIS Archives, #6832).

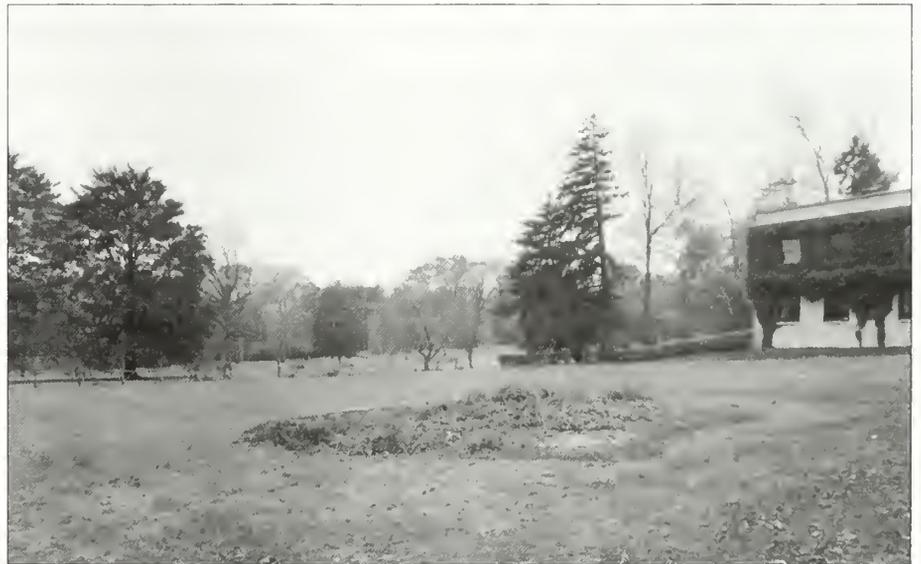
Figure 1.74. View looking northwest towards the former pasture area in 1960. Seen in the background is an additional burning area defined by a stone wall (EDIS Archives, #6833).

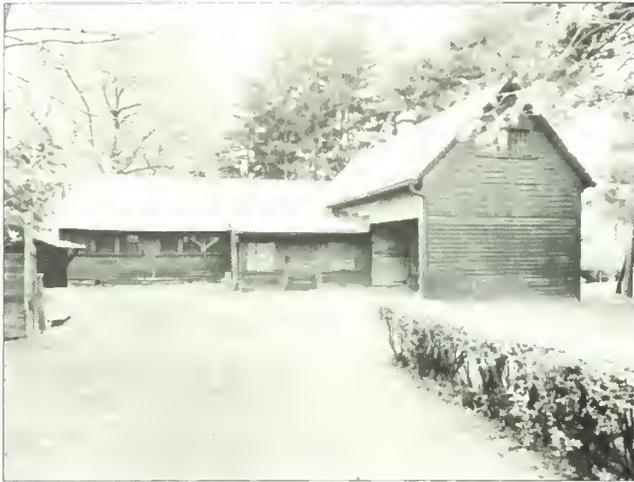
Figure 1.75. (left) View looking southeast towards the barn, constructed in the 1880s and relocated in between 1908 and 1909. The hedge shown in the foreground was historically used to screen the laundry that was hung from the clothesline previously located within the space (EDIS Archives).

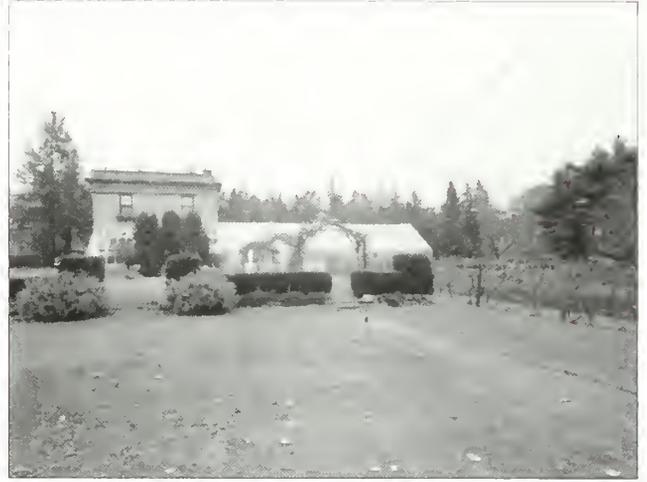
Figure 1.76. (right) View looking north towards the greenhouse, gardener's cottage and potting shed, and remaining flower garden in 1960. The flower garden was redesigned in 1937 (EDIS Archives).

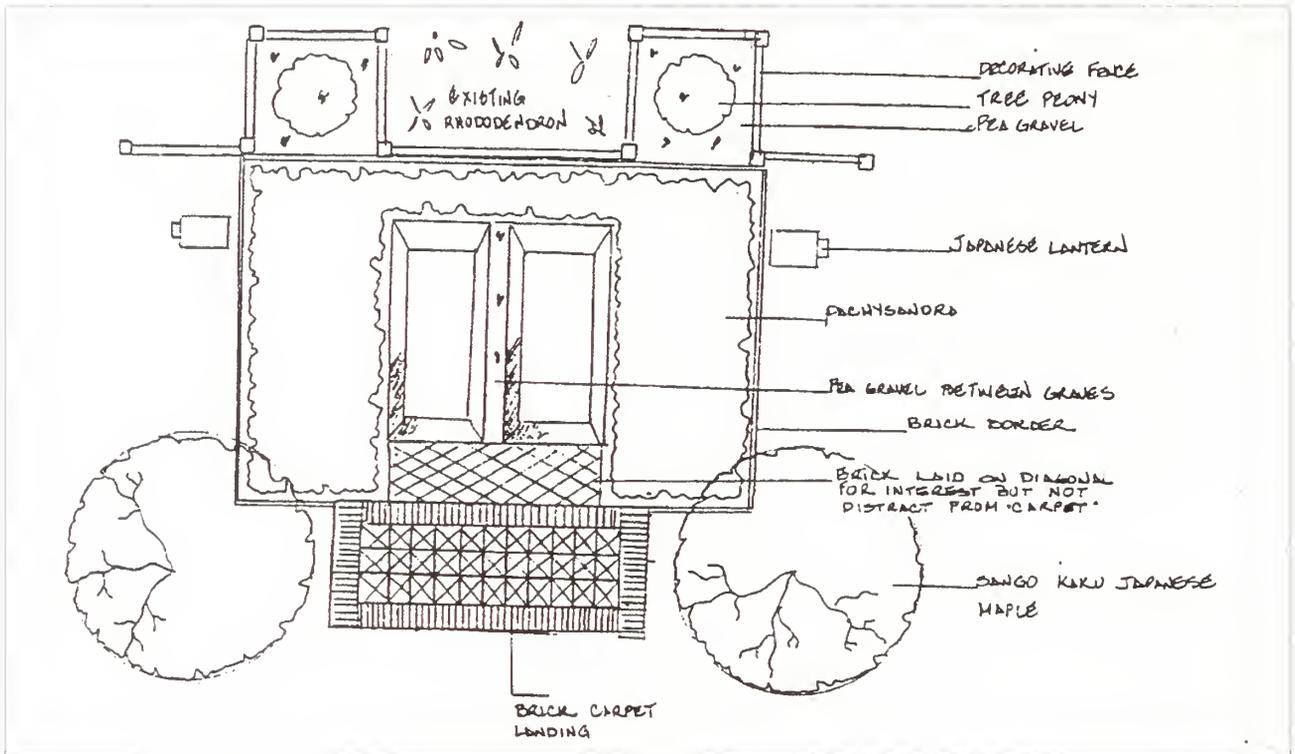
Figure 1.78. The 2004 Plan, entitled "Thomas Edison Grave Plots", which shows the improvements that were made to the Edison gravesite in 2003-2004. The work included the installation of a cedar decorative fence, an "oriental carpet" brick observation landing, the removal of the Japanese Holly hedge and goldmoss stonecrop groundcover, and the planting of pachysandra (*Pachysandra terminalis*), tree peonies (*Paeonia suffruticosa*), and two 'Sango Kaku' Japanese Maples (*Acer palmatum* 'Sango Kaku'). 'In addition, two Yunoki-type stone lanterns were included as a backdrop (EDIS Archives).

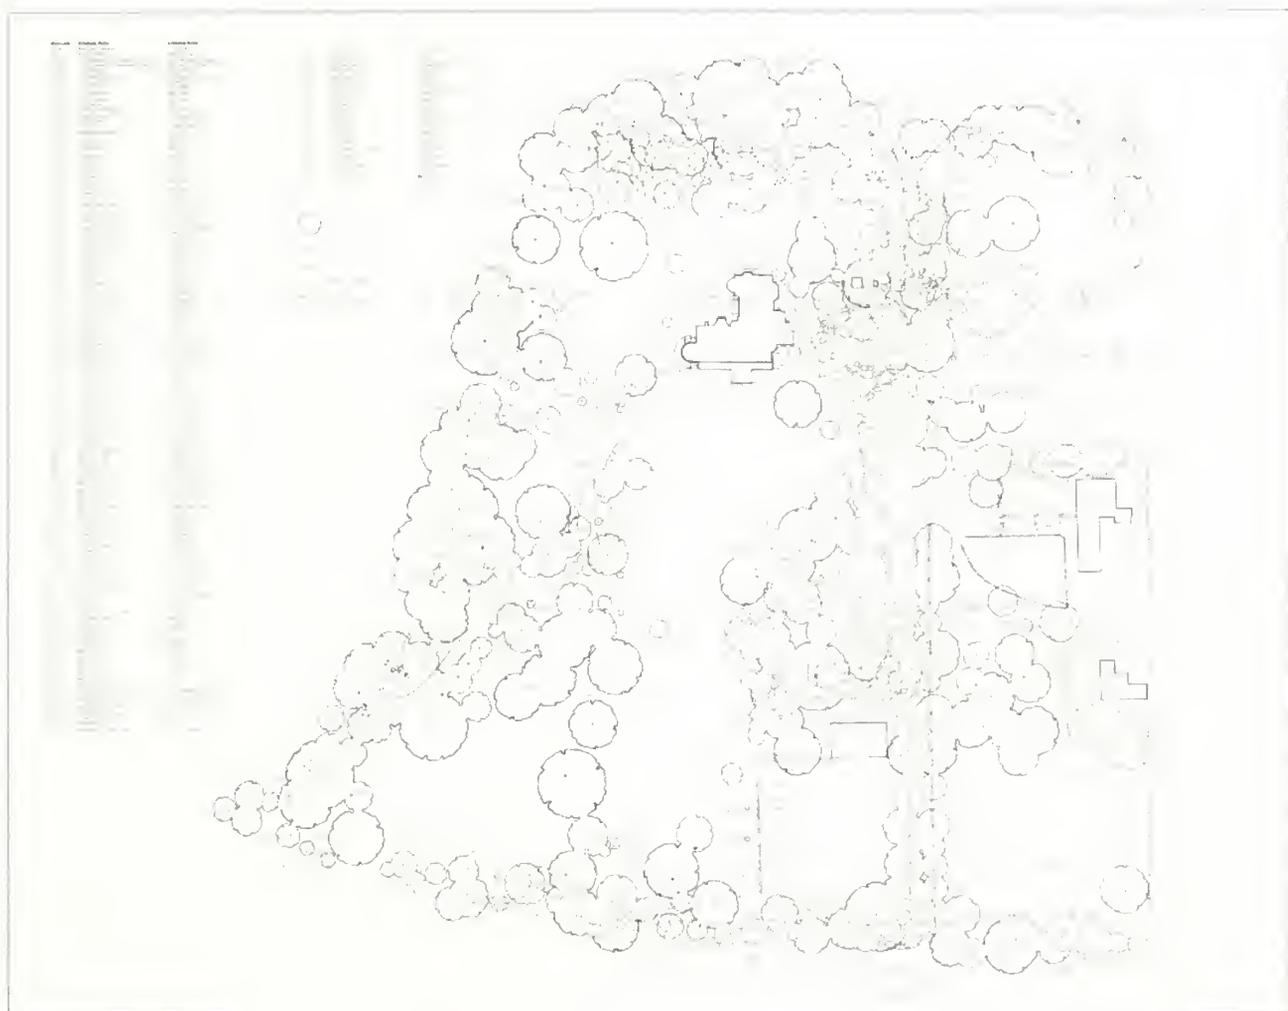
Figure 1.84. A 1995 historic plant inventory completed by the Olmsted Center for Landscape Preservation. The inventory identifies all buildings and structures, circulation patterns, and all trees and shrubs found within the property (Olmsted Center for Landscape Preservation, 1995).

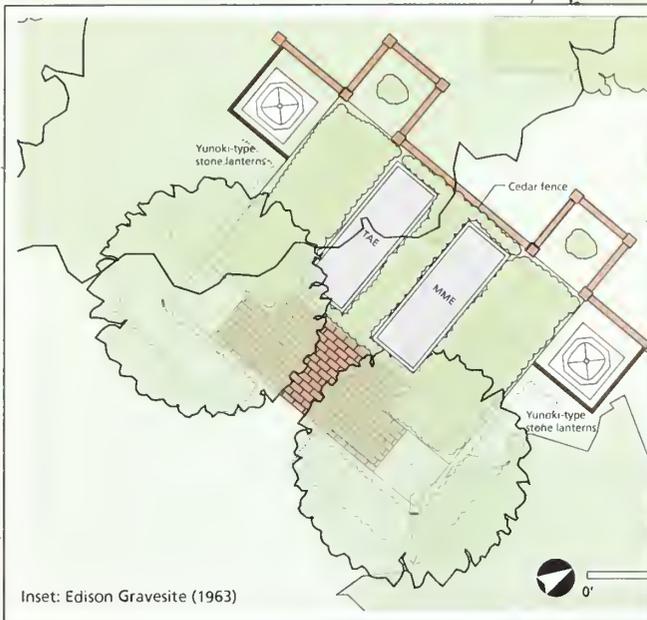
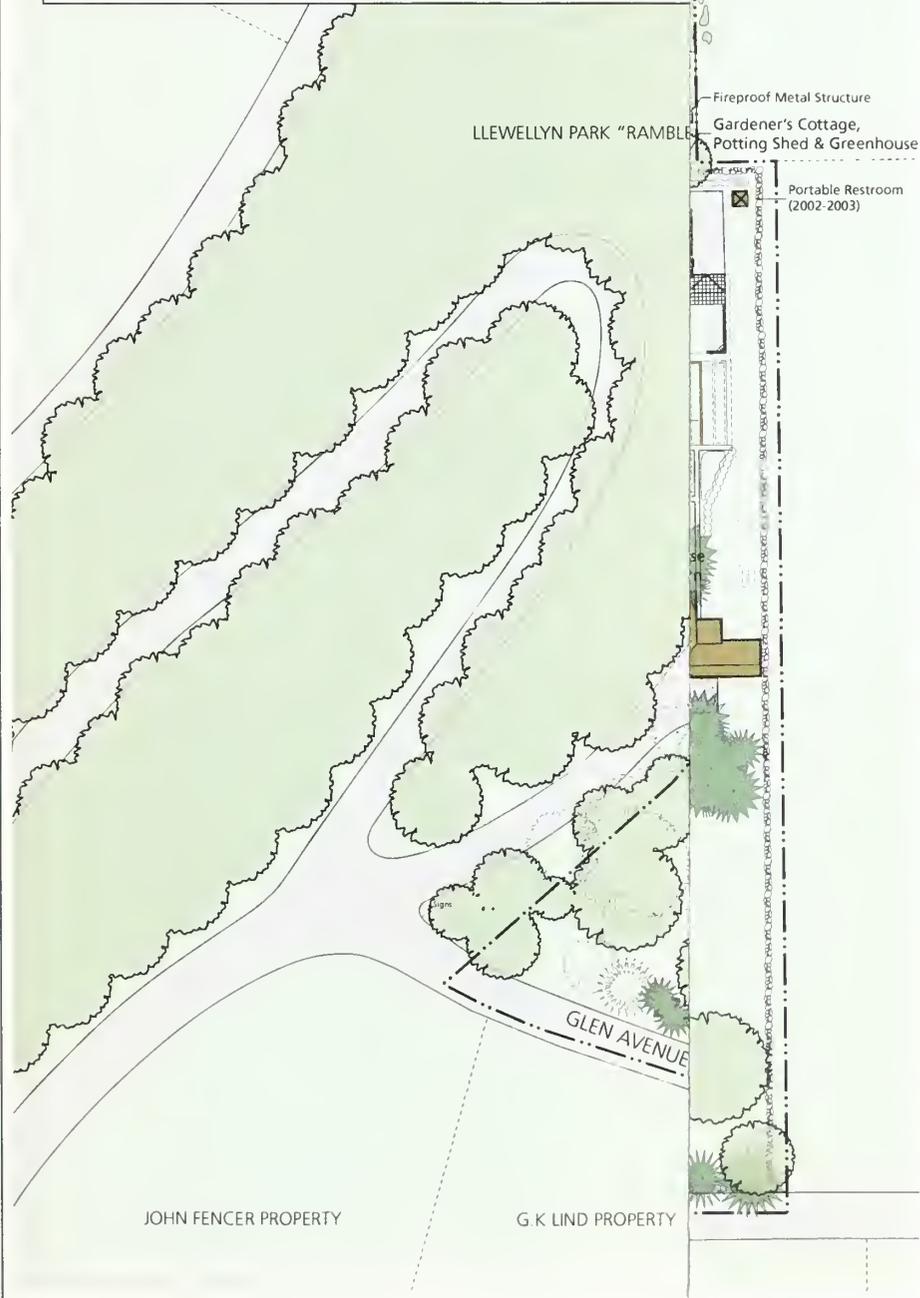
Drawing 1.5

- Plan shows conditions in 2009 with changes since 1959
- All features shown in approximate scale and location
- Contours shown only in project area and not in Tilney Property
- Information on plant identification for 2009 is detailed on the 2009 *Existing Condition Plans* and 1995 *Historic Plant Inventory for Edison National Historic Site*

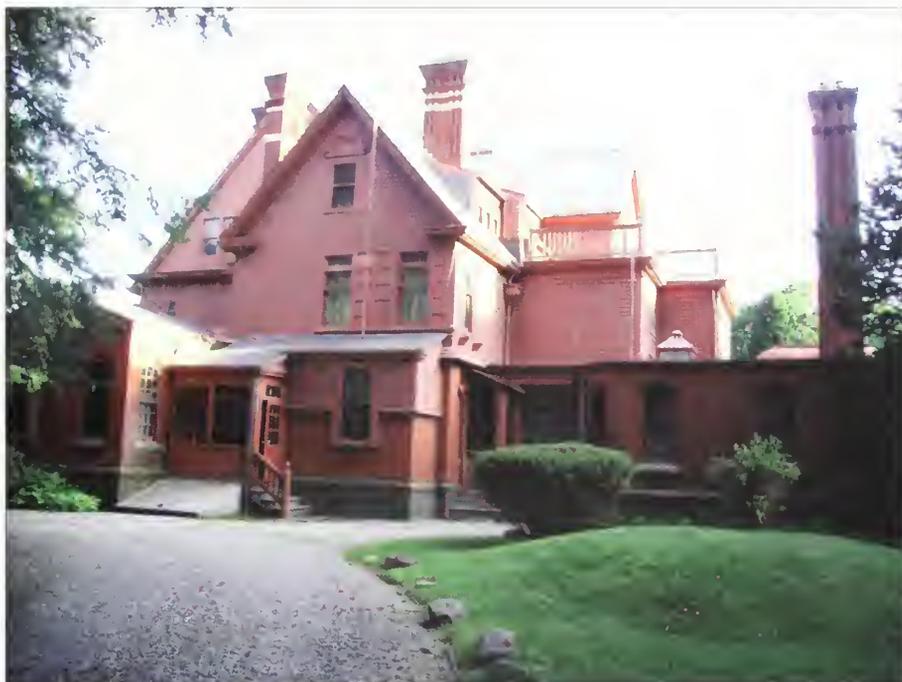
**Figure 2.01: Natural Systems and Topography.** Views of the west lawn mound constructed between 1879 and 1884 (OCLP, 2009).

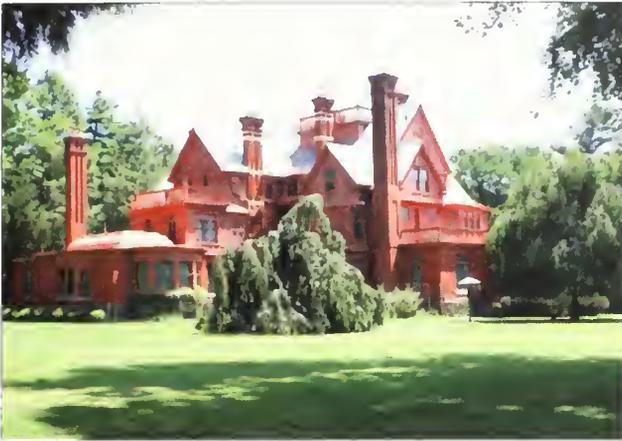
Figure 2.04: (left) Spatial Organization. View looking east of the west lawn, established between 1879 and 1884. Although the majority of paths and some perimeter plantings have been removed, the west lawn remains intact and continues to illustrate a major component of the original Nathan Barrett design (OCLP, 2009).

The west (back) lawn is bounded by Park Way on the west and south, Honeysuckle Avenue on the north, and the path along the perimeter of the house and main and secondary drives to the east and south. The space is bounded by mature perimeter plantings of oak, beech, maple, and ash trees. The interior is largely open with several specimen trees and features the Edison gravesite, pump house, and numerous small-scale features (Figures 2.04).

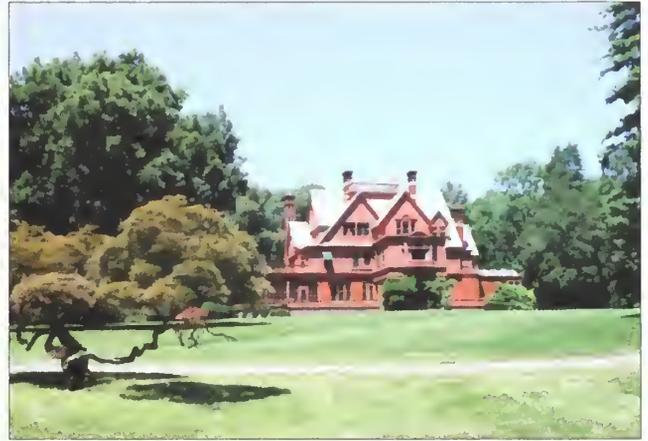
Figure 2.05: (right) Spatial Organization. View looking northwest towards the front lawn. The space encompassed the house and foundation plantings, as well as the oval lawn area encircled by the main drive. With exception to the foundation plantings, the space was largely open with scattered specimens along the perimeter of the oval lawn (OCLP, 2009).

The front lawn encompasses the Glenmont house and foundation plantings and the oval lawn area delineated by the main drive circle. The oval lawn area is open in character and consists of highly manicured turf bordered by deciduous and evergreen trees and shrubs, which includes copper beech (*Fagus sylvatica* 'Cuprea'), hickory (*Carya* sp.), Norway spruce (*Picea abies*), white pine (*Pinus strobes*), royal paulownia (*Royal paulownia*), Carolina silverbell (*Halesia carolina*), maple (*Acer* sp.), yellow birch (*Betula alleghaniensis*), flowering dogwood (*Cornus florida*), umbrella magnolia (*Magnolia tripetala*), magnolia (*Magnolia* sp.) and Canadian hemlock (*Tsuga canadensis*) (Figure 2.05).

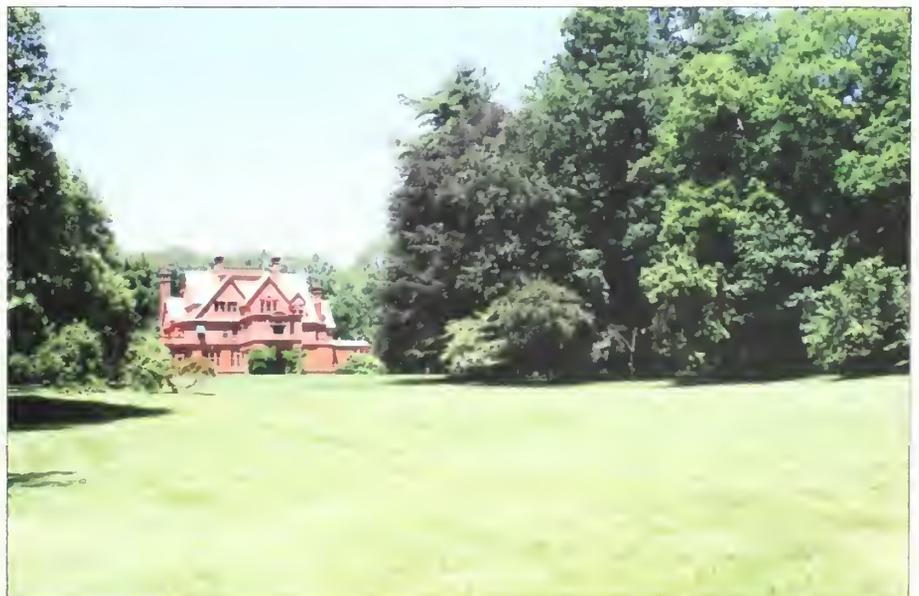
Figure 2.06: Spatial Organization. View looking northwest of a portion of the south (lower) lawn (OCLP, 2009).

The south (lower) lawn, east of the house, is defined by Park Way on the south, Honeysuckle Avenue on the north, Glen Avenue on the east, and the main and secondary drives to the east. The interior of the space is largely open lawn dotted with several specimens and clumps of deciduous and evergreen trees, as well as remnant apple orchard. It includes the garage, a rose trellis—partially outlining the former location of the vegetable garden, and numerous small-scale features (Figures 2.06 and 2.07).

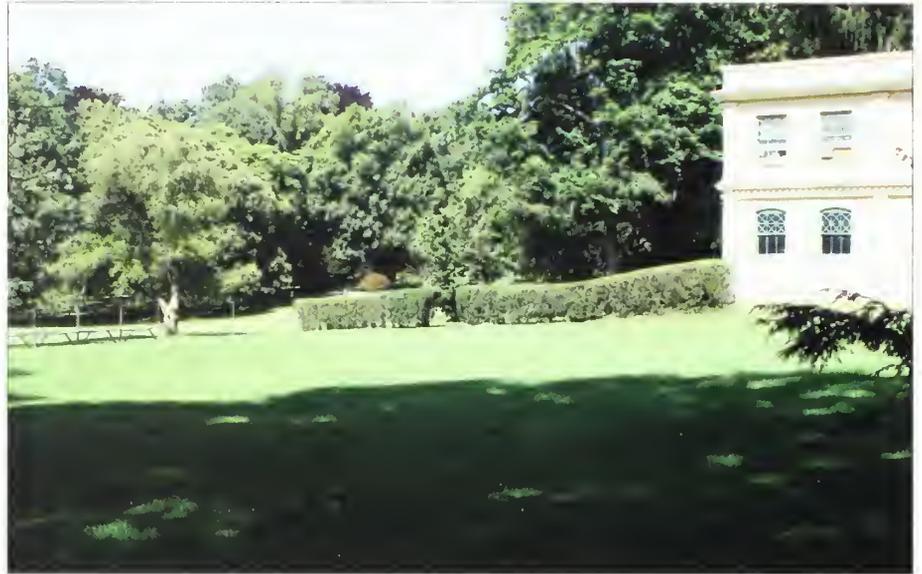
Figure 2.07: Spatial Organization. View looking southwest towards a portion of the south (lower), which historically was a vegetable garden;

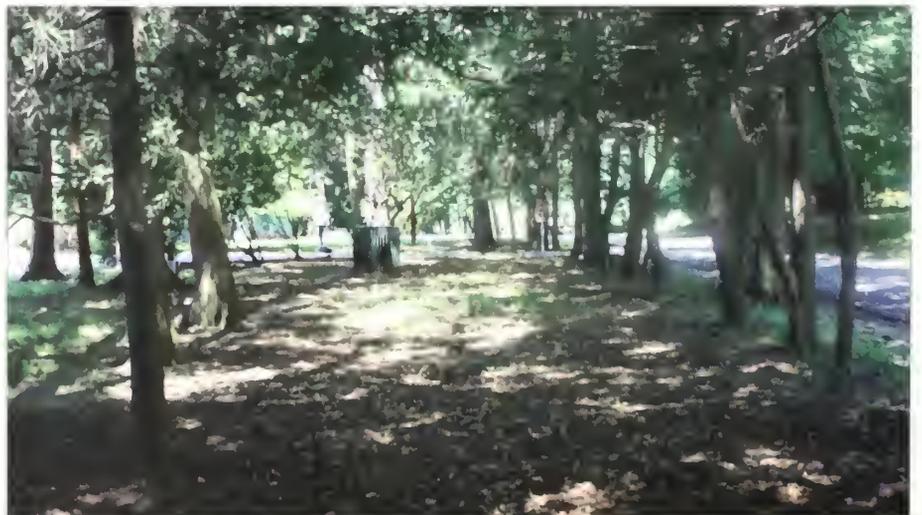
Figure 2.08: Spatial Organization. View looking northeast towards the woodland. The interior of the space remains largely wooded consisting of evergreen and deciduous trees and remnants of the woodland garden, as well as an organically-shaped depression marking the former location of the skating pond (OCLP, 2009).

The woodland is defined by Honeysuckle Avenue to the north and the main and secondary drives to the south, east, and west. With exception to an organically-shaped depression marking the location of the former skating pond, the interior is largely wooded consisting of cypress (*Chamaecyparis sp.*), hemlock (*Tsuga sp.*), Austrian pine (*Pinus nigra*), white pine (*Pinus strobus*), golden larch (*Pseudolarix amabilis*), American linden (*Tilia Americana*), sweet birch (*Betula lenta*), and Norway maple (*Acer platanoides*). Although the space lacks buildings, it includes many utility structures (cisterns and gas vault), as well as features associated with the former skating pond including rustic stone steps (Figure 2.08).
