## CULTURAL LANDSCAPE REPORT FOR GLENMONT

THOMAS EDISON NATIONAL HISTORICAL PARK  
WEST ORANGE, NEW JERSEY

# CULTURAL LANDSCAPE REPORT FOR GLENMONT

SITE HISTORY

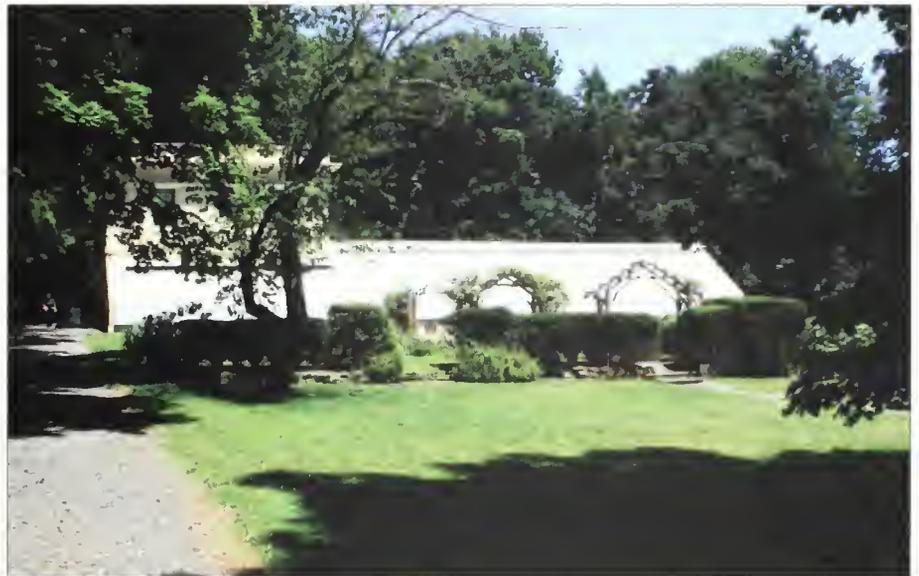
Figure 2.11: Spatial Organization. View looking north towards the service area, located in the northern portion of the property across Honeysuckle Avenue. It includes the gardener's cottage, potting shed, greenhouse, and concrete basin (pool) (OCLP, 2009).

The service area occupies the northern portion of the property across Honeysuckle Avenue. It is defined by a stone boundary wall on the north, the gardener's cottage, potting shed, and greenhouse driveway on the west, Honeysuckle Avenue on the south, and Glen Avenue to the east. Historically, the space contained a pool and service related buildings and structures, including a gardener's cottage, potting shed, chicken house and cow barn, greenhouse, and hot beds/cold frames, all surrounded by a series of paths and gardens. While the service related buildings and paths remain intact, the majority of the flower and vegetable have been removed and a filled concrete basin is all that remains of the pool (Figures 2.09-2.11).

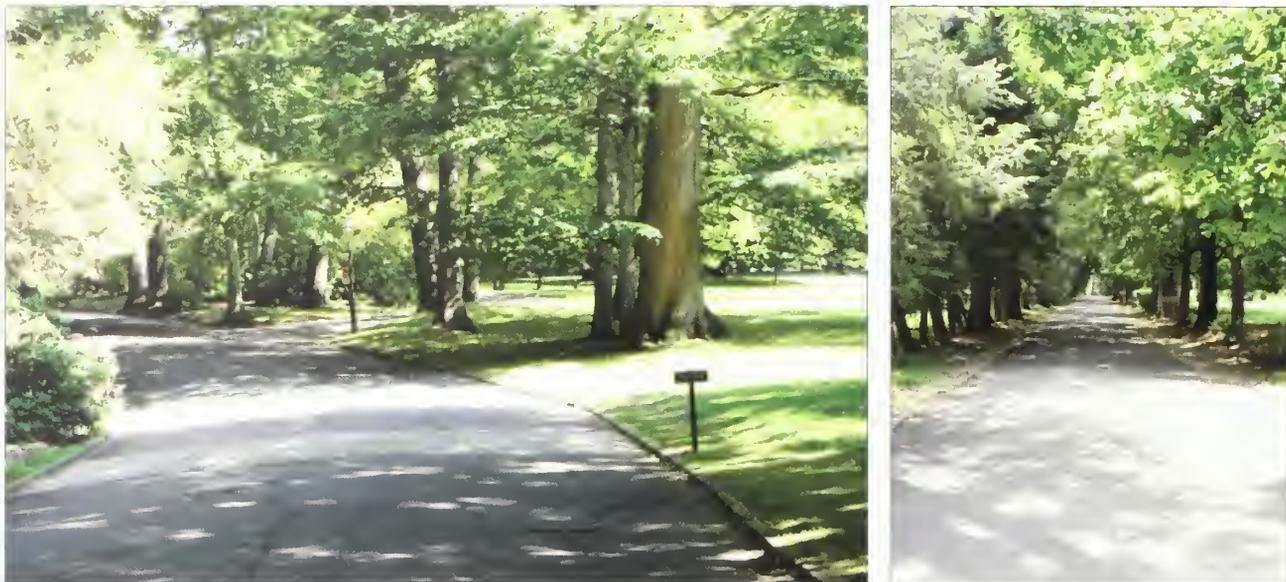
Figure 2.12: Circulation. (left) View looking northwest of Park Way. In the development of Llewellyn Park in the 1850s, approximately ten miles of sinuous roads encircled the ramble, the park's common park. The perimeter of the ramble was defined by Park Way on the east (shown above), Tulip Avenue on the west, and Mountain Avenue on the north (OCLP, 2009).

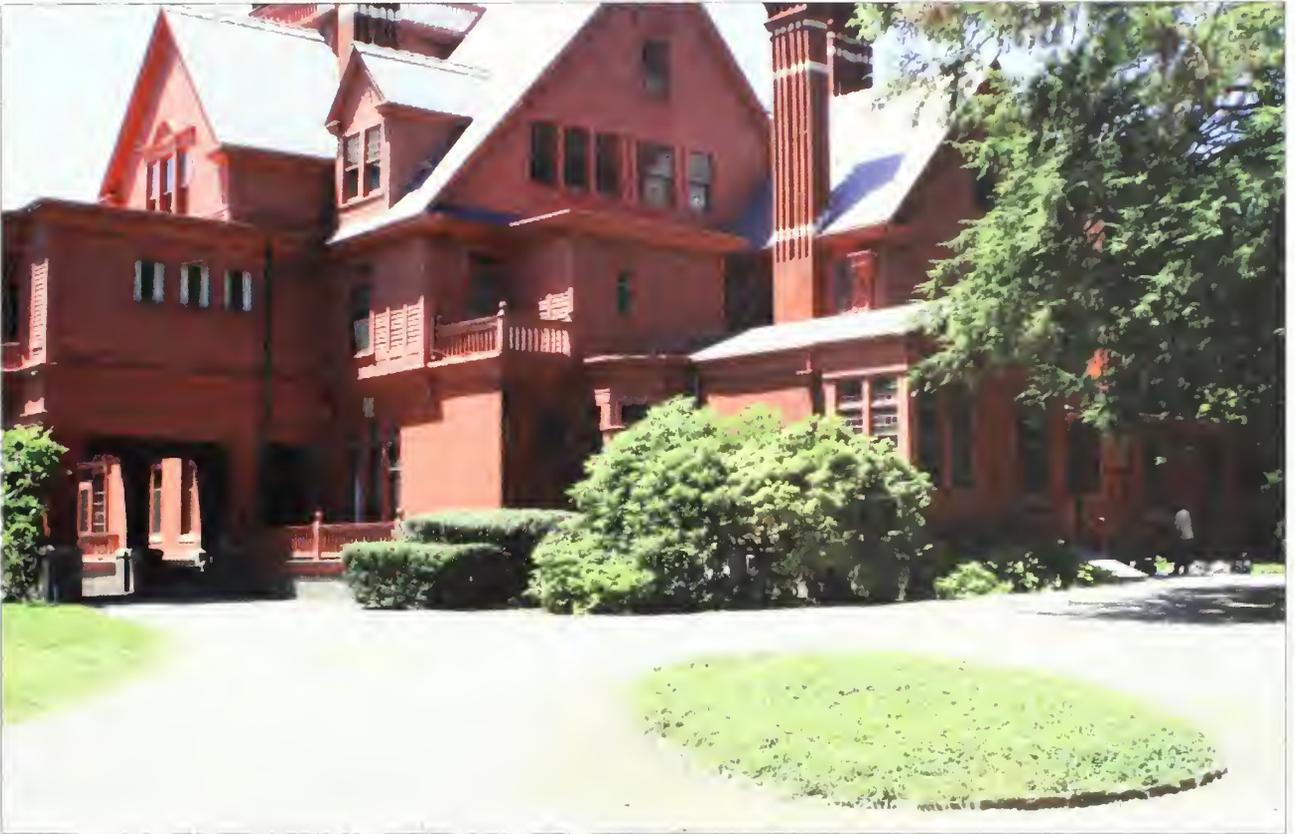
Figure 2.14: Circulation. View looking southwest of a portion of the main and secondary drives (right side of the house). Within the main and secondary drives, islands (as shown above) were embellished with ornamental flower beds. Following the death of the Mina Edison in 1947, many of the islands were simplified (OCLP, 2009).

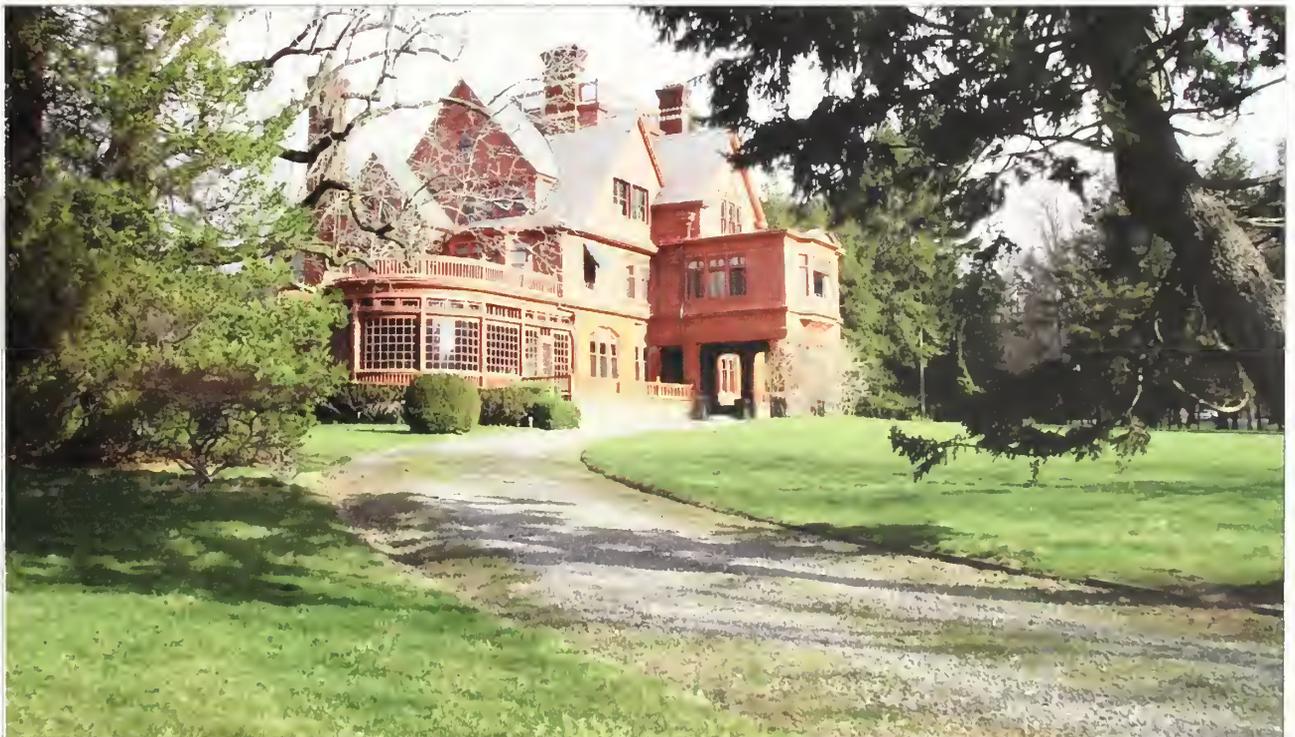
Figure 2.15: Circulation. View looking north of the main drive. The main drive curves through the landscape in a naturalistic alignment and ends in oval-shaped loop that passes beneath the porte-cochere of the house (OCLP, 2009).

The circulation of the Glenmont grounds consists of vehicular and pedestrian systems. The formal main entrance to the landscape, now inaccessible for visitor use, begins at a "Y" intersection off Park Way and curves through the landscape before gently rising to the east side of the Glenmont house where it terminates in a circular turnaround that passes beneath a porte-cochere. Two secondary drives, located near the laundry yard and garage, connect to the main drive by way of Honeysuckle Avenue, a service road that now serves as the primary pedestrian and vehicular entrance to the park. The width of the main and secondary drives is approximately ten feet and lined with flagstone curbing. Honeysuckle Avenue, approximately twelve feet in width, is surfaced in asphalt and lined with cobblestone gutters. Visitor and staff parking areas are located on the adjacent Tilney-Johnson property and along the barn driveway. Pedestrian circulation within the grounds is limited to a small path gravel path around the perimeter of the Glenmont house and a series of paths adjoining the Gardener's Cottage and Potting Shed and Greenhouse (Figures 2.12-2.20).

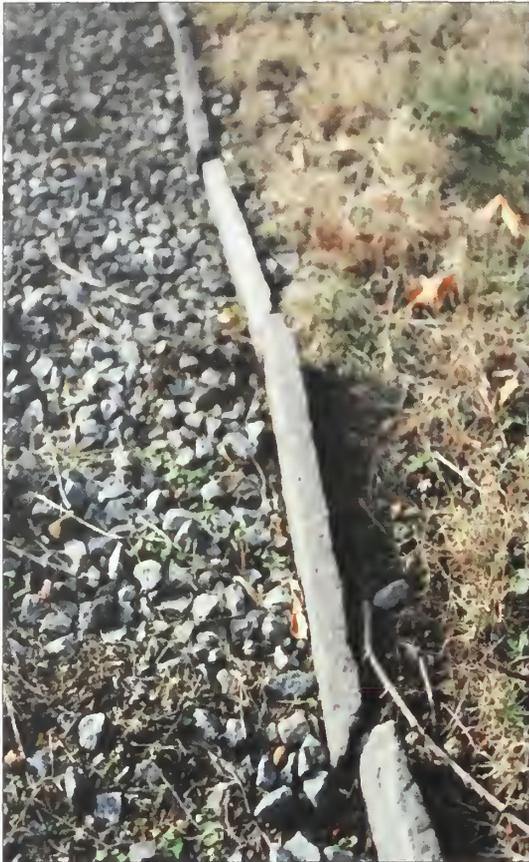
Figure 2.16: Circulation. The main and secondary drives measures approximately ten feet wide and are surfaced in crushed gravel and lined with flagstone edging (OCLP, 2009).

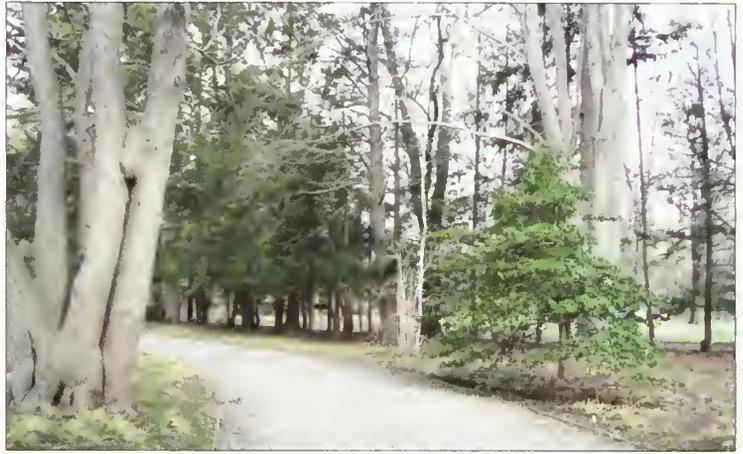
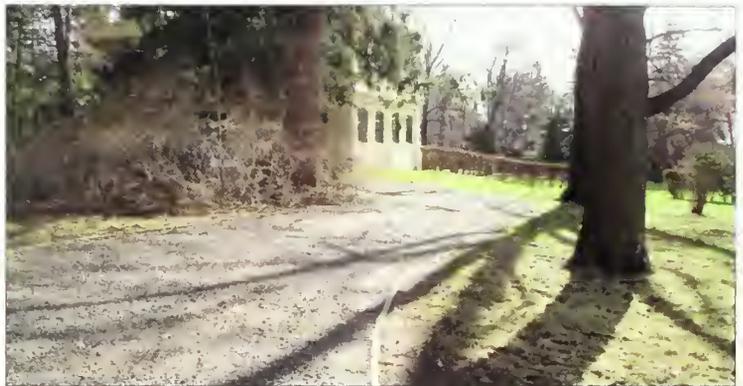
Figure 2.17: Circulation. (top) View looking north of a section of the main drive; (bottom) View looking south of a section of the main drive (OCLP, 2009).

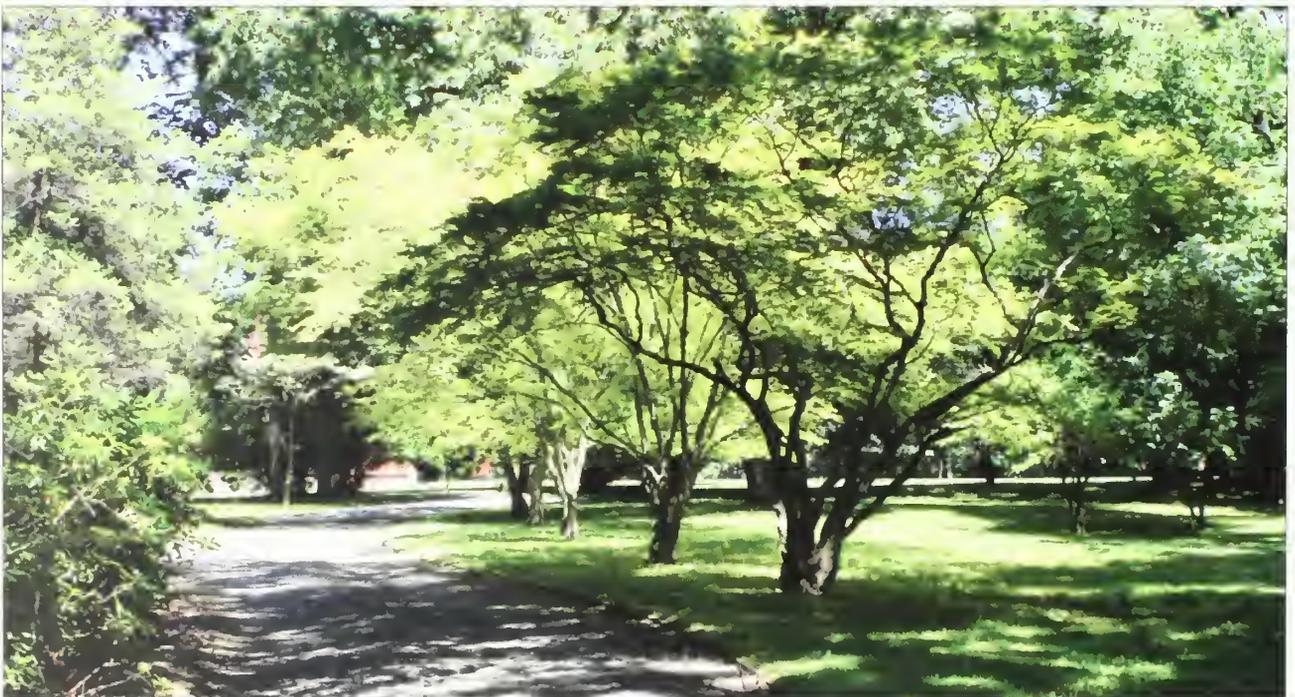
Figure 2.18: Circulation. View looking north of a portion of the main drive, which begins at Park Way where it branches into two legs that form two triangular islands before entering the front lawn (OCLP, 2009).

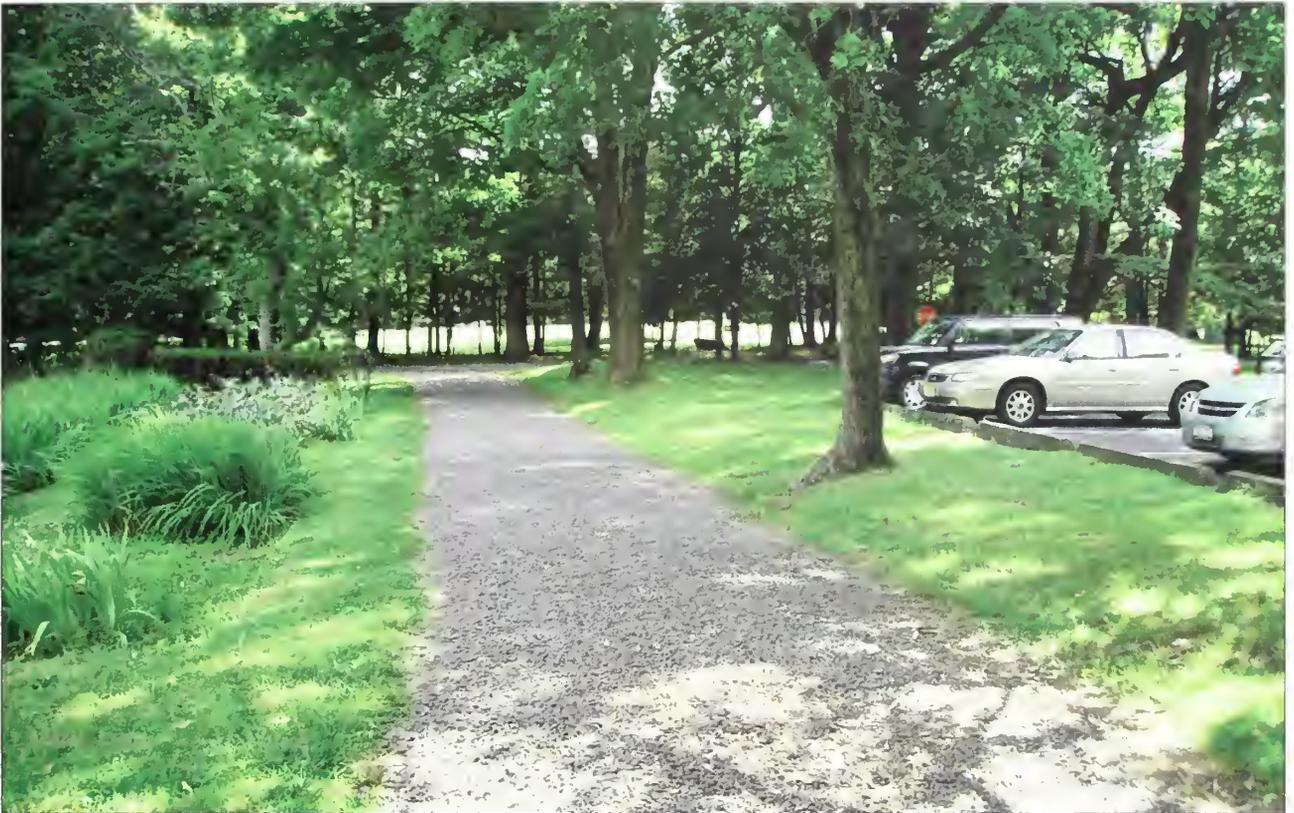
Figure 2.19: Circulation. View looking south towards the gravel driveway that leads to the gardener's cottage and potting shed (OCLP, 2009).

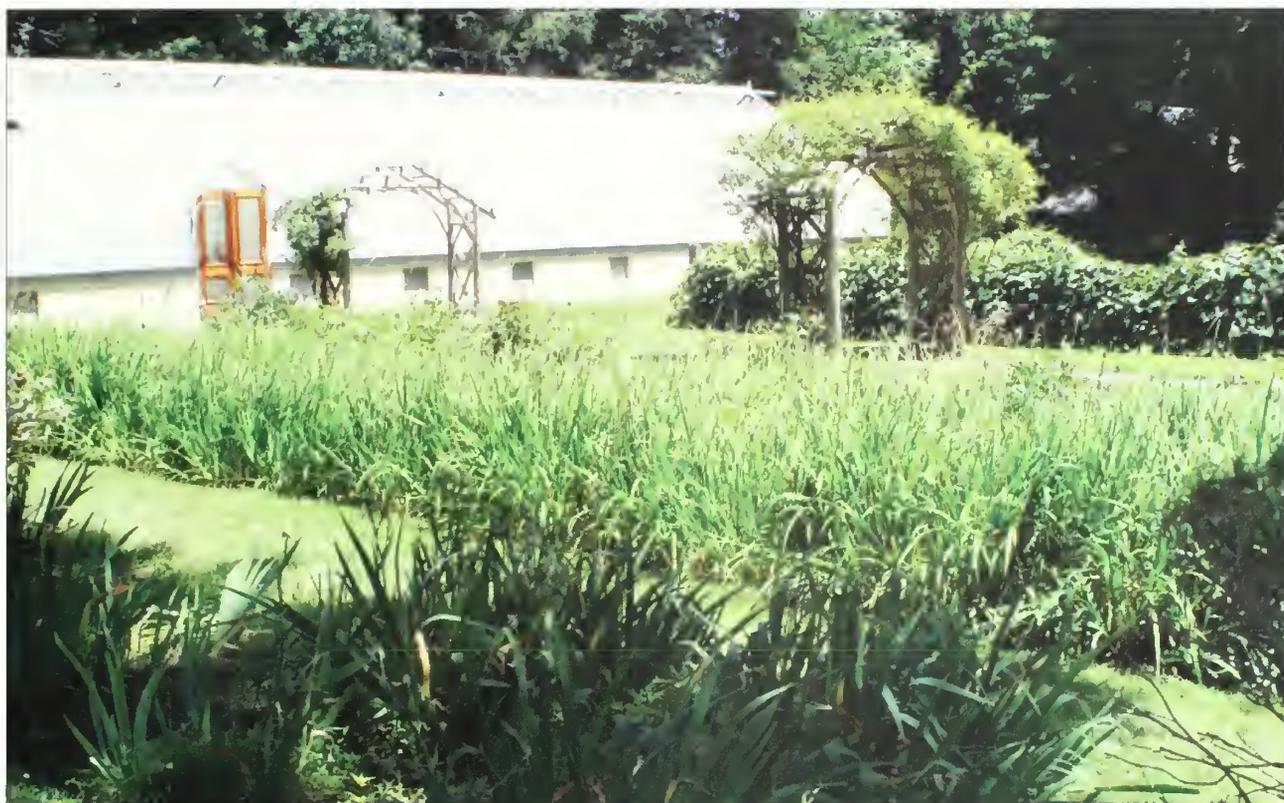
**Figure 2.32: Vegetation.** In 1937, Mina directed the redesign of the formal flower garden choosing to include features that had been recommended in a series of earlier 1929 Ellen Shipman plans. The new garden (shown above) was rectangular, incorporated axial grass paths, and was embellished by old-fashioned naturalized plantings and perennial borders that included peonies, hollyhocks, irises, achillea, larkspur, anemisis, and lilies. In addition, a rustic dry-laid stone retaining wall was constructed, a marble bench surrounded by arborvitae was added, and an additional rose arbor was built (OCLP, 2009).

plantings around the perimeter of the house, a flower garden located adjacent to the gardener's cottage and potting shed, and a linear flower bed—planted with peonies and hosta (*hosta sp.*), along Honeysuckle Avenue. The flower garden is structured by a series of grass walks that break the rectangular space into approximately three linear beds planted with irises, peonies, and daylilies. The garden features a rustic dry-laid retaining wall and rose arbors (Figures 2.32).

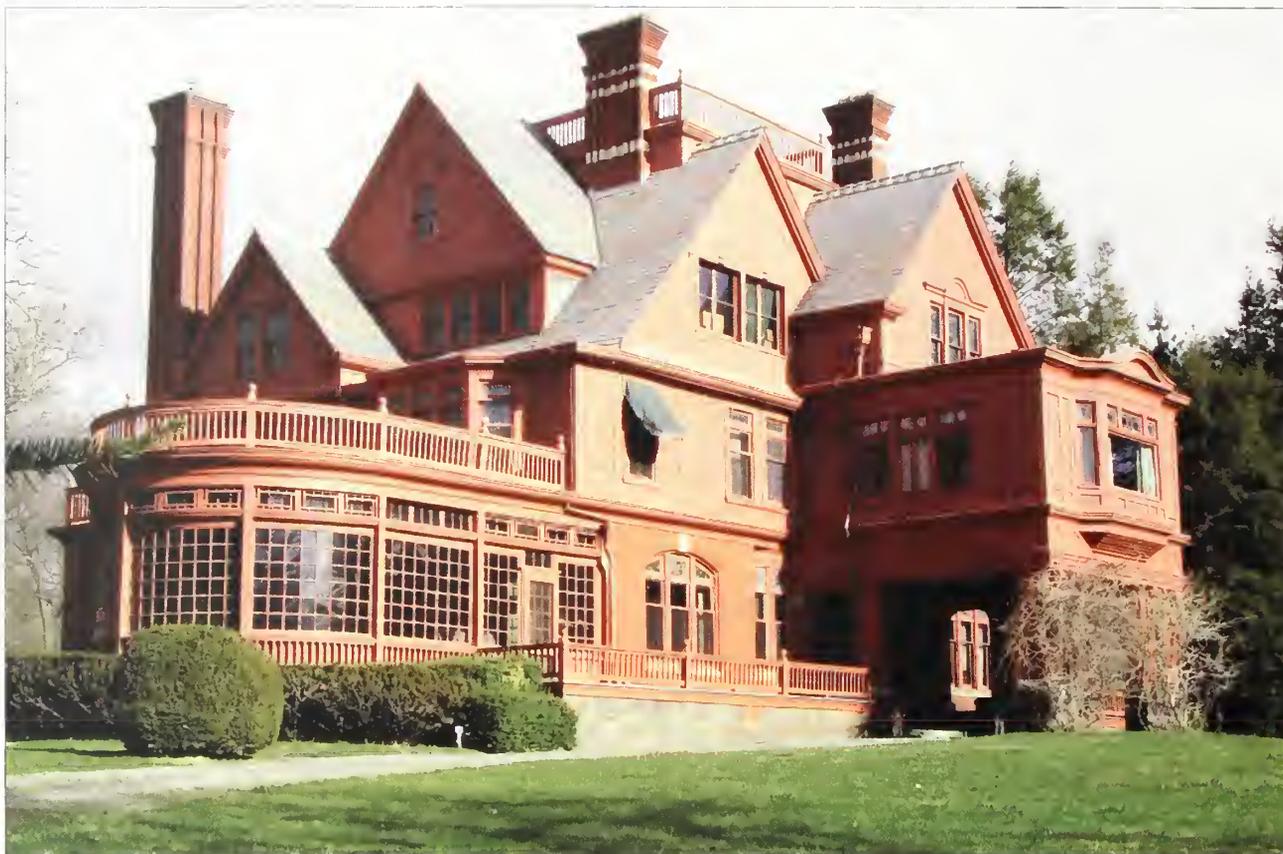
Figure 2.33: Buildings and Structures. View looking north of the Glenmont house. The house was built between 1880 and 1882, following the plans of prominent New York architect Henry Hudson Holly for Henry and Louisa Pedder. The three-story multi-gabled Queen-Anne style mansion is constructed of stone, brick, and stick and shingle design, and includes an attic, basement and contained twenty-nine rooms (OCLP, 2009).

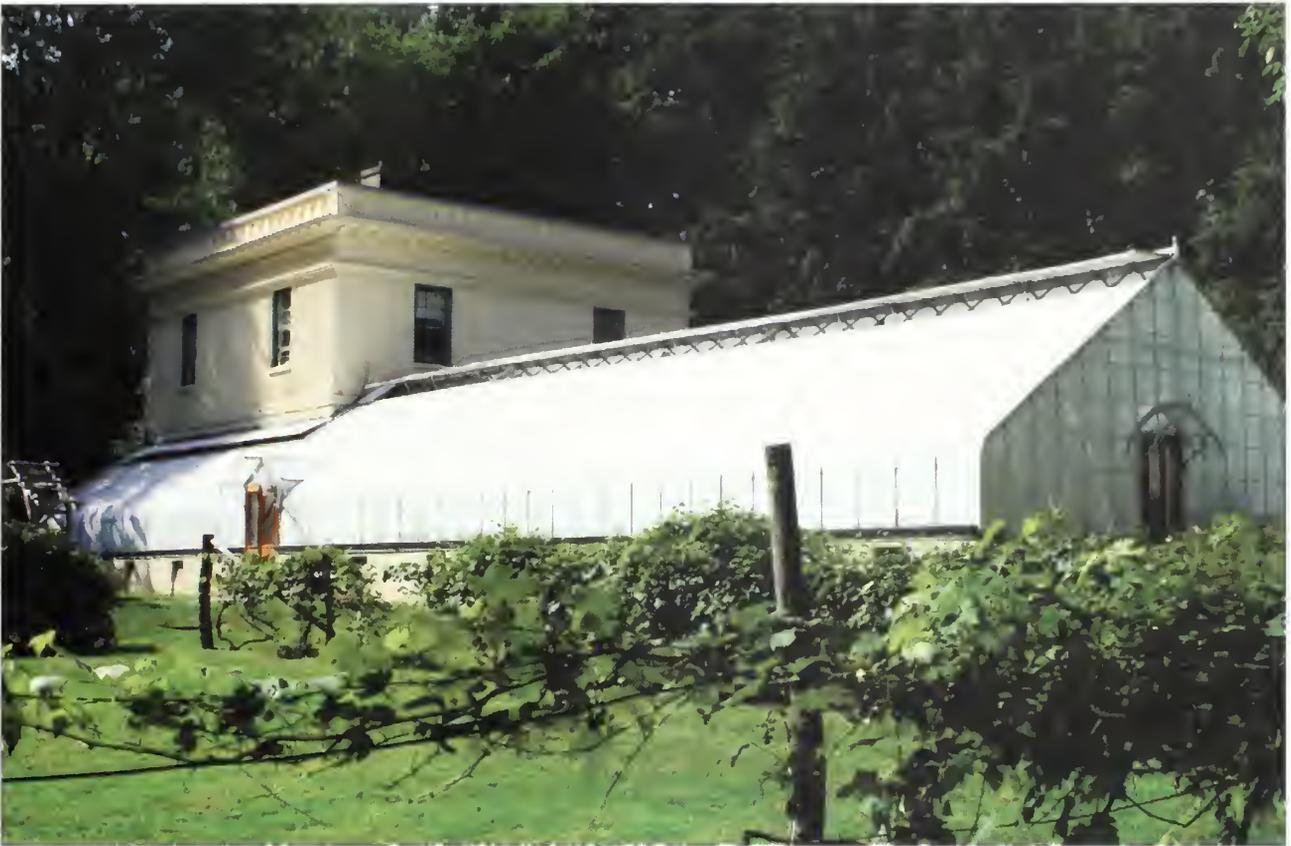
**Figure 2.34: Buildings and Structures.** View looking north towards the gardener's cottage, potting shed, and greenhouse. The gardener's cottage and potting shed, built in c.1908, is one of the earliest examples of monolithic concrete construction developed by Thomas Edison (OCLP, 2009).

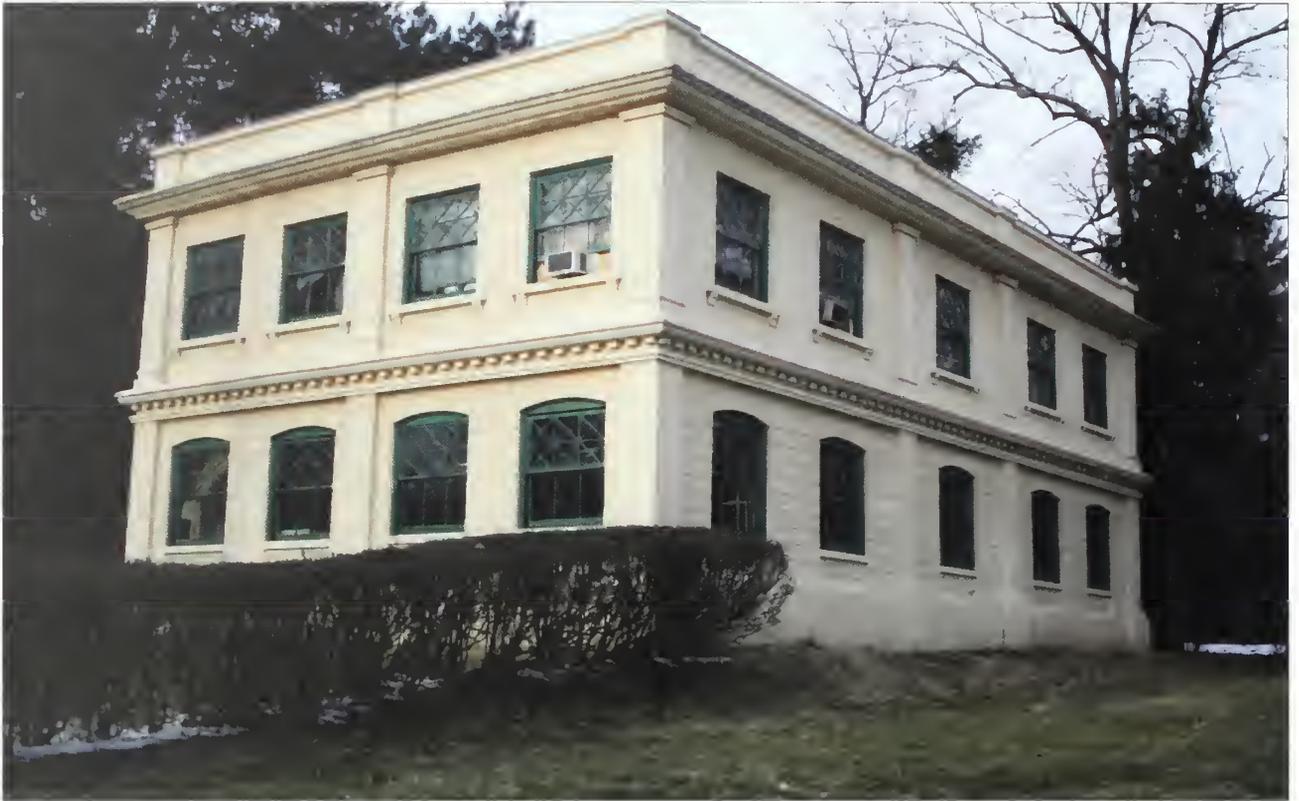
**Figure 2.35: Buildings and Structures.** View looking north towards the garage. It is one of the earliest examples of monolithic concrete construction developed by Thomas Edison. The two-story structure was erected in 1908, east of the house along Honeysuckle Avenue, and in the former location of Pedder's L-shaped chicken house and cow barn (OCLP, 2009).

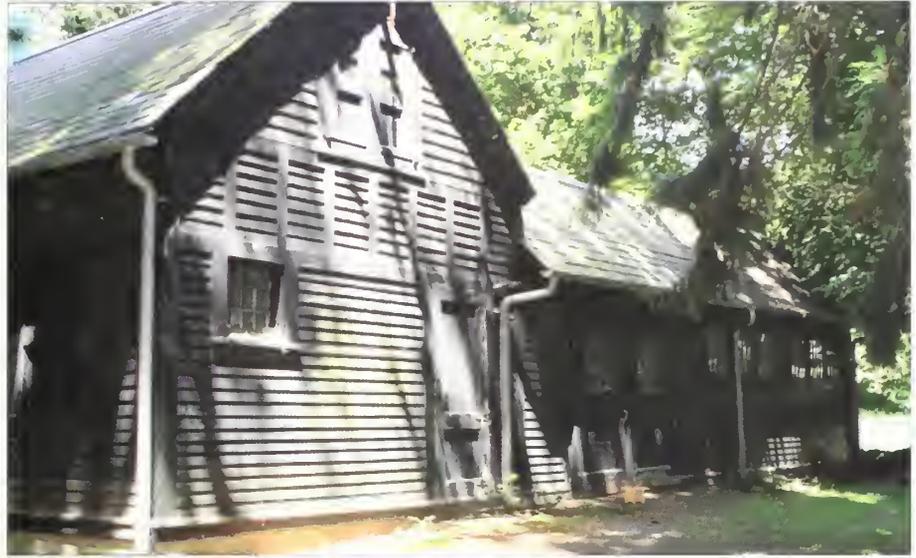
**Figure 2.36: Buildings and Structures.** View looking northeast of the chicken house and cow barn. The Victorian style chicken house and cow barn, built between 1880 and 1882, is east of the house along Honeysuckle Avenue. The L-shaped wood frame structure is one story high with a loft over the main portion. The exterior is sheathed in wood shingles and has a slate covered roof (OCLP, 2009).

The chicken house and cow barn (identified as “barn” in the list of classified structures database), built between 1880 and 1882, was originally situated on the site of the present garage, but was relocated to its current location across Honeysuckle Avenue in the service area in 1908. The Victorian style barn is an L-shaped structure, measuring approximately fifty-one feet by forty-two feet. The one-story structure is wood frame on a concrete foundation. The chicken house and cow barn is currently used for storing artifacts and maintenance equipment (Figure 2.36).

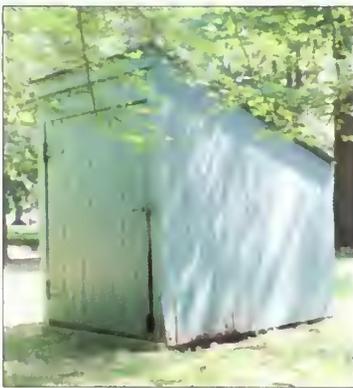
**Figure 2.37: Buildings and Structures.** The hose house, constructed in 1904, is a small-wood-frame structure used to house a fire-hose cart. It is situated within the laundry yard (OCLP, 2009).

yard, was originally constructed c. 1904-1905, and reconstructed in 1964. It is the smallest building at Glenmont, historically used to house a fire-hose cart (Figures 2.37-2.38).

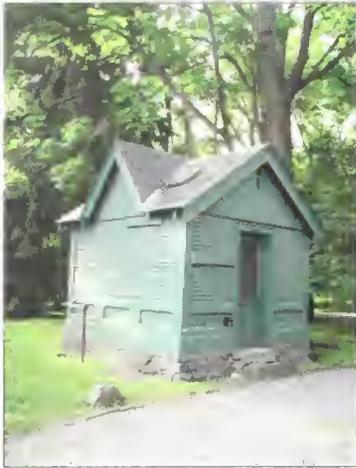
Figure 2.38: Buildings and Structures. Similar in Victorian architectural design and construction as the house, the pump house built between 1882 and 1884, is a small wooden structure with a cross gable roof set on a fieldstone and mortar foundation (OCLP, 2009).

The pump house, built between 1882 and 1884, is located north of the house and is adjacent to the laundry yard. Similar in Victorian architectural design and construction as the house, the pump house is a small wooden structure with a cross gable roof set on a fieldstone and mortar foundation. It is set over a drilled well and contains a water-pump and electric-motor combination to draw potable drinking water for the house. The pump house is currently not in operation. The hose house, located approximately sixty feet from the house in the laundry

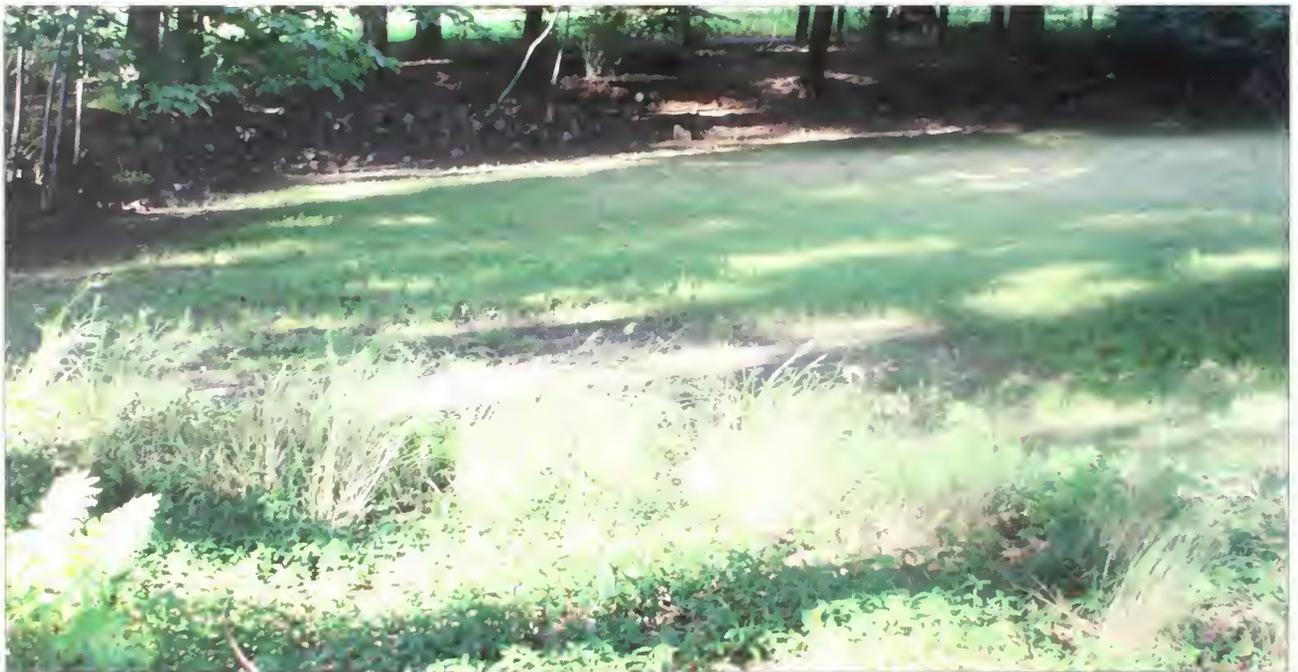
Figure 2.39: Buildings and Structures. View looking east towards the skating pond site, currently situated within the woodland space along Honeysuckle Avenue in the former location of the Pedder barn—removed in 1920. All that remains of the skating pond, is a roughly 90’ x 75’ organically-shaped earthen depression lined with stone, rustic dry-laid stone steps, and associated plumbing systems (OCLP, 2009).

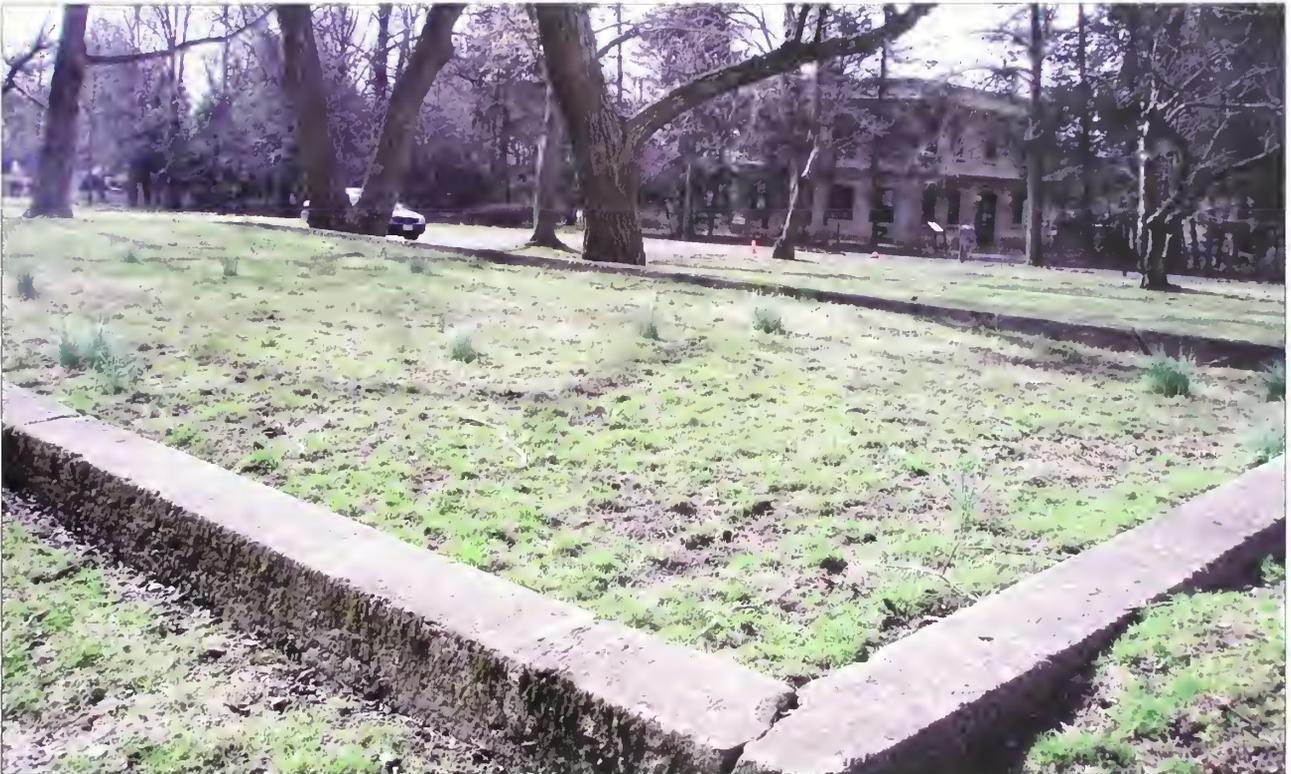
Figure 2.40: Buildings and Structures. View of the concrete basin historically used as a swimming pool. In the mid-1970s, the National Park Service filled in the pool with swamp mud from Morris County, leaving the concrete sides exposed. The structure was later stabilized in 2003. The rectangular concrete basin is approximately 26'x45' (OCLP, 2009).

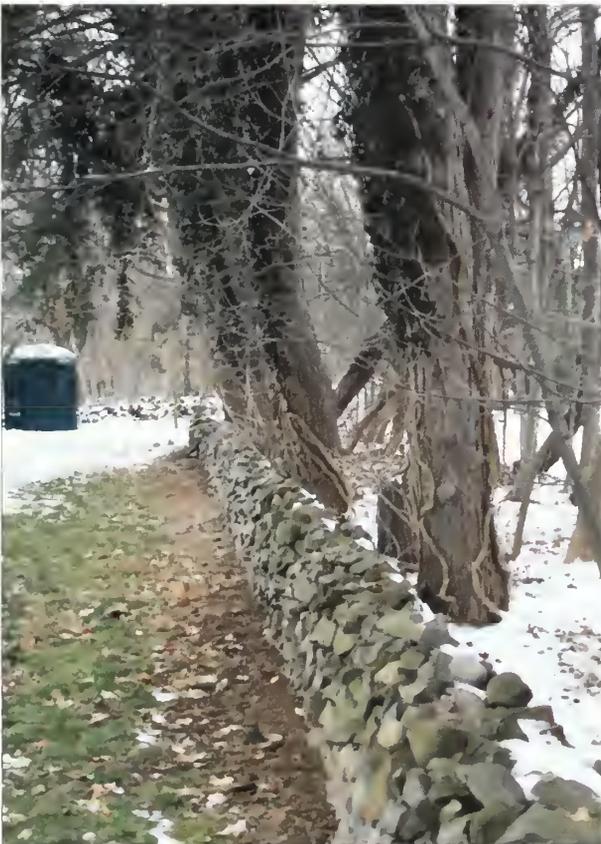
Figure 2.41: Buildings and Structures. The stone boundary wall, located along the northern boundary of the service area across Honeysuckle Avenue, was constructed c.1908 when several improvements to the grounds were underway (OCLP, 2009).

the garage, gardener's cottage and potting shed, and swimming pool, and the relocation of the chicken house and cow barn. It is an approximately three feet high loose-laid, rubble wall comprised of brownstone, bluestone, bricks, and concrete chunks. Originally two hot beds/cold frames were located east of the greenhouse's north wing. While the exact date of construction is uncertain, only one hot bed foundation remains. The U-shaped concrete wall is approximately forty-two feet long by two feet high and is comprised of mortared brick sheathed in concrete. A rustic dry-laid retaining wall, constructed c.1937, is located within the flower garden area south of the gardener's cottage and potting shed. The wall, approximately forty feet in length and two feet in height, is surmounted by a manicured yew hedge. A handicap portable restroom, installed between 2006 and 2007, is located adjacent to the gardener's cottage and potting shed. The restroom is an approximately 5' x 5' plastic structure. In recent years, a fireproof metal structure was installed near the visitor parking area. The rectangular structure is currently used for storing maintenance equipment (Figures 2.41-2.43).

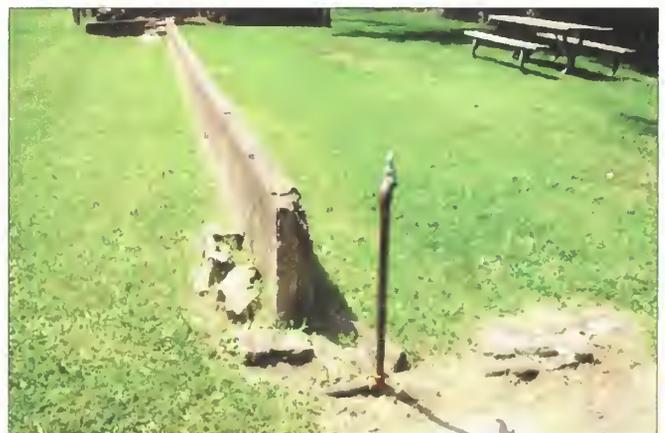
Figure 2.42: Buildings and Structures. The hotbed (or cold frames) foundation, built between 1882 and 1884, contributes to the significance of Glenmont as a remnant of the original greenhouse complex that was constructed by Henry Pedder. (OCLP, 2009).

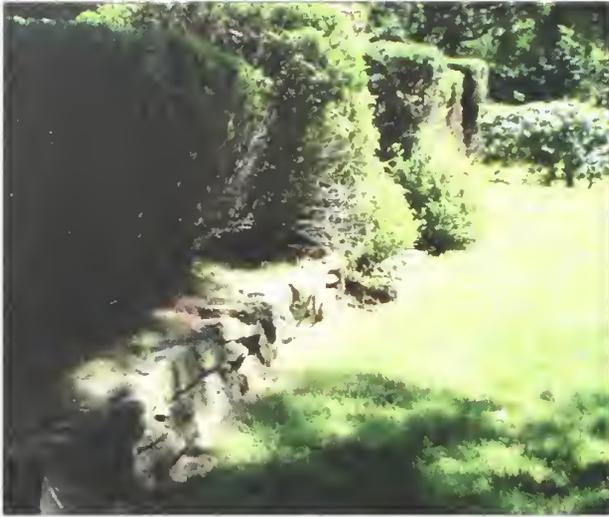
Figure 2.43: (left) Buildings and Structures. View looking east of the rustic dry-laid retaining wall. In 1937, the wall—located near the gardener’s cottage, potting shed, and greenhouse—was built as part of the redesigned flower garden. At the time of its construction, the wall was built over an early cistern, which required the use of iron bars for stability and support. In recent years, the bars have rusted causing the wall to fail in certain areas, specifically in the location of the stone steps (OCLP, 2009).

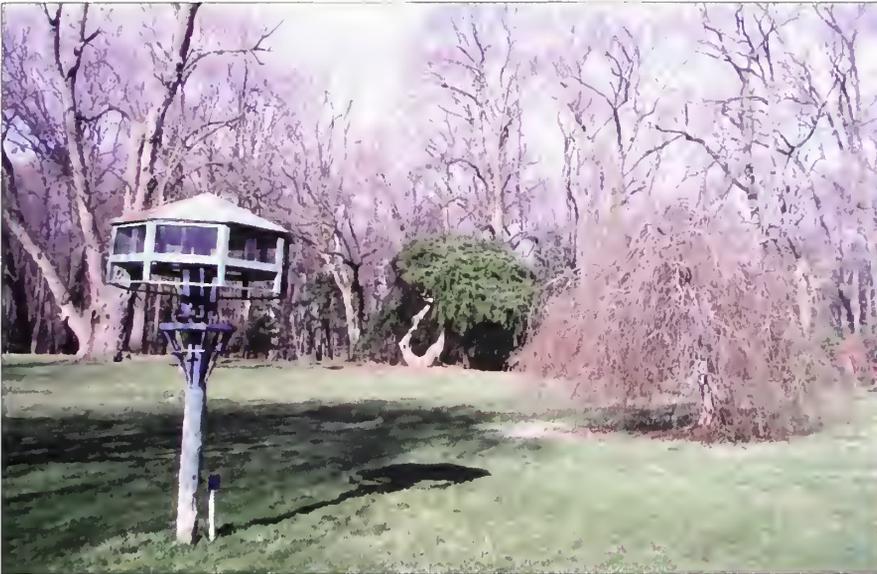
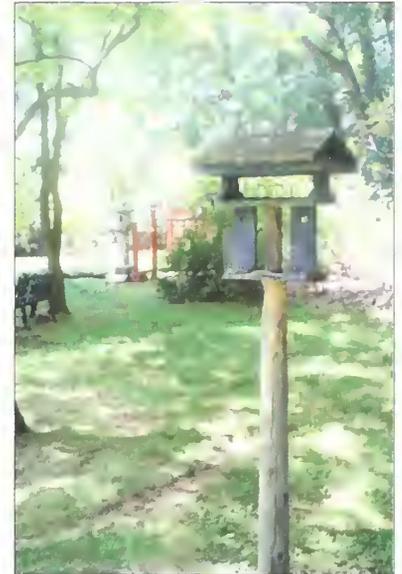
Figure 2.46: (left) Small-scale features.

The gazebo bird feeder, restored in the late 1960s, is located southwest of the conservatory. It is perhaps the largest of several types of bird feeders installed at Glenmont. The bird feeder is a six foot high, metal-clad, glazed octagonal shelter with a hipped roof and sill perches. Below the feeder box is a rustic multi-bracketed seed tray with a segmented wood "tension ring." (OCLP, 2009).

Reflecting Mina Edison’s interest in bird watching, bird baths and feeders of various sizes and materials are found throughout the Glenmont grounds. In particular, the gazebo bird feeder, restored in the late 1960s, is located southwest of the conservatory. It is perhaps the largest of several types of bird feeders installed at Glenmont. The bird feeder is a six foot high, metal-clad, glazed octagonal shelter with a hipped roof and sill perches. Below the feeder box is a rustic multi-bracketed seed tray with a segmented wood “tension ring.”<sup>16</sup> Additional bird feeders and bird baths are located throughout Glenmont grounds (2.46-2.47).

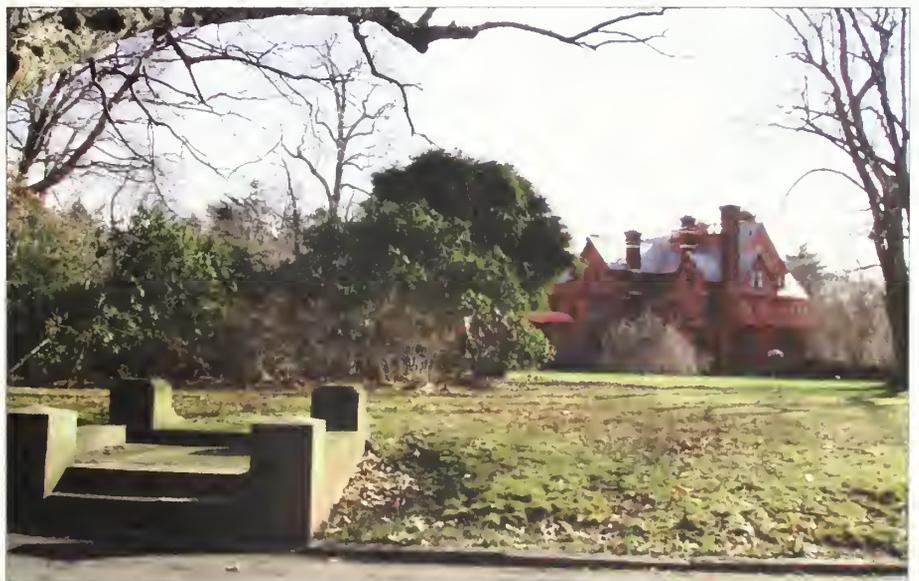
Figure 2.48: (bottom) Small-scale features. View looking north of the bluestone stoop, constructed between 1880 and 1882. Located along Park Way, the rectangular bluestone stoop was more than likely used for mounting carriages and consists of two steps with nosings; a large square landing with mitered border; and is flanked on each side by monolithic stone piers connected by low walls (OCLP, 2009).

network of sinuous paths that meandered through the west and southwest portion of the property, eventually leading up to and around the house. It is comprised of two steps and a large square landing, flanked on each side by monolithic stone piers (Figure 2.48).<sup>17</sup>

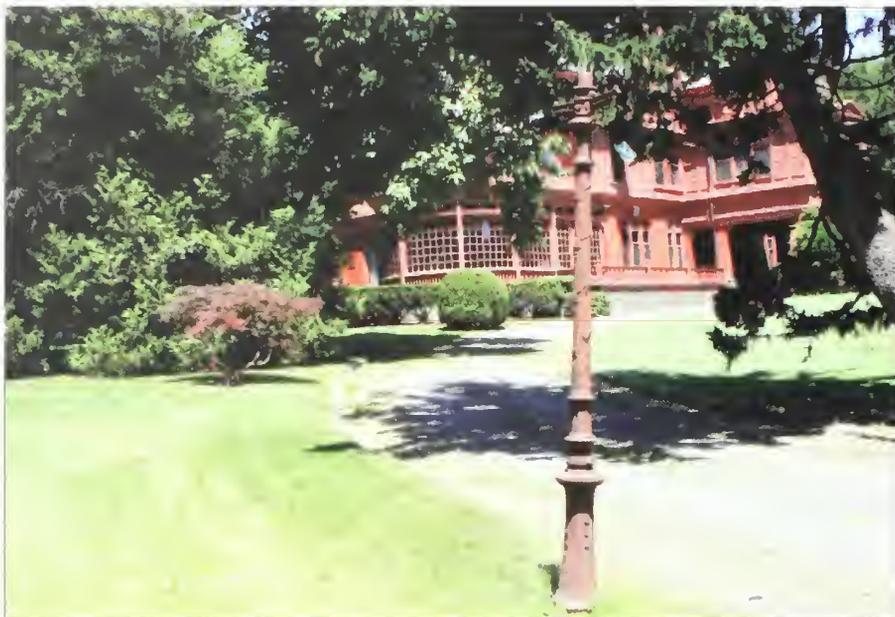
Figure 2.49: Small-scale features. A gas light pole found within the Glenmont property, installed in c.1880. Only two gas lamp posts remain from the historic period (OCLP, 2009).

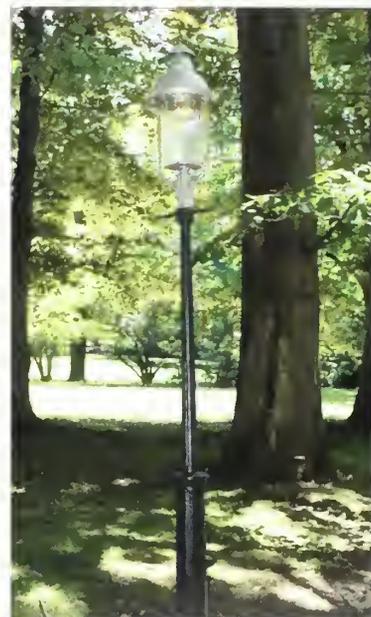
Figure 2.50: Small-scale features. Llewellyn Park gas lamp posts, installed 1880s (OCLP, 2009).

As part of the initial development of Glenmont in the early 1880s, Henry Pedder built extensive above and underground utility systems for water and gas (lighting) throughout the Glenmont grounds. These systems, still extant within the landscape, include two cisterns in the west and south lawns, a well, cesspool, a network of storm drains along the edges of the drives, a gas vault, and two gas cast-iron lamp standards (Figures 2.49-2.50).

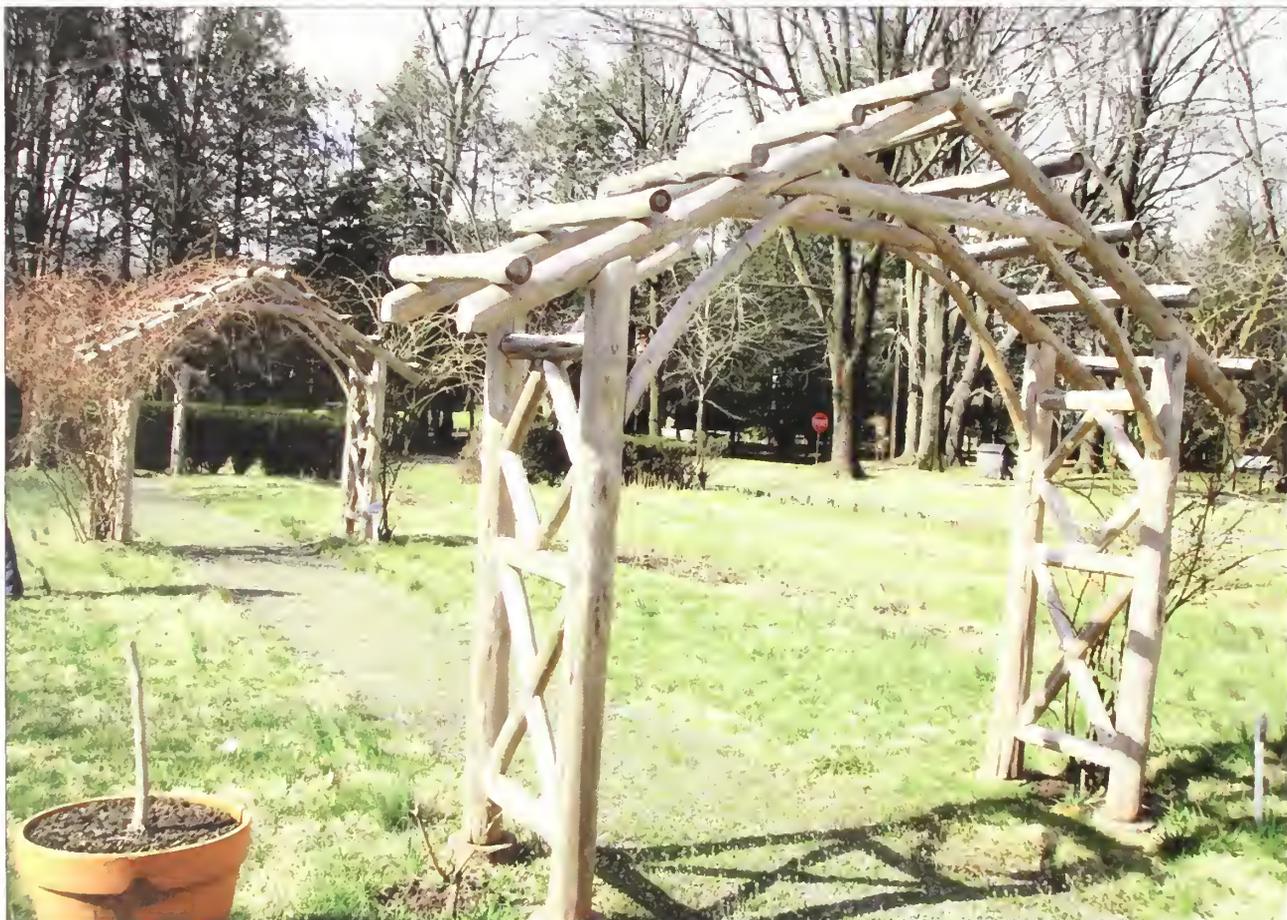
Figure 2.51: Small-scale features. Rustic arbor found within the flower garden adjacent to the greenhouse complex. These rustic arbors were reconstructed in 2008 (OCLP, 2009).

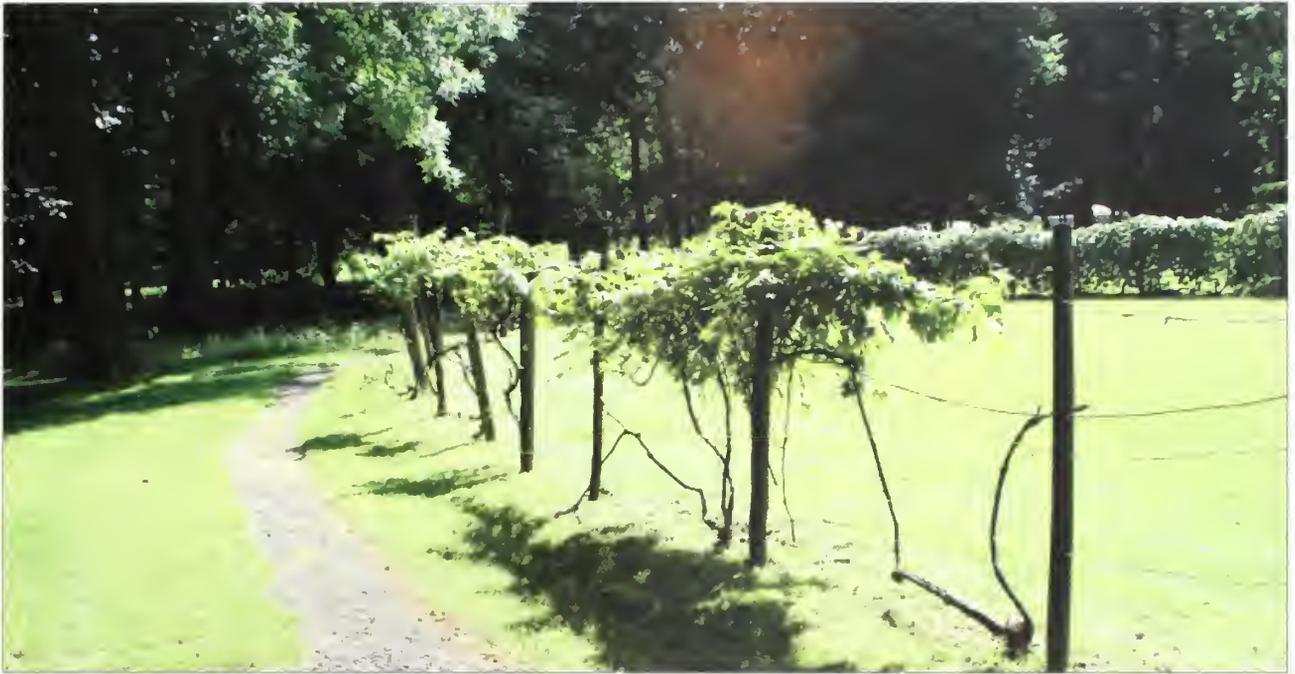
Figure 2.52: (top) Small-scale features. Grape arbor/trellis found within the service area (OCLP, 2009).

Features of the flower and vegetable gardens that once existed within the Glenmont grounds include rustic arbors and a section of wooden fencing. The three wooden rustic arbors, constructed between 1886 and 1931, are located along the walkway within the remaining flower garden, adjacent to the gardener’s cottage, potting shed and greenhouse. The section of wooden fencing, constructed c. 1882, is found south of the garage in the former location of the vegetable garden (Figures 2.51-2.54).
