## CULTURAL LANDSCAPE REPORT FOR GLENMONT

THOMAS EDISON NATIONAL HISTORICAL PARK  
WEST ORANGE, NEW JERSEY

# CULTURAL LANDSCAPE REPORT FOR GLENMONT

SITE HISTORY

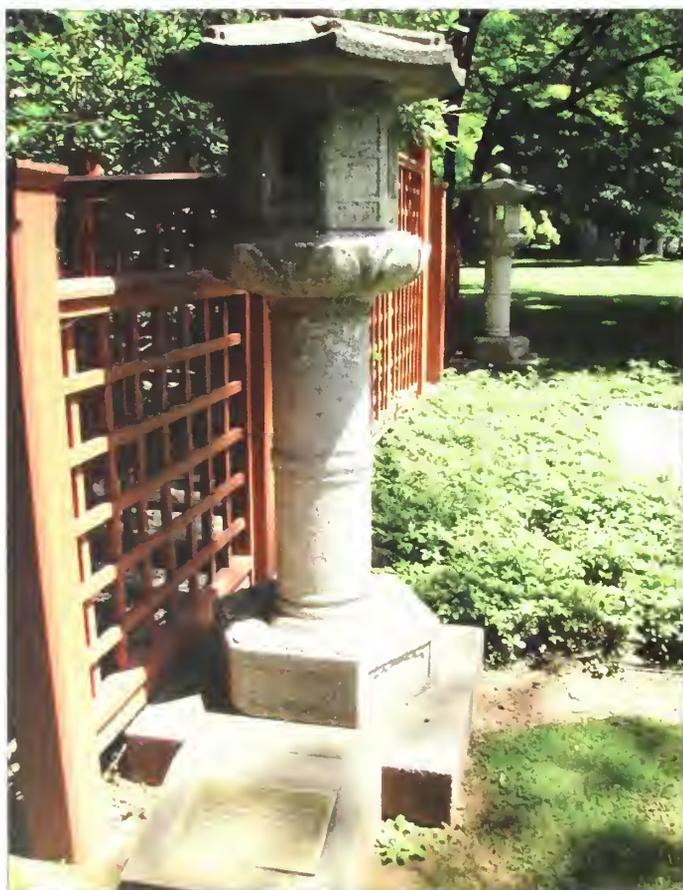
Figure 2.57: Small-scale features. In 2003, two Yunoki-type stone lanterns and a cedar decorative fence were included as a backdrop to the Edison gravesite. The stone lanterns were a gift from Japan in 1935 as an expression of the "Japanese people's appreciation of Edison's contribution to the welfare of mankind."

The Edison gravesite, located within the west lawn (back lawn), is situated within a large grouping of rhododendrons, laurels, and Japanese maples. It is marked by two rectangular marble tablets memorializing Thomas and Mina Edison. The tablets rest atop granite slabs, surrounded by pachysandra, and are bordered by two Yunoki-type stone lanterns and a cedar decorative fence (Figures 2.56-2.57)

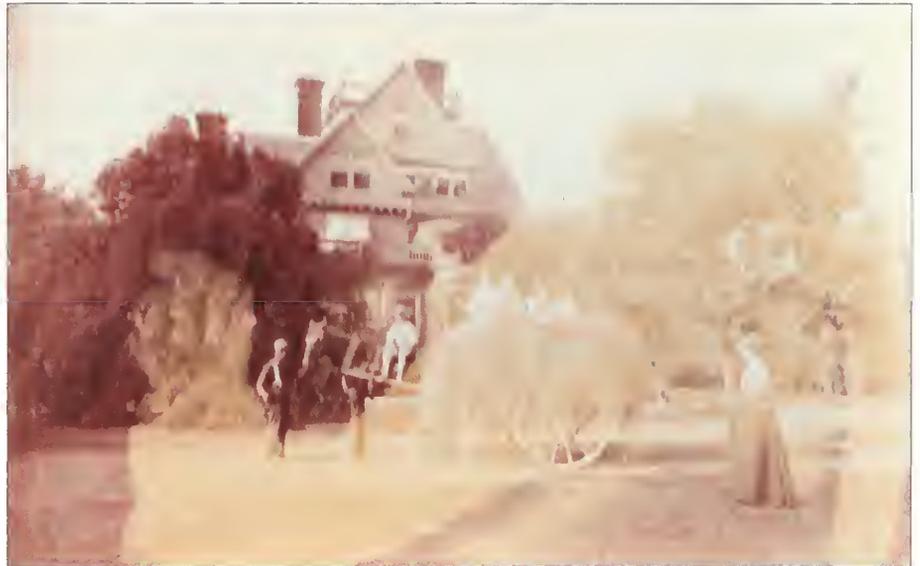
Figure 3.00: Spatial Organization. A c.1890s view of the west lawn looking north towards the weeping cherry (*Prunus subhirtella*) and house (EDIS Archives, 14.335.7).

of the hemlock hedges between 1910 and 1925 and the removal of a path that proceeded from the Conservatory to Park Way, southeast of the house (Figures 3.00-3.05).

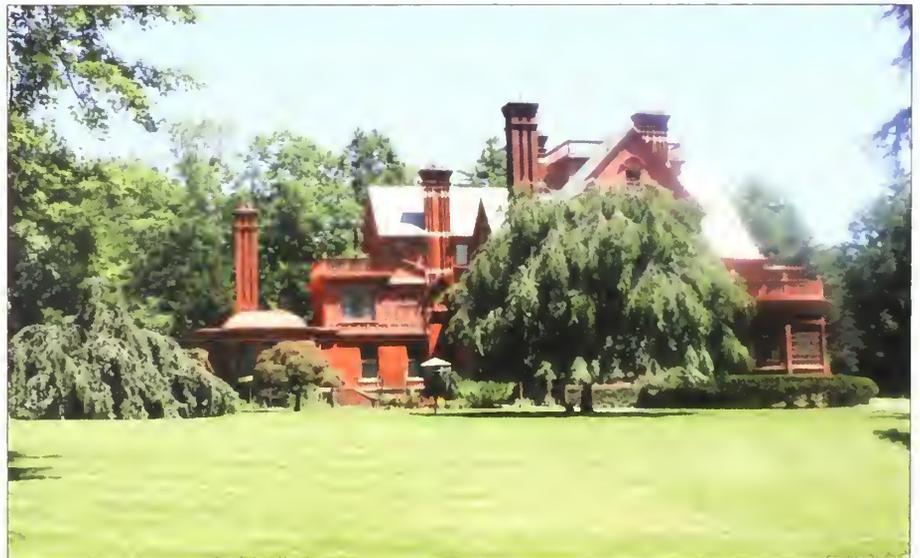
Figure 3.01: Spatial Organization. A 2009 image, taken at a similar vantage point, of the west lawn looking north towards a weeping cherry, (*Prunus subhirtella*) and weeping beech (*Fagus sylvatica*). Both trees were replaced in-kind between 1980 and c1990s (OCLP, 2009).

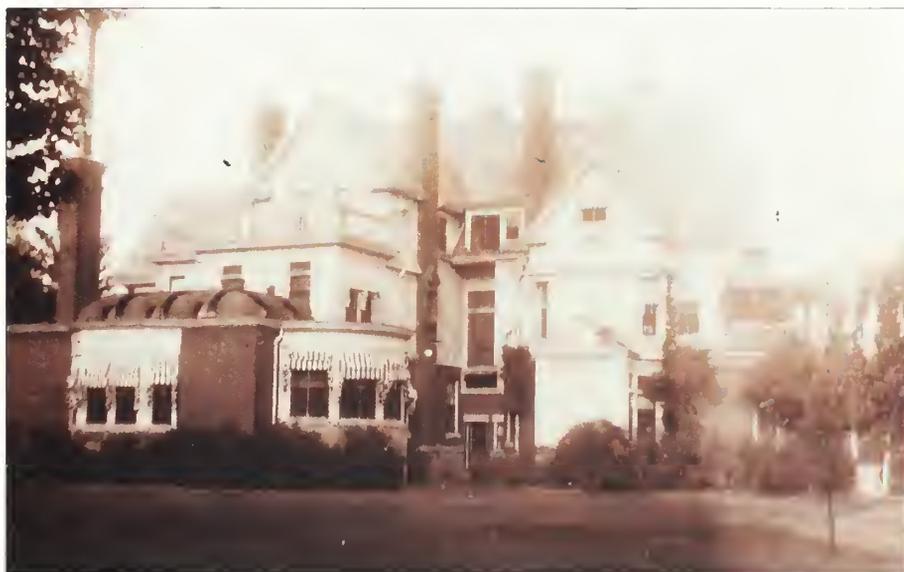
**Figure 3.02: Spatial Organization.** View looking northeast towards the house and young trees within the west lawn, c. 1905-1909 (EDIS Archives, 12.420.26).

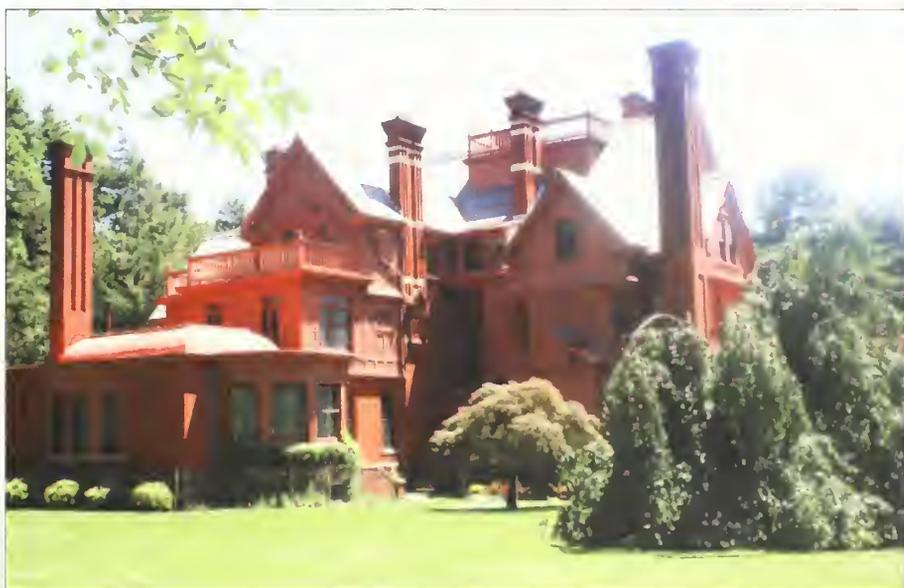
**Figure 3.03: Spatial Organization.** Similar view looking northeast towards the house. The open spatial character and vegetation remain very similar today as it existed during the historic period (OCLP, 2009).

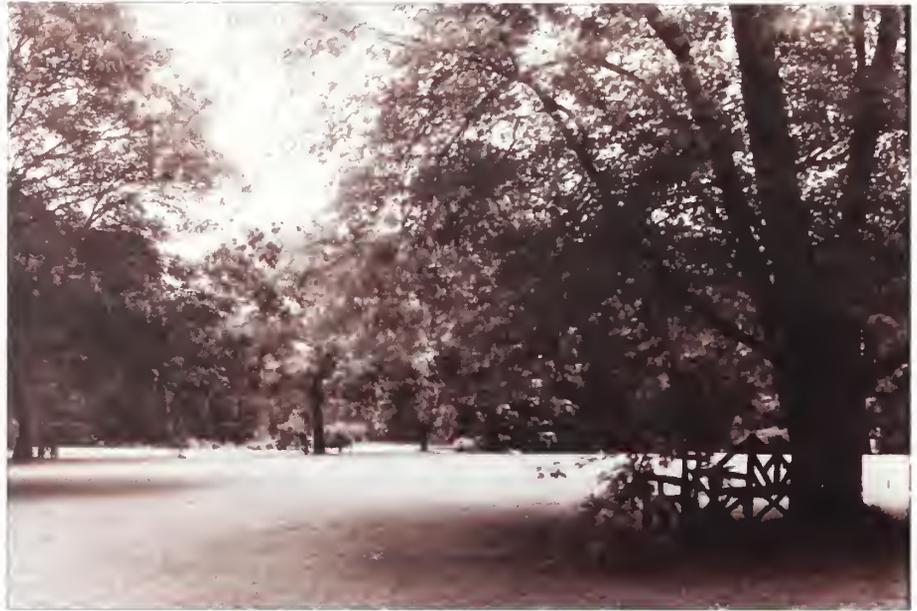
Figure 3.04: Spatial Organization. A c. 1913 view looking southeast of the west lawn. Note the open character of the west lawn and orchard in the background (EDIS Archives, 12.420.37).

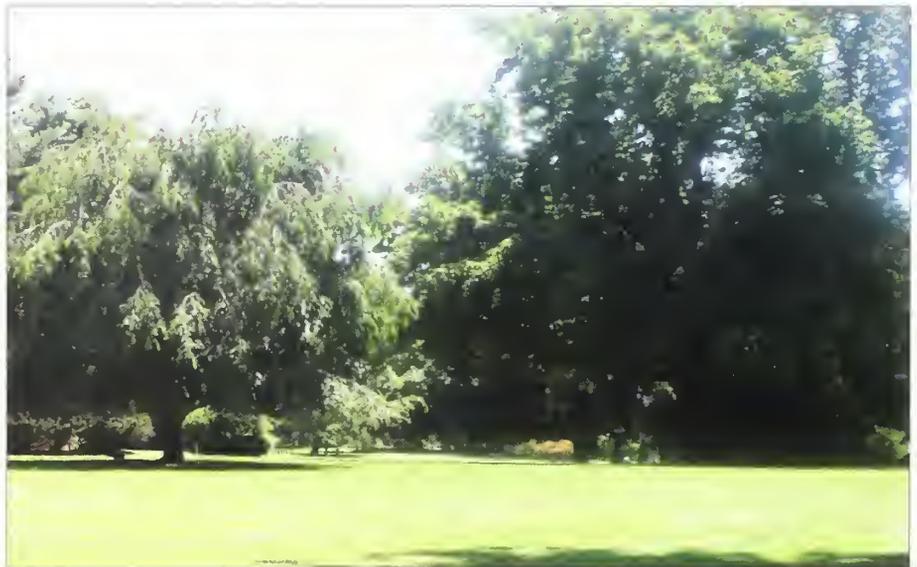
Figure 3.05: Spatial Organization. This image, oriented in the same direction, shows the west lawn and similar open character. Note the planter (right) and orchard (left) in the distance (OCLP, 2009).

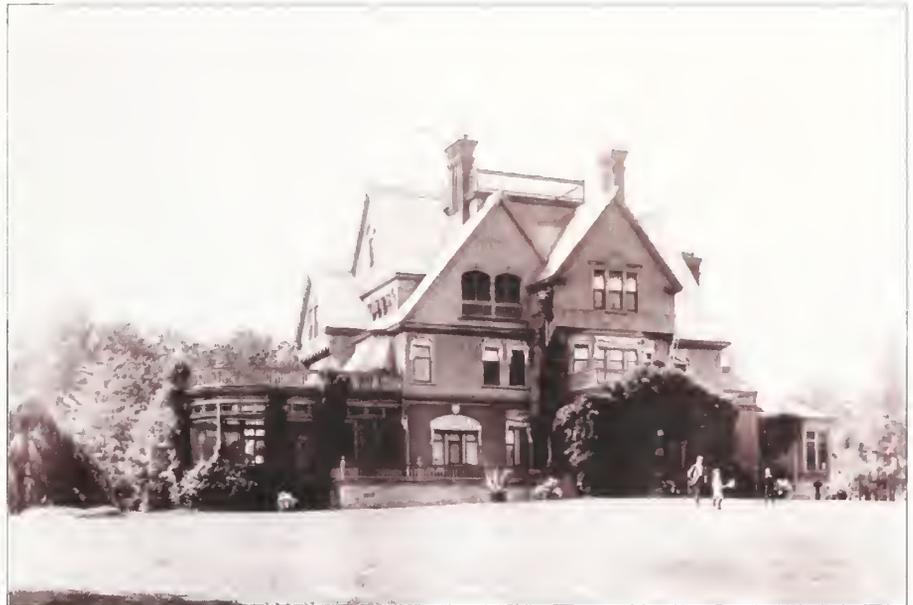
Figure 3.06: Spatial organization. Pre-1905 view looking northwest towards children playing tetherball in the front lawn. The image documents the open character of the front lawn, various planters, vines on the house, and the absence of foundation plantings (EDIS Archives).

(1886-1931), the oval lawn was partially enclosed with the planting of deutzias along the southern edge of the oval lawn and the establishment of evergreen and deciduous trees along the eastern edge of the oval lawn to screen the service related functions—the barn, chicken house and stable, and vegetable garden (Figures 3.06 and 3.07).

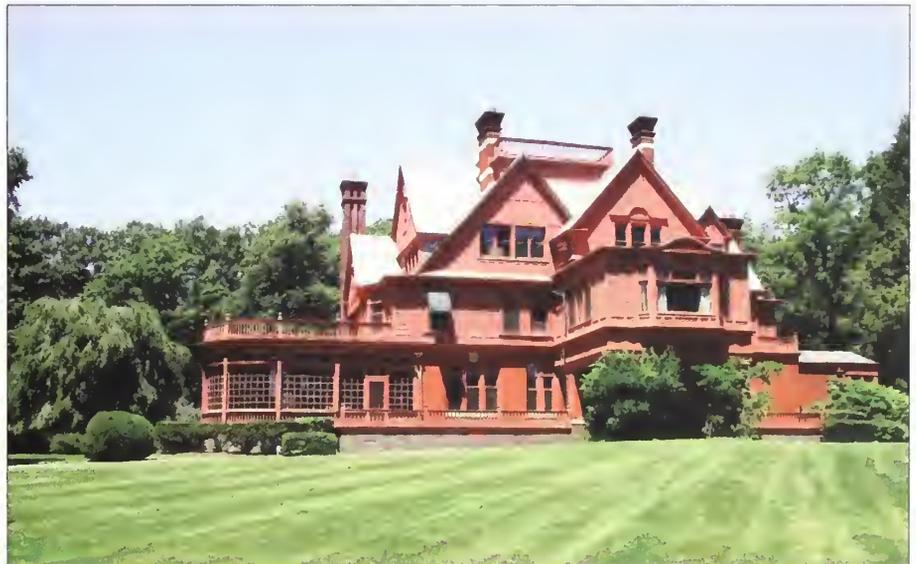
Figure 3.07: Spatial organization. A 2009 image looking northwest towards the front lawn. While the front lawn remains open in character and wisteria remains extant on the porte-cochere, the conservatory is no longer embowered by vines and foundation shrubs exist around the conservatory and along the east elevation (OCLP, 2009).

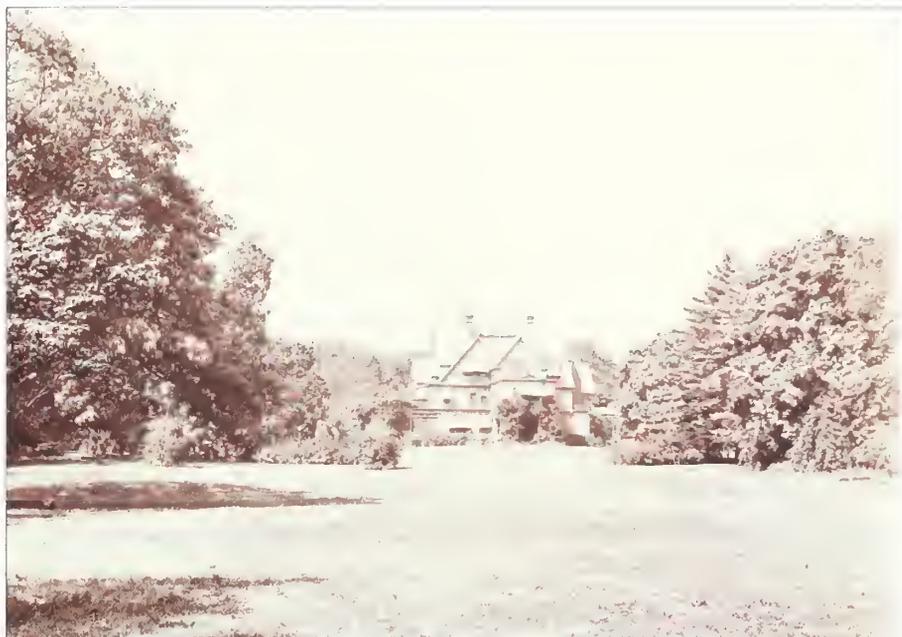
**Figure 3.08: Spatial Organization.** A c. 1918 image looking northwest of the south (lower) lawn area and front lawn. Shown in the image are deutzias along the main drive and a variety of ornamental trees and shrubs (EDIS Archives, 12.420.46).

In the initial development of the Glenmont landscape between 1879 and 1884, the south (lower) lawn was created as part of Nathan Franklin Barrett's overall design for the grounds. Located east of the house, and defined by the local roads and the main and secondary drives, the space was largely open pasture—dotted with clumps of trees and shrubs—and contained service related functions, which included a chicken house and stable (now known as the chicken house and cow barn), a vegetable garden, and small orchard. During the Thomas Edison years (1886-1931), minor changes occurred within the space including the relocation of the chicken house and stable in c.1907-1908; and the construction of a garage (in the former location of the chicken house and stable) in 1908 (Figures 3.08 and 3.09).

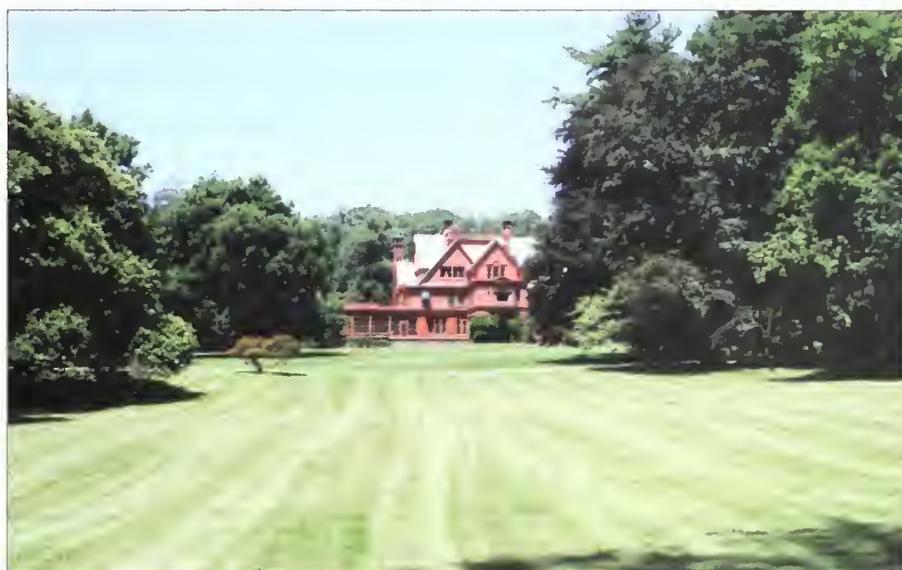
**Figure 3.09:** This is the same area, taken in 2009, showing the evergreen and deciduous trees along the eastern edge of the front lawn. Despite the loss of pasture and meadow, the open spatial character remains similar to the historic period (OCLP, 2009).

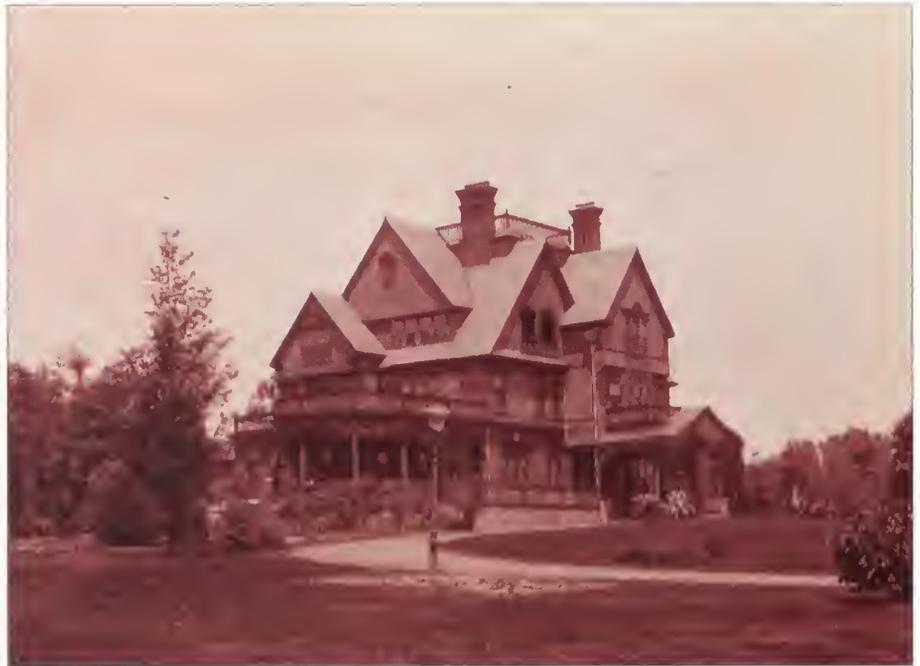
Figure 3.10: Circulation. A c. 1886-1890 image looking north of the main drive. The main drives curves through the landscape in a naturalistic alignment and ends in an oval-shaped looped that passes beneath the wisteria covered portecochere. Note the young trees and shrubs along the drive (EDIS Archives).

Along with the drives, the landscape included a network of sinuous paths and walks. Marked by a rectangular bluestone stoop on the west and set of steps to the south, the paths began at Park Way and meandered through the west and southwest portions of the property, eventually leading up to and around the house. Additional paths were located within the service area across Honeysuckle Avenue. By 1914, the walking path that proceeded from the Conservatory to Park Way heading southeast was removed. Around the same time, paths located south of the greenhouse complex changed from curvilinear to straight walkways to create a rectangular formal flower garden (Figures 3.10-3.13).

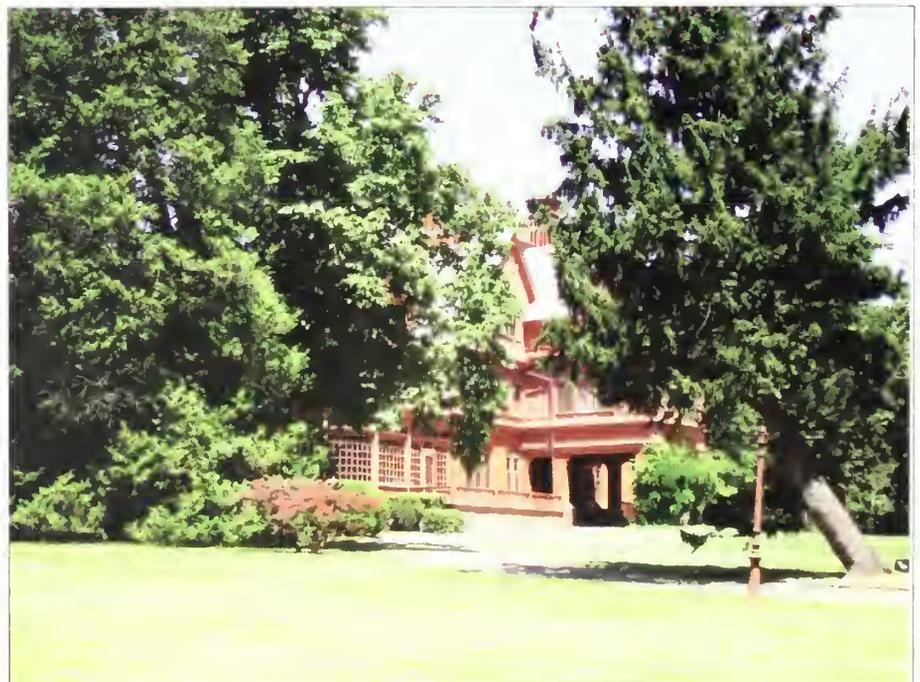
Figure 3.11: Circulation. A 2009 image, taken in the same area, that shows a mature landscape with the wisteria on the absence of the southwest path and carpet bedding. Note the overgrown dwarf alberta spruce (*Picea glauca* 'Conica') (right) (OCLP, 2009).

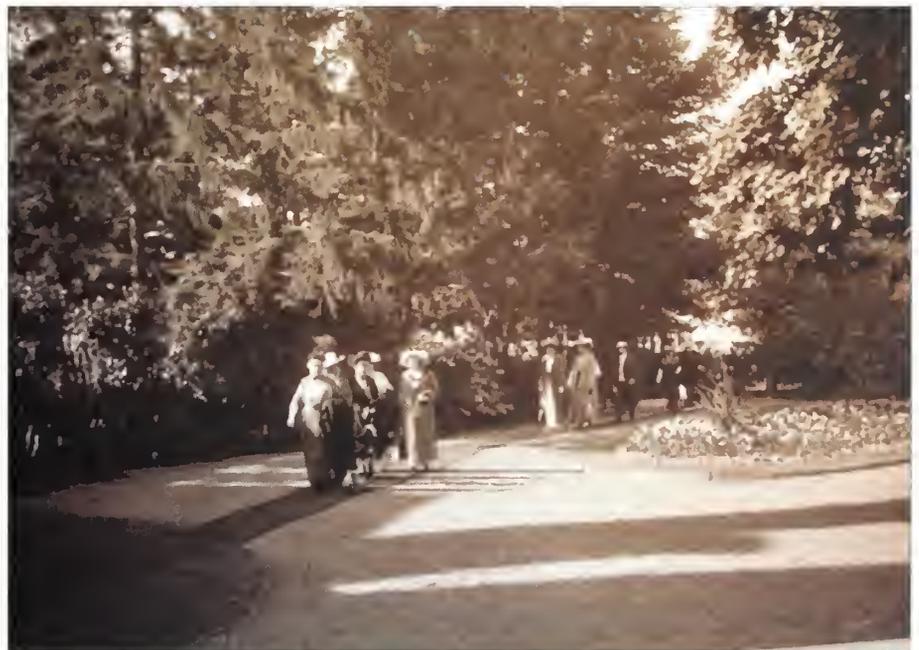
Figure 3.12: Circulation. A photograph taken during Madeline Edison's wedding in 1914. Note the triangular island planted with annuals and dracaena. Islands within the main drive were often embellished with ornamental flower beds throughout the historic period (EDIS Archives, Album 113).

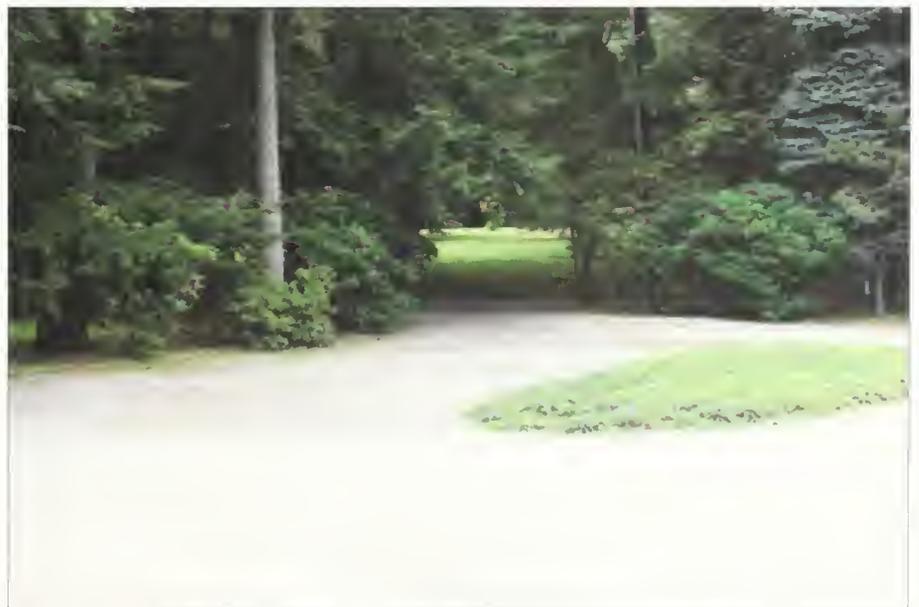
Figure 3.13: A similar view looking northeast towards the same island within the main drive. Following the death of Mina Edison, many islands were simplified. This particular island currently contains periwinkle (*Vinca minor*) (OCLP, 2009).

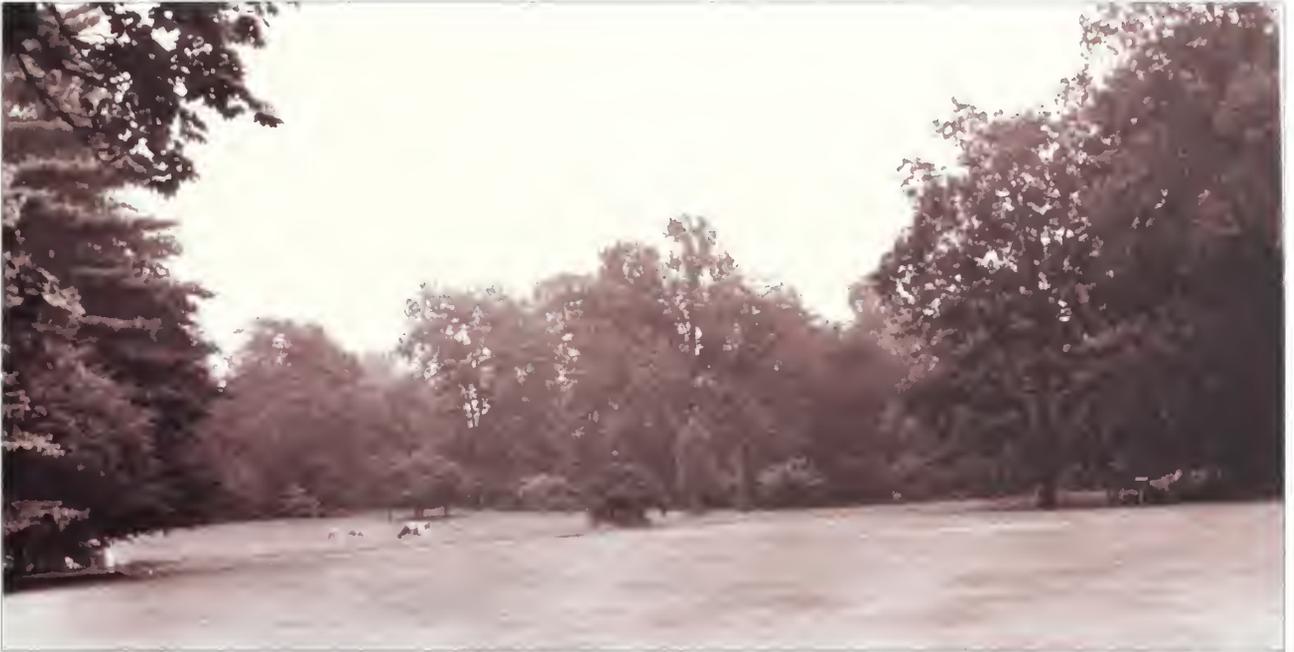
Figure 3.14: (top) Vegetation. A c.1918-1930 image looking south towards the south (lower) lawn pasture area (Edison Archives, 12.420.42).

During the Henry Pedder (1879-1884) and Thomas Edison (1886-1931) years, the house and front lawn and west lawn (back lawn) areas were maintained as low, manicured lawn, while the south (lower) lawn and north pasture areas were maintained as meadow and pasture. While the types of grasses Pedder and Edison established within the front and west lawns are unknown, they were cut with a mechanical mower, and in the spring and fall were overseeded and enriched with fertilizers and manure. The pasture and meadow areas, tinted with daisies (*Chrysanthemum sp.*), black-eyed Susans (*Rudbeckia hirta*), buttercups (*Ranunculus sp.*) and other wildflowers, were used as grazing areas for the cows and horses and cut for hay (Figures 3.14 and 3.15).

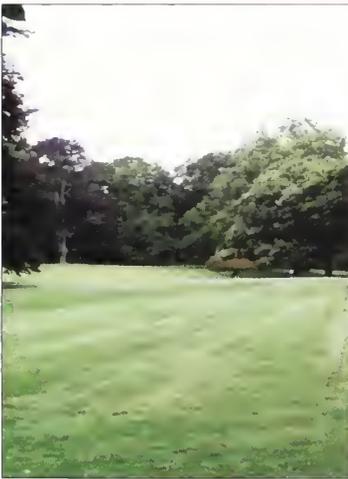
Figure 3.15: (bottom) Vegetation. Following the death of the Thomas and Mina Edison, the pasture areas were maintained as manicured turf area (OCLP, 2009).

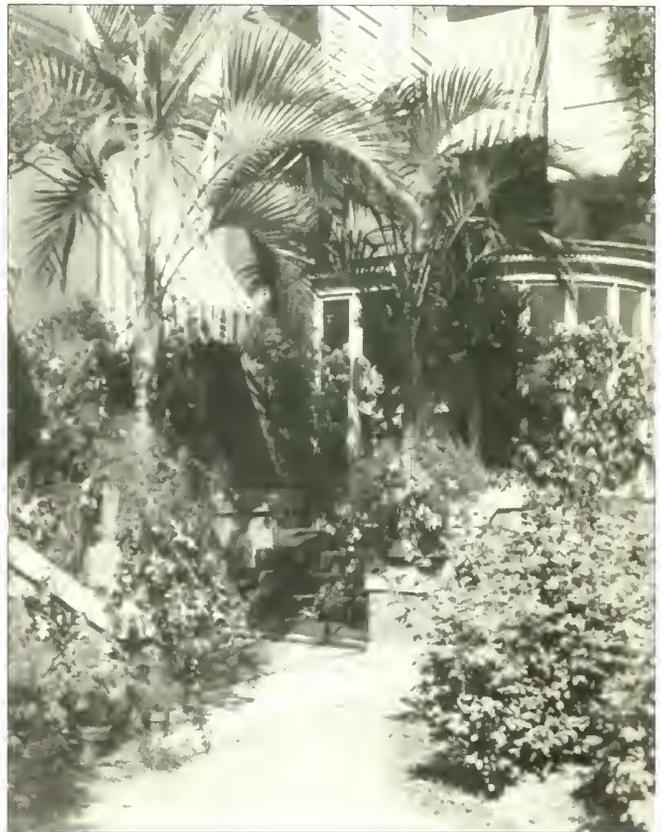
Figure 3.17: (right) Vegetation. This image, taken in 2009, shows the fern house without awnings, potted plants, and foundation plantings (OCLP, 2009).

During the initial development of the Glenmont grounds in early 1880s, Henry Pedder incorporated a series of showy ornamental garden beds—consisting of mostly annuals, and a few deciduous shrubs along the south and west foundations of the Glenmont house. With exception to vines growing on the house and potted plants, the north and east sides of the house were devoid of vegetation. During the Thomas Edison era (1886-1931), additional evergreen shrubs were added around the foundation of the house, specifically along the east elevation and near the Conservatory (Figures 3.16-3.17).

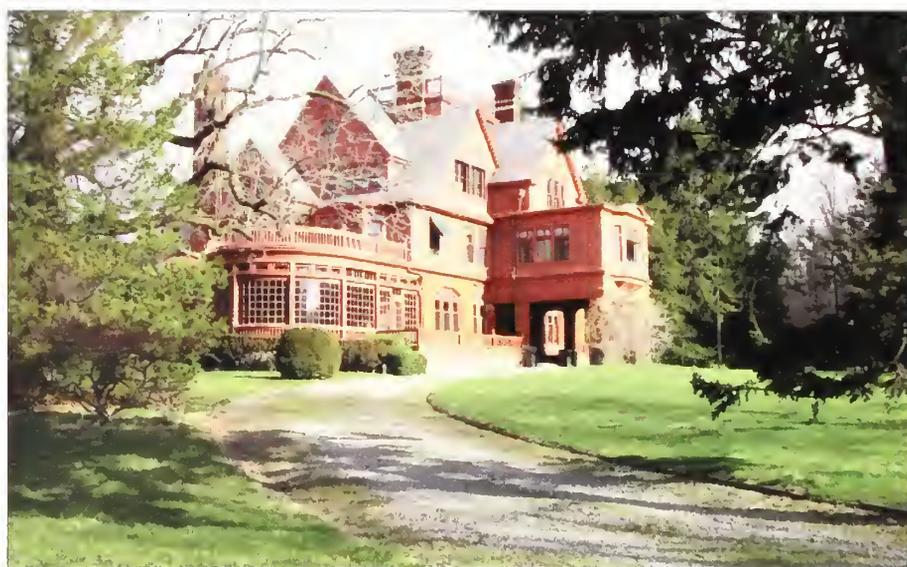
Figure 3.18: Views and Vistas. A 1907 image looking north along the main drive towards the Glenmont house. Note the southwest path and carpet bedding (EDIS Archives, 12.420.13).

years, the layout and alignment of the main entrance drive remained the same and the views of the house were retained (Figures 3.18 and 3.21).

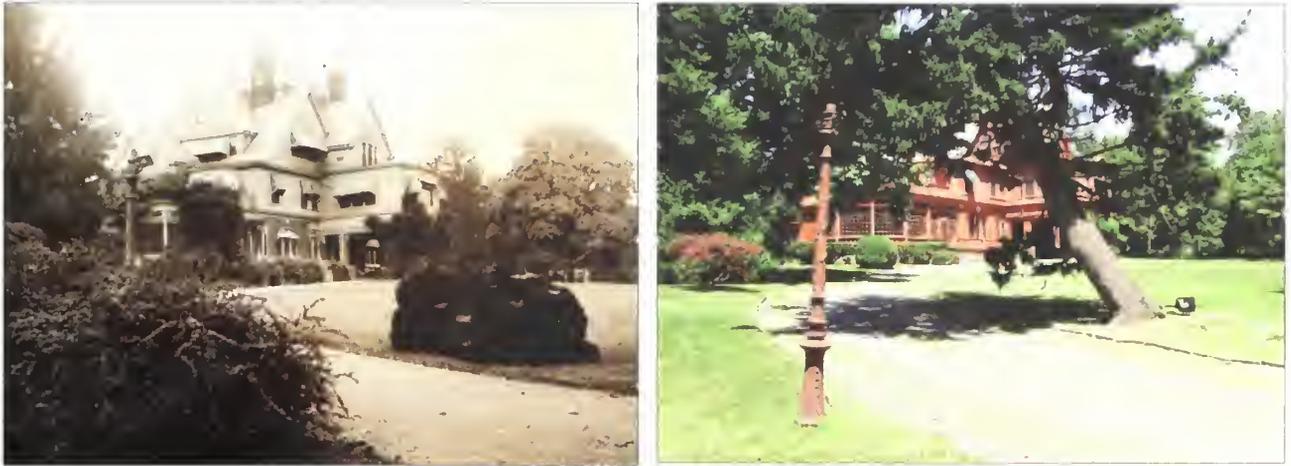
Figure 3.20: (left) Views and Vistas. A c. 1914 views looking north towards the Glenmont house. The image shows barberry (*Berberis species*) surrounding a lamppost (left), and a clump of dwarf alberta spruce (*Picea glauca 'Conica'*) (right). (EDIS Archives, Album 113).

Figure 3.21: (right) Views and Vistas. A 2009 image looking north towards the Glenmont house that shows only one overgrown dwarf alberta spruce (*Picea glauca 'Conica'*). Absent is the barberry (*Berberis species*) around the lamppost (OCLP, 2009).

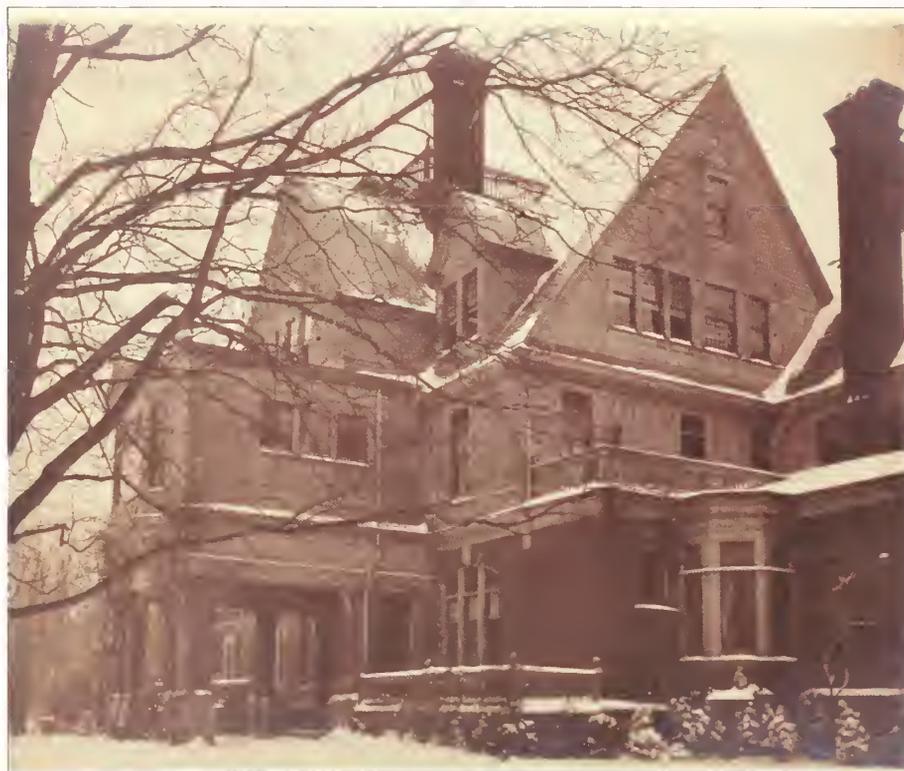
Figure 3.22: Small-scale features. A 1912 winter image of the Glenmont house that shows a planter surrounded by recently planted evergreen foundation plantings. Note the Norway maple (*Acer platanoides*) in the foreground (left) (EDIS Archives, 12.420.11).

During the Thomas Edison period, a variety of garden fixtures were added to the Glenmont landscape; these included planted vases and urns; three rustic arbors near the formal garden adjoining the greenhouse complex and a collection of cast-iron and rustic wooden lawn seats set out in the front, west (back), and south lawns. As an avid birdwatcher, Mina Edison had a variety of bird baths, feeder, and houses situated throughout the Glenmont landscape. <sup>23</sup> In 1920, Mina had a bird fountain designed and placed on the lawn near the house. The fountain was electronically wired to keep the water from freezing in winter. It was later moved from the lawn to the roof of the Conservatory where it remained until the 1940s (Figures 3.22 and 3.23).

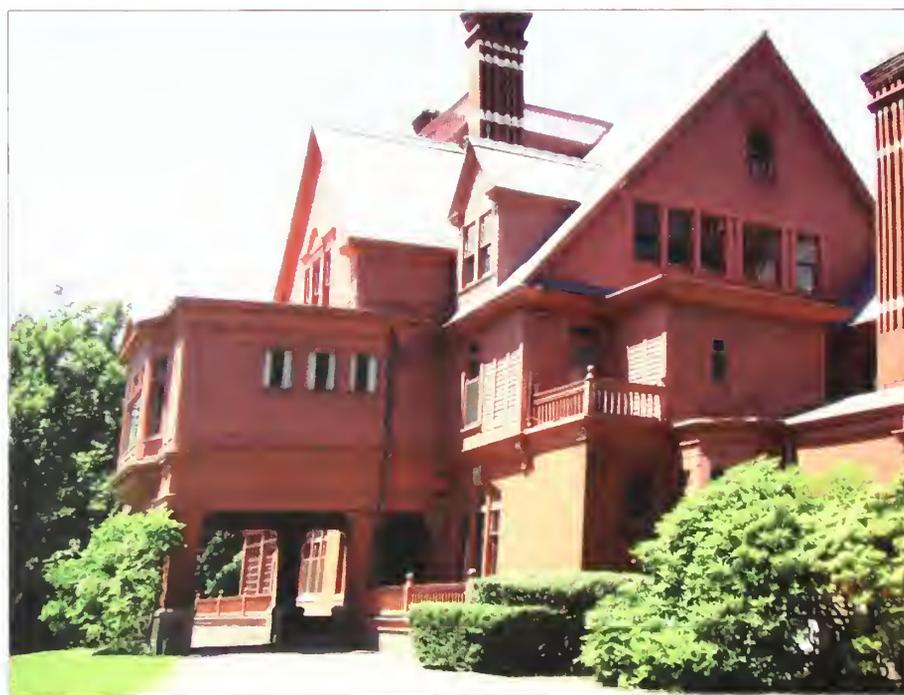
Figure 3.23: Small-scale features. A 2009 image, taken in the same area, shows the planter surrounded by a mass of rhododendrons, Japanese holly, and mountain laurel (OCLP, 2009).

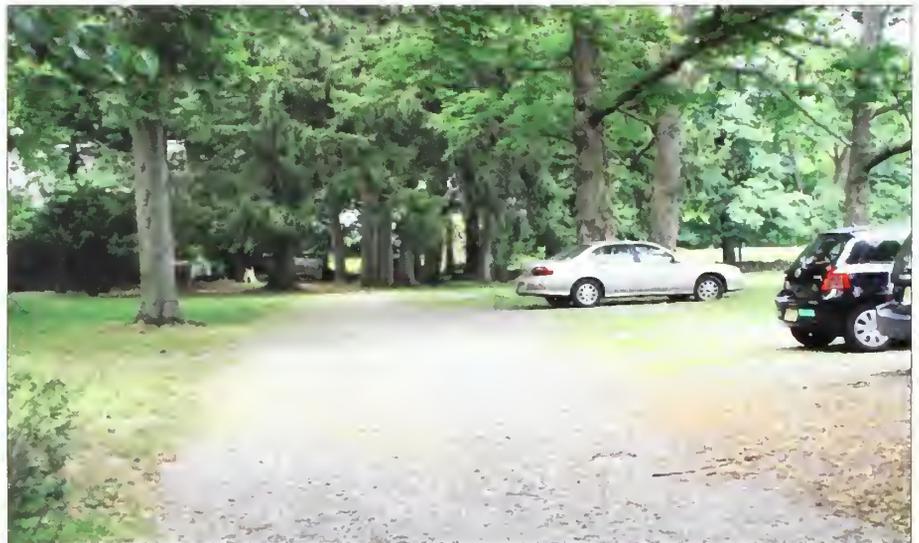
Figure 4.00. View looking at the parking area near the chicken house and cow barn in the service area (OCLP, 2010).

As part of the greenhouse rehabilitation in 2002-2003, a contractor parking area was constructed in the vicinity of the barn, directly across from the garage. It was retained following the project and now serves as a parking area for National Park Service staff. The former gravel-surfaced unmarked lot, measuring roughly 60 feet by 18 feet parking area, is incompatible with the historic rural character of the landscape. To address this contemporary use and enhance the historic character of the Glenmont landscape—specifically the service area, the gravel parking area should be removed and be reestablished as pasture. The visitor parking area on the Tilney-Johnson property should be enlarged (refer to CR Task 2 for recommended surface treatment) (Figures 4.0 and 4.1) (Drawing 4.0: Treatment Plan).

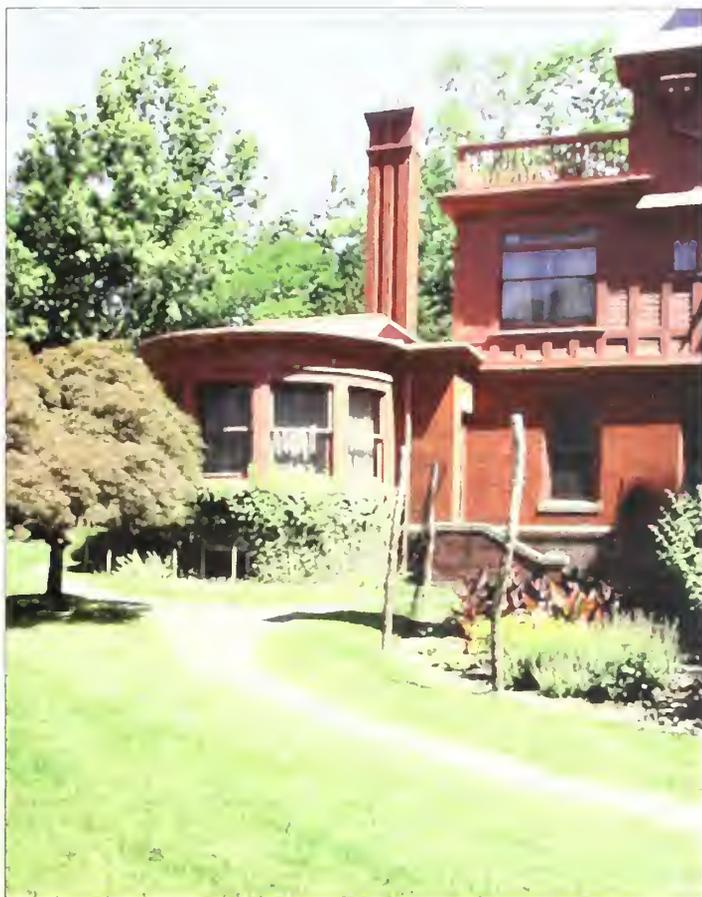
Figure 4.03. View looking at the proposed location for universal access into the Glenmont house (OCLP, 2010).

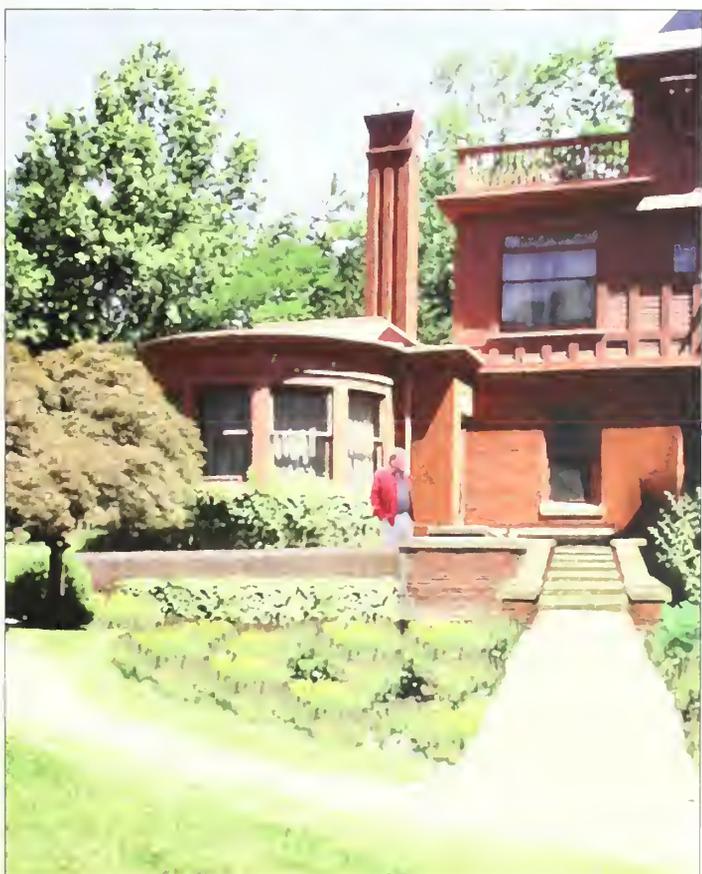
Figure 4.04. This photo simulation depicts the den entrance along the south elevation of the Glenmont house with a compliant accessible ramp. This ramp will allow for the greatest opportunity to view the majority of the interior rooms, and minimally impact the architectural fabric, views, and cultural landscapes (OCLP, 2010).

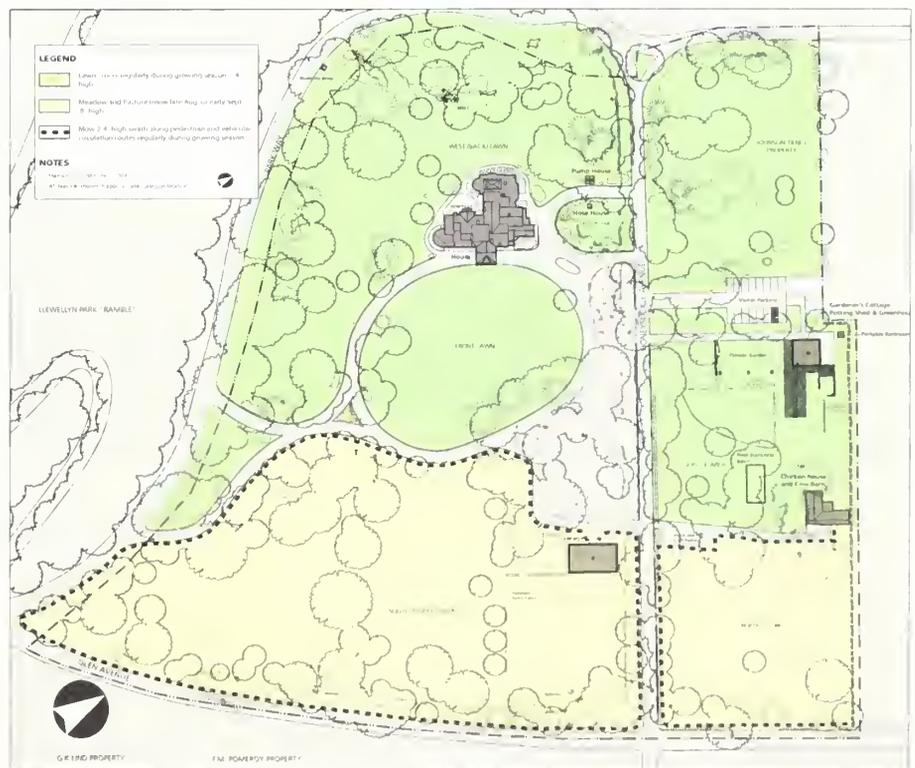
Figure 4.05. Diagrammatic mowing plan to enhance the historic landscape character of Glenmont's open spaces. The plan indicates the area, frequency, height, and season for mowing (OCLP, 2010).

herbaceous material. Following their removal, both the south (lower) lawn and north pasture areas should be seeded with a mixture of native and warm season grasses and wildflowers, which include daisies, black-eyed Susans, and buttercups. After the newly seeded areas are established, they should be mown once during the growing season (Figure 4.5).

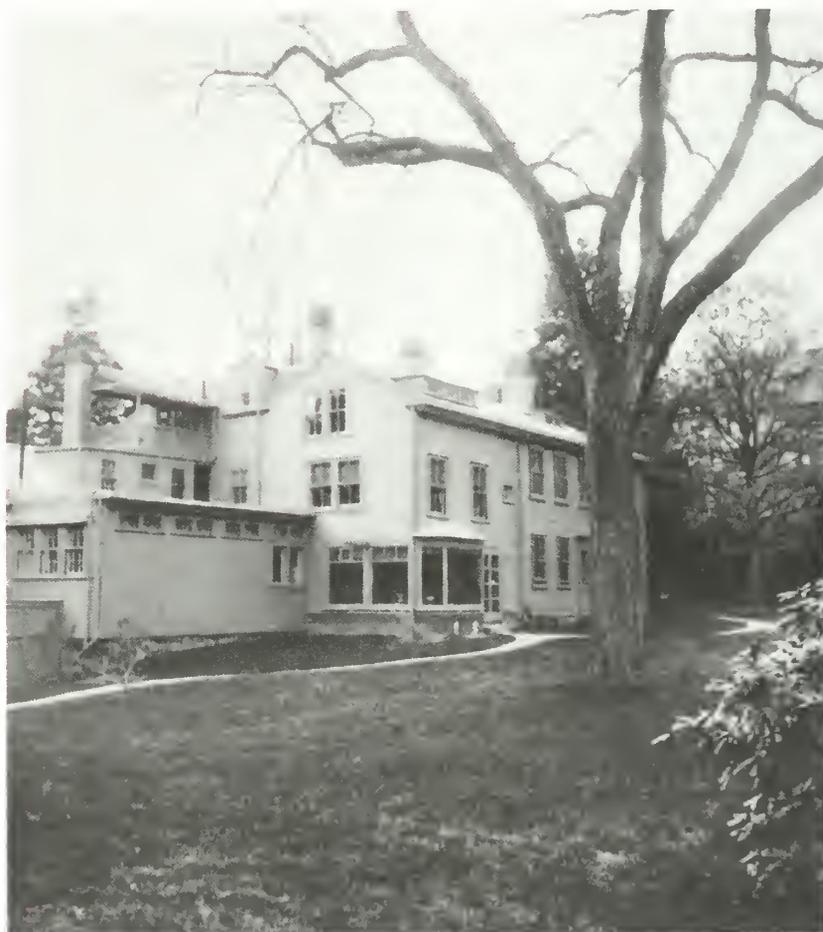
Figure 1. Historic plant materials can be retained while restoration of the historic structure is underway. The *Wisteria* and *Actinidia* vines that were historically used by Olmsted, were cut back during the restoration of Fairsted in 1988. Photo by Charles Pepper, courtesy of the Olmsted National Historic Site.

Olmsted's intention (see figure 1). Furthermore, long-term frequent pruning risked a higher incidence of pest-related problems to the plants and restricted their natural climbing habit. It was therefore important to the public site that a new trellis system be devised that would protect both the historic vegetation and the historic structure, while re-establishing the appearance of a "vine clad mansion."

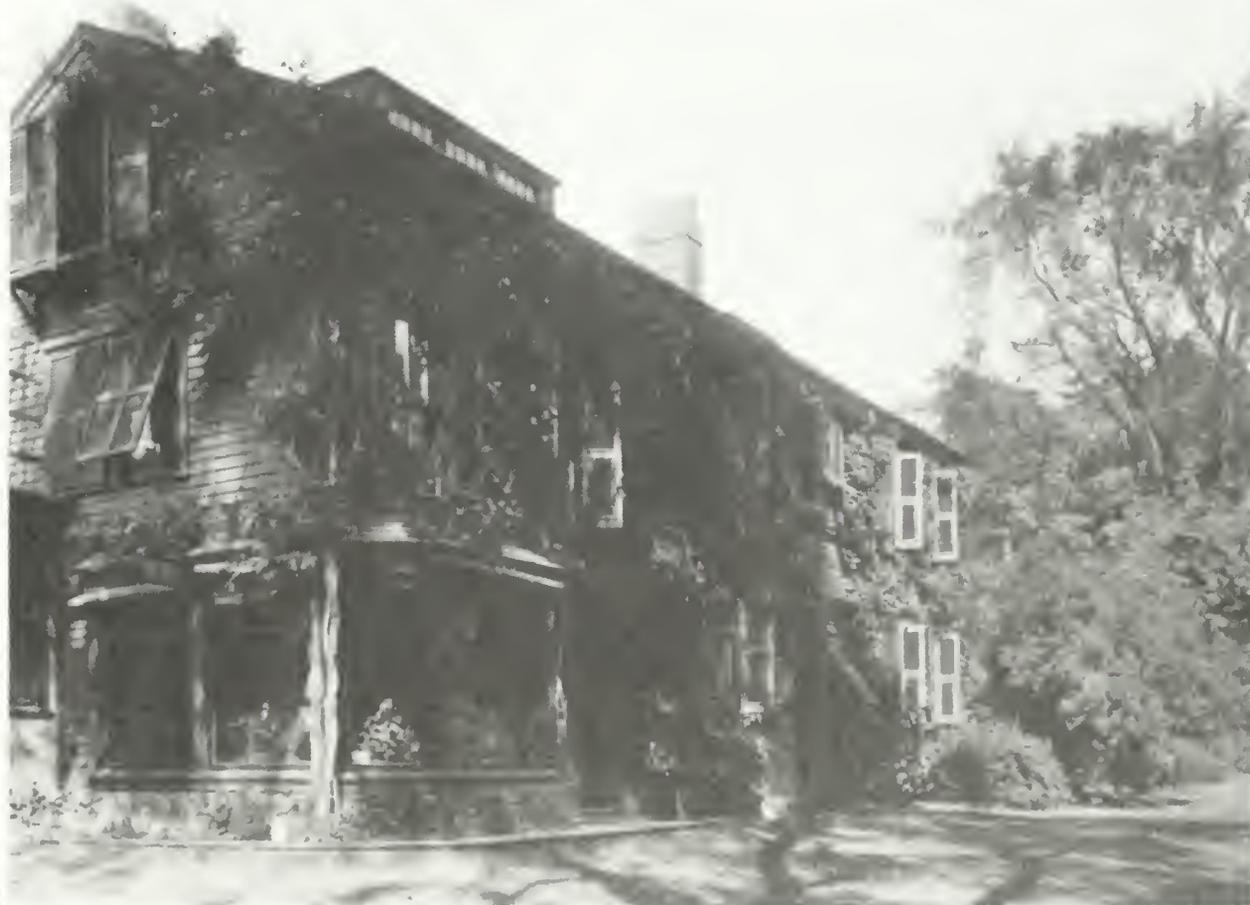
Figure 2. View of the west elevation at Fairsted which shows a steel strapping trellis system built as early as 1884. Photo courtesy of Olmsted National Historic Site.

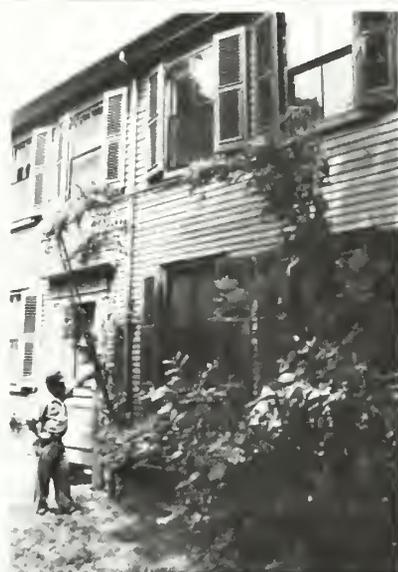
**Figure 4.** The pipe and strapping system, constructed with swivel sockets, allows the rigid support system to fold down away from the house. The strapping can also be removed from the pipe support for limited maintenance. Photo by Karen Day.

More than one person is required to remove this system. The rigid system folds out away from the house on the swivel sockets near the base of the house (see figure 4).

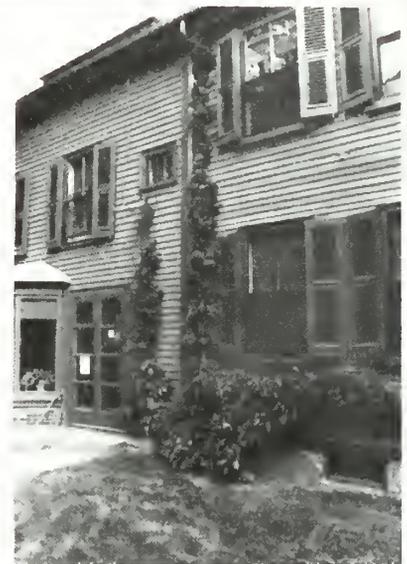
Figure 7. View of south facade, the experimental trellis systems have been in place for two growing seasons. Photo by Karen Day.

aged rapid rusting. The flexible aircraft cable (system 2), with the added weight of a mature vine will make removal and replacement difficult for one person. A temporary pulley system is recommended to aid in hoisting the vines back into place. The third design is a rigid modular pipe system (system 3). Although the rigidity of the system is advantageous to the stability of the vegetation, the weight of the vines may also be prohibitive for easy removal and replacement. The combination strapping and pipe system (system 4) does not re-create a historically accurate appearance. The system was designed in order to remove the vines on the strapping without removing the pipe supporting system. The vines growing on the strapping do not provide sufficient coverage to hide the pipe system behind. Furthermore, additional maintenance is required to keep the vines from growing on the pipe. After the multi-year test period is complete, one of the four systems will be selected, modified as needed, and installed to the east, south and west facades of the house (see figure 7).
