**RECONNAISSANCE INVENTORY AND PRIORITIZATION  
OF EXISTING AND POTENTIAL BOTTOMLANDS  
IN THE UPPER COLORADO RIVER BASIN  
1993-1994**

**Final Report  
July 1995**

**U. S. FISH AND WILDLIFE SERVICE**

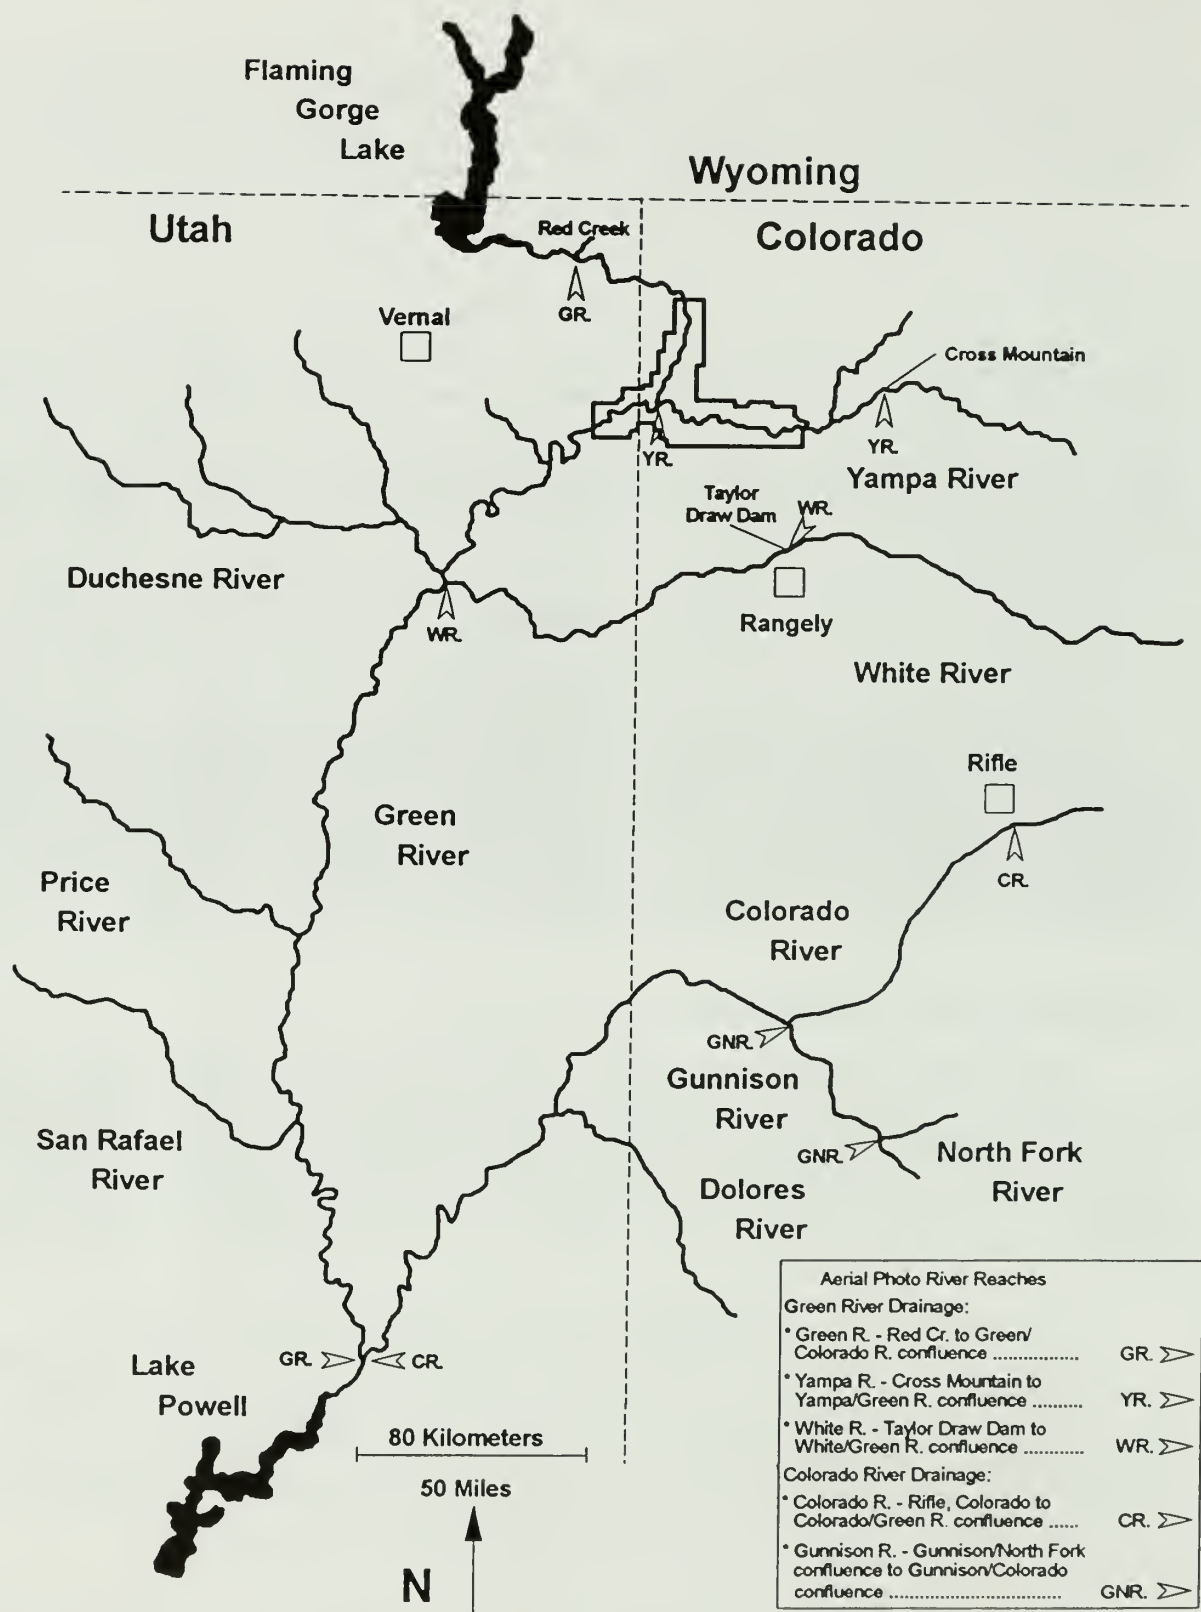
Figure 1. Bottomland habitat inventory of the Upper Colorado River Basin, Colorado and Utah, 1993.
