CULTURAL LANDSCAPE REPORT
FOR GLEN HAVEN VILLAGE HISTORIC DISTRICT

SLEEPING BEAR DUNES NATIONAL LAKESHORE
EMPIRE, MICHIGAN

CULTURAL LANDSCAPE REPORT FOR GLEN HAVEN VILLAGE HISTORIC DISTRICT

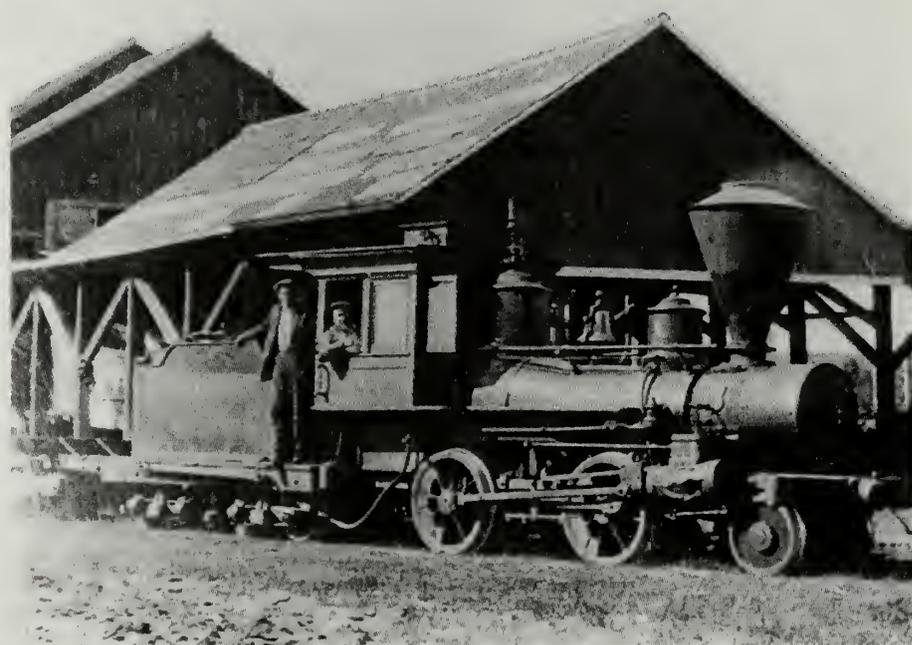
Figure 7. Postcard of the locomotive at D.H. Day's sawmill, n.d. (SLBE 3793)

- 1907 D.H. Day purchases narrow-gauge railroad tracks and a locomotive from the dismantled J. O. Nessen Mill at Glen Arbor, and installs them between the sawmill on Little Glen Lake and the dock (Figure 7). As aligned, the tracks follow about one mile of the wooden tramway constructed by 1870, then detours west of Glen Haven to by-pass the center of the town. The narrow-gauge railroad provides quicker access between the mill and the dock than the original horse-drawn tram, increasing the operation's profitability. As aligned in 1907, the narrow-gauge railroad tracks arched around the Glen Lake swamp to the foot of a knoll behind the Sleeping Bear Inn then entered a roundhouse. The construction date of the roundhouse is unknown and may have occurred later than the realignment.²⁷

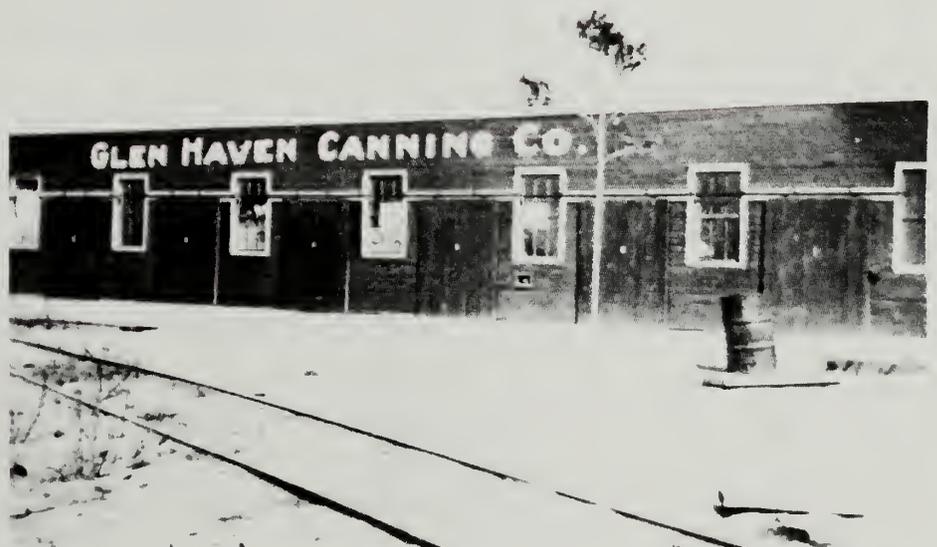
Figure 8. View northeast of the Glen Haven Canning Co., c. 1933. Note the narrow-gauge railroad tracks. (SLBE 1923)

1925 By April, 1925, construction of the Glen Haven Canning Company “canning plant” had begun. Constructed on the shoreline near the dock, the canning company processed cherries and apples from D.H. Day’s farm and from local orchards. The processed fruit was shipped from Day’s dock to down lake markets. D.H. Day, Jr. managed the cannery (Figure 8).³³

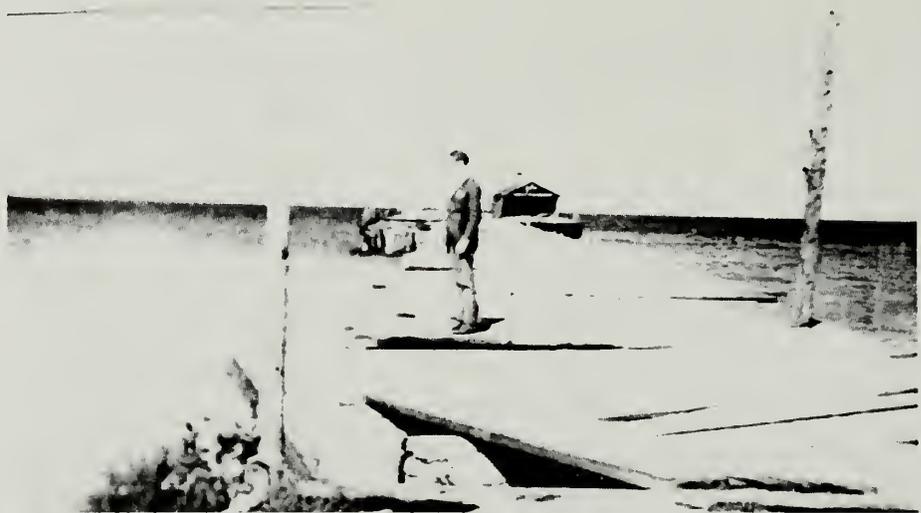
Figure 10. View north of the Glen Haven dock, c. 1938. (1922 SLBE)

Steamboat service continues to Glen Haven until 1931. Since the late 1920s there had been little cargo and few passengers disembarking at the dock, due to the poor economy and the popularity of motorized vehicle travel (Figure 10).⁴⁰

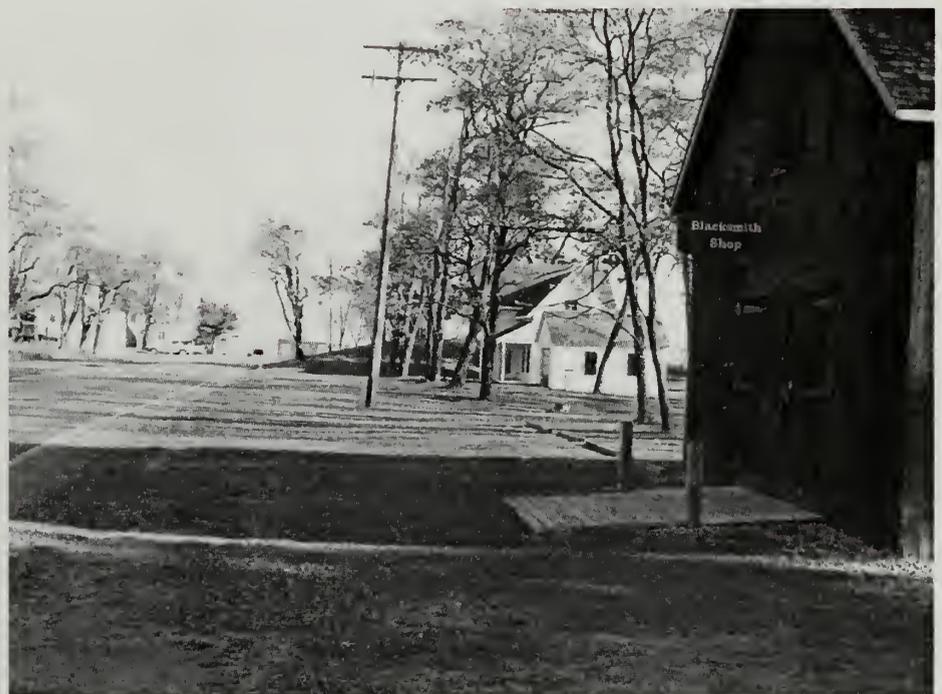
Figure 12. View north toward Sleeping Bear Bay from the blacksmith shop, 2005. Note the Glen Haven Canning Company (distance center), the Sleeping Bear Inn and garage (distant left), and the Day house and garage (middle right) and row of black locust (foreground right). Also note the contemporary utility poles bordering Glen Haven Road. (OCLP)

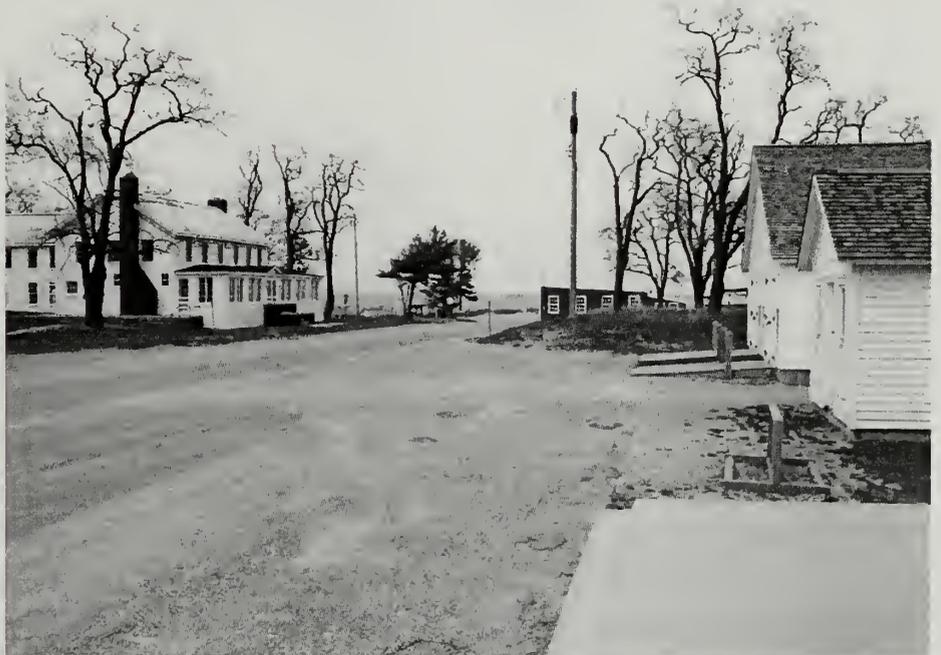
Figure 16. View north from the concrete porch in front of the D.H. Day Store, 2005. Depicted are the Sleeping Bear Inn (left), the Glen Haven Canning Company (distance), and the D.H. Day garage and generator building (right). Also note the contemporary utility poles. (OCLP)

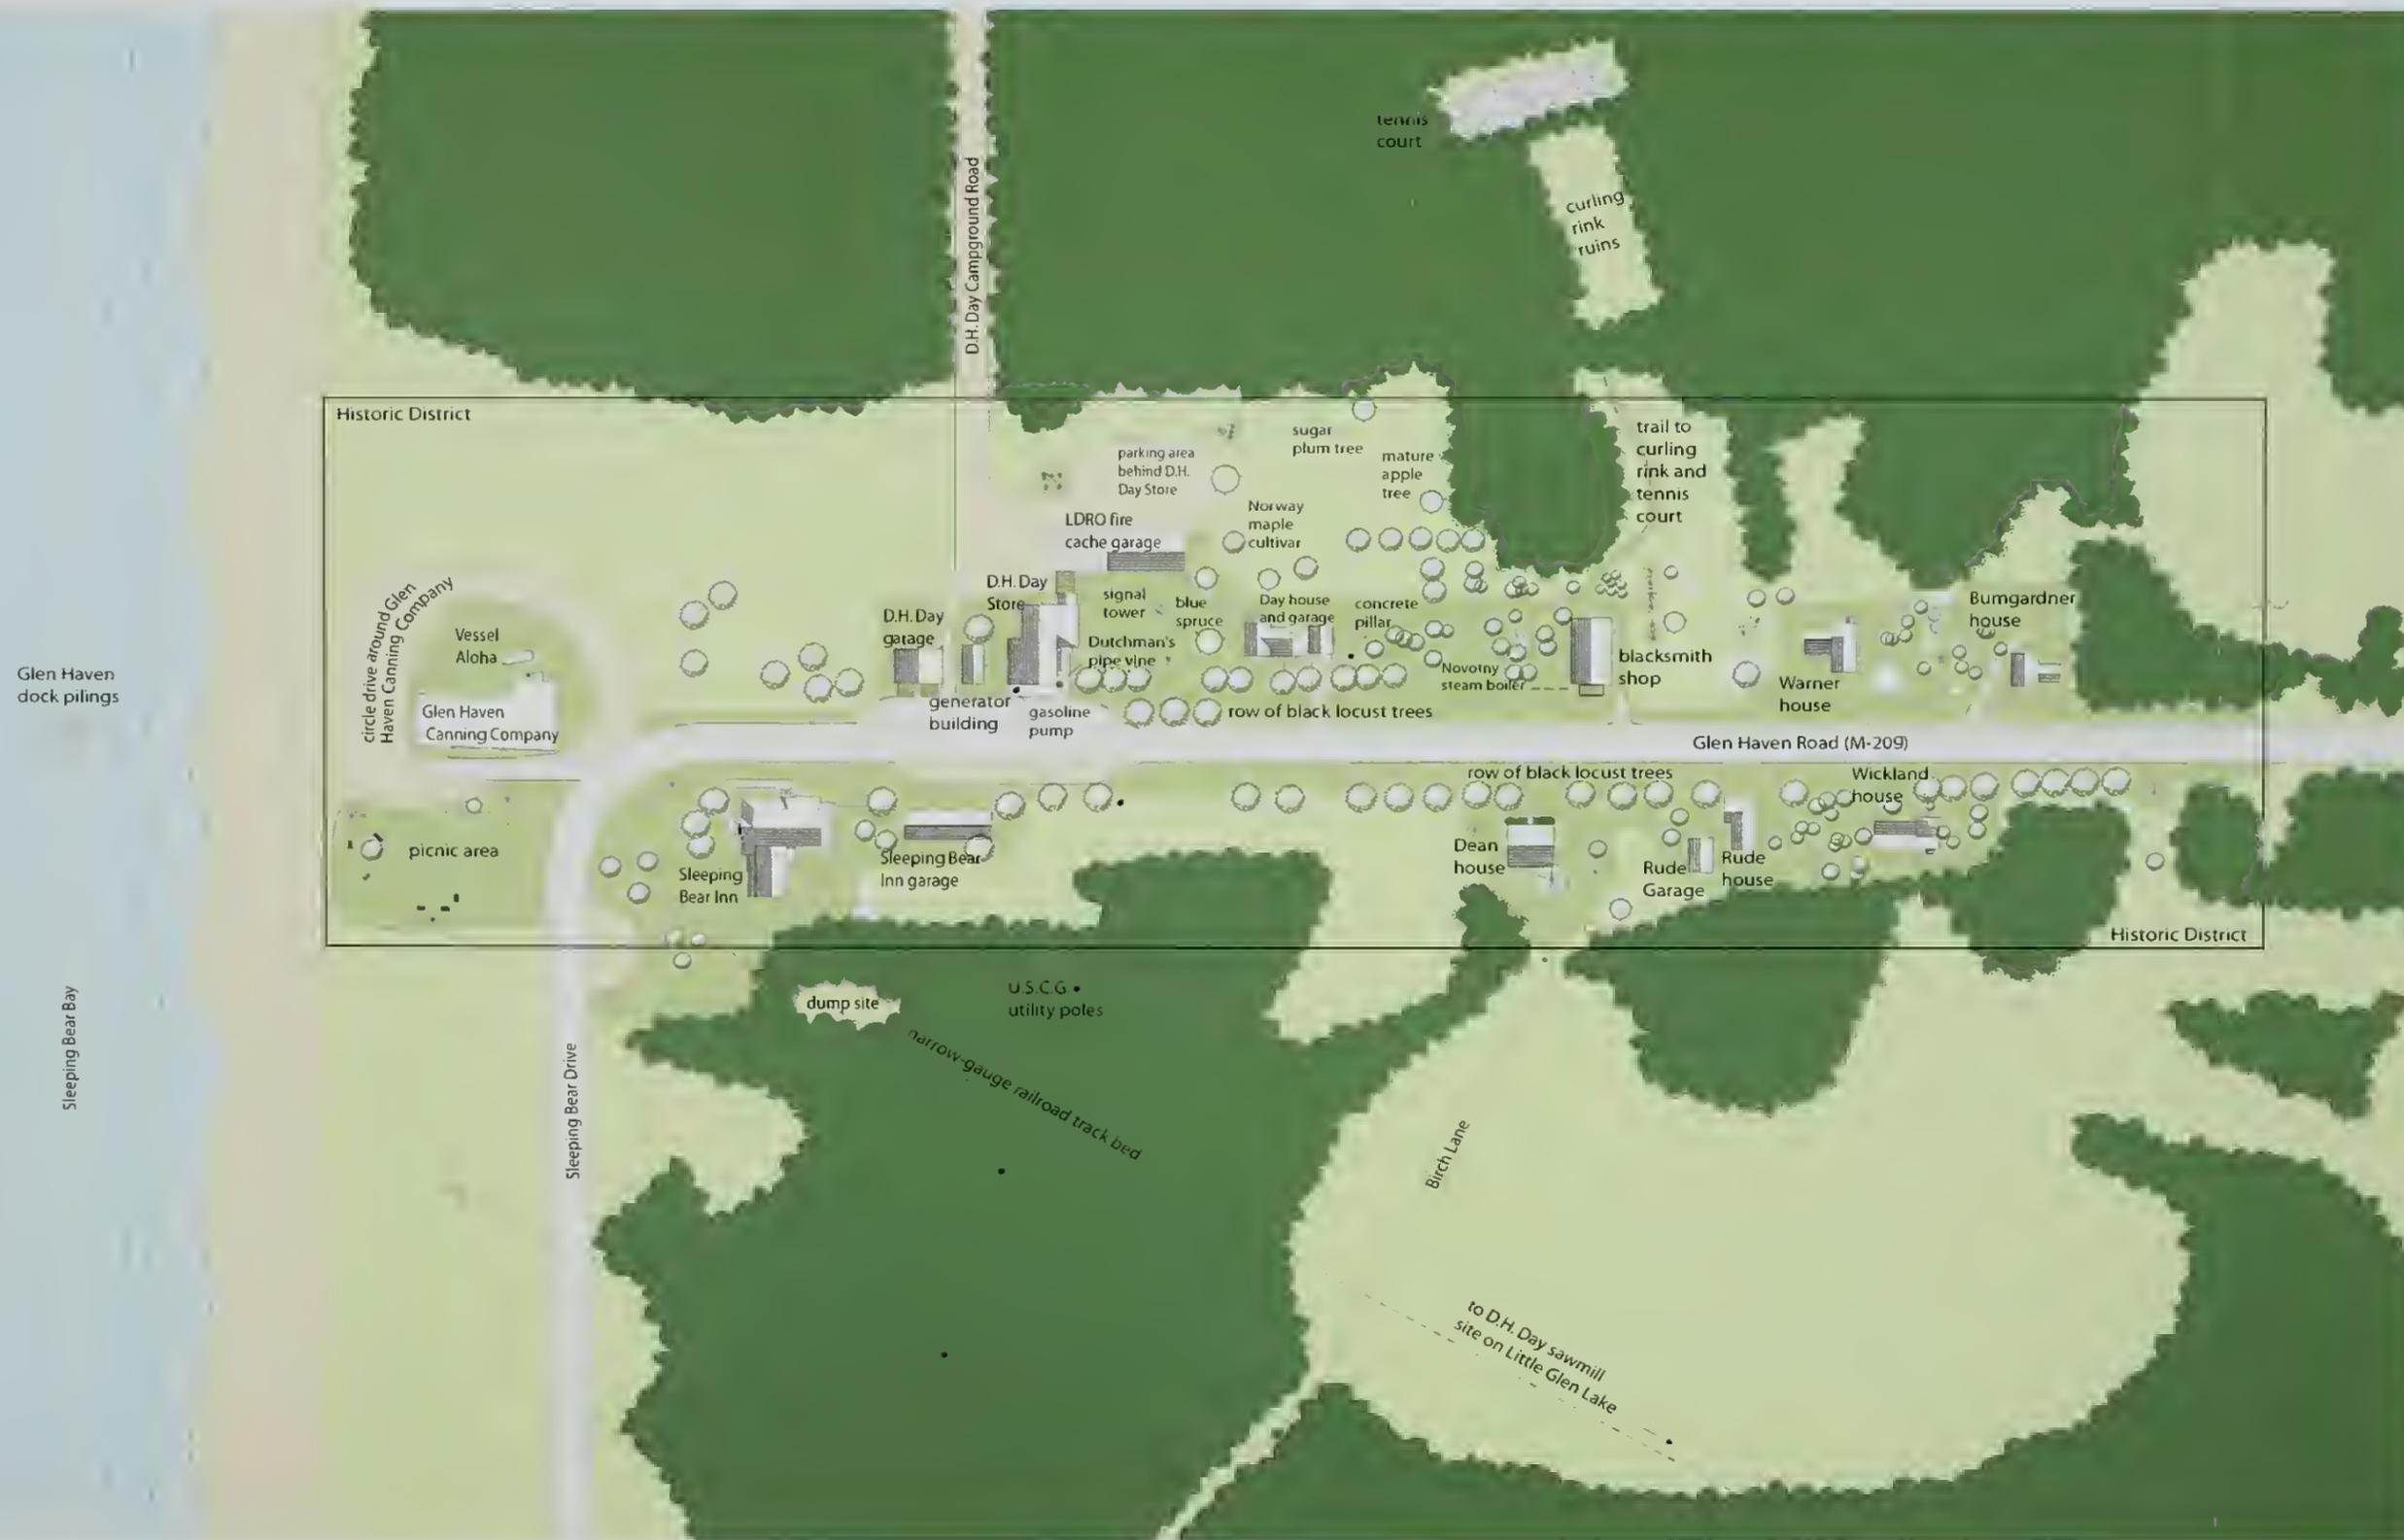
Drawing 2:
Existing Conditions

Drawing 2 depicts existing conditions. Feature level existing conditions are included in Chapter 3: Analysis and Evaluation.

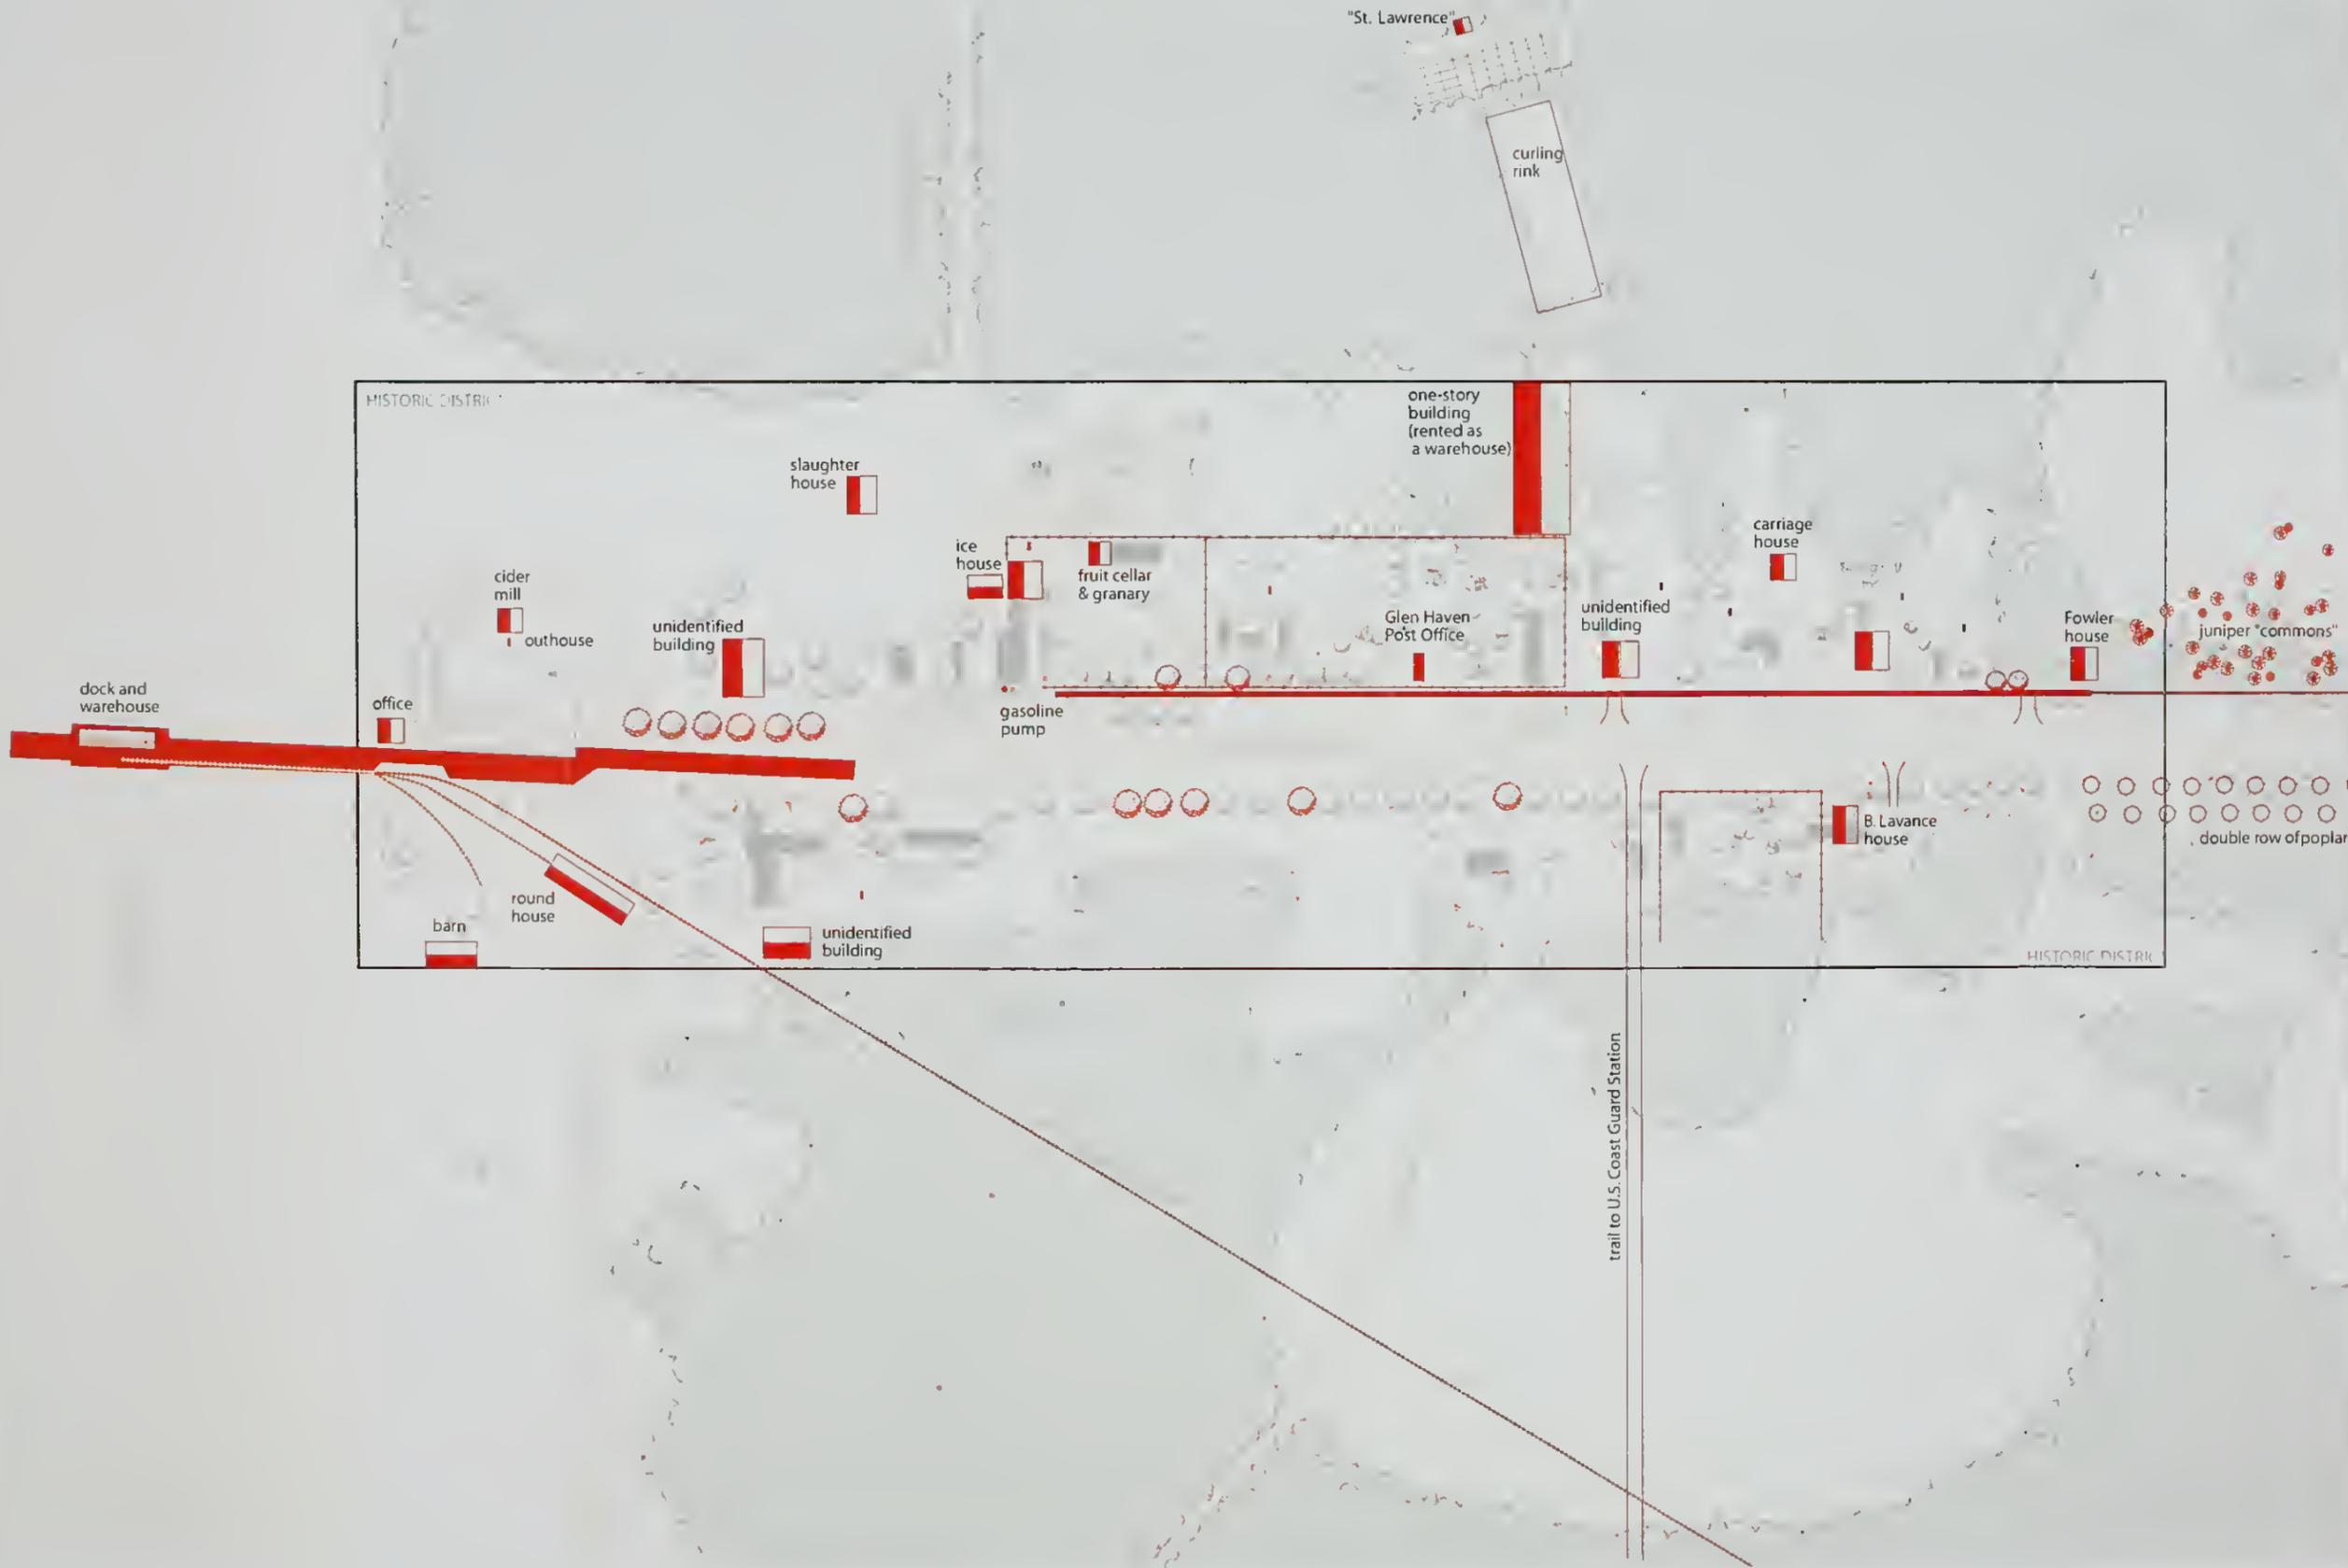
Drawing 3:
Missing c. 1931 Features

- Existing Features
- Missing c. 1931 Features

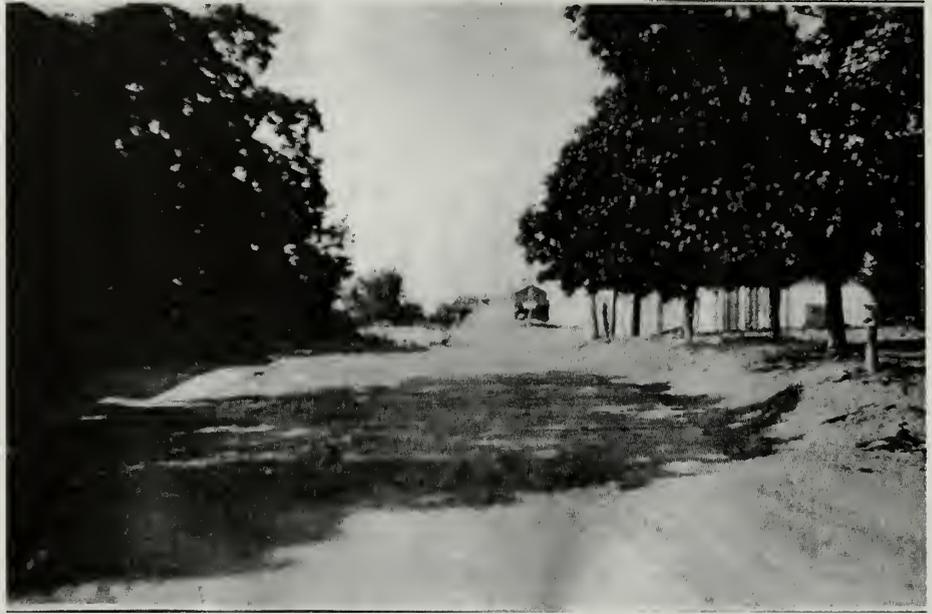
Figure 17. View north of the plank road on Glen Haven Road (center), pre-1925. Note the warehouse on the dock in the distance, the row of locusts tree (right), and a boardwalk along the west side of the road (left). (Courtesy Bill Phillips)

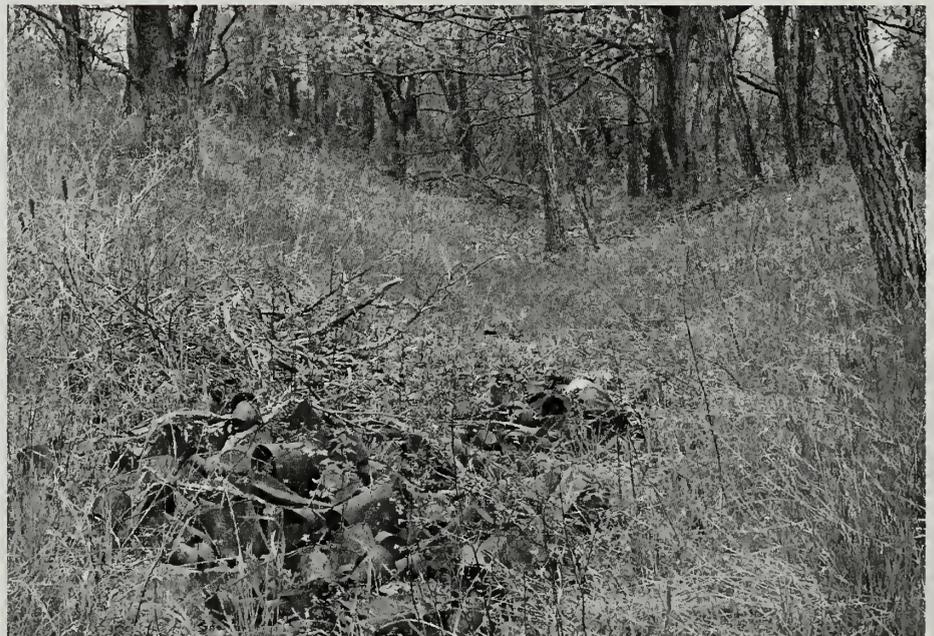
Figure 18. View southwest of the narrow-gauge railroad track bed in back of the Sleeping Bear Inn. Note the dump site in the foreground, 2005. (OCLP)

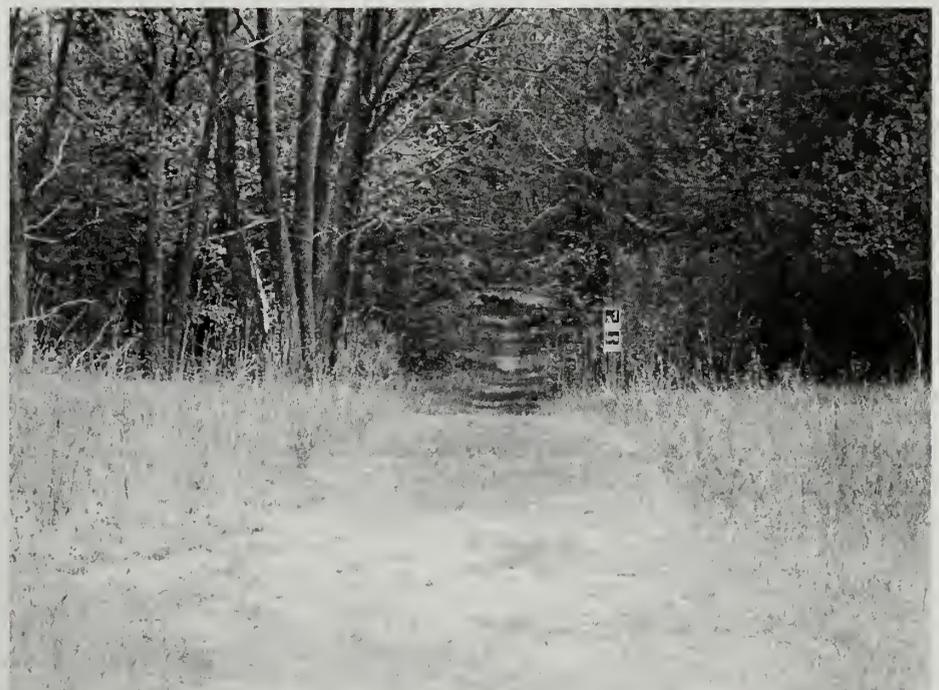
Figure 19. View east of the D.H. Campground Road; today a footpath, 2005. (OCLP)

Existing Condition: Although still designated as a road by Leelanau County, the earthen road currently serves as a footpath between the former D.H. Day State Park (D.H. Day Campground) and Glen Haven (Figure 19). The road is owned and maintained by Leelanau County.

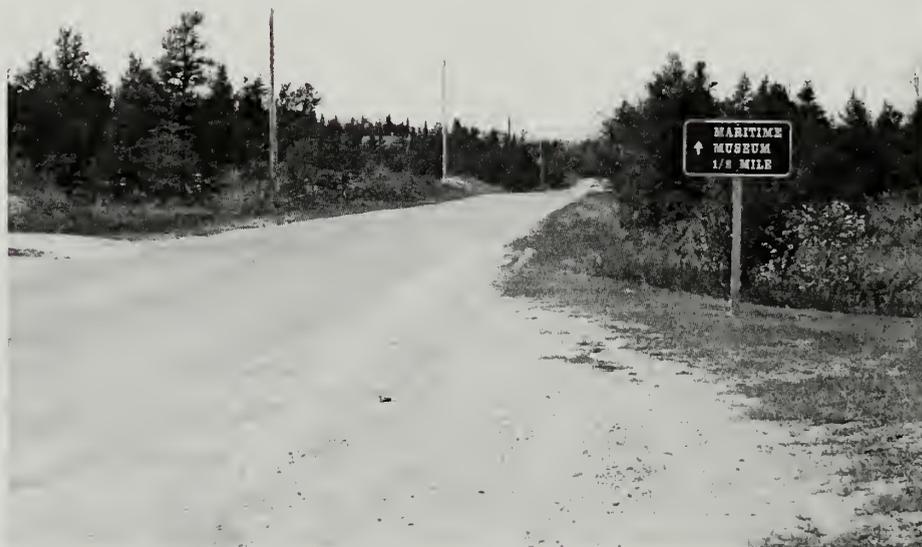
Figure 20. View west of Sleeping Bear Drive, 2005. (OCLP)

Existing Condition: Sleeping Bear Drive measures approximately 22 feet wide and has an asphalt surface (Figure 20). The road is owned and maintained by Leelanau County.

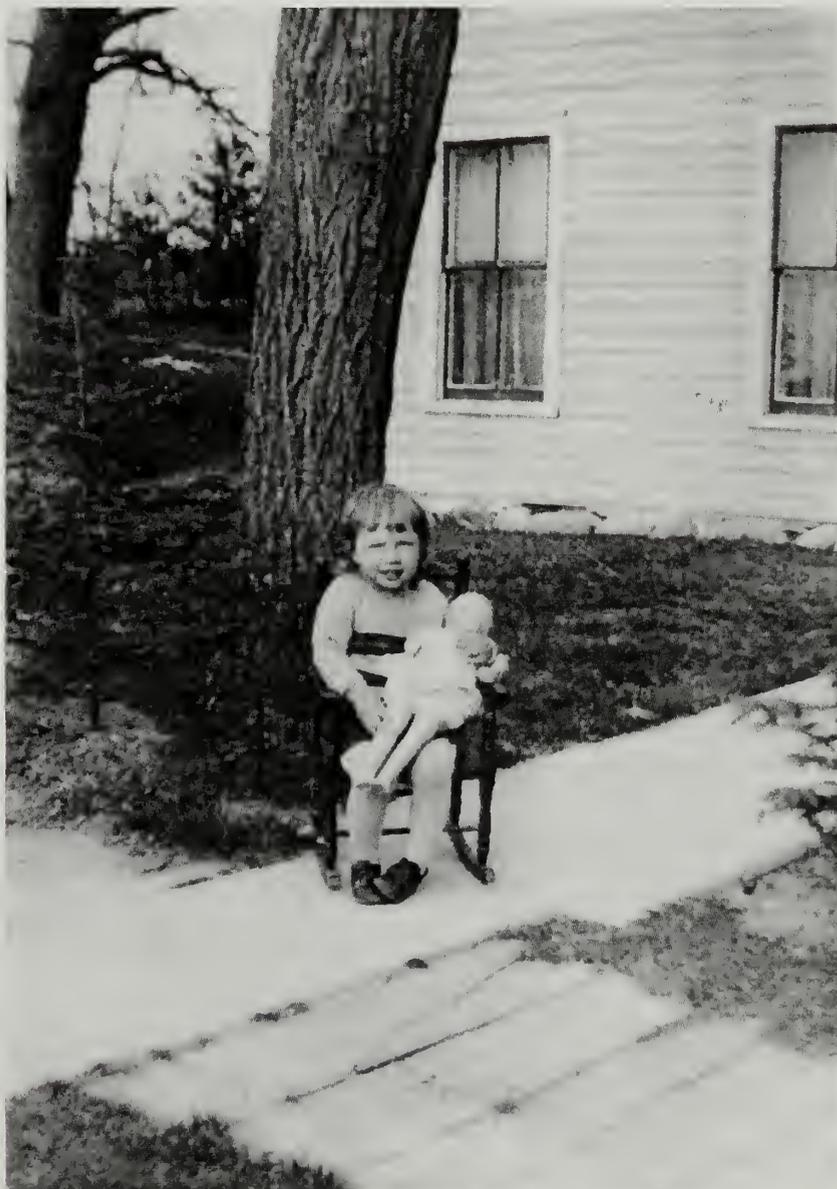
Figure 21. Boardwalk in front of the Day house, c. late 1930s. Also note the concrete walkway, the stones lining the foundation of the house, and one of the locust trees along Glen Haven Road. Depicted is Pat (Day) Bennett with her doll. (Courtesy of Pat (Day) Bennett)

Historic Condition: A concrete sidewalk leading from the front door of the Day house to the boardwalk was constructed c. 1929 to 1939. The sidewalk is not depicted in a 1929 photograph of the Day house; it is depicted in a c. 1937-1939 photograph (see Figure 21).

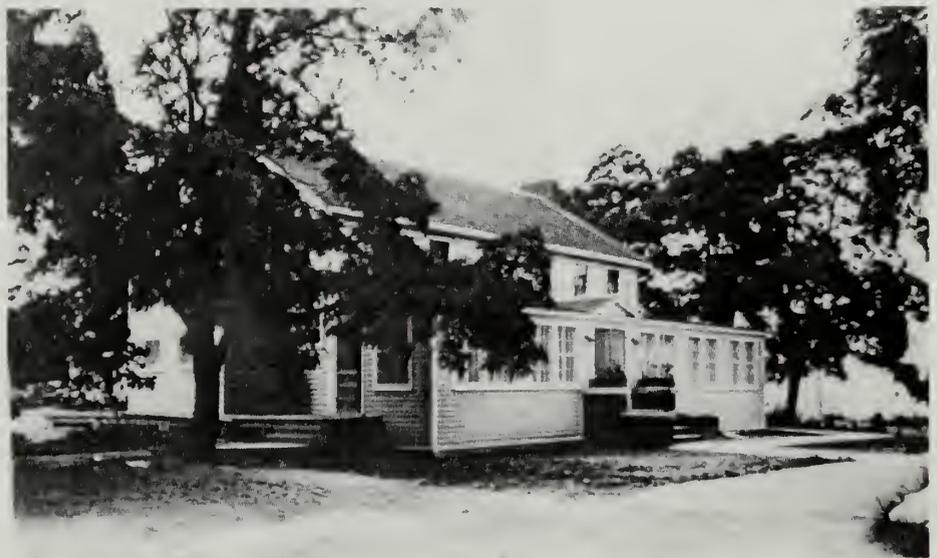
Figure 22. Boardwalk (lower right) in front of the Sleeping Bear Inn, c. late 1920s-early 1930s. Also depicted are concrete sidewalks (constructed c. 1928) mature locust trees, and a maintained lawn. (SLBE 3767)

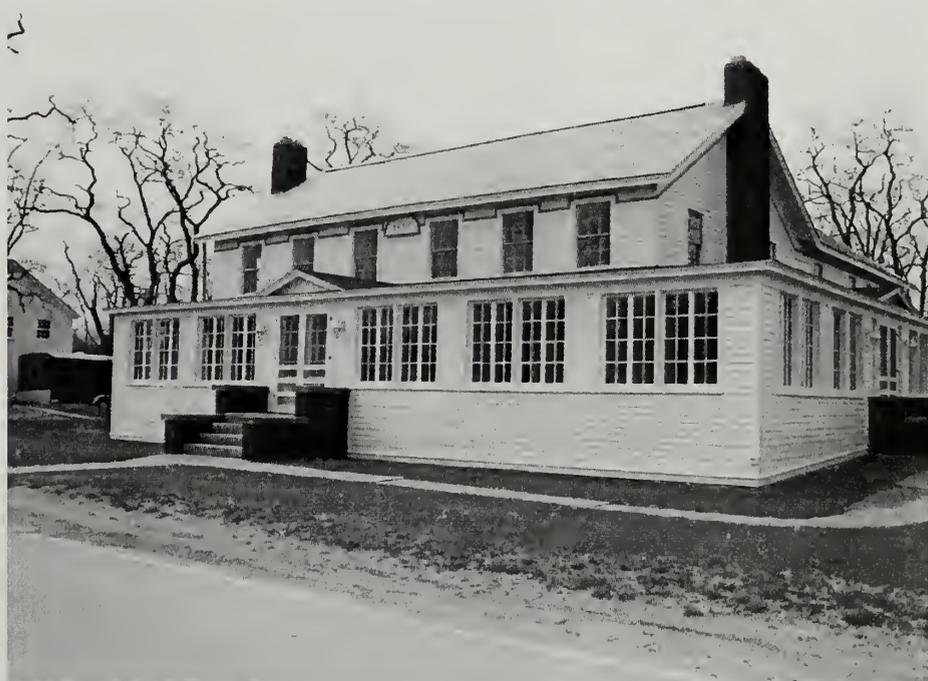
Figure 24. View southwest of the Sleeping Bear Inn, 2005. Also notice the concrete sidewalks around the inn. (OCLP)

Existing Condition: The two-story wood frame building has an L-shaped plan, clapboard siding, and a gable roof (Figure 24)

The Sleeping Bear Inn contributes to the significance of the historic district.

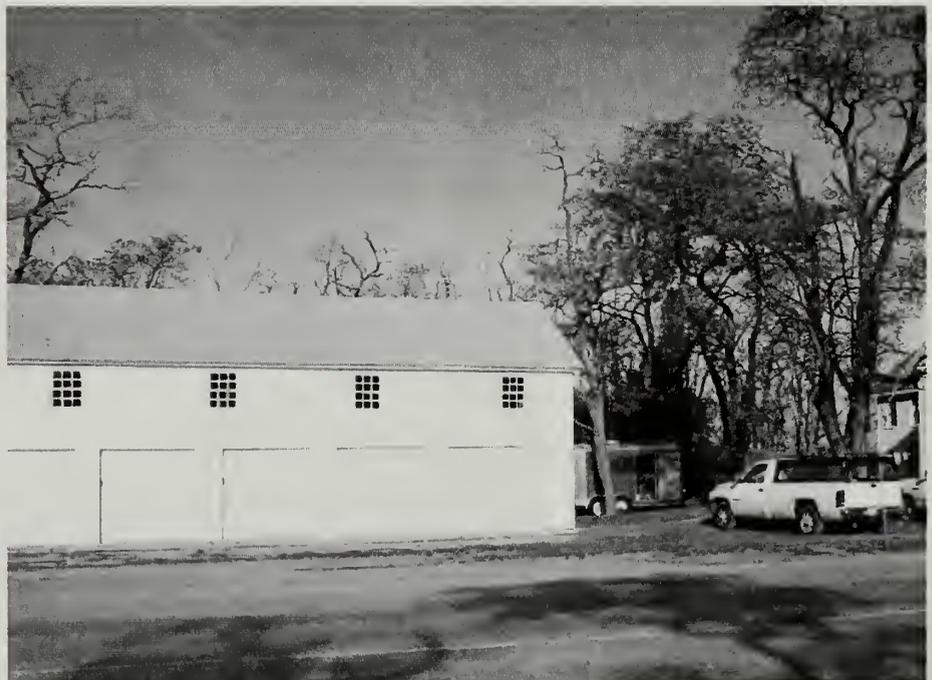
Figure 25. View west of the Sleeping Bear Inn garage, 2004. (OCLP)

Historic Condition: The two-story garage was constructed in 1928 during the restoration of the Sleeping Bear Inn. The structure included a six-bay garage on the first floor and sleeping quarters on the second floor.

Existing Condition: The two-story wood frame structure has clapboard siding and a gable roof (Figure 25).

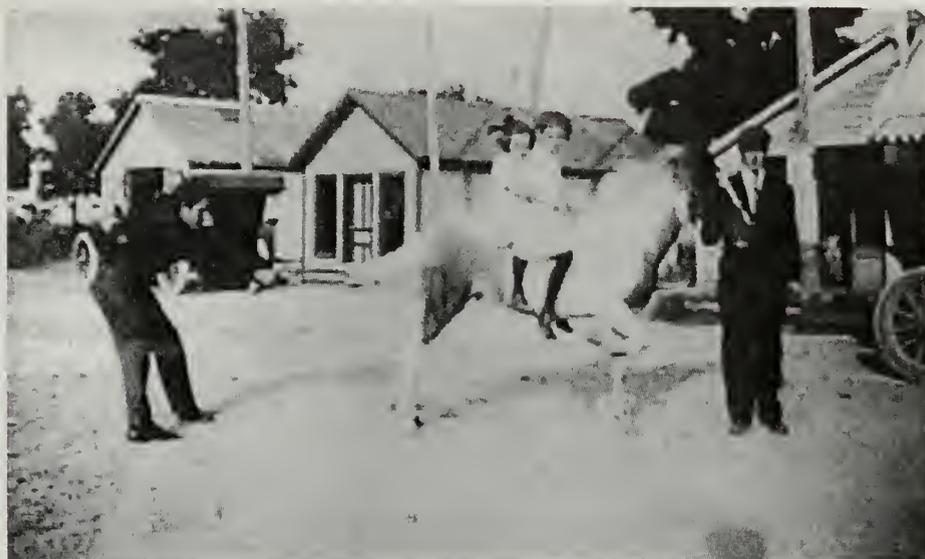
Figure 28. View northeast of the generator building (middle), c.1911. Also note the D.H. Day Store (right), and a small unknown building (left). (Courtesy Marion (Day) Warnes)

Historic Condition: The small wood frame structure was built c. 1910 (Figure 28). The generator building contained a fifteen horsepower dynamo gas engine generator that provided village power prior to the installation of electrical lines. Later, the front half of the building served as an office for Louis Warnes, who would marry Marion Day, D.H. Day's youngest daughter, c. 1929. Warnes was employed by D.H. Day from 1922 until Day's death in 1928. In 1935, two public bathrooms were installed in the back half of the generator building, and two entrance doors were added to the building's southern façade.¹⁴ The NPS removed the inner most bathroom, and a partition between it and the front half of the generator building.¹⁵

Historic Condition: The two-bay garage was built in the mid-1910s. It replaced an earlier one-bay structure, similar in shape and size of the extant generator building (see Figure 28). The Day family cutter was stored in the new two-stall garage, and then later D.H. Day's automobile. The original structure may have also been used to store the family cutter and/or buggy. The garage remained in private use until November 1993.¹⁶ The NPS has rehabilitated the building to reflect the c. 1925-1931 appearance and renovated the interior to serve as a visitor comfort station.

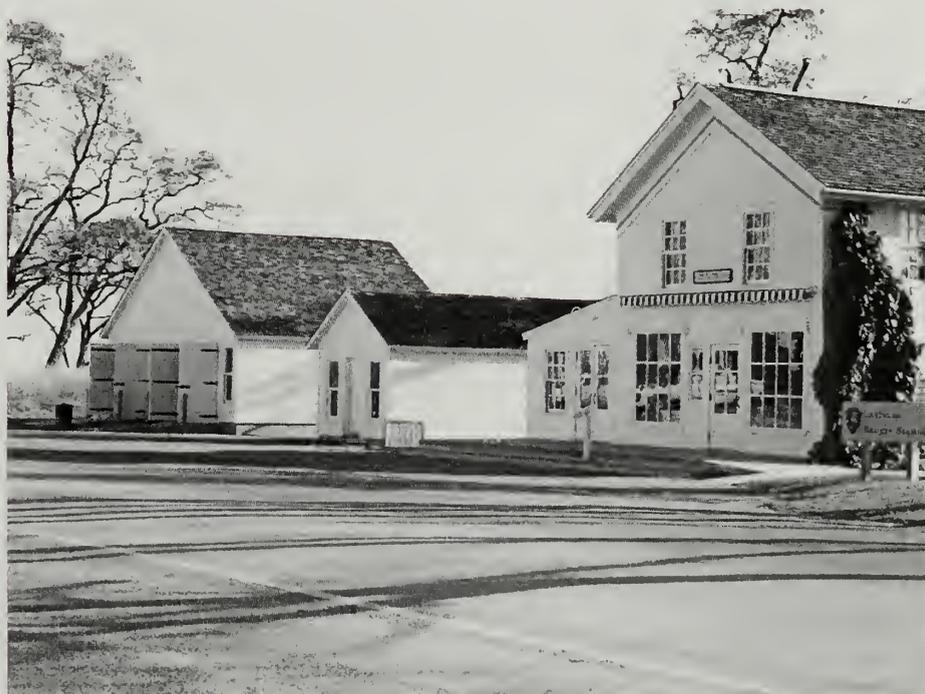
Figure 29. View northeast of the D.H. Day garage (left), the generator building (middle), and the D.H. Day Store (right), 2004. (OCLP)

Existing Condition: The one-story rectangular frame (12' by 29') building has a front gable roof and clapboard siding. The frieze board is not as deep as other buildings built during this period (Figure 29).

Existing Condition: The 24' by 34' wood frame building has a front gable roof and clapboard siding. The frieze board is not as deep as other buildings built during this period (Figure 29).

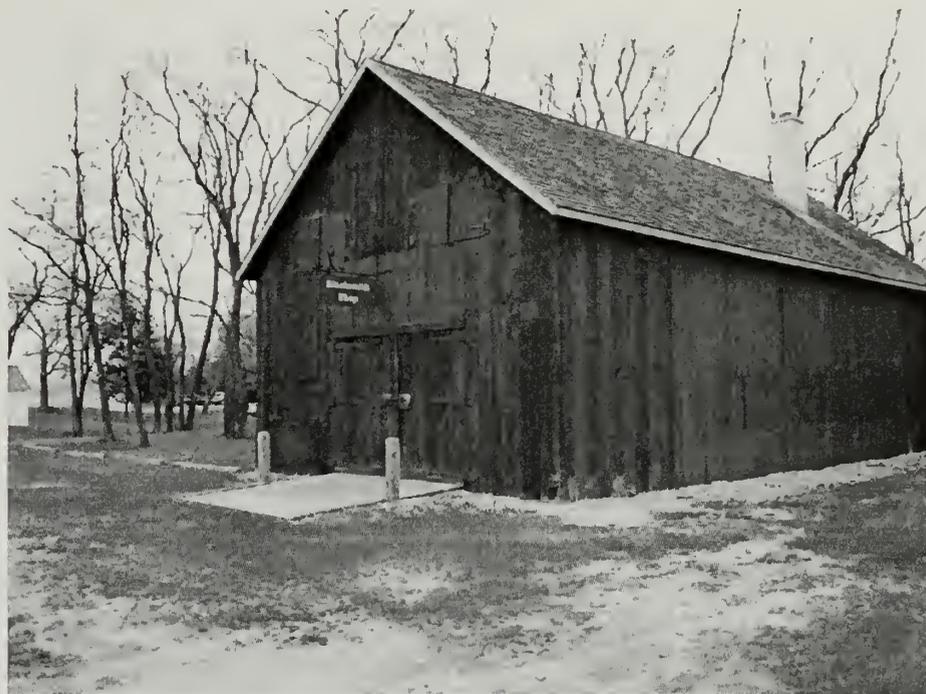
The blacksmith shop contributes to the significance of the historic district (Figure 30).

Figure 30. View northeast of the blacksmith shop, 2005. (OCLP).

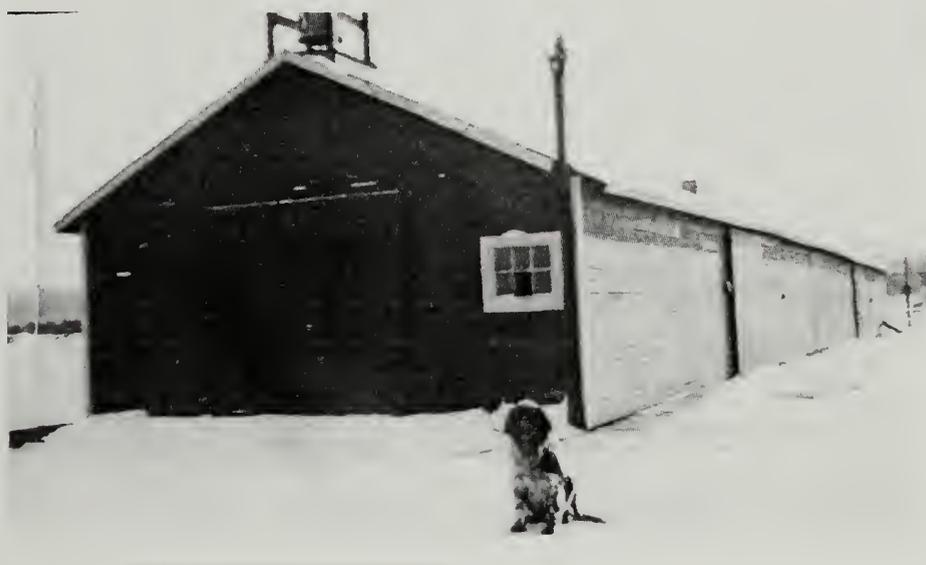
Historic Condition: A long warehouse (approximately 100' by 20') was built on the widest (middle) section of the c. 1893 dock. The warehouse held materials delivered to the dock and also materials waiting to be shipped (Figure 31).

Figure 31. Warehouse on the dock, n.d. (Courtesy Bill Phillips)

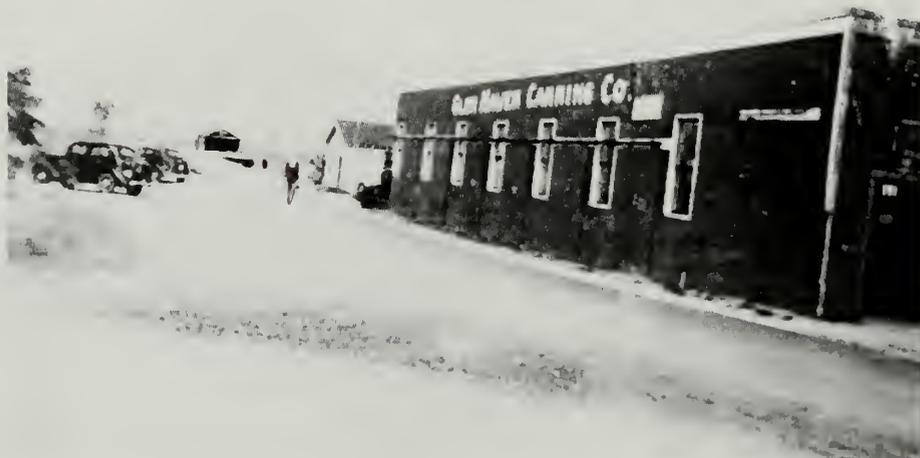
had begun.²¹ The canning company processed cherries and apples from D.H. Day's farm and from local orchards. The processed fruit was shipped from the Day's dock to down lake markets. D.H. Day, Jr. managed the cannery until it closed during World War II (Figure 32).

Historic Condition: A small white building just north of the Glen Haven Canning Company was used as an office for the cannery (Figure 32).²³ The building does not appear on the State of Michigan right-of-way map "Final Plans, June 25, 1929" (see Figure 9) indicating it was probably constructed after 1929.

Figure 32. View northeast of the Glen Haven Canning Company, the office building for the Glen Haven Canning Company (middle), and the warehouse on the dock. The car in the photograph date c. 1936-1937. Note the railroad tracks have been removed (see Figure 5). (SLBE 1935)

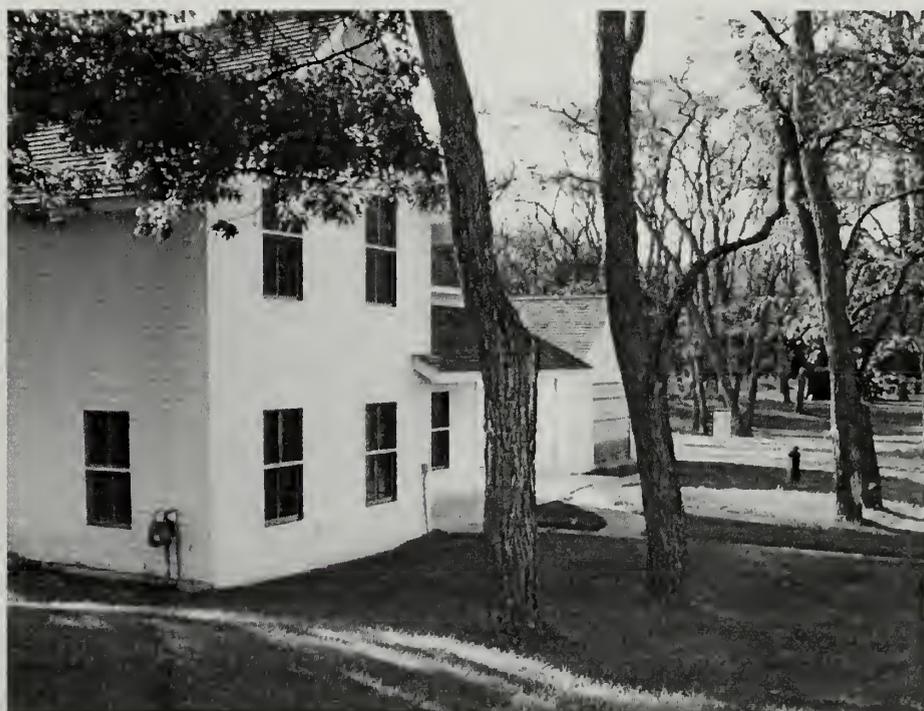
Existing Condition: The two-story wood frame house has a T-shaped plan, front gable roof, and clapboard siding (Figure 33).

Figure 33. View southeast of the Day house, 2005. Note the Day house garage (right) and row of black locust trees. (OCLP)

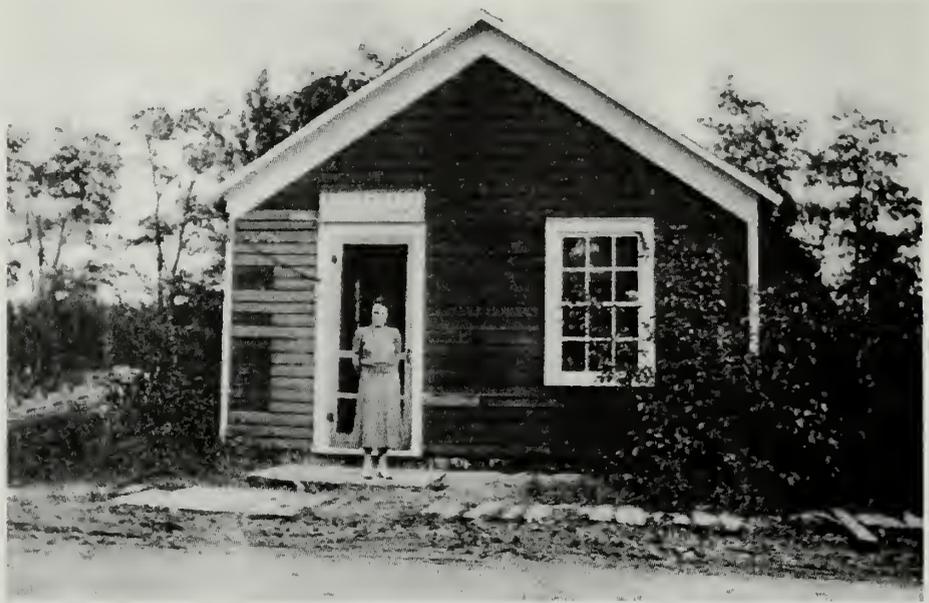
Historic Condition: The Day house garage was originally constructed as the village paint shop, and then later used as the Glen Haven Post Office (Figures 33-34). The post office closed in 1936. Originally located just north of the blacksmith shop, the building was moved c. 1941 to its current location (adjacent to the Day house) and converted into a one-car garage.²⁷

Figure 34. Photograph Estella (Day) Phillips standing in front of the Glen Haven Post Office, c. 1935. Note the remnant section of boardwalk in front of the building. Prior to serving as a post office, the building was the village paint shop. In 1941, the building was relocated to the Day house where it was converted into a garage. (Courtesy Bill Phillips)

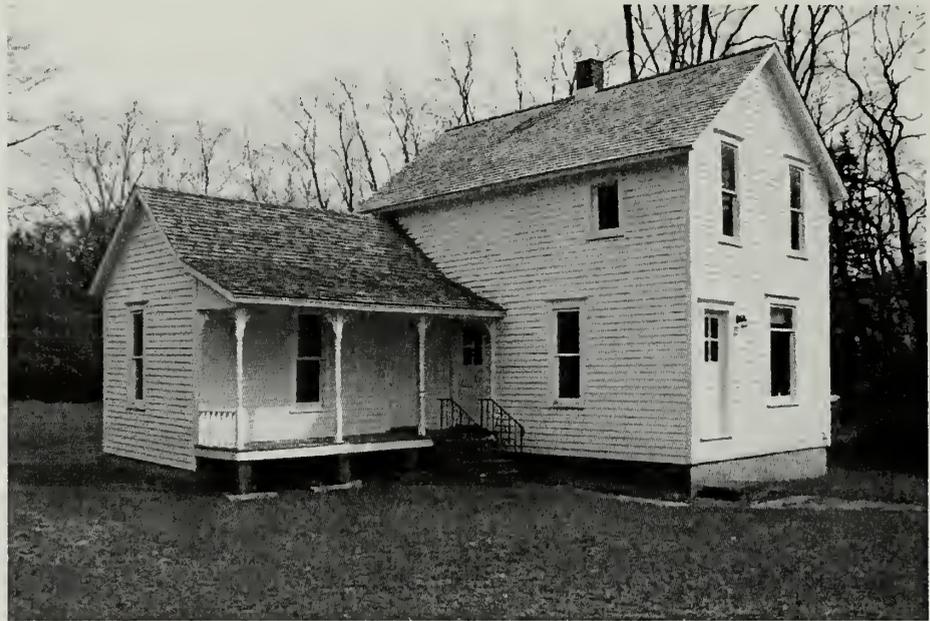
Existing Condition: The Warner house includes a 15' by 25' two-story main block with a 15' by 20' one-story wing. The wood-frame building sits on a concrete block foundation and has clapboard siding. The frieze boards on the two-story gable are less pronounced than most of the remaining village structures built about the same time (Figure 36).

Figure 36. View southeast of the Warner house, 2005. (OCLP)
