CULTURAL LANDSCAPE REPORT
FOR GLEN HAVEN VILLAGE HISTORIC DISTRICT

SLEEPING BEAR DUNES NATIONAL LAKESHORE
EMPIRE, MICHIGAN

CULTURAL LANDSCAPE REPORT FOR GLEN HAVEN VILLAGE HISTORIC DISTRICT

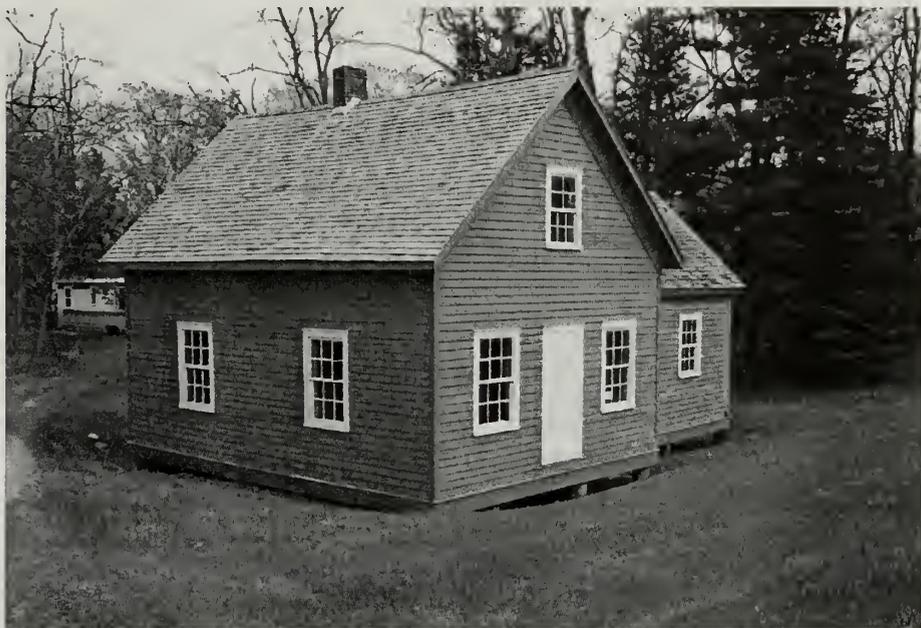
Existing Condition: The wood frame house has a T-shaped plan and clapboard siding. The front gable has a wide frieze board typical of other village residences built during the same period (Figure 37).

Figure 37. View southeast of the Bumgardner house, 2005. (OCLP)

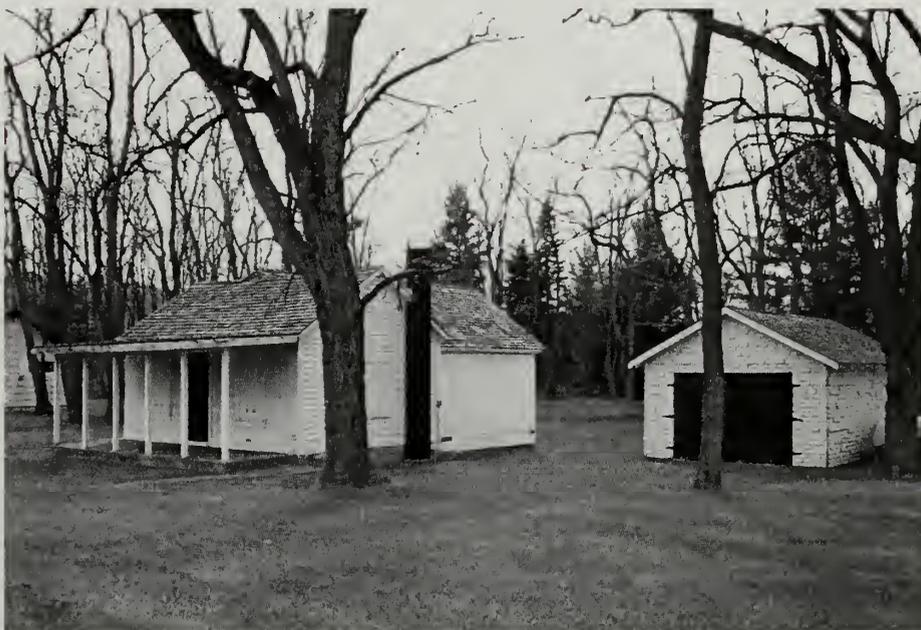
Existing Condition: The one-story L-plan wood frame house has a shingled cross-gabled roof with clapboard siding (Figure 38). According to park staff, evidence suggests the L-shaped building consists of two cabins placed together to form the house. Day family members interviewed did not remember this.

Existing Condition: The one-car wood frame garage has asbestos siding (Figure 38).

Figure 38. View southwest of the Rude house and garage, 2005. (OCLP)

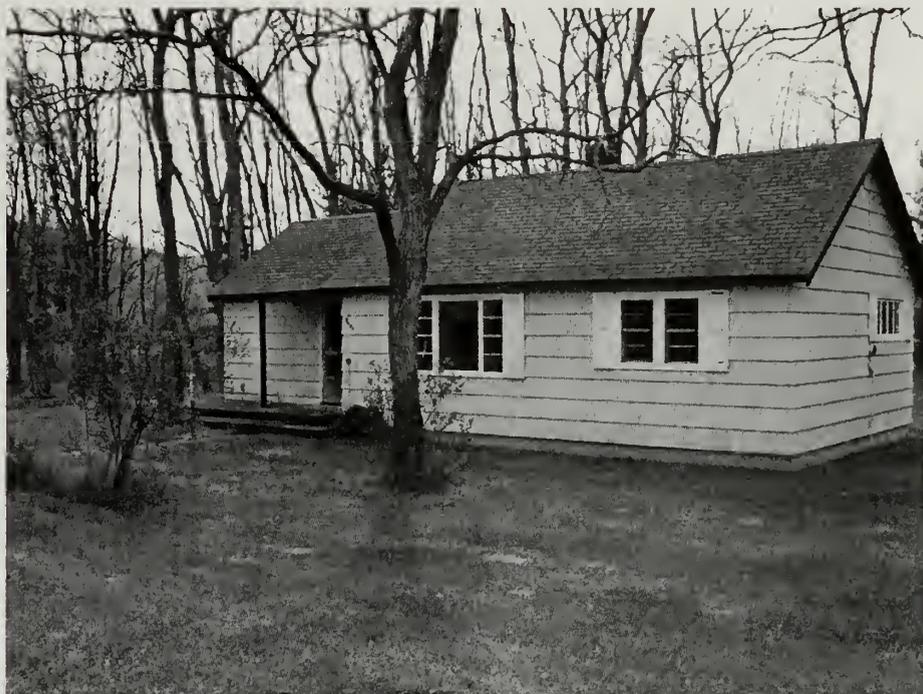
Existing Condition: The 860 square-foot Wickland house is built on a concrete foundation (Figure 39).

Figure 39. View southwest of the Wickland house, 2005. (OLCP)

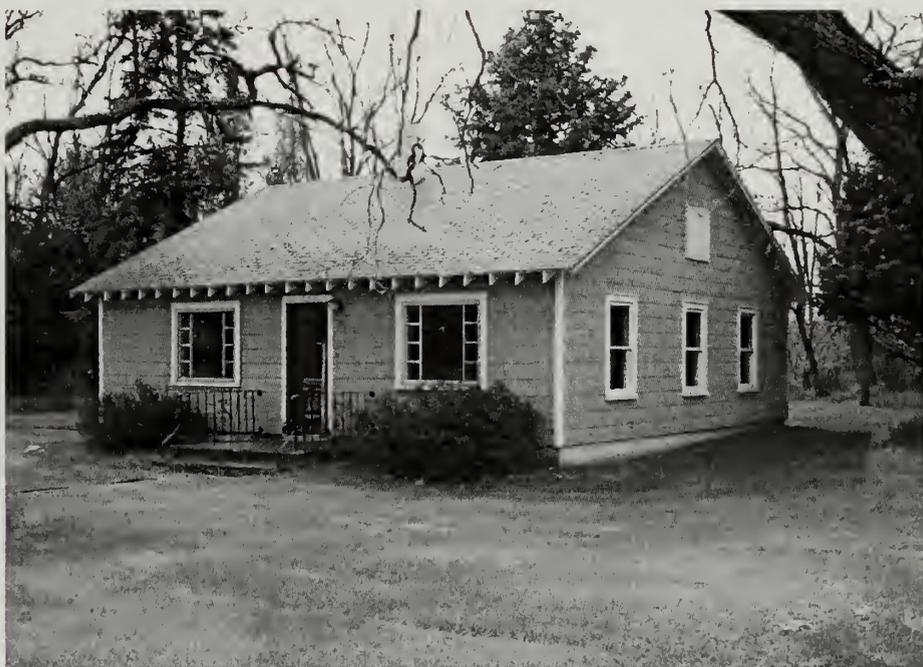
Existing Condition: The one-story frame house has a rectangular plan (30’ by 40’), side-gabled roof, and asbestos siding (Figure 40).

Figure 40. View southwest of the Dean house, 2005. (OLCP)

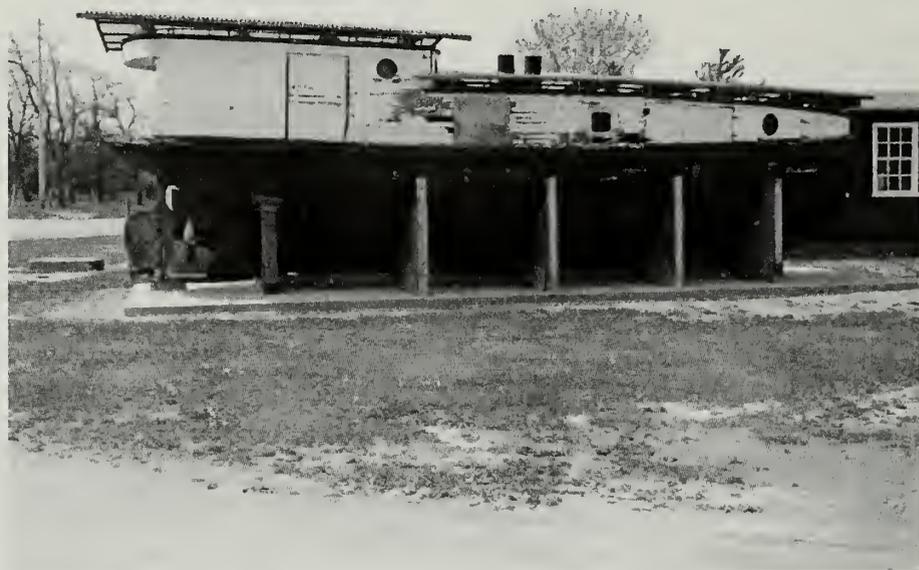
Existing Condition: The fishing tug is displayed outside the Glen Haven Canning Company building, which serves as the Cannery Boat Museum (Figure 43).

Figure 43. View west of the Vessel
Aloha, 2005. (OCLP)

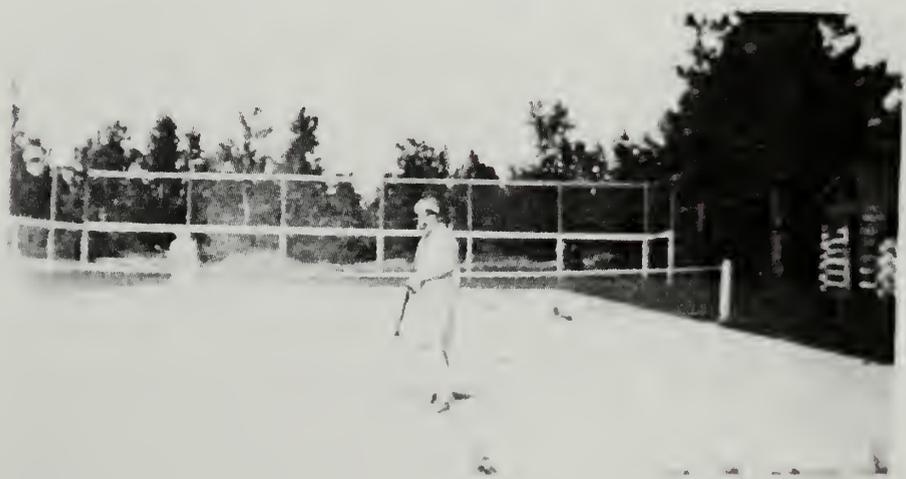
Historic Condition: Constructed by the early 1900s, the private tennis court was only for use of Day family and friends. An early photograph depicts the court with a lawn surface. By 1928, the court was re-surfaced with sixty rectangular concrete slabs, together measuring approximately 50' by 110'. A tennis net attached to iron hooks, supported by two concrete pillars, and a tall wood and wire fence surrounded large sections of the court. Bill Day, D.H. Day's youngest son, remembered bleachers adjacent to the court; other Day family members do not recall bleachers. The tennis court was in use until at least the 1950s (Figure 44-45).⁴⁸

Existing Condition: The court remains in fairly good condition. The sixty concrete slabs and the two concrete net supports are extant. The tennis net and the wood and wire fence are missing.

Figure 45. View of the tennis court with concrete slab surface, c. 1920s. Note the "St. Lawrence" (right), the wood and wire fencing, and the weeds growing between the concrete slabs. (SLBE 3805)

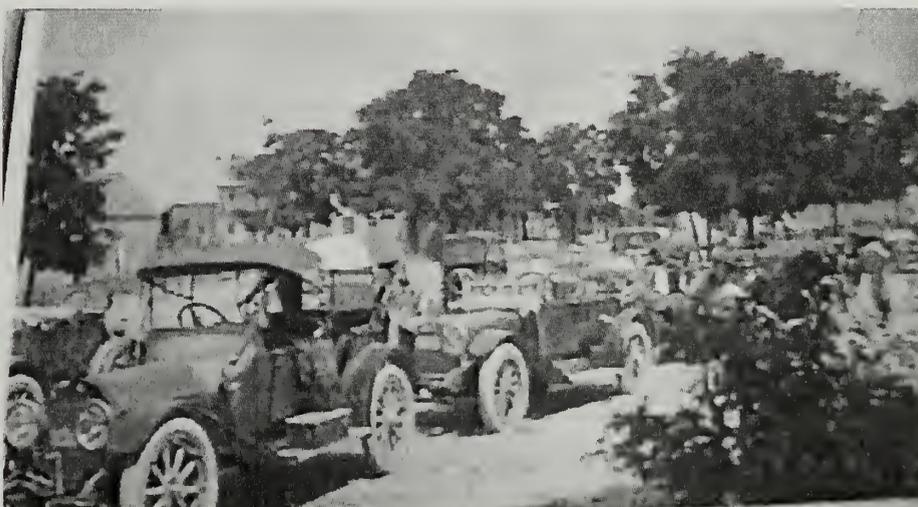
Historic Condition: By the late 1800s or early 1900s rows of black locust trees had been planted along both sides of Glen Haven Road, about 30 feet apart (Figures 46-47). As indicated on the State of Michigan right-of-way map “Final Plans, June 25, 1929” (see Figure 9) a row of about 29 trees stood along the west side of the road, from the Sleeping Bear Inn to the Rude house. The line of eight inch caliper

Figure 47. View northwest of the west side of Glen Haven Road during the 1915 Pike Tour. Note the young black locust trees bordering the road. Also visible, is the large barn depicted in Figure 46, the Sleeping Bear Inn, and the building in back of the inn (center, partially obscured by trees). (Courtesy of Marion (Day) Warnes)

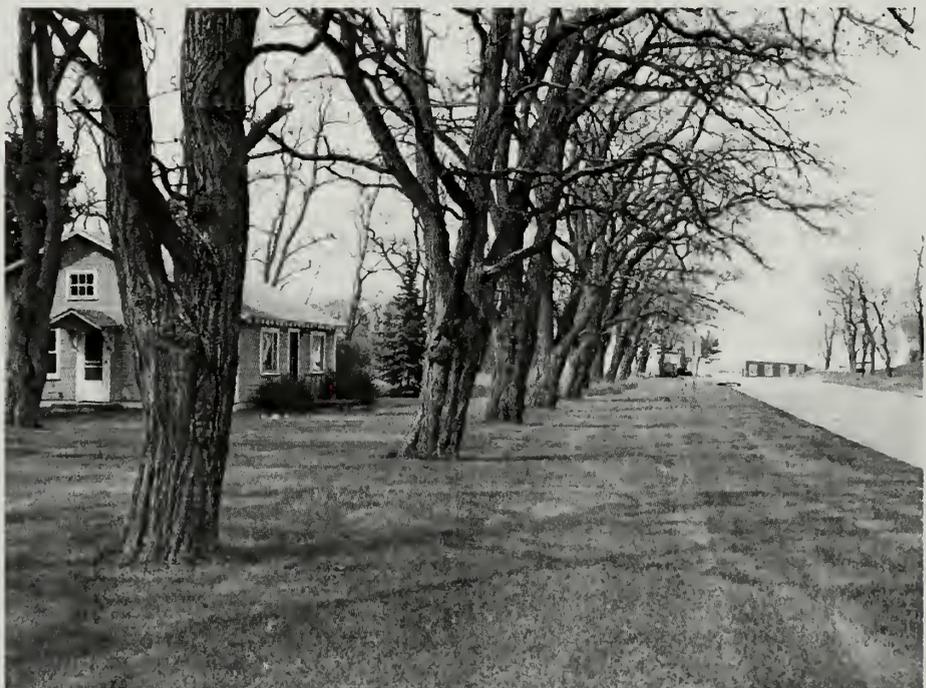
Figure 48. View north of the row of black locust trees along the west side of Glen Haven Road, 2005. (OCLP)

Existing Condition: Today, 23 black locust trees remain along the west side of the road, and 11 along the east side of the road. No trees from the row north of the D.H. Day Store, along the plank road, exist. Several trees were recently removed or their canopies topped in front of the Day house (Figure 48).

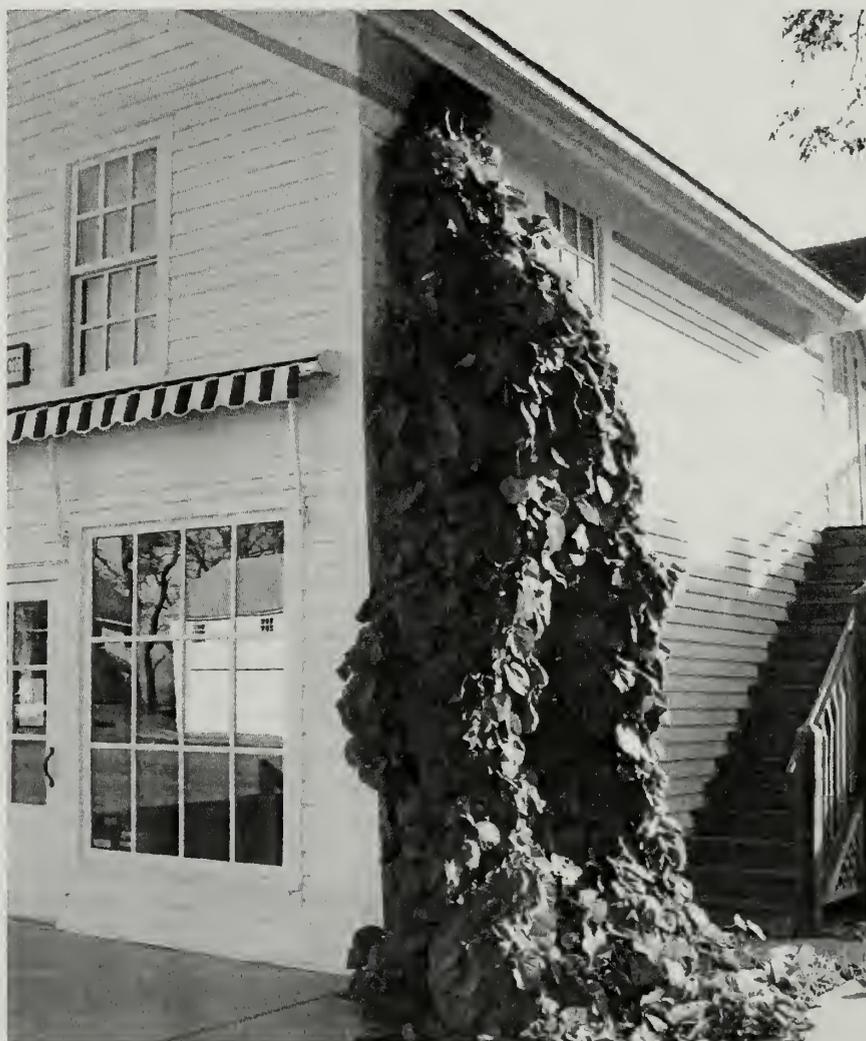
Existing Condition: The Dutchman's pipe extends to the roof of the D.H. Day Store (Figure 51).

Figure 51. Dutchman's pipe vine growing on the southwest corner of the D.H. Day Store, 2004. (OCLP)

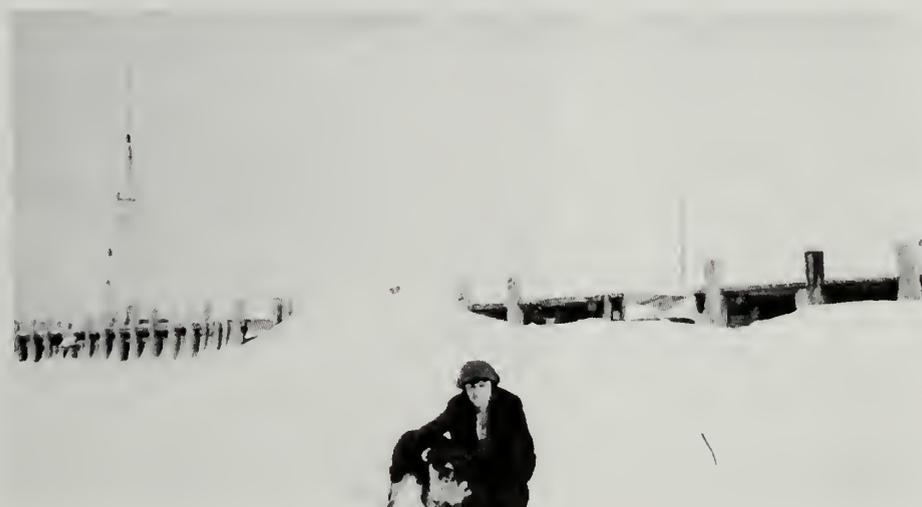
Figure 53. View northeast of U.S. Weather Bureau storm signal tower on the dock, c. 1920s. Marion (Day) Warnes is depicted in the photograph with a dog. (Courtesy Pat (Day) Bennett).

same or similar tower is depicted on a mid-1920s photograph of the dock (Figure 53). The land location of the U.S. Weather Bureau storm signal tower depicted in the photographs is unknown. The topography in the photographs indicates the location of the signal tower in c. 1928 was not the same as its current location. Additional features depicted in the photograph, such as fencing, garden areas, and a mowed lawn, indicate it may have stood in back of the Day house. Day family members interviewed do not remember the tower in any other location. It's possible that at one time two signal towers stood on land, one at the current location and another in the location depicted in the historic photographs.

Existing Condition: A U.S. Weather Bureau storm signal tower is located on the knoll located between the D.H. Day Store and the Day house (Figure 54). This signal tower may be the same tower depicted Figures 52-53. The extant signal tower is a diagonally-braced, fabricated metal, pyramidal signal tower standing 50 feet tall, with a 20-foot flagstaff topped by an eagle finial. Given the evidence presented above, and the fact that a similar (if not identical) structure known to date to 1914 is located at the Sleeping Bear Point Coast Guard Station, the tower is presumed to be historic.

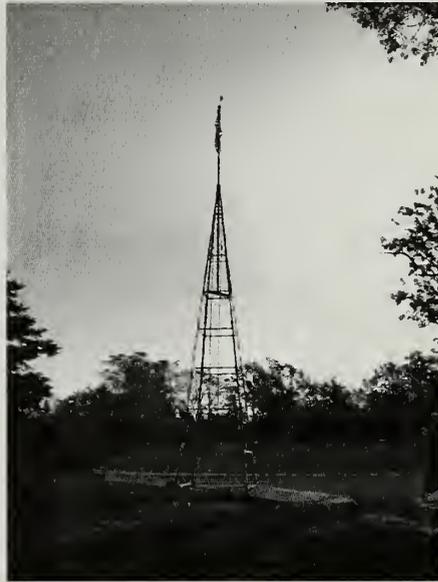
Figure 54. View east of the U.S. Weather Bureau storm signal tower on knoll south of the D.H. Day Store, 2004. (OCLP)

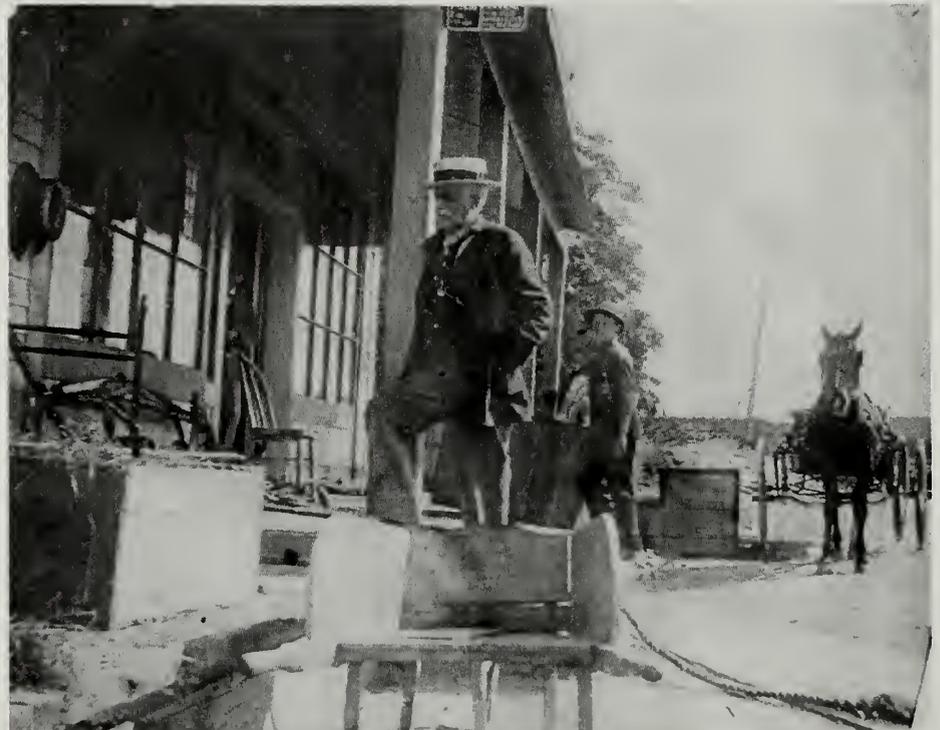
Figure 55. View of porch in front of the D.H. Day Store, early 1900s. Notice the wheelbarrow, plow, wooden crate, chair, and two-step next to horse and buggy. (Courtesy D.H. Day III)

Historic Condition: An early 1900s photograph depicts a wooden wheelbarrow, crates, a chair, roping, a plow, and a horse and buggy in front of the store (Figure 55). Also show in the photograph is a free-standing wooden two-step, for climbing into and out of buggies and wagons. The same or a similar stair is also depicted in a 1913 photograph of the store. Other features would have included a hitching post, tin advertising signs, and produce for sale in baskets. A tin public telephone sign attached to a telephone pole in front of the store is depicted in several c. 1920s photographs. Additional 1920s features included gasoline pumps (see below), oil cans displayed on a rack, and a watering can for car radiators (Figure 56).⁶⁰

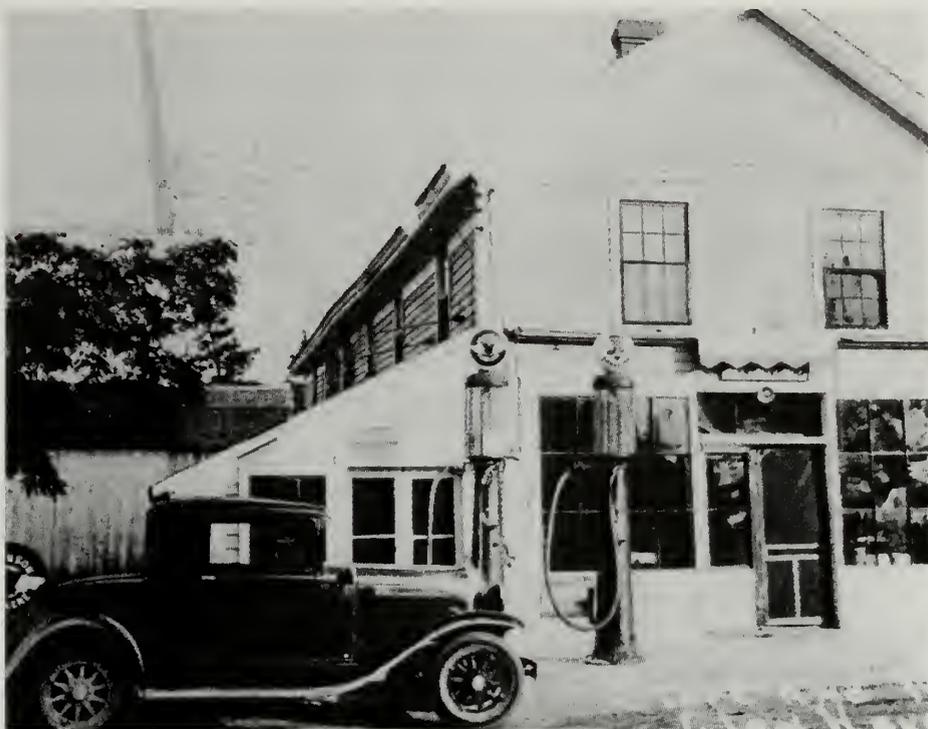
Figure 56. Gasoline pumps in front of the D.H. Day Store, c. late 1920s-early 1930s. Also note the concrete porch and the tin advertising sign. (SLBE 1108)

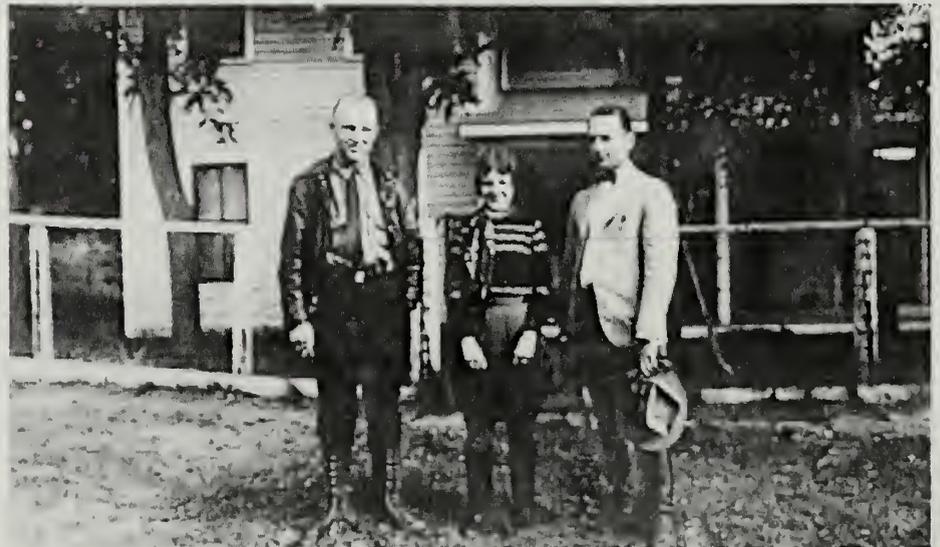
Figure 57. Wood and wire fence in front of the Day house, 1929. Also note the row of black locusts in back of the fence. Identity of people in photograph is unknown. (Courtesy of Marion (Day) Warnes)

Historic Condition: Day family members remember a fence encircling a large section of the village between the D.H. Day Store and the blacksmith shop. According to Marion (Day) Warnes, the fence was wood and wire with a board across the top. The family constructed the fence to keep horses out of the residential area. Several historic photographs depict this fence style, including Figure 57 taken in front of the Day house. The location of two fencelines extant during the period of significance are shown on the State of Michigan right-of-way map “Final Plans, June 25, 1929” (see Figure 9): one associated with the Rude house - enclosing the property on the south, west (along road), and north sides; and another between the Day house and the D.H. Day Store – running perpendicular to the road. Additional fence styles illustrated in c. 1910 to 1930 photographs include board-on-board, wooden post and wire, and wooden lattice. Two historic photographs illustrate gate styles: a wooden picket style gate at the southwest corner of the D.H. Day Store (Figure 58), and a chain link or iron and wire fence, location unknown.

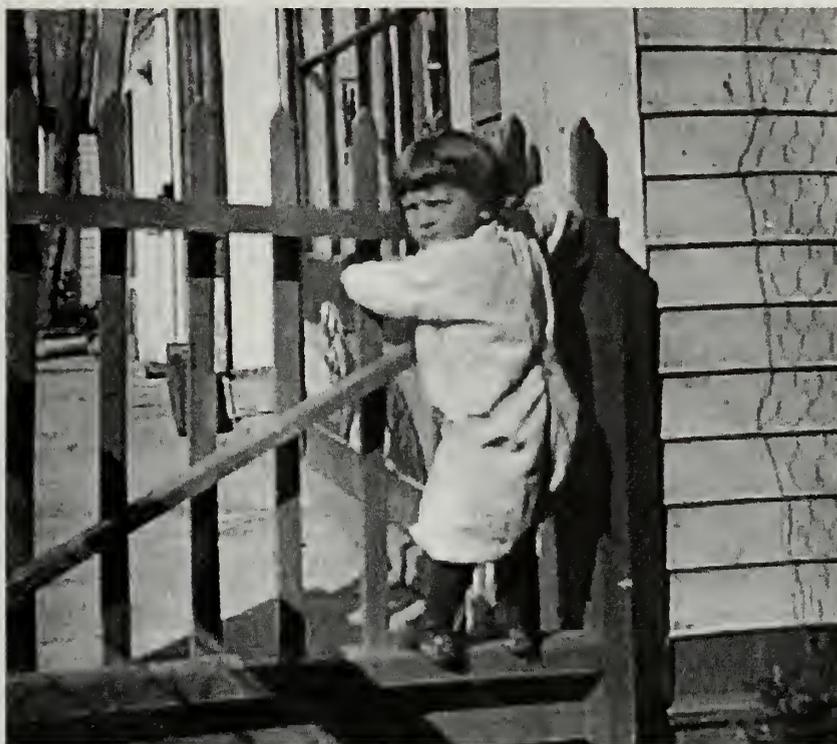
Figure 58. Marion Day standing on a wood picket gate at the southwest corner of the D.H. Day Store, 1915. Also note the chicken wire trellis and the small Dutchman's pipe vine (left). (Courtesy of Marion (Day) Warnes)

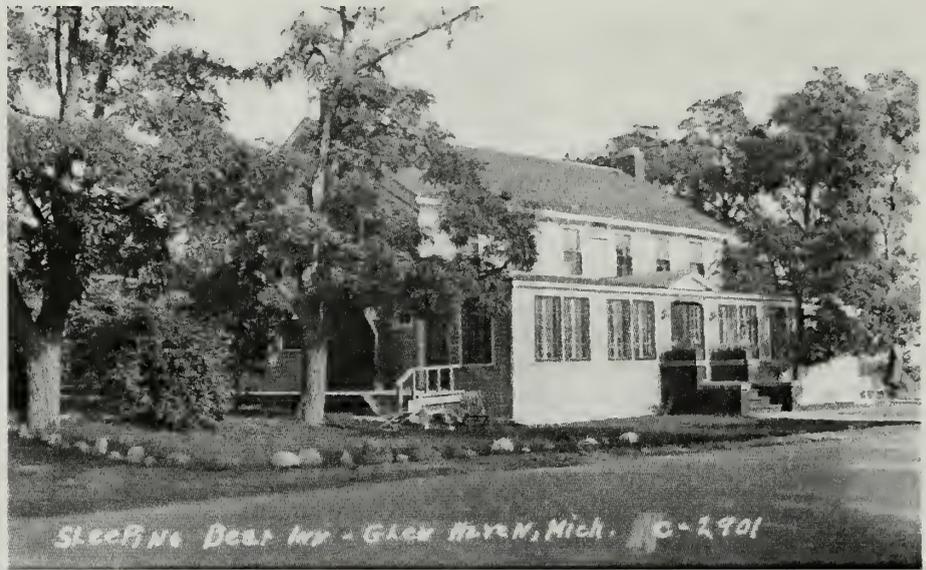
Figure 59. View northwest of stones lining the driveway in front of the Sleeping Bear Inn garage, c. 1930s. Also note the locust trees, the maintained lawn, the lawn chairs in front of the Sleeping Bear Inn, and the lightning rods along the roofline. (Archives of Michigan, Kufta Collection)

Historic Condition: A c. 1930s photograph clearly depicts four lightning rods (with decorative balls) attached to the roof-line of the Sleeping Bear Inn. Lightning rods similar to the illustrated in the photograph were typically found on buildings and structures in the 1800s and early 1900s.

Existing Condition: The NPS will replace the four lightning rods removed during replacement of the roof.

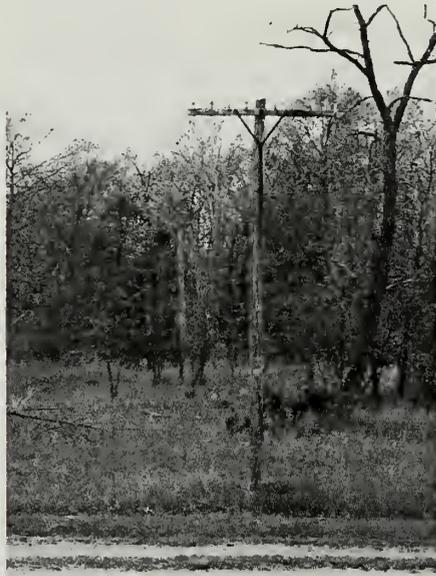
Figure 63. View west of the crossbeam U.S.C.G. utility pole with a mounted row of glass insulators, 2005. Glen Haven Road is in the foreground. (OCLP)

the historic poles are visible. The remaining poles have been buried by shifting sand. Of the four exposed poles, only one is within the historic district. This pole is the older crossbeam style with a mounted row of clear insulators, mentioned above (Figure 63). The three exposed poles located outside the historic district are the oldest style with glass insulators attached directly to the pole (Figure 64). Many of the original glass insulators are extant on the poles, and some of the wiring between the poles remains. Heavy vine growth has overtaken some of the poles and wiring.

The crossbeam style U.S.C.G. utility pole may date to c. 1925-1931. The three oldest style U.S.C.G. utility poles are outside the historic district, within the park boundary. If the historic district boundary is re-drawn to include the three utility poles, the poles would contribute to the significance of the historic district.

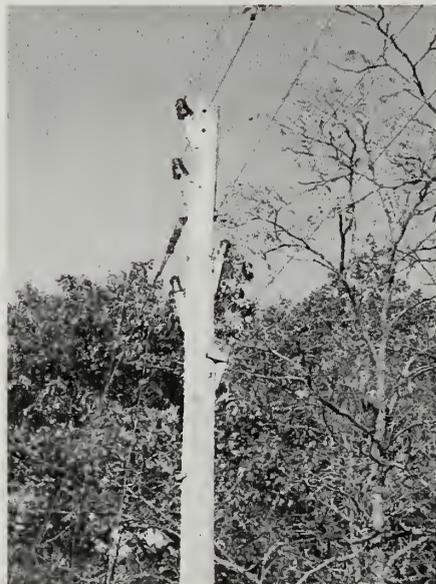
Historic photographs illustrate two styles of pre-1940s utility poles in Glen Haven. Early photos depict utility poles (approximately 30' tall) with glass insulators

Figure 64 . U.S.C.G. utility pole and lines with glass insulators attached directly to the pole, 2004. (OCLP)

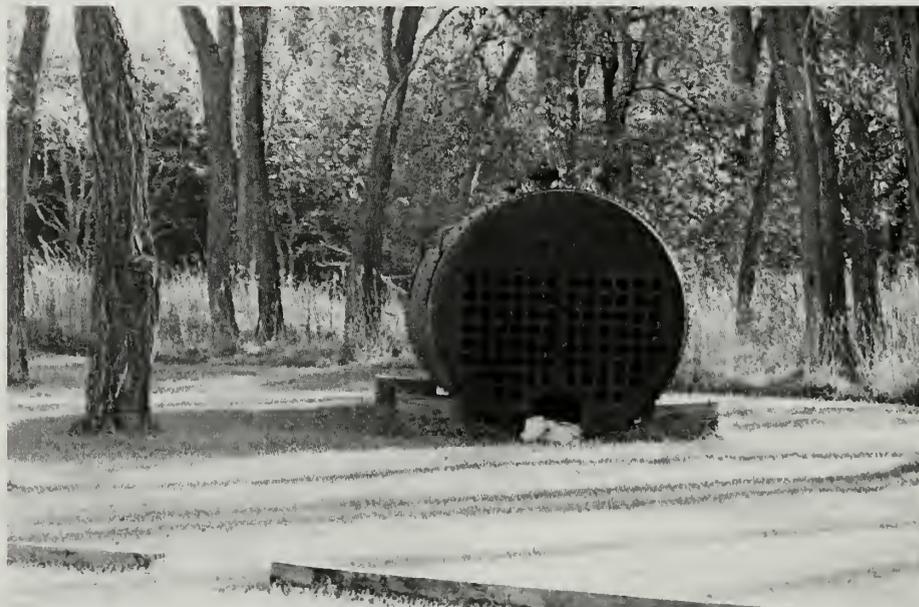
Historic Condition: The NPS purchased the steam boiler from the Novotny sawmill and placed it in the village for interpretative purposes. The Novotny steam boiler is similar to the boiler that would have been used at the D.H. Day sawmill.⁶⁹

Existing Condition: The boiler's exterior is rusted (Figure 65).

Figure 65. View east of the Novotny steam boiler, 2004. (OLCP)

The Novotny steam boiler does not contribute to the significance of the historic district. However, as a typical type of feature that may have stood outside the blacksmith shop awaiting repair, the steam boiler contributes to the character of the landscape.

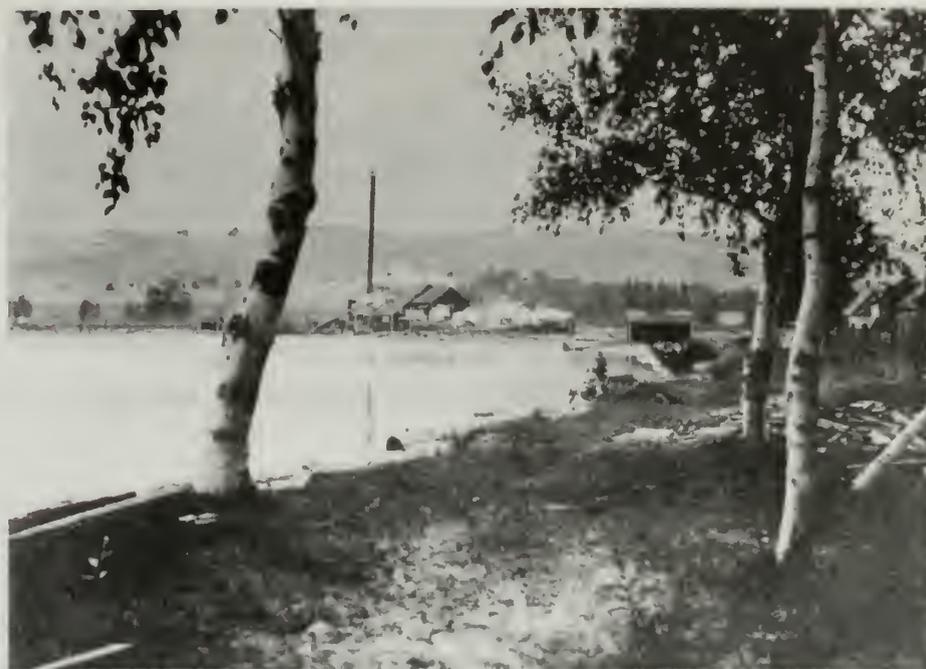
Figure 66. View of D.H. Day's sawmill on Little Glen Lake, n.d. (Courtesy of Bill Phillips)

cordwood to their fleet of steamships. D.H. Day subsequently purchased the mill from Northern Transit Company in 1881 (Figure 66).⁷⁰ By the late 1800s, the conversion of steamers to coal fired engines reduced cordwood production. In its place, hardwood trees were increasingly harvested and processed in the mill then shipped from the dock to Chicago and Milwaukee where the lumber was distributed to developing Midwest towns. In 1907, D.H. Day replaced the horse-drawn tramway with a narrow-gauge railroad. Shortly after closing in 1923, the sawmill was dismantled and the building razed.⁷¹
