Memorandum

Subject: ASR in Fort Sumter Core Drill Specimens

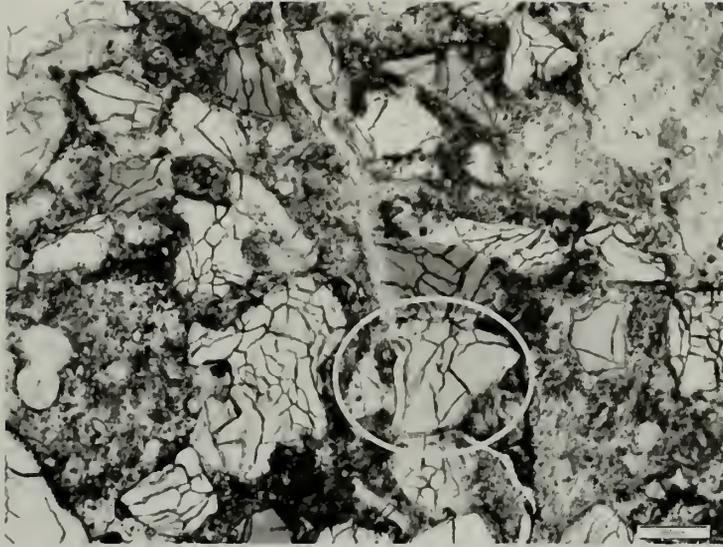
In addition to global swelling, directional swelling due to ASR can result in splitting of aggregate in concrete (Reference 2). An example is shown in Figure 4, but it is unclear if internal swelling (as in a porous aggregate) is possible in sand grains of high density and hardness. Fracture of strong aggregate indicates the matrix phase (binder phase) of this mortar exhibited very high strength.

Figure 4: Fracture of Quartz Grain in Core 6-1-25 (circled)
