FOUR HISTORIC LANDSCAPE STUDIES

OLYMPIC NATIONAL PARK

Olympic National Park

Summer 1984

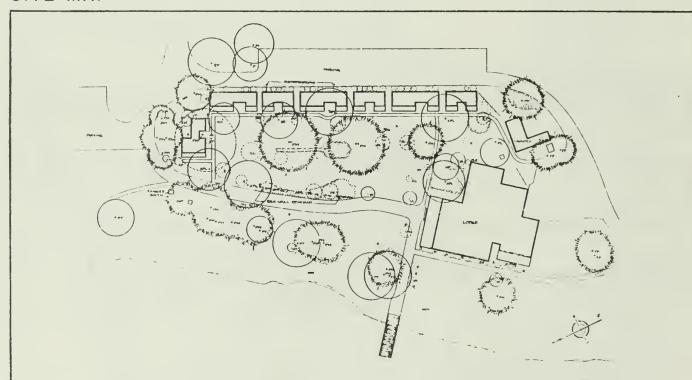
SITE MAP

SITE BOUNDARIES

Topographic Distant mountains visually enclose site

☑ Vegetation High tree canopy creates ceiling and dense surrounding forests enclose site

☑ Circulation Major pedestrian path divides semi-private and public areas

Water Lake Crescent creates boundary on west

Structural Linear row of cabins encloses the historic core and forms east

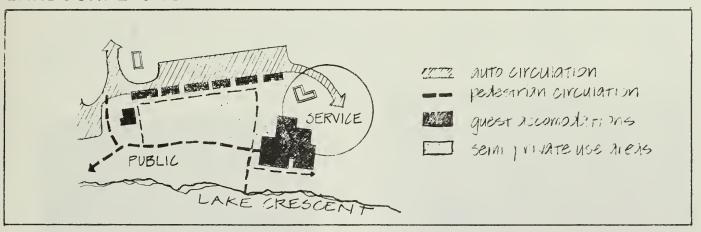
LANDSCAPE ORGANIZATION

<u>Cluster arrangement</u> - The lodge and small cabins to the northeast form a semi-circle, enclosing the historic core and semi-private garden area, directing attention to the lake.

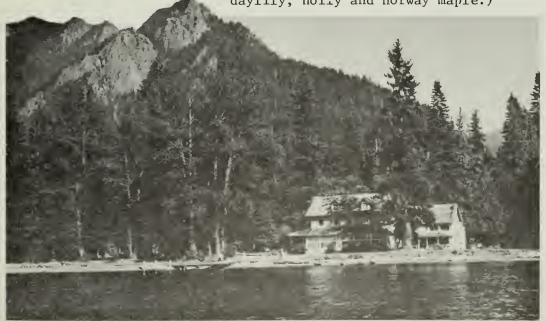
Historic Views and Perceptions - Remnants of stonework which formed the foundation for a fence around the horseshoe pits in the twenties, and later edged formal planting beds in the thirties are still visible along the major walkway. "Old-fashioned" non-native plant materials evoke feelings of an earlier era, and hint at the former structure of the gardens. (Rose, lilac, daylily, holly and norway maple.)

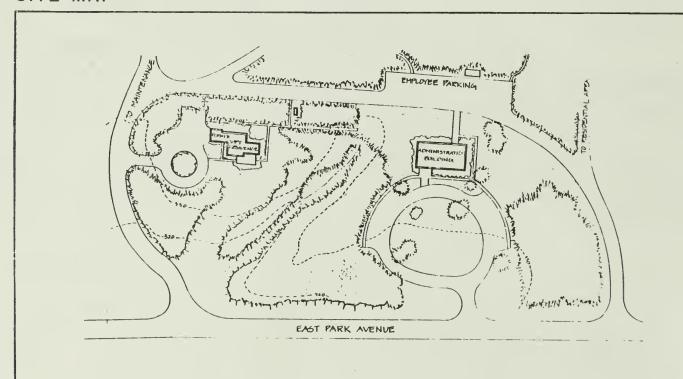
SITE MAP

Topographic Sloping terrain in front of Supt.'s residence creates visual edge

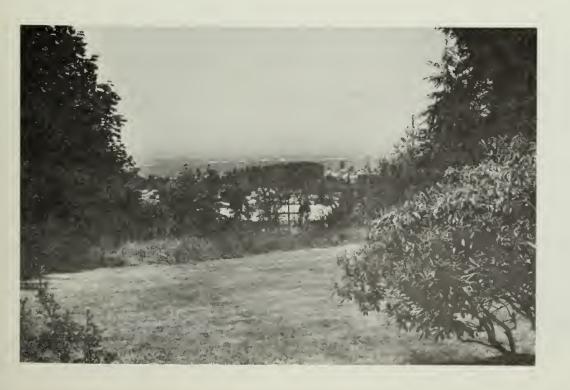
<u>Historic Views and Perceptions</u> - Views to the north from the buildings were a significant factor in the original siting of the structures and, despite, encroachment by trees and new residences, they are still intact.

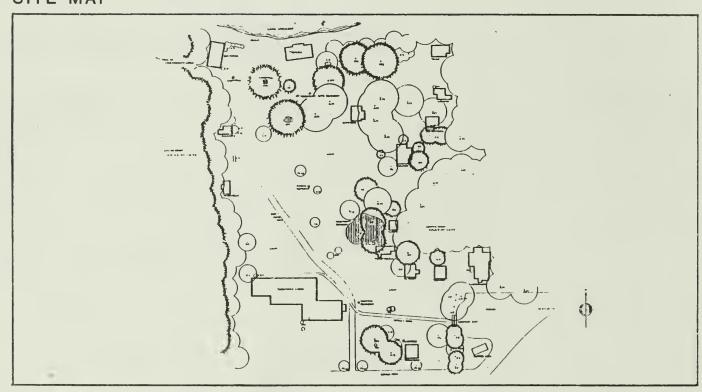
SITE MAP

Z Topographic Distant mountains visually enclose site

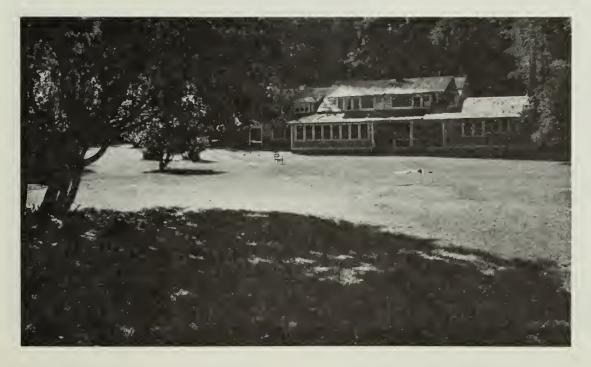
Historic Views and Perceptions - Rosemary Inn including the structures and grounds have retained the flavor of a rustic resort in a wilderness setting. Although plant materials in the historic core are reduced to scattered remnants of the original gardens, the original fabric of the site remain intact giving the complex the feeling of a place caught in time.

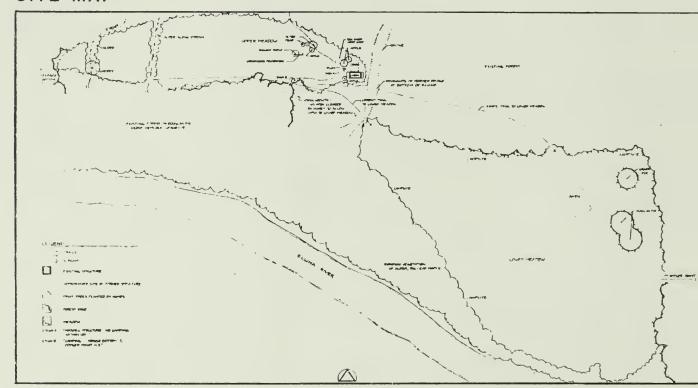
SITE MAP

Topographic Ravine and terrace edges isolate meadows as two distinct. land units

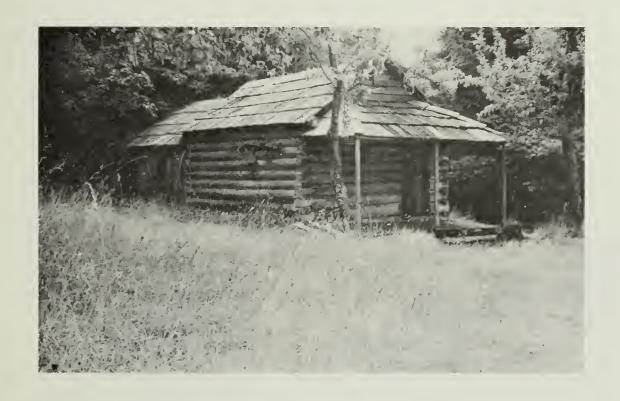
Historic Views and Perceptions - Old fruit trees stand in front of the cabin, framing views out to the upper pasture. Remnants of the trail that led to the lower pasture, including a bridge over a ravine, and trails to other outbuildings (no longer standing) are still evident. A remnant concrete foundation is located in the upper pasture about 100 feet in front of the cabin.
