Final Report

**Forensic Analysis of Building  
Materials Obtained by Core Drilling;  
Fort Sumter National Monument**

Denis A. Brosnan  
Professor, Clemson University

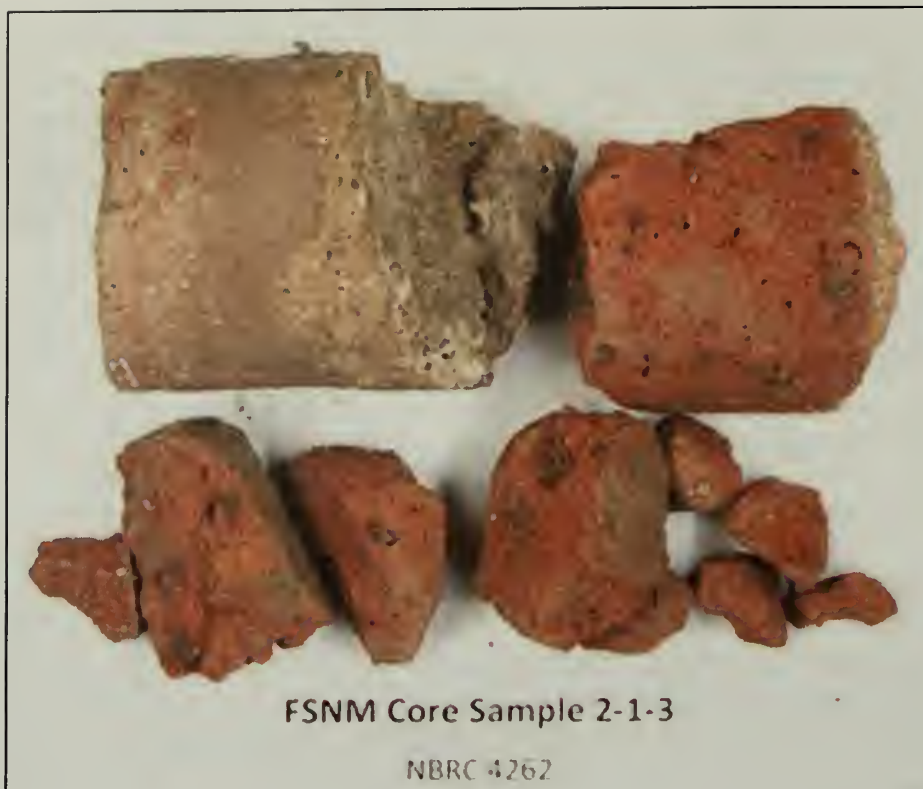
**Figure 2: FS Core Drill Mortar 2-1-3**

Photographs of specimens obtained by core drilling are shown in Figures 2-7. Tabby concretes are clearly distinguishable by their shell content (Figures 5-7); however, shell fragments can be found in the masonry mortar specimens originating in incomplete burning of shells in producing oyster lime and/or in job site contamination (See Figure 3).

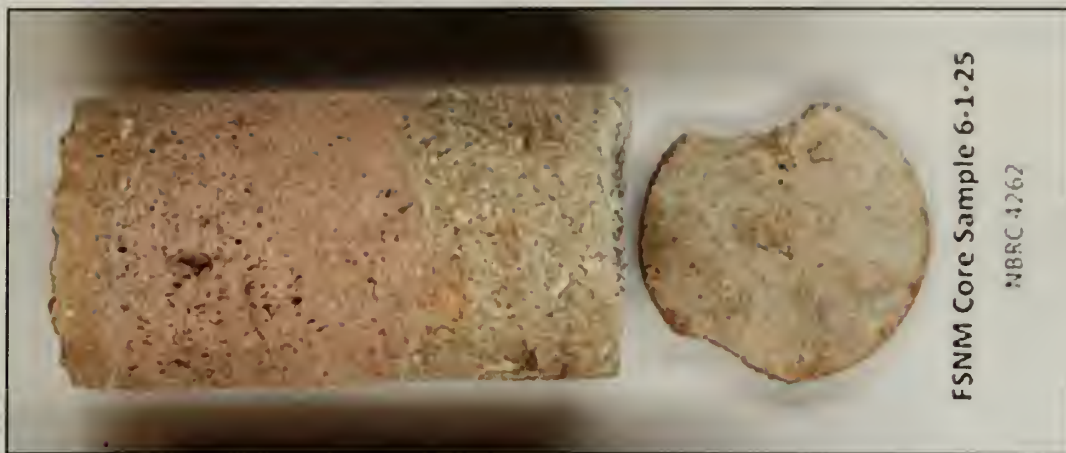
**Figure 4: Core Mortar/Tabby Concrete 6-1-25**

This specimen had the macroscopic appearance of a mortar containing small shell fragments (Figure 4). The insoluble residue or sand content of 58.6% also suggests a mortar composition (Table 2), but natural cement particles were not found in the microstructure (Figures 19-23). Larger shell fragments were not present in the microstructure. Therefore, the specimen was considered a lime-sand mortar composition.

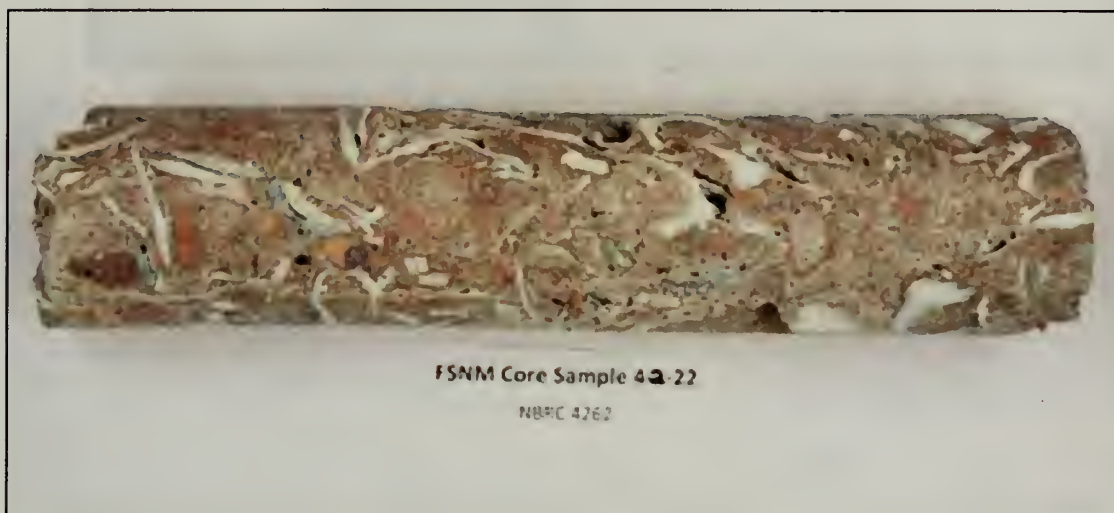
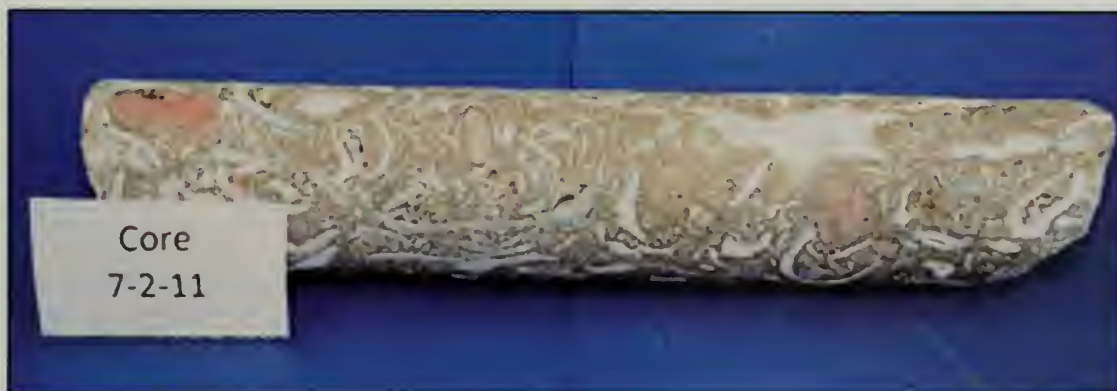
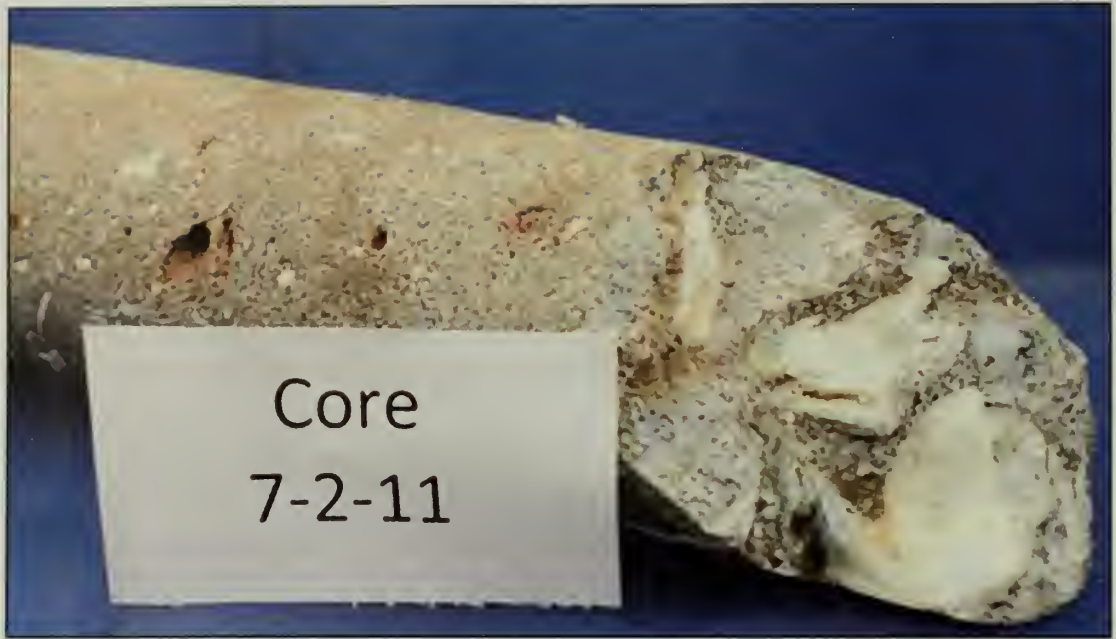
**Figure 5: Core Tabby Concrete 4-2-22**

**Figure 6: Core Tabby Concrete 7-2-11**

**Figure 7 – Detail of Tabby Concrete Core 7-2-11**

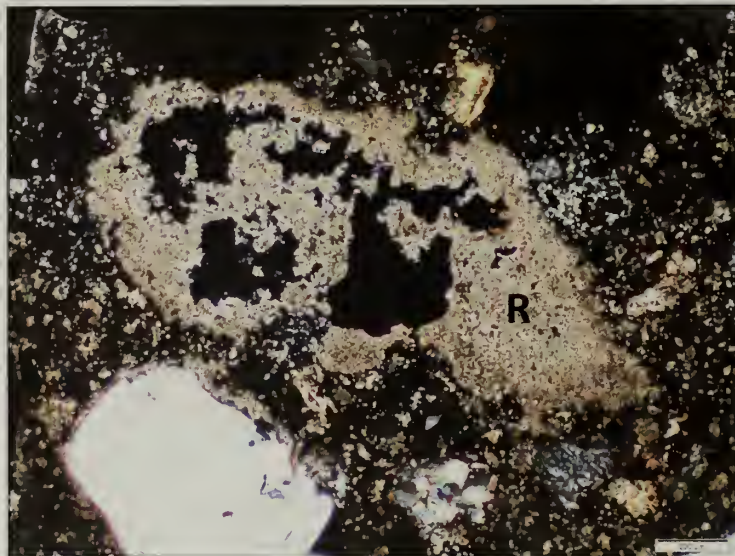
**Figure 16: Microstructure of Mortar 3-1-14 with  
Lime Agglomerate XPL**

Microstructural Features: Sand (S), cementitious matrix (M), Pores (P), Lime relic (R) and Cement relic (C); PPL=plane polarized transmitted light and XPL=transmitted light crossed nicols.

A lime agglomerate is clearly visible in mortar 3-1-14 in Figures 15 and 16. The lime appears to be hollow [where residual  $\text{Ca(OH)}_2$  dissolved leaving a periphery of calcite crystals]. In observation using crossed nicols (Figure 16), the carbonated phase appears as white crystals in the residual agglomerate. An intact lime agglomerate is seen in material 6-1-25 in Figure 19.

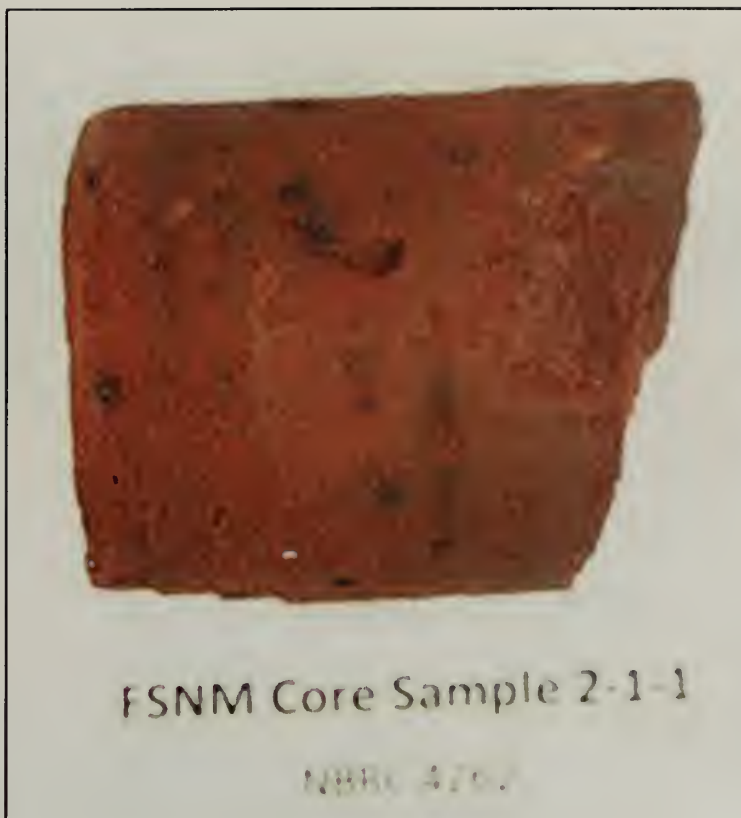
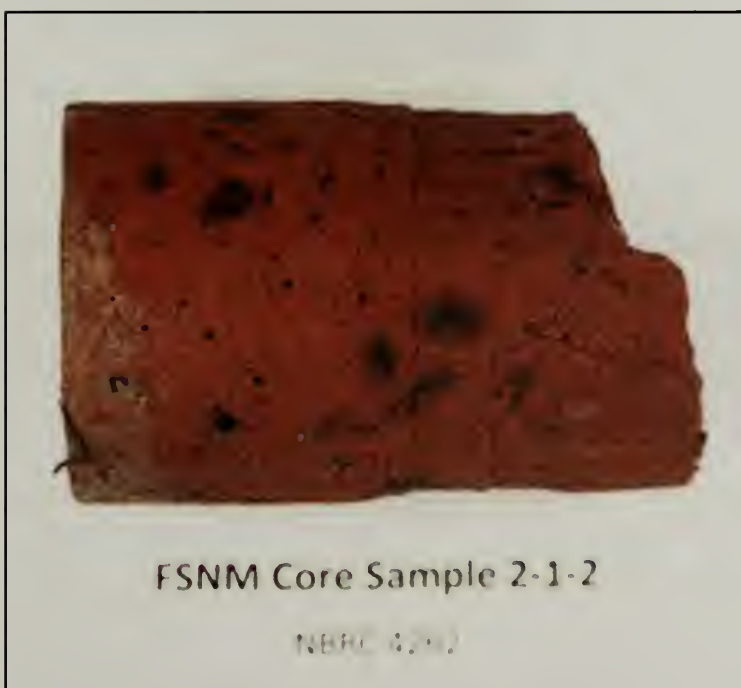
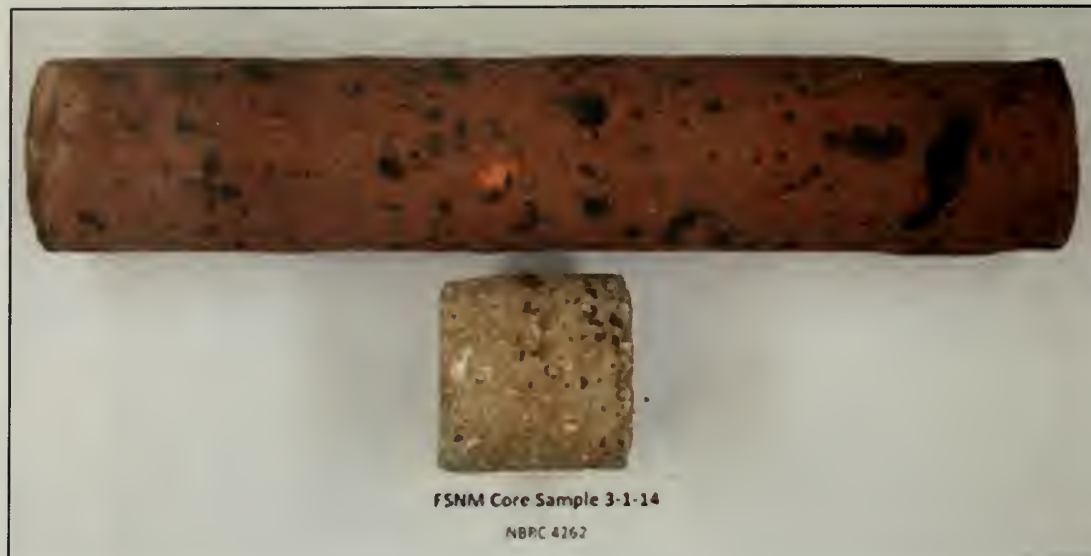
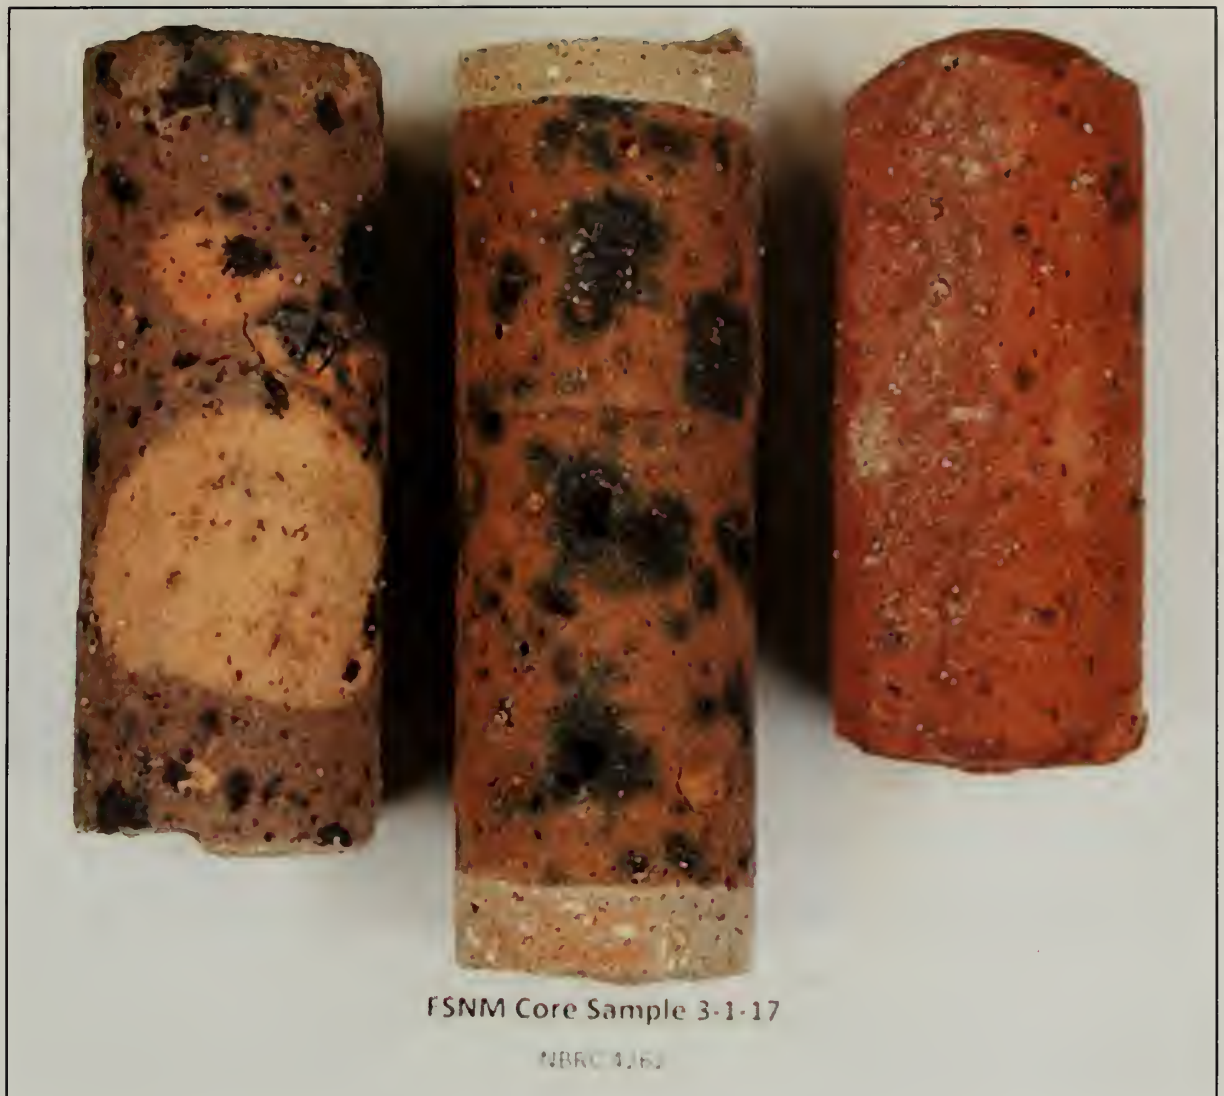
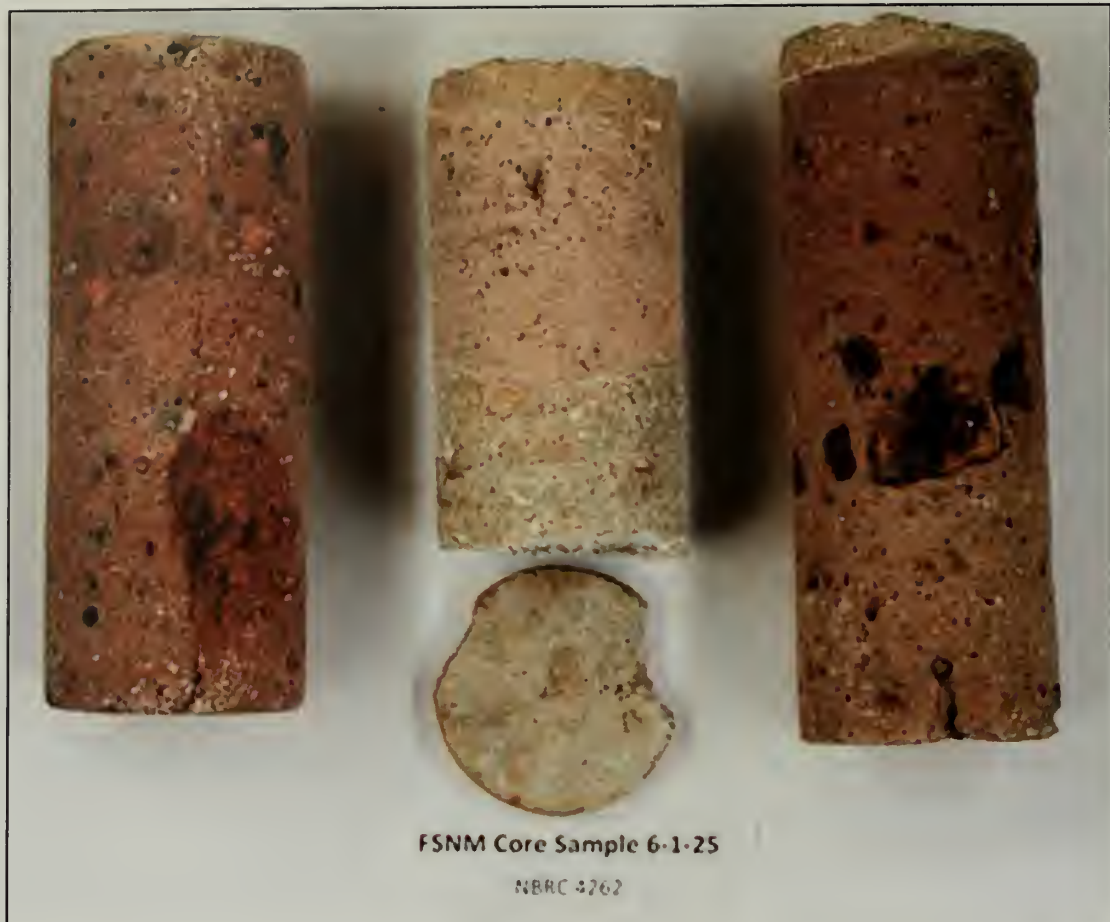
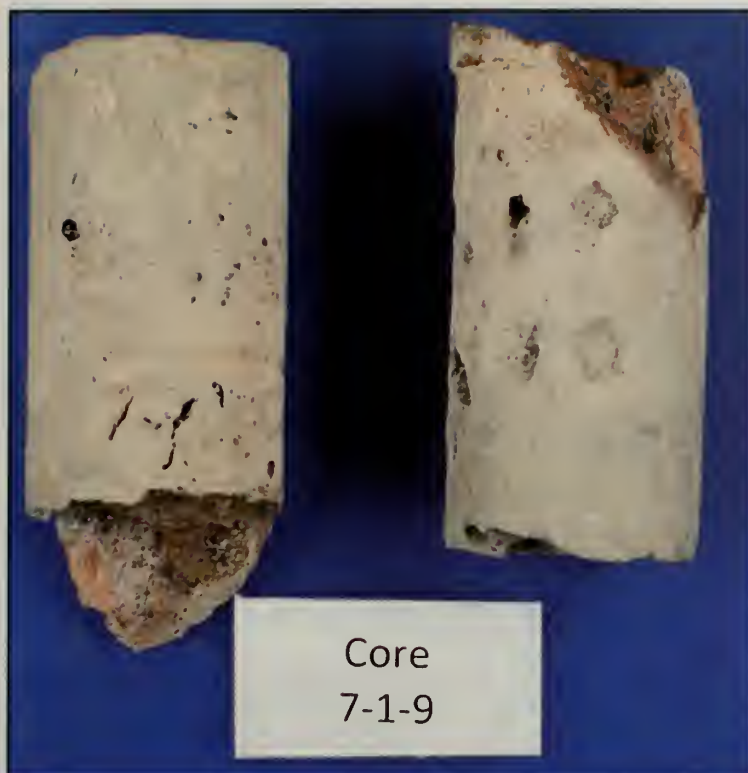
The core specimens of bricks are shown in Figures 35-40, with most bricks exhibiting black chert nodules that are typically found in “Charleston Grey” bricks reflecting their production on the sea islands around Charleston. The bulk of bricks on the walls of FSNM exhibit a similar appearance (Reference 3). The bricks shown in Figure 39 were possibly a type known as “Charleston Brown”, a type possibly produced in the upper reaches of the Ashley or Cooper River estuaries and found in a minority of the bricks used on FSNM walls. The chemical, mineralogical, and physical data for the bricks is given in Table 5.

**Figure 38: Brick Specimens 3-1-17**  
**(Left to Right – Grey Brick, Grey Brick with Mortar, Red Brick)**

- The composition of repair and restoration materials is revealed for use in future construction activities where authenticity of materials is of importance.
- Bricks in repairs should have a similar thermal expansion characteristic as the original bricks to ensure that no harm is done to the structure. It is also well-known that repair bricks should exhibit a similar modulus of elasticity as the original bricks.

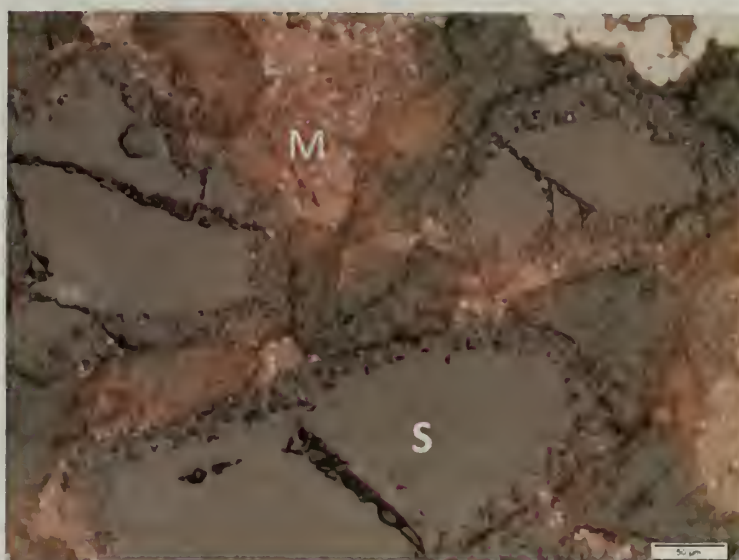
**Figure 50: Microstructure of Brick 4-1-20 RXPL**

Microstructural Features: Sand (S), Vitrified matrix (M), Pores (P), and Chert nodule (C); RPL = reflected polarized light and RPXL = reflected light crossed nicols. No analytical measurements were made on Core 4-1-20 bricks.

Microstructural features of brown bricks are shown in Figures 49-53. These bricks contain only a few chert nodules (as in Figure 49), and their vitrified phase contains iron spinel

crystals that appear as white angular features in reflected light (Figure 52). In reflected light with crossed nicols, the spinel crystals appear red and are concentrated near pore walls (Figure 53). This spatial orientation of spinel crystals suggests precipitation from the vitreous phase as the brick cooled, i.e iron oxide exsolved near pore walls forming crystals at the periphery. The high temperatures involved in brick firing resulted in defined reaction rims around some quartz particles (Figure 50). These rims are not related to ASR seen in the mortars without natural cement in their composition.

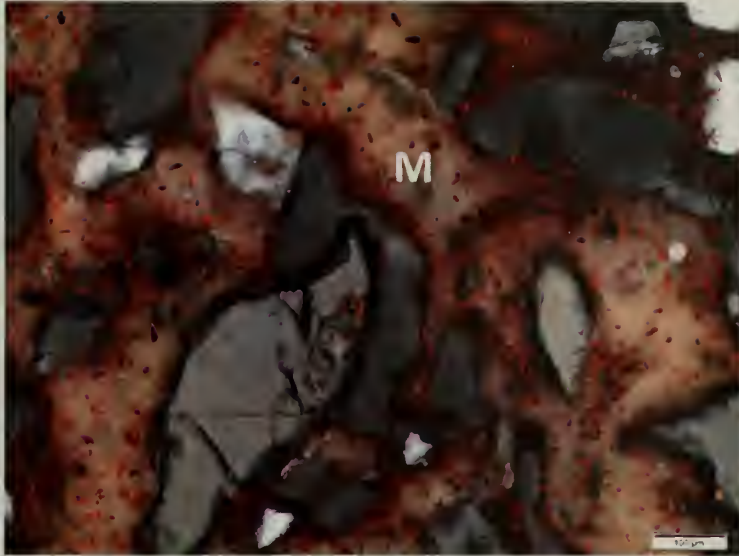
**Figure 53: Detail of Brick Matrix of 6-1-25 RPL**

Microstructural Features: Sand (S), Vitrified matrix (M), Pores (P), and Chert nodule (C); RPL = reflected polarized light and RPXL = reflected light crossed nicols.
