STREAM DISCHARGE RATING CURVES FOR THE FALL RIVER, ROCKY MOUNTAIN NATIONAL PARK

WRFSL PROJECT REPORT NO. 83 - 5P

Mark Siegenthaler
Department of Civil Engineering
Colorado State University

August 1983

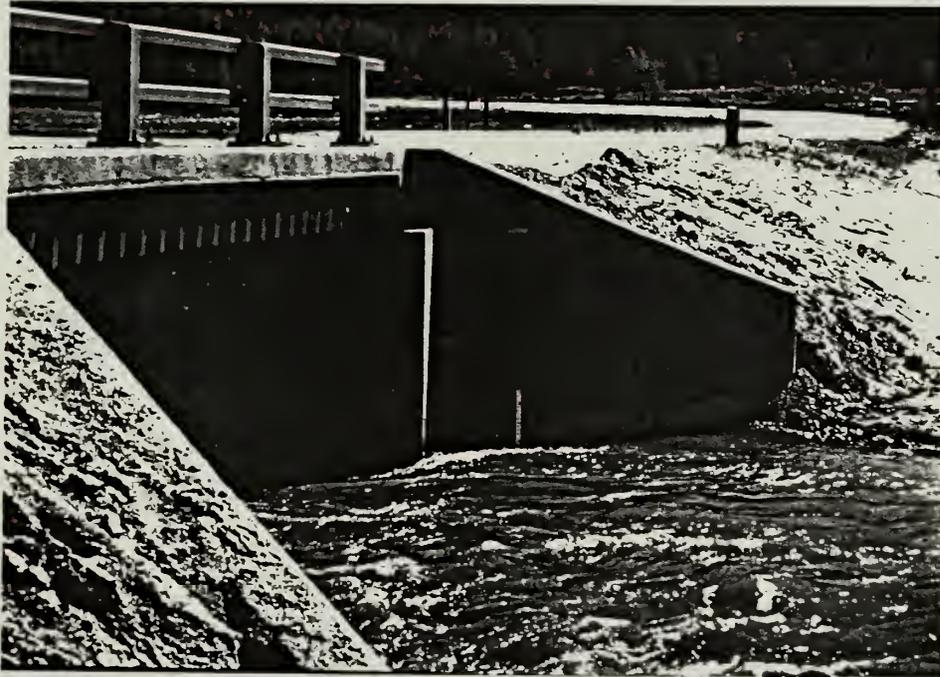
Figure 2. Gage site at Horseshoe Park. The gage staff is visible on the wing wall.

A gage staff (Figure 2) was bolted to the southwest wing wall by Park Service workmen on June 17, 1983.

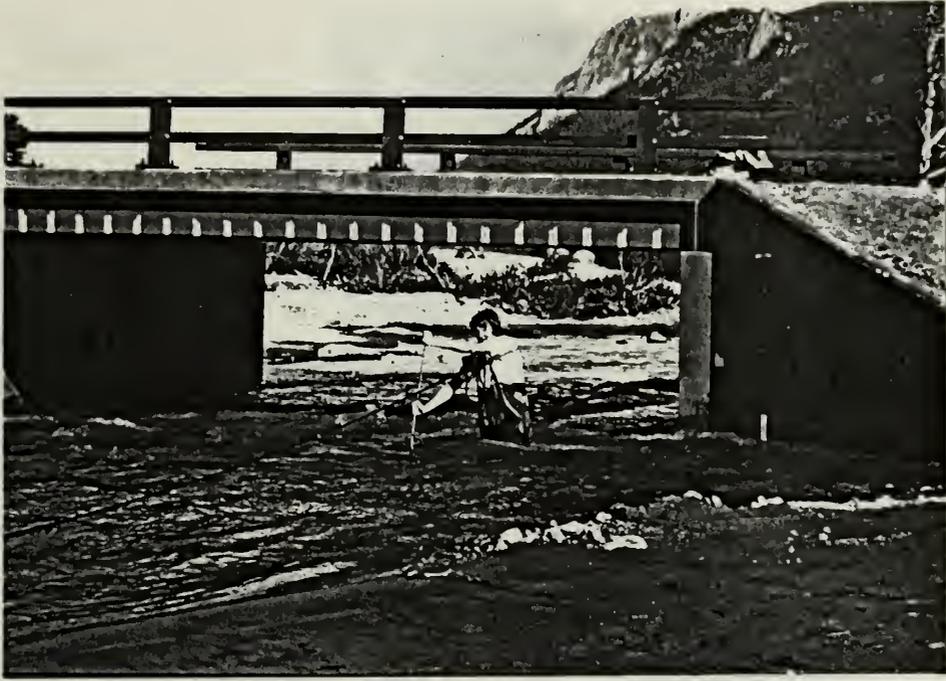
Figure 3a. Stream gaging using wading rod with rotary cup meter.

Measurements were taken using cup-type rotary current meters, commonly referred to as Price meters. Several meters and measurement techniques were employed, being necessitated by flow conditions and equipment availability and breakdowns. Wading, with meter mounted on a wading rod, proved satisfactory for low and moderate flows of up to about 250 cubic feet per second (Figure 3). A cable-mounted meter suspended from the bridge deck using a winch and crane was necessary for high discharges (Figure 4). Various combinations of instruments and measurement techniques were used in data collection (Table 1; these are subsequently referenced by number in Table 2).

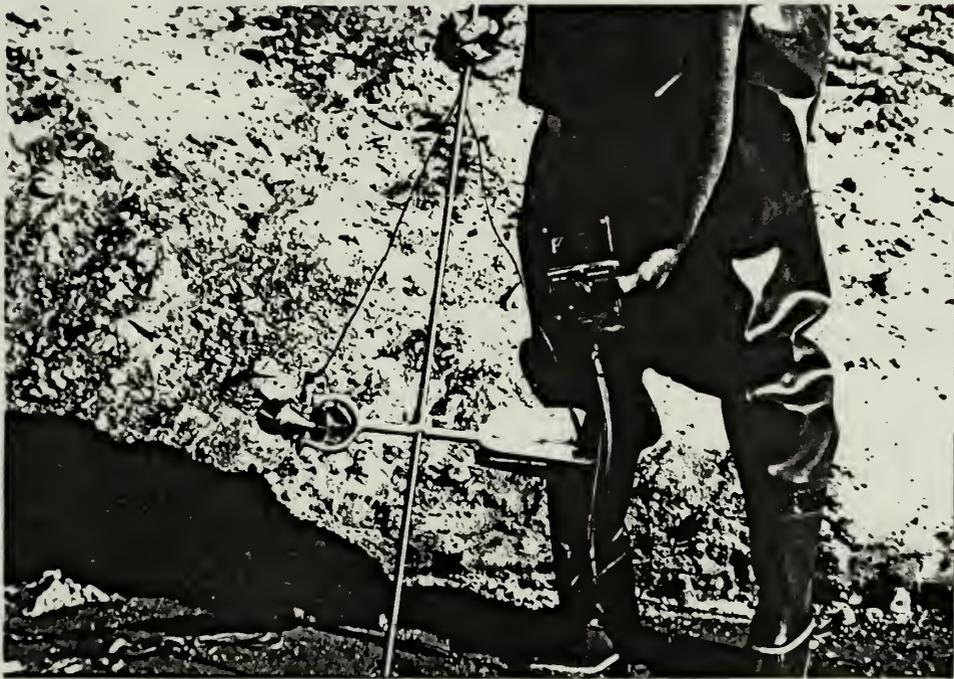
Figure 3b. Rod-mounted Type AA #T01581 rotary cup meter with Swoffer Model 2200 fiber optic tachometer.

| Description | Method No. |
|---|---|
| Rod-mounted Type AA #T01581 rotary cup meter. Sec and Rev read from Swoffer Model 2200 fiber optic tachometer while wading. | 2 |
