# CULTURAL LANDSCAPE REPORT FOR BLACKWOODS AND SEAWALL CAMPGROUNDS ACADIA NATIONAL PARK

History, Existing Conditions, Analysis  
& Treatment Recommendations

CULTURAL LANDSCAPE PUBLICATION NO. 11

September 1996

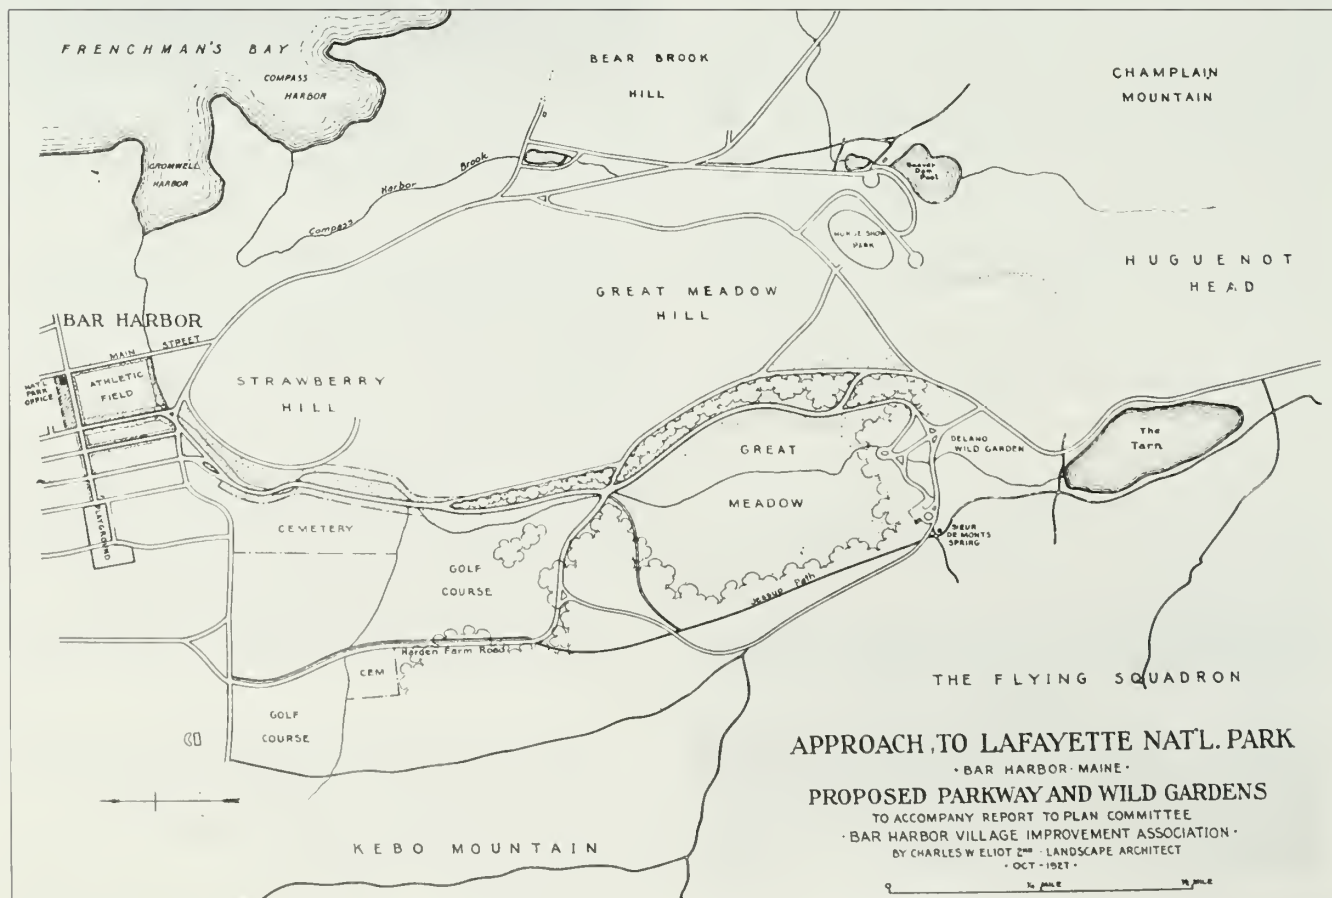
Figure 7: Map from "The Future of Mount Desert Island," by Charles Eliot 2nd, 1928.

This report, written by landscape architect Charles Eliot 2nd of Boston, addressed the physical planning of the entire island, inside and outside park boundaries (Figure 7). With respect to camping facilities, Eliot's master plan reported with a tone of reluctance towards the issue of public campgrounds:

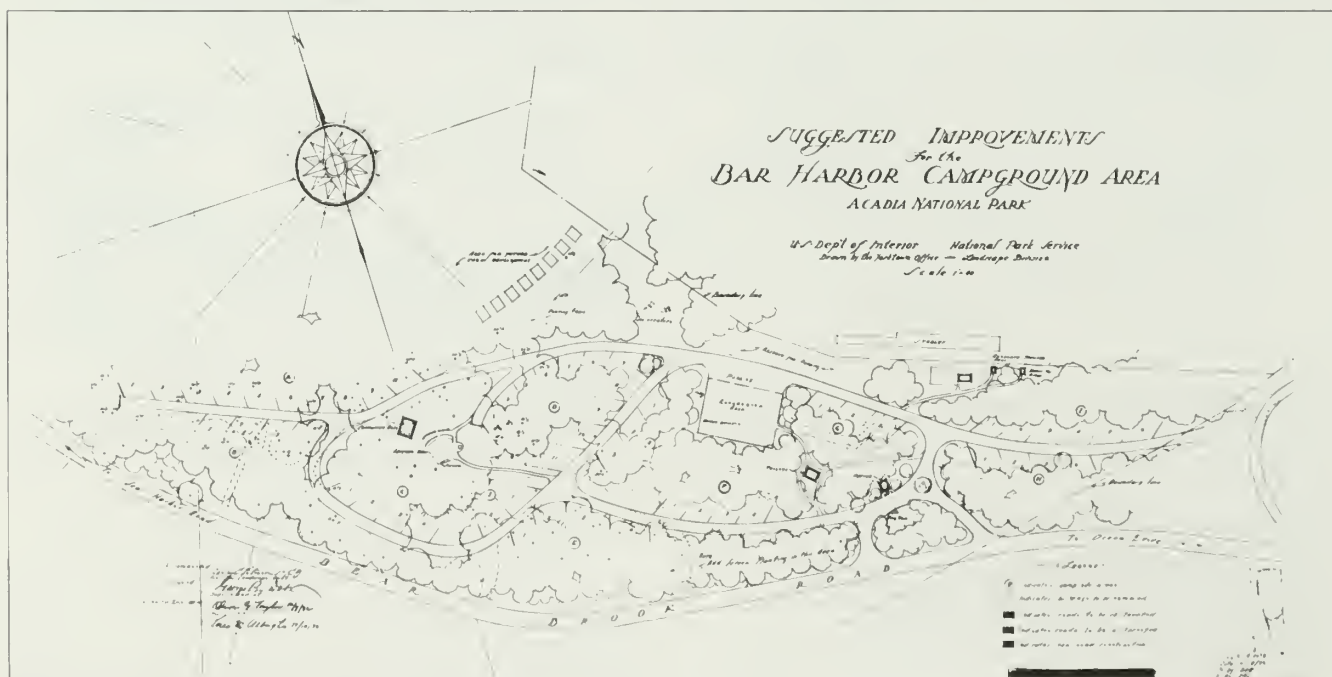
Figure 10: "Suggested Improvement for the Bar Harbor Campground Area," Drawing A1073, 1932.

and roadways, and the introduction of screen plantings. The plan also specifies the location of a new amphitheater, recreation area, office and toilet. Parking for campsites was provided at an angle to the campground roads (Figure 10).

The layout of this redesign clearly reflects the ideas of forest pathologist E.P. Meinecke. Director Mather had first contacted Meinecke in 1926 to study the deteriorating campgrounds in Sequoia National Park, and his early findings pointed to the destructive impact of years of human and vehicular traffic. This traffic damaged both the understory vegetation and the sensitive roots of the giant trees.<sup>27</sup> Meinecke later consulted with the United States Forest Service and the California State Parks, and in time developed a unique specialty in the

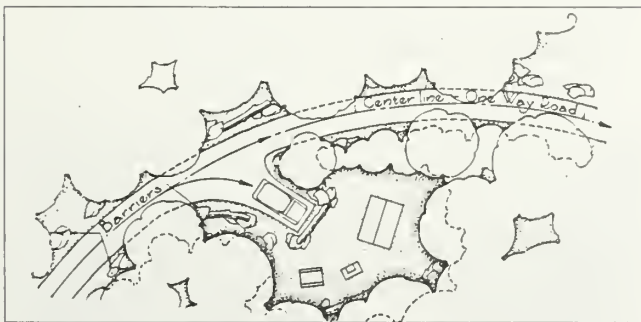
Figure 11: Drawing of the typical spur camp site as specified by E.P. Meinecke.

pathology of compacted forest soils. His recommendations for the reconstruction of damaged camping areas, and the planning of new campgrounds were adopted as policy by the Forest Service in 1932. Meinecke's recommendations for the planning of new campgrounds focused on the provision of discreet boundaries for both automobile and foot traffic.

Automobiles were to be kept to narrow one way roads, which naturally held down speeds and decreased impermeable surface area. Boulders and logs were placed naturalistically at the shoulders, half buried in the soil. These barriers provided a subtle barrier to those motorists who would otherwise leave the road surface and park in the undisturbed forest. Special attention was directed to the design of the individual campsite. Meinecke believed that by adequately providing for the campers needs, one would not feel compelled to seek out the forest for the satisfaction of basic requirements. The three features of Meinecke's prototypical campsite included a well defined parking spur, which was to serve as an open air garage, the fixed immovable fireplace, and the fixed picnic table (Figure 11). The Forest Service circulated their new policy containing Meinecke's thinking among landscape designers in the National Park Service. His ideas soon began to appear in new NPS campground design (Appendix A).<sup>28</sup>

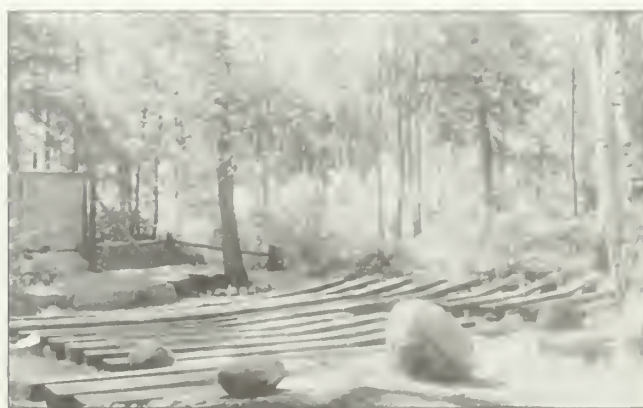
Figure 14: Amphitheater at Bear Brook campground constructed by Acadia’s CCC company NP1 in 1934.

The infusion of approximately 600 CCC enrollees, as well as independent contractors of the PWA, made the work of carrying out the plan for improving Bear Brook campground a relatively small matter within a much larger program of park development projects. During the first enrollment period of 1933, the proposed amphitheater at Bear Brook campground was completed using CCC labor (Figure 14). This area was used by park naturalists as an outdoor lecture area. Electric lighting and a projection screen were provided to accommodate illustrated presentations, and a place for a camp fire was provided to the left of the stage.<sup>37</sup>

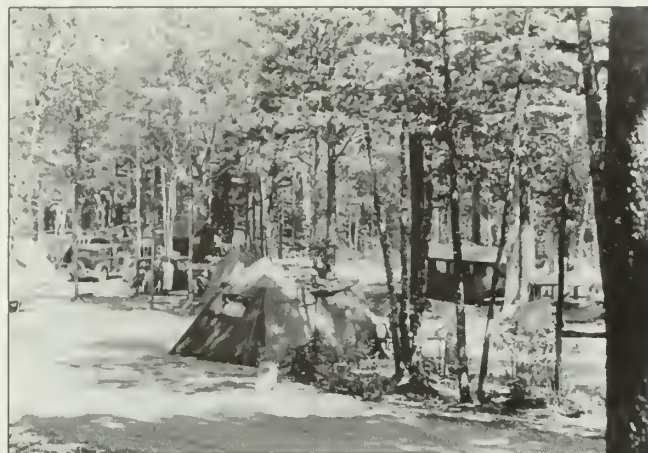
Figure 15: Crushed stone aggregate placed on the surface of Bear Brook campground to mitigate soil compaction, c. 1934.

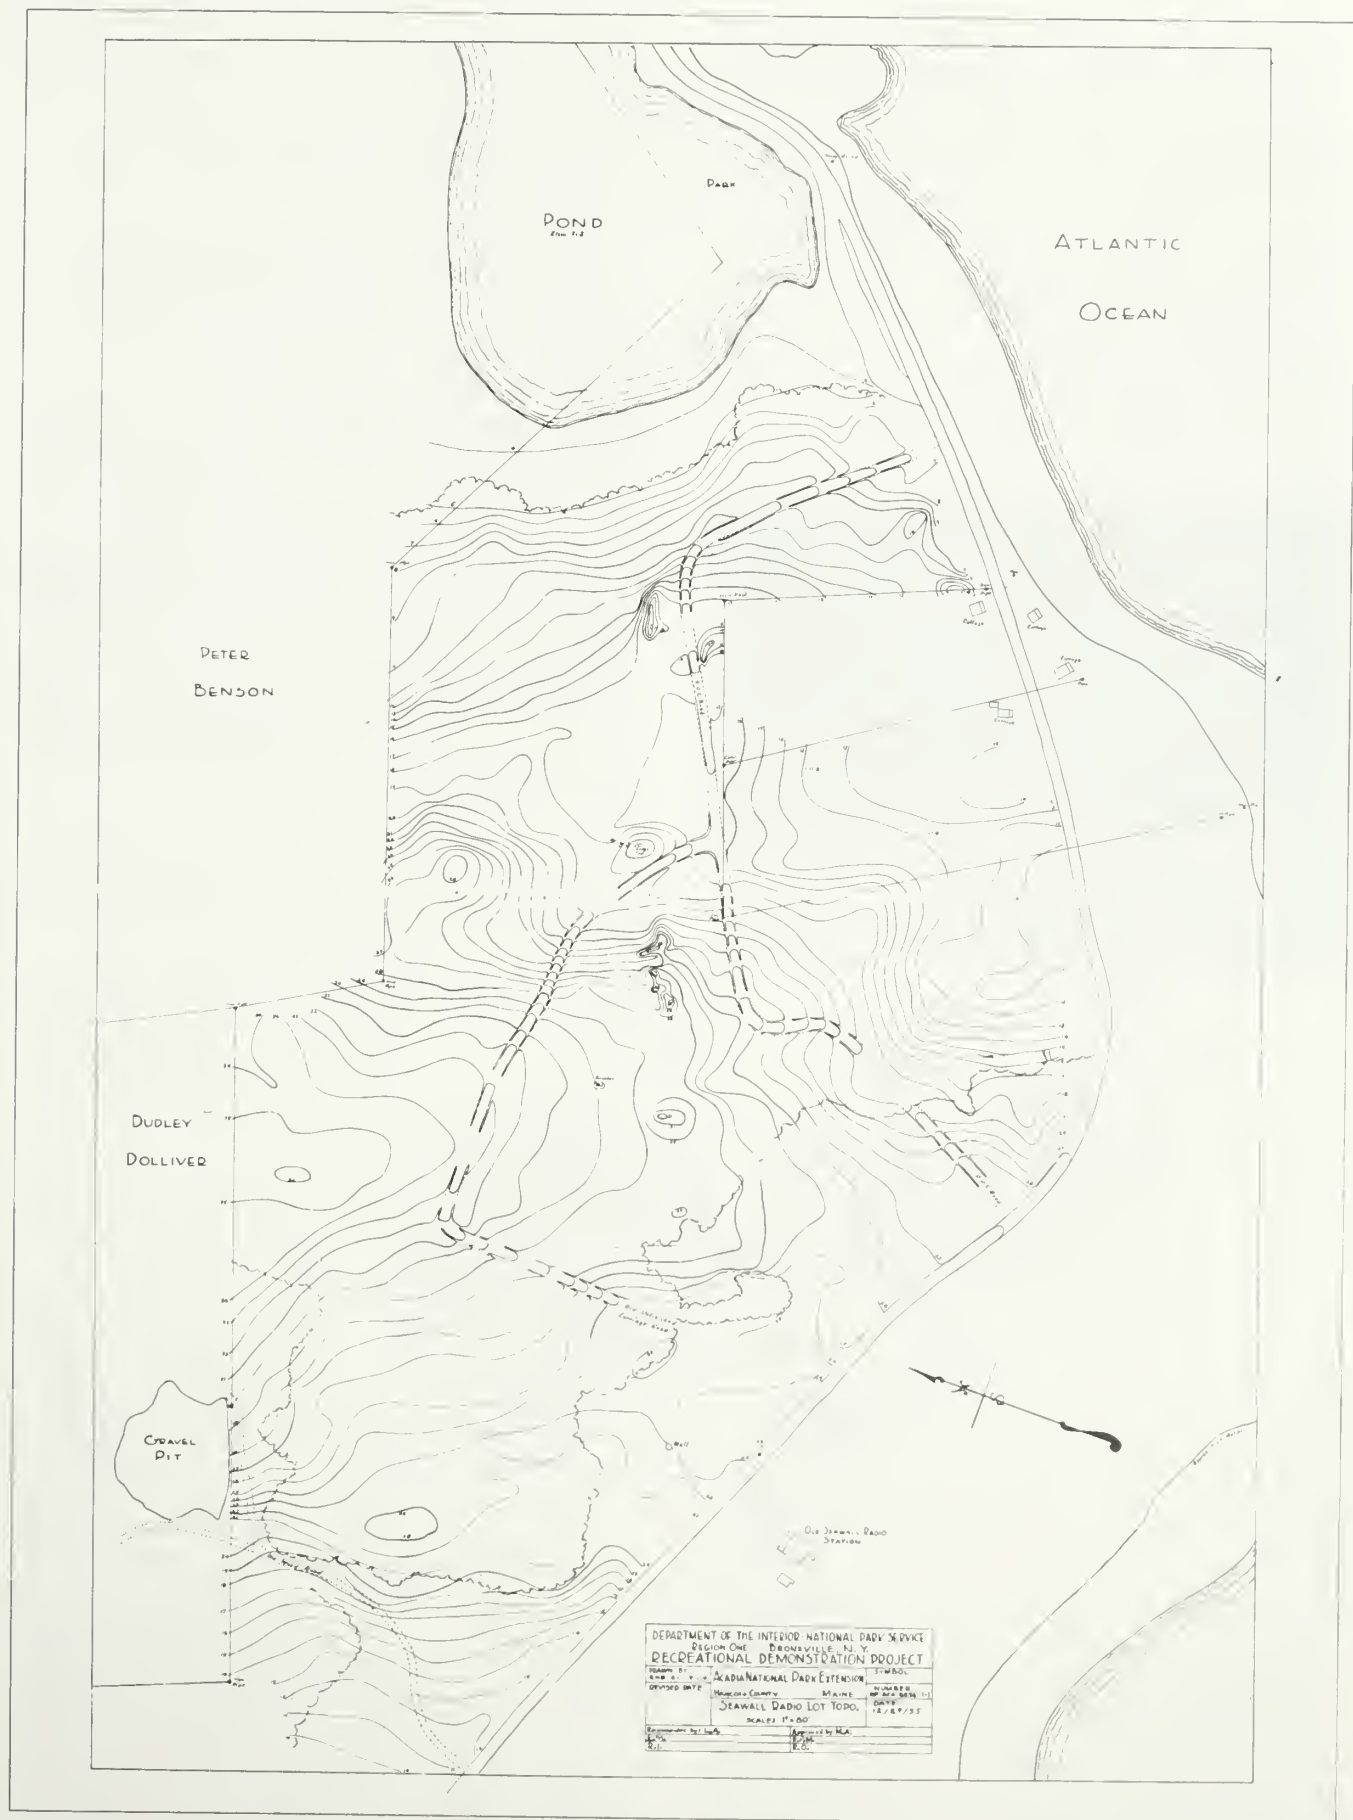
Figure 17: "Seawall Radio Lot Topo," Drawing NP-ACA-8036-1-1. Drawing shows conditions prior to campground development, 1935.

Soon after the park resident landscape architect's appeal for new campgrounds, preliminary work was begun to investigate the suitability of a tract of Rockefeller's land in Hull's Cove as the possible site for a new campground. This site, near the location of the current visitor's center, was eventually excluded from consideration in favor of a western site in the Seawall area. The FERA submarginal lands program had under study approximately 8,000 acres on the western side of Mount Desert Island as a potential Recreational Demonstration Project. These lands were purchased and developed for their recreational value as an extension to the holdings of Acadia National Park. In addition to the acquisition of land, RDP funds were expended for development of recreational facilities in the Seawall area, near lands already owned by George Dorr, and John D. Rockefeller, Jr. (Figure 16). Survey work began in November of 1935 and by June of 1936, WPA Job# 303 and #705 were in progress for public campground and picnic ground development (Figure 17).

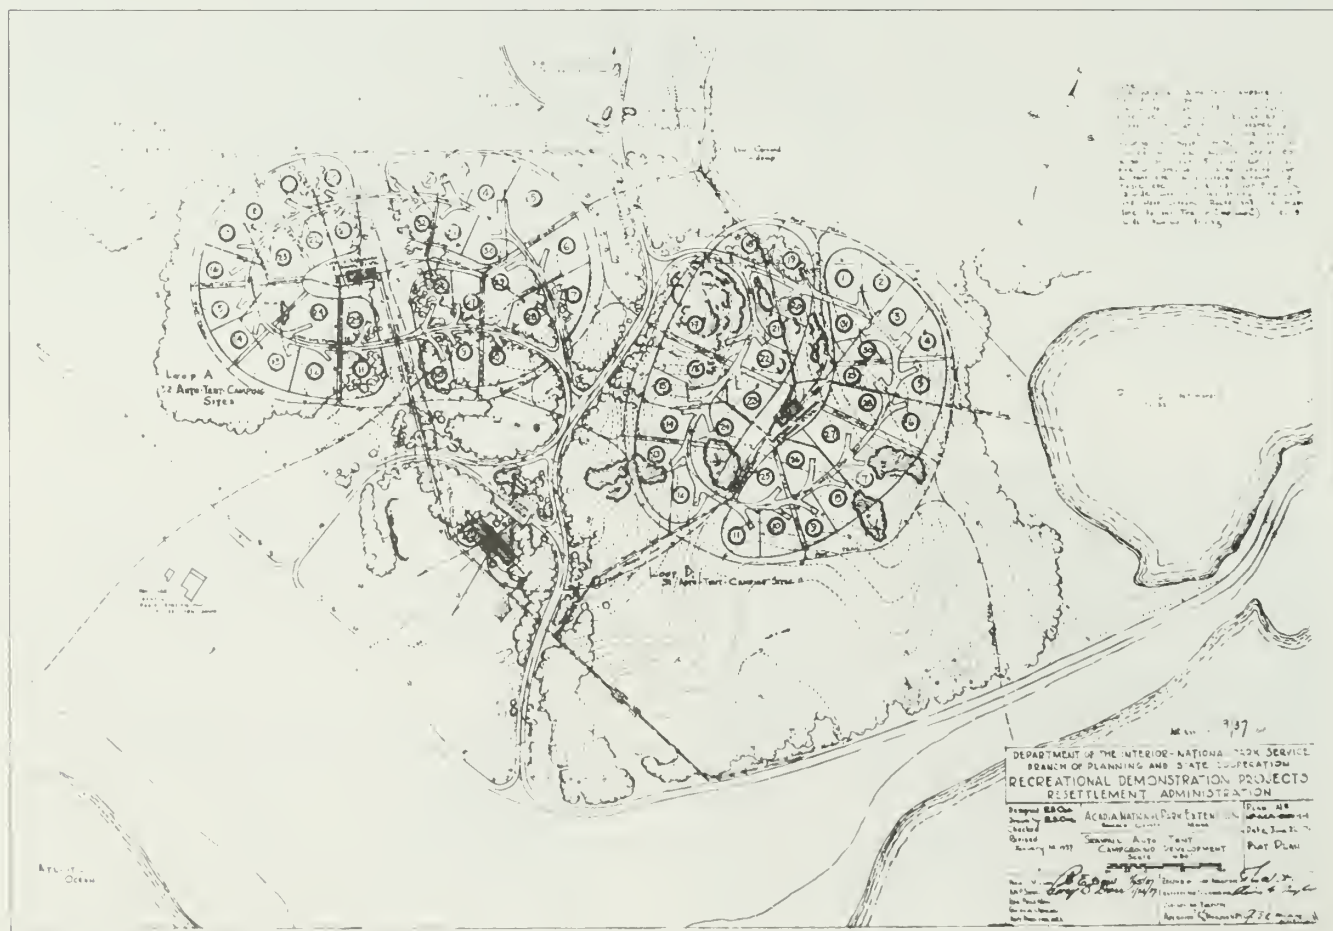
Figure 18: "Seawall Auto-Tent Campground Development," Drawing NP-ACA-8030-1-1, 1937.

The initial development of Seawall campground consisted of two separate one way loop roads, featuring parking spurs and camp sites laid out using the Meinecke system of campground development. Drawing #NP-ACA-8030-1-1 titled: "Seawall Auto-Tent Campground Development" illustrates an "A" loop consisting of "32 Auto-Tent Camping Sites" and a "B" loop consisting of "31 Auto-Tent Camping Sites." It is important to recognize that "A" and "B" loops were not designed to accommodate trailers. The plan originally featured a single "Latrine, Washroom and Shower Bldg" at the center of each loop. To the north of the "A" and "B" loops, the drawing made reference to two possible future loop developments, including a loop reserved for trailers (Figure 18). Notes on the drawing describe what was intended:

cupy an area approximately 80 feet by 100 feet (or about 1/5 of an acre). Each site will provide an auto parking spur, a tent site, a fireplace, a hewn log table, etc. Loop A and Loop B will be 12' wide with one way driving. The east and West Entrance Roads and the main line to the Trailer Camp (Loop C), will be 18 feet wide, - two way driving."

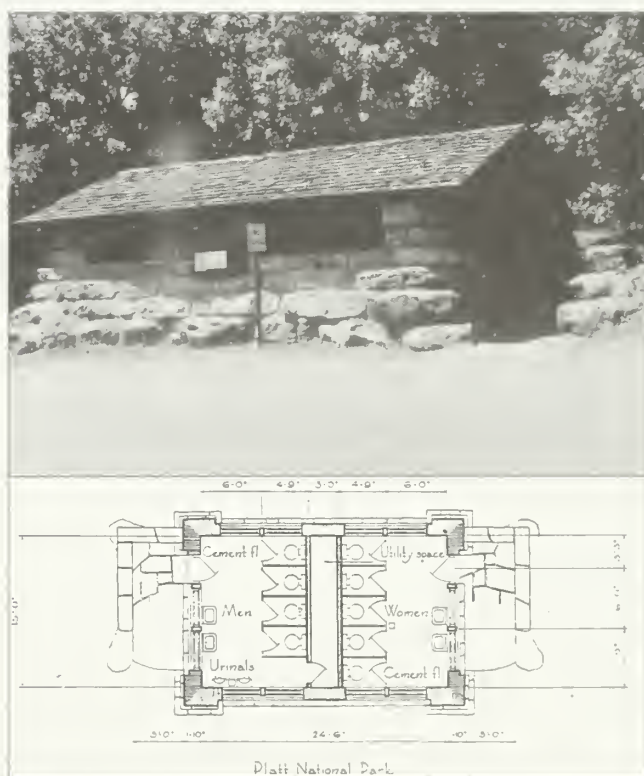
Figure 19: Platt National Monument Comfort Station.

tion. Because of these published materials, is not surprising that the comfort stations constructed at Acadia would have been derivative of National Park Service designs elsewhere (Figure 19). The original "Portfolio of Comfort Stations and Privies" was updated and expanded between 1934 and 1938. The final publication, edited by architect Albert Good, consisted of a three volume, comprehensive document titled: *Park and Recreation Structures*. These volumes document many regional examples of CCC era construction, and the design motives behind the work.

Hadley to Vint: 3/10/37: "I also concurred in the Platt plan, except for the stone exterior. This was after consulting with Mr. Breeze. We both felt that in a wooded area a stone building would not harmonize with its surroundings. Our opinion is that a log-finished structure will be much more appropriate, especially with hand-split shingles on the roof."<sup>44</sup>

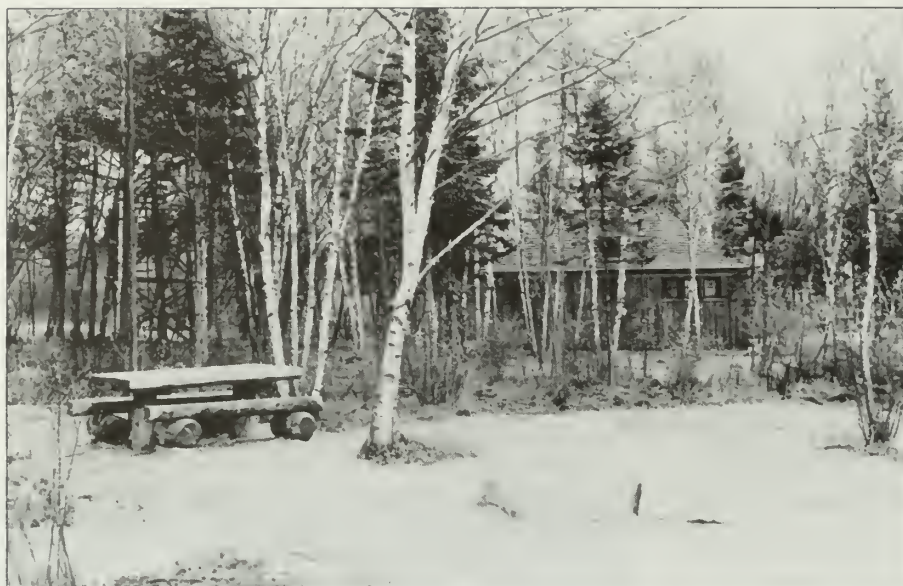
Figure 20: Seawall campground development in 1937.

Thus the first new comfort station prototypes were designed and constructed in Loop A of Seawall campground (Bldg. #102 and #103) during 1937 (Figure 20). They were constructed with a special allotment of \$5,000 of ECW funds, with separate projects authorized to provide for both sewer and water service. Investigations

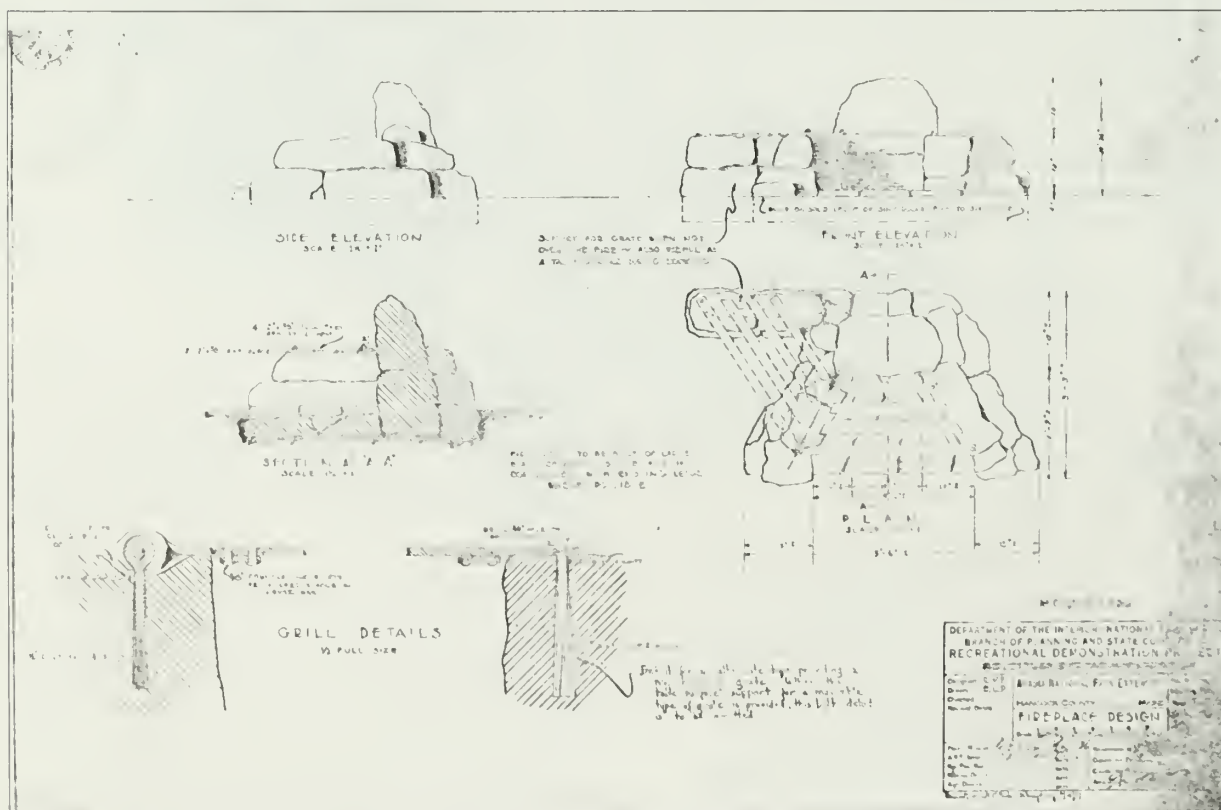
Figure 21: "Fireplace Design," Branch of Planning and State Cooperation, Recreational Demonstration Projects.

construction of the immovable fireplaces and heavy timber picnic tables that were specified by Dr. Meinecke's system of campground development (Figures 21 and 22). By September of 1937, the two loops of the Seawall campground had been completed except for a comfort station to serve Loop B (Figure 23). The B Loop comfort station, (Bldg #104) was constructed between 1938 and 1939 as funds became available.

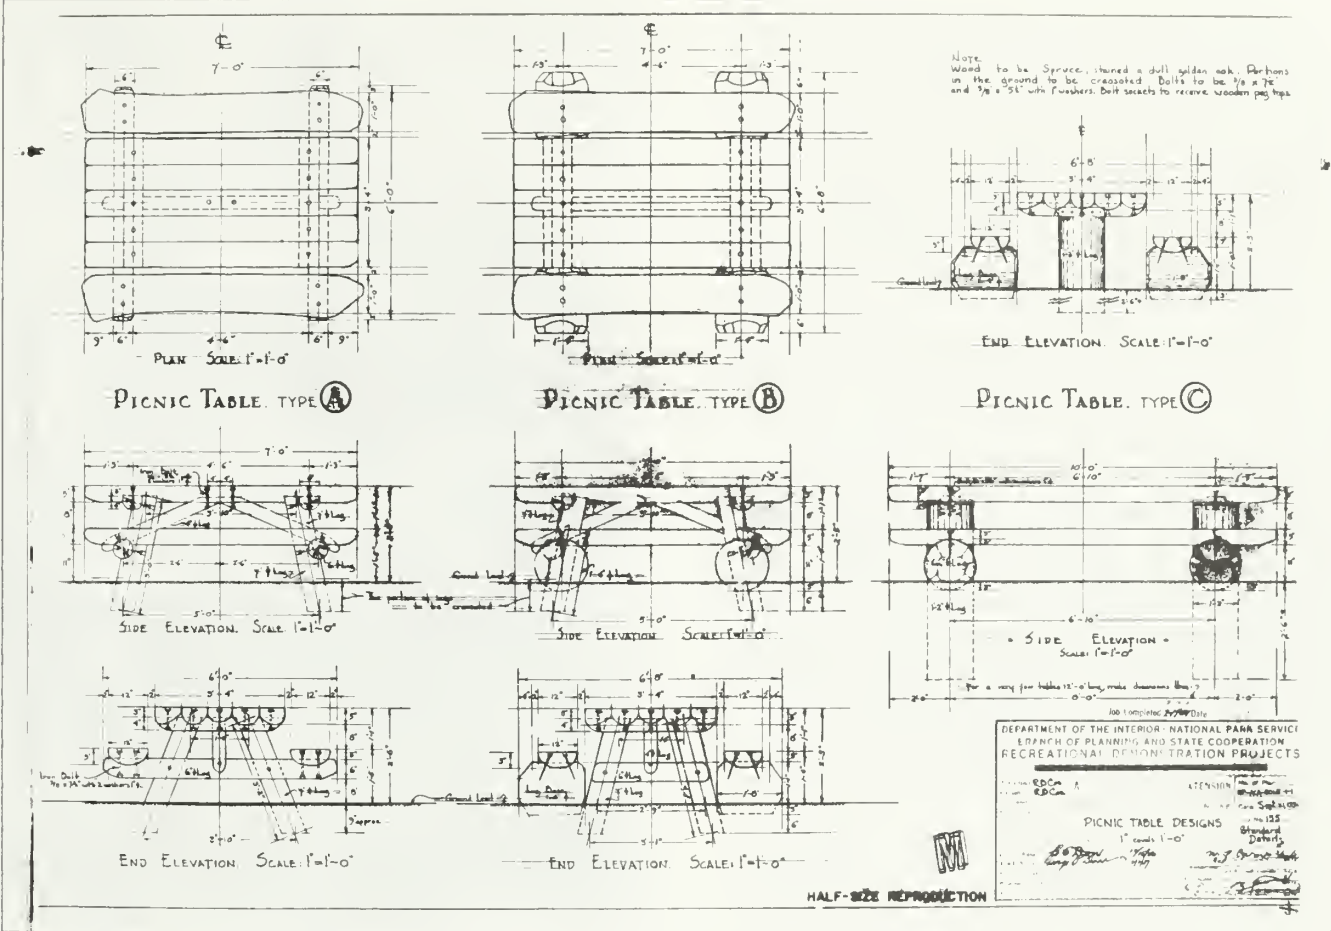
Figure 22: "Picnic Table Designs," Drawing NP-ACA-8065-1-1, 1936.

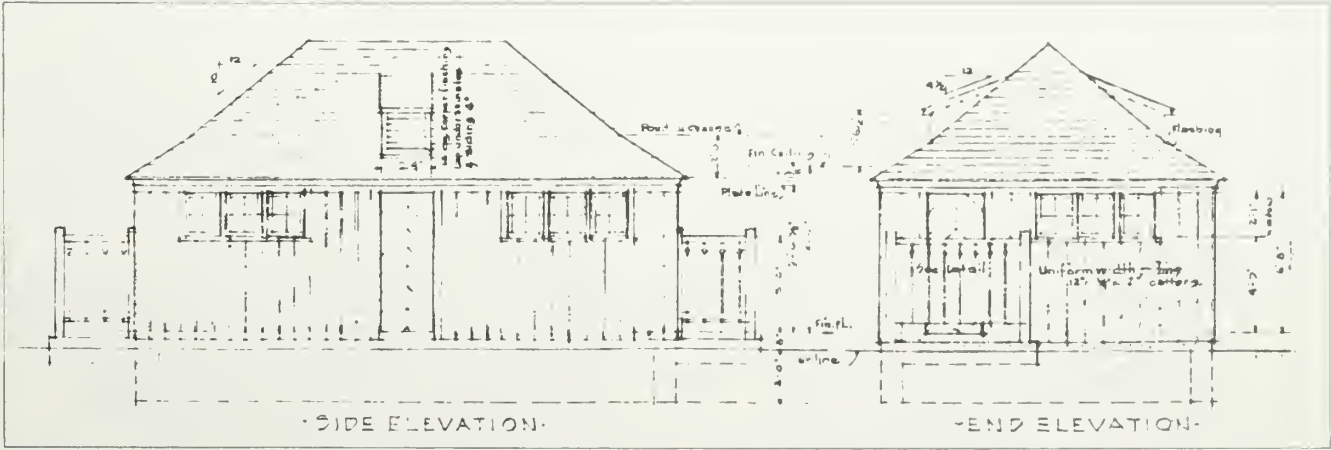
Figure 23: Prototypical comfort station design, used from 1937 to 1948, Acadia National Park. Drawing NP-ACA-1128, 1937.

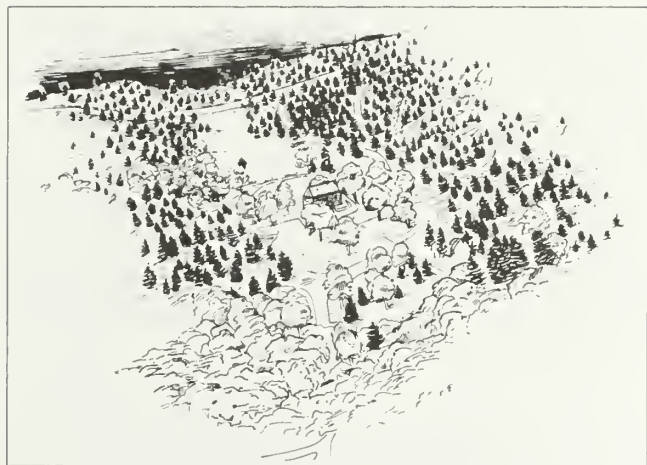
Figure 25: Conceptual drawing of the Blackwoods campground "Camp Court," 1937.

The CCC transit crew conducted preliminary topographic surveys of the property in 1937. Preliminary designs were developed for the new Blackwoods campground featuring a formal "camp court" at the center, flanked by three separate campground loops. The "camp court" was to feature an administration/concession building on the east, perched above an open vista looking down slope to the waters of Otter Cove (Figure 25). Access to the campground was originally designed from both the village of Otter Creek and from the Blackwoods segment of the motor road (Figure 26).<sup>52</sup>

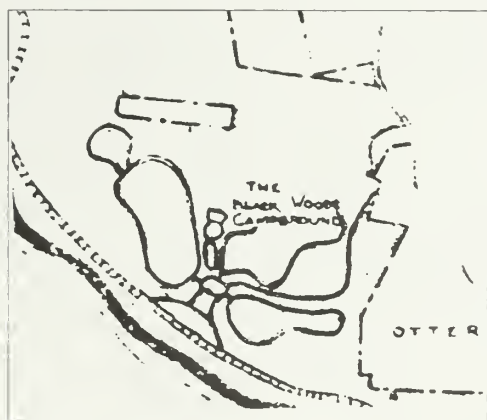
Figure 26: Small location diagram for Blackwoods campground showing proposed crescent shaped access road from the park motor loop road. From drawing NP-ACA-5353-1-1, 1938.

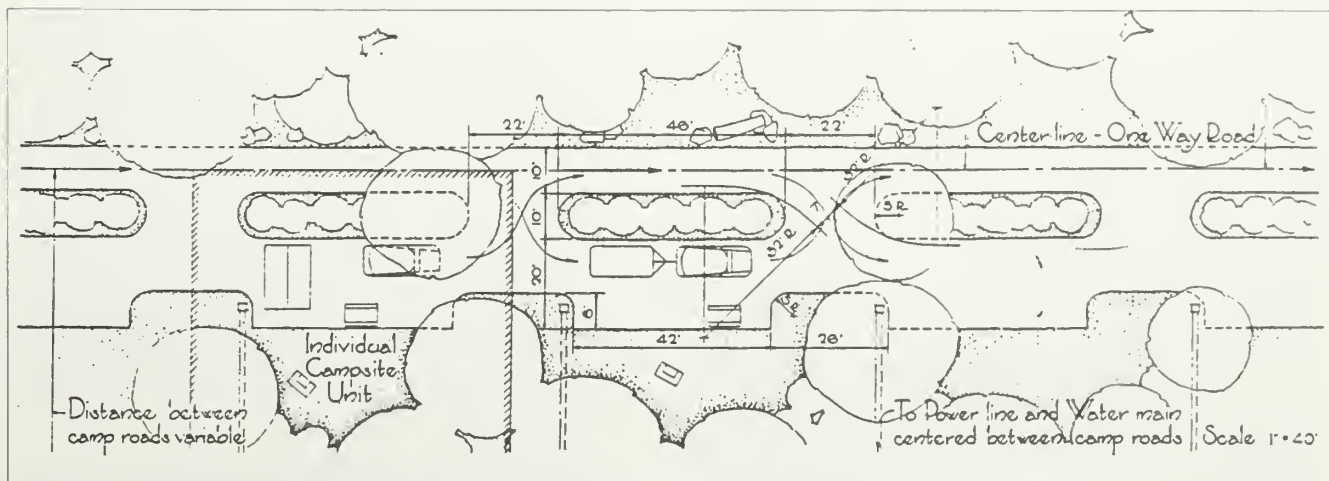
Figure 27: Diagram showing example of campground design utilizing a "bypass" approach to campsite development.

The *bypass* is any arrangement permitting the trailer camper to drive tow-car-and-trailer off the traveled camp road, park, and drive onto that same road again without backing [Figure 27]. In its simplest expression it is merely a defined widening of the camp road to allow tow-car-and-trailer to park out of the traveled lane...

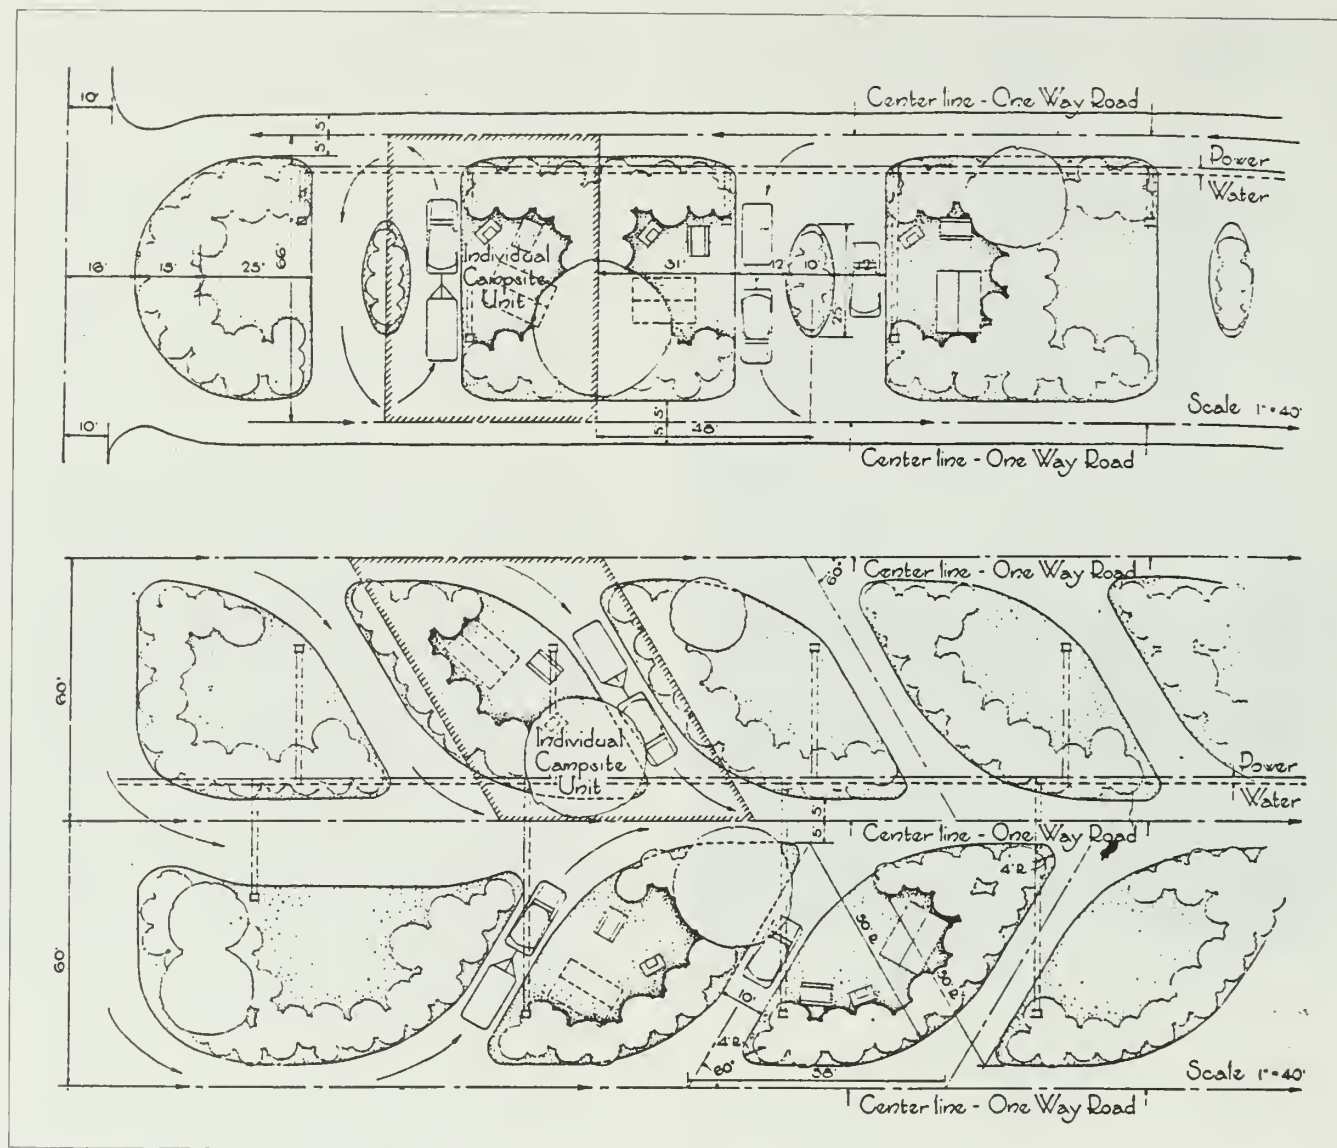
Figure 28: Diagram showing two examples of campground design utilizing a "link" approach to campsite development.

The *link* is any arrangement allowing the trailer camper's rolling stock to be driven off a traveled camp entrance road to suitable and sufficient parking whence it can be driven onto another roughly parallel camp exit road without any necessity of backing [Figure 28]. Variations of the link result mainly from the distance between the entrance and exit camp roads. This may be as little as 50 feet or, owing to affecting topographical conditions or desire for greater privacy, 100 feet or even more..."

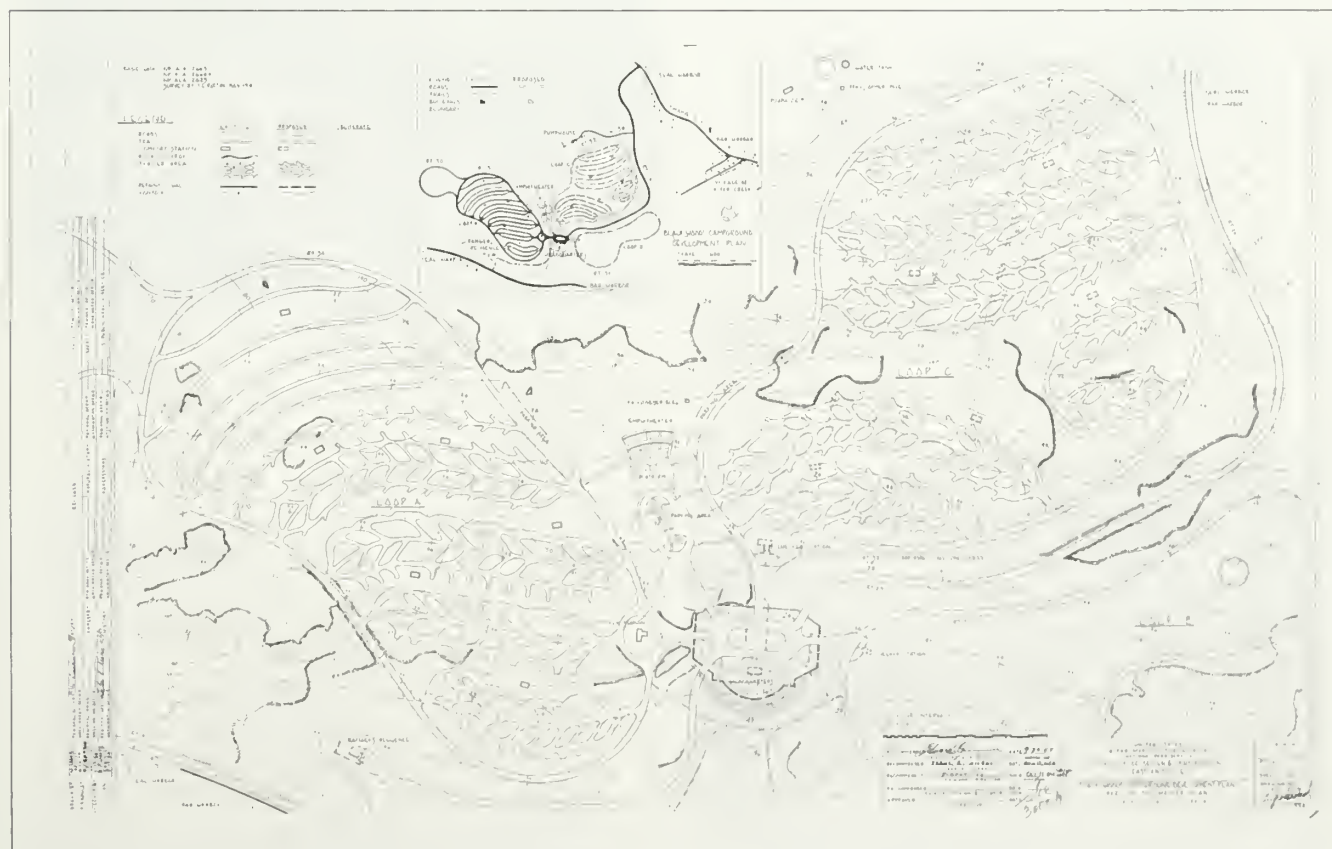
Figure 29: "Black Woods Campground Development Plan," part of the Master Plan for Acadia National Park. Drawing NP-ACA-3000, 1954.

Conceptually, the Blackwoods campground was of a very ambitious scale (Figure 29). With all three loops fully built, Blackwoods would feature approximately 400 campsites compared to the 63 campsite Seawall campground then under construction. Early planning efforts recognized that construction of the entire Blackwoods campground was beyond the limits of the existing CCC program labor and funding for the entire park. Indeed today, after fifty seven years and two generations of major development campaigns, all the elements of the campground specified in the original plan have yet to be constructed, indicative of the discretionary nature of many of the campground's planned elements. Awareness of the overwhelming scope of the Blackwoods project prompted a letter from park management to the

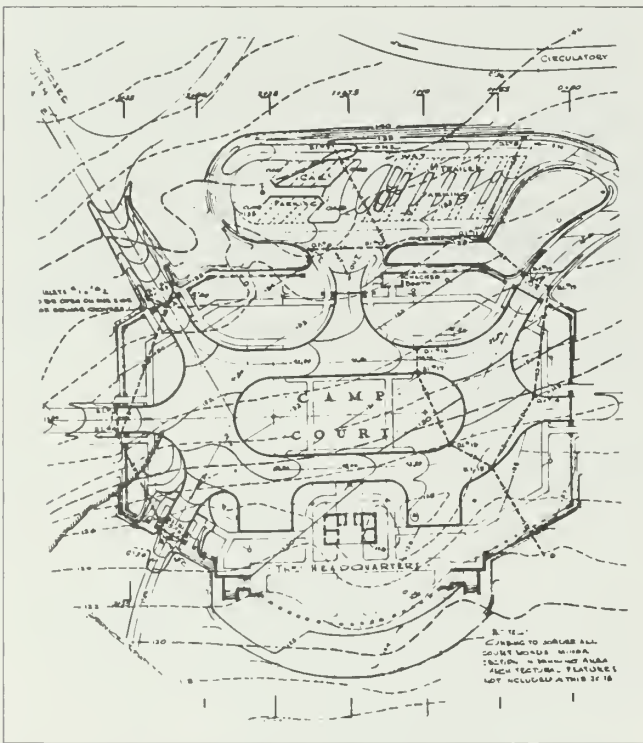
Figure 31: Grading and drainage plan for the camp court showing extensive subsurface stormwater drains.

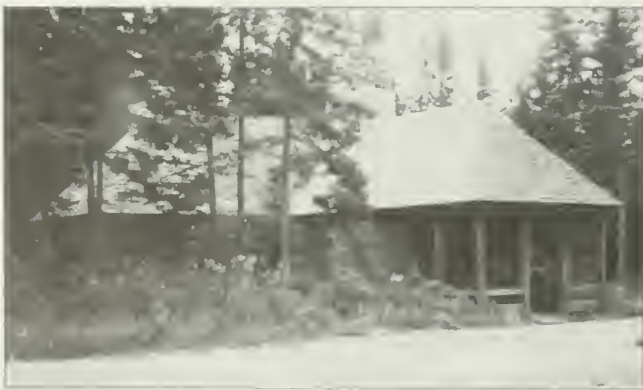
Figure 32: Checking station for Seawall campground. Building design was later duplicated at the Backwoods campground.

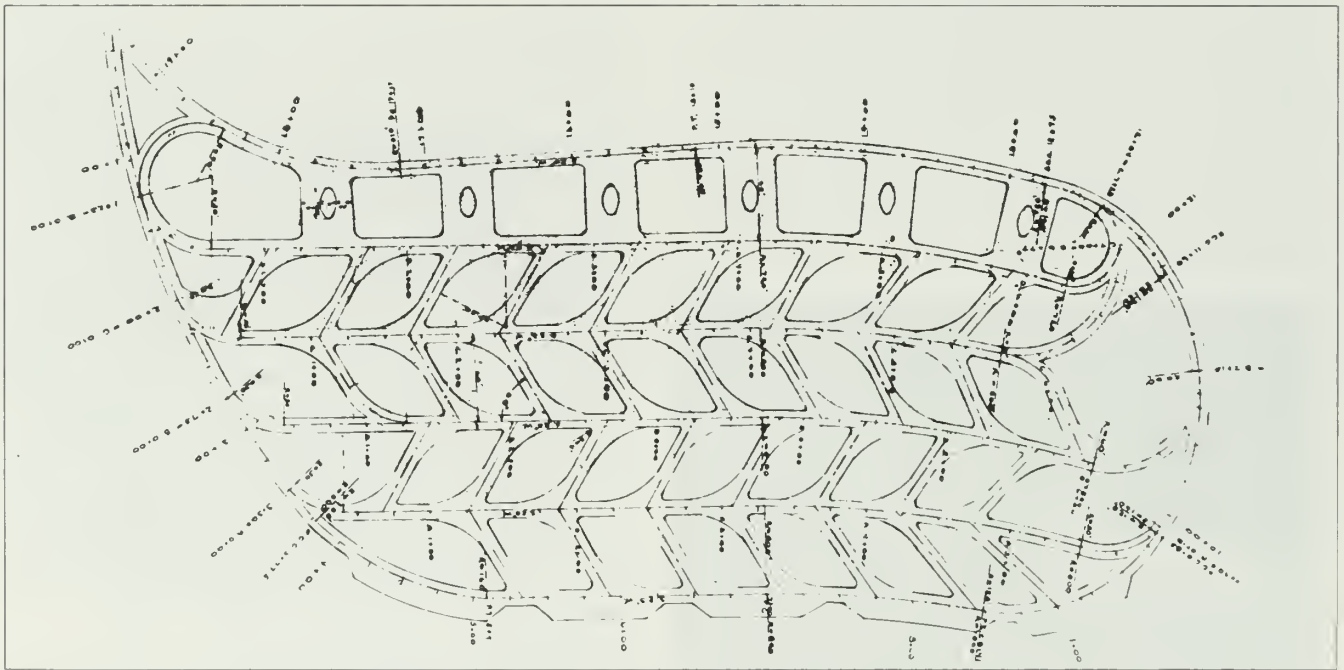
Figure 34: Seawall campground's trailer loop (loop "C"), Drawing NP-ACA-5357-2-6, 1939.

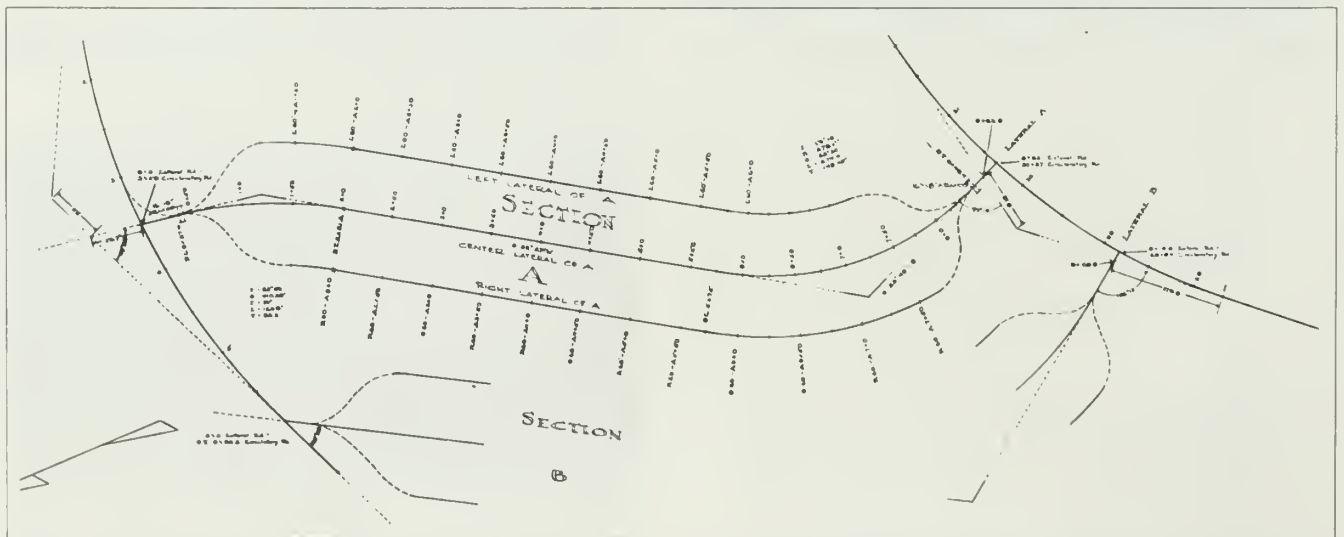
Figure 35: "Minor Road Development at Black Woods Campground, Loop A." Drawing NP-ACA- 5353-6-17. Image shows the typical layout of the typical 35 campsites at Blackwoods, built before the CCC program was dissolved in 1942.

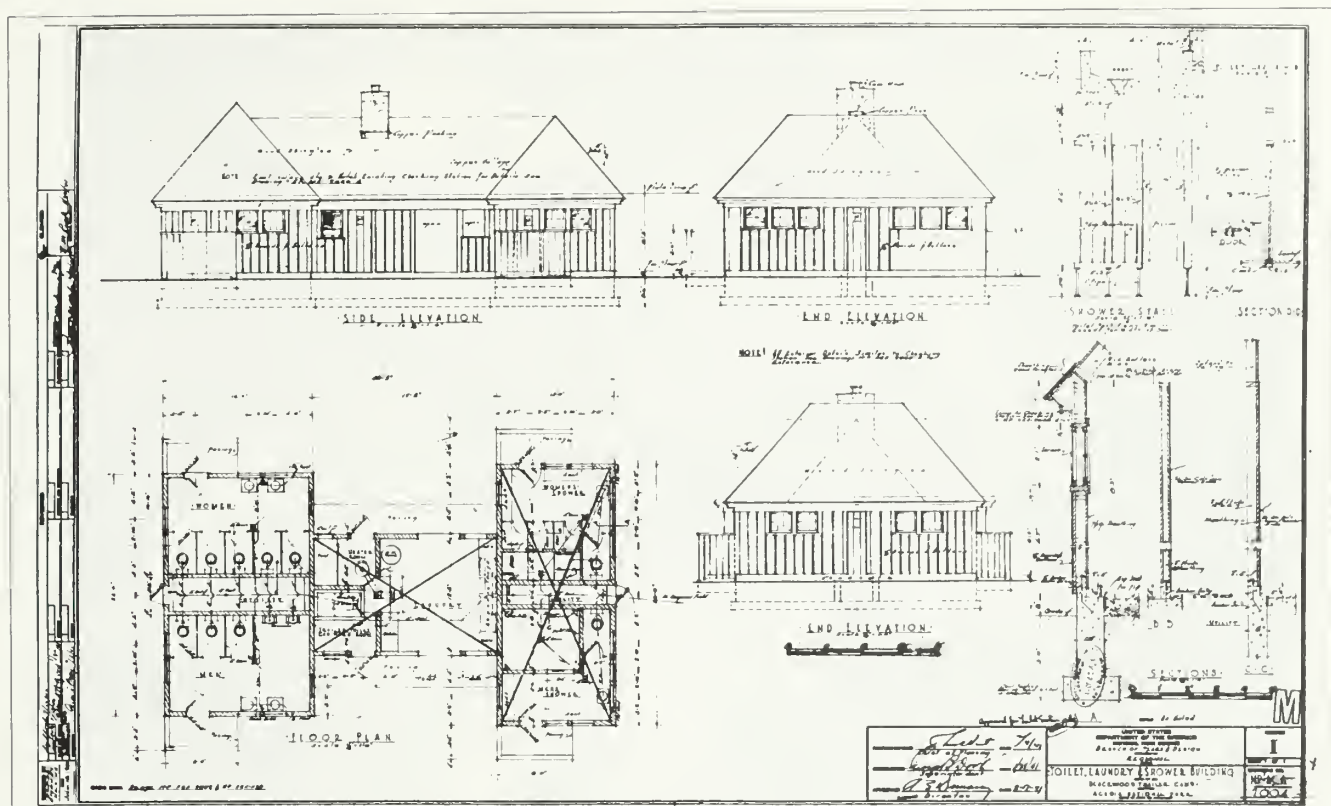
Figure 36: "Toilet, Laundry & Shower Building." Design for a bathing and laundry addition to existing campground comfort stations, Drawing NP-ACA-2004, 1941.

The reactivation of Camp NP-2 in July, resulted from a visit to Acadia by NPS Assistant Director Conrad Wirth, who had responsibility for all Recreation Demonstration Projects within the National Park Service. Wirth instructed the park to make the completion of the Seawall RDA a top priority.<sup>61</sup> The plans for Seawall had been revised to include the development of wash house and laundry facilities, and an amphitheater, similar to the one then in use at the Bear Brook campground. The earlier Bear Brook campground was at this time providing visitors with cold water shower and laundry facilities. Similar or better facilities were desired for Acadia's new campgrounds. The "Camp Services" regional design team organized by the NPS for the design of CCC projects, had developed plans to add on to the existing prototypical comfort station, providing additional space for bathing and laundry (Figure 36). However by late fall, little progress had been made towards the initiation

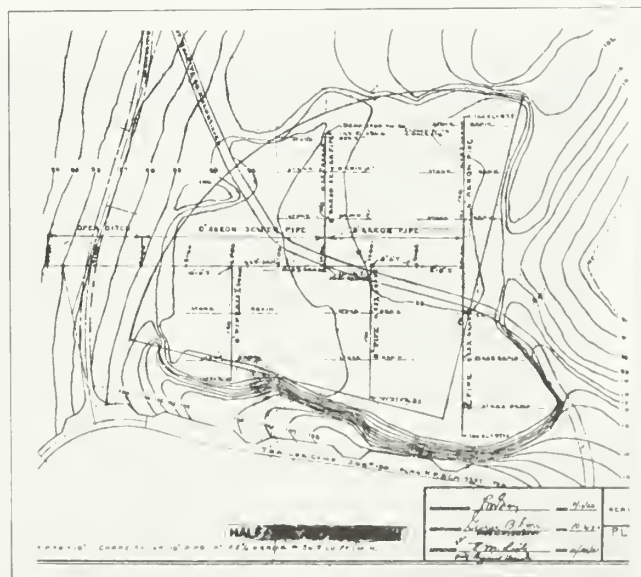
Figure 37: "Playground - Seawall." Playing field constructed at Seawall Campground, is now the site of the group camping area, Drawing NP-ACA-5366-1-1, 1940.

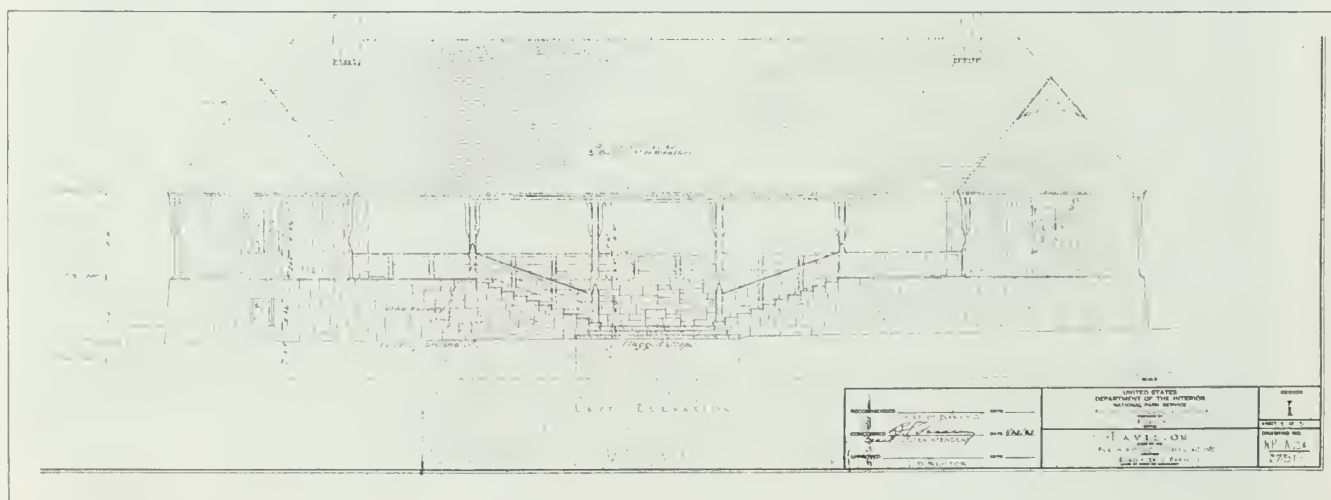
Figure 42: Plans for the Blackwoods amphitheater pavilion, never implemented, part of the NPS “plans for the shelf” initiative during WWII. Drawing NP-ACA-2751, 1943.

While little campground construction took place during war time, a great deal of planning work was accomplished, aided by a program of advance work by the NPS sometimes referred to as “plans for the shelf.” The purpose of this effort, which began in 1942, was to “complete a full shelf of well-planned future proposals, rather than plans for immediate construction.”<sup>67</sup> These advance planning projects included plans for a recreational swimming area at Otter Cove, an amphitheater and pavilion for Blackwoods campground, and a headquarters building for Blackwoods. These advance planning projects were never carried out as originally conceived (Figures 42 and 43).
