# CULTURAL LANDSCAPE REPORT FOR BLACKWOODS AND SEAWALL CAMPGROUNDS ACADIA NATIONAL PARK

History, Existing Conditions, Analysis  
& Treatment Recommendations

CULTURAL LANDSCAPE PUBLICATION NO. 11

September 1996

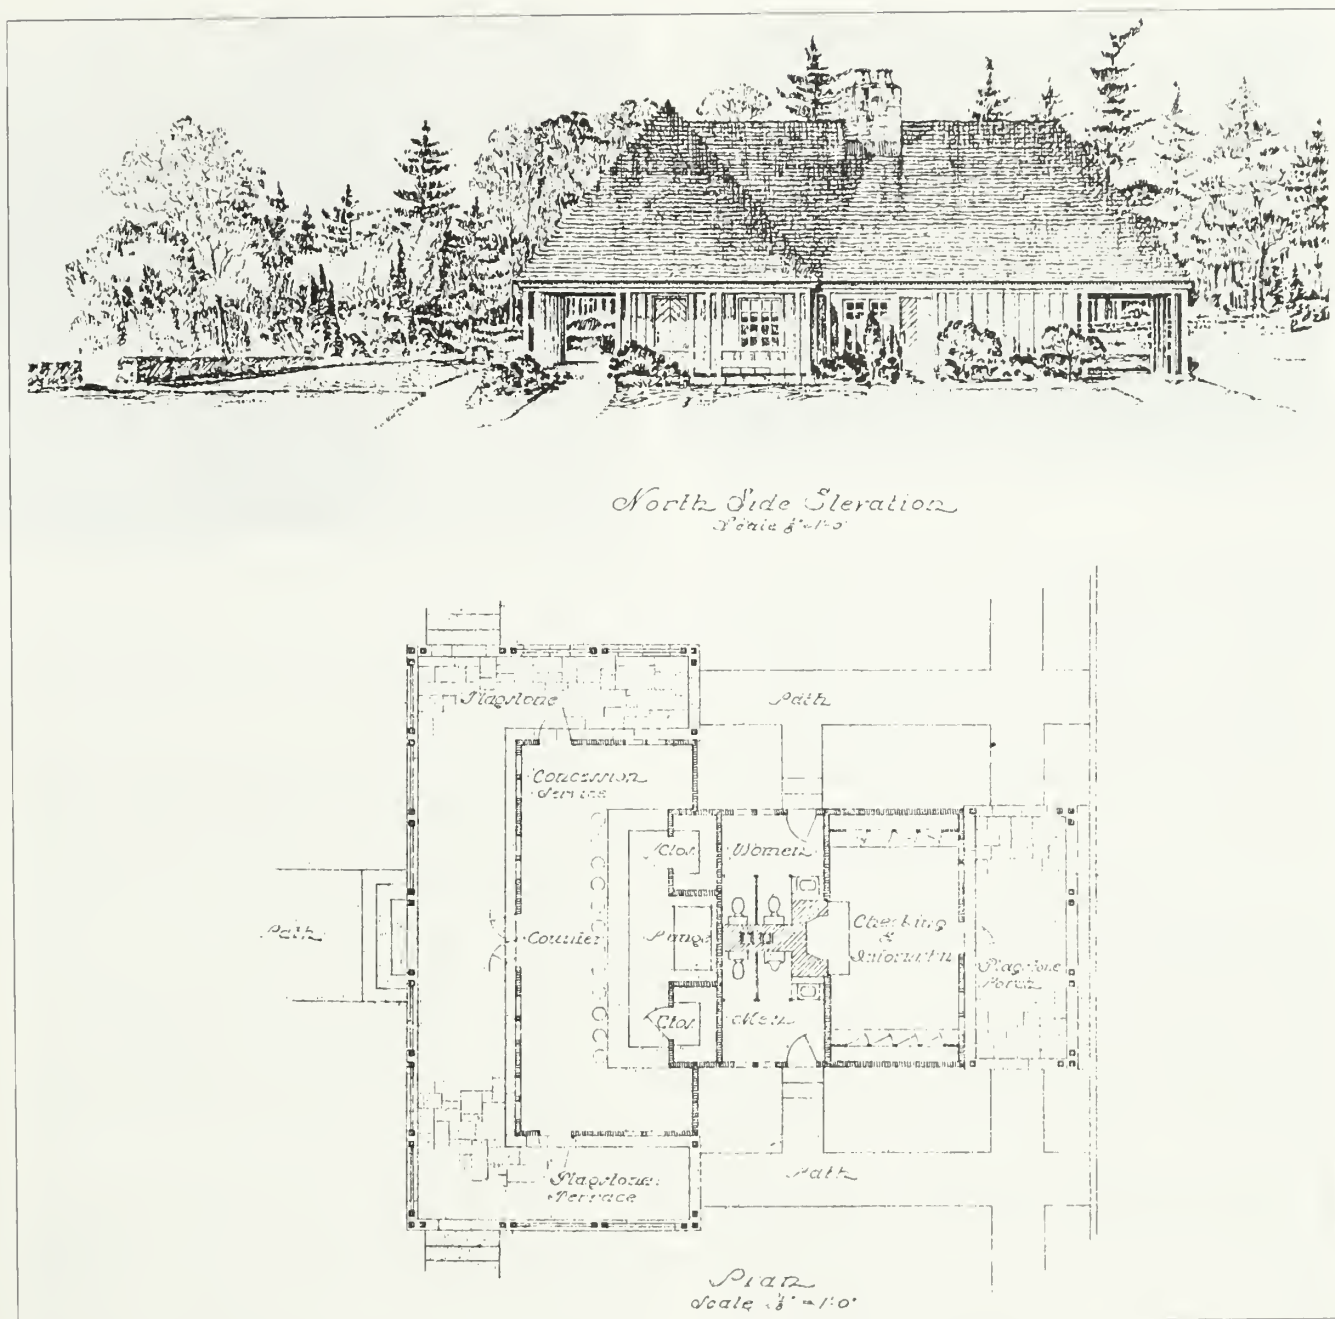
Figure 43: Plans for the Blackwoods campground headquarters building, never implemented. Drawing NP-ACA-2757-D, 1943.

While little campground construction took place during war time, a great deal of planning work was accomplished, aided by a program of advance work by the NPS sometimes referred to as “plans for the shelf.” The purpose of this effort, which began in 1942, was to “complete a full shelf of well-planned future proposals, rather than plans for immediate construction.”<sup>67</sup> These advance planning projects included plans for a recreational swimming area at Otter Cove, an amphitheater and pavilion for Blackwoods campground, and a headquarters building for Blackwoods. These advance planning projects were never carried out as originally conceived (Figures 42 and 43).

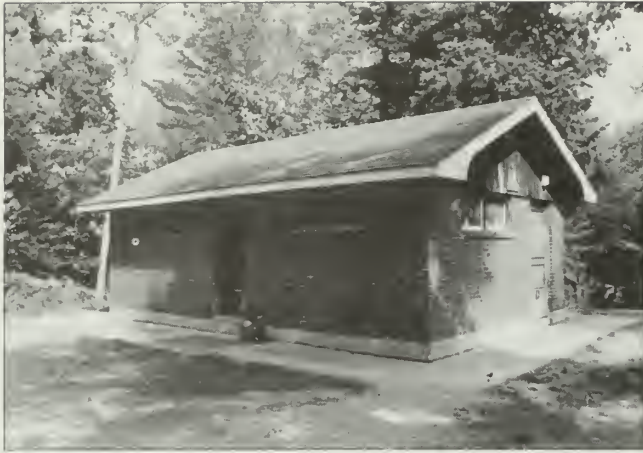
Figure 44: Blackwoods campground comfort station, Building #96, constructed 1950.

was still limited at this time.<sup>71</sup> Acadia's campground development projects during the late 1940's and early 1950's included the construction of two additional comfort stations in Blackwoods loop "A" and the development of an amphitheater with associated parking. The construction of two additional comfort stations brought the total in loop "A" to six. One of these two comfort stations (Bldg #101) was constructed in 1948 using the prewar prototype for its design. The second of the two (Bldg #96) was constructed of brick during 1950, breaking away from established precedent (Figure 44). The low level of design and craftsmanship of this later comfort station is illustrative of the austere fiscal circumstances that affected the National Park Service at this time.<sup>72</sup>

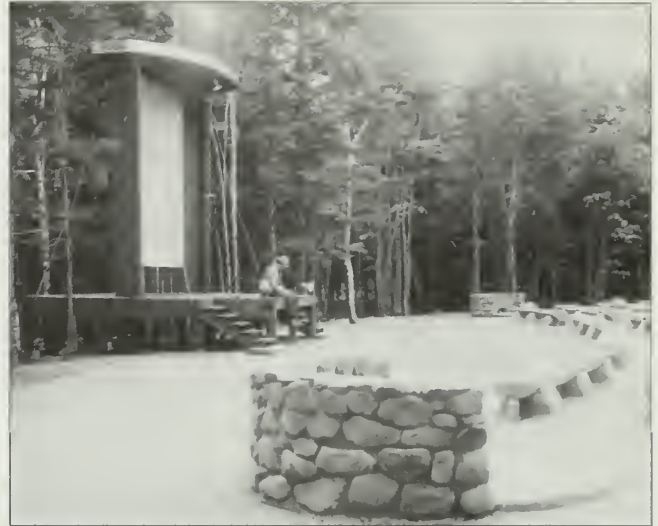
Figure 45: Blackwoods campground amphitheater, constructed in 1950.

The construction of an amphitheater, which had been an unachieved goal of the Seawall Recreational Demonstration Project before the war, was instead completed in 1950 at the Blackwoods campground. The development of a new amphitheater at Blackwoods may have been given higher priority in an effort to quickly replace the aging facilities at the Bear Brook campground, as Blackwoods was in closer proximity to the majority of park visitors than the western facilities at Seawall. Beginning with advance planning projects undertaken during the war, several grand proposals were put forward concerning the new amphitheater. These great plans were never realized in the meagerness of postwar development budgets. The new amphitheater, as constructed, featured a simple stage/screen structure and projection booth flanked by two matching campfire rings (Figure 45). Benches were of half-round logs, supported by low

concrete piers. The surface of walks and the seating area was crushed stone.

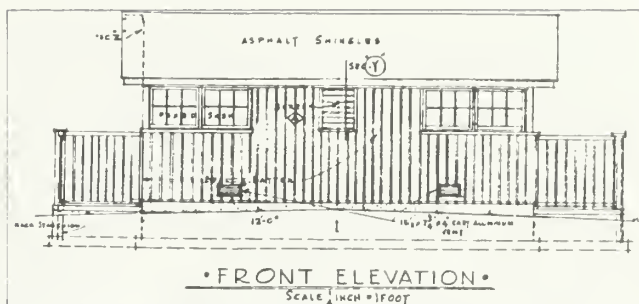
Figure 46: Blackwoods campground loop “B” comfort station design.

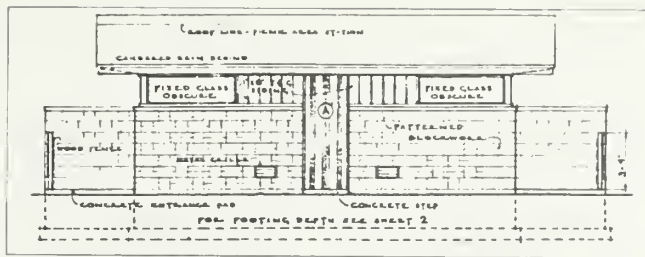
Figure 49: Seawall campground's loop "D" comfort stations, constructed 1960-61. This style building was also constructed at the edge of Seawall's playing field when the area was converted to group camping in 1960. Drawing NP-ACA-3021B, 1959.

In 1958, “Life” magazine listed Seawall Campground as one of America's “50 Best Camping Areas.” However, acquisition of an in-holding adjacent to the campground soon made additional improvements possible. During 1959, plans were underway for the development of an additional campground loop (Loop “D”) for the exclusive use of “walk in” campers (Figure 48). This walk in campground loop, features a spur road off the main campground road that ends in a parking area. Three comfort stations were placed at the perimeter of this parking area to serve individual campsites located farther back in the woodland, accessible by foot. The design of these comfort stations reflects an attempt to standardize similar structures throughout the National Park Service (Figure 49). This effort at standardization contrasted sharply with older structures, that had been specifically developed to provide a regional architectural expression.<sup>57</sup>

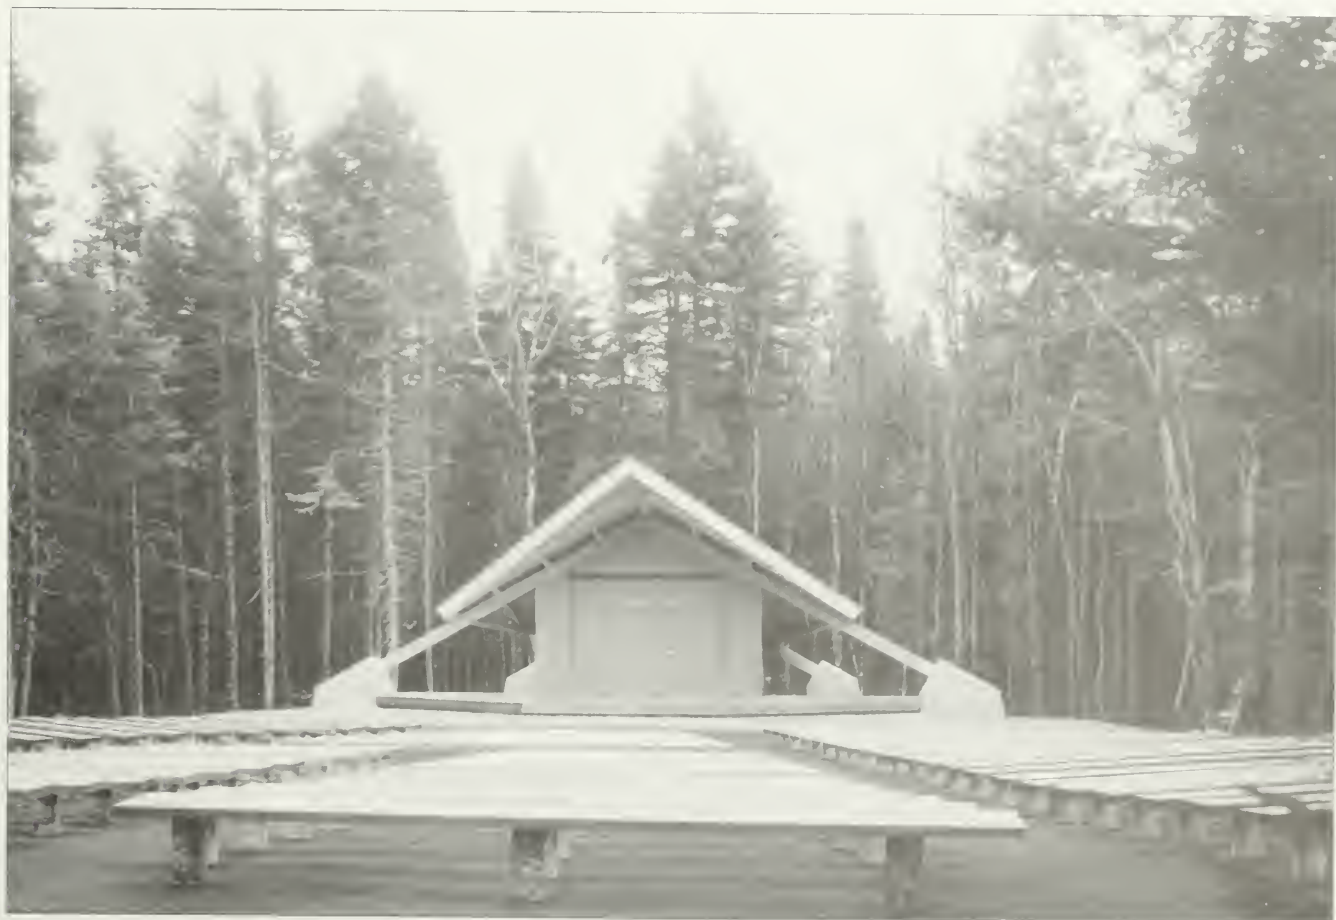
Figure 50: Seawall campground's amphitheater in 1962.

structed of large glue-laminated beams rising from heavy concrete bases to form an "A frame" style roof (Figure 50). The influence of standardization can also be seen in the adoption of new details for picnic tables featuring dimensioned lumber, and campground fireplaces fabricated from precast, reinforced concrete (Figure 51 and 52).

Both Blackwoods and Seawall campgrounds have had their amphitheater facilities upgraded in recent years, beginning with the redesign of the Blackwoods amphitheater in 1977. This project replaced the twenty-seven year old structure with a more contemporary design (Figure 62). The layout of this new stage, eliminated one campfire circle and relocated another. Evening interpretive programs continue to be scheduled at the amphitheater. A rehabilitation of the Seawall amphitheater took place in 1986, retaining the "A-frame" structure originally constructed in 1961.

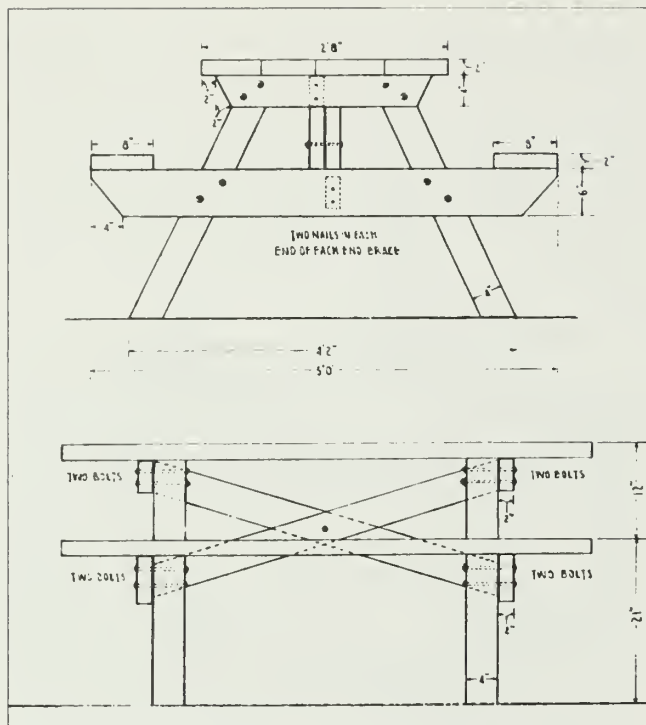
Figure 51: Standard detail for picnic tables of the Mission 66 period. Drawing NP-ACA-2991, 1958.

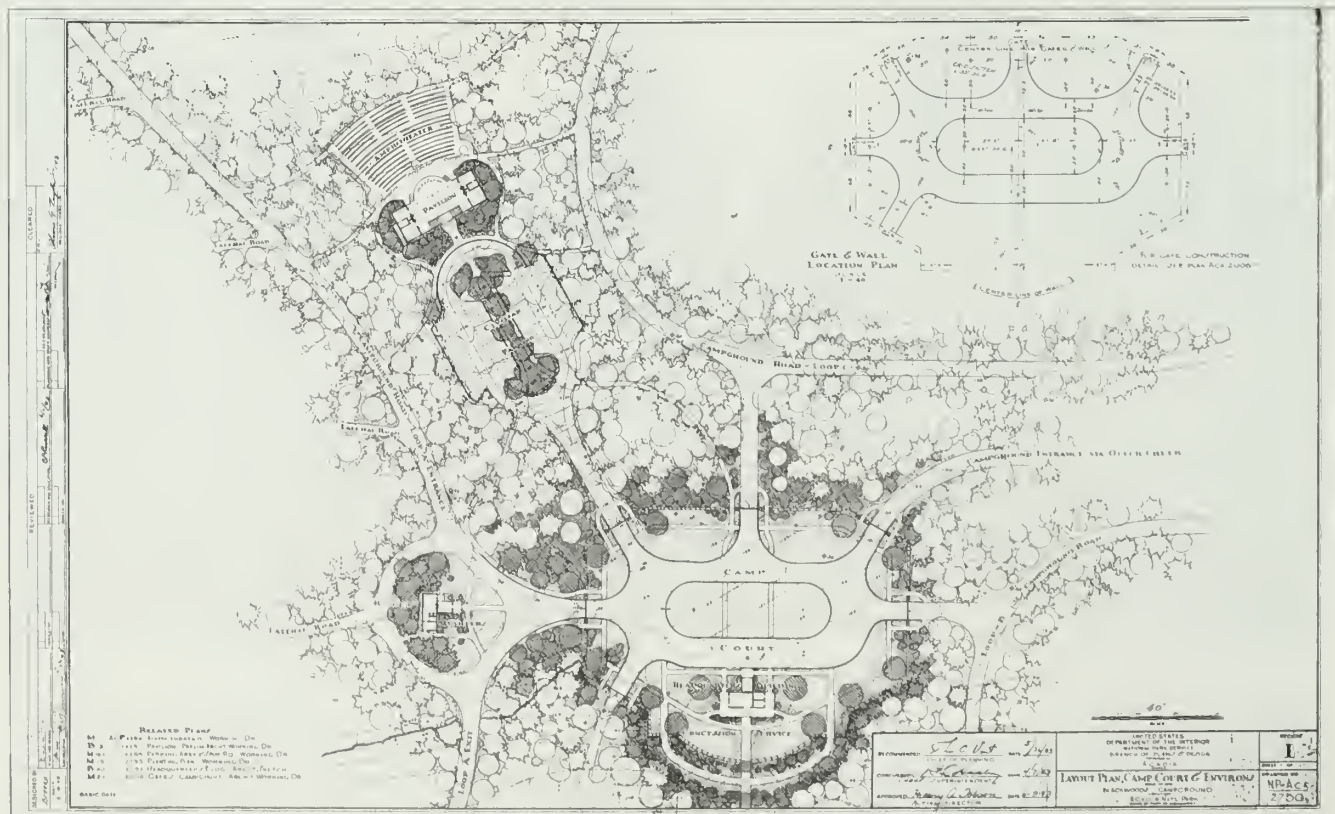
Figure 53: Plans for the Blackwoods "camp court" were suspended in 1960. Drawing NP-ACA-2750, 1943.

Mission 66 work at Acadia National Park is also curious for its divergence from longstanding park development plans. The original development plan for Blackwoods campground's "camp court" called for a central headquarters and concessionaire building, with the camp court itself surrounded by rustic walls and gates (Figure 53). It appears that plans for these features were dropped in 1960. The Blackwoods campground development plan of 1954 included these longstanding features, but National Park Service records show that this plan was suspended, with reference to a letter of 21 October 1960 to the Study for the Outdoor Recreation Resources Review Commission.<sup>78</sup>

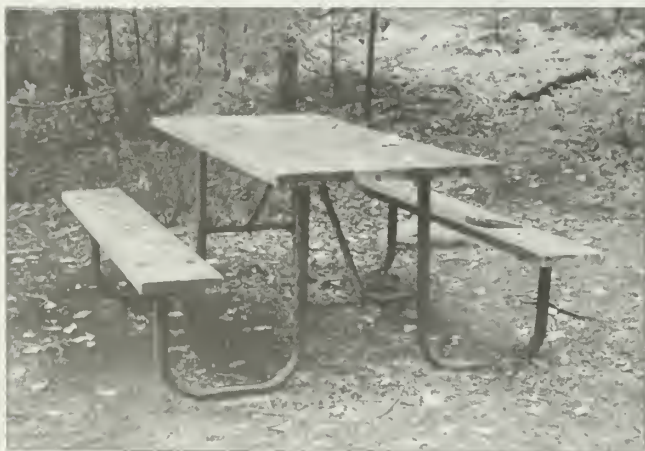
Figure 56: Job Corps era ('65-'69) picnic table, Blackwoods campground.

Beginning in 1965, Acadia National Park became host to the “Job Corps.” Part of the Johnson Administration’s “War on Poverty,” the Acadia Job Corps Center occupied new buildings on MacFarland Hill that was formerly the site of the Civilian Conservation Corps Camp NP-1. One of the biggest projects of the Acadia Job Corps Center was its “Obliteration Project,” which removed traces of homes, and roads that were abandoned or destroyed during the fire of 1947.<sup>83</sup> The enrollees of the Job Corps were also involved with the fabrication of park entrance signs, and the construction and placement of picnic tables and steel fireplaces in the campgrounds (Figures 55, 56 and 57). The Job Corps began to be phased out by the Nixon Administration in 1969.

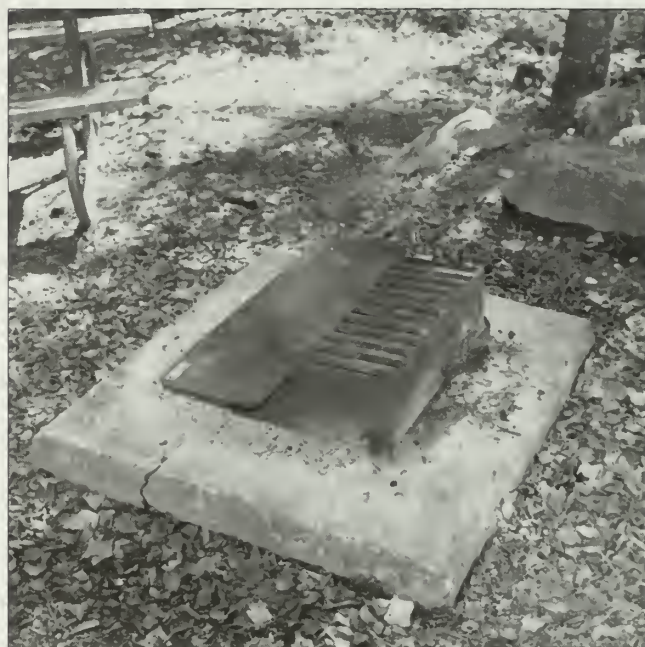
Figure 57: Job Corps era ('65-'69) steel fireplace, Blackwoods campground.

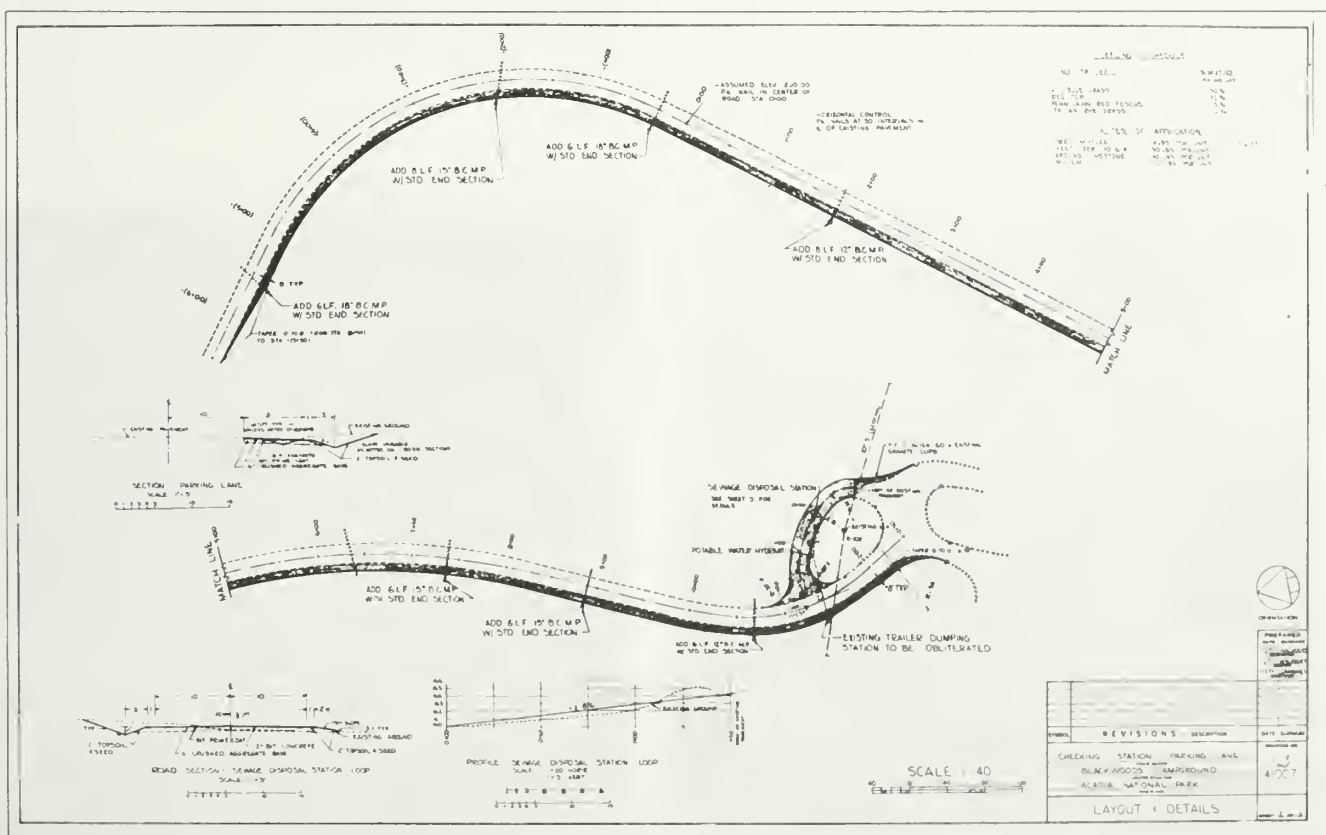
Figure 59: Design for widening campground access road to provide a waiting lane for motorists to check in to the Blackwoods campground. Drawing also shows the relocation of sewage dump station. Drawing 123-41007-2-5, 1971.

Ignoring the advice of the 1971 study of the environmental conditions at Blackwoods, most rehabilitative work on Acadia’s campgrounds during recent years has focused on structures, furnishings and utilities rather than on the campsites themselves. Increasing visitation and the absence of a campsite reservation system at Blackwoods necessitated plans for the widening of the campground access road in 1971 (Figure 58). This project added an additional lane to the access road to make space for a line of waiting cars and trailers. The sewage dump station for Blackwoods was also reconfigured at this time (Figure 59). Four years later, during 1975, plans for a new entrance station were

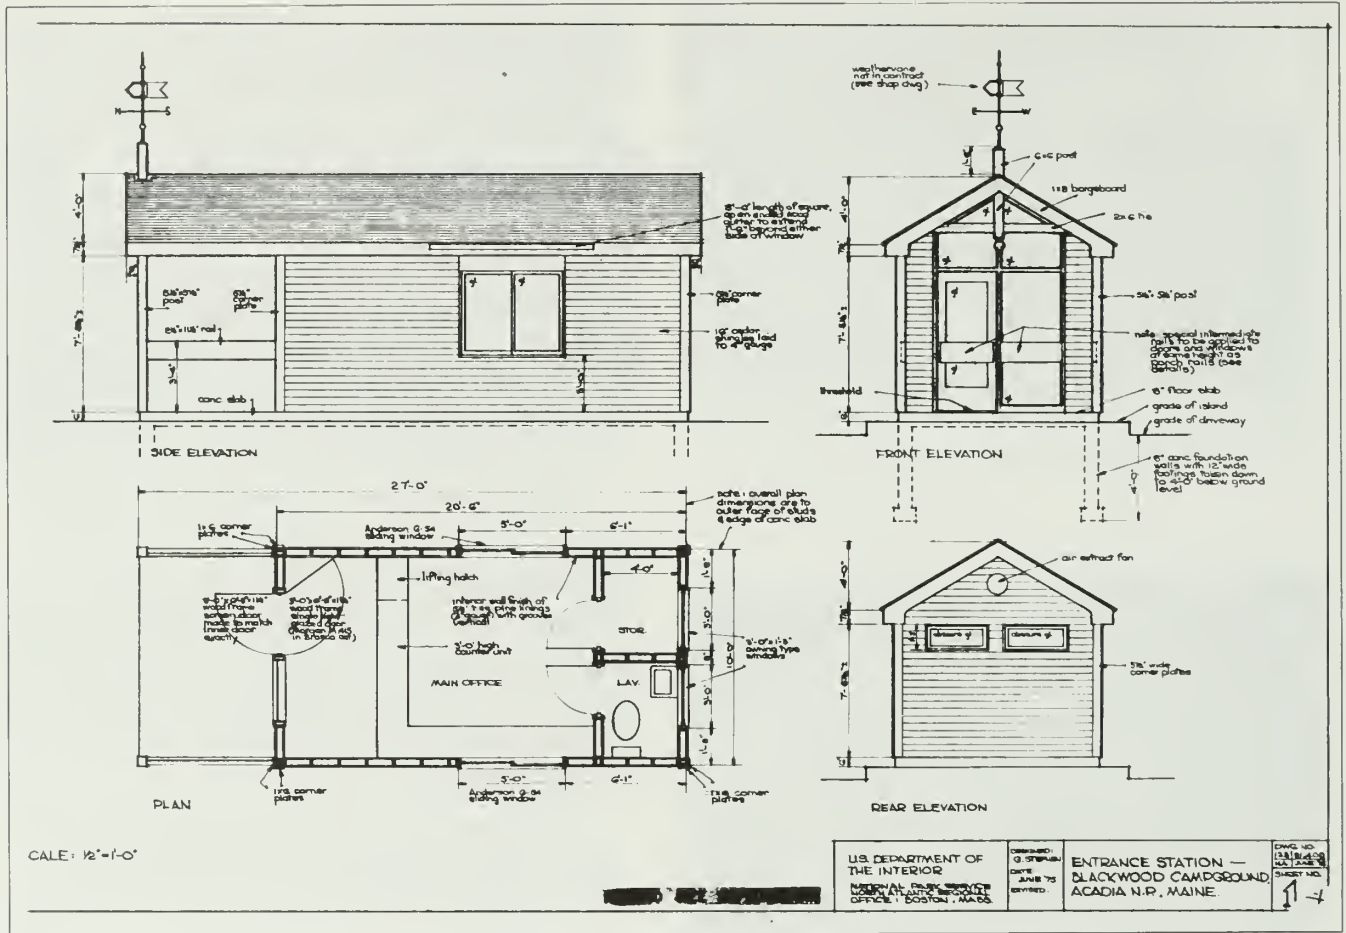
Figure 60: New Blackwoods checking station designed to serve both loops "A" and "B." Drawing 123-81400, 1975.

completed for the Blackwoods "camp court." The placement of this new entrance station represented a more practical solution that allowed park staff to check campers into both loops of the campground (Figure 60). The original checking station had been substantially completed in 1942 at the entrance to Blackwoods loop "A" and this building continued to be used as a ranger residence and administration building until it was destroyed by fire in 1978 (Figure 61).

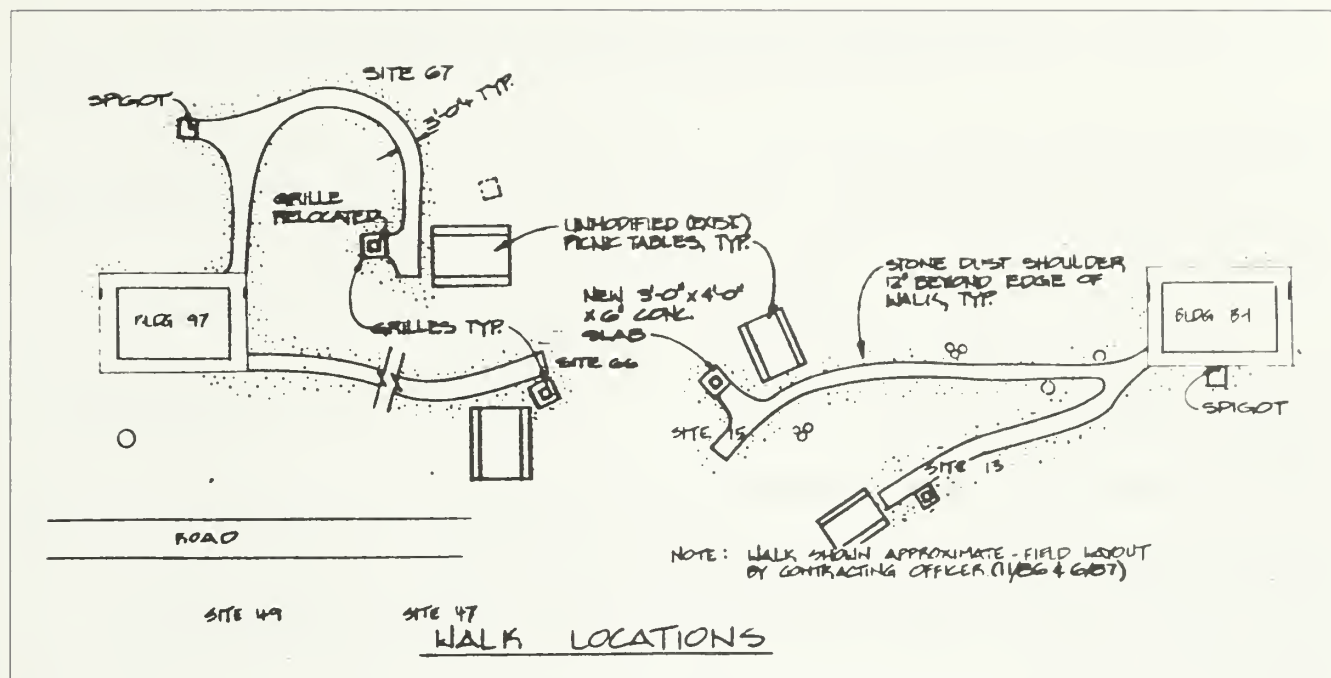
Figure 63: Handicapped accessible camp sites, constructed during the 1985-1987 rehabilitation of facilities at Blackwoods campground, Drawing 123-41046B.

The last major project undertaken for the benefit of Acadia's campgrounds was a rehabilitation of the Blackwoods comfort stations and sewer system between 1985 and 1987. This project replaced deteriorated board and batten siding on both CCC and Mission 66 comfort stations, and added quarry tile flooring. Accessible camp sites were added next to selected comfort stations at this time (Figure 63).

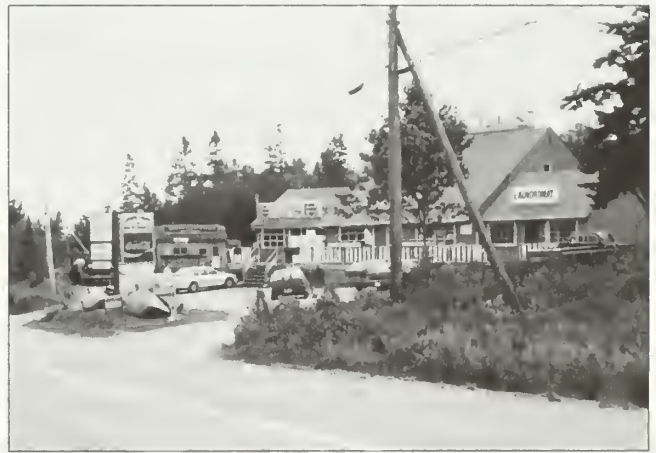
Figure 64: Private business providing services east of Seawall campground on Route 102A.

social trails. Showers are not provided on site. Coin-operated bathing facilities are available a short distance outside the campground through a private company on land outside the park boundary (Figure 64). Only one campsite (A27) is programmed for handicapped accessibility at Seawall campground. Evening interpretive programs are offered at the campgrounds at an outdoor amphitheater located in the campground.

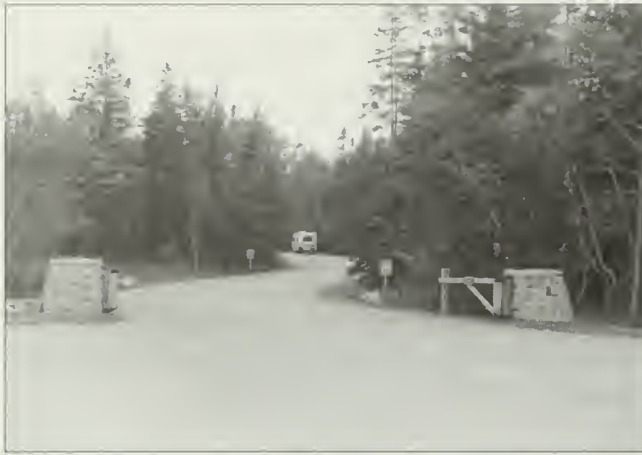
Figure 65: Entrance to the Seawall campground looking north from Route 102A.

Access to Seawall campground is through a rustic gate at the intersection of the campground entrance road and State Route 102A (Figure 65). The three lane entrance road becomes divided by a grass median at the campground checking station where campers are required to stop and register (Figure 66). Past the checking station the main campground road is designed for two way traffic, featuring an average 18 foot pavement width. Roads within the separate campground loops are

The entrance gate to Seawall campground is the only remaining gate out of three that were located at this intersection. In July of 1942, the U.S. Navy closed off a portion of Rt. 102A to provide a secure zone around their newly constructed radio station. Part of this project included the construction of three similar gates designed by the National Park Service, one across Rt. 102A, one across the campground access road, and a third across the picnic ground access road. Civilian traffic was routed around the Naval radio station, north by way of the campground access road and then east through loop A. The existing gate at the entrance to the Seawall is constructed of two massive stone masonry piers onto which are mounted heavy timber single crossbar gates. This gate has been rebuilt to a wider span within the last ten years due to the widening of the campground entrance road and is in excellent condition (Figure 65).

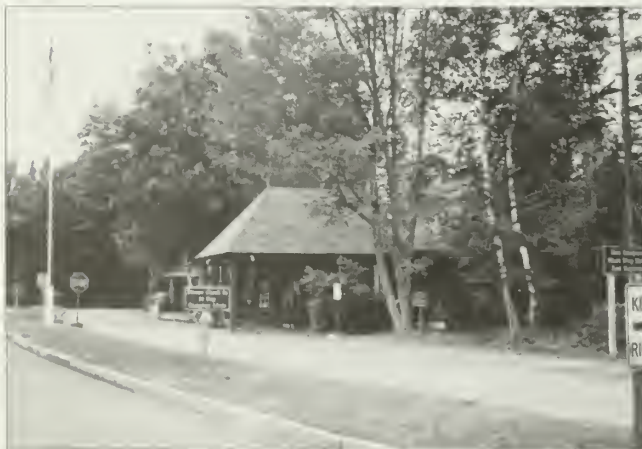
Figure 66: The Seawall checking station and entrance road.

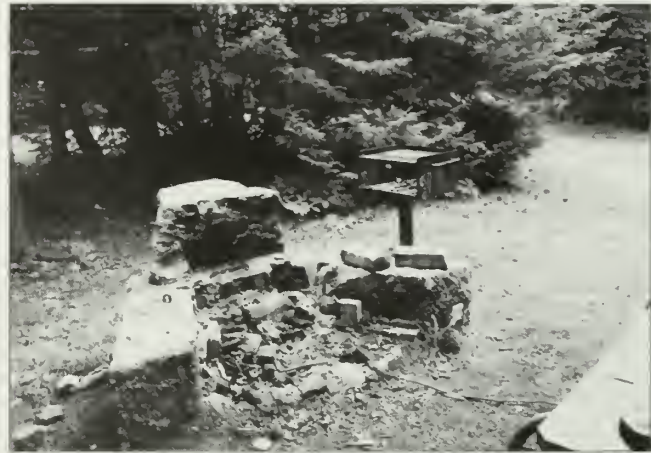
Figure 67: Badly deteriorated stone fireplace in Seawall campground loop "A". This "accessible" site has a new grill oriented in a direction impossible for campers to use.

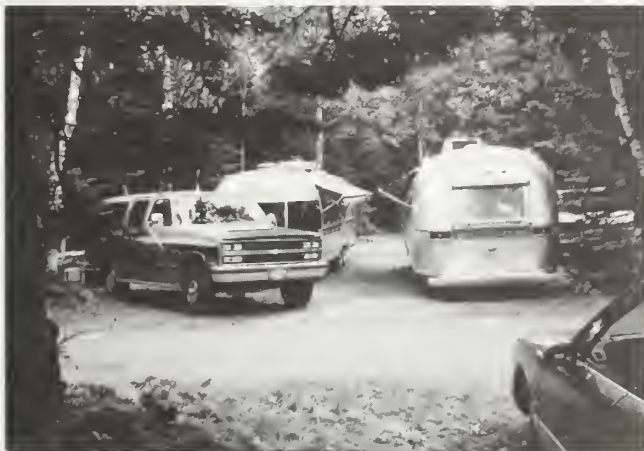
Figure 68: Crowded conditions in Seawall loop “C,” trailer loop.

concrete masonry units. Loop C is laid out in a branching pattern, featuring 43 “link” type campsites on well drained soil. This type of layout makes it unnecessary to back up a camping trailer, something which inexperienced drivers find very difficult. The trailer loop is served by a single trailer waste dump station installed between 1960-61. Owing to the large size of modern recreational vehicles and trailers and to the small size of Loop C, this is a very densely occupied area. There is little vegetative screening between campsites (Figure 68). The link type parking spurs are not particularly well defined or protected by barriers. As a result, the width of the spurs appears to have increased with time. Each campsite area is furnished with a rustic stone fireplace and a board and tubing picnic table of the same deteriorated condition consistent with Seawall’s loops A and B.

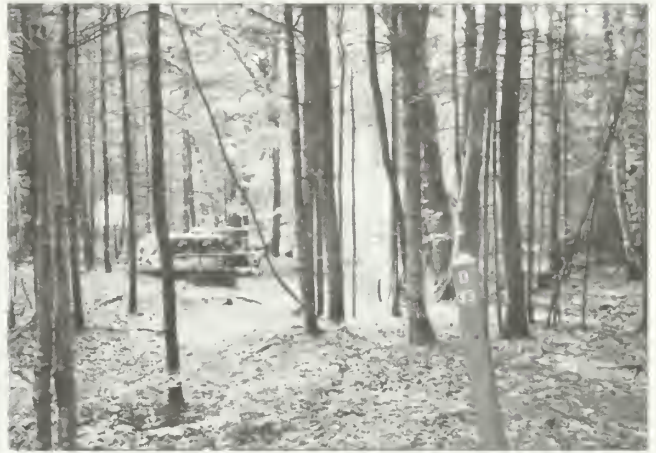
Figure 69: Seawall loop “D,” walk-in campsite with wood post campsite marker in foreground.

Loop D, was constructed in 1960 during the “Mission 66” park development program, as a “walk-in” campground. This loop features 104 campsites arranged around a central parking area. Sites are marked with routed wooden trailside posts (Figure 69). The parking area is flanked by three comfort stations (bldgs #178,179,180) built between 1960-61 of patterned concrete masonry units and are in fair to poor condition (Figure 70). Access to the campsites is via unsurfaced foot trails. The vegetation around these walk-in campsites is generally in much better condition than elsewhere in the campground due to the lack of damage and stress from vehicular traffic. However, many sites lack privacy due to the lack of vigorous understory vegetation. Site furnishings include board and tubing picnic tables and

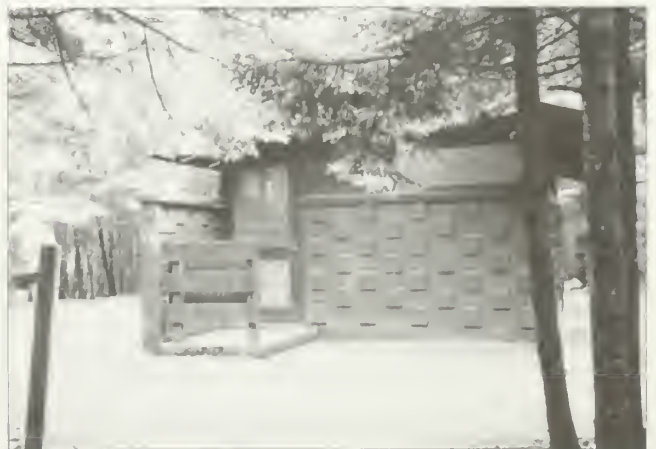
Figure 70: Side facade of “Mission 66,” concrete block comfort station, bldg #180 Seawall loop “D.”

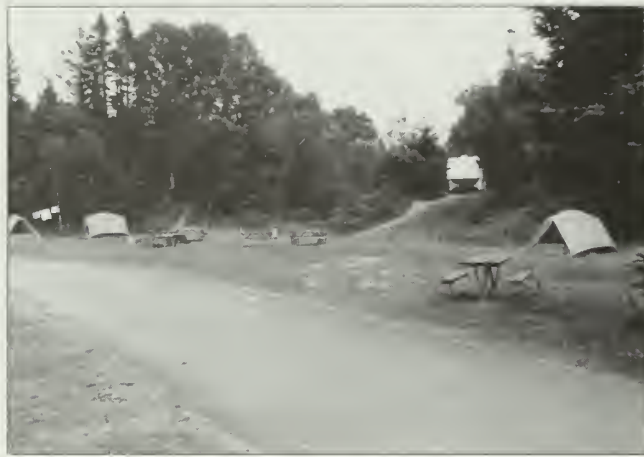
Figure 71: Seawall campground's group camp sites. These sites were built c. 1960 in an area that was formerly a recreational field.

mass-produced steel ring fireplace units. From two to three board and tubing type picnic tables are also furnished for each group site. Pedestrian access from the group campsites to the rest of Seawall campground is via an eroded footpath down a steep embankment. (Figure 71).

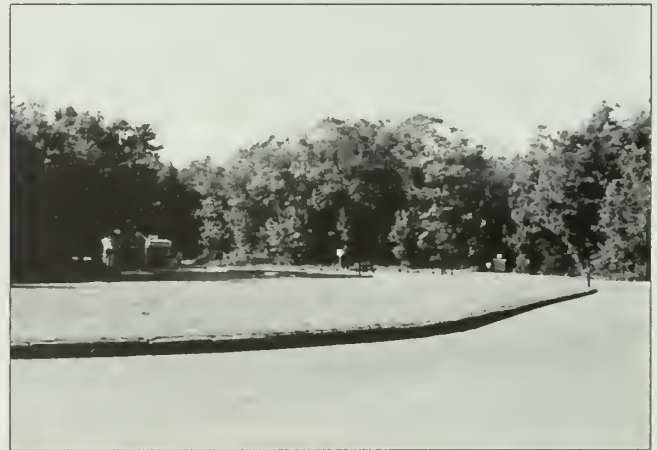
Figure 72: The Blackwoods "camp court." The Blackwoods campground is organized around this central open space.

Blackwoods campground is located on the eastern side of Mount Desert Island, just west of Otter Cove. The campground consists of two large loops organized around a central open space originally referred to in design drawings as the "camp court" (Figure 72). Blackwoods campground occupies approximately 160 acres. Camping is limited to numbered campsites, as Acadia National Park does not permit backcountry camping (Figure 81). Sites are identified with painted numerals on the pavement at the edge of the road. Since Blackwoods campground is closer to the attractions of the eastern side of the island, it is more heavily used than the Seawall campground. To manage supply and demand, the park requires that campers at Blackwoods make reservations for campsites in advance. A computerized reservation system is managed by a private company which uses toll-free telephone numbers to book campground reservations at Acadia as well as 12 additional National Parks across the country. Site assignments are made according to the type and quantity of equipment that the camping party intends to use during their visit. Only one self-propelled vehicle per campsite is permitted,

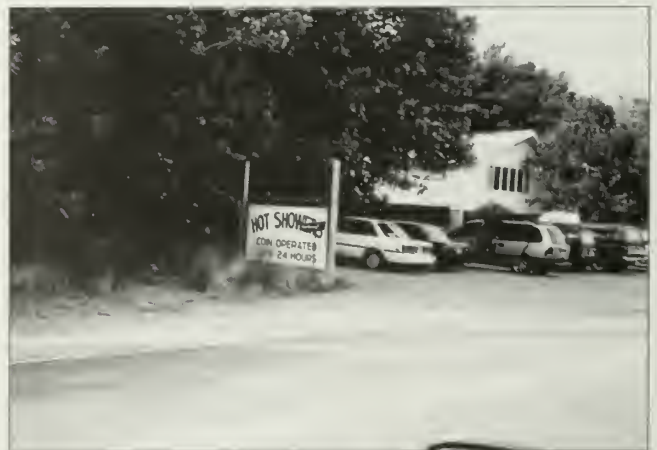
Figure 73: A private business providing services outside the park boundary near Blackwoods campground.

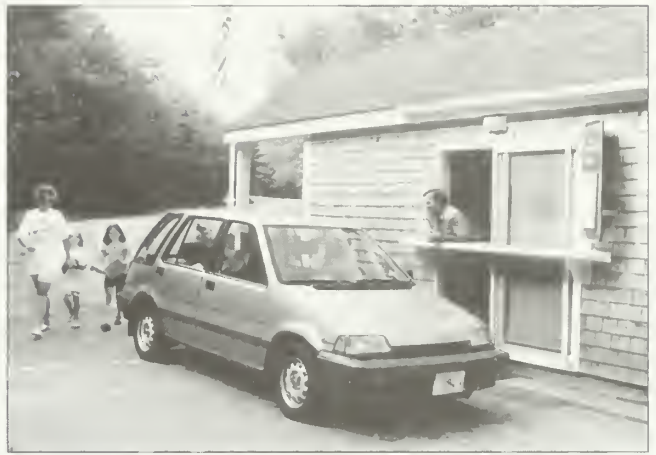
Figure 75: Blackwoods checking station, constructed in 1975.

As presently located, the checking station at Blackwoods presents an obstacle to vehicular circulation, appears out of character with the rustic architectural traditions of the park, and is too small to meet the needs of the campground staff and visitors (Figure 81 and 140).

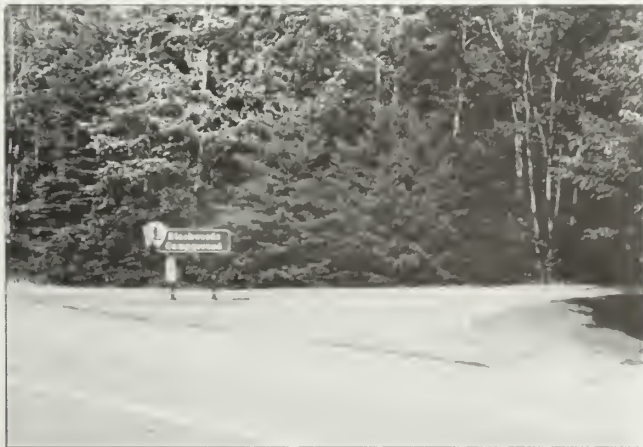
Figure 74: Entrance to the Blackwoods campground from Route 3, west of the village of Otter Creek.

Access to Blackwoods campground is via a triangular intersection with State Route 3 just west of the village of Otter Creek (Figure 74). A three quarter mile long access road, paved with bituminous asphaltic concrete leads to a checking station constructed at the edge of the central “camp court” where campers are required to stop and check in (Figure 75). Campground loops “A” and “B” intersect with the oval road of the camp court. These roads are designed to direct vehicles in a counter-clockwise direction through each loop. Lateral campground roads intersect with the main perimeter road of each loop leading the motorist to campsites (Figure 76). A limited number of spur type campsites have been constructed along the perimeter roads. Both the perimeter roads and lateral roads of loops A and B are hard surfaced with bituminous asphaltic concrete. Parking spurs off of these main roads are surfaced with crushed stone aggregate or bare soil. Neither the margins of the paved roads or the campsite parking spurs are adequately protected with boulders or logs as barriers. As a

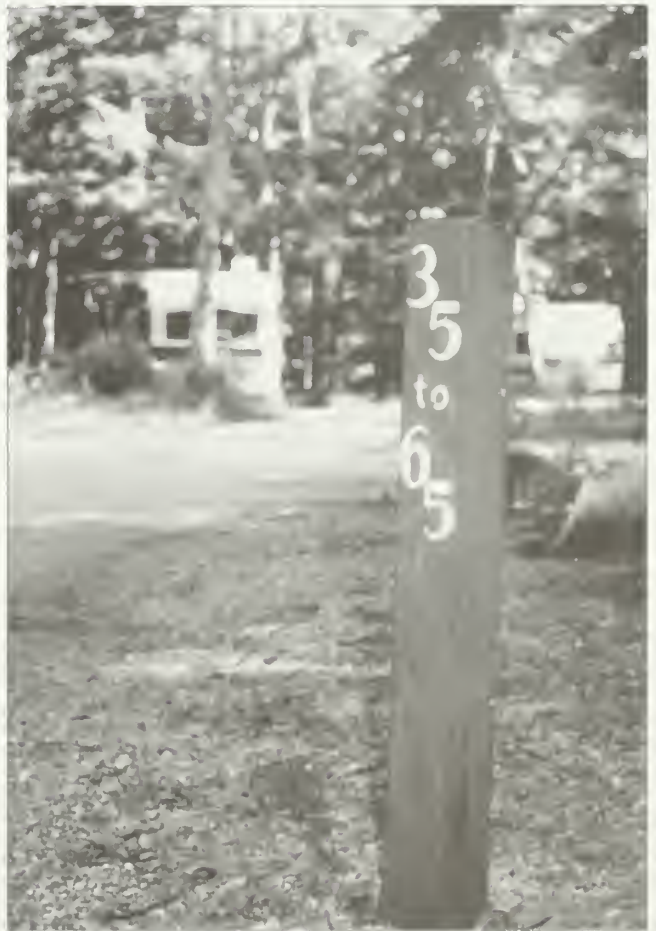
Figure 76: Typical wooden marker at the intersections of perimeter and lateral campground roads. Loop “A,” Blackwoods campground.

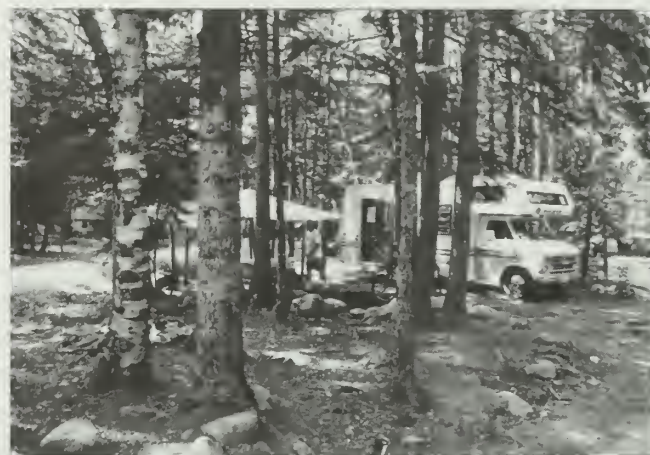
Figure 77: “Link” type trailer campsites, loop “A,” Blackwoods campground. These sites are the only campsites laid out by the CCC before its dissolution in 1942.

The link/bypass sites are the most densely occupied in the campground in which large motor homes are separated by very little distance and/or vegetation (Figure 77). In some instances, picnic tables and fireplaces are inconveniently located on the side of the parking spur opposite the passenger door. Loop A is served by six comfort stations, five of which are of the prototypical design constructed by the Civilian Conservation Corps during the 1930’s and 1940’s. These early comfort stations are all in fair to good condition. A brick restroom, located at the bottom of Loop A was constructed in the 1950’s. This brick building has served as a winterized comfort station for those campers visiting Blackwoods after the close of the regular camping season (Figure 78). Site furnishings for each individual campsite consist of commercially fabricated fire rings made of steel and picnic tables constructed of wooden boards and bent steel tubing.

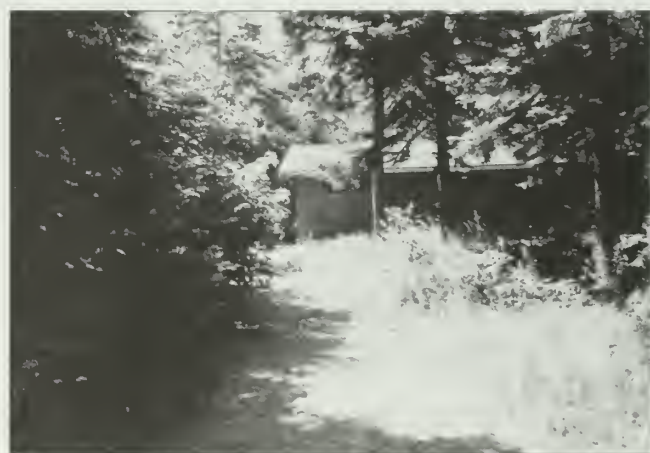
Figure 78: Brick comfort station, building 96. Loop “A,” Blackwoods campground.

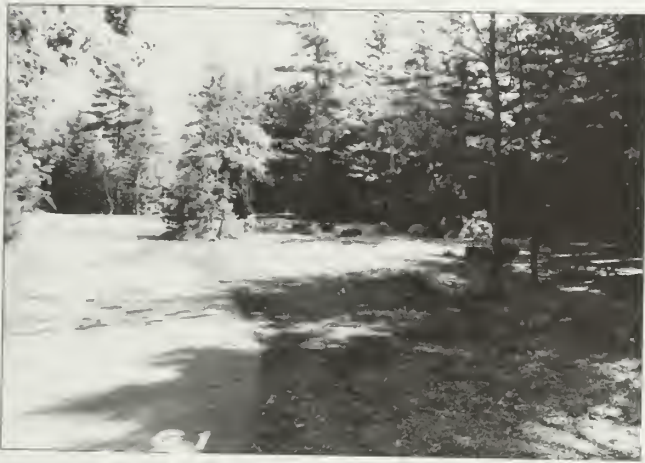
Figure 79: Group campsites, loop "B," Blackwoods campground.

offers a greater sense of privacy between sites due to distance and vegetation. The exception to this is the location of five large group campsites within loop B. These group sites are large enough to accommodate more than one large recreational vehicle, including converted highway buses. Within the group sites, landscape values have been sacrificed to accommodate large groups and equipment (Figure 79). The five comfort stations in Blackwoods loop B were constructed with board and batten siding similar to that used on the Civilian Conservation Corps (CCC) period comfort stations. However,

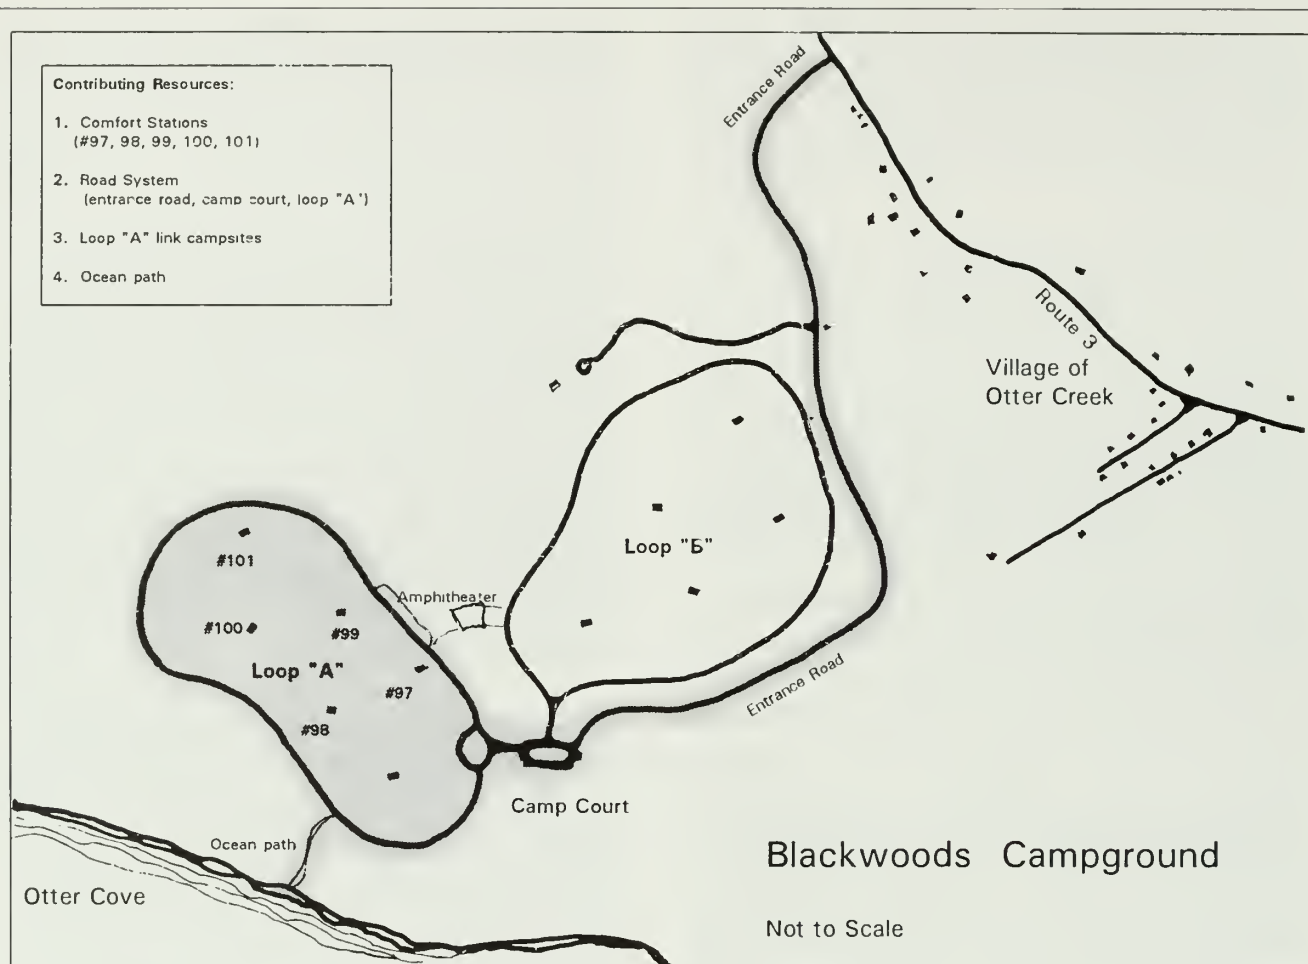
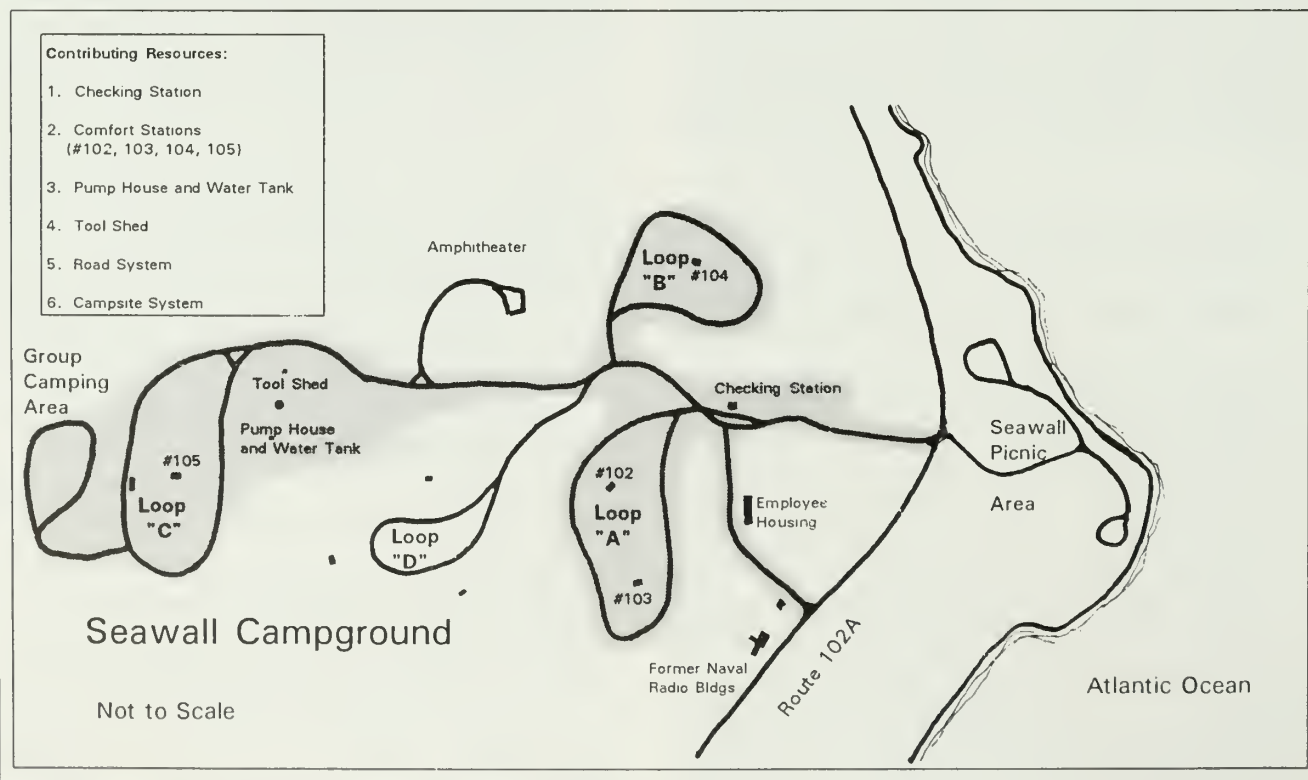
Figure 82: Historic property boundary(ies) Blackwoods and Seawall campgrounds.

The boundaries of the historic properties are illustrated in Figure 82. At Seawall, the historic property includes the entrance road, loops A, B, C, and the group camping area. The historic property of Blackwoods campground includes the entrance drive, camp court, loop A, and the Ocean Path.

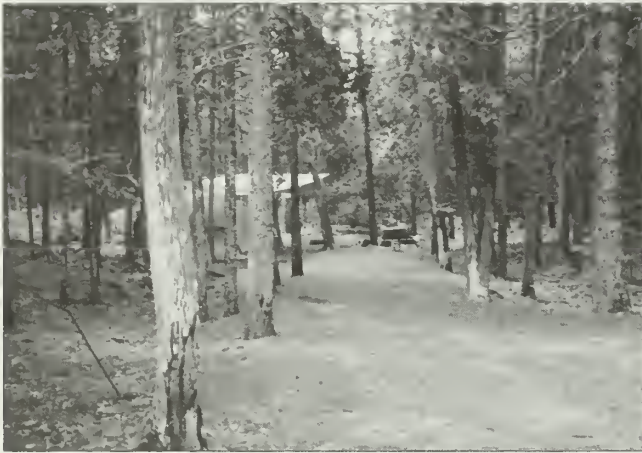
**Figure 83:** Where vegetation has been damaged from years of campground use, the spatial qualities of the individual campsite are diminished.

spatial definition of individual campsites was historically delineated with stone boulders as barriers. Removal of barriers has caused a growth in the physical size of campsites. The mortality of screening vegetation and deterioration and modernization of site furnishings has resulted in a change in the rustic character of most individual campsite units. For these reasons, the spatial quality of the *individual* campsites of loops A, B and C has deteriorated since the historic period (Figure 83).
