# CULTURAL LANDSCAPE REPORT FOR BLACKWOODS AND SEAWALL CAMPGROUNDS ACADIA NATIONAL PARK

History, Existing Conditions, Analysis  
& Treatment Recommendations

CULTURAL LANDSCAPE PUBLICATION NO. 11

September 1996

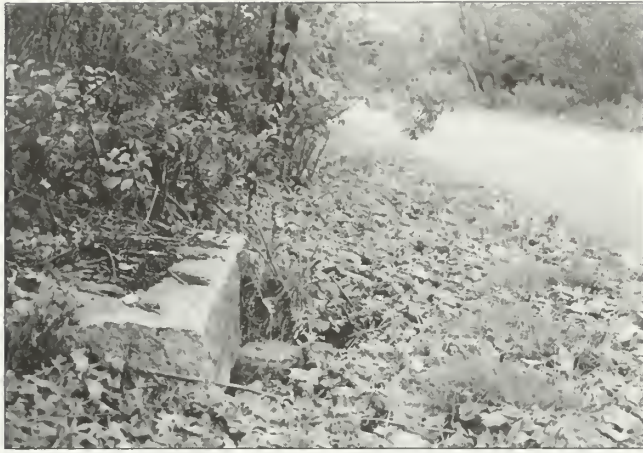
Figure 84: Stone drainage inlets and headwalls help define the rustic character of campground roads.

The campground loop roads occupy relatively level ground and have not required the installation of elaborate drainage features. However, in the instances where stone headwalls and drop inlets occur, they help to define the rustic character of these roads (Figure 84).

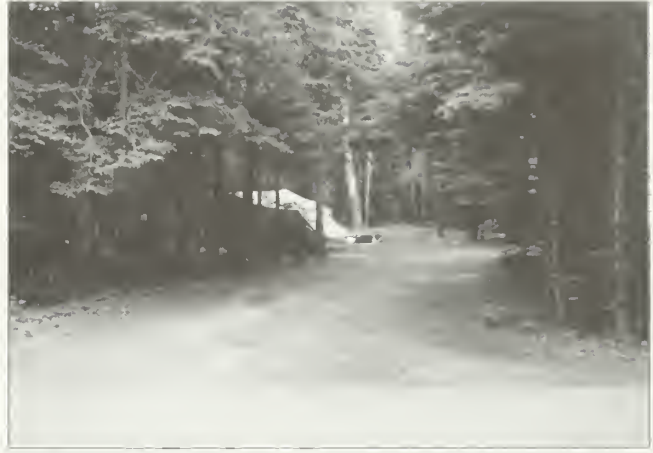
Figure 85: Campsite parking spur, lacking vehicular barriers.

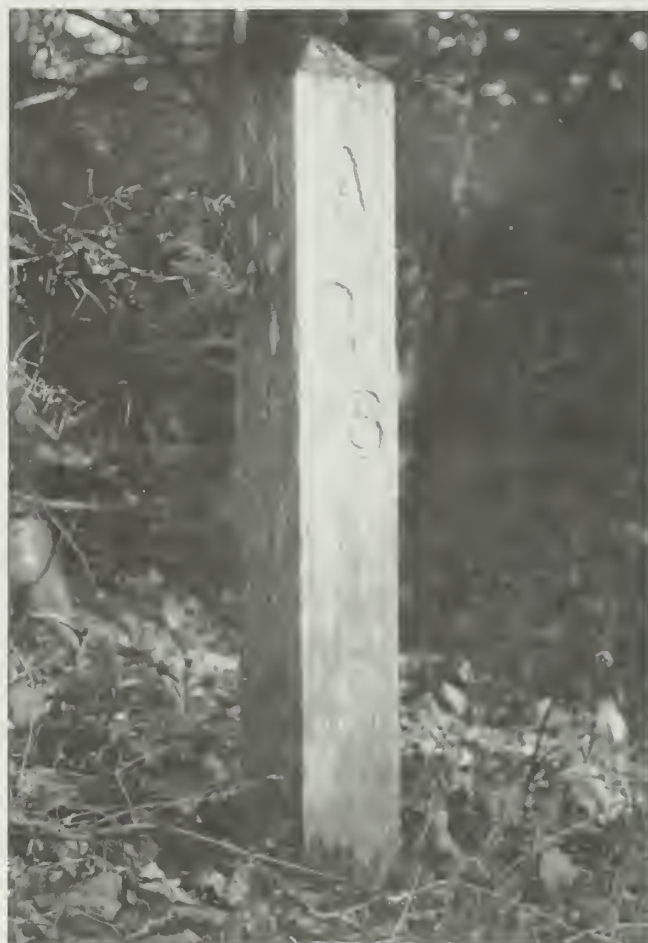
Before the widespread introduction of bituminous concrete to pave the surfaces of the campsite loop roads, numerals were routed into low wooden posts to identify the location of individual campsites. The contemporary solution of painting campsite numbers at the pavement edge would have been impossible on a gravel or chip sealed surface. A few of these wooden posts remain in loops A, B and C, though they are in poor condition. However, wooden posts continue to be used to identify campsites in loop D, the “walk-in” campsite loop that was constructed in 1960 (Figure 86).

Figure 86: Historic wooden post campsite marker at Seawall campground. These markers were used before the campground roads were paved with bituminous concrete.

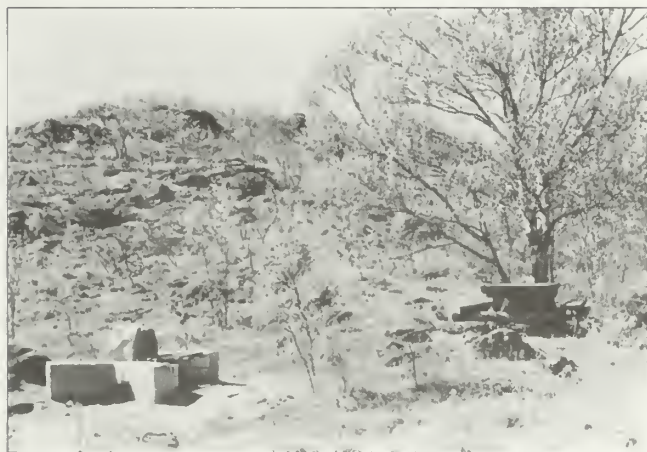
The most outstanding character-defining feature of the individual campsites in the Seawall campground are the stone fireplaces constructed by the CCC. The fireplace design in use at Seawall appears to be a variation on a theme used throughout the western national parks.<sup>2</sup> The overall dimensions of these fireplaces range from five to six feet across and three to four feet deep. The firebox is formed by two splayed low stone arms attached to a stone backing approximately two and one half feet high. The higher back wall serves as the visual vestiges of a chimney and is purely aesthetic, serving no useful purpose.<sup>3</sup> The firebox is lined with beige firebrick. The cooking grate is fabricated from wide strips of cold-rolled milled steel many of which are permanently fixed in place. Other individual fireplaces units at Seawall feature a third splayed arm to serve as a prop to rest a hinged fire grate that could be swung away from the fire box. This third arm also serves as a small but useful surface to aid the preparation of meals (Figure 87).

Figure 87: Historic view c.1937-38 of an Acadia National Park picnic area. Stone fireplace is typical of that installed at the Seawall campground.

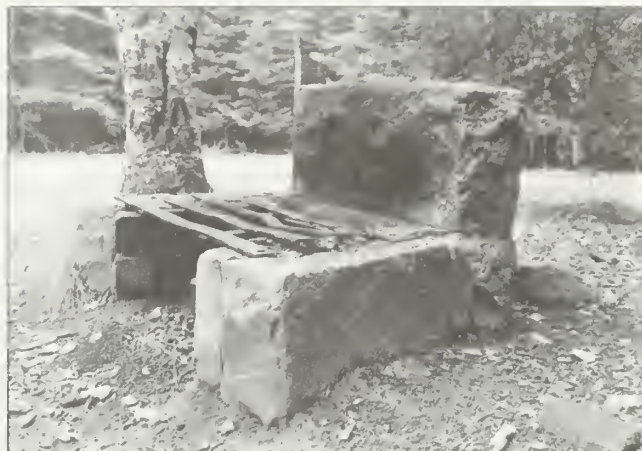
In spite of the high maintenance required, the stone fireplaces at Seawall campground have not been replaced with low maintenance alternatives. This decision may have occurred out of respect for these fireplaces as an appropriate use of native materials in a national park. Unfortunately, no parallel decision was made to adequately maintain these features, and they exist on the site in poor condition. The fireplaces however are not beyond repair. Most of the original stones remain on site (Figure 88).

Figure 88: Contemporary view of deteriorated stone fireplace at the Seawall campground.

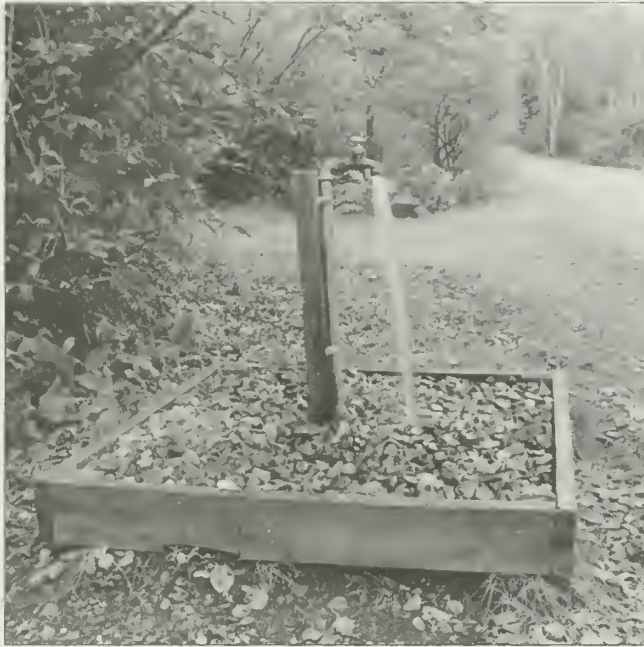
Good discusses the pros and cons of concealing the water tap or pump by various devices, including its camouflage inside a hollow log, or small building. He also recognizes that some may object to such tricks as unprincipled in design, false and misleading. In any case, the water taps in use at Seawall are simple and unadorned and it appears that they have always been so despite the inevitability of countless repairs over the years. The taps are two and one half to three feet high, featuring common hose bibs as fixtures. These hose bibs are not fitted with backflow prevention. A gravel pad is provided below the taps to provide dry footing for those using the fixtures. The continuity of use of this kind of fixture is well established within the setting of the Seawall campground (Figure 89).

Figure 89: Utilitarian water supply tap, typical of those found at the Seawall and Blackwoods campgrounds.

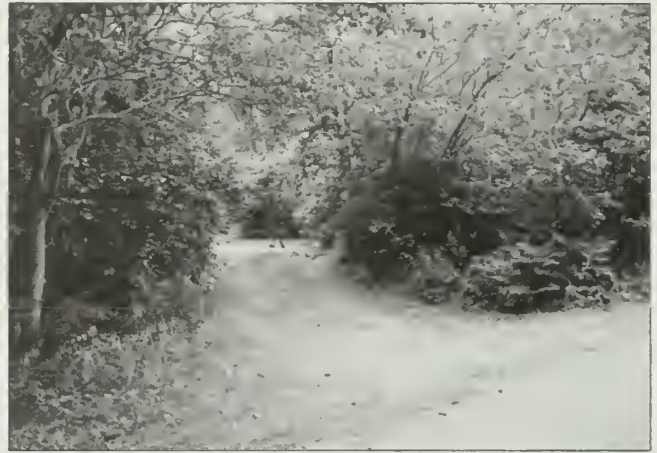
used historically to create “buffer zones” between sites. Seawall loop A is located within a forested area of uneven age and as a result is vegetated with a great quantity and variety of screening vegetation. The situation in loop A is much better than elsewhere at Seawall. Campsites within loops B and C lack clear spatial definition due to the lack of screening vegetation. As a feature, screening vegetation within loop A may be described as being in moderate condition, while screening vegetation within loops B and C may be described as in poor condition (Figure 90).

Figure 90: Screening vegetation between campsites offers privacy and defines the boundaries of the campsite.

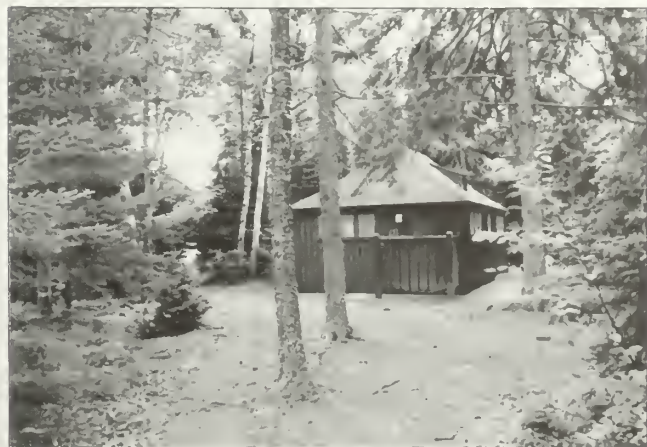
Constructed between 1937 and 1941, these buildings are of a simple rectangular plan with a hipped, bellcast roofs (Figure 91). Built upon granite ashlar masonry foundations, the board and batten walls are trimmed with a plain sill, corner, and fascia boards. The eaves consist of a small wooden cove molding. All wooden exterior elements are painted dark brown, but were originally finished with stain. The asphalt-shingled roofs contain single shed-roofed dormers with rectangular wooden louvered vents, on one or both of its long sides. The roofs of the comfort station buildings were originally covered with wooden shingles. A single plumbing vent

Figure 91: Typical CCC comfort station, Seawall loop "A."

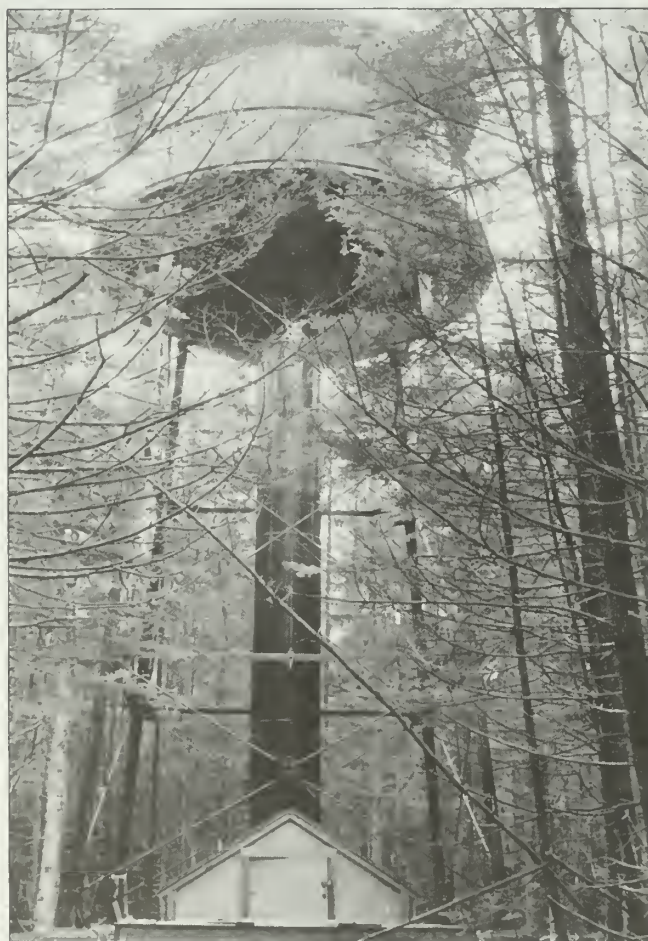
The adjacent water tower is virtually invisible except from its immediate environment (Figure 92). It is a standard water tower of steel construction and is supported on six steel legs with diagonal tension rods between. A steel ladder provides access to a steel deck walkway around the 15,000 gallon tank. The walkway is enclosed with a steel railing with x-bracing between its posts. The tank is of rivetted steel plate construction and is topped with a shallow conical steel roof with plain projecting eaves over the walkway.<sup>13</sup>

Figure 92: Steel water tank constructed between 1938 and 1939 at Seawall campground.

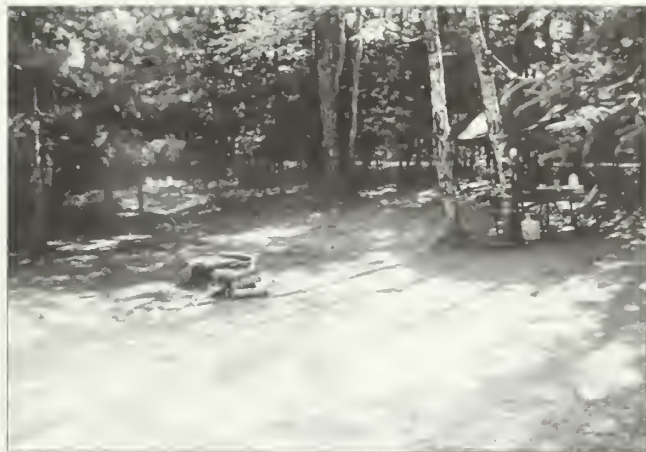
Parking links were historically designed for trailer campers. These awkward vehicles have always had difficulty in backing up within the narrow campsite loop roads. Parking links provide separate entrances and exits on parallel roads, eliminating the need to back up a trailer. The growing size of recreational vehicles and the desire for flexibility in accommodating a variety of equipment has created pressure to remove many boulder barriers or “parking management stones” defining the campsite parking areas. The result has been an overall growth in the physical size of parking spurs and links, at the expense of the overall campsite area. Although examples of well defined parking spurs exist within the Blackwoods campground, the majority of parking spurs and links throughout the campground are in very poor condition (Figures 93 and 94).

Figure 93: Typical campsite parking spur, Blackwoods campground. View shows a lack of spur definition due to lack of boulder and log barriers.

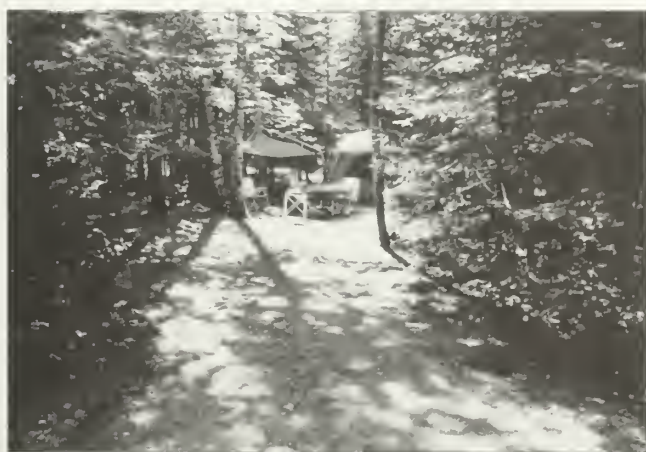
Figure 94: Well-defined parking spur, Blackwoods campground. Screening vegetation is in good condition.

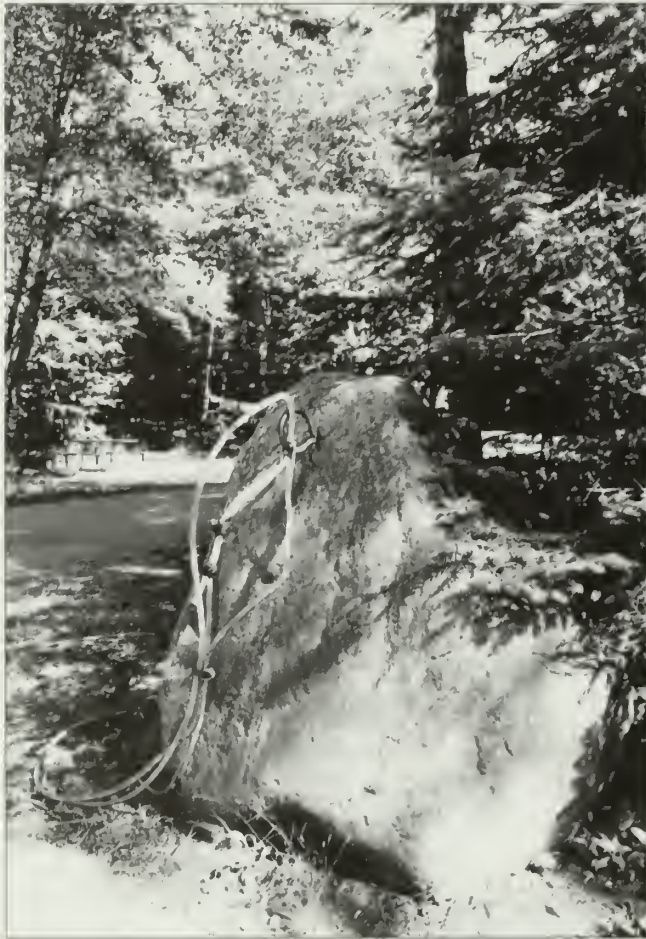
using two massive boulders with steel rings leaded in place on which to fasten a chain or cable. This simple type of gate is used elsewhere in Acadia National Park and may have been installed historically as a temporary measure until a more formal gate could be installed. As is often the case elsewhere, a temporary solution has become permanent (Figure 95).

Figure 95: Typical boulder gate used at Blackwoods campground and elsewhere at Acadia National Park.

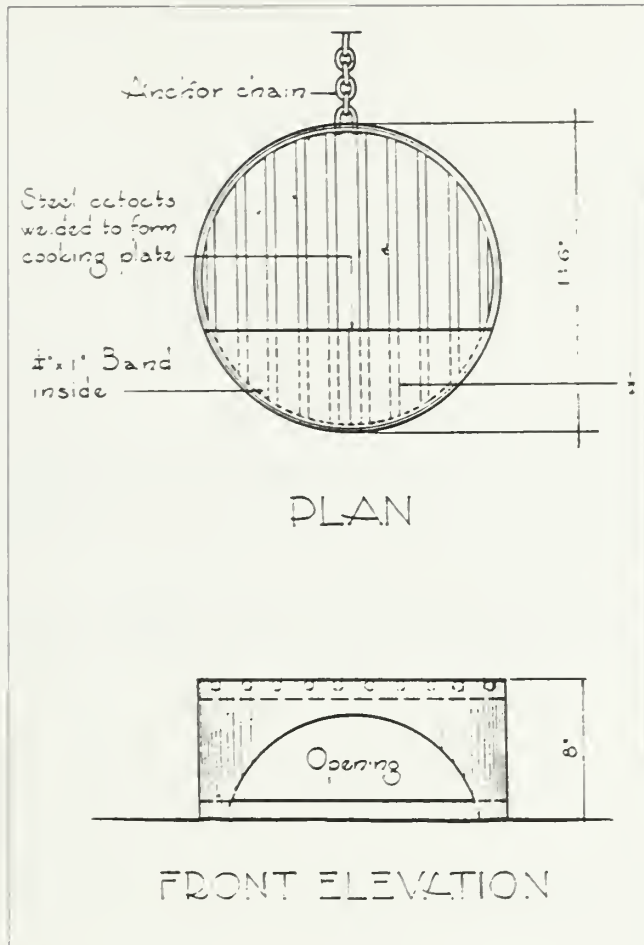
As has been covered in the discussion of the stone fireplaces at the Seawall campground, concrete and steel alternatives to rustic stone fireplaces were being developed and constructed in state and local parks during the historic period of the CCC campground development program. Among these alternatives was a steel ring fireplace developed by the Cook County Forest Preserve of Illinois.<sup>15</sup> The contemporary commercial steel fireplace in widespread use at Acadia National Park has evolved from this early prototype (Figure 96). Although research conducted thus far has not found unequivocal proof, it is possible that a version of the existing steel fireplaces at Blackwoods campground were in place during the historic period.

Figure 96: Contemporary steel fireplaces at Blackwoods campground have evolved from this early prototype published in 1938.

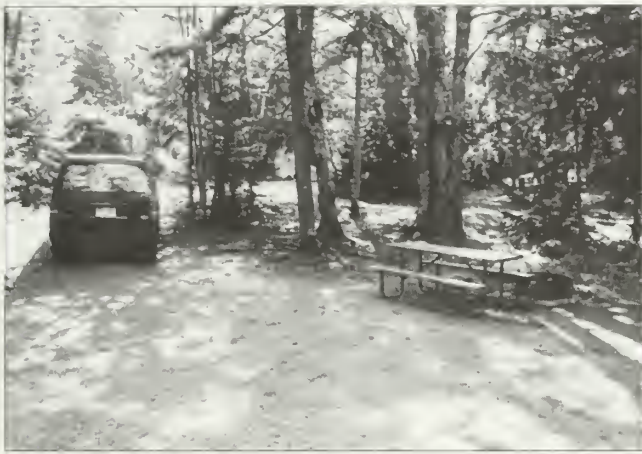
Figure 97: Typical campsite, Blackwoods loop “A.” Photo shows the impact of years of use and inadequate restrictions on the placement of vehicles and equipment.

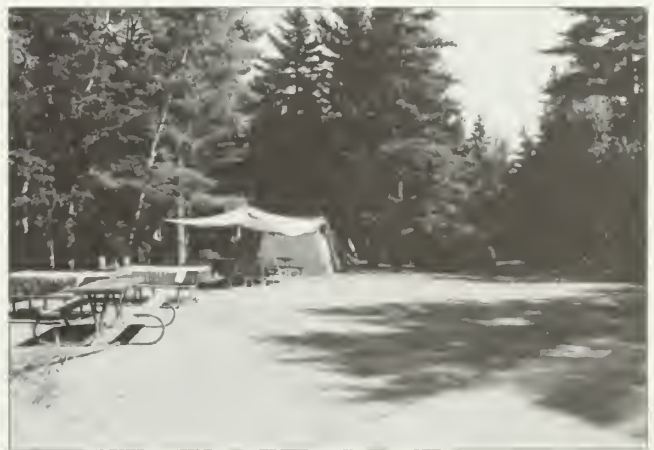
Figure 98: Group campsites, Blackwoods loop “B.” These large sites are more in the character of parking lots than campsites.

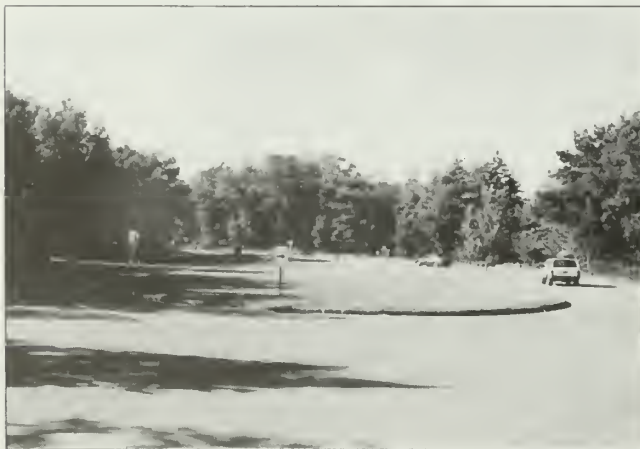
The park has stated a need for campground administrative space, a bus stop, and more centrally located telephones, all of which would naturally fit within a public area of the campground. Current plans for additional park employee housing at both campgrounds propose housing to be located in areas originally designed, yet never actually constructed for public uses (Figure 99).

Figure 99: The Blackwoods central "camp court." The area to the right of this view had originally been planned for administrative and public uses.

Although strict adherence to a historic yet unbuilt site plan for public facilities is **not** recommended, some accommodation for these public oriented uses is appropriate. While details of any planned administrative facilities may properly reflect contemporary needs, it is strongly recommended that these new facilities should occupy sites historically reserved for their use. These locations are the most centralized in both campgrounds and the logic of programming public uses for these sites continues today (Figures 81 and 100).

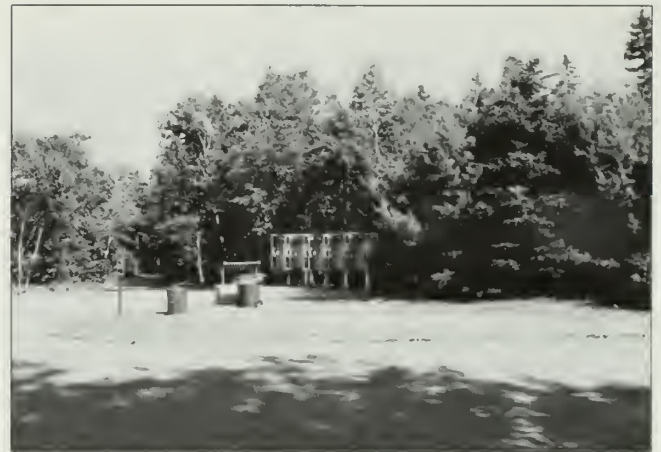
Figure 100: Telephones located at the entrance to Blackwoods loop "A." This site had formerly been the location of a ranger/checking station before it burned in 1978.

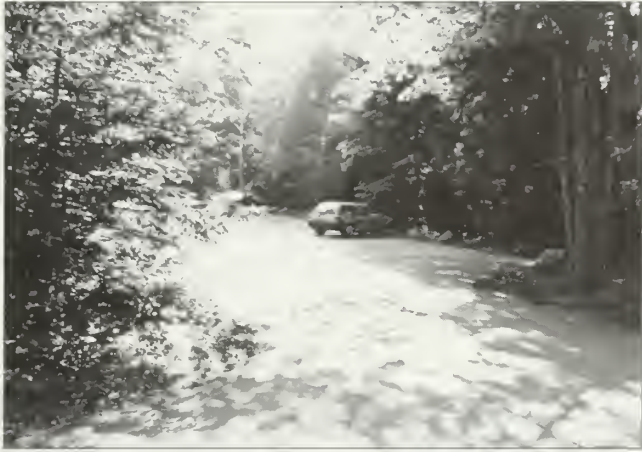
During evening campfire programs and special events at Blackwoods, there is a shortage of parking for those attending the event but not staying overnight at the

campground (Figure 101). Additional amphitheater parking was originally intended at the Blackwoods loop B but was not constructed.

Figure 101: Parking for amphitheater programs and campground overflow, Blackwoods campground loop "A."

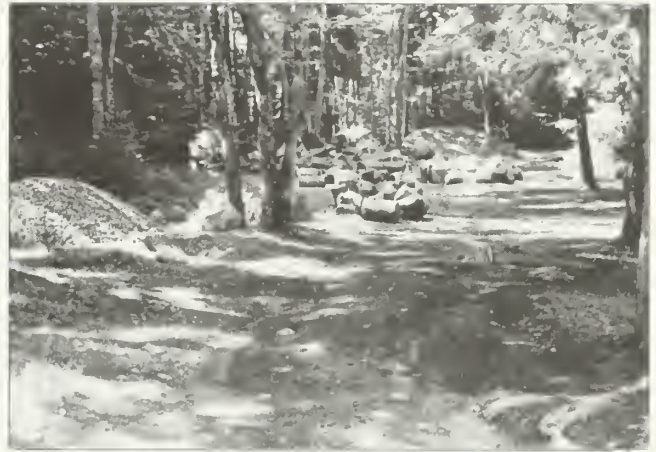
Location and design of fireplace ash and wood disposal yards needs to be re-examined for reasons of aesthetics and environmental protection at both campgrounds (Figure 102).

Figure 102: Wood and fireplace ash disposal area, Blackwoods campground loop "A."

The wood yard/ash disposal areas at both campgrounds are not character-defining features of either landscape. While the current placement of the "wood yard" at both campgrounds has limited impact to the cultural landscape, these service areas would benefit from

the installation of screening vegetation and a method to contain leachate percolating through the wood ashes.

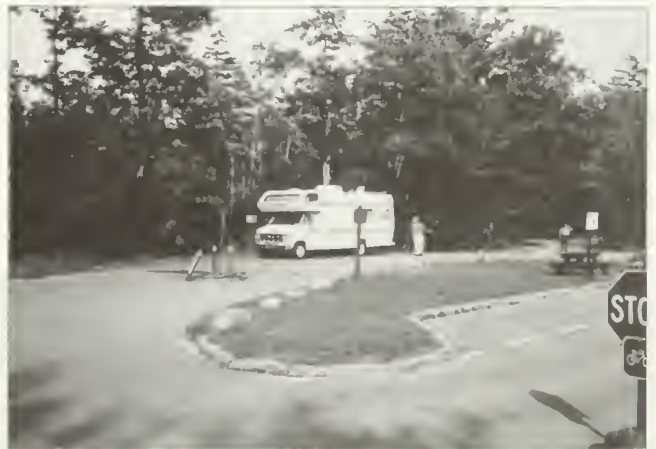
Figure 103: Blackwoods trailer sewage dump station, poorly located at the entrance to the campground.

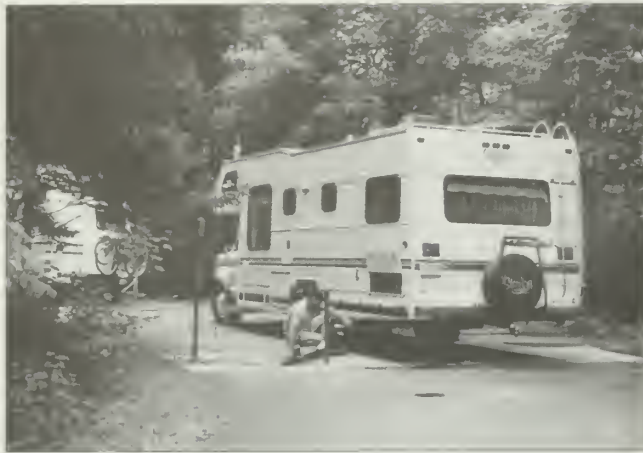
Blackwoods trailer sewage dump station is functionally inadequate and is poorly located in a very prominent location of the campground. The current placement of the dump station contributes to driver confusion within the Blackwoods "camp court." The existing layout of the dump station also makes it difficult to use the dump station and then maneuver a trailer back to the campsite area. Alternately, the Seawall campground trailer dump station is perceived as adequate for current needs and appears to be well located (Figures 103 and 104).

Figure 104: Seawall trailer sewage dump station, well located in a secluded wooded area adjacent to trailer campsites.

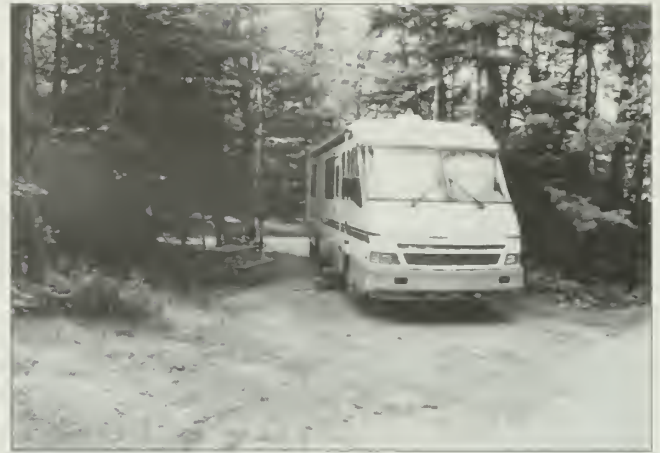
Accessible campsites require both practical and aesthetic improvement (Figure 105 and 106).

Figure 105: Typical accessible campsite, Blackwoods campground loop "A."

It is recommended that existing accessible sites be redesigned. The use of bituminous concrete at these accessible sites creates a difficult transition between hardened and non-hardened surfaces. Alternatives should be developed for accessible campsite surfacing which does not use bituminous concrete. The choice of an alternative hardened surface would permit a larger and more gracious campsite surface without degrading adjacent landscape values.

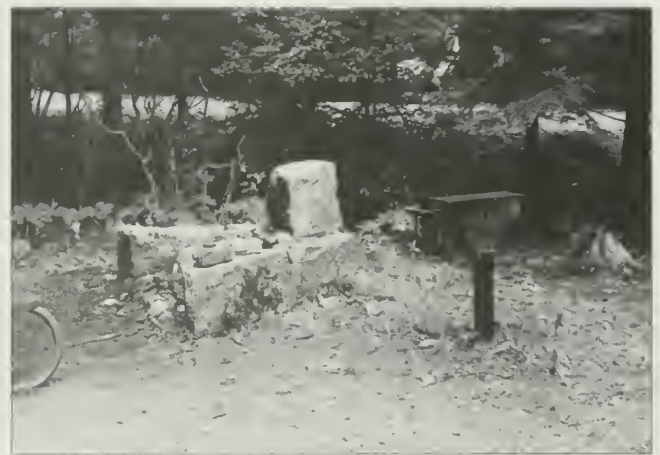
Figure 106: Accessible campsite, Seawall campground loop "A." Accessible grill faces the wrong direction.

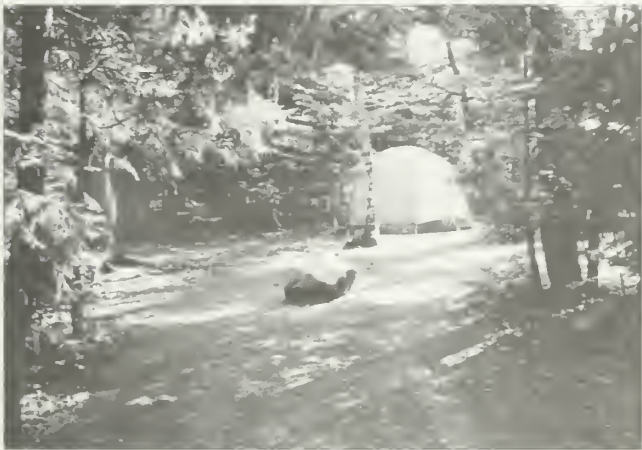
The lack of vehicular barriers along both camp roads and parking spurs has led to degradation of soil conditions, mechanical damage of vegetation and as a result, the loss of well-defined campsites (Figures 107 and 108).

Figure 107: A well-placed boulder serves as vehicular barrier, marking the end of a parking spur.

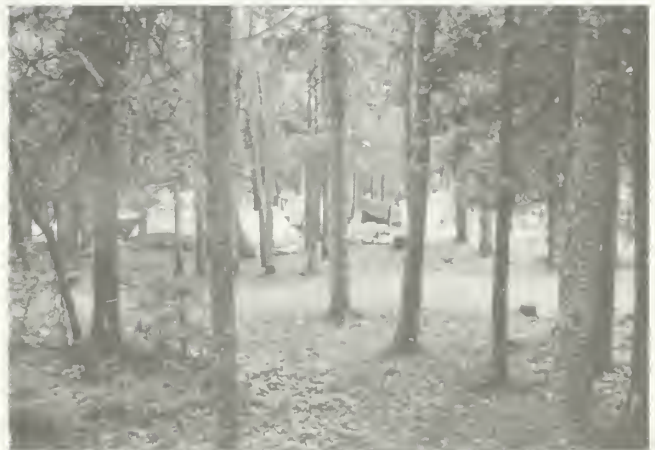
The deterioration of screening vegetation along roadsides and between campsites is perhaps the single greatest threat to the rustic character of both campground landscapes. Forty to fifty years of intense campsite use has degraded the landscape values which people seek in a camping experience. Understory species along the camp roads and at the edges of campsites are most affected due to the compaction by pedestrian and vehicular traffic (Figures 109 and 110).

Figure 109: Understory shrubs and young trees are lacking, resulting in poor screening between campsites, Seawall campground loop "B."

In the course of preparing the historical base map for Blackwoods and Seawall campgrounds, areas were tentatively identified that would benefit from additional vegetative screening. However, the development of site specific planting plans, which is outside the scope of this report, will require collaboration with park natural resource specialists and campground personnel before planting plans can be developed. Using the historic base map for both campgrounds, a detailed review of each campsite with design professionals and park staff is required to develop site-specific planting recommendations. These planting recommendations may involve the complete closure and revegetation of the most degraded sites.

Research Agronomist Jim Patterson of the National Park Service has provided recommendations for both the planting and the care and protection of these plantings once they are designed and installed (Appendix E). Patterson advises that new plantings of small trees and shrubs should be planted in masses so to benefit from “shared rooting space.” These plants should be transplanted so that the root crown is at the same height that it originally grew, and mulched with not more than 4 inches of well seasoned wood chips. If placed near the path of automobiles, these mass plantings should be protected by an installation of vehicular barriers such as boulders. Other plantings may need to be temporarily protected with snow fencing for a number of years until they become established.

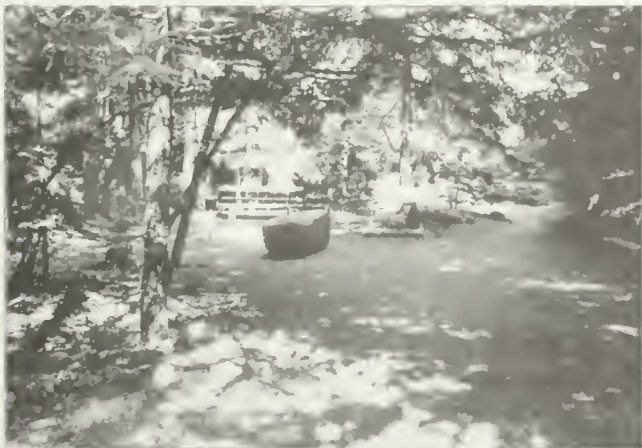
Figure 108: Boulder/barrier appears to have been pushed to one side to accommodate longer recreational vehicles.

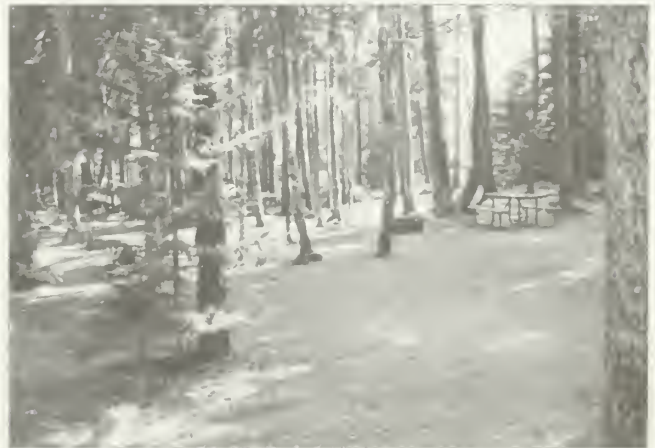
Figure 110: Many areas in Blackwoods campground lack sufficient screening vegetation between campsites, Blackwoods loop "B."

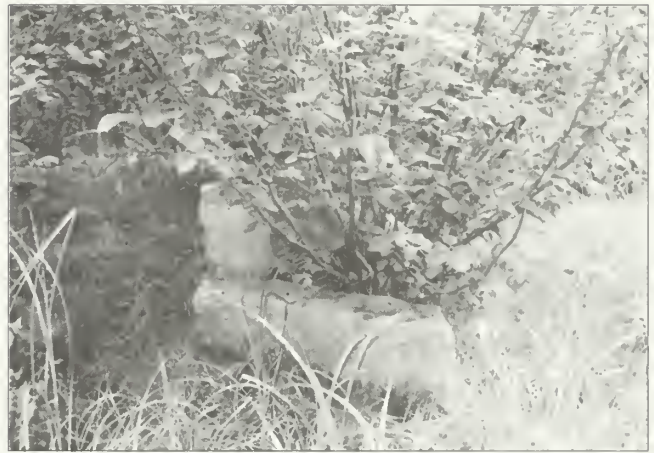
Figure 111: Alder, a small wetland tree species is shown growing out of a stone fireplace in the center of Seawall loop "B." Inadequate or blocked drainage culverts in this area have created boggy conditions.

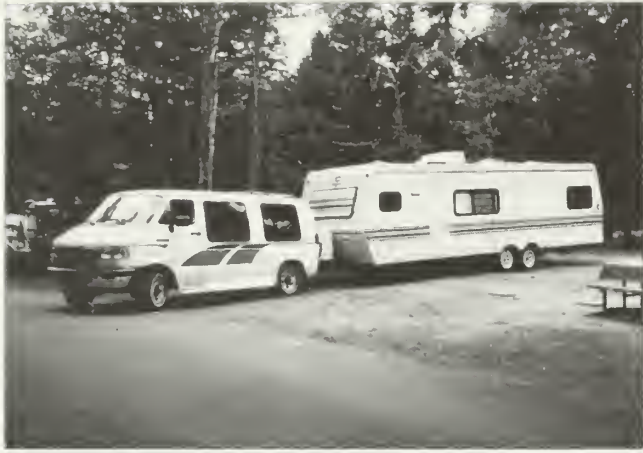
The largest vehicles currently using the campground roads are too big for the campground as originally designed (Figure 112 and 113). Motor homes and the park's trash truck have difficulty maneuvering on the narrow campground roads.

Figure 112: Recreational vehicles have outgrown the historic design of the Seawall loop “C” trailer loop. Limits on the combined maximum size of RV’s and tow vehicles should be enforced.

The narrow width of the Blackwoods and Seawall campsite loop roads defines the character of these roads and also helps to naturally slow traffic, making walking safer for pedestrians. For these reasons, modifications to road width and layout should be minimized within the Blackwoods camp court, loop A, and Seawall loops A, B and C which constitute the majority of the historic landscape at both campgrounds. Modifications to road layout, width and surface in Blackwoods loop B and

pedestrians, and bicyclists creates the potential for conflict. The growing popularity of in-line skates creates yet one more user group. Rather than widen camp roads to suit the ever increasing size of recreational vehicles, the park should set and enforce a reduced maximum size of recreational vehicle that may be permitted in the campgrounds. The GMP states that 35 feet is the maximum size for any combination of vehicle or vehicle with trailer using the campground. However, this upper limit provided by the GMP should not be interpreted as a directive to redesign all campground roads specifically for these large vehicles.

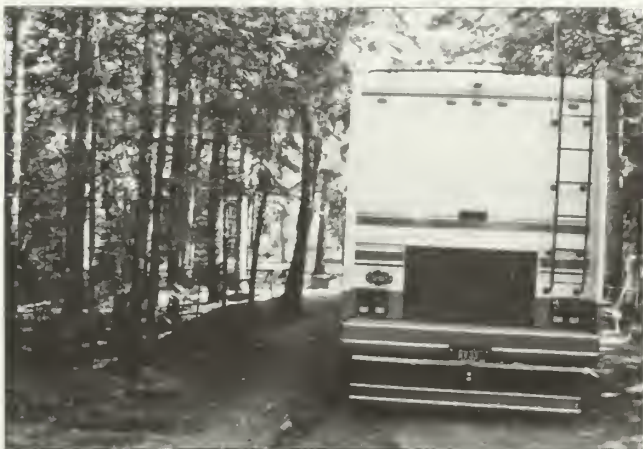
Figure 113: “Link” trailer site in Blackwoods loop “A”. Extremely large recreational vehicles now use this historic part of the campground, originally constructed by the CCC before 1942.

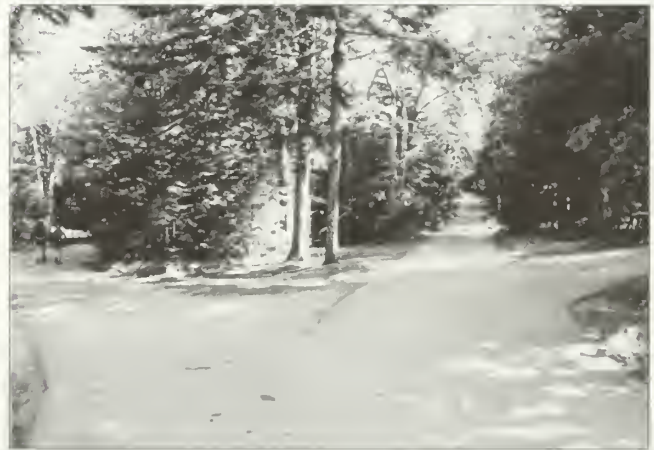
Figure 114: Overall widening campground roads is not recommended, however, minor adjustments to intersections may be accomplished with little impact to the landscape character.

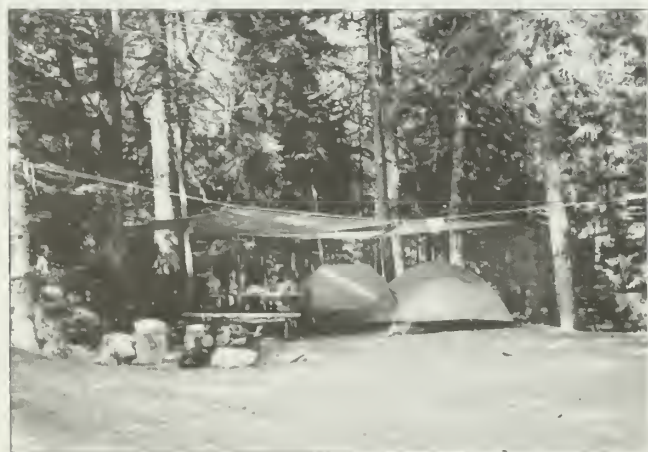
Figure 115: Lack of specificity in the placement of equipment and vehicles promotes the growth of the campsite area through damage to soil and vegetation. As a result this campsite in Blackwoods loop "B" offers little privacy.

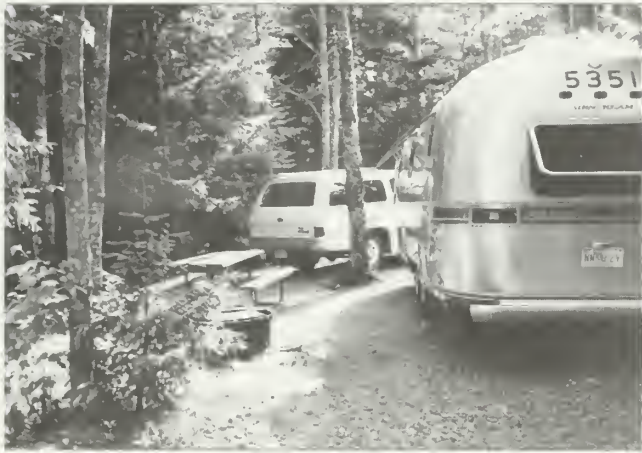
Alternative #3: Another alternative to reversing vehicle direction would be to selectively convert sites suitable for trailer use to “bypass” type sites which would not require the backing of a trailer. Only campsites on the “right-hand” side of a road would be suitable to conversion to bypass sites. To do otherwise would create a situation where the passenger side of the RV/trailer would face the bypass island rather than the usable portion of the campsite (Figure 116).

Figure 116: Many “bypass” trailer campsites are improperly located on the left side of the one-way camp roads. Doing so places the main door of the RV facing the bypass island rather than the campsite.

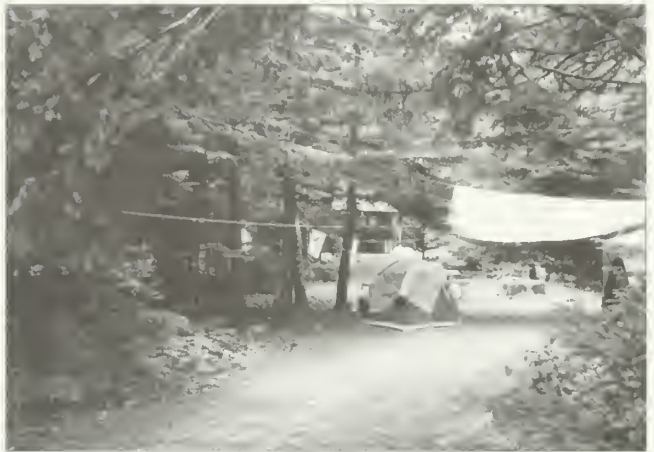
Figure 117: This Seawall loop “A” campsite is poorly located in the direct route of the path to the comfort station, offering little privacy to campers.

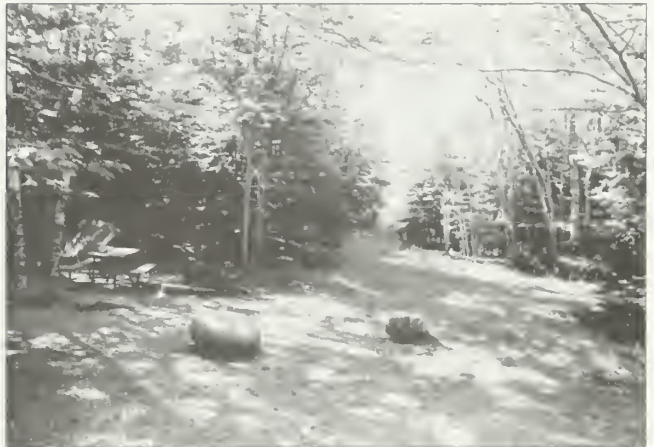
The privacy of many campsites is impaired by the existence of “social” trails which lead from other areas of the campground to facilities such as comfort stations or water taps. In some cases, these trails have been created through campsites by the spontaneous and repeated foot traffic over the years. Other trails have developed in clearings for underground utility lines or abandoned road beds which pre-existed the campground (Figures 117, 118 and 119).

Figure 118: This Blackwoods loop “B” campsite is located next to an underground utility line which has become a “social trail” between lateral roads.

affected by the existence of social trails. Social trails that are to remain should be lined with timber poles or stones and surfaced with well aged wood chips. The installation of additional bituminous surfaces should be avoided.

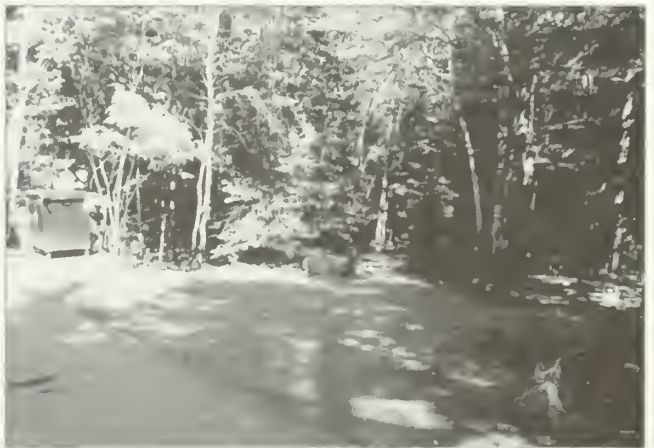
Figure 119: This Blackwoods campsite is poorly located next to the footpath to a comfort station, and refuse dumpster.

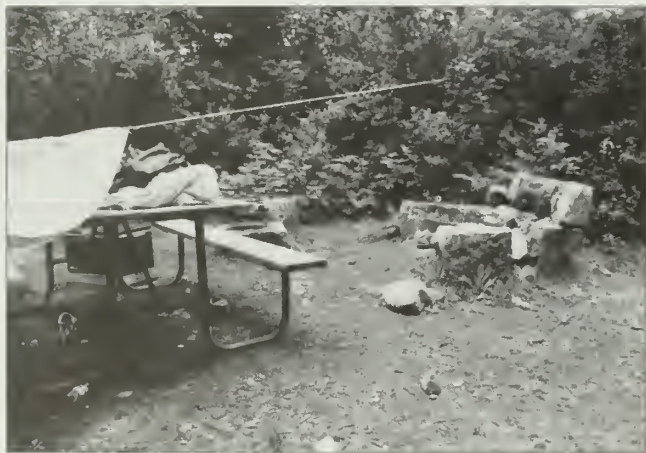
Figure 120: An example of an historic stone fireplace in very poor condition, Seawall campground loop "A".

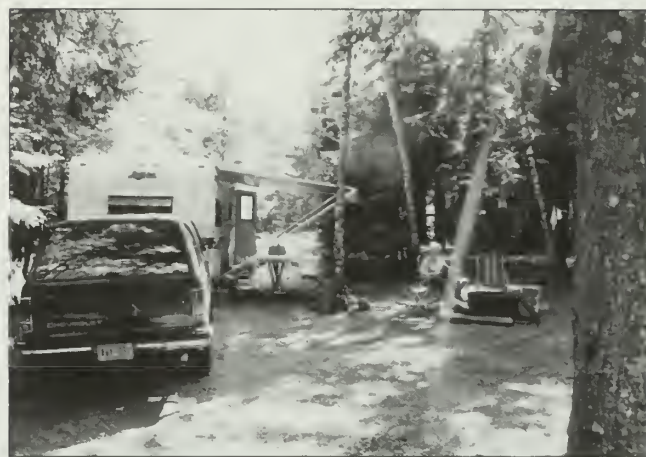
Within the area of "link" trailer campsites in Blackwoods loop A, many of the steel fireplaces currently in use are installed on the driver's side of the parking link. This effectively separates the fireplace from the defined campsite area and picnic table on the

passenger side of the parking link. Trailer and RV campers typically use propane or gasoline stoves for cooking so this is of little practical consequence. However, the illogical placement of the picnic table on one side of the trailer and the fireplace on the other creates a wider area of soil compaction (Figure 121 and 122).

Figure 121: "Link" trailer sites, Blackwoods loop "A." In order for the main door of this trailer to face the fireplace and campsite area, the driver was forced to travel the wrong way on the one-way camp road.

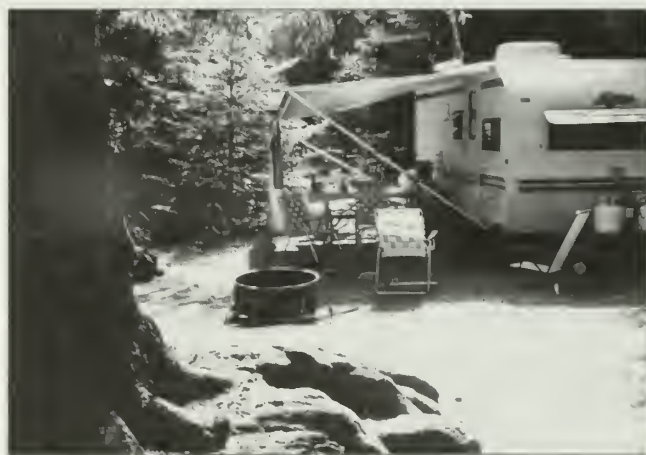
Figure 122: Typical circular steel fireplace, Blackwoods campground.

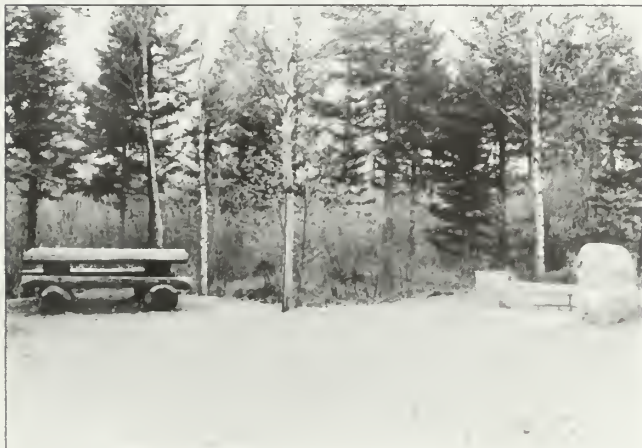
Figure 123: Historic view c.1937-38, Seawall campground. Photo shows one of the types of timber picnic tables used at Acadia National Park's campgrounds and picnic areas during the historic period.

It would be appropriate to recapture the rustic spirit of the original furnishings wherever possible without creating a false sense of history. A variety of design alternatives for picnic tables could be developed within the scope of Package ACAD-232. These alternatives should be consistent with the historic character of the campgrounds, yet easily maintained and distinguishable as contemporary features. The design options explored could include a variety of methods, materials, and finishes. Some alternatives are described here.

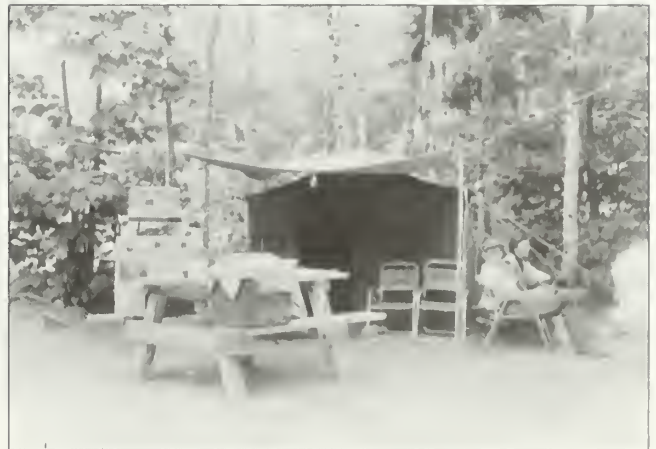
The picnic tables currently in use at the campgrounds are not themselves historically significant. These tables are constructed of bent steel tubing, on to which is fastened wooden boards for table top and bench surfaces. They are unmistakable as modern features and are not particularly rustic. The oldest examples date to the mid-1960, during the tenure of the Job Corps. These "Job Corps" style tables replaced two earlier generations of furnishings. During the 1930's and 40's, the original tables were constructed out of rough hewn timbers (Figure 123). The second generation of tables, installed during the 1950's, was constructed of rough-sawn dimension lumber (Figure 124).

Figure 124: View c. 1950's at Blackwoods campground shows a picnic table constructed of rough-sawn dimension lumber.

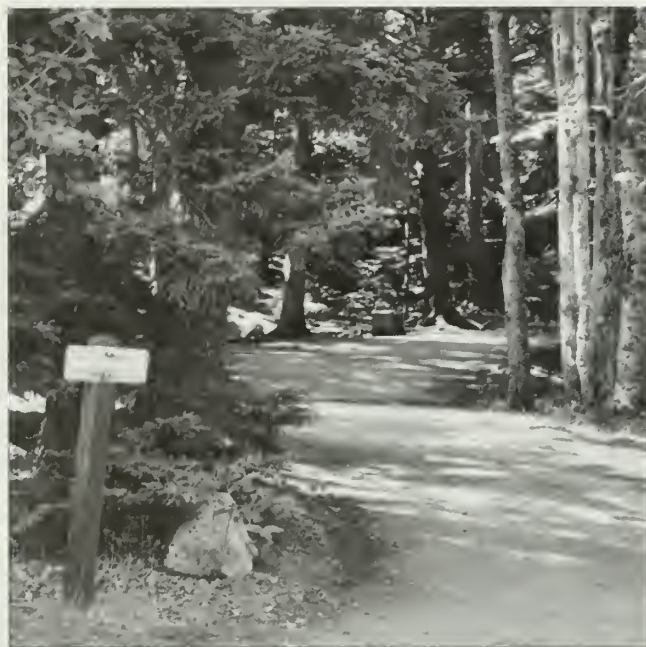
The review of existing miscellaneous signs installed within the campground suggests that many signs are installed too high. Historically, minor signs were unobtrusive due to their low horizontal placement (Figure 125 and 126).

Figure 125: Appropriately sized and placed pedestrian signage, Blackwoods campground.

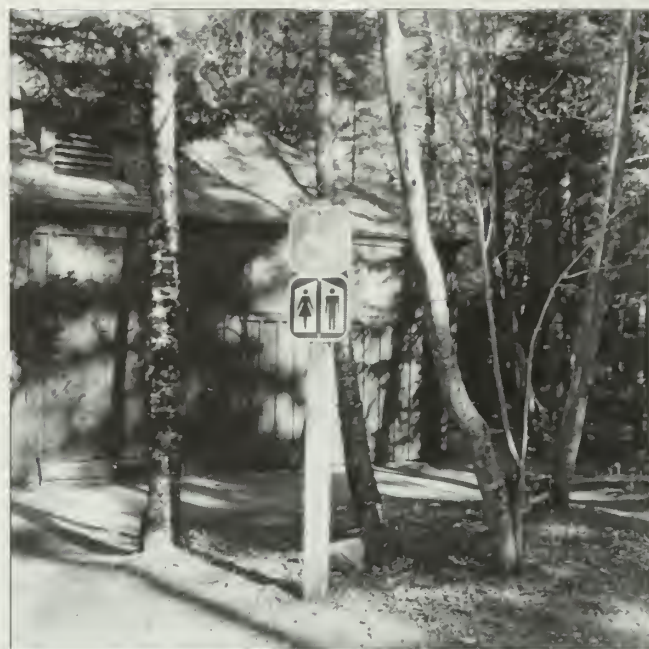
Figure 126: Many small signs are placed too high. As a result, the sign seems out of place in its setting.

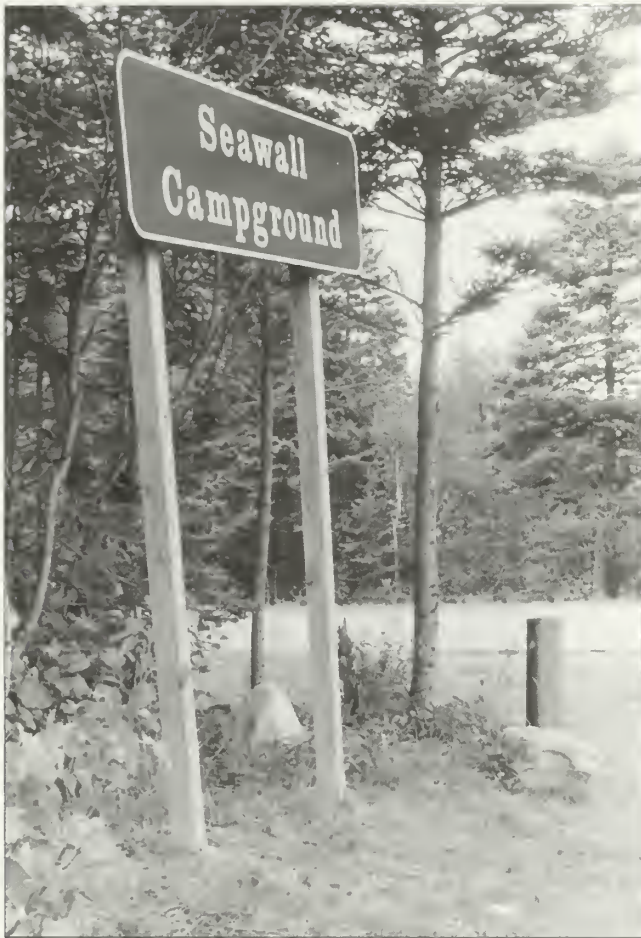
Figure 127: Seawall campground entrance sign. Other than its brown background, little differentiates this kind of sign from state and federal highway signage.

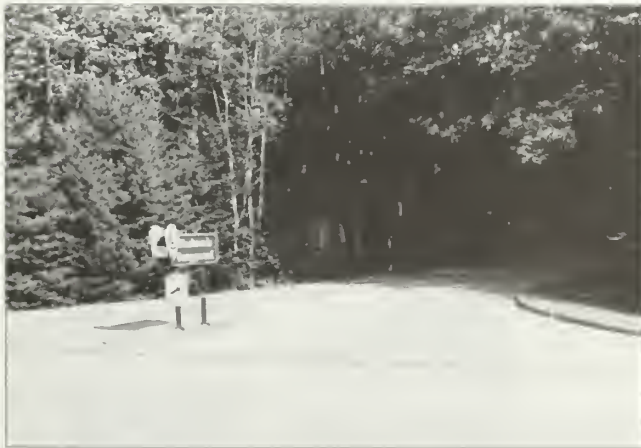
The entrance signs for both campgrounds, as they currently exist, are not compatible with the rustic values of the campgrounds. These signs are typical of the UNICOR signage system used throughout the national park system. Other than white lettering on a brown field, very little differentiates the NPS signage from the green and white reflective signage used on state and federal highways (Figures 127 and 128).

Figure 128: Blackwoods campground entrance sign.

Research conducted thus far has not discovered the historic design of the original campground entrance signs, however examples of other entrance signs at Acadia National Park typical of the period have been documented (Figures 129 and 130). Contemporary

design alternatives for entrance signage should be developed that are in keeping with both the rustic character of the campgrounds and consistent with a park wide signage plan.

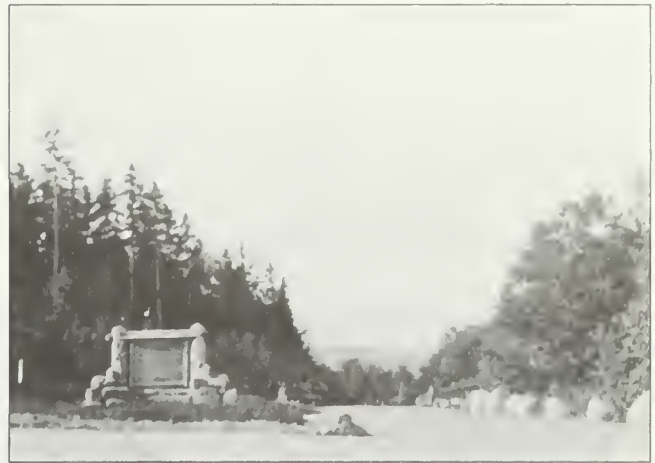
Figure 129: Example of typical rustic entrance sign of the 1933-1942 historic period, Cadillac Mountain Road.

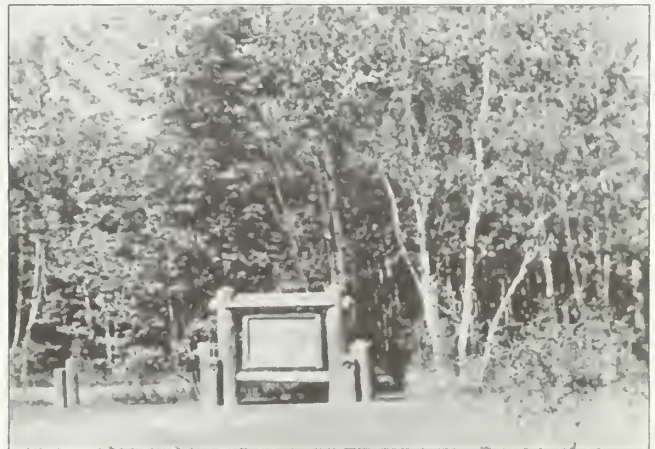
Figure 130: Example of typical rustic entrance sign of the 1933-1942 historic period, location unknown.
