# CULTURAL LANDSCAPE REPORT FOR BLACKWOODS AND SEAWALL CAMPGROUNDS ACADIA NATIONAL PARK

History, Existing Conditions, Analysis  
& Treatment Recommendations

CULTURAL LANDSCAPE PUBLICATION NO. 11

September 1996

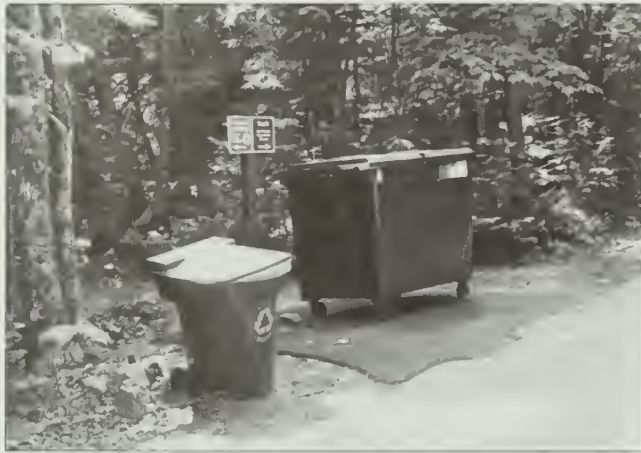
Dumpster pads constructed of bituminous concrete are too soft to bear the weight of the dumpsters and are damaged. Dumpster casters have sunk into the surface of the pads, making the units difficult to move (Figure 131).

Figure 131: Typical contemporary dumpster installation, Blackwoods campground.

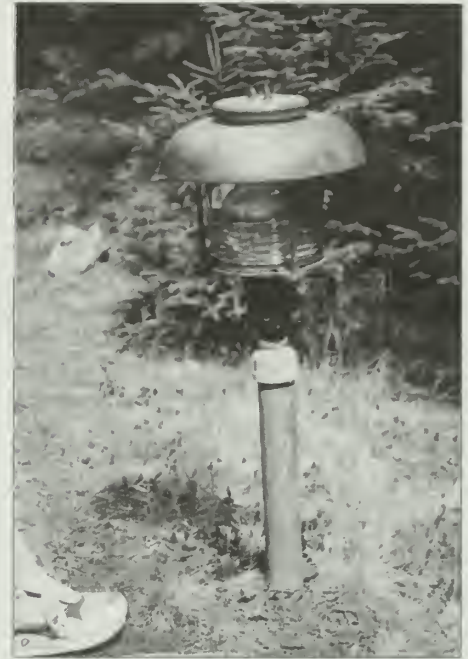
outdoor lighting in the campsite loops. Area lighting at the amphitheaters is inconsistent with the rustic values elsewhere in the campgrounds (Figures 132, 133 and 134).

Figure 132: An appropriate, low-placed path light leading to the Seawall amphitheater, constructed 1961. The style and fresnel lens used in these fixtures may indicate their salvage from the former Seawall Naval Radio Station.

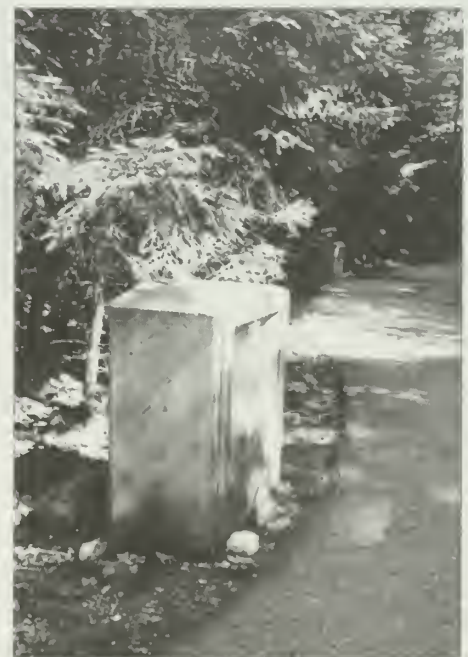
Figure 133: A contemporary low concrete path light appropriately used at both Seawall and Blackwoods amphitheaters.

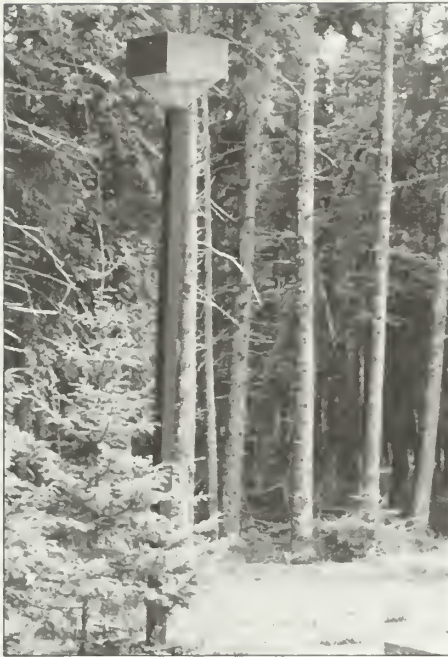
Figure 134: Inappropriate urban style light fixture used at the Seawall amphitheater.

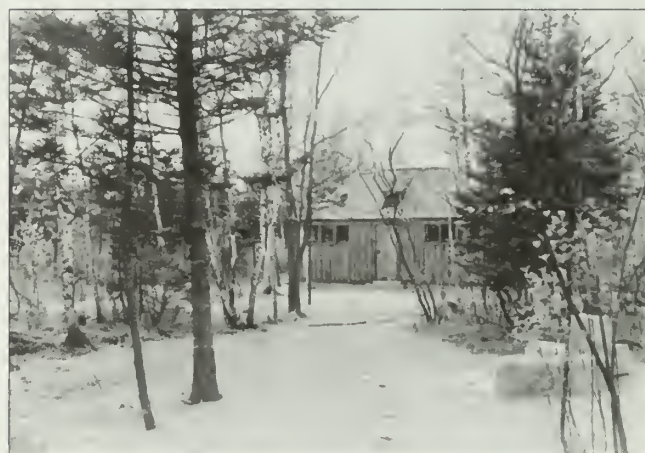
The return to a stain finish for the comfort station buildings is consistent with research findings and the rustic character of the campgrounds. A stain finish would allow the wood siding to breathe and more easily adjust to fluctuations in temperature and humidity. This would mean greater longevity for the surface and reduce maintenance costs. However, while the use of stain appears in the historical record, research conducted thus far has not determined the historic color of this stain. Historic black and white photography indicates that the buildings were tinted with a dark pigment. If portions of original siding or other exterior woodwork can be located, it may be possible to determine the exact tint by using paint analysis procedures (Figures 135 and 136).

Figure 135: Historic view c.1937 of a comfort station in Seawall loop "A." Photo clearly shows the absence of any highly pigmented stain or paint. However, the photo may be construction documentation prior to the final finish.

comfort stations. A semi-transparent gray stain is more appropriate for buildings in a relatively open area or very close to the seashore. The choice of a brown semi-transparent stain would help the comfort stations blend into the darker wooded settings of Blackwoods and Seawall campgrounds.

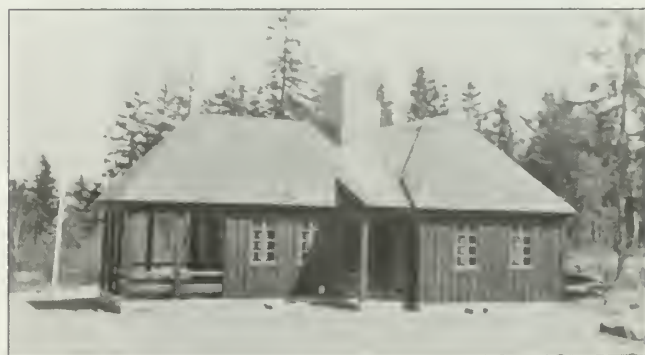
Figure 136: Construction photograph c.1942. This photo shows the former Blackwoods checking station obviously given a dark colored final finish.

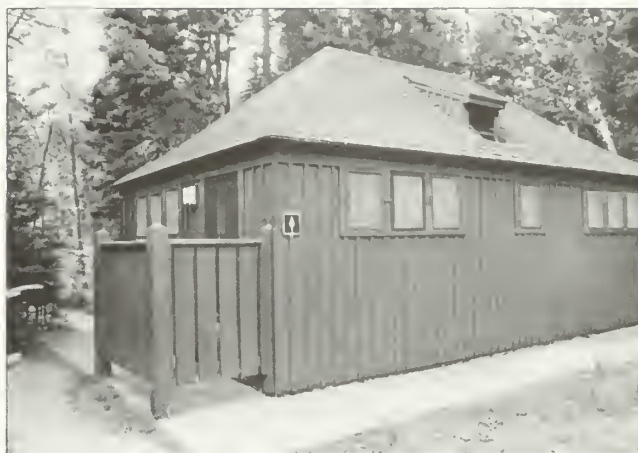
Privacy screens for historic comfort stations featured vertical boards with small "V" notches in their sides that created a diamond pattern. These screens stood away from entrance doors, reaching into the landscape. Repairs over the life of the campgrounds in many instances have removed this original design pattern from the comfort station privacy screens (Figure 137).

Figure 137: Historic comfort station at Seawall campground showing its privacy screen lacking the historic diamond pattern.

Original design drawings for historic comfort stations should be consulted and missing privacy screens should be replaced. The application of this detail to contemporary comfort stations is not appropriate (Figure 138).

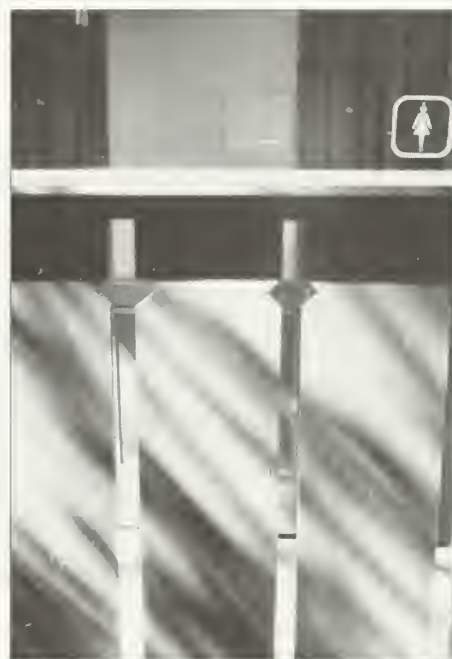
Figure 138: A renovation during the 1980's inappropriately introduced historic details into this contemporary Loop B comfort station.

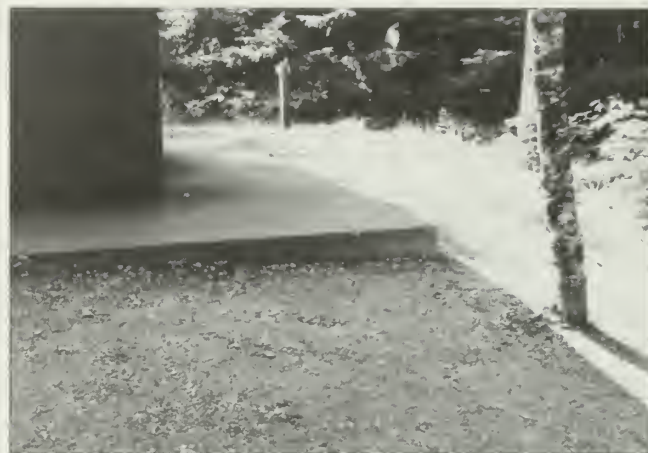
Figure 139: Typical small step near the entrance to many historic and contemporary comfort stations. Accessibility modifications to historic buildings and placement of accessible campsites needs to be thoughtfully considered.

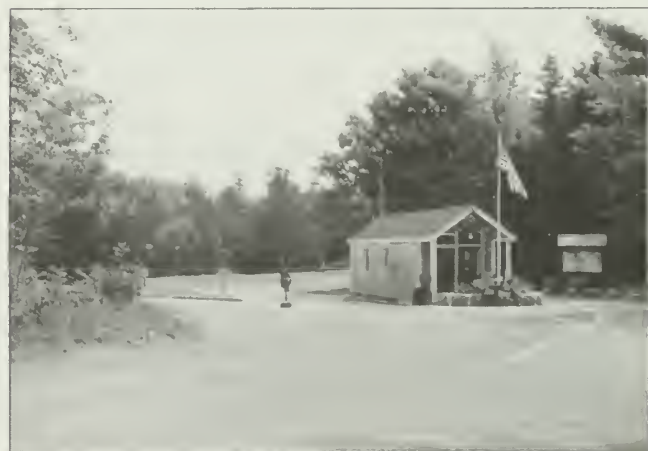
Figure 140: Blackwoods checking station, constructed 1975. Plans to redesign the circulation at the northern end of the "camp court," may require moving or modifying this building.

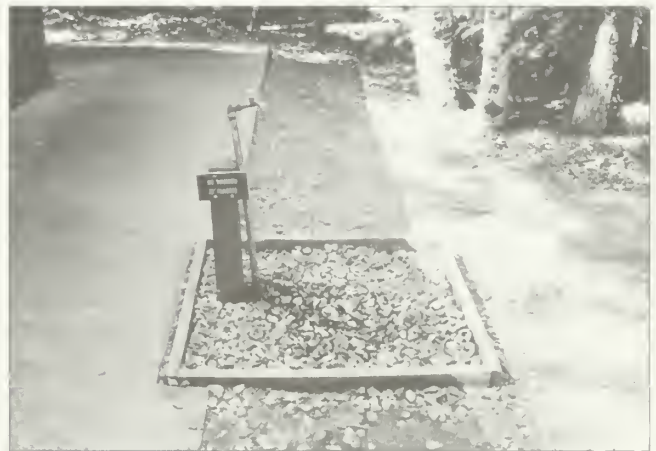
Figure 141: The sign on this water supply tap reads: "No Washing At Faucets," an indicator of an operational/public safety issue at both campgrounds.

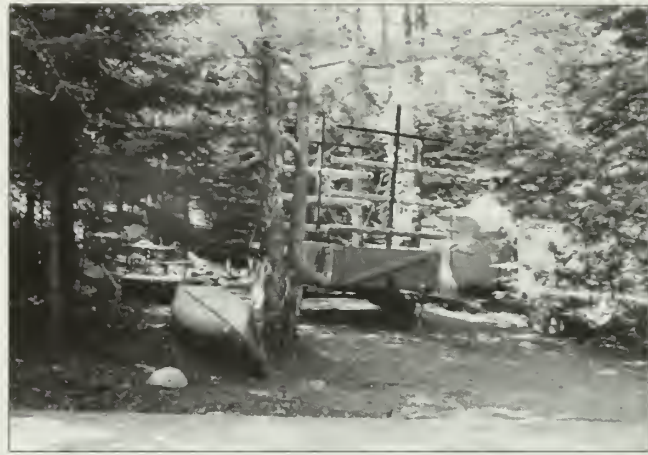
Figure 142: Campsites were not designed to accommodate this much equipment. Blackwoods loop “B.”

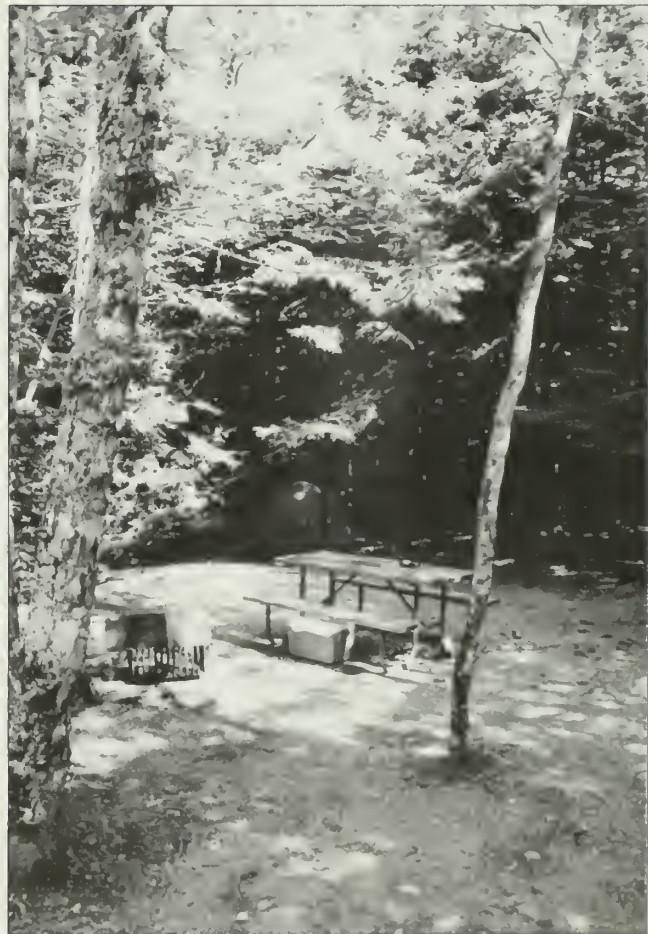
Many existing campground rules need to be adequately enforced. These rules apply to resource protection and to the safe and efficient operation of the campground. Examples of this are limits to one vehicle per campsite, erecting tents outside the defined campsite area, quiet hours and even pet leash rules (Figures 142 and 143).

Figure 143: This campsite appears unoccupied, however, a tent has been pitched in the shadowy wooded area nearby. This practice promotes destruction of adjacent vegetation and widens the campsite area.

infractions that will occur. This program, and the thinking behind it, should be developed and shared with all employees involved with the campgrounds, not just enforcement personnel.

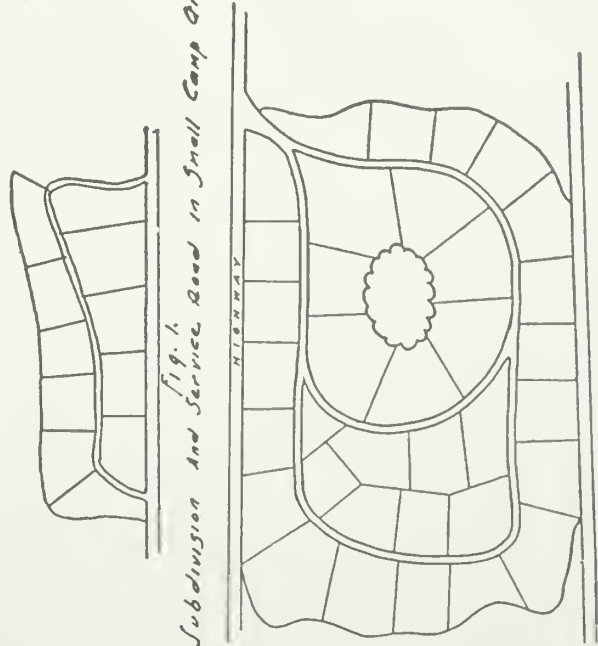
The best utilization of the whole camp ground is secured by a one-way road which is lined on both sides by campsites. In the simplest case, that of a relatively narrow strip, the road leads through its middle, serving lots on either side. On larger grounds the road may swing back at the end to serve another single or double tier, parallel to the first. In broader camp grounds of rectangular or square outline connecting roads break up the area into smaller units, each laid out in individual lots. These connecting roads run back into the main road at such an angle that the driver is forced to continue in the one direction, and large rocks or other obstacles are placed so that he will not attempt to turn against the one-way travel. (Figures 1 and 2 give examples of subdivisions and road systems.) The distance between two par-

*Fig. 1.*  
*Subdivision And Service Road in Small Camp Ground.*

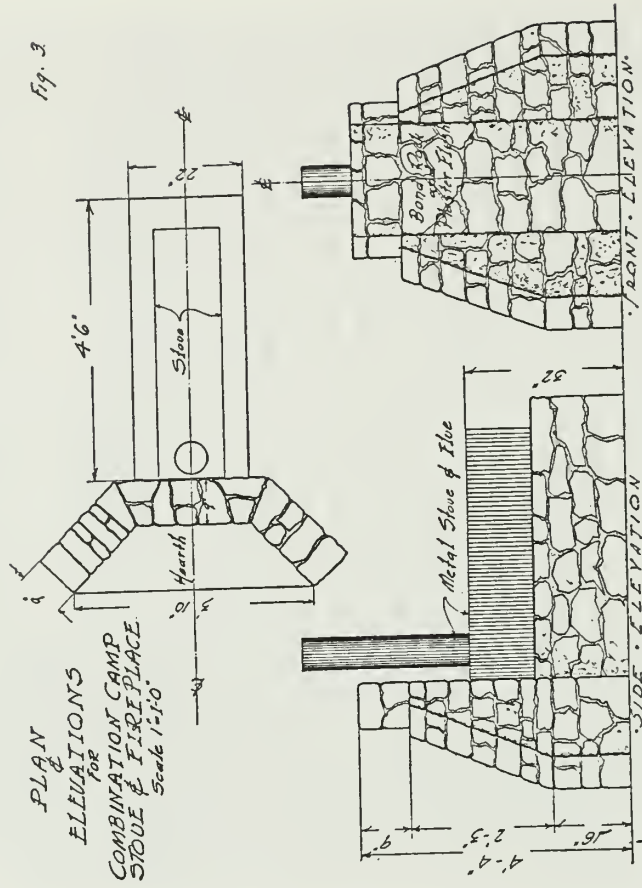
Fig. 3

the angle of camp protection. In large camp grounds it is undoubtedly preferable to provide a central community campfire, so located in an open space that no danger to trees and shrubs is to be feared. There will still be a number of campers, especially in small camp grounds, who prefer the privacy of their own campfire. Under no circumstances should they be allowed to build a fire on a place of their own choosing. The best solution of the problem may be to build, onto the stovepipe end of the foundation, a small fireplace with short, sloping wings and raised back for better draught, made of re-enforced concrete or, preferably, of rocks. (Fig. 3.) Concrete easily cracks

and disintegrates in winter frosts and also from the intense heat of the fire. Old-fashioned mortar may be preferable when the use of fireclay entails too great an expense. If the orientation of the cook stove with regard to the evening winds is such that the smoke from the suggested type of fireplace makes its use inconvenient, a variant may be employed in which the opening of the fireplace is at an angle of 45 degrees to the length axis of the stove. This fireplace is a simple rectangle, one side of which is formed by the narrow side of the cook stove foundation, while the other is a prolongation of one of its long sides. (Fig. 4.)

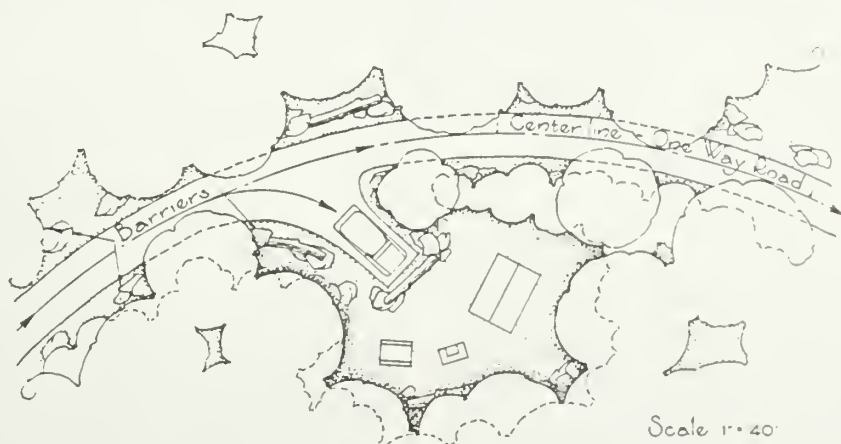
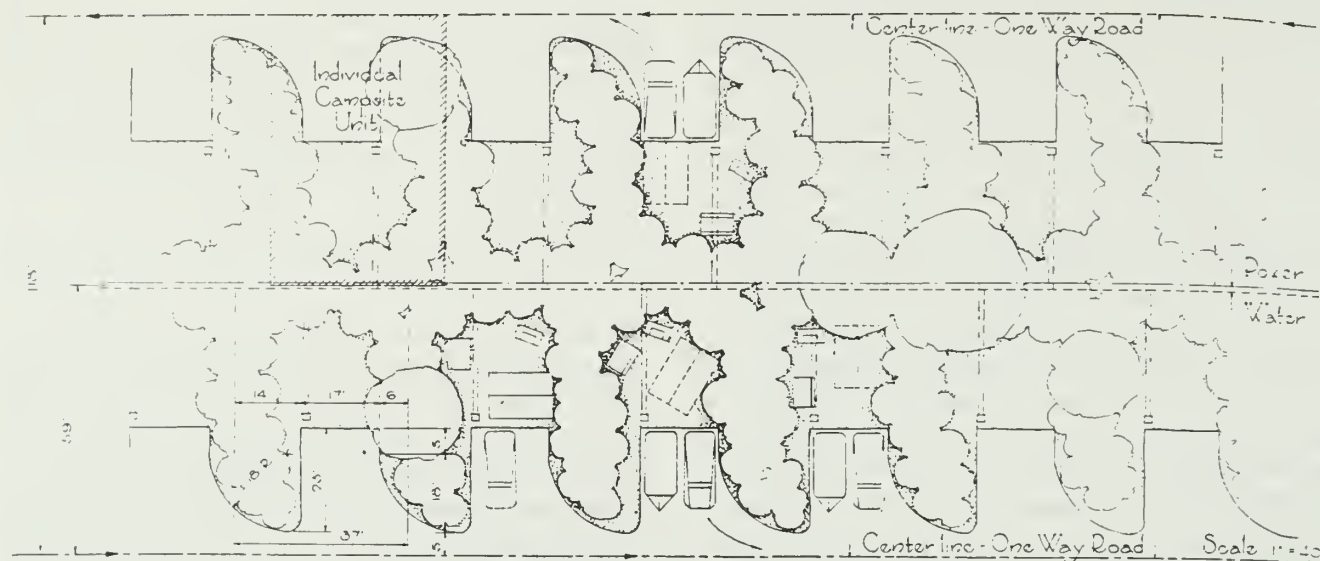
Immediately below is a lay-out illustrative of the lack of receptiveness to tow-car-and-trailer characteristic of the typical tent campsite—a dangerously awkward condition which, in the lay-outs presented by the plates following, it has been sought to avoid.

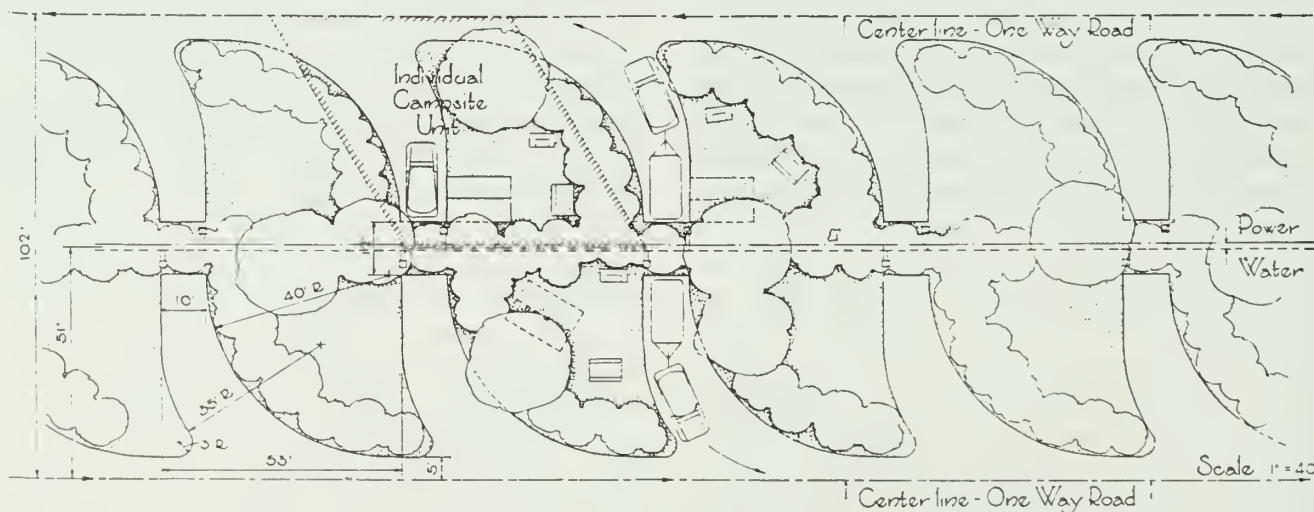
TRAILER CAMPSITE UNIT A (Area per unit—2,183 square feet including half of roadway. Approximate road surface per unit including spur—80 square yards. Campsites per acre—approximately 20).

In this compact spur type unit the tow car and the trailer are parked side by side. The type is shown adapted to the left side of a one-way road which permits the right hand side of the trailer (normally the door side) to face the open area. A campground might be laid out to utilize both sides of a

one-way road by combining this type on the left and types such as C or D on the right. Unit A might also be adapted to the right side of a road, by interchanging the parking berths of the tow car and the trailer. In that case a less compact spacing will make for easier maneuvering of the vehicles.

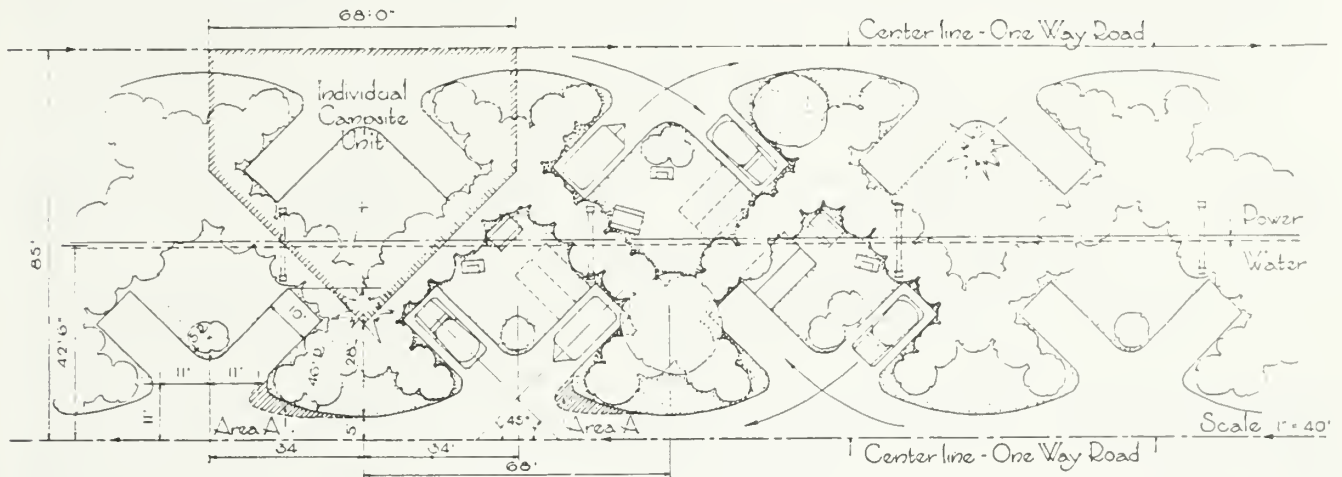
TRAILER CAMPSITE UNIT B (Area per unit—2,703 square feet including half of roadway. Approximate road surface per unit including spur—106 square yards. Campsites per acre—approximately 16).

In this spur type of unit the trailer is backed into its parking place and the tow car is parked in front of it. As shown, adapted to the left side of a one-way road, the right hand side of the trailer faces the camp clearing. The unit is con-

vertible to the right side of a one-way road and the door will still front on the open area, if the cleared campsite is rearranged to be on the opposite side of the spur. Combinations with other types of units for variety are, of course, many.

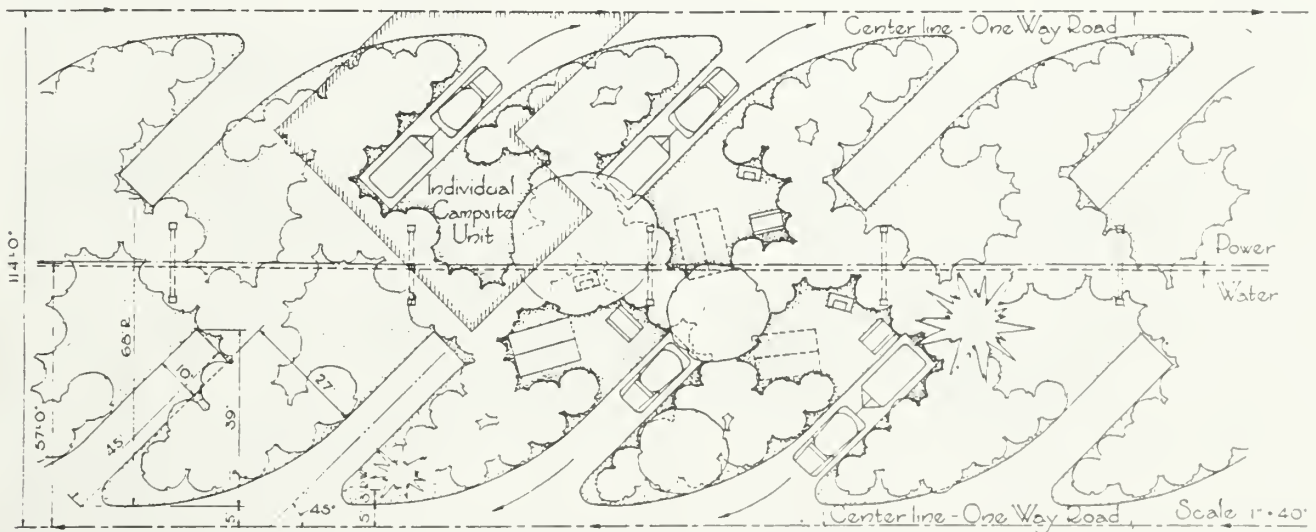
TRAILER CAMPSITE UNIT C (Area per unit—2,890 square feet including half of roadway. Approximate road surface per unit including spur—130 square yards. Campsites per acre—approximately 15).

This unit offers separate parking spurs for the tow car and the trailer in an arrangement that makes for a hemmed-in privacy. As shown above, it occurs on the right side of a one-way camp road, yet it might be used on both sides of a two-way road of suitable width and still desirably allow the

normal door side of the trailer to face the camp clearing. C units can also be laid out along a one-way road in combination with the strictly left hand types. The adaptability of this unit is considerable. Parking of the tow car can be negotiated without the shaded area "A" being surfaced as a road.

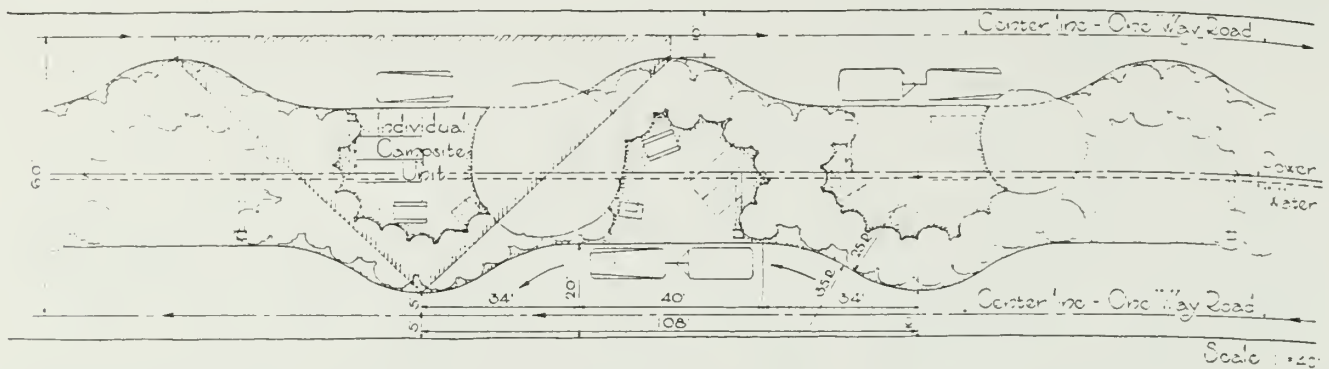
TRAILER CAMPSITE UNIT D (Area per unit—3,076 square feet including half of roadway. Approximate road surface per unit including spur—118 square yards. Campsites per acre—approximately 14).

A type of spur parking site, in which the trailer may be readily backed into its fixed parking berth with space between it and the roadway for parking the tow car, as in type B. Although, as shown above, these units are only on the right side of the one-way roads, it will be apparent that they might at the

same time be repeated on the left side of these same roads, subject only to an entirely feasible rearrangement of the cleared areas to front on the right hand side (normally the door side) of the trailer in its parked position. Several lay-outs combining this and other unit types are possible.

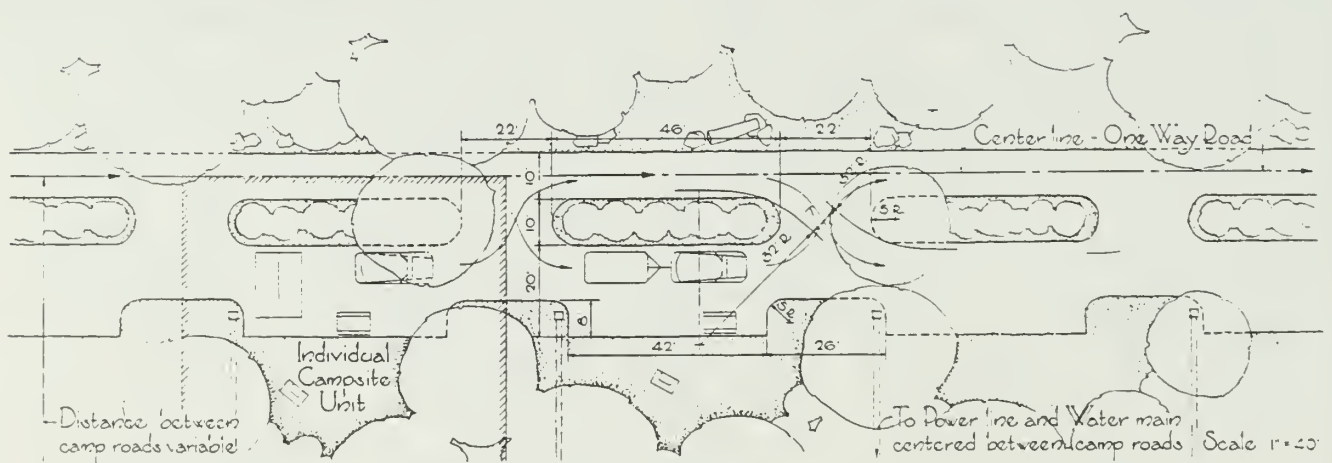
TRAILER CAMPSITE UNIT E (Area per unit—3,240 square feet including half of roadway. Approximate road surface per unit including bypass—130 square yards. Campsites per acre—approximately 14).

This simplest and most space-conserving of all campsite units based on bypass parking of the tow-car-and-trailer is merely a defined widening of a camp road so that the two vehicles can be parked off the traveled roadway. Where consideration is properly given to the normal right hand door of trailers, this unit lends itself only to locations on the

right side of a one-way road. The drawing above is so arranged. In one-way road systems, combinations with other left hand types are possible. Adjacent to two-way roads, E units are usable on both sides without sacrifice of the desirable feature of the right hand trailer door facing the campsite clearing.

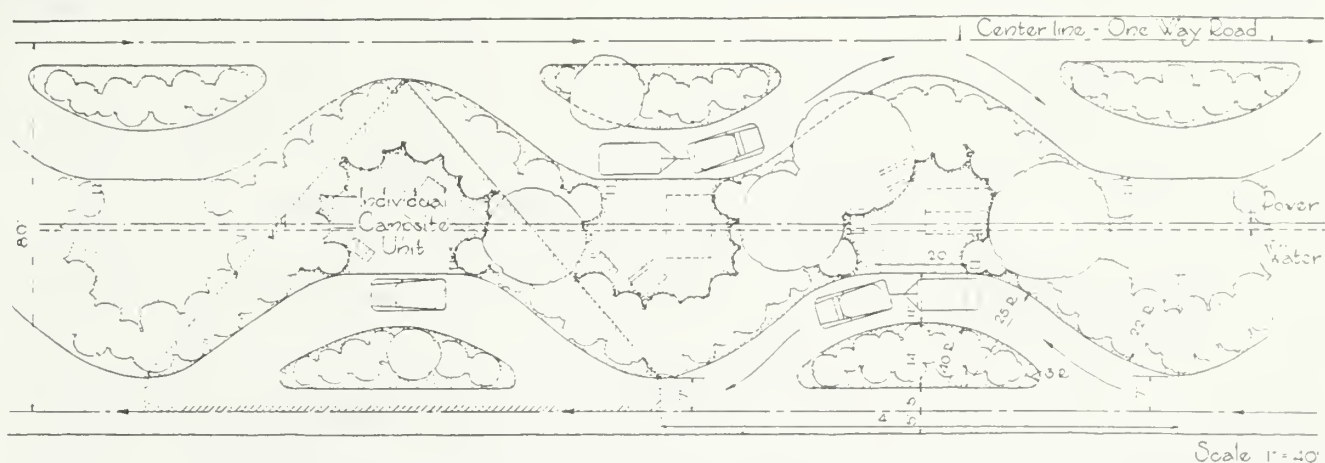
TRAILER CAMPSITE UNIT F (Area per unit, assuming depth of 60 feet—4,080 square feet including half of roadway. Approximate road surface per unit including bypass—190 square yards. Campsites per acre—approximately 11).

This bypass unit employs a formal island to separate the bypass parking space from the traveled roadway. As above drawn, the units are laid out along the right side only of a one-way road. There is no apparent reason why these units could not be ranged also

along the left side of a one-way road. The surfaced bypass of considerable width allows leeway for parking the trailer so that its right hand door need not be blocked when the bypass is thus entered. Obviously, F units are usable on both sides of a two-way road.

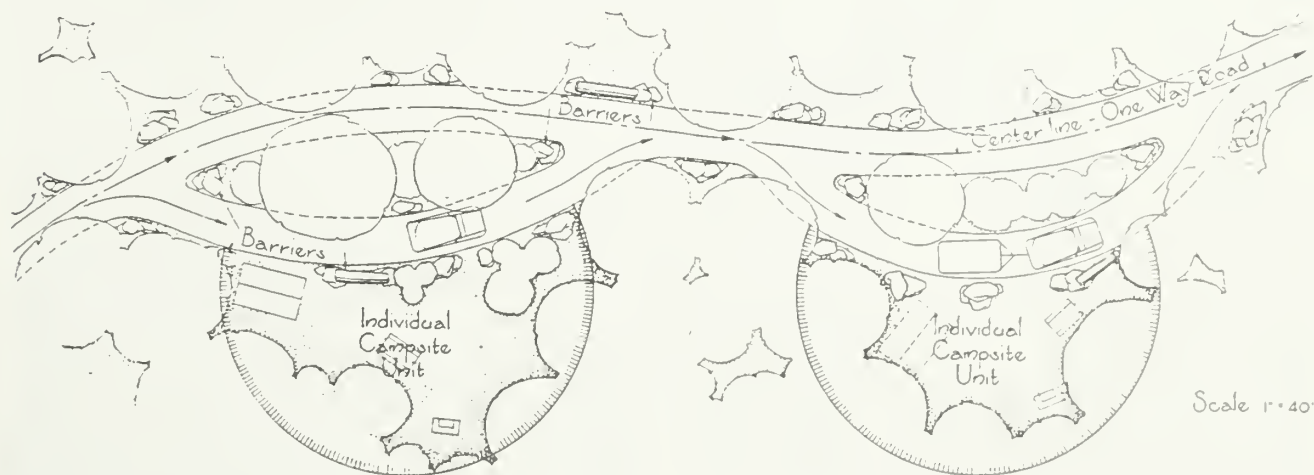
TRAILER CAMPSITE UNIT G (Area per unit—1,500 feet including half of roadway. Approximate road surface per unit including bypass—183 square yards. Campsites per acre—approximately 10).

Here again an island separates the bypass parking lane serving the individual campsite from the traveled roadway. These units, if the more customary right hand trailer door is to be served, are only usable on the right side of a one-way road; therefore, if campsites on both sides of a one-

way road are projected, some more adaptable unit is better chosen for the left side. Naturally, if a two-way road system is projected, G units are well-suited to both sides of the roads. With all units shown on these facing pages, backing is unnecessary in berthing either tow car or trailer.

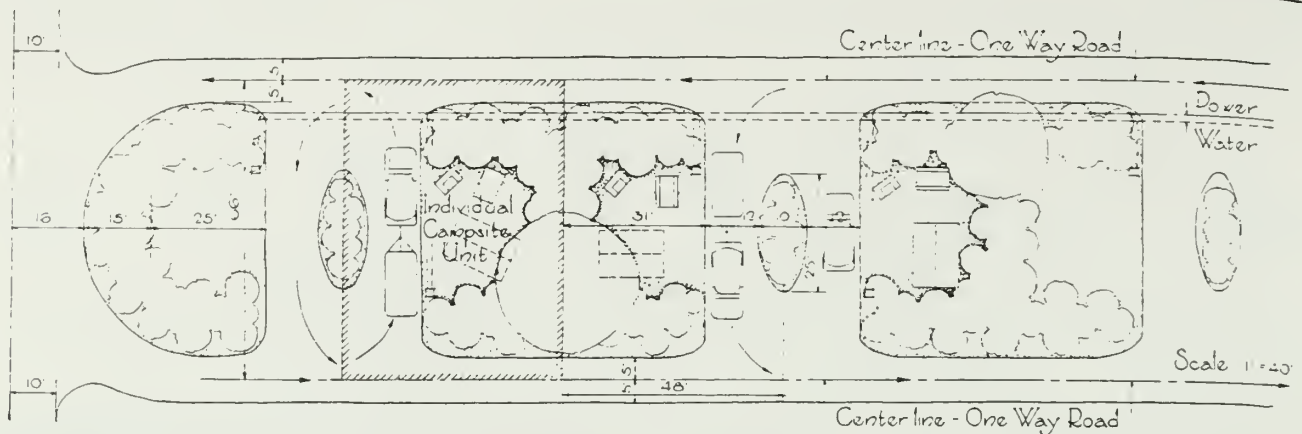
TRAILER CAMPSITE UNIT H (Statistics of campsite units such as these are indeterminate, because space allocation, road surface area per unit, and the number of campsites per acre are governed entirely by natural factors individual to site).

This bypass unit is obviously a development of unit G along less formal lines, approached not with a determination to produce the maximum number of campsites per acre, but instead with the triple objective of (1) suiting an irregular topography, (2) sparing existing desirable natural features, and (3) gaining greater privacy for each campsite. The roadway curves to follow natural

contours; spacing and naturalized barriers acknowledge, preserve, and protect natural features of site deemed of value; and retained cover and wider, varied spacing of units add to the privacy of individual campsites. Although only well-suited to the right side of a one-way road, and so shown above, these informal units are adaptable to both sides of two-way roads.

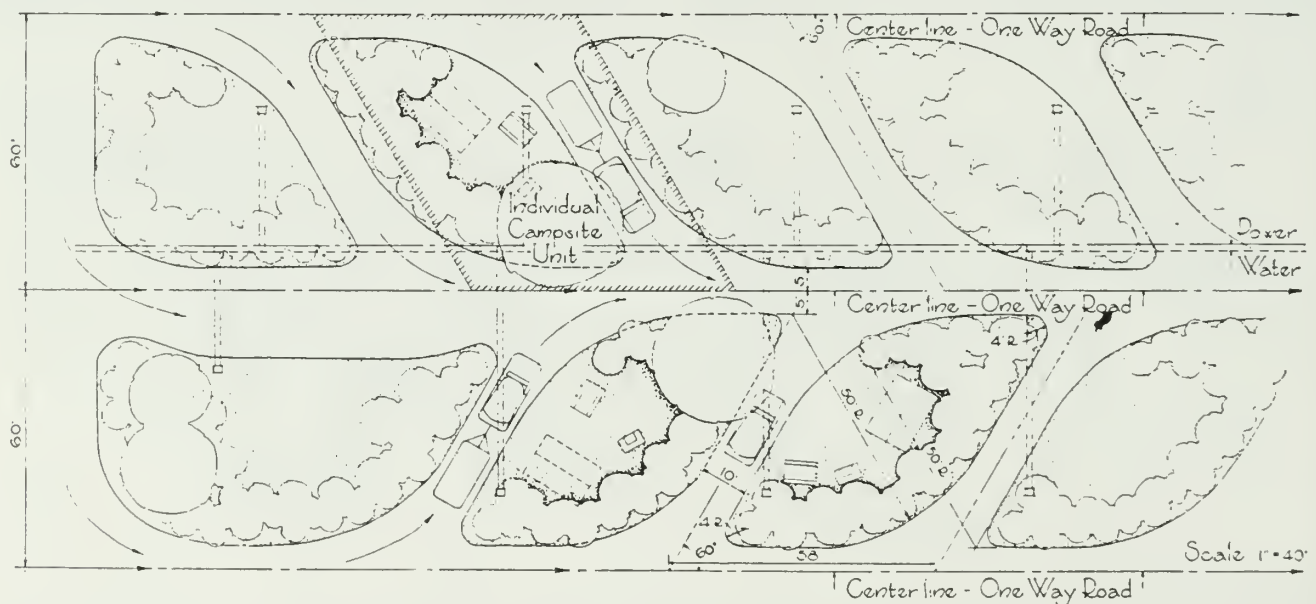
TRAILER CAMPSITE UNIT I (Area per unit—3,168 square feet including half of roadway. Approximate road surface per unit including link—160 square yards. Campsites per acre—approximately 14).

As usual, a lay-out along one-way roads is shown in the above delineation of this most compact of the link-lane types of parking here presented. Use of this particular unit in any two-way road system is to be discouraged, for every entrance

into and exit from a parking link requires a left turn, crossing an opposing traffic lane. An ingenious and space-conserving unit, but combinations with other types will wisely be limited to the utilization of a right hand unit along a one-way road.

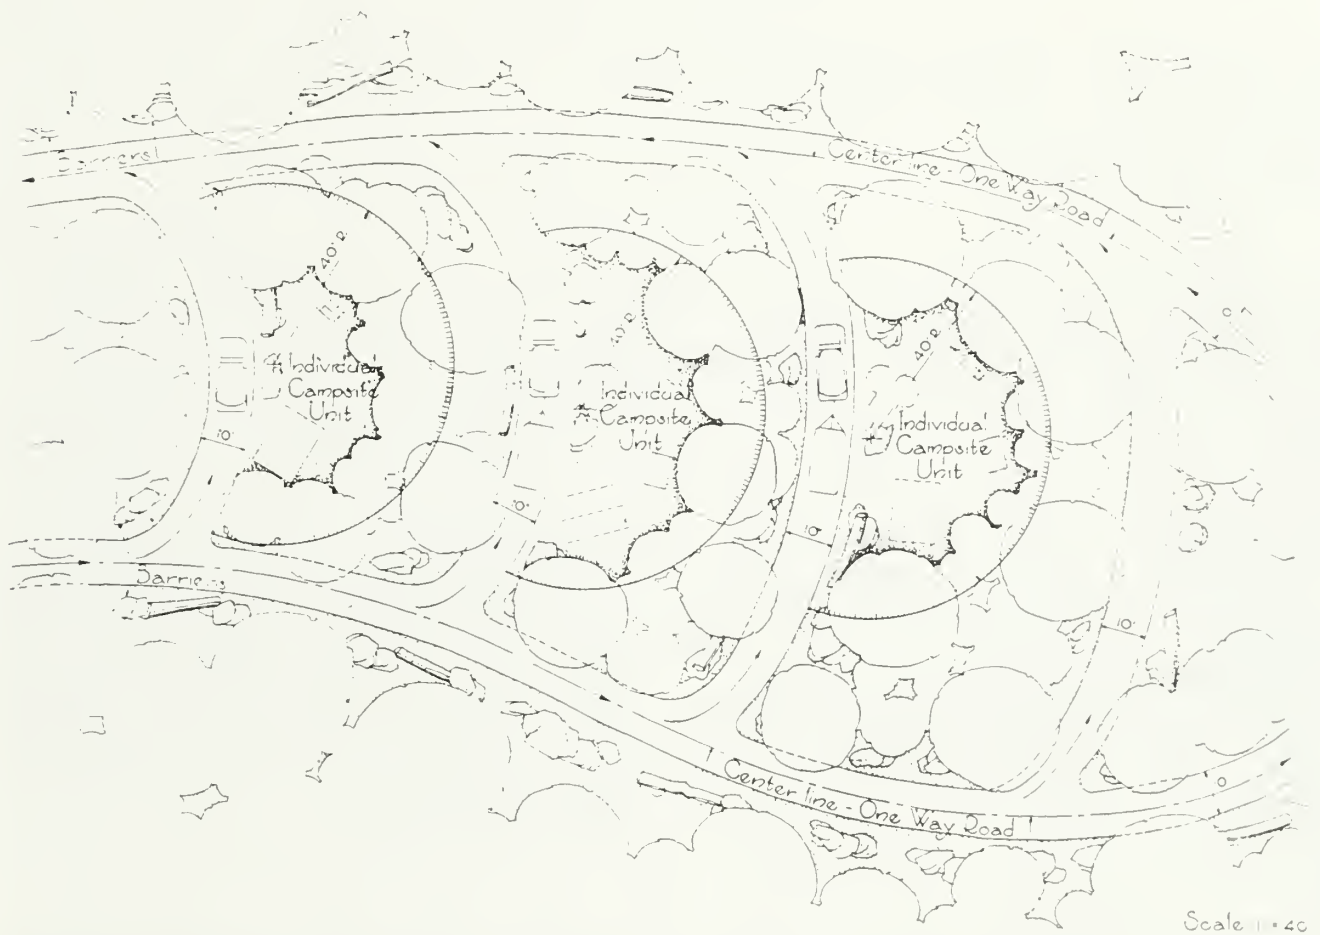
TRAILER CAMPSITE UNIT J (Area per unit—3,480 square feet including half of roadway. Approximate road surface per unit including link—163 square yards. Campsites per acre—approximately 12).

That link lanes for parking are desirably confined to campground lay-outs employing one-way roads exclusively is proved again by this example. The fact that traffic of all roads in the arrangement above shown is in one direction suggests that the best possible utilization of this scheme would be a large-scale adaptation in which the one-way roads

serve as links between the entrance and exit stretches of a main camp road that loops around the entire campground development. The parking lanes would constitute links between links, so to say, and the result would be one-way traffic throughout the campground and traffic hazards at a minimum.

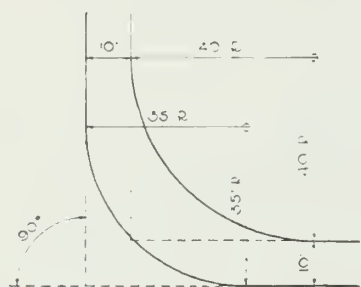
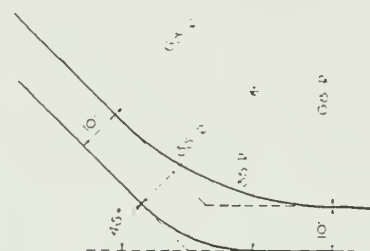
Minimum turning radii for Car  
and Trailer - One Way Road

The diagrams above show the development of turning radii for tow-car-and-trailer which have governed a number of the campsite lay-outs of the preceding pages.

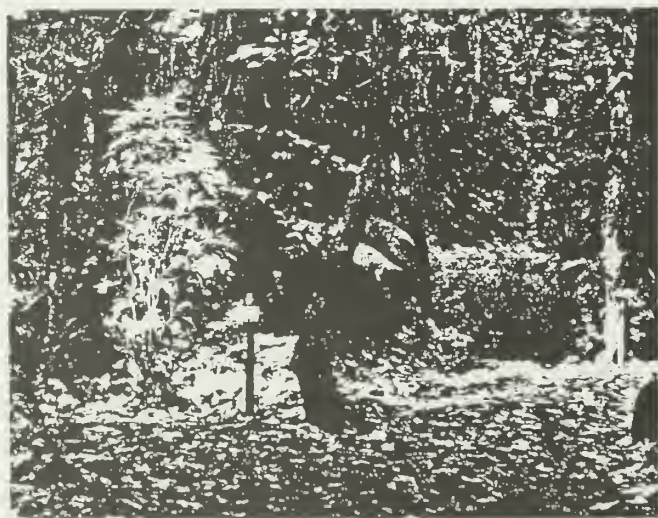
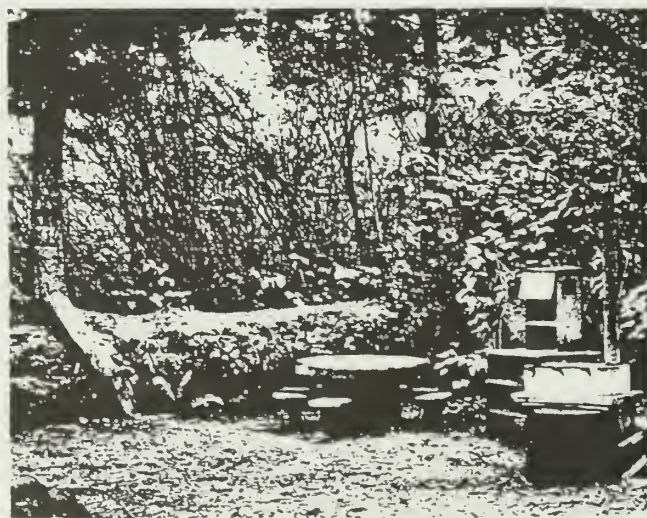
The illustrations below indicate the sort of low growth and ground cover which must extend through trailer campgrounds to screen individual campsites if the illusion of privacy is to obtain.

Although both picture the superlative undergrowth found in the redwood forests of the Pacific slope, something approaching the density and varied height of these is possible in many other sections of the country if encouraged by barriers of such effectual size that they will prevent the destructive movement of vehicles and by unremitting replanting and care.
