Cultural Landscape Report for Morro Bay State Park Campground

CULTURAL LANDSCAPE REPORT FOR MORRO BAY STATE PARK CAMPGROUND

By John W. Hammond Historical Landscape Architect

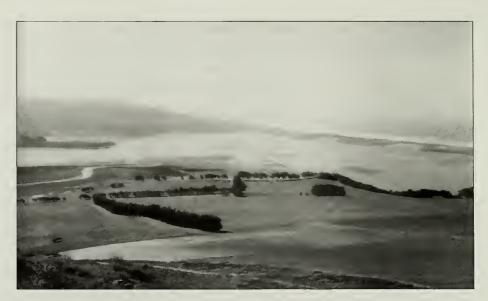
Figure 5. View from Black Hill looking south toward the bay with the eucalyptus windrows planted by John Schneider in the 1880s, c. 1925. (Castle and Ream, *Images of America: Morro Bay*, 2006.)

One of the residents that contributed to the planting of the eucalyptus trees in Morro Bay was John Schneider, a bachelor farmer and eldest son of German immigrant Mathias Schneider. In the 1880s, Schneider was farming hay on the small peninsula south of town, which he was leasing from R. E. Jack, one of the prominent ranchers of San Luis Obispo County (Figure 4). One of the agreements of the lease of the property was that Schneider plant and maintain large numbers of eucalyptus tree seedlings. Mr. Jack provided the trees, and Schneider planted them along the shore of the bay and in long hedgerows that established some protection from the wind (Figure 5).9

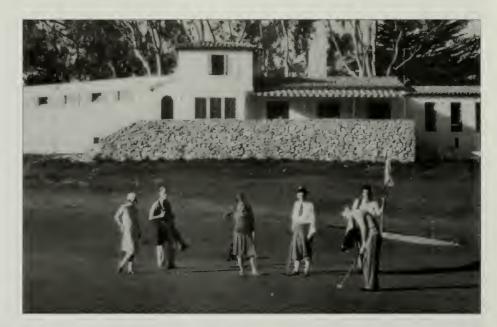
Figure 11. Golfers putt on the ninth hole of the golf course at the Cabrillo Country Club with the clubhouse and rubble stone retaining wall in the background, c. 1930. (Gates and Bailey, Morro Bay's Yesterdays, 198.)

earlier plans in a number of ways. The nine hole golf course was laid out on the western edge of the property, instead of occupying the southeast portion of the land as was indicated by the Olmsted plan. The clubhouse was constructed on the north side of the rocky outcrop that comprised White Point, again in contrast to previous plans that located the clubhouse in the eucalyptus hedgerow to the north. Stables were placed in a eucalyptus grove just north of the clubhouse, and bridle trails wound through the hedgerows. The envisioned hotel, pool, tennis courts, and other recreational facilities were not constructed (Figures 11 and 12).

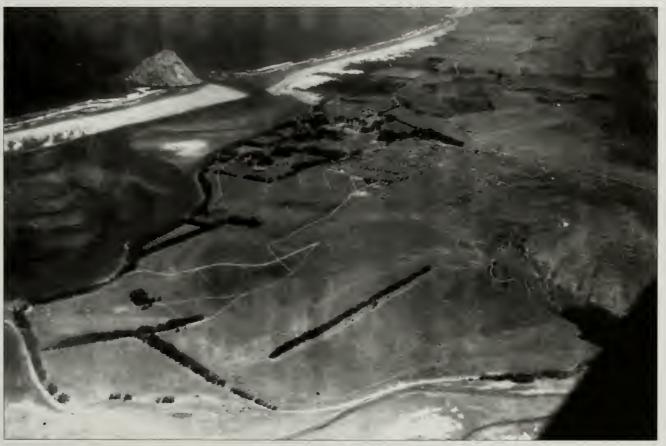
Figure 13. Aerial view of the Cabrillo Country Club, c. 1933. The clubhouse and golf course are visible on the left side of the photo. Also prominent are the eucalyptus windrows and the roads coming into the property form the housing developments to the north. Black Hill is visible on the right side of the photo. (Castle and Ream, Images of America: Morro Bay, 2006.)

The main circulation routes into and within the property appear to have been carried over from what was in place before development of the country club (Figure 13). The main entrance to the property, and the main connection to the town of Morro Bay, was from the north through Morro Bay Vista Tract #1. This entrance road was a continuation of Kings Avenue, which passed through the Morro Bay Vista tract and the Morro Heights development before entering the property. To the west of Black Hill, the road forked leading to the eucalyptus grove that served as the public campground and to White Point and the clubhouse. A second entrance road also came from the north through Morro Bay Vista Tract #3, an extension of Kern Avenue. On the east side of the property, a road followed the edge of the wetland area around the peninsula to exit at Osos Road (today South Bay Boulevard). Other circulation routes within the property were informal truck or bridle trails.

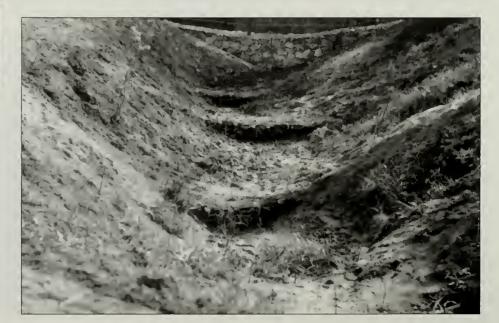
Figure 15. View of stone-lined spillway in Chorro Creek, 1934. Flood and erosion control also included the construction of stone and earth dams and the channelization of Chorro Creek. (NARA, RG79.)

In 1934, Chorro Willows was a boggy flood plain choked with vines and willow thickets and prone to flooding. While it was recognized as a potentially charming location for a campground, flood and erosion control would be needed to take advantage of the site. Reclamation of the area for use as a campground involved the construction of check dams in the creek and on side gullies to slow the flow of water and reduce debris and sedimentation. CCC crews constructed dams in the west channel of Chorro Creek to direct all of the flow of the creek to the east channel. Some of the dams and spillways were built of stone and concrete, with hard channel walls and bed. Dams in the small canyons and side hills were less formal, consisting of wattles of woven willow branches anchored by timber posts placed at regular intervals in the narrow drainages (Figures 15 and 16).

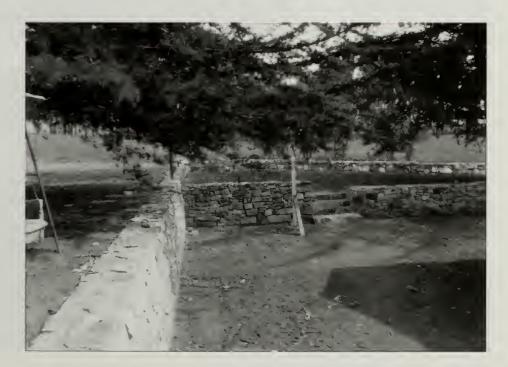
Figure 17. View of the stone retaining walls and steps around the Warden's Cottage, 1935. (NARA, RG79.)

The eucalyptus grove that had been serving as a public campground featured a number of makeshift cabins for visitor use. The CCC moved five of these cabins from the campground and remodeled them to create a cottage for the park warden. Regrading around the new Warden's Cottage required the construction of a retaining wall. The wall was built of stone with stone steps and extended around three sides of the cottage (Figure 17).

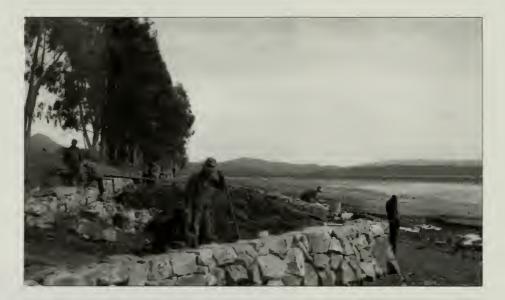
Figure 18. View of construction of the retaining walls at the beachfront picnic area, 1935. (NARA, RG79.)

The first major visitor amenity the CCC constructed in Morro Bay State Park was the picnic area on the waterfront east of White Point (Figure 18). The project included several sections of stone retaining wall, steps, cook stoves, and picnic tables. Stone used in the construction, a roughly stratified sandstone of cream and rust coloring, was quarried from a rock outcrop on the eastern slope of Black

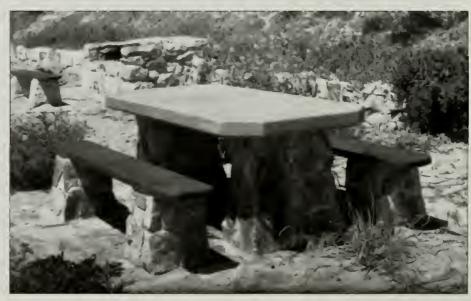
Figure 19. View of one of the picnic table designs constructed at the beach-front picnic area, 1935. The table featured a stone base with a rectangular concrete top and wooden seats. (NARA, RG79.)

Hill within the park (see Drawing 2). A total of five picnic units were constructed, each with a cook stove and one or two stone picnic tables, a retaining wall beneath the road bank, a sea wall, and steps up to the road. Tables were of two designs, a traditional rectangular table with two benches, and an octagonal table with eight pedestal seats around it (Figures 19 and 20). Both types featured a concrete table top and bench seats with stone bases. The workmanship of the picnic features was complimented repeatedly in project inspection and progress reports. The picnic area soon became a popular place for visitors to enjoy the park, views, and the proximity to the bird sanctuary in the adjacent tide lands.

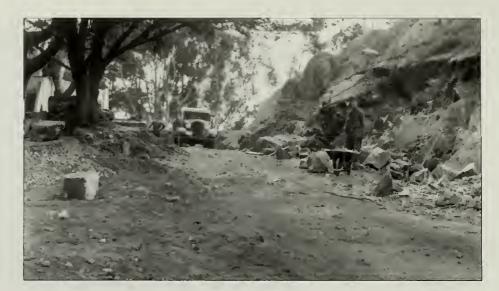
Figure 21. View of construction of the drive and parking lot on the south side of the clubhouse, 1935. (NARA, RG79.)

Work at the clubhouse area at White Point included improvements to the approach drive and new parking areas along the south side of the building (Figure 21). A considerable amount of stonework was completed in support of this project, including retaining walls, guard walls, curbing, and new stairs and walls on the north side of the building. The grade of the drive was lowered to improve the approach, and three parking areas were constructed to accommodate a total of twenty cars. Low masonry walls bordered the road and retained parking areas, and a guard wall was constructed above the steep slope down to the beach on the southeast side. As part of this project, a short flight of steps was created on the bluff behind the clubhouse, providing pedestrian access to the top of the hill on the point. Hewn directly into the native rock, the steps, described upon their completion as "a very unusual and beautiful feature," were likely a bit of novelty showcasing the stonecraft of the workers (Figure 22).

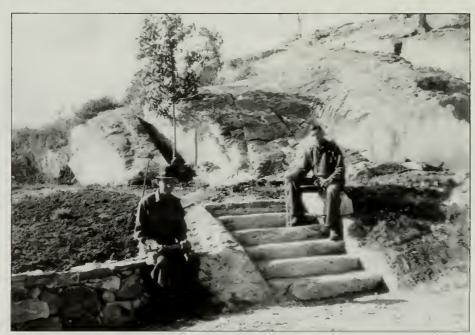
Figure 22. View of the stone retaining walls (seen in the left foreground) and steps carved out of a cleft in the rock in the clubhouse parking area, south of the clubhouse, 1935. (NARA, RG79.)

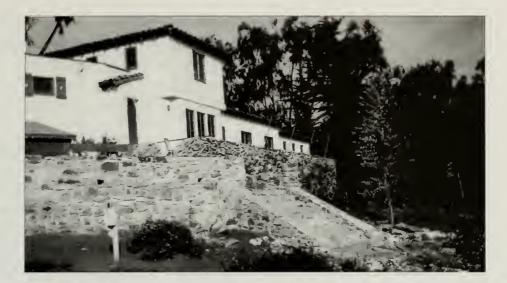
Figure 23. View of the north side of the clubhouses showing new terrace and stairway built by the CCC, 1935. The new features are in the foreground and the original wall and steps constructed in 1928 are of the darker stone behind the new steps. (NARA, RG79.)

clubhouse terrace, and stairs descended at the southeast end, providing convenient access to the first tee. Over the winter of 1935, the CCC built new walls that created a lower terrace at the southeast end of the original wall. The original steps, instead of leading down to the ground level, led onto this lower terrace. A new flight of steps descended from this lower terrace to a walkway below the wall (Figure 23 and Drawing 3).

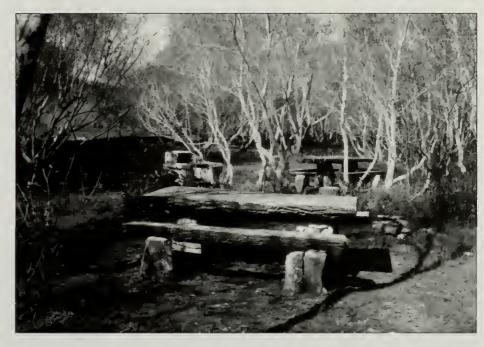
Figure 24. View of the camp furnishings constructed at Chorro Willows, 1935. The furnishings at Chorro Willows were similar to those built at the beach-front picnic area, but had a more rustic character. The tables, shown here along with a cook stove, featured split log tabletops and benches. (NARA, RG79.)

area was also constructed at Chorro Willows, including stone and log picnic tables and stone cook stoves (Figure 24). Compared to the site furnishings found at the beach, however, the Chorro Willow tables and cook stoves were more rustic in character. The tables featured half-round logs for tops and benches and the cook stoves were smaller and less formal. Inspection and progress reports from the period comment repeatedly on the charm of the Chorro Willows area as the campground developed.

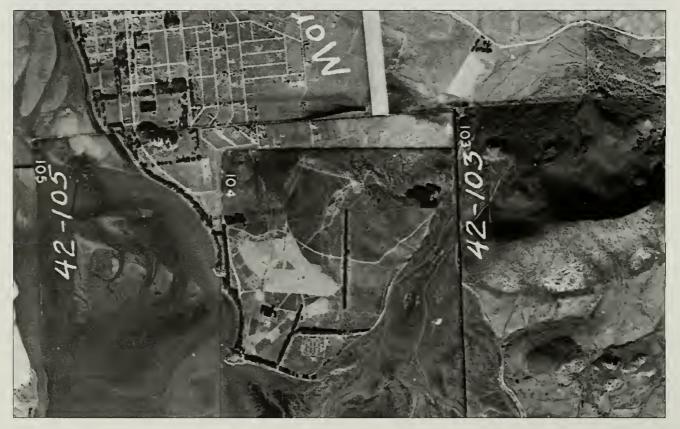
Figure 25. Aerial photo showing the CCC camp enclosed in the hedgerows in the bottom center, as well as the golf course under rehabilitation, 1937. The golf course rehabilitation was started by the WPA in 1935 and 1936 and completed by the CCC. (University of California Santa Barbara (UCSB) Map and Imagery Laboratory, AXH-1937.)

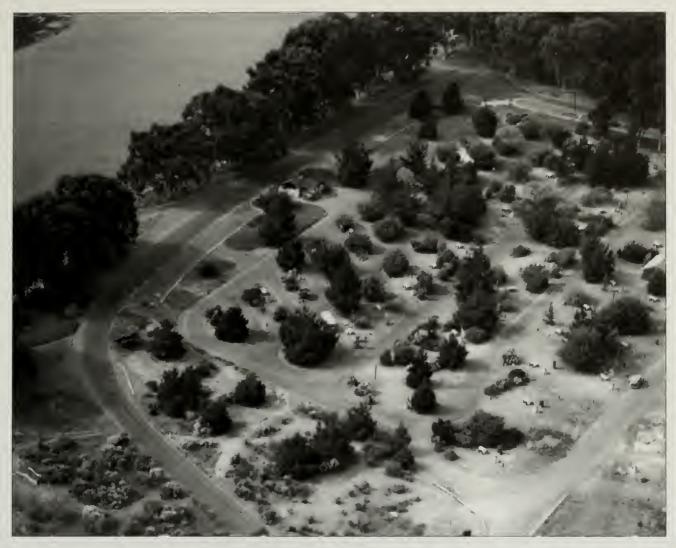
Figure 27. Aerial photo from 1948 showing the Monterey pines, Monterey cypresses, and shrubs that were planted by the CCC in the campground in 1938. (Image on file at Morro Bay State Park Archives.)

locker. Vegetation planted within the campsites consisted primarily of pine and cypress seedlings (*Pinus radiata* and *Cupressus macrocarpa*, respectively) and shrubs such as Catalina cherry (*Prunus lyonii*) (Figure 27).

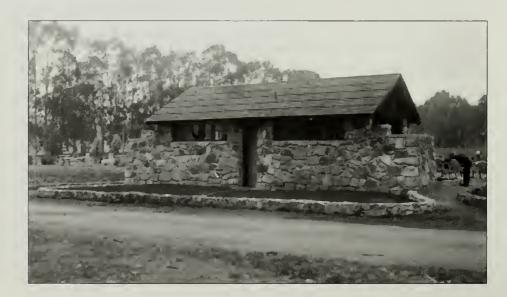
Figure 28. View of the completed combination building on the south side of the campground, 1938. (NARA, RG79.)

stone with large, exposed timber rafters, wood shingle roof, and rustic doors, the 630-square-foot tee-shaped building accommodated men's and women's restrooms, showers, wash stations, and storage (Figure 28). The locally quarried stone matched the stone used for numerous other features in the park, including walls, curbing, gutters, the entrance pillars, and the campground furnishings, creating a unified aesthetic that blended with the landscape of native vegetation and views of the surrounding area.

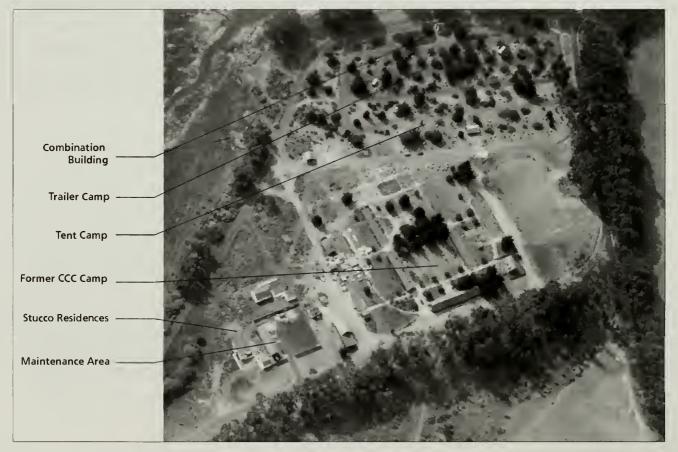
Figure 29. Aerial photo showing the layout of the campground and former CCC camp, 1948. The photo shows the changes made in the late 1940s, including the new combination building, new entrance and contact station on the west (left), and stucco residences. All but two of the CCC buildings have been removed, and the maintenance area has been fenced and surfaced. (Image on file at Morro Bay State Park Archives. Annotations by OCLP, 2010.)

Following the war, the park endeavored to expand the campground and bring it up to date, reversing some of the impacts of the military use of the site. Between 1945 and 1950, most of the buildings associated with the CCC camp and additional structures constructed by the military were removed. By 1954, only one of the CCC barracks buildings remained, which was being utilized as a group camp site. In 1947, two new residences for park employees were built just west of the former CCC camp near the maintenance area. The modest stucco bungalows each featured a double garage. The maintenance area was expanded to include a six-bay garage opposite the workshop, a gas pump, lumber shed, and pipe rack, all enclosed with a board fence and surfaced with plant mix bituminous paving (Figure 29).²⁸

The first improvements to the campground began toward the end of the 1940s. A new entrance was constructed on the east side of the campground from the main park road. The original entrance on the southwest corner of the campground was retained as an exit. A small contact station that doubled as a park office was built in the median of the new entrance, providing a place to collect fees and provide information. A second combination building, Combination Building #2, equipped with restroom, shower, and cleaning facilities was built on the north side of the campground opposite the original combination building.

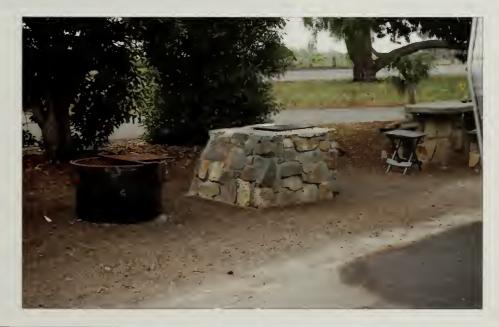
Figure 33. A group of campground furnishings including a metal fire ring. (OCLP 2009.)

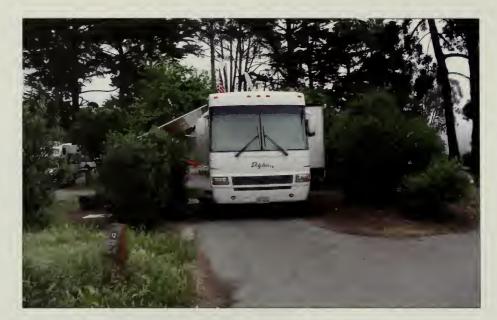
Figure 34. View looking north showing one of the original pull-through trailer sites. The photo shows the narrow pull-through parking space and the mature vegetation screening the campsite. (OCLP 2009.)

This arrangement dictates the direction that a trailer must pull into the site (Figure 34).

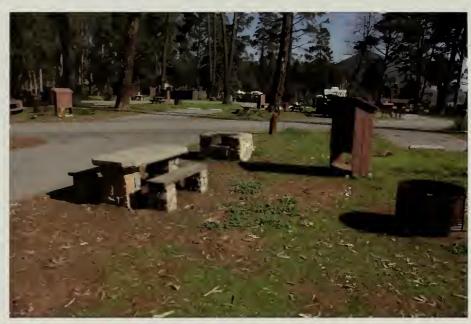
Figure 35. A typical campsite group in the spur parking area of the campground comprising a stone picnic table, stone cook stove, metal fire ring, and wooden food cupboard. (OCLP 2009.)

third loop are larger and further apart than in the first two loops (Figure 35). Two combination buildings are located in this loop, one on the eastern edge and one on the interior of the western end.

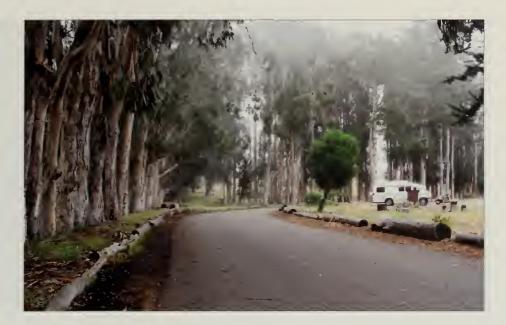
Figure 36. View looking north from the campground access road. The access road is wider than the loop roads and is lined with log barriers for much of its length. Note the lack of vegetative screening between the campsites on the right and the access road. (OCLP 2009.)

The four loops are connected by an access road that enters the campground from the southwest and proceeds along the western side of the first three loops before curving east and then north between the third and fourth loops. The access road exits the campground to the north toward the group campsites (Figure 36). On the eastern side of the campground is the trailer sanitation loop and an administrative area with maintenance, office, and residential buildings. The administrative area and the group campsites are outside of the campground study boundary.

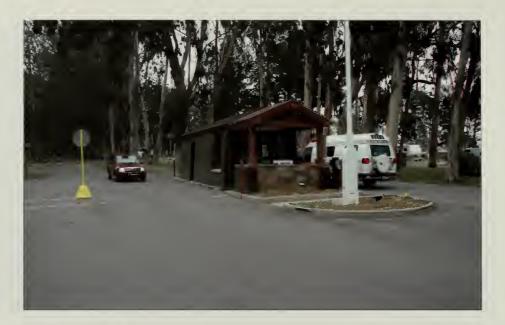
Figure 37. View looking north showing the contact station and entrance circulation. (OCLP 2009.)

The vehicular circulation in Morro Bay State Park Campground is provided by the system of loop roads, connecting access roads, and parking spaces. The main access to the campground is from State Park Road, which wraps around two sides of the campground on the south and east. The campground entrance on State Park Road just west of the campground leads to the wide campground entrance drive. The entrance drive is a serpentine road five hundred feet long and thirty-four feet wide that is designed to allow large camping vehicles to queue during busy times. After passing the campground contact station located on an island in the middle of the drive, the drive splits around an oval median dividing traffic into two one-way roads that separately intersect the campground access road forming a separate entrance and exit (Figure 37).

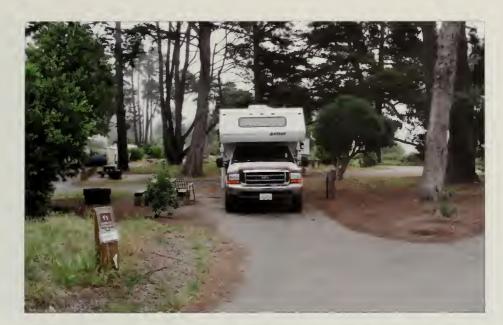
Figure 38. A typical pull-through trailer site in loop 1. This site, one of the original twenty trailer sites, is narrower, at eight feet, than the newer pull-through sites, which are ten feet wide. (OCLP 2009.)

Parking is provided for each campsite with either a pull-through parking space that connects two parallel roads or an angled spur parking space. The pull-through spaces are eight feet wide and seventy feet long in the first two rows, and ten feet wide in the third row (Figure 38). Three of the pull-through spaces in the third row are designated as ADA accessible and are double-width at twenty feet (Figure 39). The angled spur spaces vary in width and length, accommodating between one and three vehicles each (Figure 40). Angled or perpendicular parking

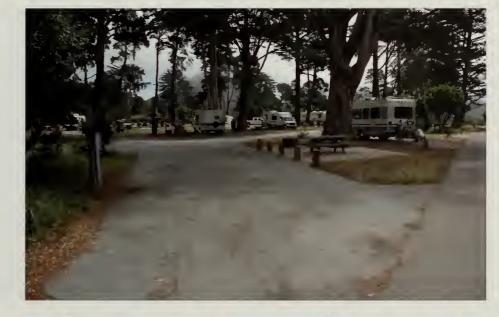
Figure 39. View looking north showing one of the newer pull-through trailer sites. This site is one of the ADA accessible sites which features an extra-wide parking space, a concrete pad under the picnic table, and timber bollards separating the parking from the campsite. The ADA accessible sites do not feature stone picnic tables or stone cook stoves. (OCLP 2009.)

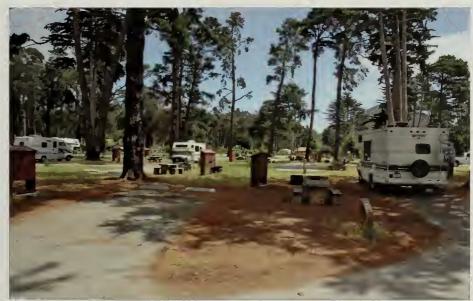
Figure 40. A typical angled spur parking space with concrete curbs. (OCLP 2009.)

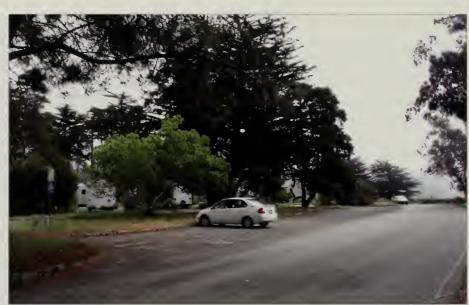
Figure 42. View looking east showing the parking along State Park Road showing the stone curbs. (OCLP 2009.)

is also provided at the contact station, in a parking area in loop 3, and in three parking areas along State Park Road (Figures 41 and 42).

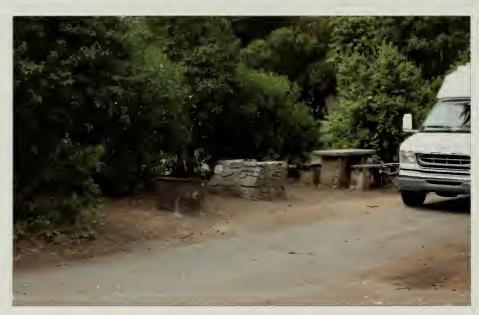
Figure 46. View of one of the original twenty pull-through trailer sites showing mature screening vegetation. The practice of using vegetation to screen and enclose campsites is consistent with the principles of rustic campground design as it was practiced in the 1930s. (OCLP 2009.)

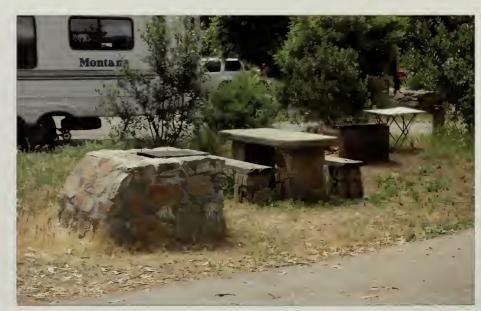
Figure 47. View of one of the pull-through trailer sites showing smaller shrubs that provide inadequate screening. The RV in the adjacent campsite is clearly visible. (OCLP 2009.)

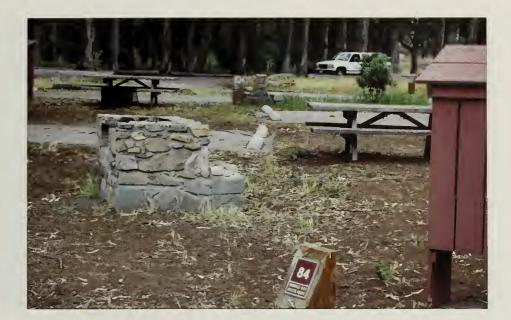
Figure 48. View of spur campsites in Loop 2 looking west. The lack of shrub vegetation makes the campsites feel close and crowded and reduces privacy and a naturalistic camping experience. (OCLP 2009.)

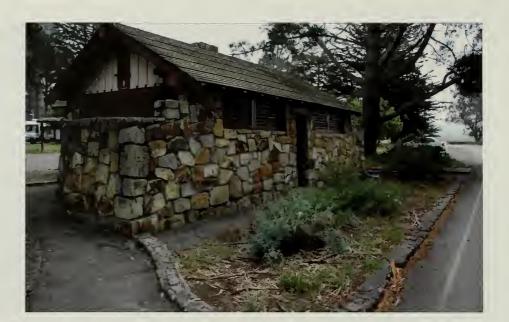
Figure 50. View looking northeast showing Combination Building #1 built by the CCC in 1938. (OCLP 2009.)

The campground contains six major buildings: five combination buildings and one comfort station. The southernmost combination building, Combination Building #1 (Figure 50), is a stone structure built in 1938 by the CCC. The building is located at the southern side of loop 1 between it and State Park Road. Combination Building #2 (Figure 51), on the north side of loop 1 between it and loop 2, is a wooden structure built in the 1940s. Three additional combination buildings in

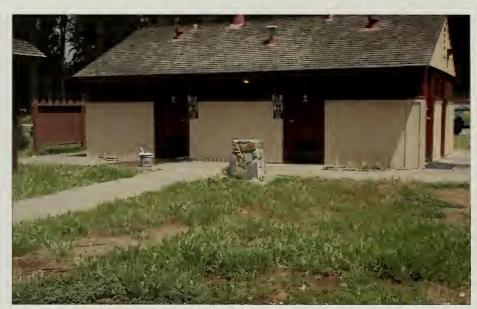
Figure 51. View looking north showing Combination Building #2 built around 1947. The stone drinking fountain was likely built at that time or shortly thereafter. (OCLP 2009.)

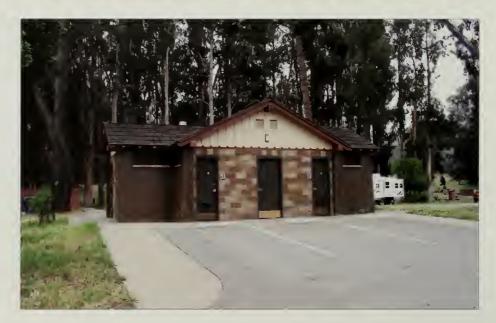
Figure 52. View looking northwest showing Combination Building #4. Combination Buildings #4, #5, and #6 were all built during the 2003 campground rehabilitation and are of identical designs. (OCLP 2009.)

the campground are of more recent construction, built of poured concrete and concrete modular unit (CMU) walls (Figure 52). All five of the combination buildings provide restroom and shower facilities for campground visitors. The comfort station, the only one built within the campground, was originally built in the 1950s to provide restrooms for the picnic areas (Figure 53). Today it is not in service as a visitor comfort station and is used as park storage.

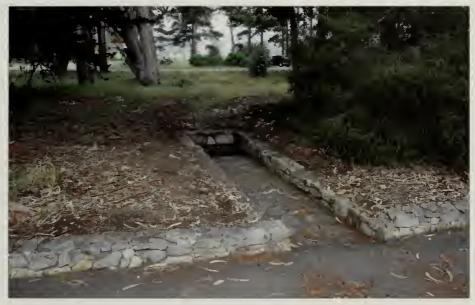
Figure 55. View of the stone curb at the southern end of the campground. The stone curbs originally lined the campground entrance road, as well as the parking on State Park Road and the walkways around Combination Building #1. (OCLP 2009.)

In the southwestern corner of the campground are several lengths of stone curbing built by the CCC in 1937. In all there are a little over a thousand lineal feet of curb along the loop road in loop 1 and along the parking areas on State Park Road. There is also stone curbing along the walkways around Combination Building #1. Integrated into the stone curbing in the southwest corner of loop 1 is a stone gutter and drain (Figures 54 and 55).

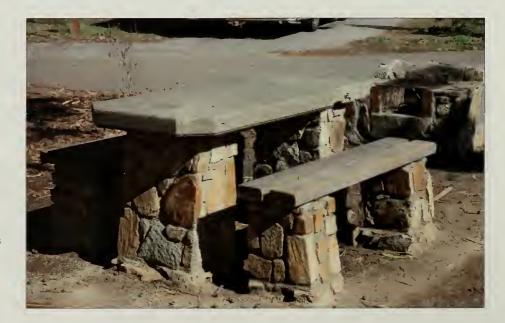
Figure 56. One of the stone picnic tables built by the CCC in 1937. Of the forty-eight original tables, forty-two remain today. The tables are constructed of stone pedestal bases, a cast concrete table top, and timber bench tops. (OCLP 2009.)

The function of the campground is accommodated by a large number of small-scale features, both historic and non-historic. Most prominent of these are the stone features: the picnic tables and cook stoves (Figure 56). There are forty-three stone picnic tables in the campground, all located in the southern half of the campground. The tables are constructed of stone pedestal bases with cast concrete tabletops and wooden bench seats. The stoves, approximately seventy in all, are of a variety of slightly different styles. All of the stoves are of substantial stone construction and are about two feet high and between three and six feet on a side. The stoves feature a rectangular fire boxes with metal barbecue grates (Figures 57–59).

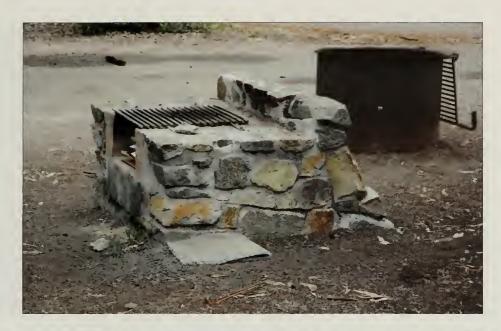
Figure 57. View of one of the stone cook stoves. The stone cook stoves reflect a number of similar but slightly different designs. This one features a small ledge along the back and a battered rear elevation. None of the cook stoves are of the design believed to be in the campground in the 1930s. (OCLP 2009.)

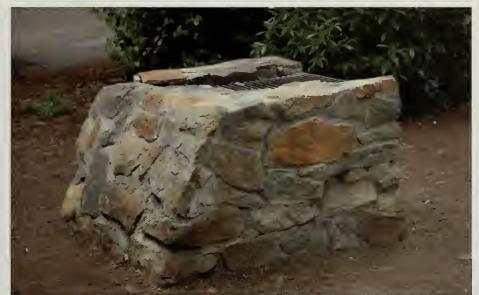
Figure 58. View of one of the stone cook stoves showing one of several designs within the campground featuring a battered rear elevation and a flush top. (OCLP 2009.)

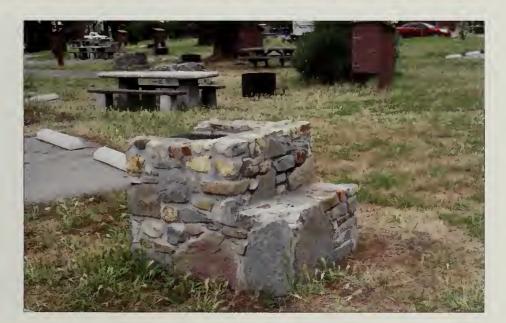
Figure 59. View of one of the stone cook stoves featuring a blocky design with vertical sides and a pot ledge on the back. (OCLP 2009.)

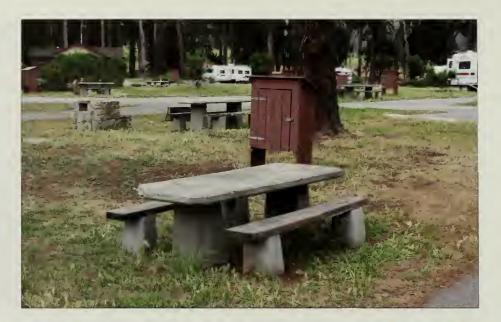
Figure 60. One of the concrete picnic tables constructed in the 1940s and 1950s. The tables are similar to the stone tables, but with concrete pedestal bases instead of stone. The single timber board used as the bench seat more closely reflects the historic condition of both the concrete tables and the stone tables than the two-board seats currently on many of the tables. (OCLP 2009.)

In addition to these stone features are a number of other campground furnishings, including concrete and wooden picnic tables, wooden food cupboards, and metal fire rings (Figures 60 and 61). Natural objects, primarily eucalyptus and pine logs, are positioned along the roadsides throughout the campground to help contain vehicular traffic within the roadways.

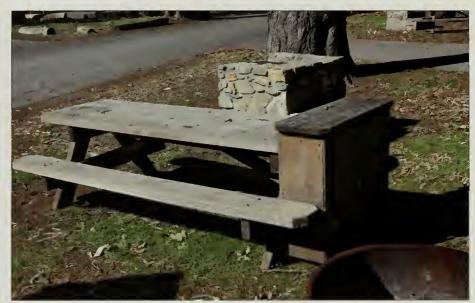
Figure 61. View of one of the wooden picnic tables with the built-in wooden food cupboards on the end. Date of construction of the wooden tables is unknown. (OCLP 2009.)

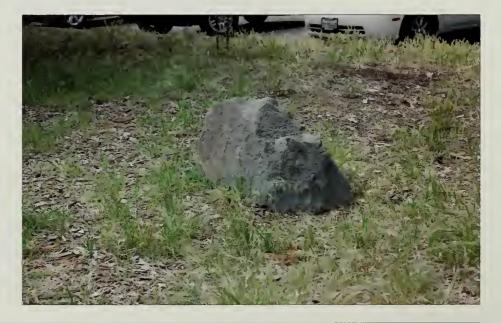
Figure 66. Large rocks, such as this rock located near Combination Building #1, may be used as barriers to control circulation or to protect vulnerable features. (OCLP 2009.)

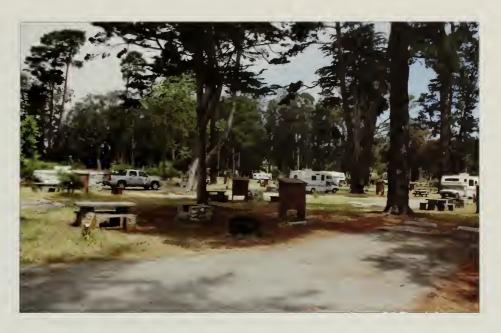
Figure 67. Mature canopy trees, such as these Monterey pines and Monterey Cypresses, help create the essential historic character of the campground, but also present hazards to visitors below. Mature trees should be carefully monitored and pruned for health and safety. If trees need to be removed, they should be replaced in kind and in location. (OCLP 2009.)

The mature canopy trees in the campground were planted either by the CCC in the 1930s or during the 1940s and 1950s. While these trees were little more than large shrubs in 1939, they quickly grew into an overhead canopy, providing shade and a sense of enclosure to the formerly open area. The high canopy and tall vertical trunks have since contributed strongly to the campground's character (Figure 67).

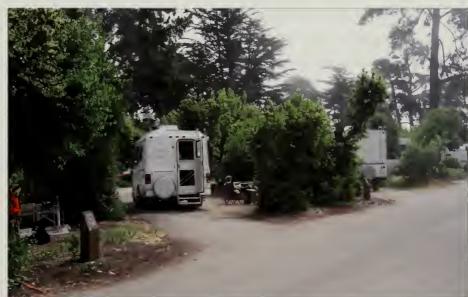
Figure 69. Mature shrub vegetation is an essential element of the campground's historic character. Maintain the shrubs through appropriate pruning and other techniques to encourage health and vigor. (OCLP 2009.)

Many of the shrubs in the campground are of advanced age and may date as far back as the CCC period. The first twenty pull-through trailer sites in particular feature several large old shrubs that help enclose and screen the campsites (Figure 69). The older shrubs are vigorous and in general are in good condition. These

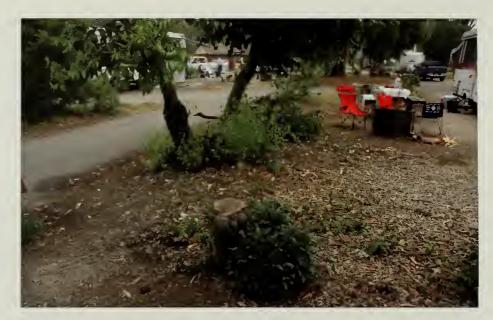
Figure 70. Many of the shrub species have a tendency to sprout from the base when pruned hard. When shrubs become leggy or their crowns begin to fail, prune them to encourage basal sprouts to reestablish screening function. (OCLP 2009.)

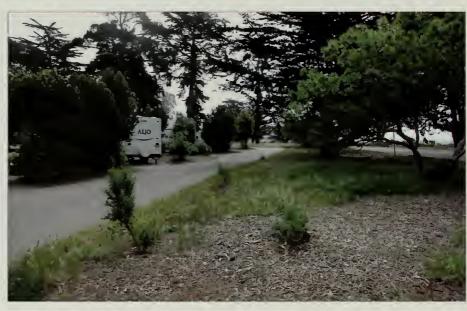
Figure 71. Many of the more recently planted shrubs are struggling to become established. Take the appropriate actions to ensure the shrubs' success, including protection, irrigation, and additional planting. (OCLP 2009.)

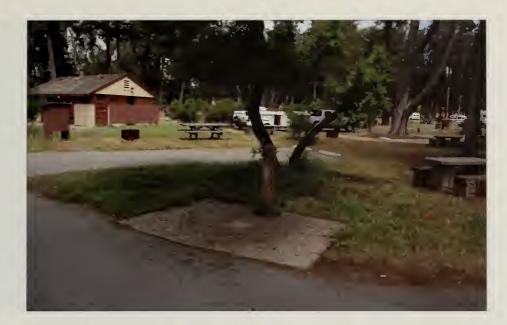
Figure 72. Many of the campsites abut public areas and utility features, such as this water spigot. Plant vegetation to screen campsites from common areas. (OCLP 2009.)

While the southern portion of the campground features numerous shrubs to screen the campsites, the northern portion features fewer, more widely spaced shrubs and exhibits a more open quality. This makes the campsites open to each other, reducing privacy and increasing a perception of crowdedness. Extensive planting of new shrubs throughout the northern half of the campground, particularly in loops two and three, can help create a sense of enclosure and privacy, promoting a naturalistic camping experience (Figures 72 and 73).

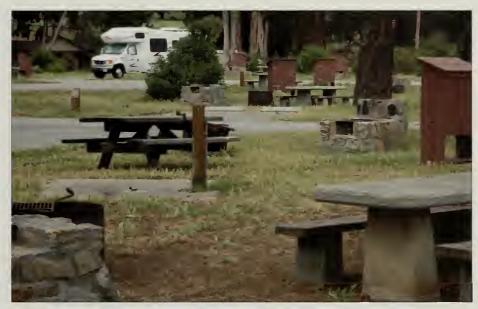
Figure 73. Plant shrub vegetation to define and enclose campsites and to screen them from adjacent sites. (OCLP 2009.)

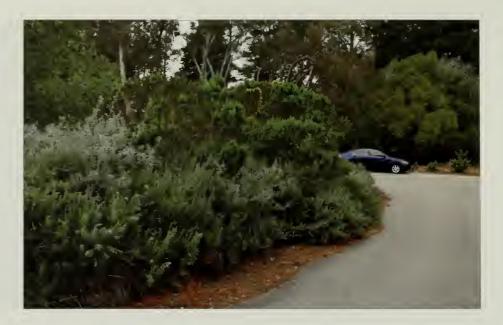
Figure 74. View of an appropriate mixed native planting located in the administration area. Plant native shrubs in mixed groups along roadsides, between campsites, and around structures. (OCLP 2009.)

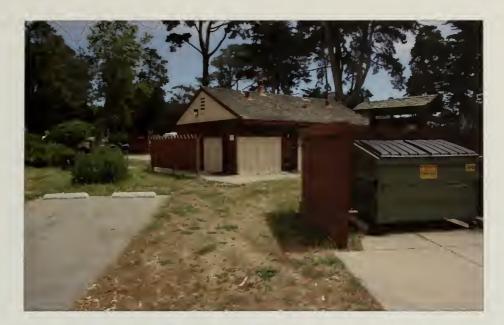
Figure 75. Plant vegetation around structures and along the faces of fencing. Such vegetation is intended to completely obscure the structures, but to break up their mass and the vertical surfaces. (OCLP 2009.)

In addition to planting groups of shrubs in open areas between campsites, shrubs should be placed around structures and utility features to screen them and break up their large mass. Plant shrubs along the foundations of larger structures like combination buildings, wooden fences, and dumpsters (Figure 75). Plant shrubs in small clusters close to water bibs to help screen them from campsites while not obscuring them completely. For smaller utility features that do not need to be visible to visitors, plant shrubs so that they are more entirely screened (Figure 76).

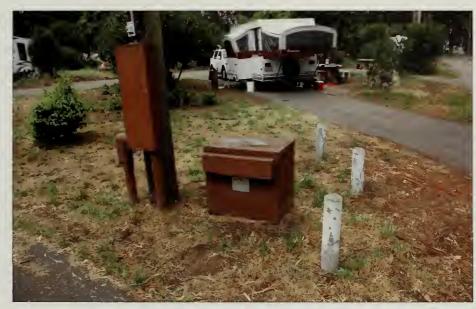
Figure 76. Plant vegetation around utility structures. Structures that do not need to be visible to visitors may be more completely enclosed by vegetation. Use natural features, like rocks and logs, to protect utilities from vehicles. (OCLP 2009.)

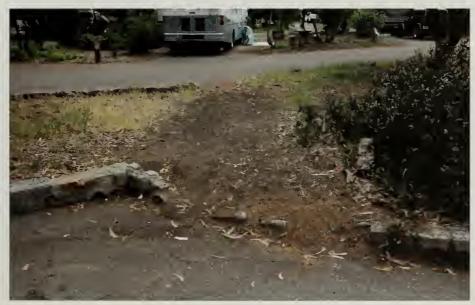
Figure 78. View of curb damage at the southern end of the campground. (OCLP 2009.)

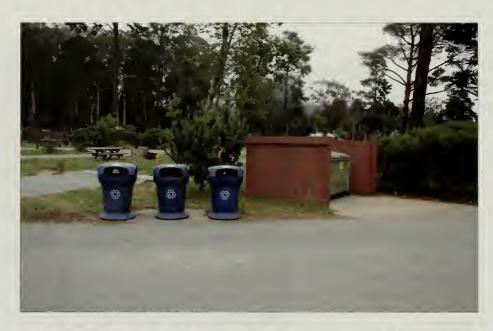
Figure 79. The numerous necessary dumpsters and recycling receptacles create a cluttered appearance and detract from the historic character of the campground. (OCLP 2009.)
