23 PRESERVATION BRIEFS

Preserving Historic Ornamental Plaster

David Flaharty

U. S. Department of the Interior
National Park Service
Cultural Resources/Preservation Assistance

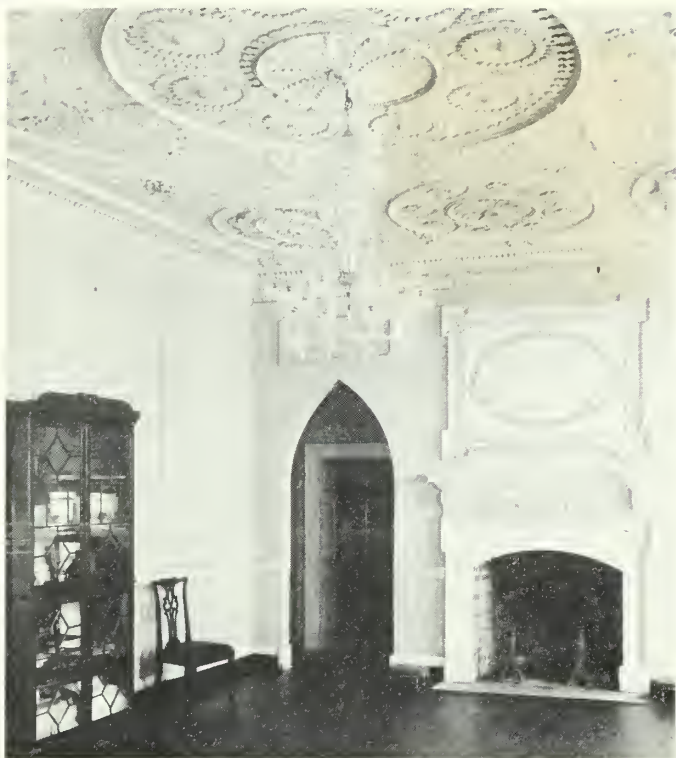
(a) **Kenmore, Fredericksburg, Virginia, c. 1752.** Georgian in style with ornamental ceilings based on Batty Langley's 1739 English style book, the plasterwork was executed by a Frenchman in the mid-1770s. This house was built by Col. Fielding Lewis and has the most elaborate ornamentation of any in the period. *Photo: Historic American Buildings Survey Collection.*

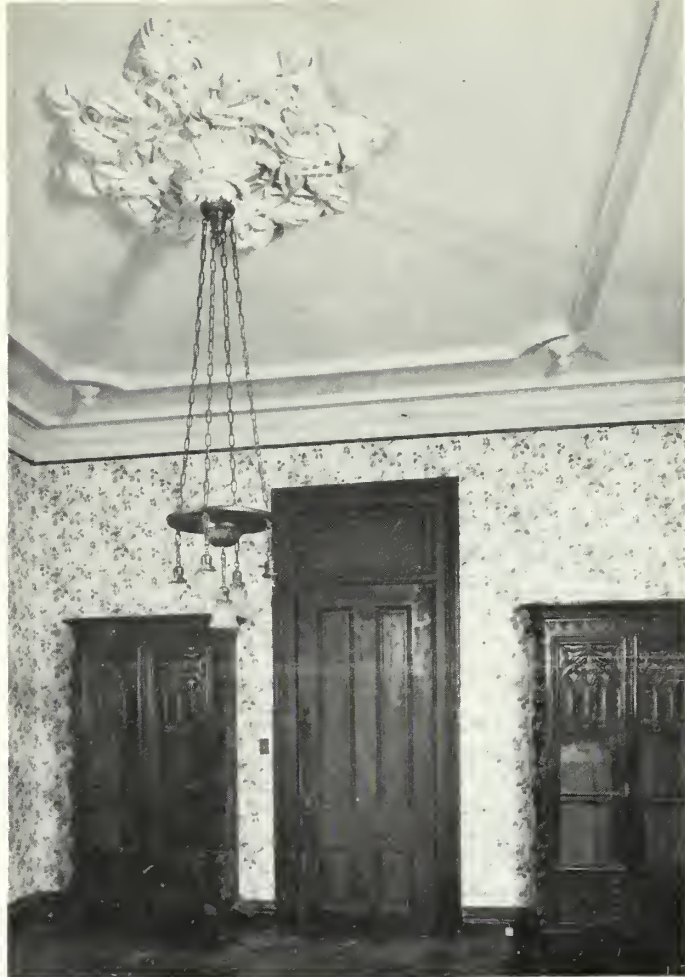
Fig. 2. This parlor medallion and pendant drops shown in a mid-19th century row house in Annapolis, Maryland were originally ordered from a catalog. A local plasterer ran the plain cornice and band ribbon, the curved corners of which were bench run, set with a plaster adhesive and pointed at the joints. Photo: M. E. Warren.

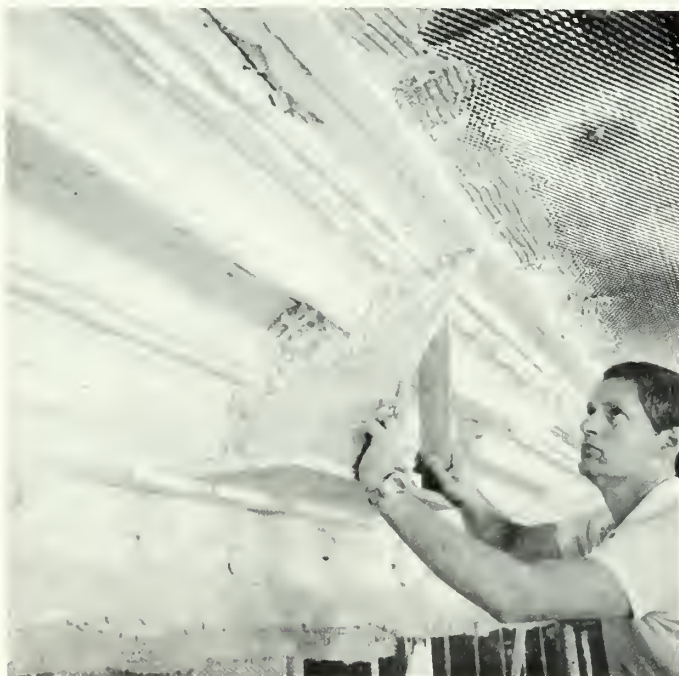
Fig. 4. Running a Cornice. The historic method of producing a cornice is unchanged today. A running mold or template is pushed along a lattice strip nailed to the wall. Base coat plaster is gypsum and sand; finishing plaster is added with small tools and stuffed wearing rubber gloves because lime burns the skin. As many as 20 passes are required to complete a smooth run; this particular cornice was formed in two stages, top and bottom, because it was so large. Cornices this size also have to be blocked and lathed to minimize the amount of applied material. Photo: Old-House Journal.

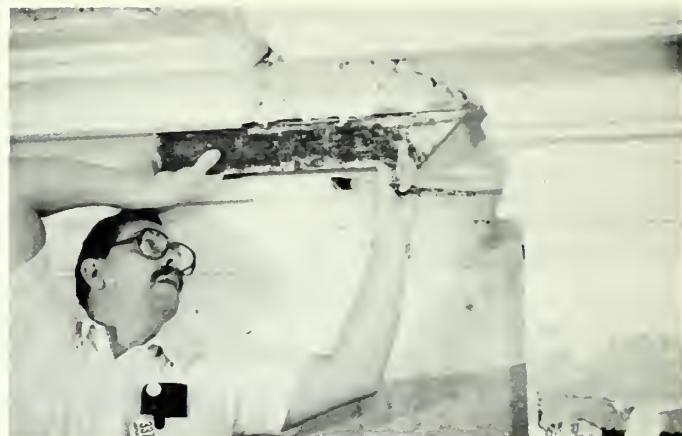
Fig. 5. Mitering a Plain-Run Cornice. Mitering requires great dexterity using the miter rod. In this case, a return at a chimney breast is tooled using an infill of gypsum and lime. Internal and external miters are required with the internal being the most difficult. Another method is to run a length of cornice (using the same blade) on a bench and set it in place, later to point the joints. Photo: Old-House Journal.

Short lengths of new cornice are best run on a bench using gypsum and lime; the reproduction molding should be somewhat longer than the required length (see Fig. 18). The new footage is cut and fit in place to match the existing cornice, then securely countersunk-screwed to studs, joists and/or blocking. The resulting joints are pointed with flat mitering rods, flush with adjacent members (see Fig. 5, above).

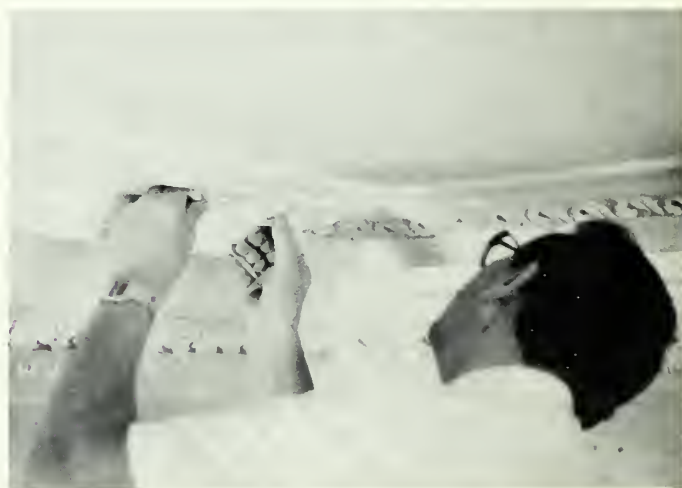
Fig. 6. Enriching a Plain-Run Cornice. After a cornice is run and mitered, cast enrichments are stuck in recessed sinkages planned to receive the casts. Ornamental models are made to engage with one another, resulting in unbroken lines or courses. A shop-cast ornament is soaked in water until saturated and pressed into its sinkage using wet plaster as an adhesive. Once the casts have been installed, they are carefully pointed at the joints and at the miters so that they appear as a continuous, repetitive design. Photo: Old-House Journal.

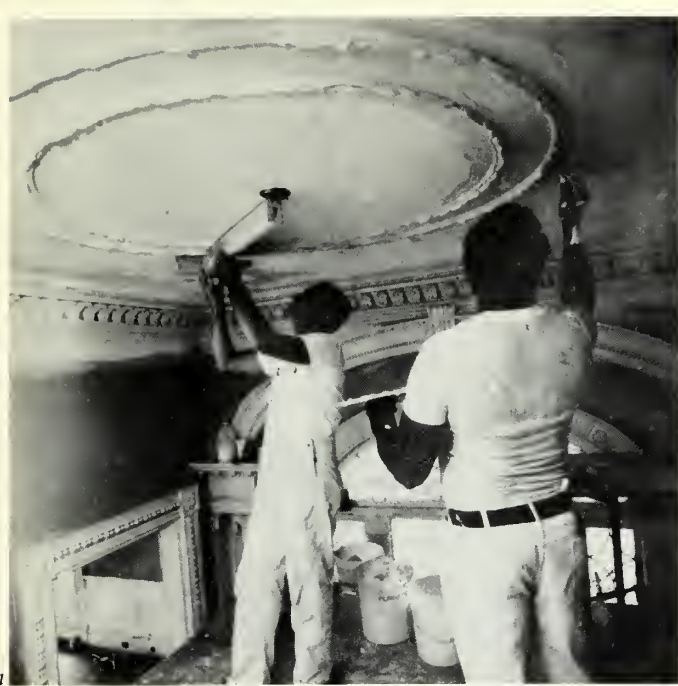
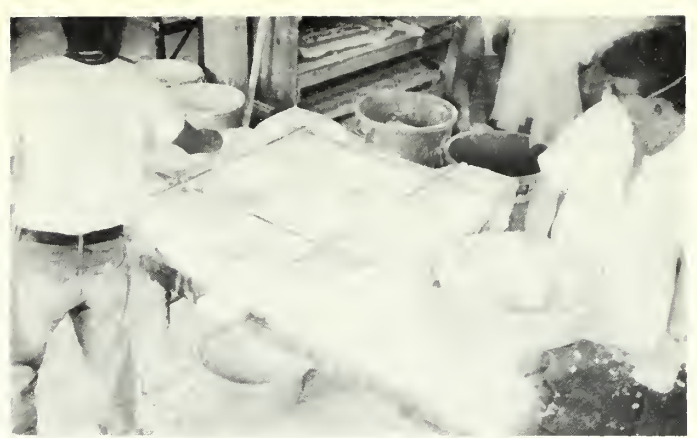
Fig. 8. Casting a Coffering Unit. Ceiling coffers are made the same way today except, historically, a hide glue mold was poured over an ornamental model whereas today urethane molding rubber is used. Now, as then, the plaster casts are made with steel channel irons embedded on the back of each panel. The coffers are hung from carrying irons fixed to the ceiling above by means of twisting wires to level each coffer to its neighbor. Afterward, the panels are fastened together and the joints pointed with plaster. Photo: David Flaharty.

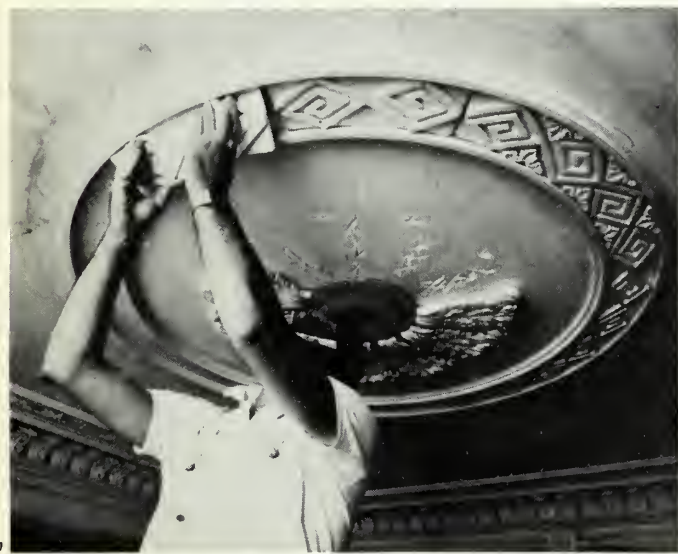
Fig. 7. Running and Enriching a Ceiling Medallion. The method of running and enriching a ceiling medallion remains the same today. (a) First, a plain-run surround is spun from a pivot point centered in the ceiling field. (b) Ornament layout is determined using plane geometric principles; segmented locations are deeply scratched to provide a rough surface for adequate bonding using plaster as an adhesive. Historically, cast enrichments could be bought from local suppliers and set individually, allowing architects to compose medallions to suit room dimensions and period motifs. Photos: Peter Sanders.

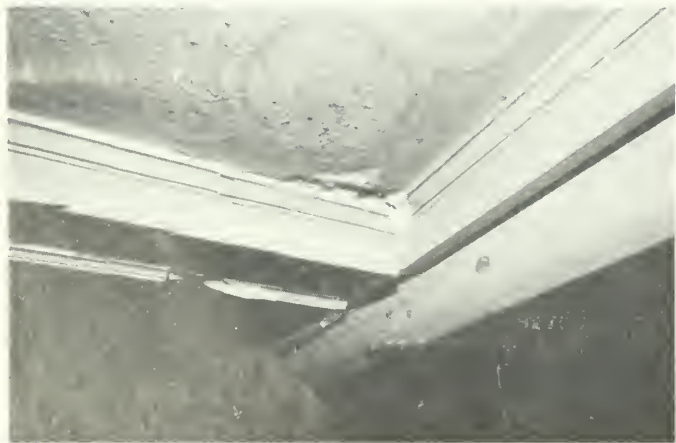
Fig. 10. Structural settling has caused this ceiling to deflect. Prior to restoring the damaged plaster and final repainting, a structural engineer experienced in historic preservation will be engaged to shore-up the ceiling from below and reattach the sagging ceiling plaster with the joists above (see also Fig. 17 under Immediate Action.) Photo: National Park Service files.

Signs of Failure. Failure of the substrate is more typical than failure of the plaster ornament itself. Among the reasons for deterioration, **structural movement** (see Fig. 10) and **water intrusion** (see Fig. 11) are the most deleterious. Buildings move and settle, causing deflection and delamination which result in stress cracking. These cracks often begin at the corners of windows and doors and extend upward at acute angles (see Fig. 12). Roof or plumbing leaks make finishes discolor and peel and cause efflorescence, especially on plain-run or enriched cornices. Unheated buildings with water intrusion are subject to **freeze-thaw cycles** which ultimately result in base coat and ornamental plaster failure (see Fig. 13).

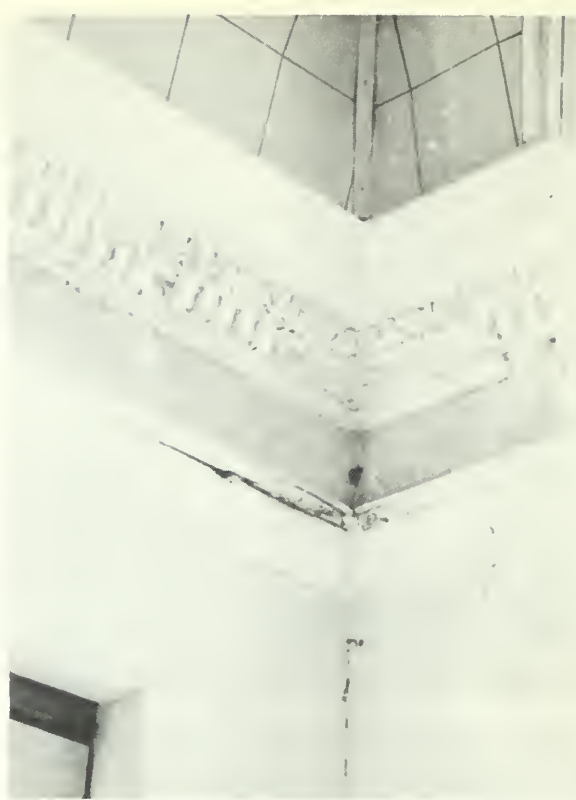
Fig. 11. The cornice of an Iowa courthouse has been severely damaged from a roof leak. In order to repair the ornamental plaster, a thixotropic rubber impression will be taken (with the paint build-up undisturbed). The efflorescence will be removed and fresh plaster casts installed so that egg and dart, dentil and leaf molding are perfectly aligned. Photo: National Park Service files.

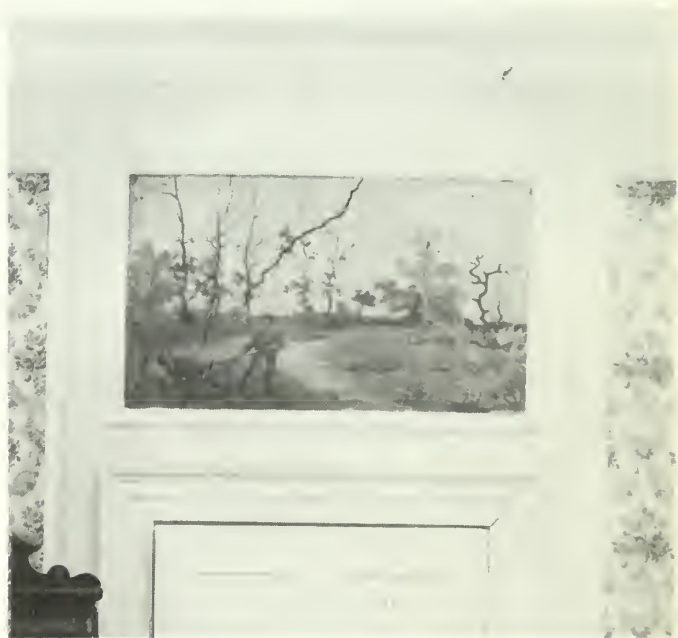
Fig. 12. Settlement caused stress cracking through both flat wall and ornamental plaster. Repairs to the cornice involve chamfering the stress cracks to a "V groove" and patching with a mixture of gypsum and lime. The cornice can be countersunk-screwed to its substrate to prevent further movement. Screw heads are then plastered over. The crack running through the painting will need to be filled carefully, and the painting restored by a trained conservator. Photo: Jack E. Boucher, Historic American Buildings Survey.

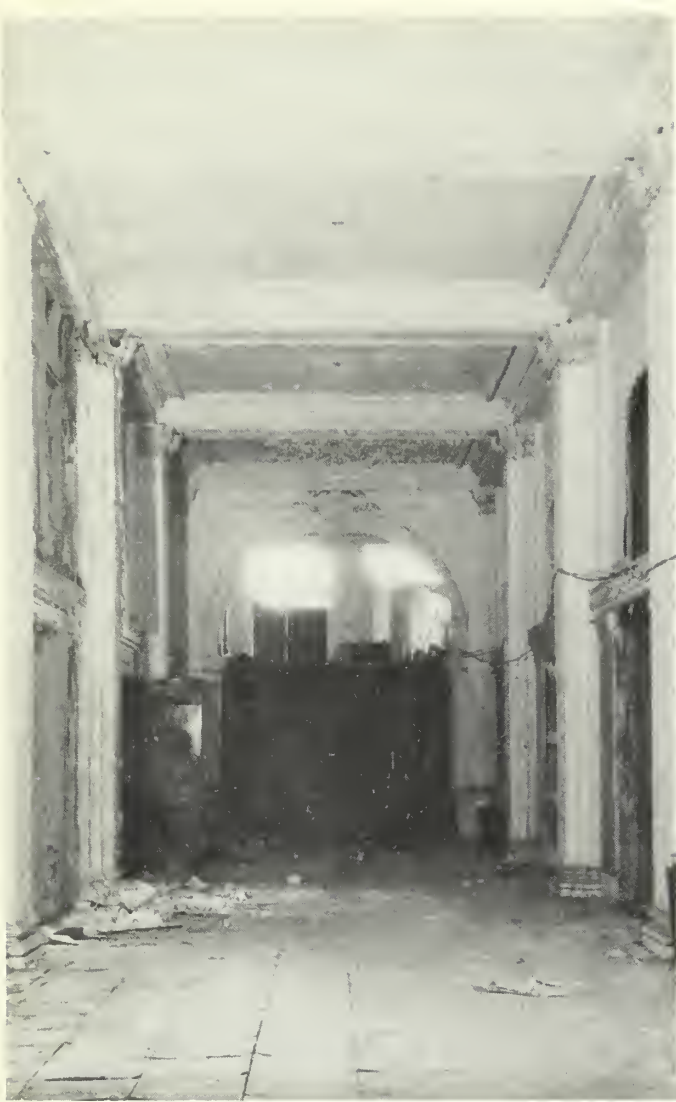
Fig. 13. Water intrusion and freeze/thaw cycles caused extensive efflorescence and ornamental plaster failure. The plaster needed almost total replacement within the rehabilitation project. Photo: Commercial Photographics.

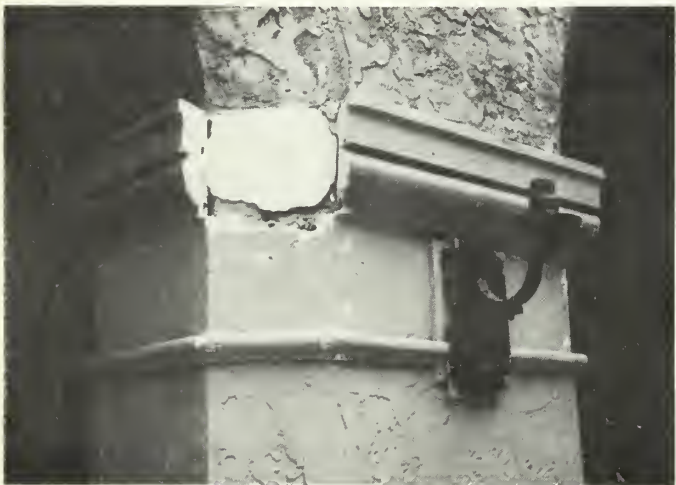
Fig. 14. A mitered portion of this impost capital abacus has fallen, revealing the plaster adhesive material. Repairs are made by obtaining a section through the abacus, making a bench-run length, cutting, fitting, and readhering the missing piece. Finally, the joints are pointed. Photo: Lee H. Nelson, FAIA.

In addition, keying and adhesive properties may be further jeopardized by **weak original mixes** (see Fig. 14) that were improperly applied. Substrate failure typically results from **faulty lathing or rusty lath nails**, causing ceilings to fall. In the 20th century, **vibration** from heavy vehicular traffic, nearby blasting, and even repeated sonic booms may contribute to damaging ornamental plaster. **Inadequate support** in an original design may also be to blame when particularly heavy units have simply broken off over time (Fig. 15). Finally, new mechanical systems, suspended ceilings and partition walls insensitively installed in adaptive use projects, show little regard for the inspired decorations of earlier periods (see Fig. 16).

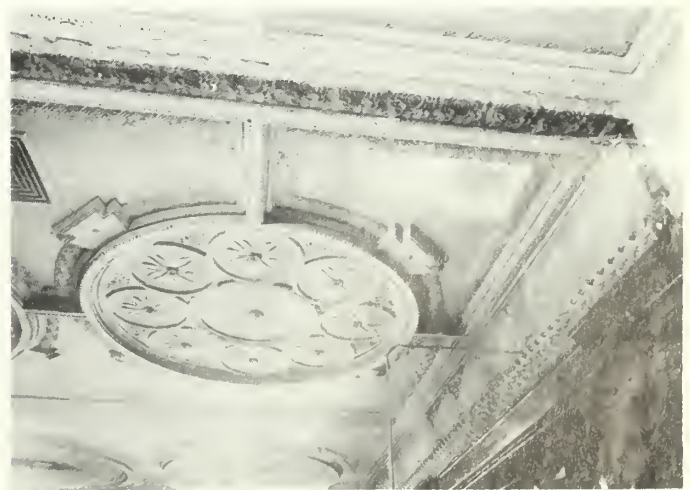
Fig. 16. The Auditorium Building, Chicago, Illinois, 1889, by Louis Sullivan. Earlier insensitive alterations were removed prior to restoration of the room. In the photo, a partition wall has already been removed; the electrical conduit and a ventilation grille followed. Plaster patching and painting were the final steps of restoration work. Photo: National Park Service files.

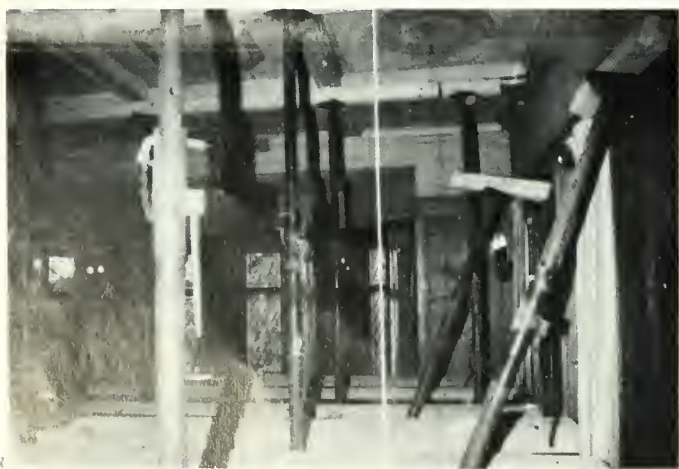
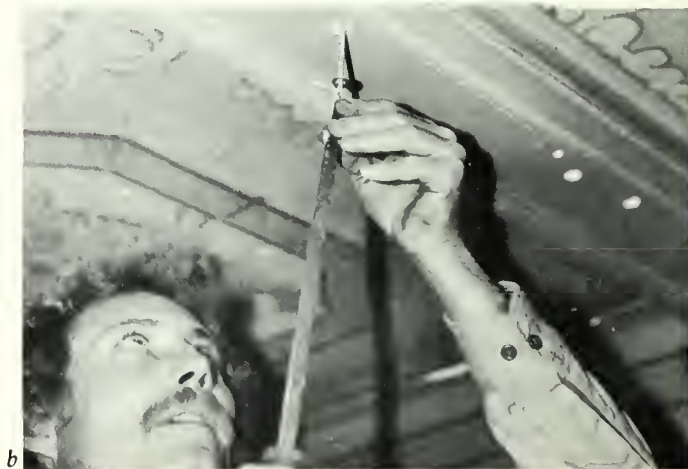
Fig. 17 (a) Where this ceiling was suffering from structural failure, the first step was to shore it up from below. (b) Toggle bolts were used to reattach the plaster molding to the ceiling joists. The ceiling was then patched with gypsum and lime, prior to restoring the significant paint finishes. Photos: National Park Service files.

First, roof or plumbing leaks must be repaired to eliminate the problem of water intrusion. General structural repairs should be undertaken to arrest building movement, which weakens the base coat plasters to which the ornamental enrichments are attached. Ornamental plaster deflection should be corrected by shoring from below followed by re-anchoring (see Fig. 17).

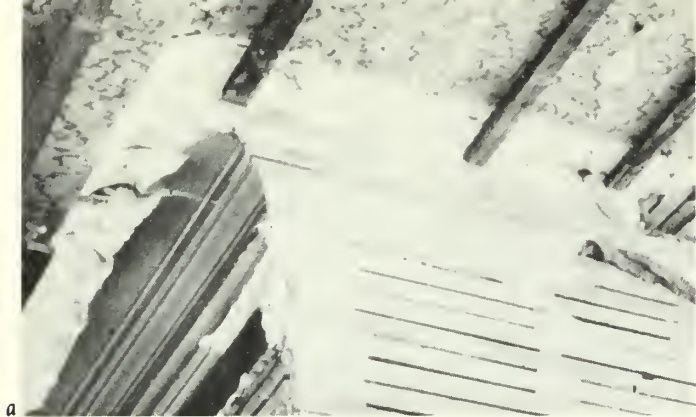
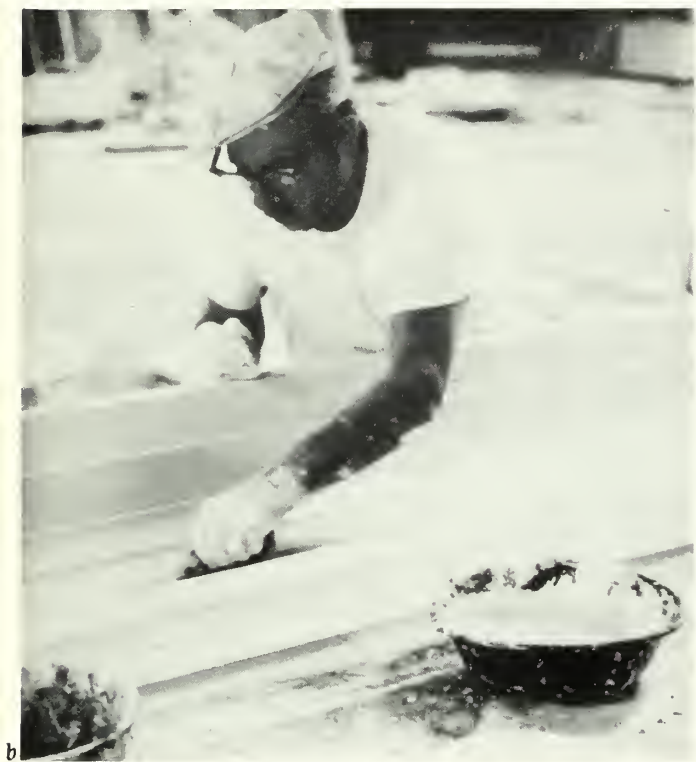
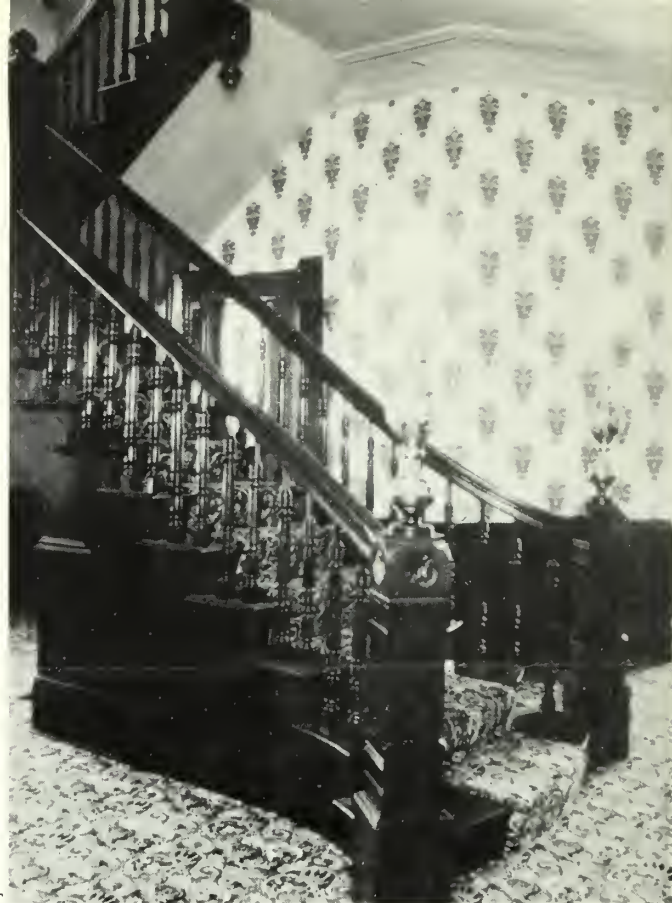
Fig. 18. *Repairing a Cornice.* (a) In the restoration of the Henry Hirshfeld House, a 19th century residence in Austin, Texas, removal of a tin ceiling revealed a damaged plain-run cornice. Photo: John Volz, AIA. (b) A section through the molding was taken, a template blade cut, horsed-up, and run on a bench using gypsum and lime. Photo: Charles E. Fisher. (c) The new cornice was then cut, fitted, and applied to new blocking between wall and ceiling. The external miter and returns were pointed using the miter rod. After the ceiling restoration was complete, other finishes, such as wallpaper, were applied. Photo: Candace Volz.

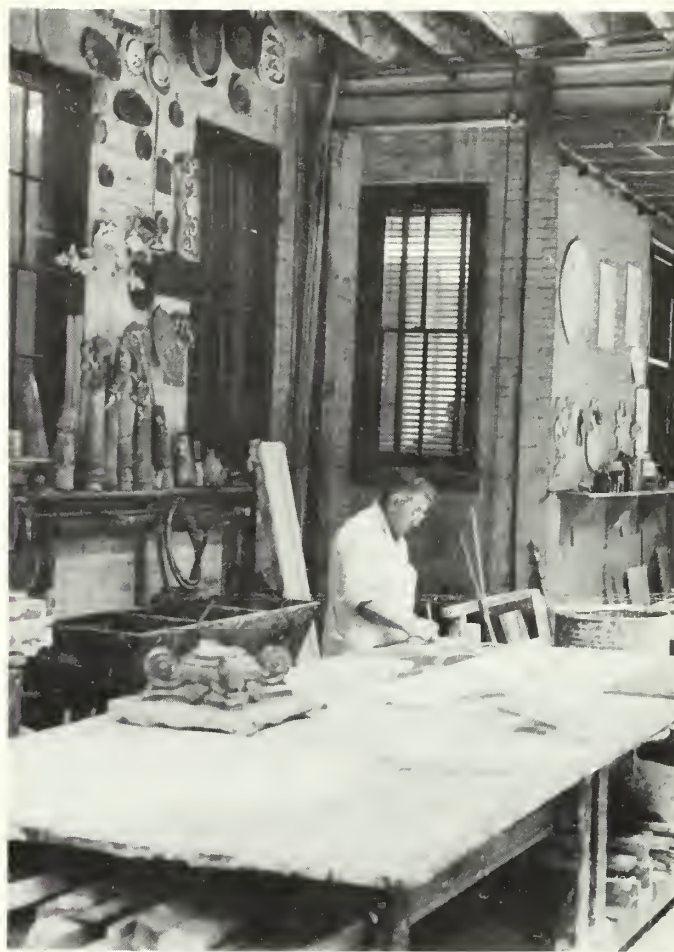
Fig. 24. This plaster studio is well organized, with ample work space. Note the plaster casts hanging neatly on the wall. Photo: Berry and Homer, Philadelphia.

or developer should secure the services of a reputable restoration contractor before proceeding further. It is clear as more and more projects are undertaken, that there is a wide disparity of skills within the trade today. This is partly due to the introduction of gypsum board as a substitute for traditional plastering. As gypsum board became popular after World War II, plasterers saw the demand for their skills decline. Plastering techniques were forgotten because they were often not passed down within shops and families. However, ornamental plaster studios have seen a resurgence in demand for their services in the last decade, particularly as more historic buildings are rehabilitated (see Fig. 24).
