# Characterization and Degradation of Cementitious Materials at Fort Sumter National Monument

Denis A. Brosnan\*, John P. Sanders\*, and Rick Dorrance\*\*

\*Clemson University, Clemson, SC; \*\*Fort Sumter National Monument, Charleston, SC

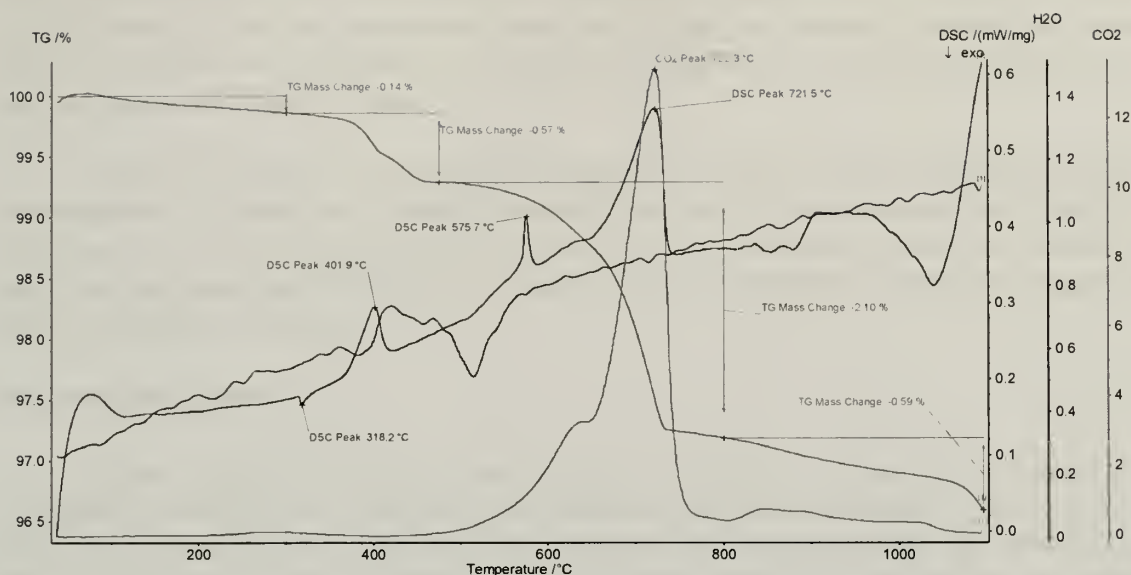
**Figure 1: Thermal Analysis of Contemporary Rosendale Cement**

The thermal analysis of ground natural cement is shown in Figure 1. This Figure contains several results on the same graph making a careful inspection necessary. For example, the green colored line is the weight change on heating (the “TG” axis) providing the percentage of the original weight left at any point in the heating process. The red line provides a measure of carbon dioxide evolution on heating, while the blue and black lines provide information on energy flows and water vapor evolutions respectively.

The thermal analysis provides the following very important information:

1. Low temperature cement dehydration occurs below 500°C implying that the as-ground cement exhibits a content of phases normally expected in set cement after use, i.e. there has been some formation of compounds during the cement in manufacture (as in grinding) and during storage prior to use. These phases may include carbonates and sulfates of the cement constituents.
2. The cement exhibits an endothermic/heat absorbing reaction at 575°C reflecting the presence of quartz "sand" in the cement rock (See also the insoluble residue analysis in Table 1).
3. The cement exhibits a major decomposition of calcium carbonate at 722°C verifying that the cement was burned to an intermediate temperature between the decomposition temperature of magnesium carbonate, a constituent of dolomitic limestone in cement rock, and that of calcium carbonate also present in the cement rock.

Another notable release of soluble material was sulfate at about 5000 ppm, and the decomposition of sulfates may explain the weight loss in the cement below 500°C (Figure 1). The release of soluble metals such as calcium and potassium provide credence to the idea that the initial set/hardening of the cement, in part, is due to atmospheric carbonation processes and the formation of sulfates.

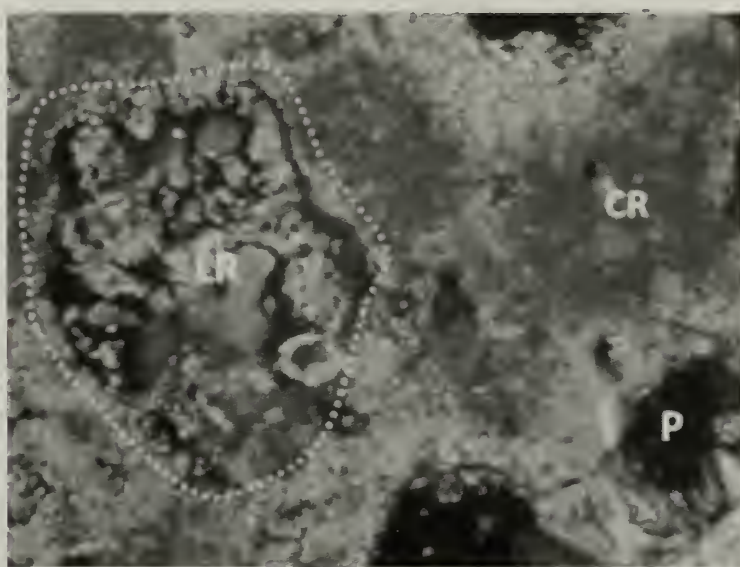
**Figure 2: Typical Mortar Photomicrograph (ca. 150X)**

Petrographic analysis using polarized light microscopy confirmed the presence of Rosendale cement in the historic mortars. A typical photomicrograph is shown in Figure 2 where a Rosendale cement relic (CR) is shown in the field with a lime relic (LR) and porosity (P) in a carbonate matrix.

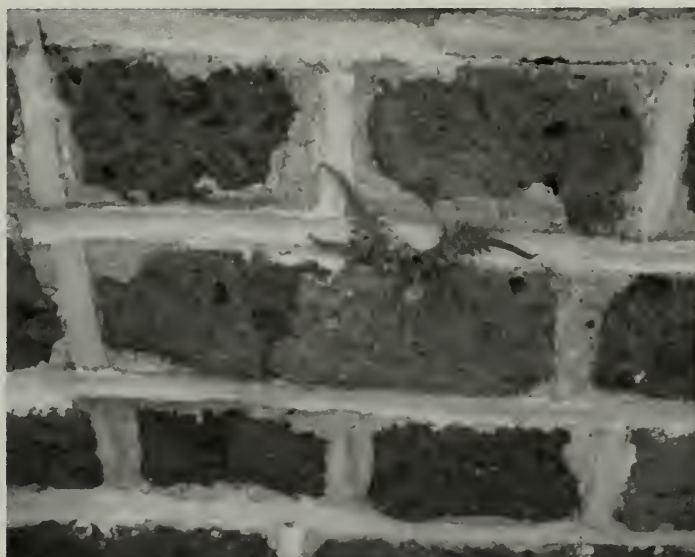
**Figure 3: Salt Scaling On the Lower Fort Walls Pointed with Portland Cement Mortar**

One very interesting finding was salt scaling on the exterior walls of the Fort where there had been pointing repairs with ordinary Portland cement mortar (Figure 3). This is a classic case of “brick scaling” caused by excessive solution of calcium from the repair mortar

in the presence of sea salts. Such scaling is technically known as cryptofluorescence, and the scaling is due to subsurface expansions within the bricks via salt crystallization. Thus, cryptofluorescence is a damaging mechanism to the historic materials, while surface discolorations known as efflorescence are a non-damaging cosmetic defect in masonry.

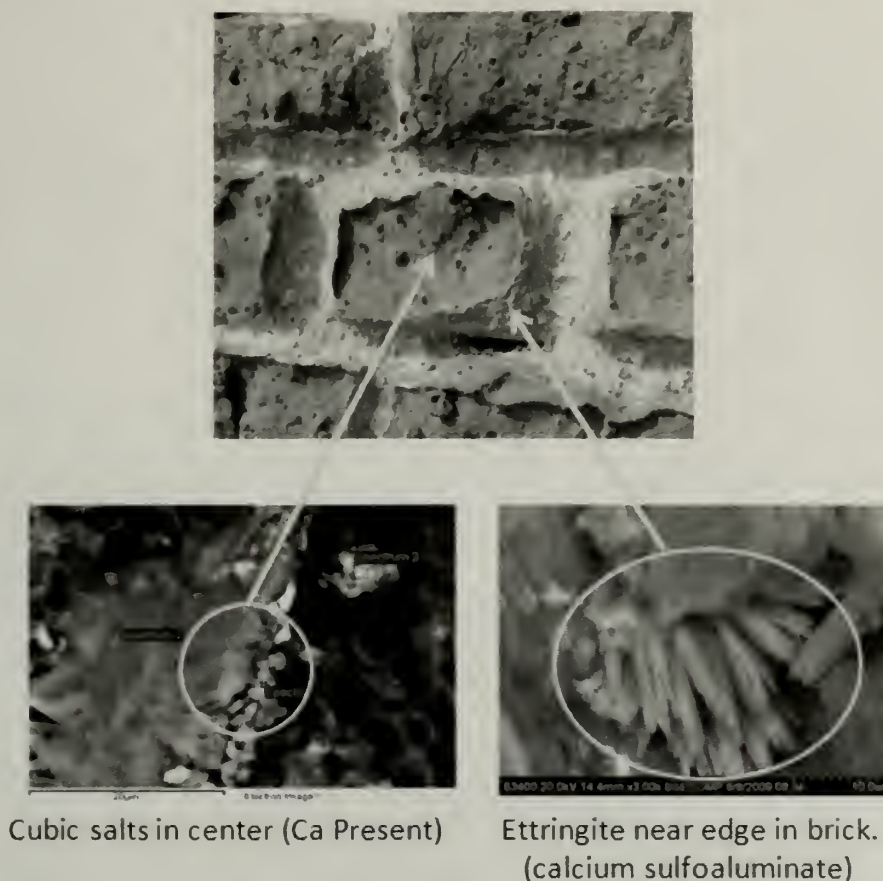
**Figure 4: Cryptofluorescence Failures on Fort Sumter**

A cryptofluorescence failure on the Fort is shown together with scanning electron microscope photomicrographs in Figure 4. On this face of the Fort, the Portland cement pointing mortar used in modern repairs has completely worn away revealing the “pink” colored Rosendale cement-based bedding mortar. The effect of the calcium solution from repair mortar and infiltration into the bricks with moisture is evident in the “cupped shape” of the residual brick. The scanning electron microscope investigation identified the mineral phase ettringite near the periphery of the brick. It is well-known that the formation on ettringite results in expansive forces. This expansion resulted in damage to the historic bricks as shown in the photograph.
